BENARTH ROAD RETAINING WALL, CONWY

Archaeological Watching Brief

Prosiect Rhif / Project No. G2527

Adroddiad Rhif / Report No. 1402

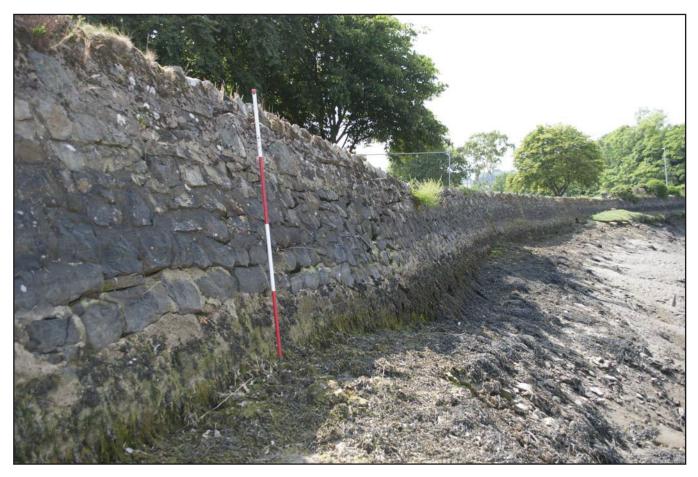
Plate 20: Collapsing section of wall, viewed from the NE (scale: 1x2m, archive image ref G2527_017).

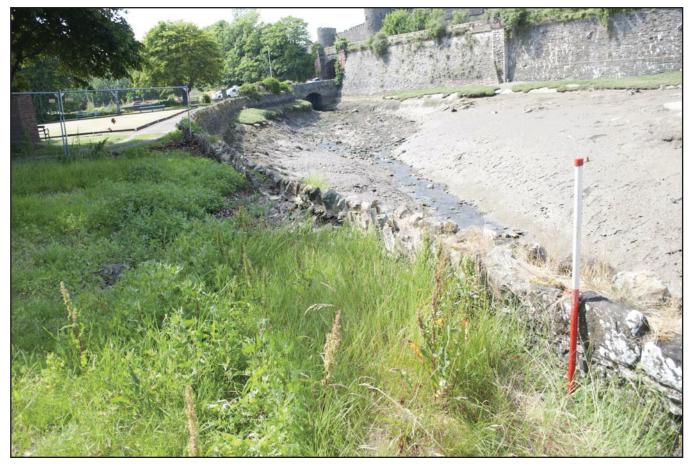
Plate 21: Southern side of collapsing section of wall, viewed from the SE (scale: 1x1m, archive image ref G2527_023).

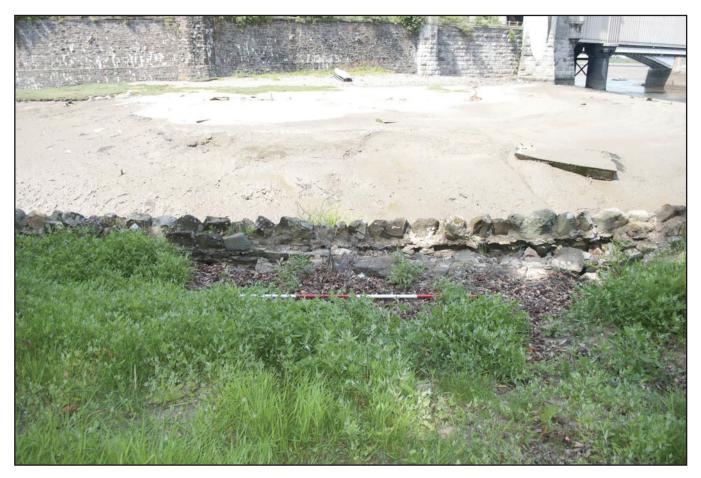
Plate 22: Southern side of collapsing section of wall, viewed from the S (scale: 1x2m, archive image ref G2527_024).

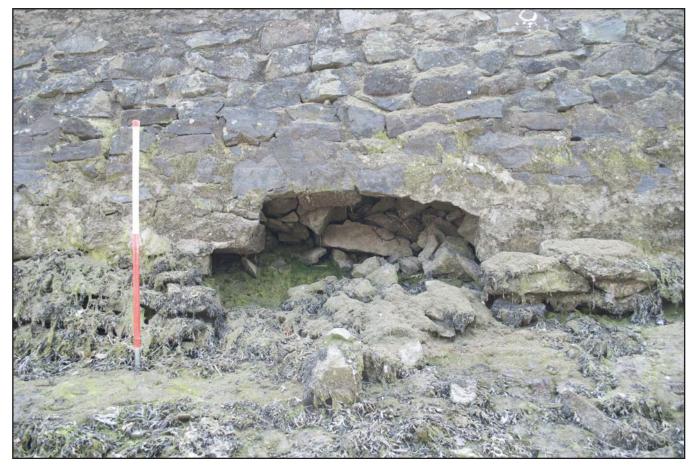
Plate 23: Collapsed part of wall, possibly a culvert, to the north of the bowling green, viewed from the NNE (scale: 1x1m, archive image ref G2527_019).

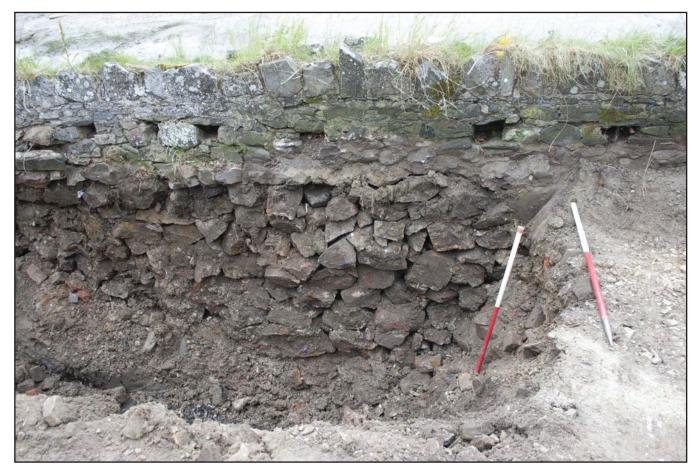
Plate 24: Revetment wall [001] showing the larger stones towards the bottom of the wall, viewed from the S (scales 2x1m, archive image ref G2527_031).

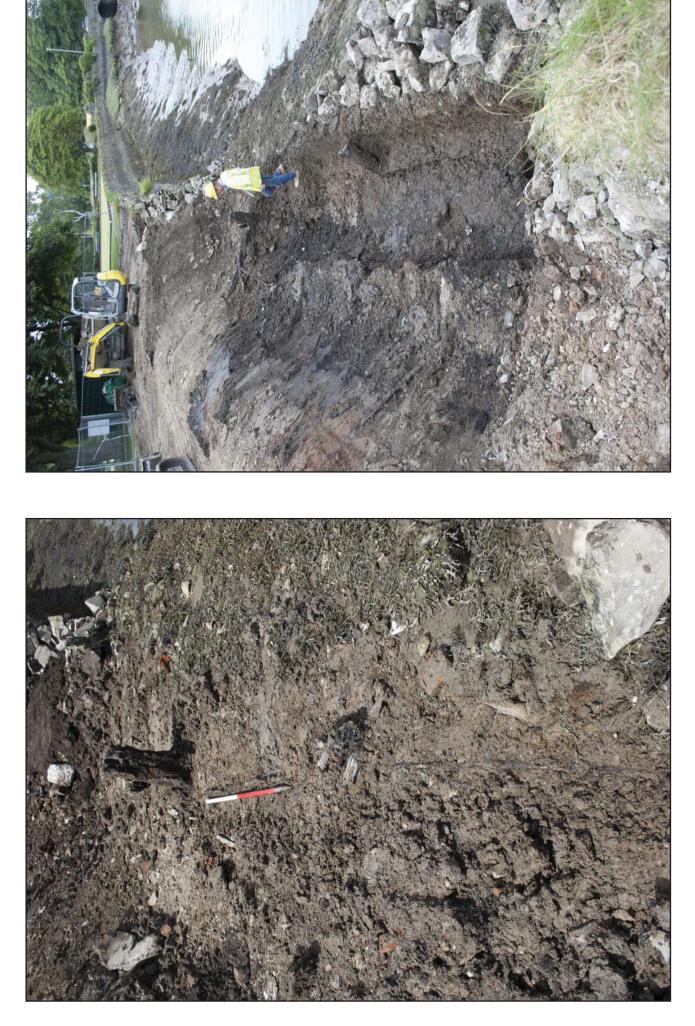
Plate 25: Wooden post and planks [005], viewed from the ENE (scale 1x1m, archive image ref G2527_038).

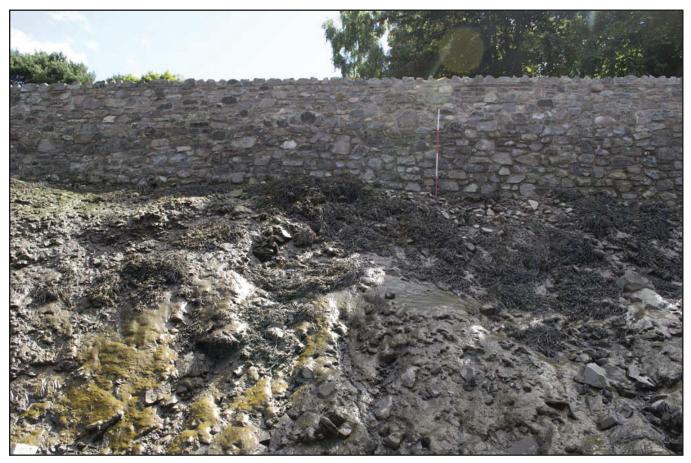
Plate 37: North face of rebuilt wall; taken from river channel (scale 1x2m, archive image ref G2527_088).

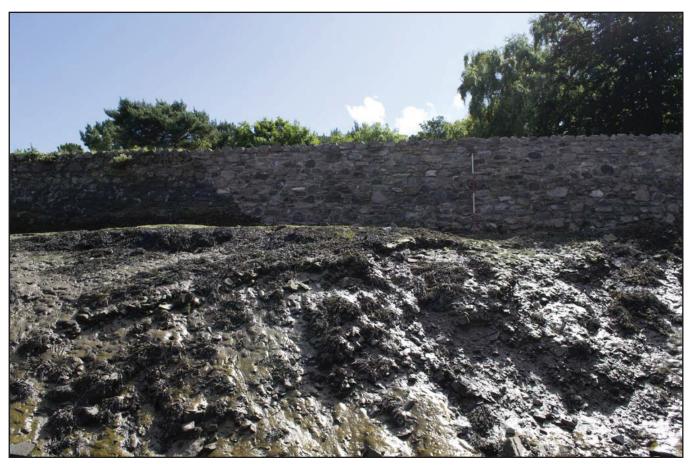
Plate 38: North face of rebuilt wall; taken from river channel (scale: 1x2m, archive image ref G2527_089).

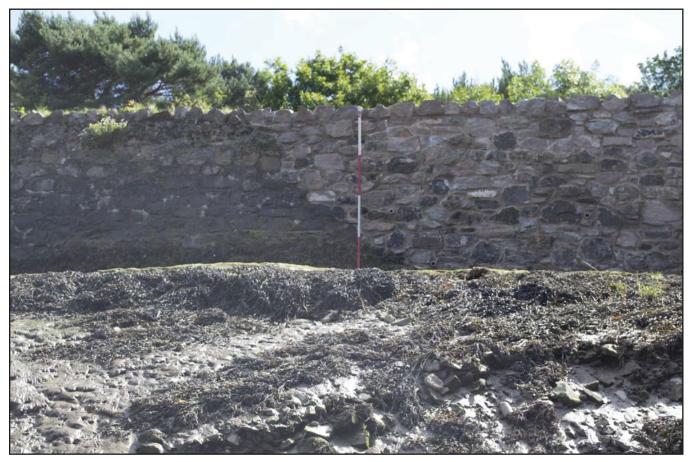
Plate 39: Close-up of north face of wall (integrated with old section of wall) (scale 1x2m, archive image ref G2527_090).

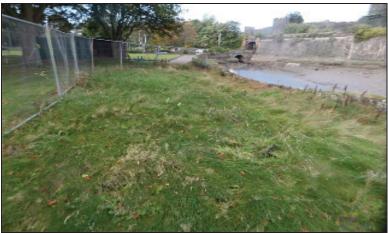
2.2.1 The area of investigation comprises a flat grassed area on the south side of the retaining wall where there is evidence of outward and downward movement of the retaining wall. The ground immediately behind the retaining wall is approximately 250mm lower than the surrounding ground as a result of the wall and ground failure and movement. The area and extent is shown on Plate 1 below:

Plate 1 – Area of Investigation
