## **Church House Farm, Llandeilo Graban, Powys**

### **Desktop Study, Archaeological Evaluation and Building Recording**

Report No. 1572

May 2017

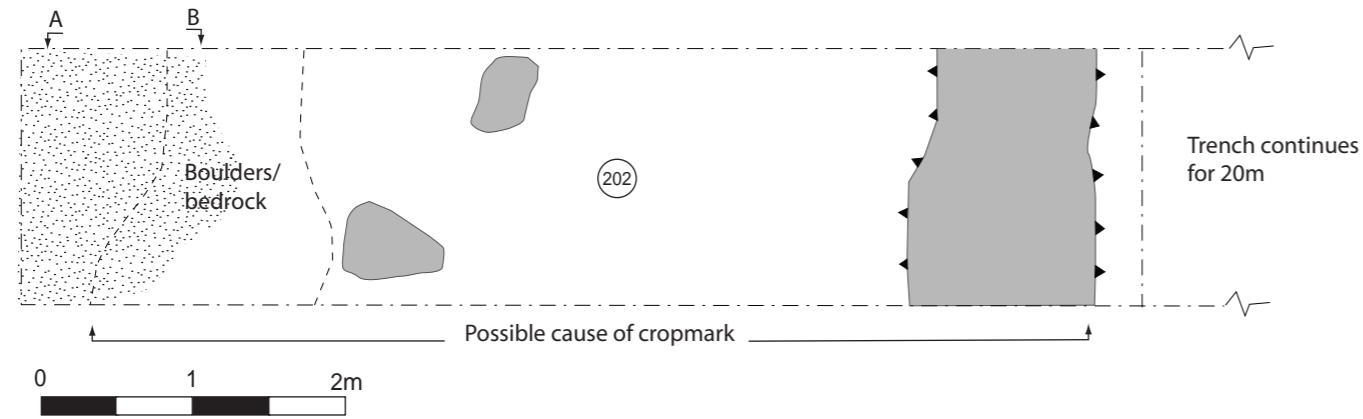
Plan of western end of Trench 2 showing natural bedrock. Possible cause of cropmark.

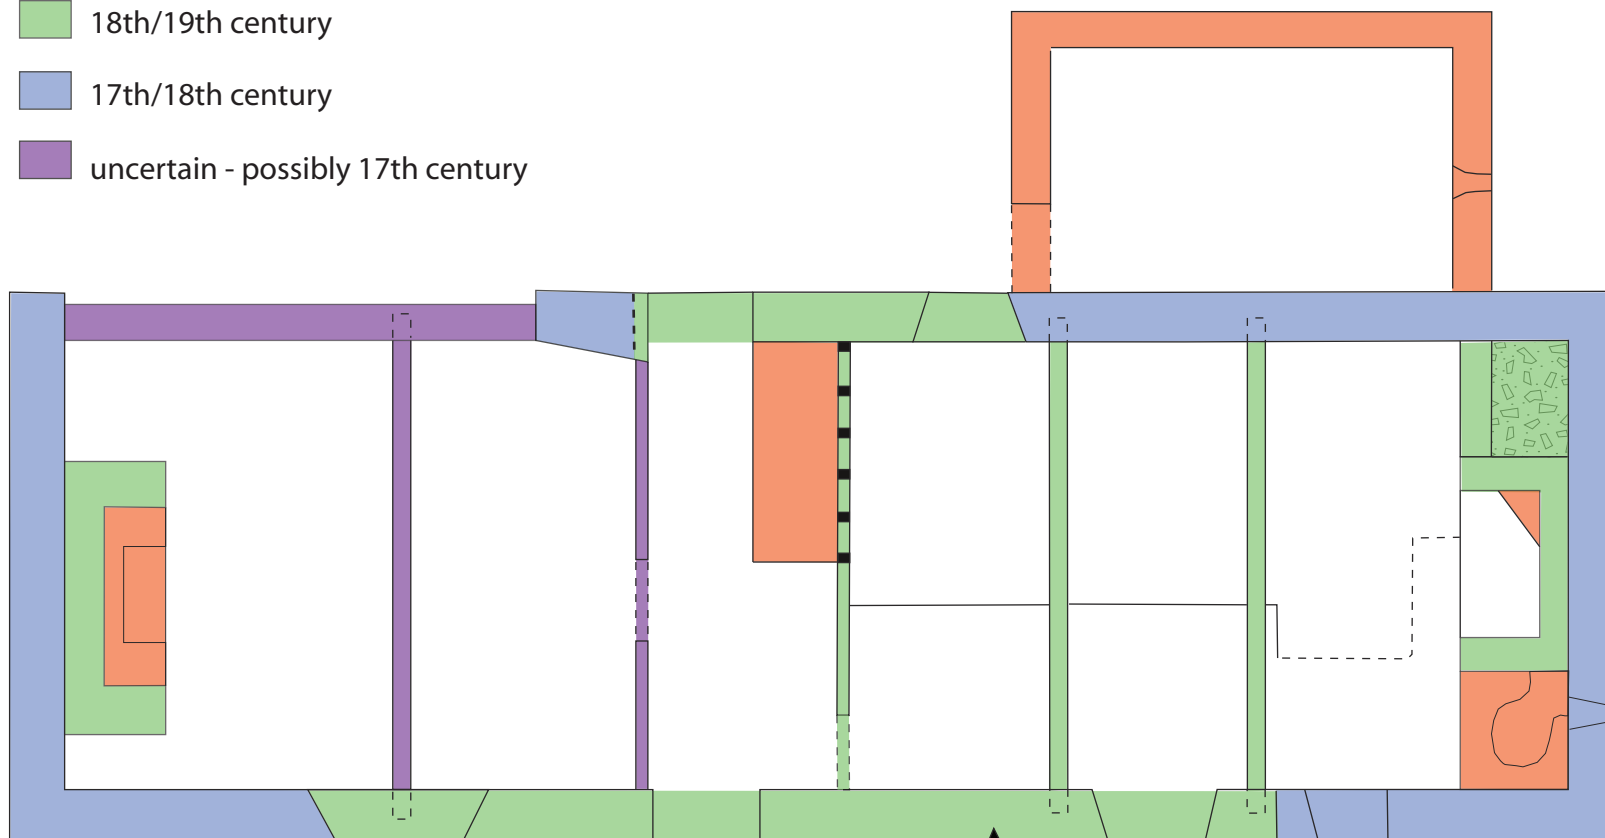
Figure 17  
Potential phases of construction  
or modification of the farmhouse

The farmhouse has multiple phases of construction and modification. The extent and date of these building phases is unclear. Nonetheless, there are some notable differences in the stonework at the eastern end of the building, and different types of window and door openings, and these collectively indicate that the east gable and parts of the northern and southern walls derive from a stone-built agricultural building. The western gable also appears to be of single-phase construction. Potential modification to the ceiling beams and trusses was noted in this part of the building (Rooms 2&4). There is in addition a large section of timber-framed wall, clad in weatherboards, that appears to have previously formed an internal division of a building or extension to the north of the present farmhouse. The latter structure is shown on the 1889 and 1904 Ordnance Survey maps.

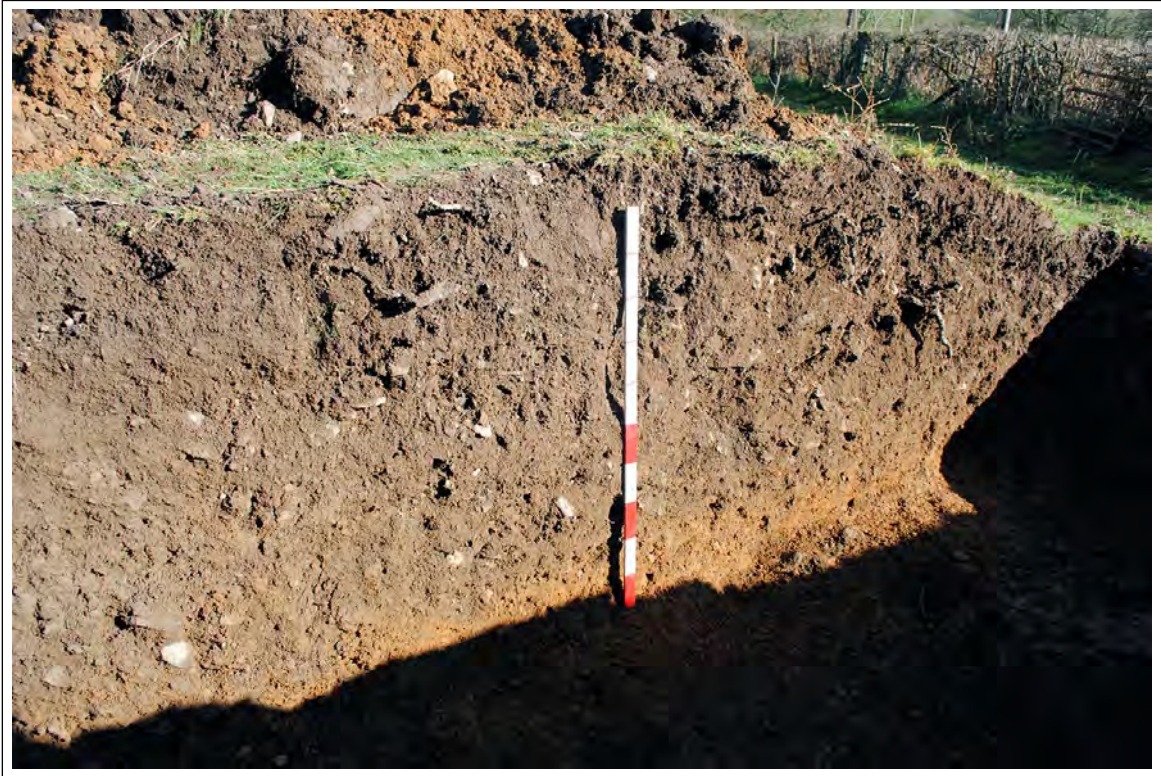
Plate 15. Trench 3, south end. Oblique view of earth bank, former field boundary (west-facing section). Scale 1m

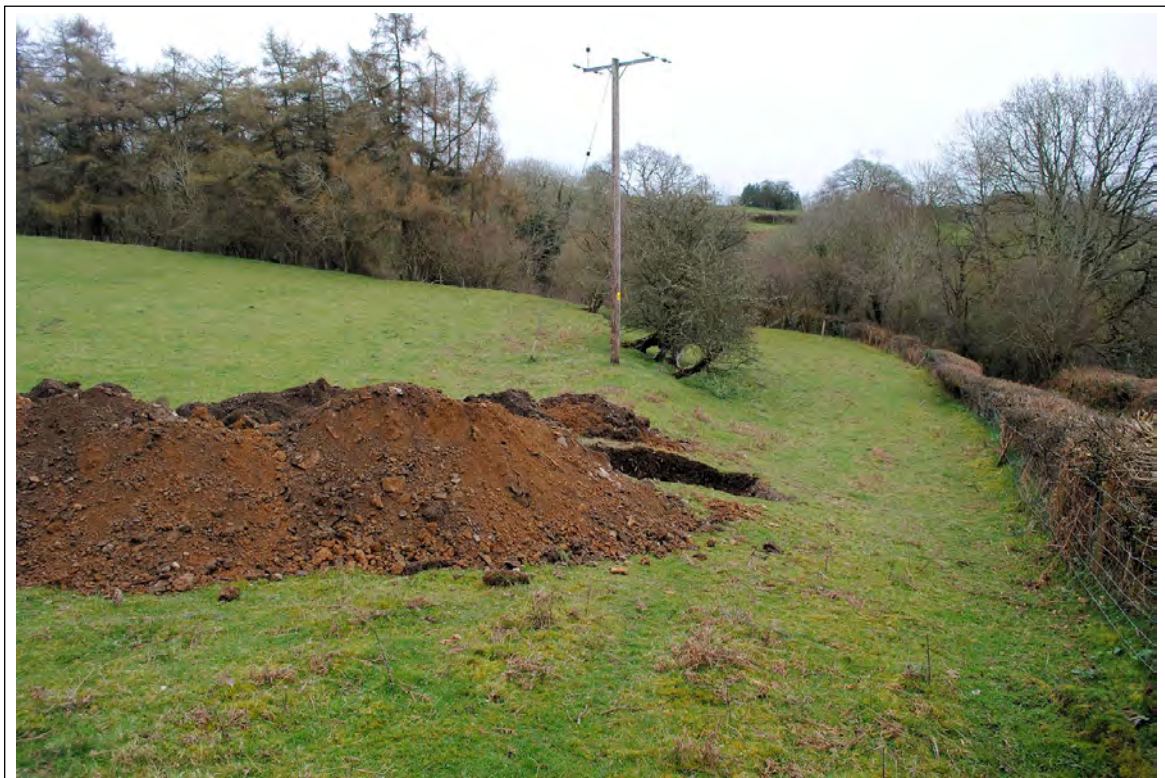
Plate 16. View of Trench 3 across the former field boundary. Looking east.

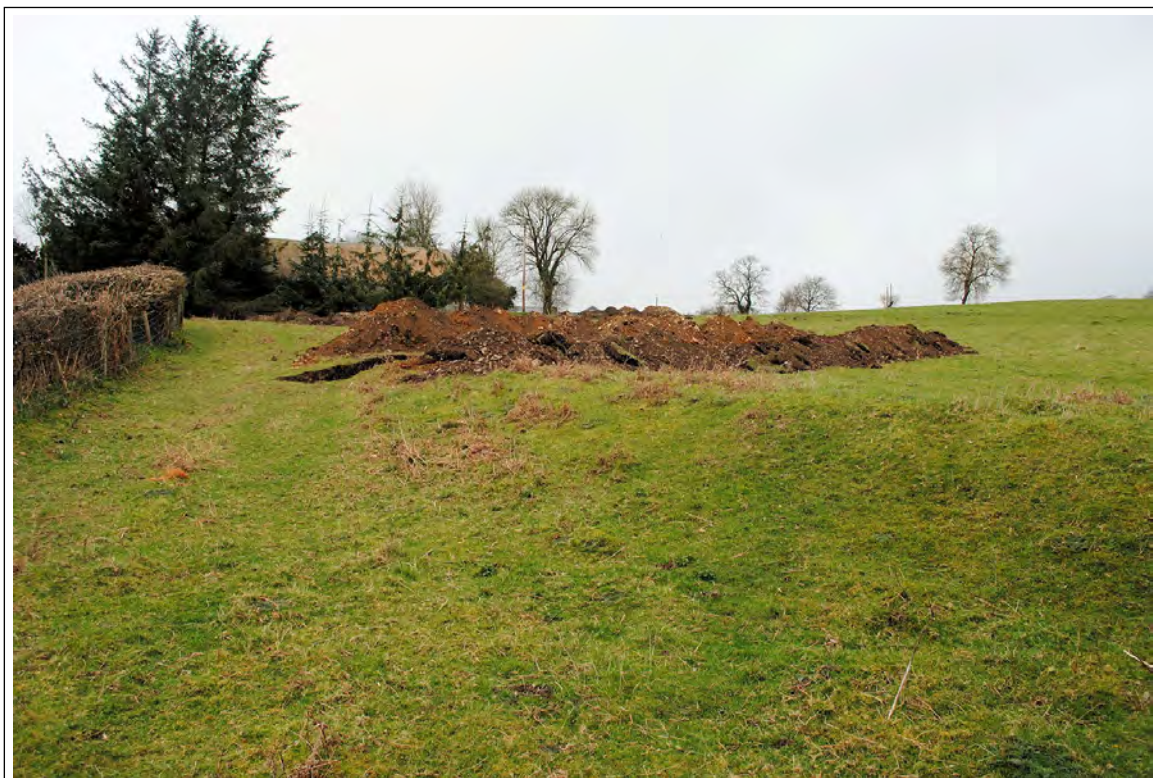
Plate 17. View of the former field bank to the east of Trench 3. Looking west.

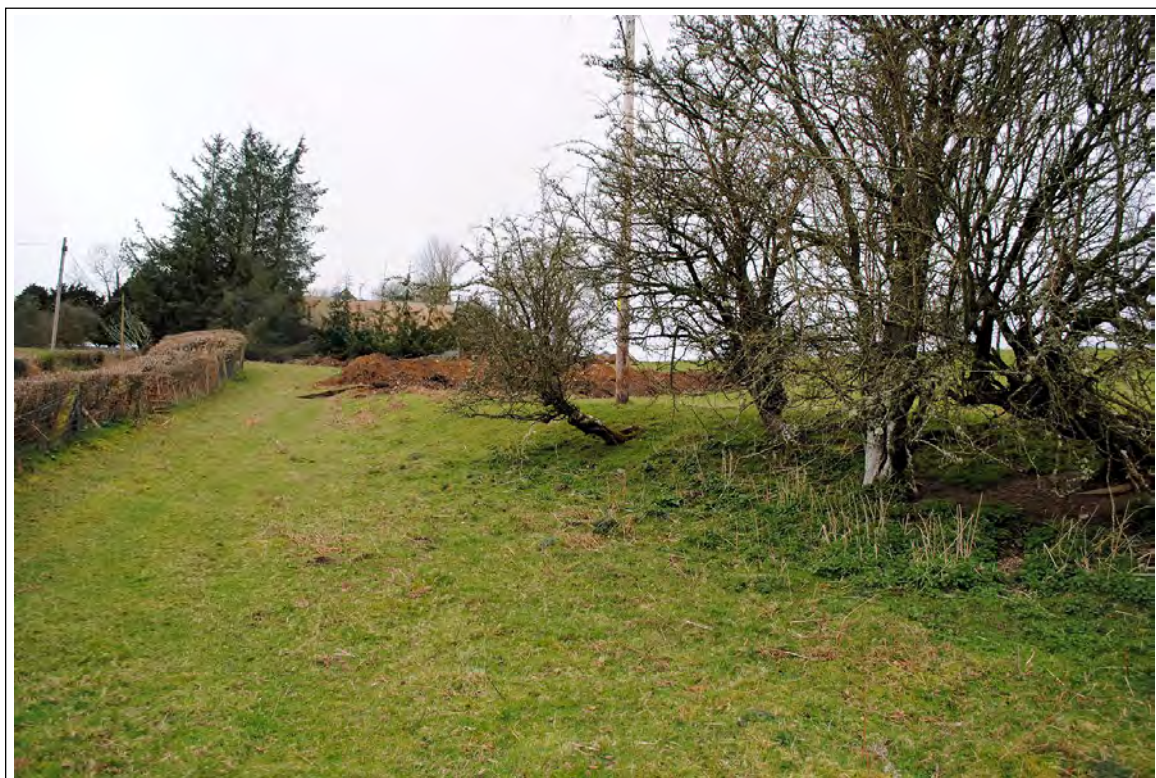
Plate 18. View of the former field boundary to the east of the evaluation area. Looking west.

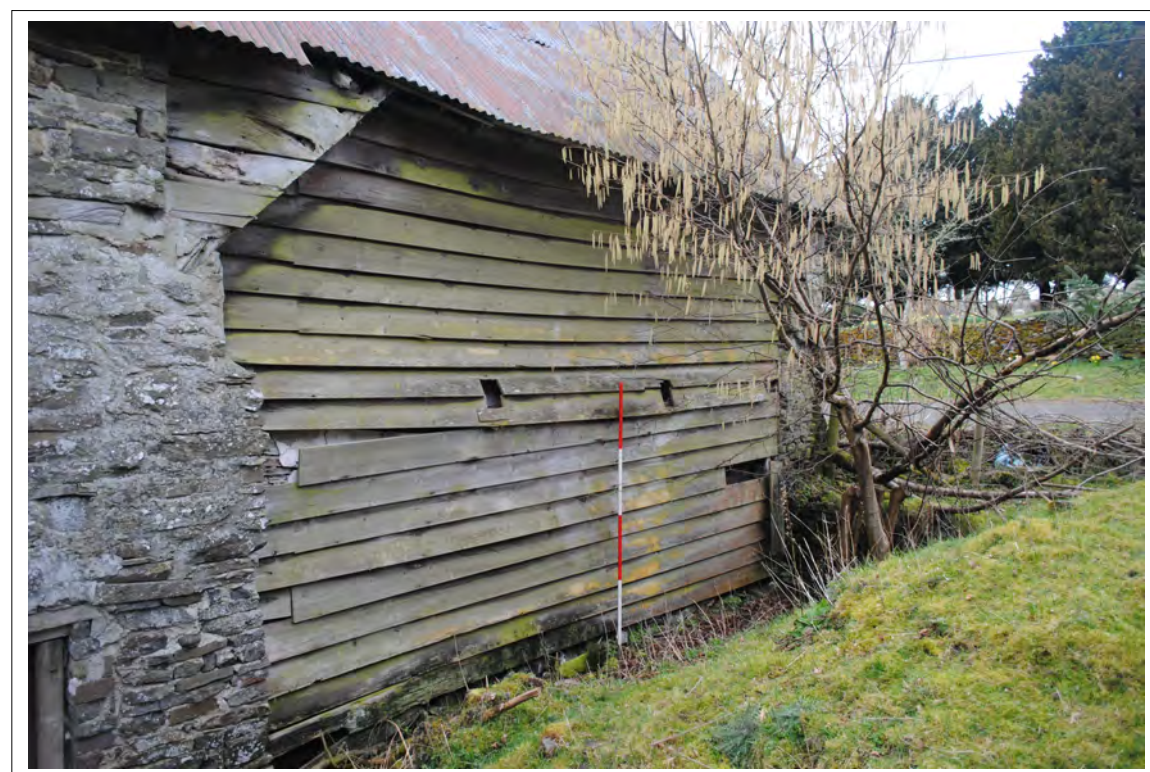
The large section of double-height weatherboarding at the western end of the farmhouse appears to represent infill of the internal wall that formerly connected to a northern extension at the back of the building. The sequence of modifications to the western end of the farmhouse is unclear. The external timber-frame is probably 20<sup>th</sup> century, but the poor condition of this structure may suggest earlier timbers may survive *in situ*, such as those supporting the ceiling beam / tie-beam (Truss A). In addition, there is a substantial lintel above the window in Room 2 which supports the ceiling beam. This is perhaps indicative of a modification to an existing structure, and suggests the ground and first floor windows have been inserted in to an older building.

Plate 48. View of weatherboarded section of external wall, over timber frame, along the northern elevation of the farmhouse. Looking west-southwest.

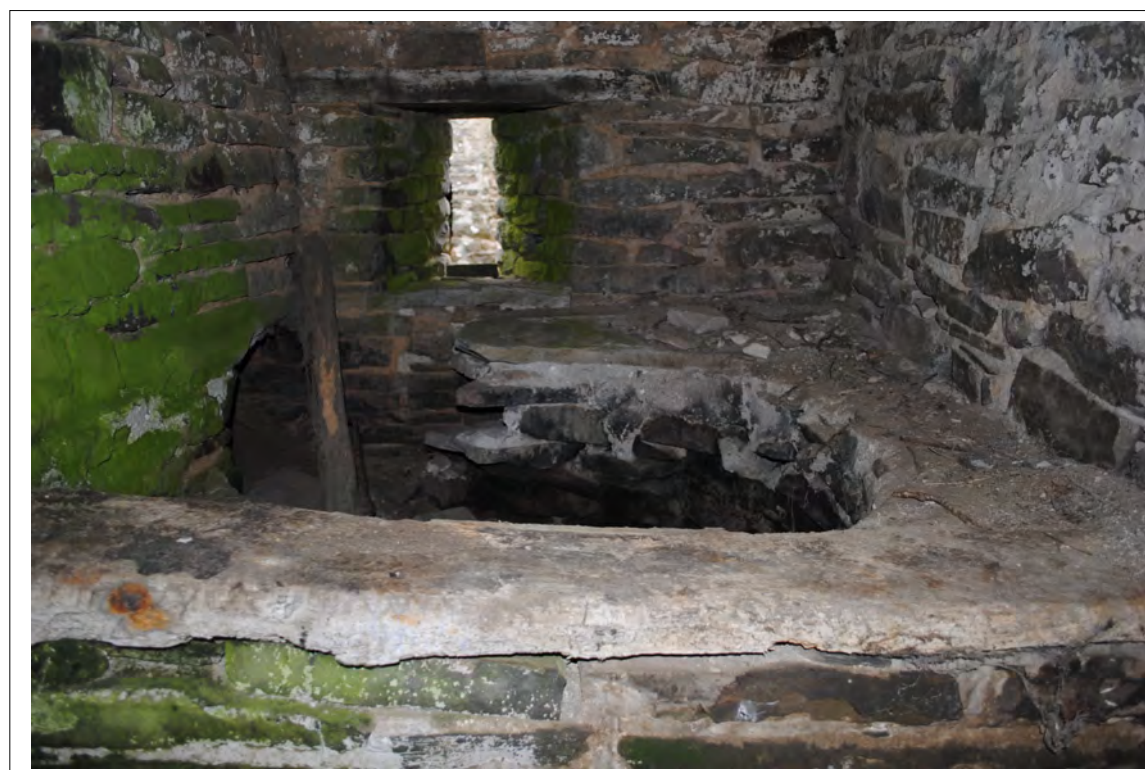
There appear to be a number of later 19<sup>th</sup> century modifications to the farmhouse. These include inserting an oven in the fireplace of Room 1, and the construction of a 'copper' water heater adjacent to this chimney, with firebox and flue. The same brick used for the oven is found in the external arch for the main entrance to the western property. During the same period the fireplace in Room 2 was part infilled with brick in order to insert a cast iron cooking range. The staircases leading to the loft also appears to have been replaced during in the late 1900s or 20<sup>th</sup> century. There is no evidence for an earlier staircase.

Plate 54. View of ventilation slit and flue for the 'copper' on the eastern wall of Room 1.

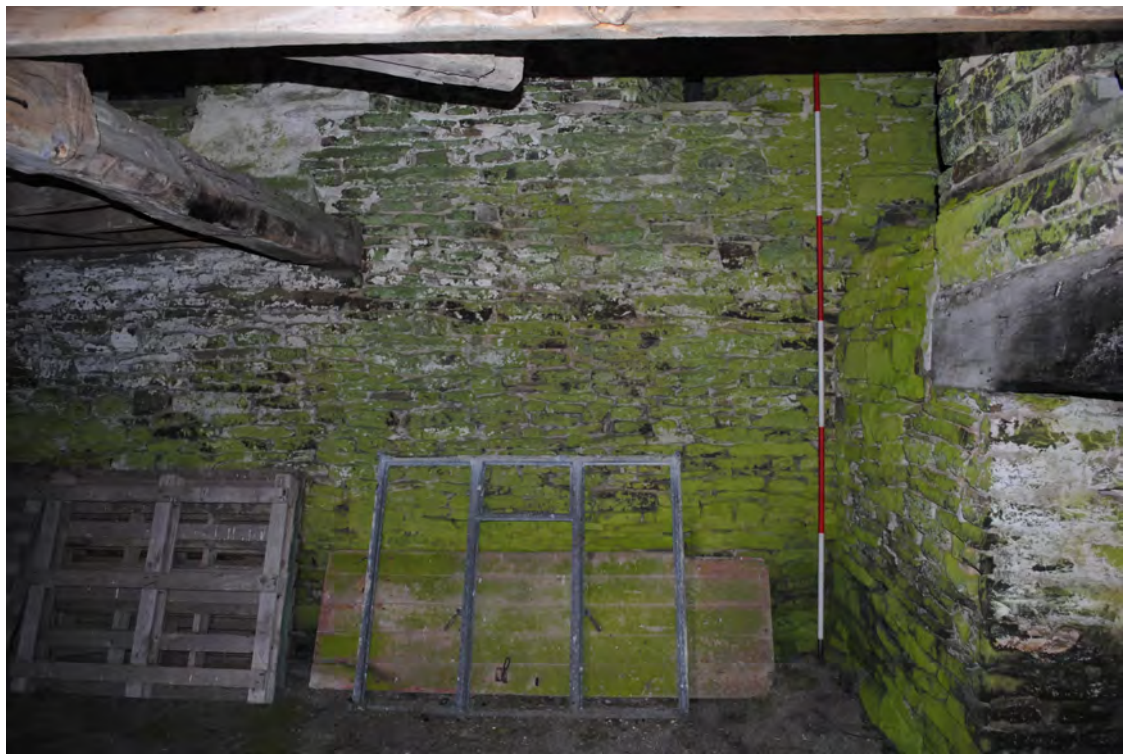
There is hatch in the ceiling (0.72m by 0.97m) set back approximately half a metre from the northern wall. A section of the ceiling is missing in the northeast corner of Room 1.

Plate 61. General view of the limewashed northern wall of Room 1, showing missing ceiling.

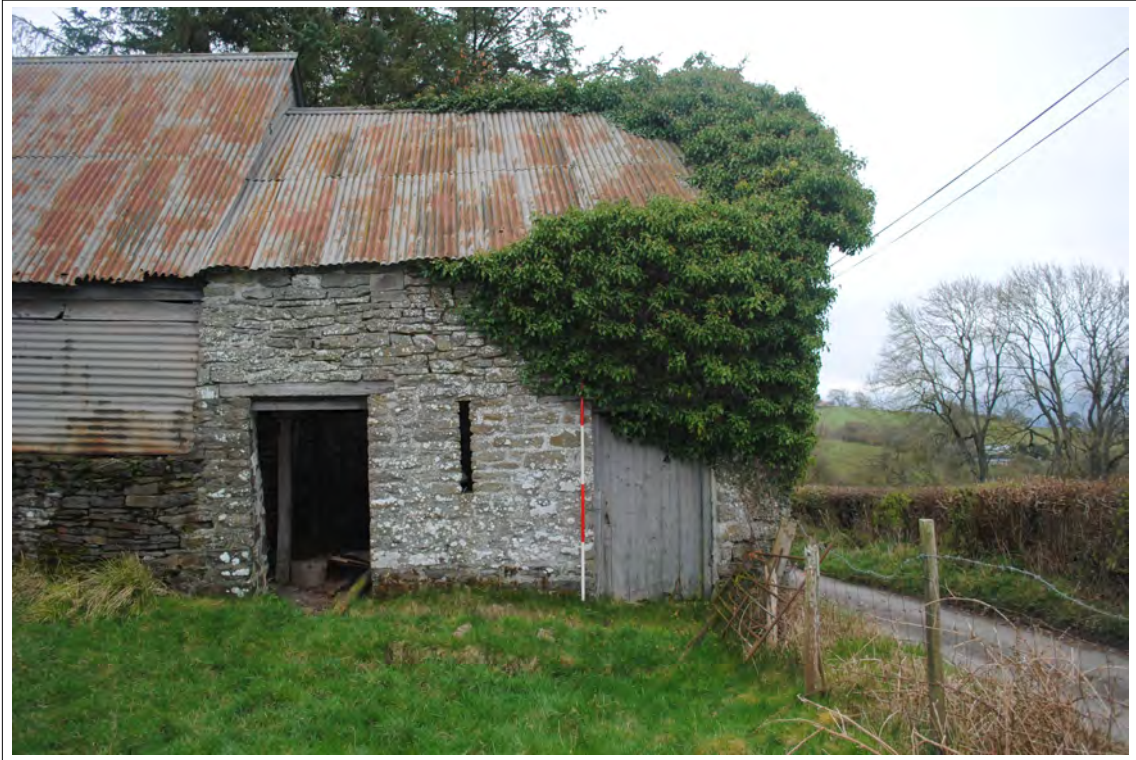
The two end bays appear to form a separate phase of construction from the barn to the north. There is a straight joint along the western wall indicating these building are not contemporary. This historically appears to have been used as a cowhouse, with a separate entrance for a feeding passage and/or loosebox. A hayloft extends across most of this area.

Plate 135. View of two entrances and a ventilation slit on the western elevation for a probable cowhouse or looseboxes (Bays F & G). Looking east-southeast.

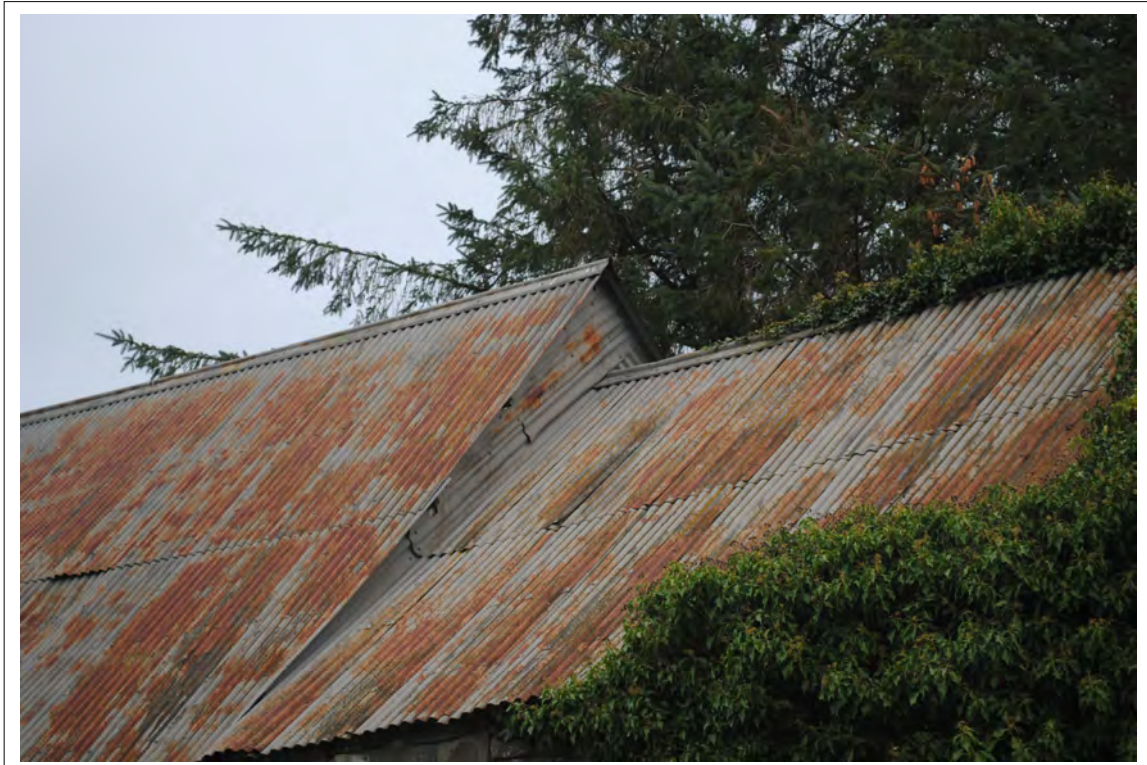
Plate 136. Detail of the corrugated steel roof, with a change in height between the main barn (left) and cowhouse or looseboxes (right). Looking east-northeast.

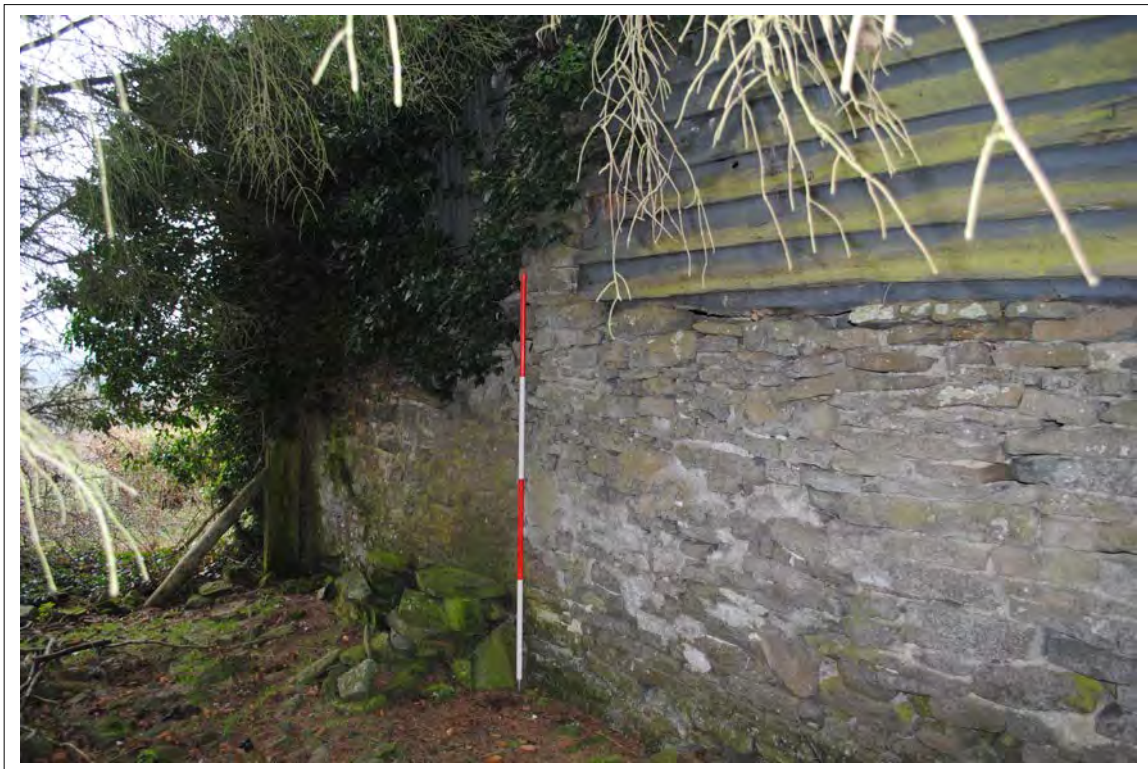
Plate 154. Oblique view of Bays E and F, the back wall of the former barn and cowhouse (eastern elevation). Looking south-southwest.

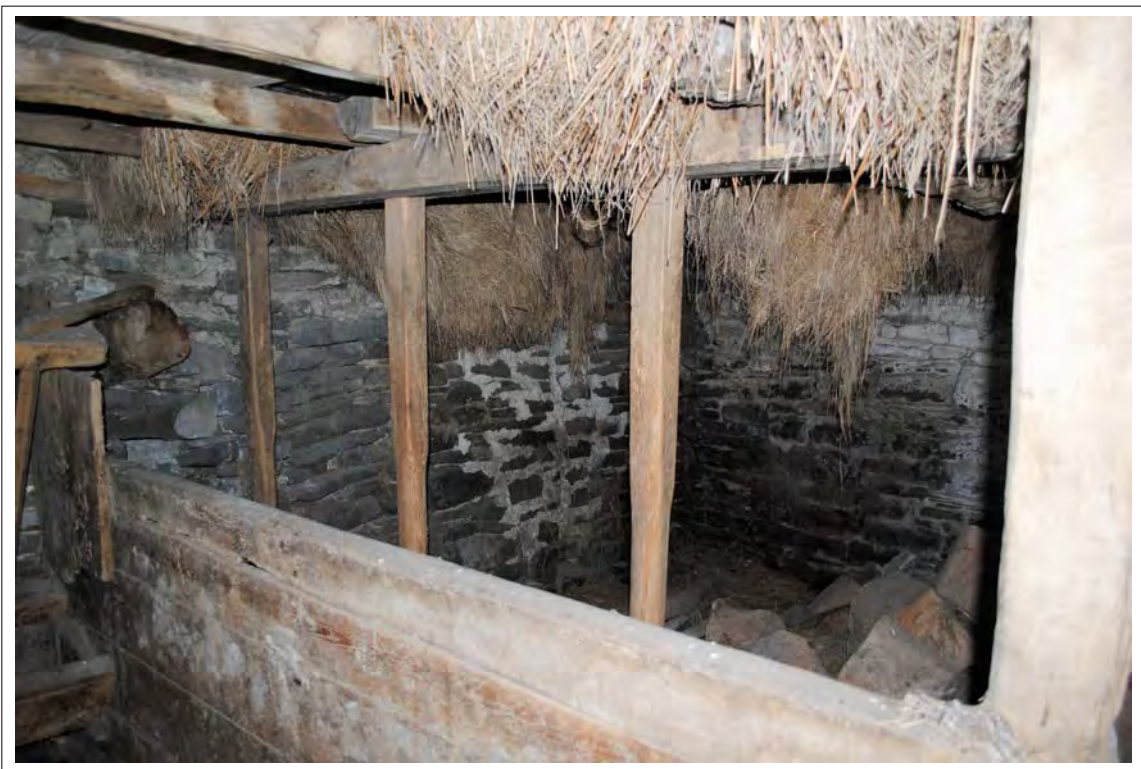
The height of the southern gable indicates this building could have originated or has been rebuilt as a barn (and subsequently used for a cowhouse): there is a straight joint along the eastern stonewall suggesting modification to this building in the past. The timber-framing on the eastern wall within Bay G appears to be 19<sup>th</sup> century or later, but may have replaced earlier timbers. There is also bowing in the upper western wall which additionally suggests other some parts of Bay G may have been rebuilt.

Plate 179. Oblique view of posts within Bay F for a probable cowhouse. Note the straight joint in the eastern masonry wall (Bay G). Looking south-southeast.

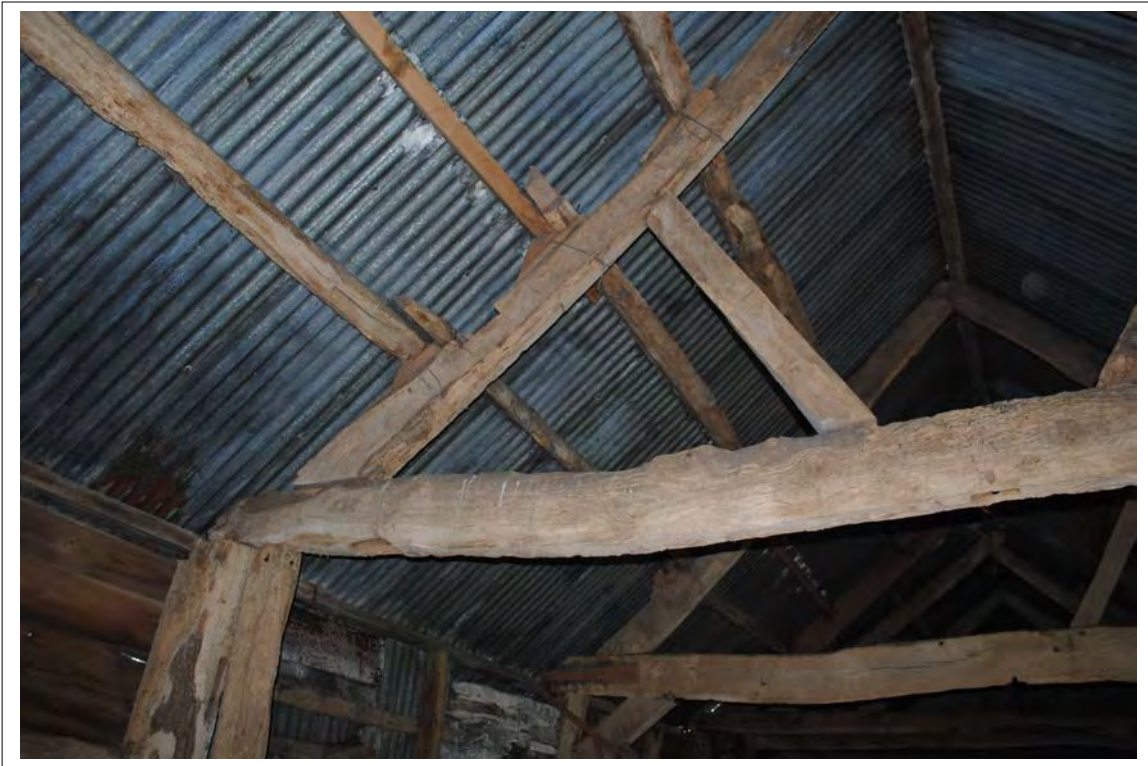
The tie-beam for Truss C rests on a stone pillar to the west, and a timber post to the east, part of the timber framing for the barn wall. The principal rafters are connected at the top by a pegged halved joint. The ridge piece is trenched into the truss. The truss has a pair of tenoned struts between the principals and the tie-beam. Vertical struts connect the tie-beam with a wall plate below, above a low stone wall within the barn, the central strut is missing. These timbers would have divided Bays C and D of the barn. The principals support three sets of staggered back purlins, held by cleats, with the eastern purlins raised on packing timbers.

Plate 198. Eastern side of Truss C. Looking south.
