CPAT Report No. 1771

4-6 Regent Street, Wrexham

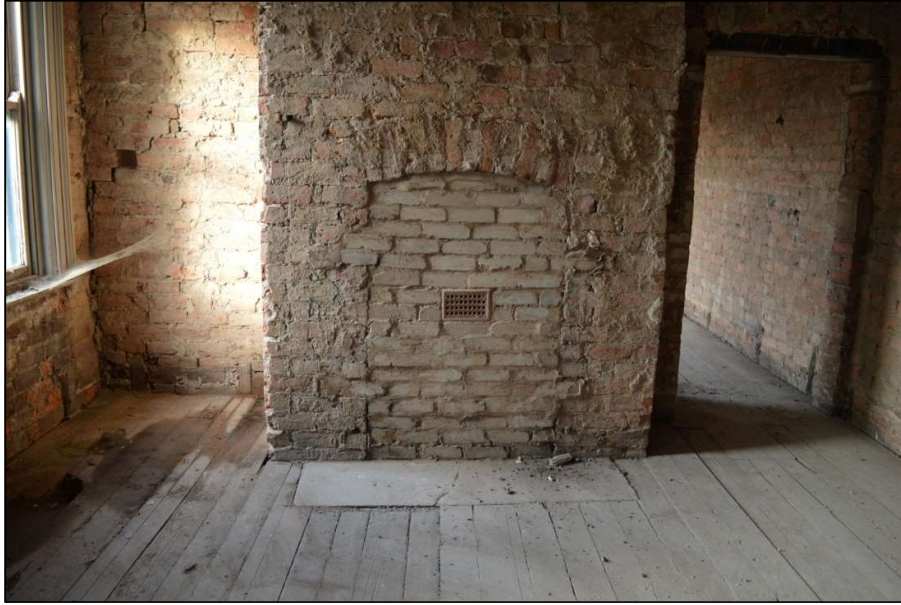
Fig 10: Blocked fireplace with hearth stone in Room 2 on second floor. Also shows wall cracks (CPAT 4853-0009)

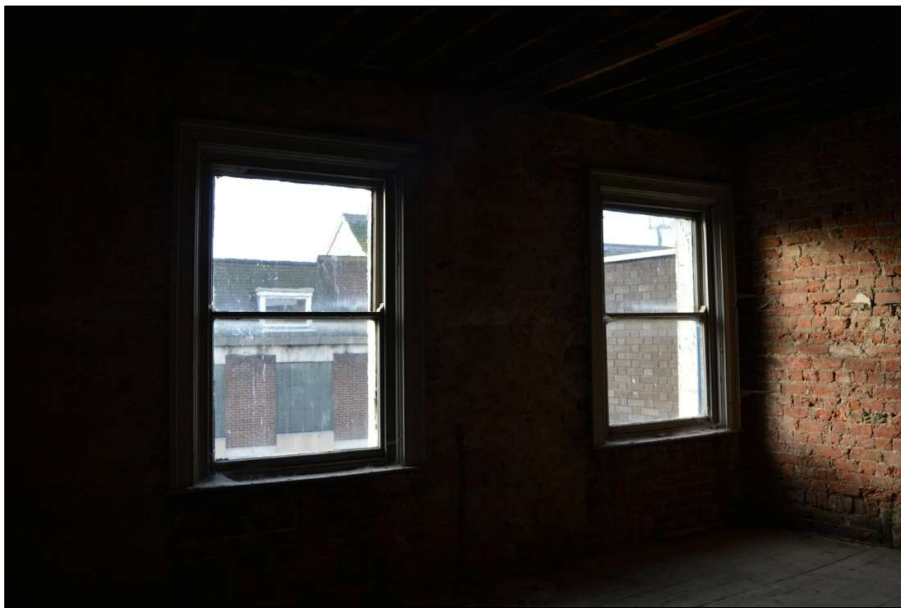
Fig 11: Windows in Room 3 on second floor (CPAT 4853-0010)

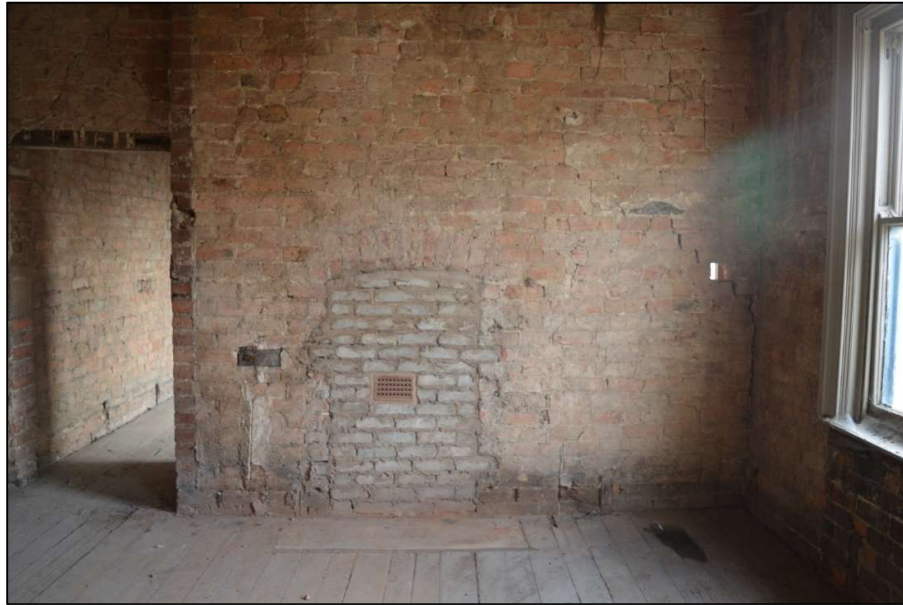
Fig 12: Blocked fireplace with hearth stone in Room 3 on second floor. Also shows wall cracks (CPAT 4853-0011)

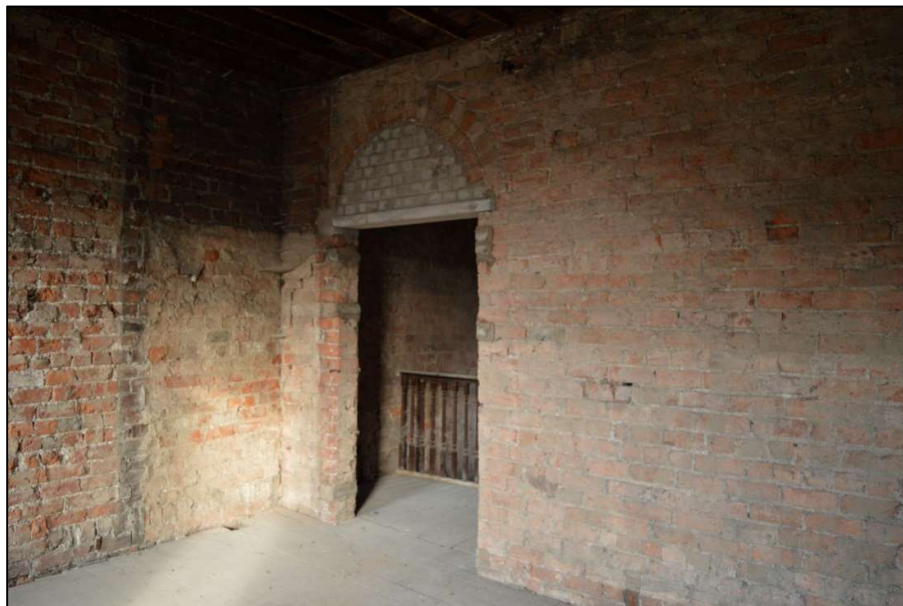
Fig 13: Partly blocked arched doorway in Room 3 on second floor (CPAT 4853-0012)

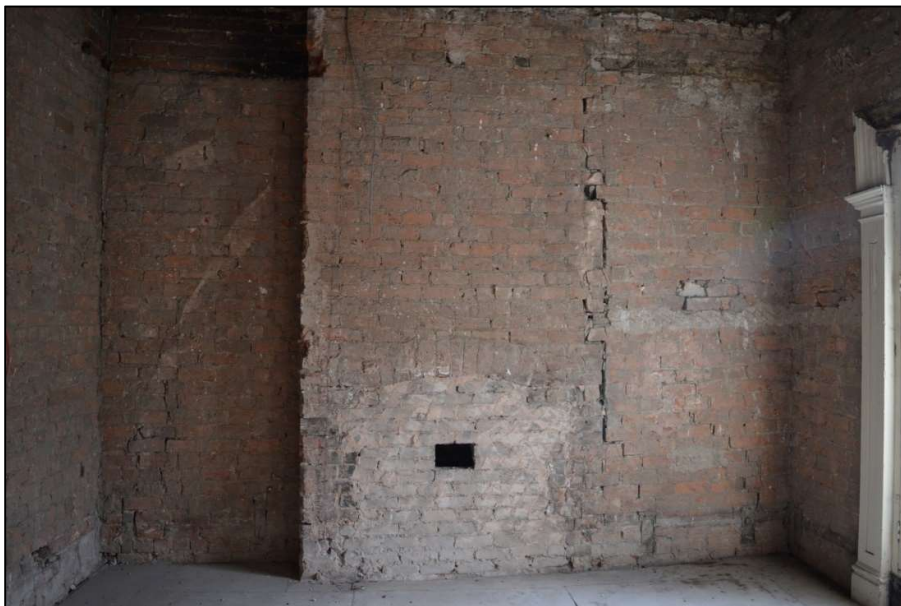
Fig 25: Blocked fireplace in Room 7 on first floor. Also shows wall cracks (CPAT 4853-0024)

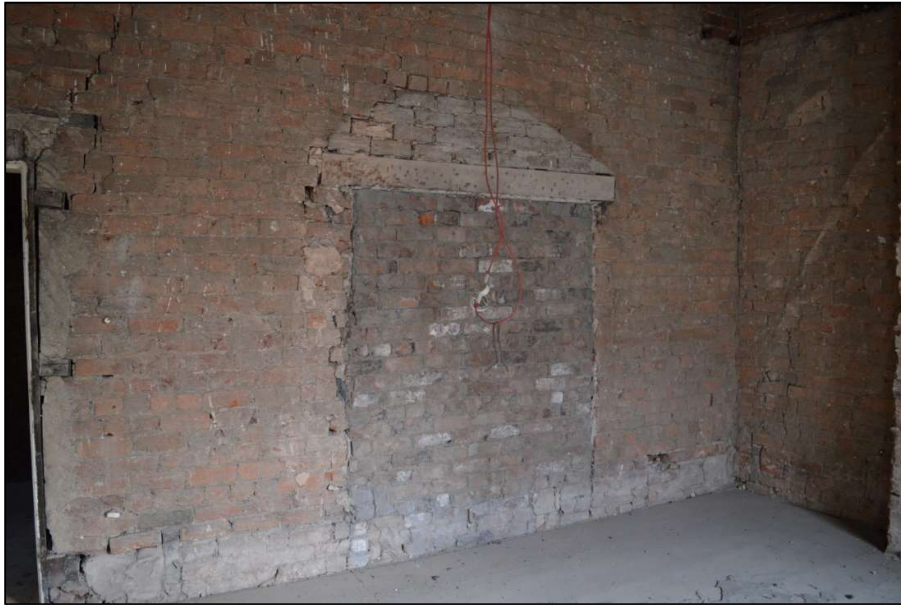
Fig 26: Blocked doorway in Room 7 on first floor. (CPAT 4853-0025)

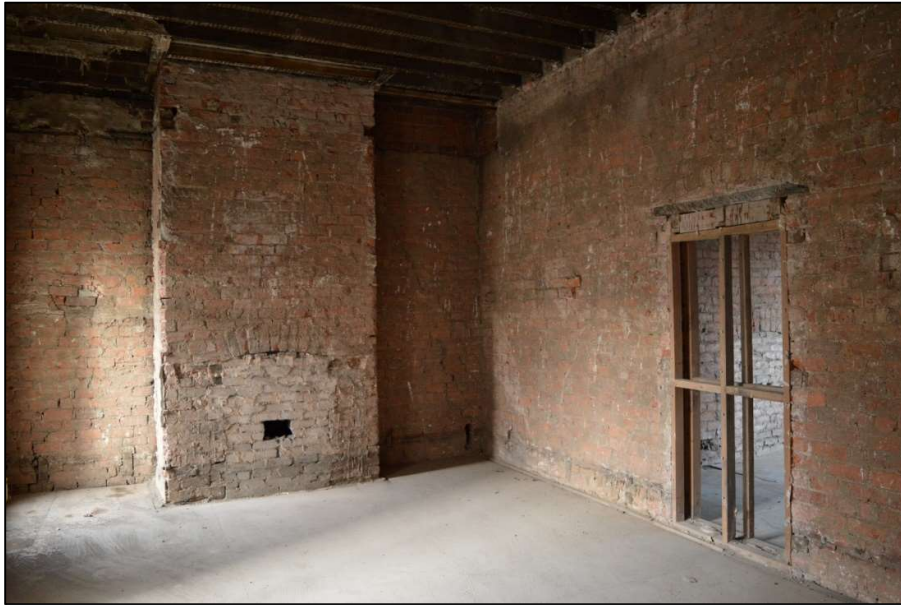
Fig 39: Blocked fireplace and door in Room 6 on first floor. Also shows wall cracks (CPAT 4853-0038)

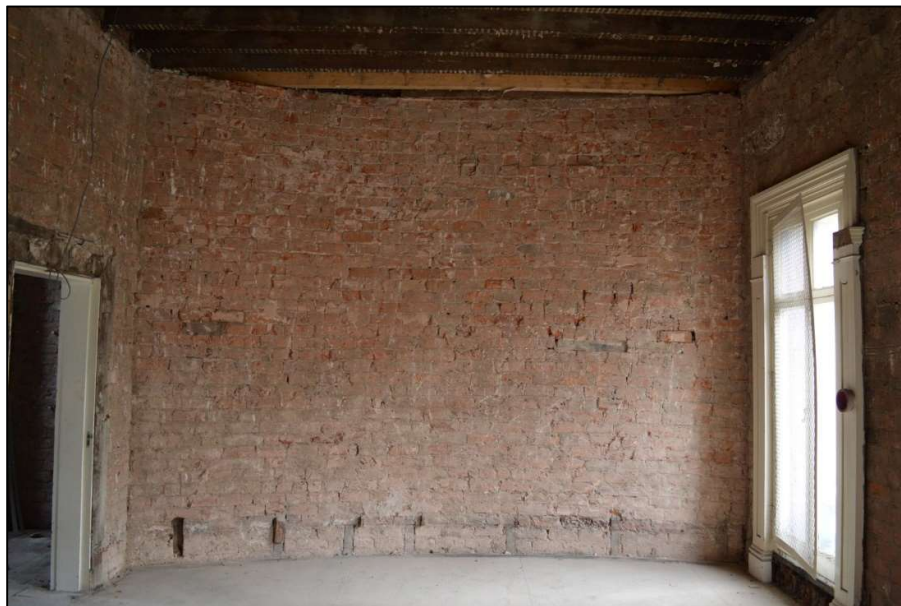
Fig 40: The curved east wall of Room 6 on first floor, doorway to east stair (CPAT 4853-0039)
