11 Stryd y Castell, Conwy

Recording of Features on the Front and SE Elevations

EAS Client Report 2014/04

**Recording of Features on the Front and SE Elevations of 11 Castle Street
Conwy and an Assessment of the Potential for the Survival of Wall
Paintings**

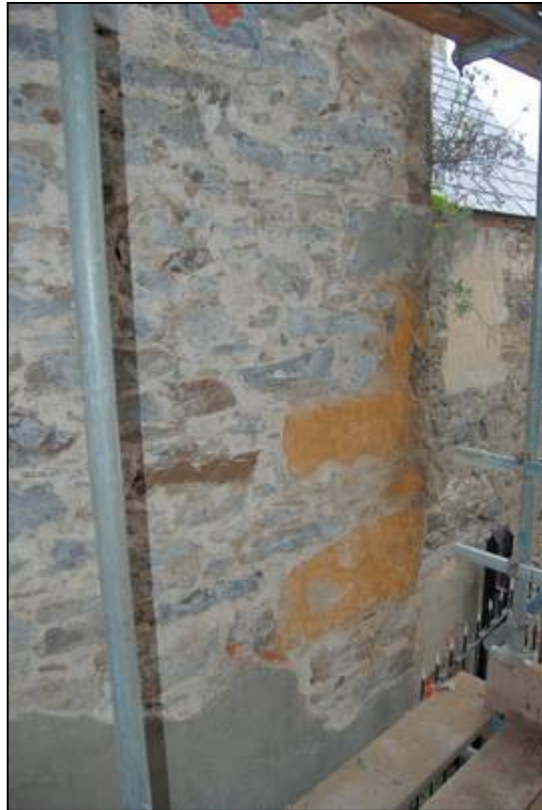
At the western end of south eastern gable a series of three, yellow, sandstone blocks were located (Plate 1). These are distinctive in their lithology and one of the blocks appears to have deliberate shaping on its lower surface (Figure 2.1, Plate 2). This block is 0.78 x 0.22 m in size, with a clear zigzag profile on its lower surface. Although it was not possible to inspect the lower surface it is likely to have been part of a chevron moulding and therefore to be possibly of Romanesque style. The original source for this block, in particular, and the other blocks of a similar lithology is uncertain, however there are a few blocks of a similar lithology built into St Mary's Church, Conwy. This was originally the church of Aberconwy Abbey which was founded in AD 1186, but moved to Maenan in AD 1283 to make way for the English town (Haslam *et al* 2009, 318-319). The extent of the monastery buildings is little understood, however it is possible that the block built in to the gable end of 11 Stryd y Castell was originally part of the monastery complex.

Plate 1: Re-used blocks incorporated within the SE Gable

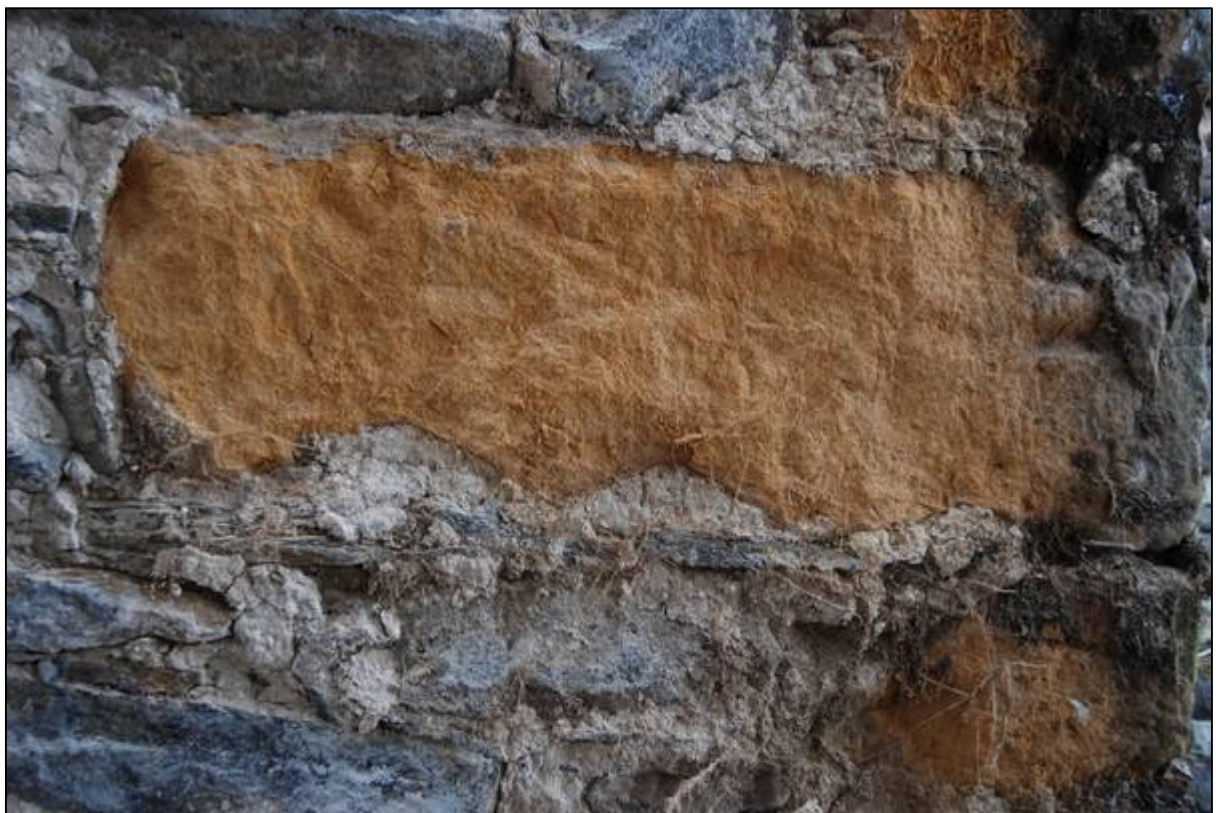
Plate 2: Shaped block in the SE Gable

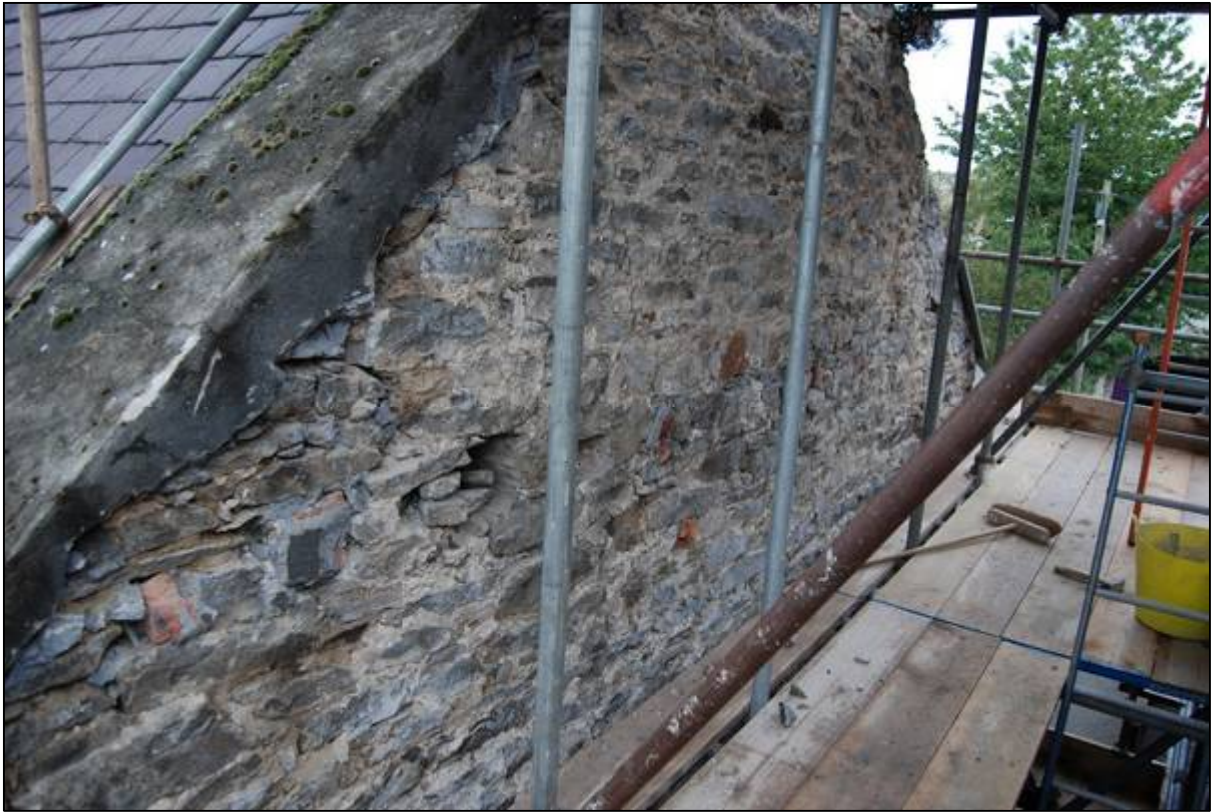
Plate 3: Sockets for joists in the SE Gable

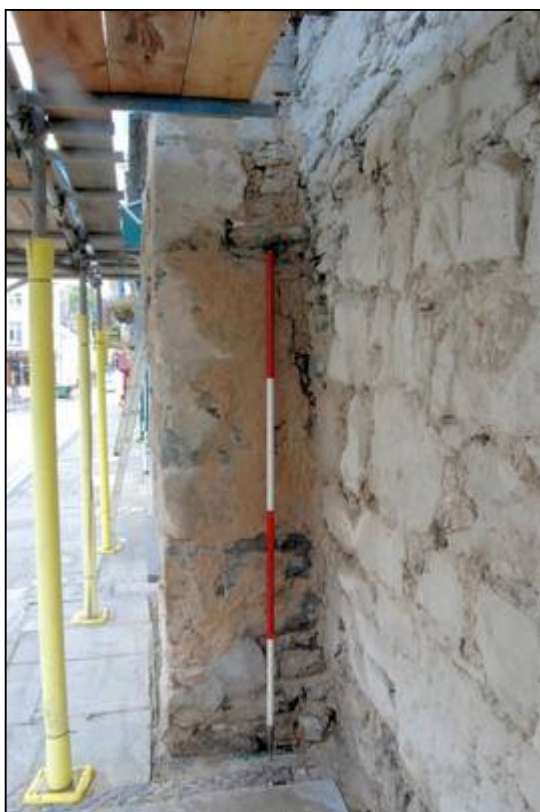
The two full bays on the front elevation and the dormer bay over the front door have been shown to be later additions to the building (Gwyn *et al* 2009, 26) possibly associated with the eighteenth century remodelling. This disparity between the bays and main structure of the house was confirmed with the removal of the render which showed the straight joints in the stonework between these features. (Plate 5).

Plate 5: Relationship between the northern bay and the main house

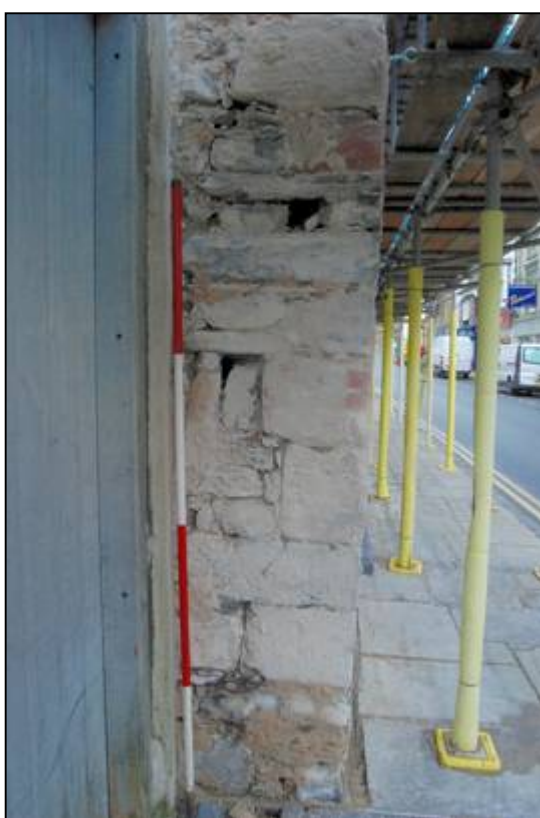
An unexpected feature revealed by the removal of the render were a series of small windows in the sides of the bays (Plates 6 – 15, Figures 3 and 4). Four of these were in the northern bay and two on the northern side of the southern bay. They consisted of narrow openings, typically only 80 mm wide and 260 mm high which run diagonally through the side walls of the bays. These “squint like” windows were lined with up to three layers of lime plaster and had sheets of glass set approximately 200 mm back from the outer face of the wall (Plates 11 – 14, Figure 3). Whilst on the ground floor it is not possible to determine the blockings on the inside of the bay, the blocked opening are visible on the first floor of the northern bay (Plates 15 and 16).

Plate 6: Blocked "squint window" in the ground floor, northern face of the northern bay

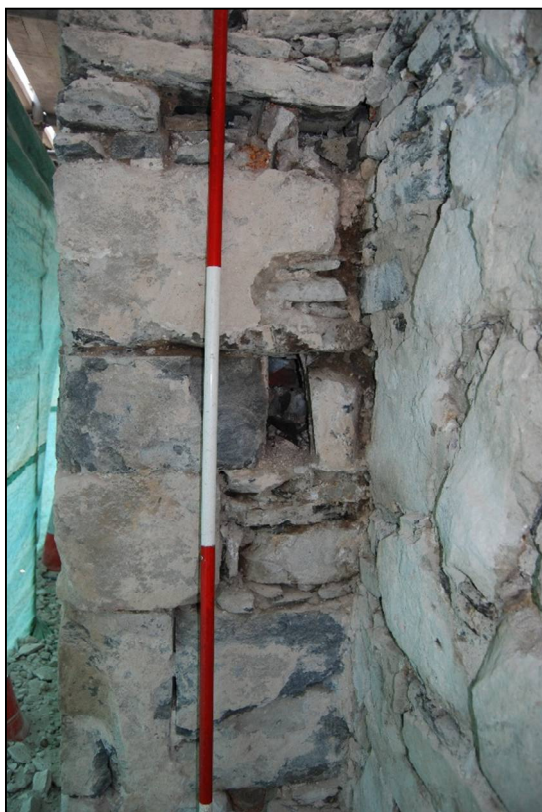
Plate 7: “Squint window” in the ground floor, southern face of the northern bay

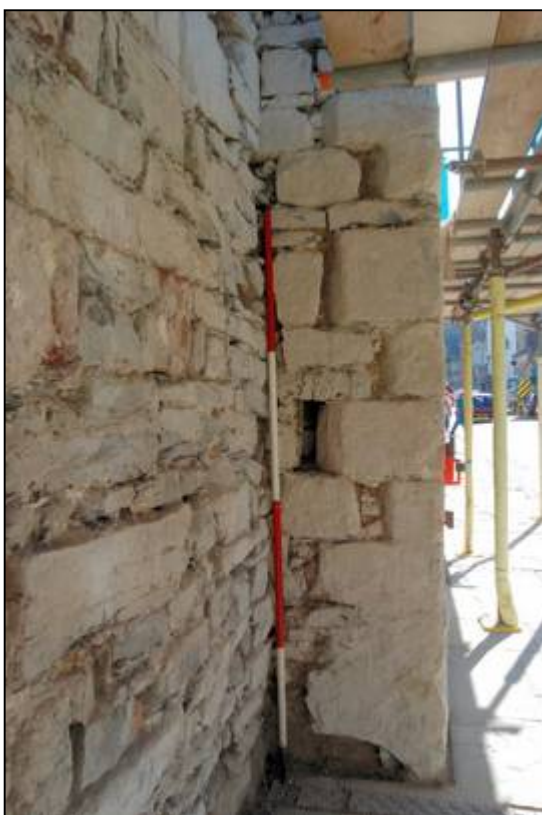
Plate 8: “Squint window” in the ground floor of the northern face of the southern bay

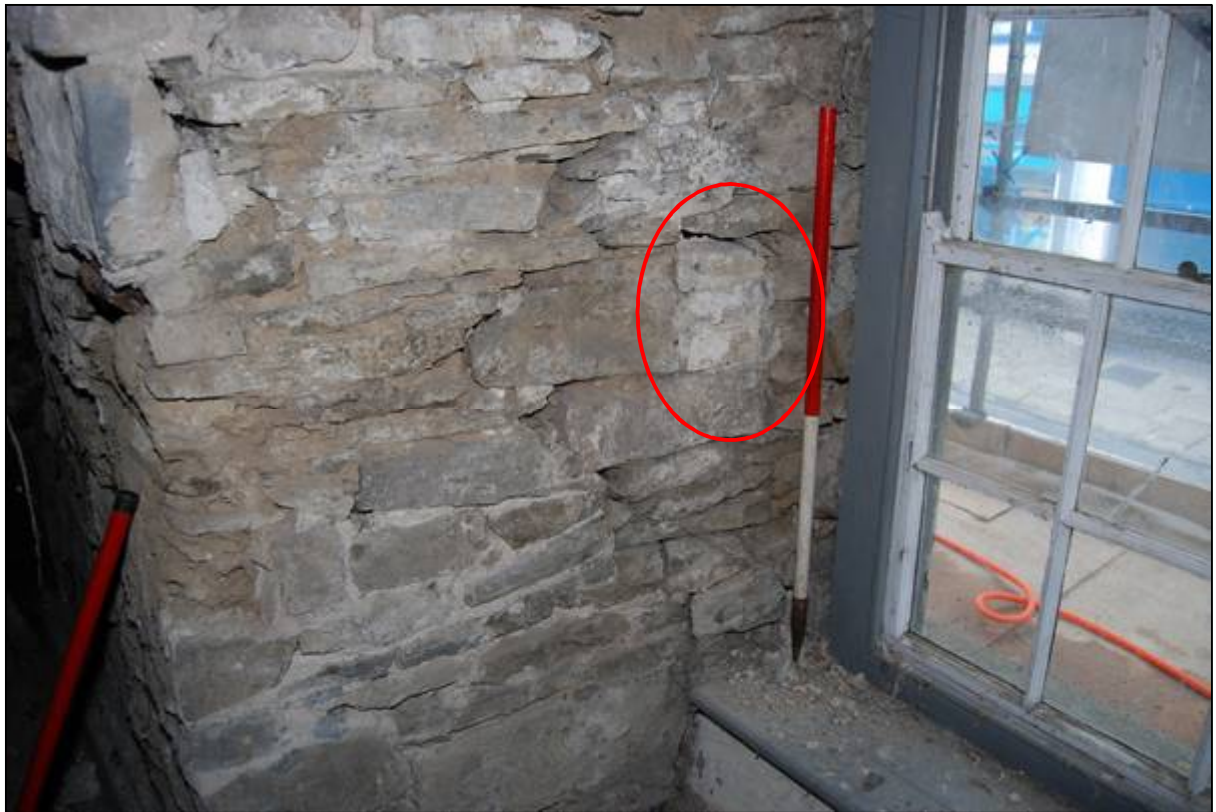
Plate 15: Internal blocking of the “squint window” on the first floor of the southern side of the northern bay

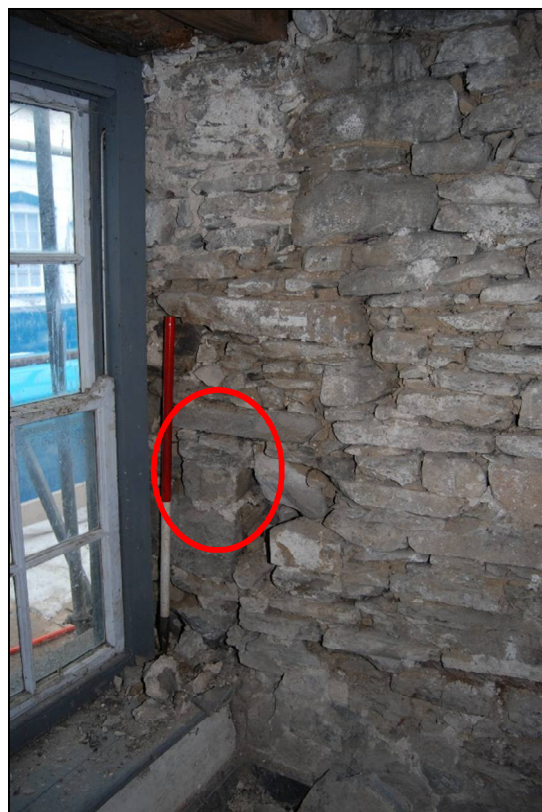
Plate 16: Internal blocking of the “squint window” on the first floor of the northern side of the northern bay

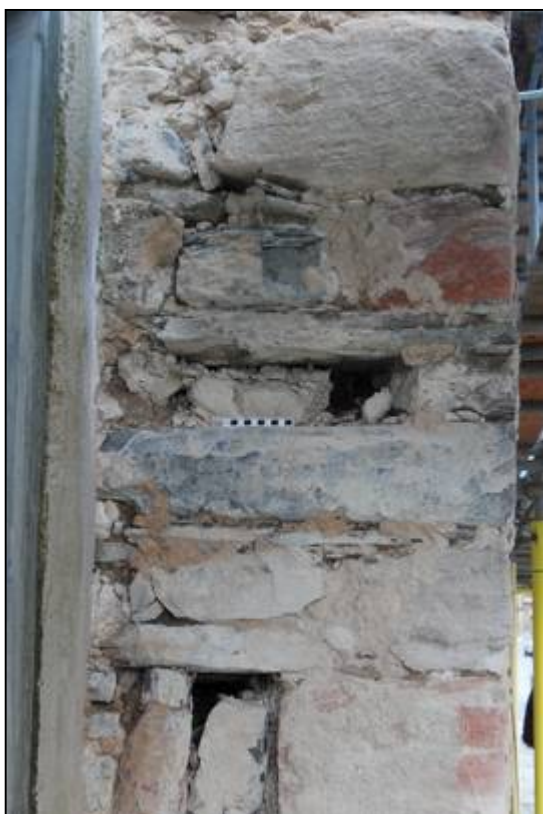
On the northern face of the northern bay, between the two “squint windows”, the end of a timber was exposed (Figure 4, Plate 17). This was at a height of 1.79 m above the street level and would appear to relate to a similar timber exposed in the front face of the building (Plate 18). It is possible that these sockets were originally linked. The function of this timber is unknown, however it may have supported a sign which would have been angled so that it could be seen from the cross roads between Castle Street and High Street. If so this must pre-date the AD 1885 photograph of the property.

Plate 17: Socket in the northern face of the northern bay

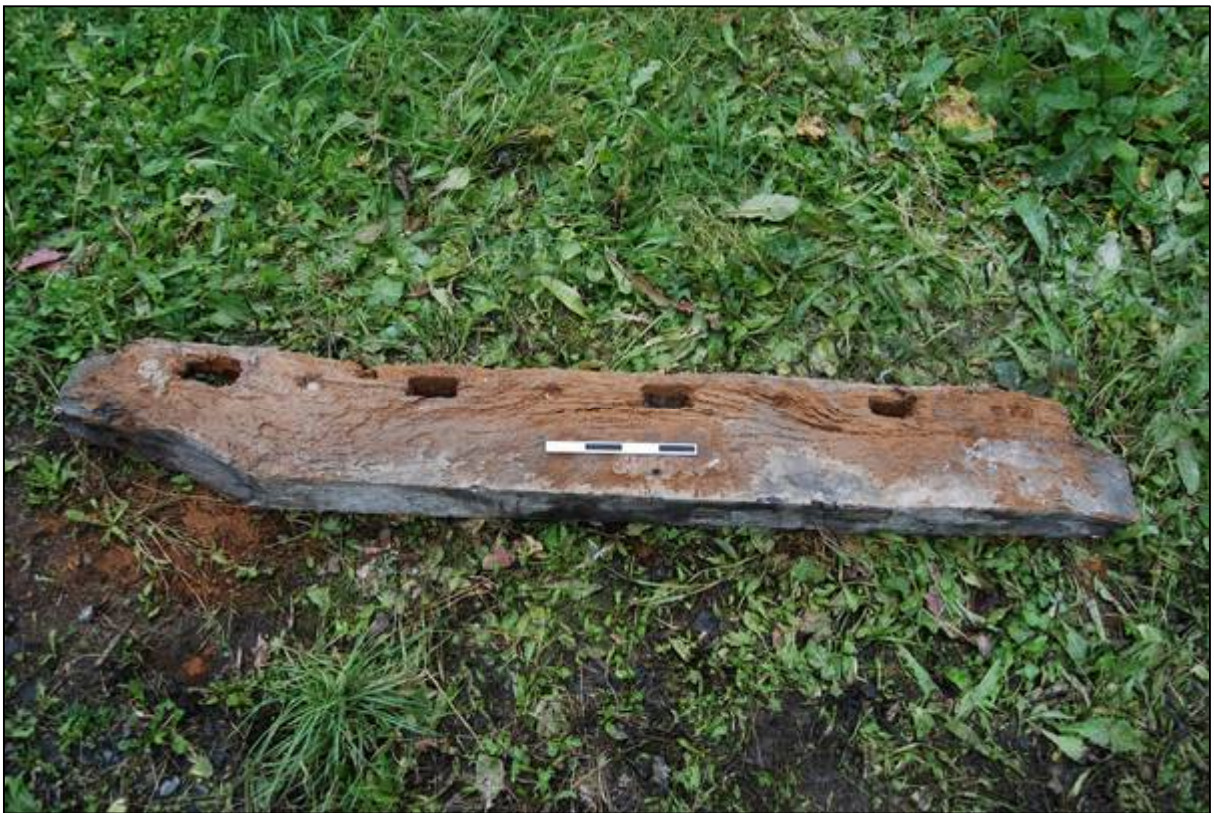
It was necessary to replace one of the lintels over the upper window of the southern bay. This proved to be a re-used timber with a series of sockets and dowel holes on one surface (Figure 5, Plate 24). The mortise holes and dowel holes in this timber would suggest that it was originally one of the rails from a partition. There is a distinct lack of wear on the surfaces of the timber, thereby suggesting that this was part of the top rail of a plank and muntin partition. Assuming that this timber was originally from the house itself, it is likely that it formed part of the cross passage within the original hall house. It is noted that the southern side of the cross passage has been replaced with an eighteenth century, brick, wall, giving an opportunity to free up this timber for re-use.

Plate 24: Re-used timber rail

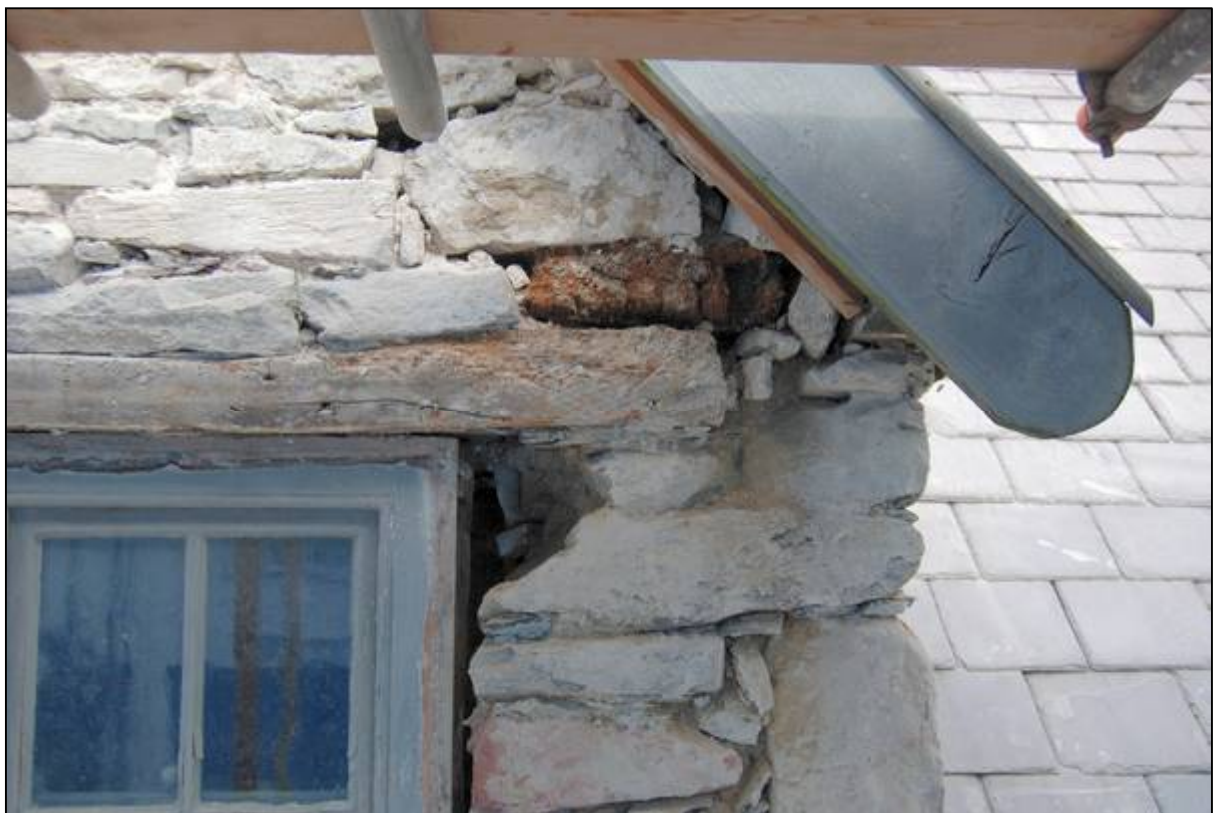
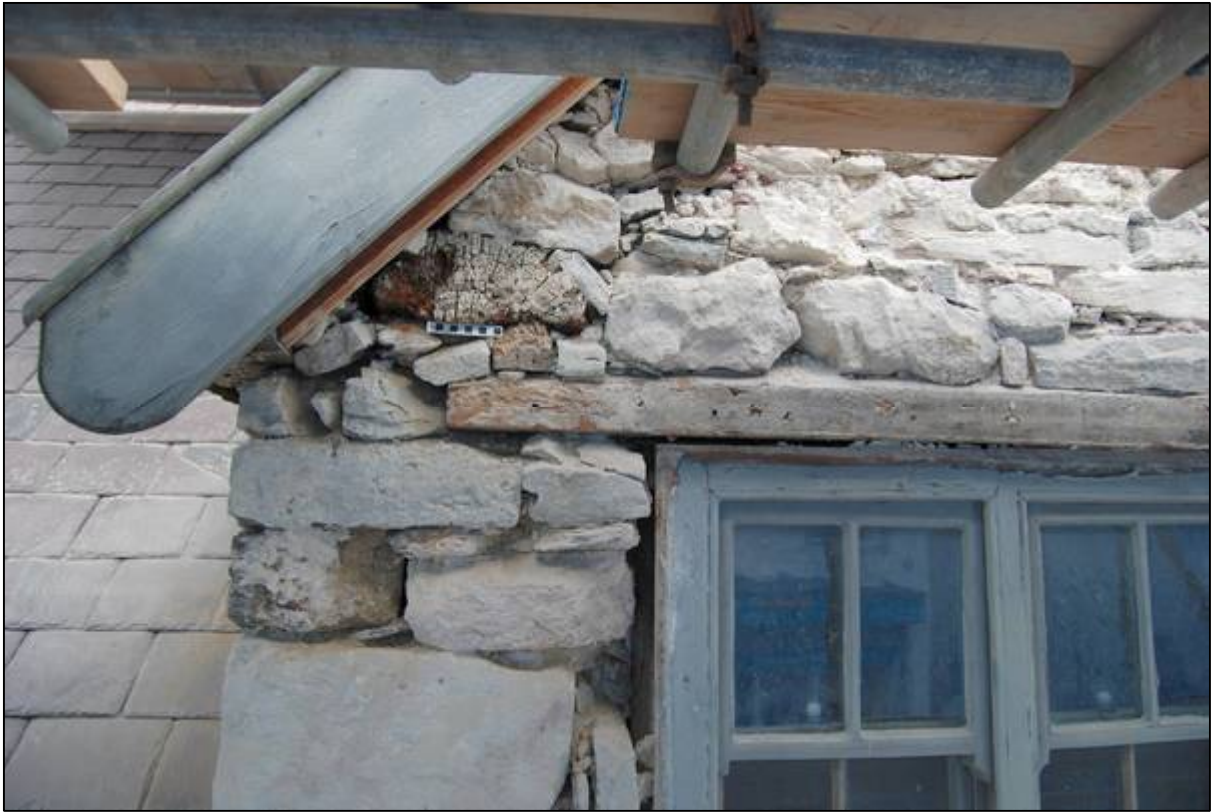
The exposed end of the purlins seen in the gable ends of the bays (Plates 26 and 27) would suggest that, at least, the bays were always intended to be rendered. The exposed ends of timbers, such as these, would be an opportunity for rot, and therefore it is likely that these

surfaces were sealed with some sort of coating. A similar pattern can be seen with the wooden lintels to the windows which were not painted or otherwise sealed.

Plate 26: Exposed purlin in the gable of the southern bay

Plate 27: Exposed purlin in the gable of the southern bay

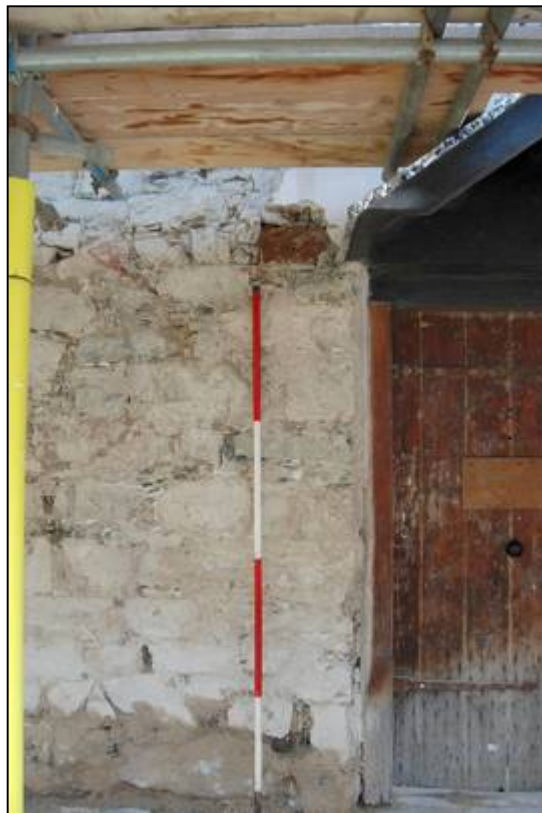
Evidence for the modification of the building were revealed around the area of the front door (Plates 28 – 30, Figure 6). A second, higher, wooden lintel was revealed together with a vertical joint in the stonework to the south. The interpretation of these features is not entirely clear. It would seem likely that the original front door was much wider, and slightly taller, suggesting a wider cross passage within the building. However the vertical joint follows the line of the southern side of the dormer, over the front door, allowing the possibility that this feature is a function of the construction of the dormer above the door. There is no correspondent joint recorded on the northern side of the door, but the door itself occupies this side of the opening.

Plate 28: Area to the north of the front door

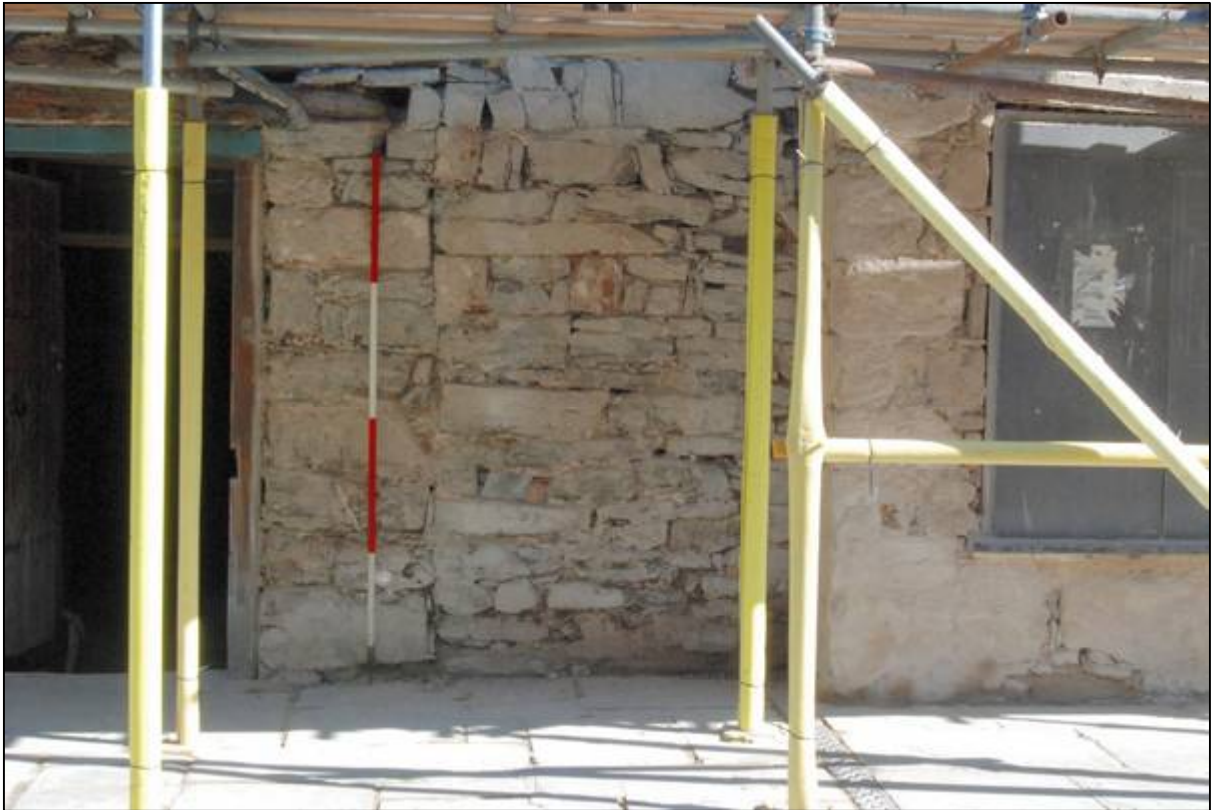
To the south of the vertical joint (Plate 29), there is a disturbance within the stonework which is suggestive of a blocked opening. Whilst not entirely clear the stonework would appear to show an opening approximately 0.50 m square, defined by a stone lintel and cill. If so this opening would appear to have been cut by the vertical joint possibly suggesting the vertical joint is most likely related to the construction of the dormer.

Plate 29: Area to the south of the front door

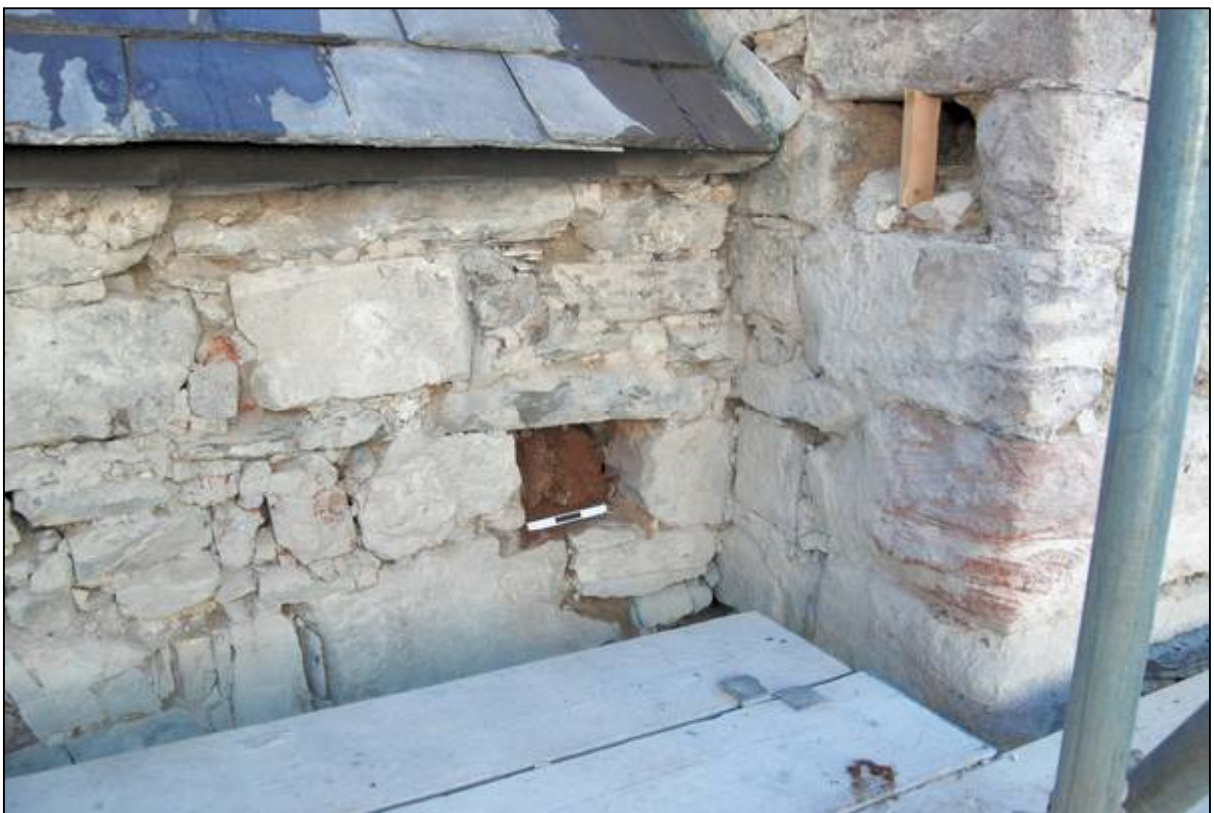
There was also the end of a timber exposed in the front elevation adjacent to the southern bay (Plate 30). This does not appear to relate any known structure within the building as it does not correspond with the location of any of the trusses or any of the ceiling beams within the house. It was a substantial timber, 0.20 x 0.17 m in size. Two interpretations are possible for this timber. Firstly that it was a strut projecting from the building to support an inn sign, however the photographic evidence back to 1885 suggest that there was no hanging sign outside the inn. Secondly the timber is the end of a ceiling beam within Room 2 for a previous ceiling, presumably before the staircase was added to the room and the composite and plaster ceiling beam added (Gwyn *et al* 2009, 18).

Plate 30: Exposed timber to the south of the front door

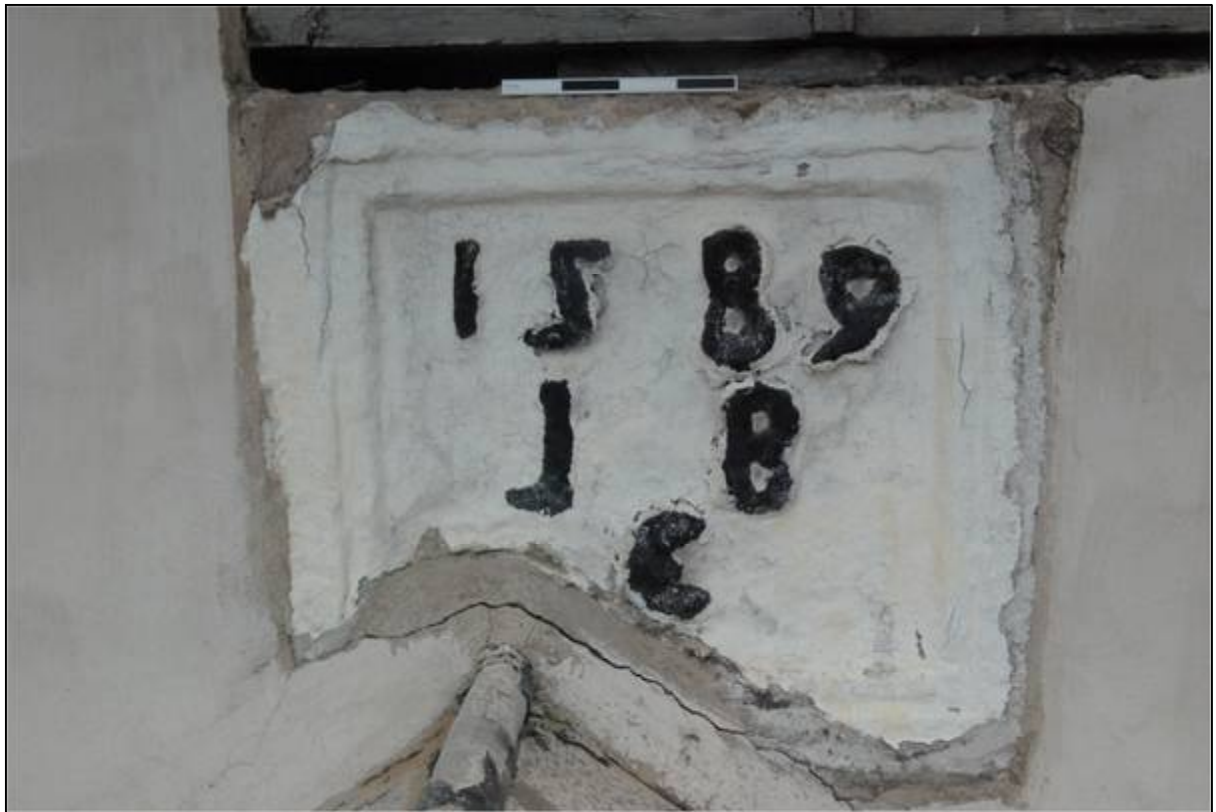
The restoration work allowed for a closer inspection of the date plaque on the front of the house (Plate 31). This is carved on a relatively thin slab (Plate 32) which has then been plastered and painted. There is some damage to the lower surface (Plate 33) where the slab has been modified to allow the insertion of the porch to the front of the house.

Plate 31: The date plaque

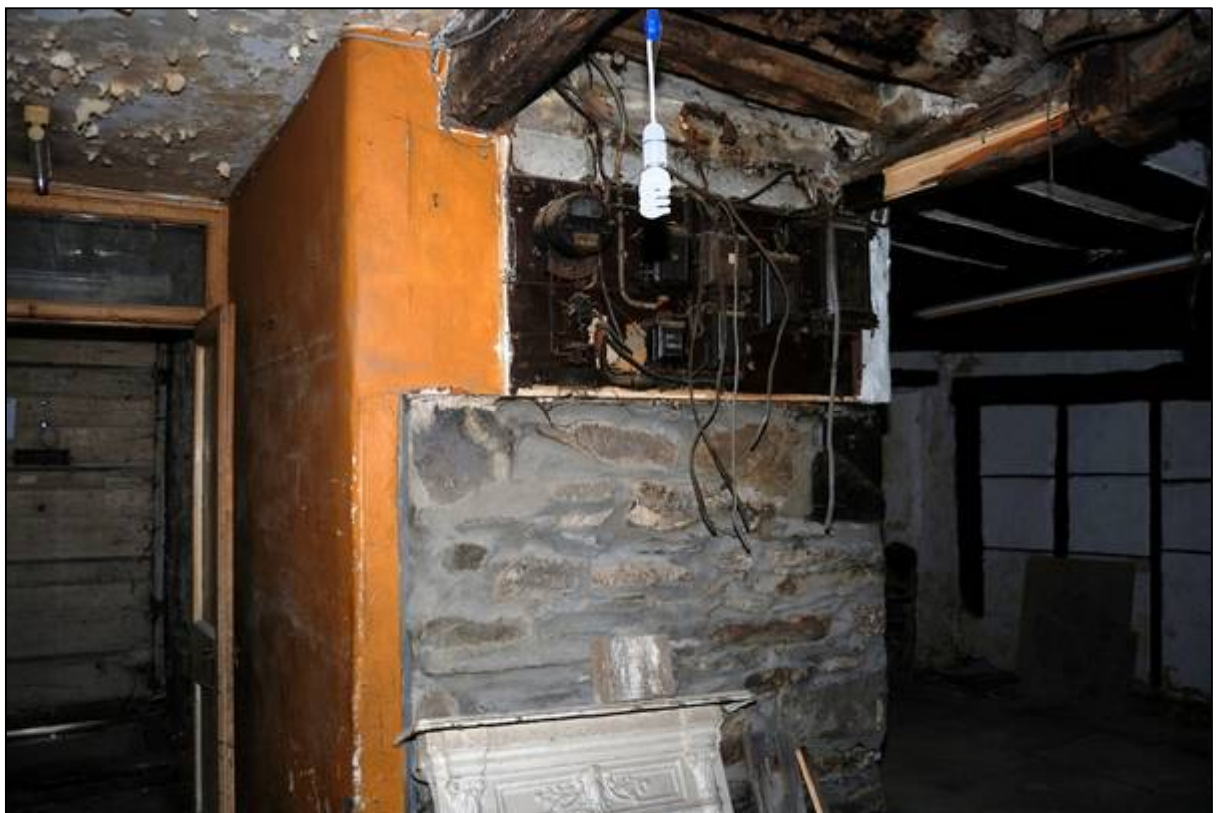
The plaster has largely been removed from the northern side of the chimney breast (Plate 36), however, the edge of the plaster running along the western side of the hall can be seen which suggests a single thick basal layer below a thin top coat. The style of the finish is similar to that on the other side of the hall (Plate 37) which is known to cover a brick wall of eighteenth century date.

Plate 36: The northern side of the chimney breast

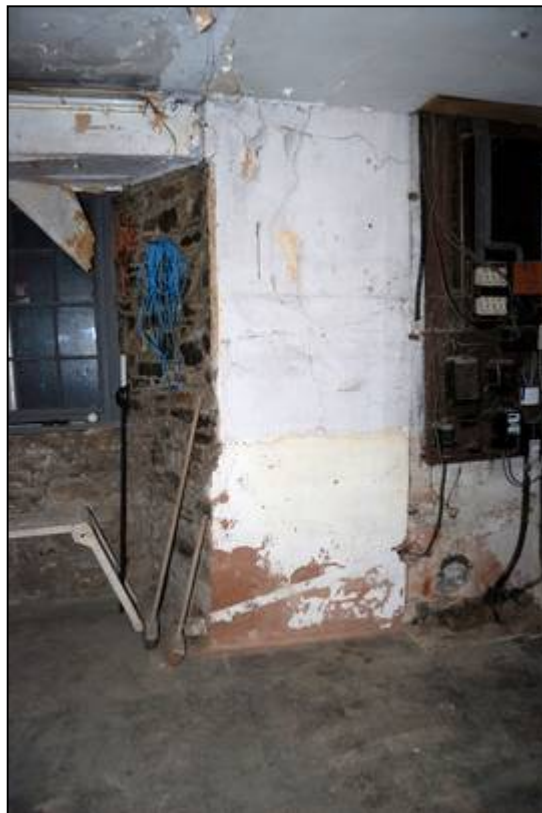
Within Room 2 (Figure 7) the surviving plaster has a pink, cementous base coat (Plate 38) and can therefore be of Medieval or Early Post Medieval date. Also where the edge of the plaster is exposed it can be seen to be a single base coat with a thin top coat (Plate 39).

Plate 38: Plasterwork in the western corner of Room 2

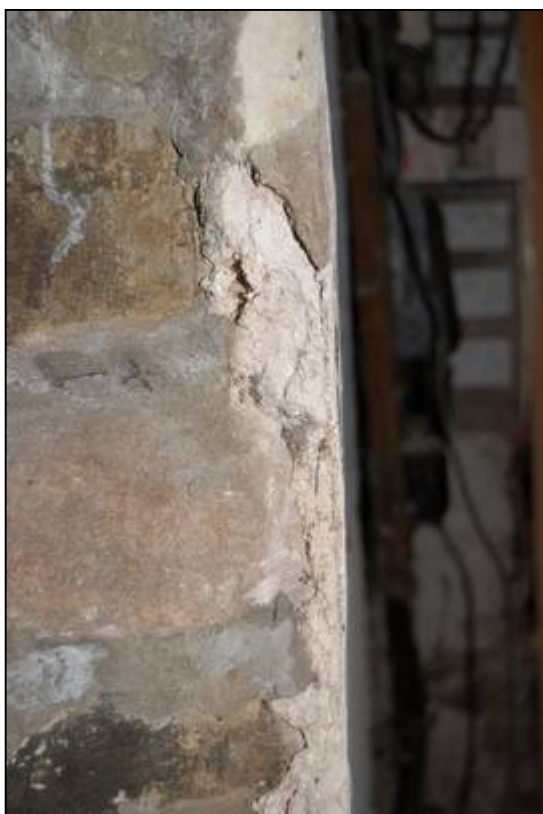
Plate 39: Detail of the section of the plaster in Room 2

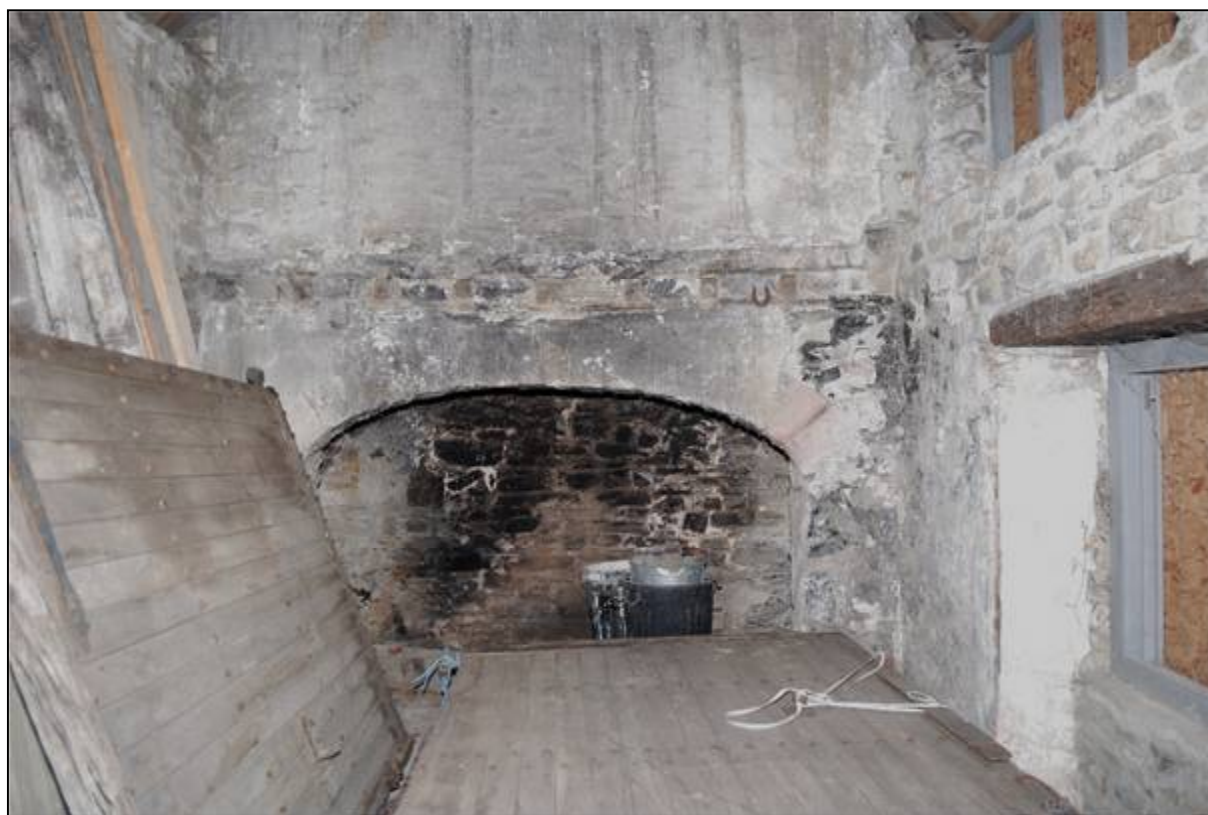
The other rooms on the ground floor consist of the “New Kitchen” which is probably a nineteenth century extension and Room 3 which was heavily modified in the eighteenth century. No plaster survives in the Service Wing (Plate 40)

Plate 40: The Service Wing

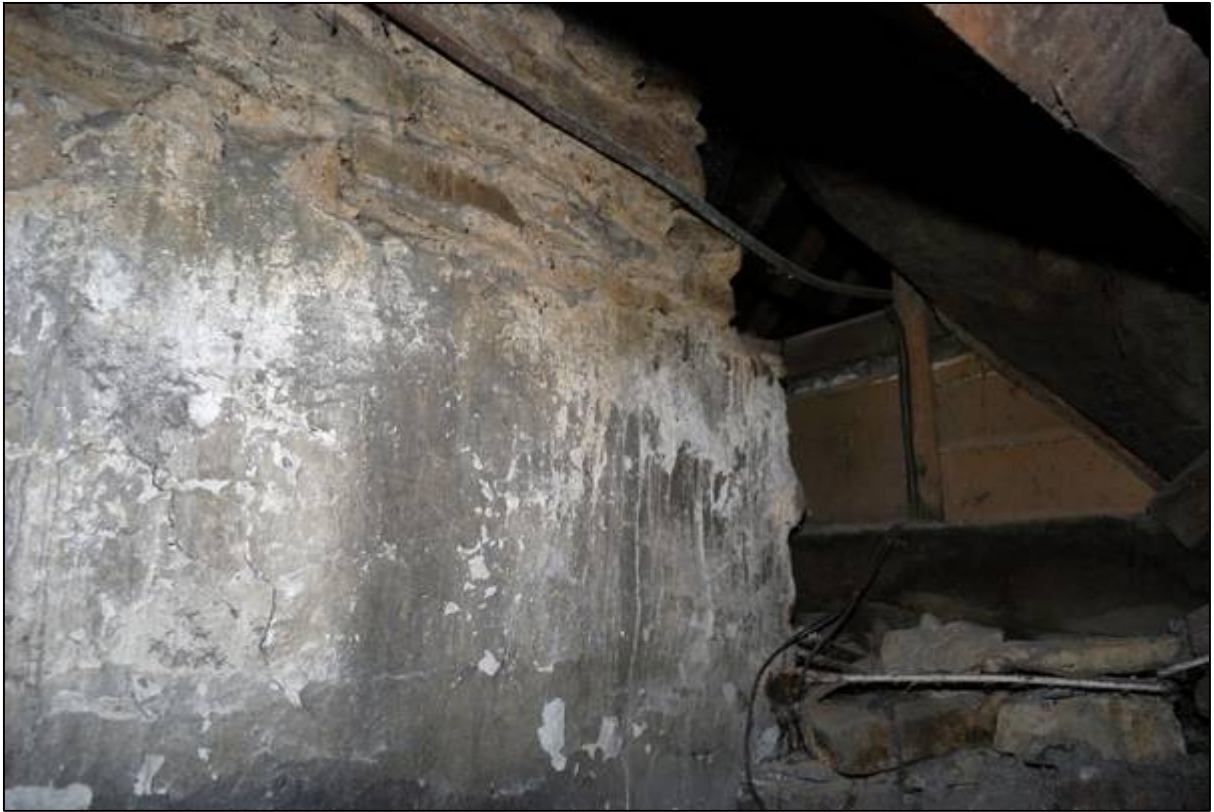
The northern side of the main chimney breast (between Rooms 4 and 7) would appear to retain a plaster surface (Plate 47) which may be earlier than other surfaces. No sign of paintwork was observed, however inspection of this surface is difficult. Room 7 has the remains of a wattle and daub partition, adjacent to the door (Plate 48). This, however, has lost its top surface. There is also an area of plaster survival to the south of the fireplace within Room 7 (Plate 49). This surface runs behind the stonework of the dormer in this room, however no signs of any paintwork survives. The eastern side of Room 7 would appear to be a plank partition (Plate 50) which is heavily covered by layers of wall paper, under which the surface is unknown.

Plate 47: Plaster on the northern side of the chimney

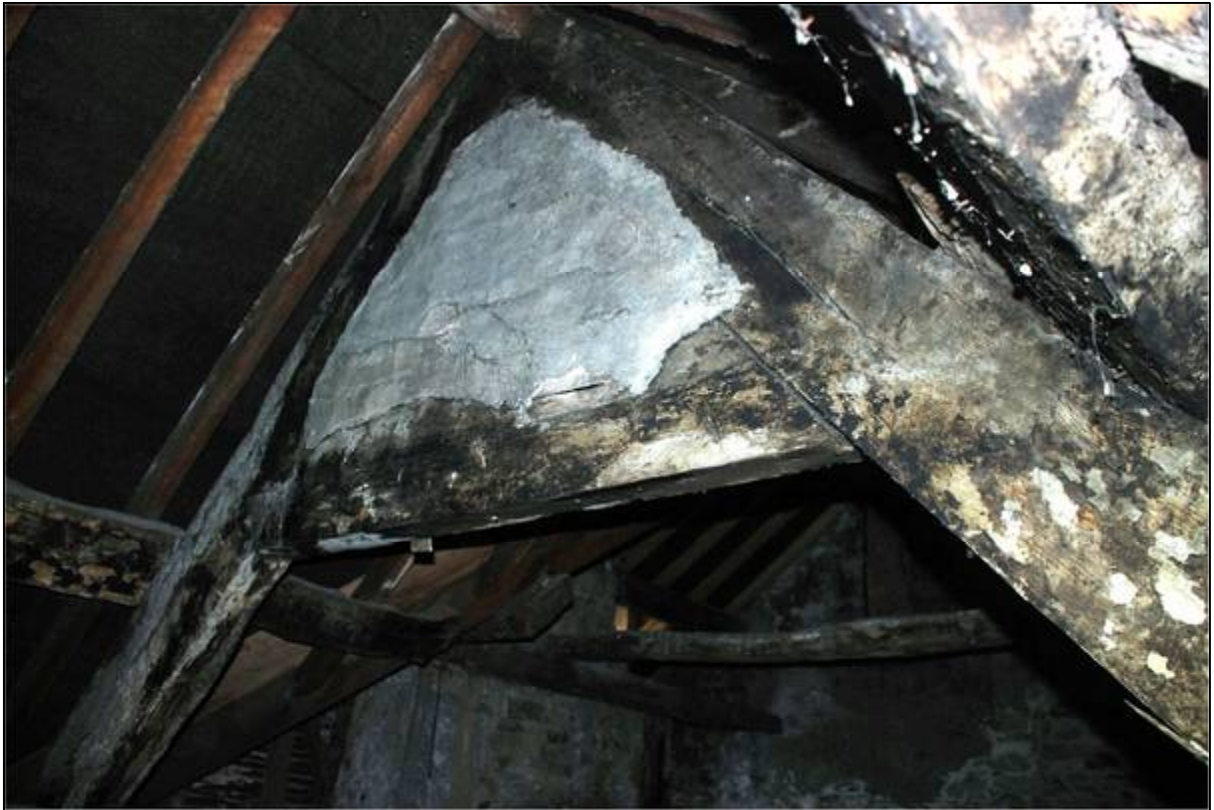
Under the peak and above the collar of Truss 3, there is a wattle and daub partition (Plates 51 and 52). This has only one finished surface to the west (Plate 51) which does not appear to have any painted surface.

Plate 51: Partition below Truss 3

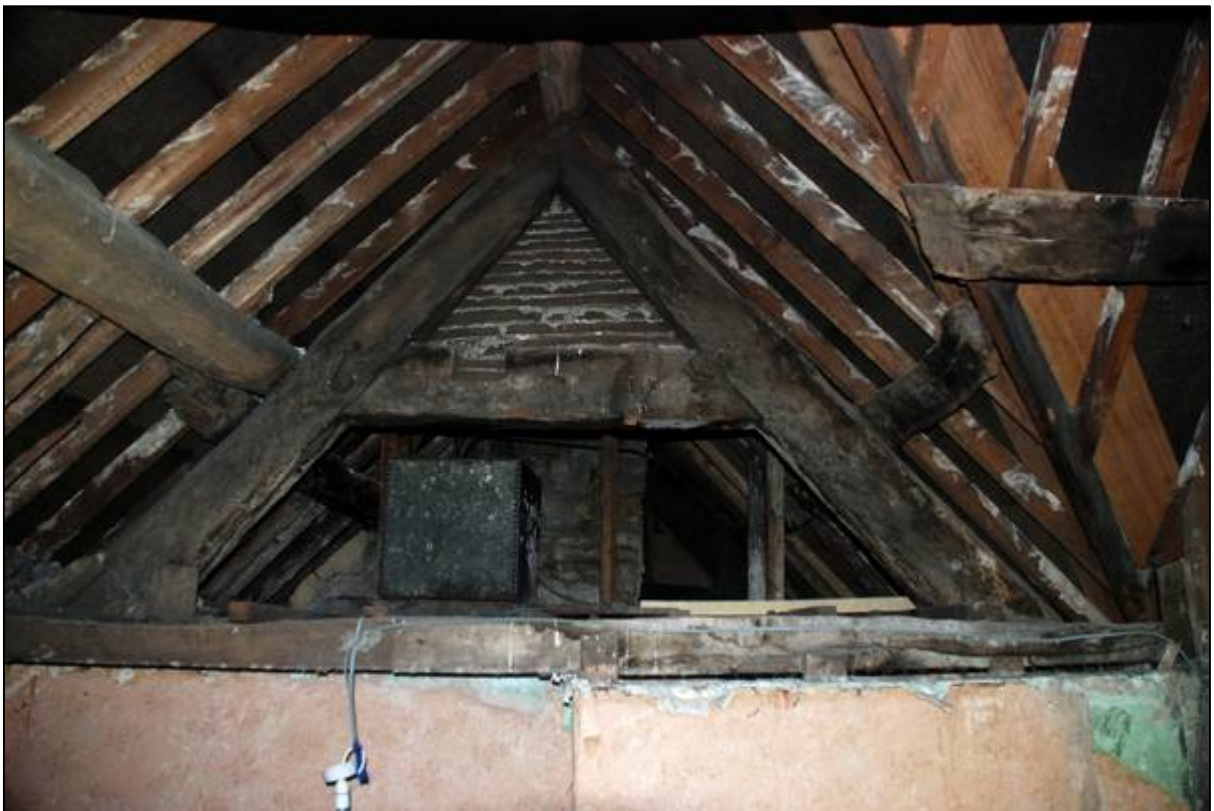
Plate 52: Rear of partition below Truss 3
