11 Stryd y Castell, Conwy

Recording of Features on the Front and SE Elevations

EAS Client Report 2014/04

**Recording of Features on the Front and SE Elevations of 11 Castle Street
Conwy and an Assessment of the Potential for the Survival of Wall
Paintings**

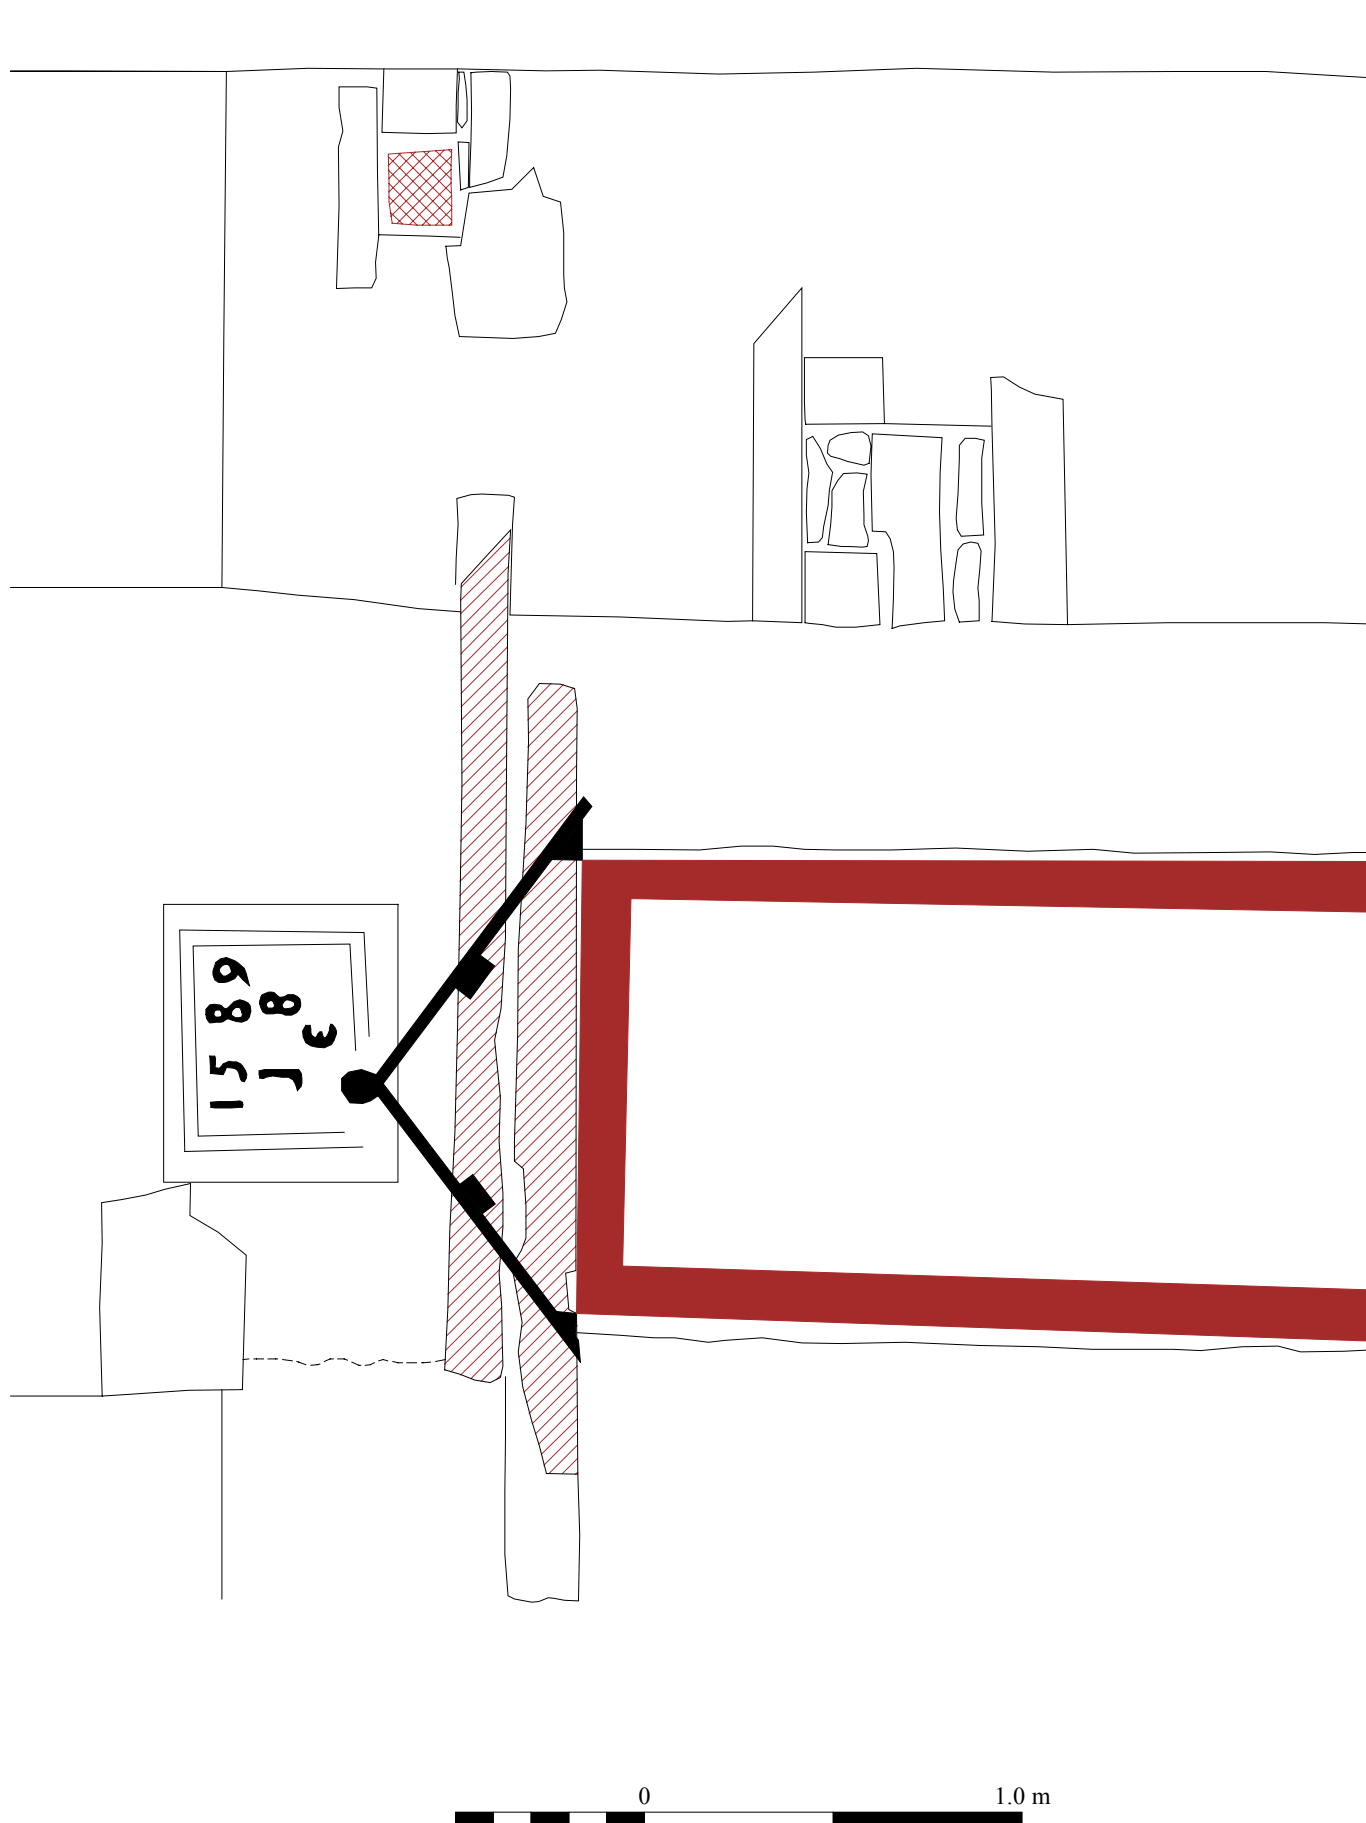
Figure 6: Area around the Front Door
Scale 1:20

Evidence for the modification of the building were revealed around the area of the front door (Plates 28 – 30, Figure 6). A second, higher, wooden lintel was revealed together with a vertical joint in the stonework to the south. The interpretation of these features is not entirely clear. It would seem likely that the original front door was much wider, and slightly taller, suggesting a wider cross passage within the building. However the vertical joint follows the line of the southern side of the dormer, over the front door, allowing the possibility that this feature is a function of the construction of the dormer above the door. There is no correspondent joint recorded on the northern side of the door, but the door itself occupies this side of the opening.
