DYMOCK ARMS, PENLEY

Date of Survey: 26th July 2012

The site was visited after fire damage, prior to refurbishment, at the request of Anna Irwin Wrexham conservation officer.

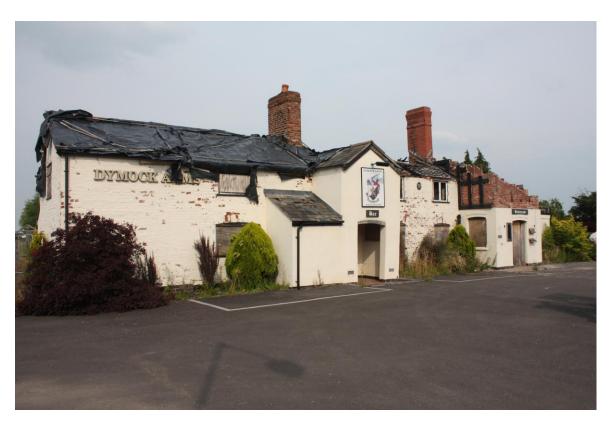
Front south-east elevation

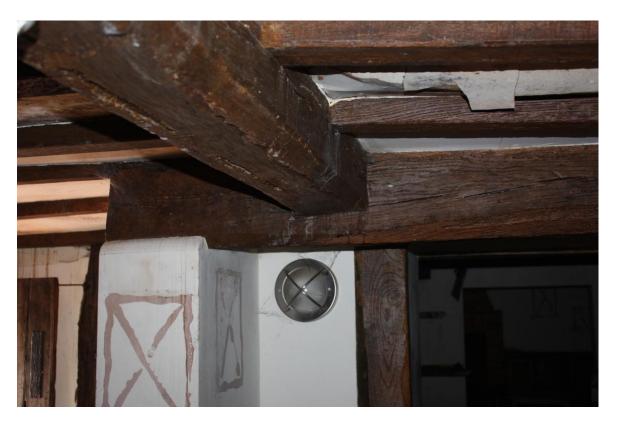
Hall fireplace bresummer, with ceiling-beam and joists

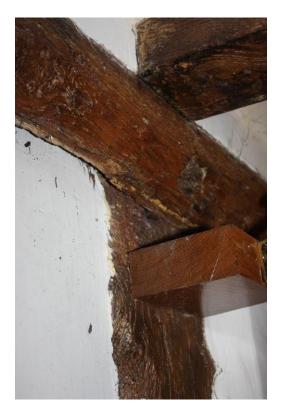
Hall side beam supporting joists.

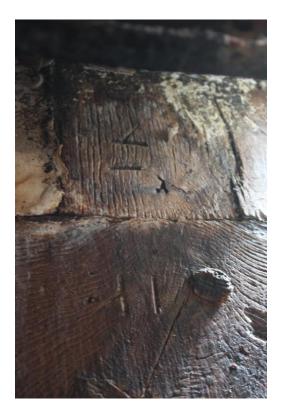
Assembly marks to truss partition in hall

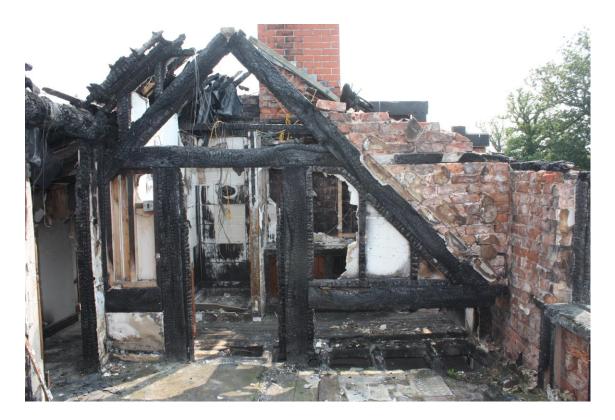
Interupted tie-beam truss between hall and inner-room at first-floor.

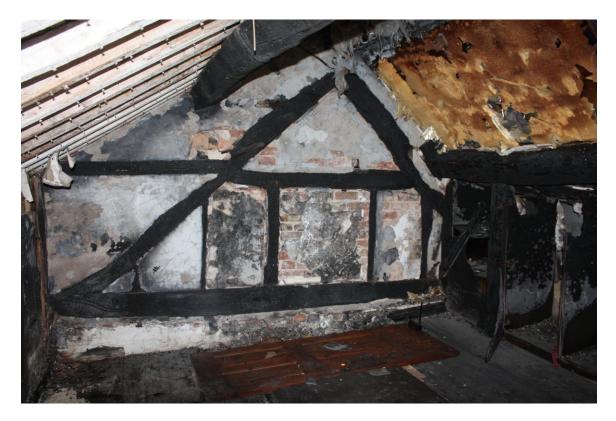
Cowhouse/stable end truss, from inside.

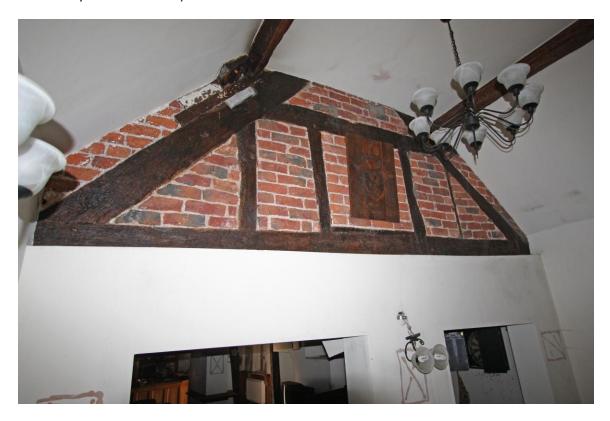
Cowhouse/stable end truss, from former outside.

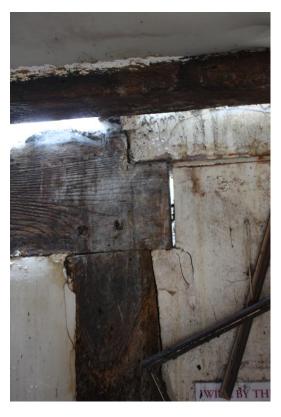
Chamfered doorway to stud in partition.

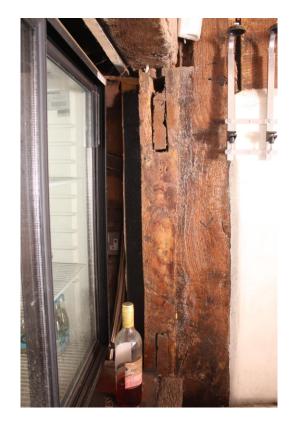
Partition post with mortices to square framing.

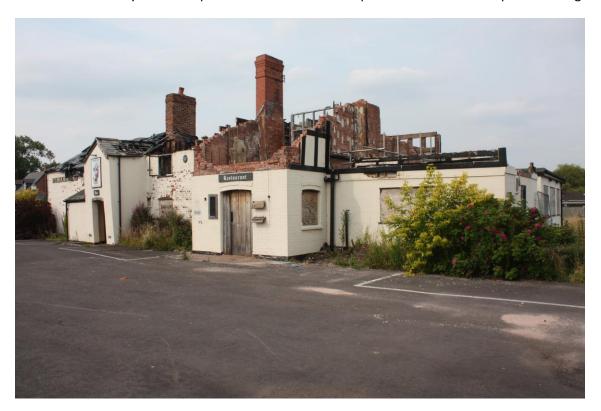
Main Façade, view from south

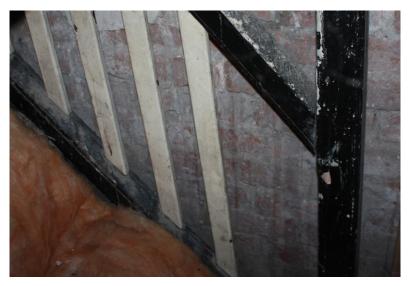
Stair in former cow-house/stable, against the front wall.

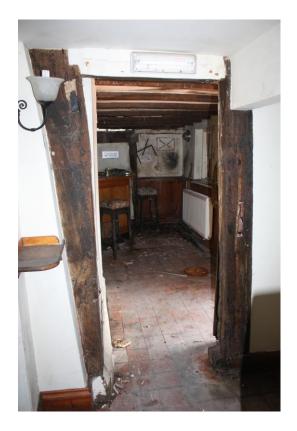
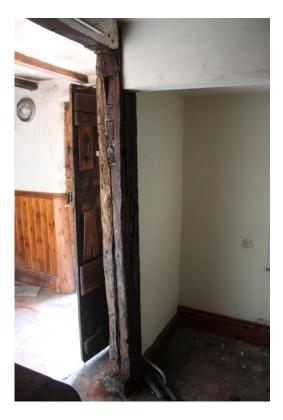
Re-used timber studs, in doorway beside fireplace, viewed from former cow-house/stable, and to right hand, stud with groove for wattle, with head mortices for a doorway.
