Cathays Library Refurbishment

Pre- Development Tree Inspection and Report

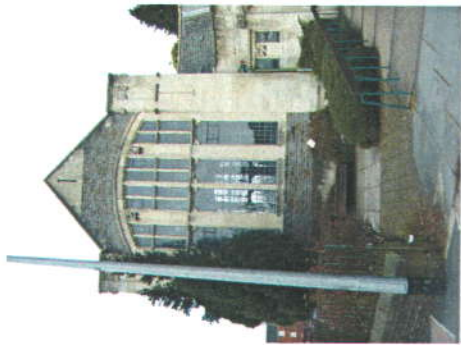
Tree T9 (front West wing)

T9	Chamaecyparis species	M	10	BB	22	Avg 2m	S	Similar tree to the above, situated to corner of building to front of library. Again could be removed if required and replaced. Both of these trees have limited value providing some landscape impact with the area. The trees within the cemetery, apart from T6, form a very important row of trees, visually providing a backdrop to the building from the cemetery. They have a medium to long life expectancy and all should be retained with minimal pruning required to prune back from the building. All require adequate protection during period of renovations.

- 3.3 2 No trees of limited value to the front amenity area and in close proximity to front walls and windows Ref tree tag reference plan(T8 & T9) are to be removed to accommodate new ramps and ground levels and enhance the symmetrical layout of this area.

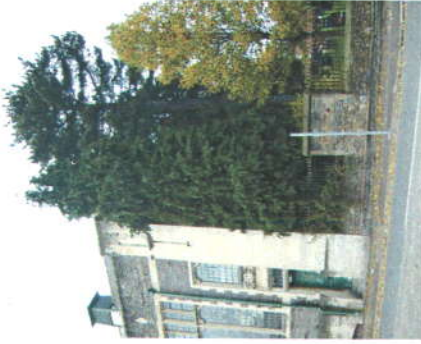
Tree T1

Tree No.	Species	Age	Hgt mtr	Ca t	DB H cms	Crow n Spread (M)	Life exp t	Condition	RPA (m2)	Protection Radius (m)
T1	Chamaecyparis lawsoniana (Lawsons Cypress)	M	12	B	31	Avg 2m	M	Single stemmed conifer, healthy condition, situated within the cemetery approx. 5 m from the corner of the building and adjacent to the road. Compact crown with moderate growth. Very stable tree with a moderate life span, unlikely to develop much bigger. Holds one main side limb which has slight impact on building.		
T2	Pyrus chanticleer (Ornamental pear)	s/m	10	B	19	2 N 2.5 S 1.5 W 3 E	L	Healthy young tree, full well developed crown, long life expectancy, growing in cemetery		
T3	Pinus nigra (Black Pine)	M	25	A	68	4 N 5 S 4 E 4 W	M	Very fine dominate tree, full healthy well balanced crown formed on single main stem. Reasonable life expectancy. Minor deadwood evident in upper crown. Crown overhangs building which will require pruning back. Growing in cemetery, 1.6m from rear of building. Important to retain

- 3.5 1 No Conifer tree within 0.5 metres of the rear corner of the building and on cemetery land Ref tree tag reference plan (T1)is to be removed. This tree is overhanging the public highway and parapet gutter which is not easily accessible from the Fair oak Road side. This tree is in close contact with the fabric of the building and in the vicinity of the existing foul drainage system and basement outer walls.

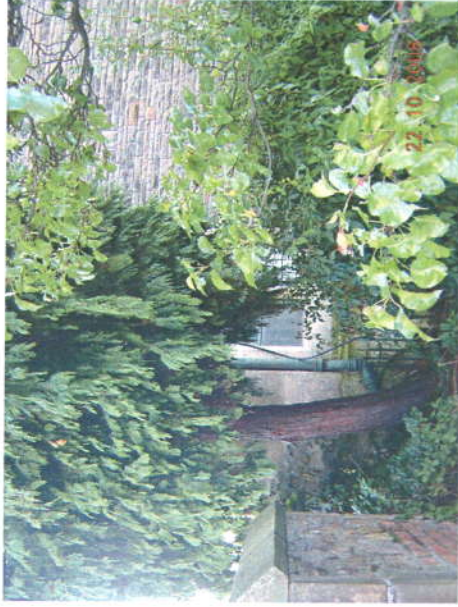
Tree T1 (proximity to building & foul drainage)

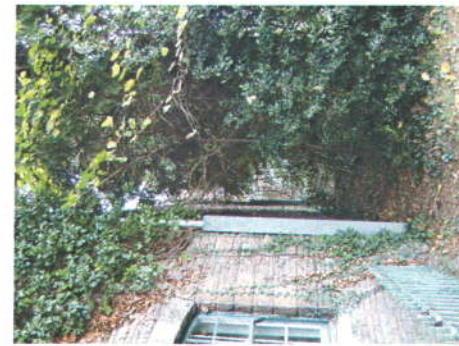
- 2.4 It is evident from the condition report that the close proximity and overhanging trees have resulted in fallen foliage and leaves at roof level and thus exacerbated the blockages and failure to the drainage systems at roof level; parapet gutters, rainwater hoppers, outlets and the rain water down pipes. The access to parapets gutters is severely restricted in particular on Whitchurch and Fair oak main road elevations with steep pitched roofs to each wing and are subject to parapet gutter blockages from the fallen foliage.

- 2.7 At ground level it is evident from the condition report that there is a deep build up of fallen foliage from the adjacent trees along the rear perimeter track by the library. This has led to retention of damp at adjacent ground levels and basement ceiling levels to the rear of the building which is further exacerbated by the failure of the rear rainwater down pipes and gulleys. These rear gulleys are blocked by foliage and their soakaways have become exhausted. Tree root penetration is evident in CCTV drainage surveys. The latter points have been established by Dyno-Rod Drain Services in their site drainage inspections on 19th December 2008 for Projects Design and Development, Cardiff City Council.

RWDP's & Ground Foliage

- 3.2 As advised by the Arborculturalist Officer and recommended in the property condition report, the adjacent trees are to be pruned back away from the building lines, climbing ivy is to be removed and fallen foliage and leaves adjacent to the building are to be taken up.

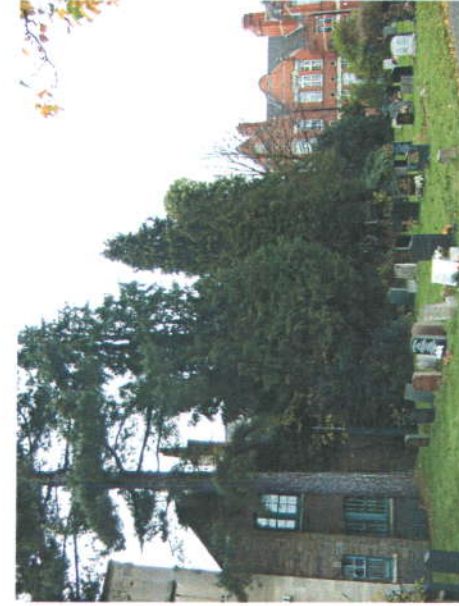
Trees T3 to T7

T4	Chamaecyparis lawsoniana	M	16	B	53	3 N 3 S 3 W 3 E	M	Fine healthy tree, single stem holding well balanced crown of good density, extensive ivy growth developing along main stem. Growing in cemetery, approx 3m from rear of building		
T5	Chamaecyparis lawsoniana	M	15	B	51	Avg 2m	M	Reasonable condition, dense crown of moderate growth, ivy developing in crown. Growing in cemetery, approx 4m from rear of building, lower branches overhang building

T6	Chamaecyparis lawsoniana	M	14	C	47	2 N 3 S 1 W 2E	S	Moderate to poor condition, extensive ivy growth as subdued crown with only lower live growth remaining, very limited life. Situated in cemetery
T7	Tilia platyphyllos (Lime)	s/m	12	B	58	6 N 6 S 5 W 5 E	L	Very fine multistemmed tree with full dense crown arising from three main limbs from base. Very healthy young tree with long useful life expectancy. Situated within cemetery to rear of toilets, upper branches impacting on building. Some crown lifting, pruning back required. A tree of good quality and high amenity value.
T8	Chamaecyparis species	M	10	BB	19	1- 1.5m	S	Small compact crown arising from 3 main stems at ground level, situated in corner of building to front of library. Slow healthy growth. Other limbs have previously been removed from base. A tree of limited life with some aesthetic value. Could be removed and replaced if required

- 3.4 1 No tree of moderate to limited life value to the rear and on cemetery land adjacent to the large lime tree Ref tree tag reference plan (T6) is to be removed to promote free air flow, light and health to adjacent trees and library building.
