North West Wales Dendrochronology Project:
The Gatehouse, Beaumaris

Report No. 853

Prepared for
North West Wales Dendrochronology Project

By
Andrew Davidson
&
Tanya Berks

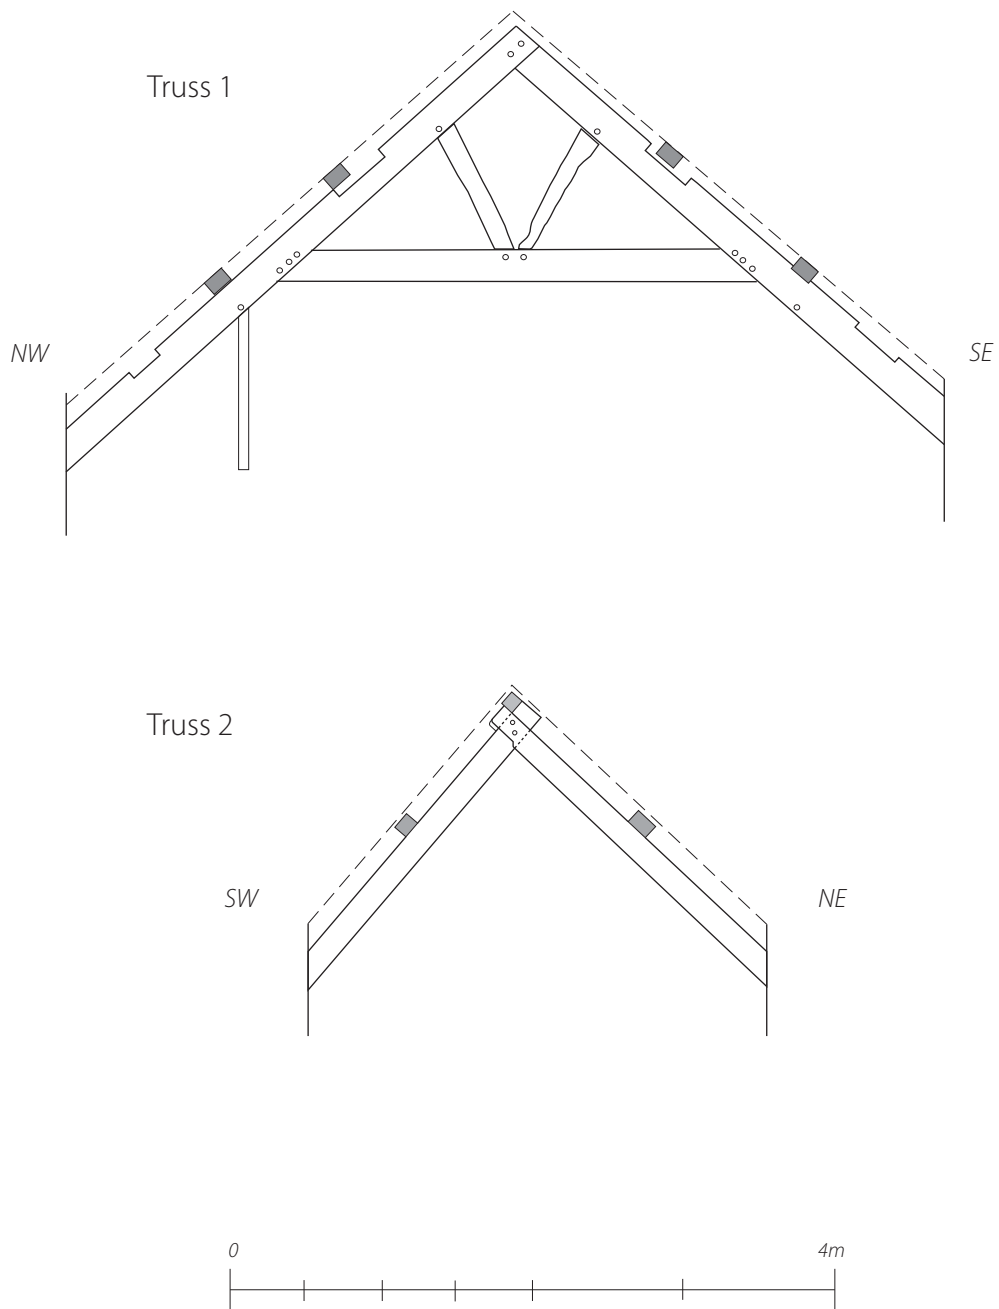
Figure 6: Trusses 1 and 2. Location can be seen in figure 5.

On the landing to the second floor is another blocked opening in the south-west wall. The roof space of the rear wing is also reached through a small door which lies half way up the stairs, but also above the level of the stairs. The second floor is the attic space. The principal roof truss, a collar beam truss with raking struts, divides the room into two bays. The former slots for wide purlins are visible in the principal rafters, but these have been removed and square purlins inserted. The rafters are not visible, but it is likely these were renewed with the purlins. A single upright on the south-east side runs between the floor and the principal rafter. A tennon for one on the opposite side shows a second one has been removed.

The second floor of the rear wing has access from a small door part way up the stairs. This is divided into two bays by a simple truss. The two principal rafters are jointed at the top with a through mortise and tennon, and a ridge beam lies in the 'V' created by the through principals. A single purlin is located on each side. The squared rafters are pegged through the purlins.

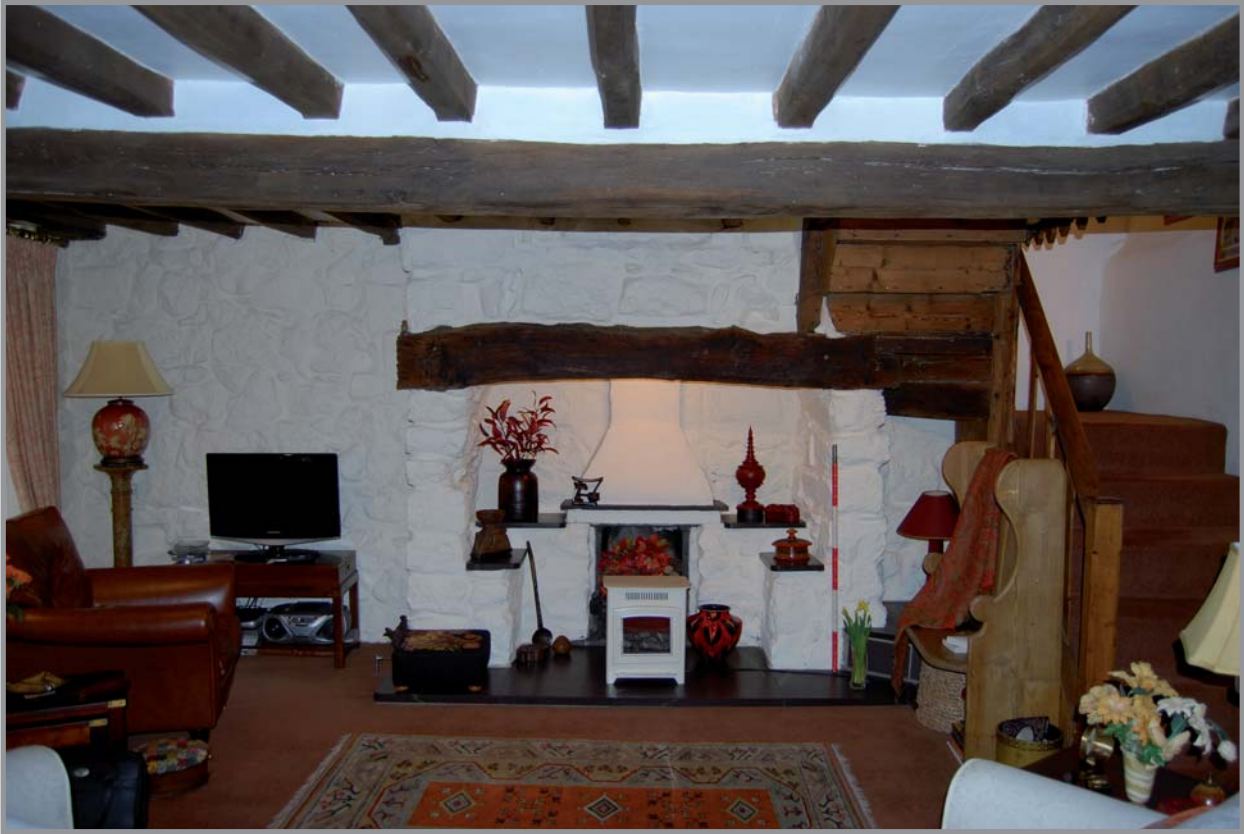
Plate 1: Ground floor living room, showing fireplace. Facing south-west

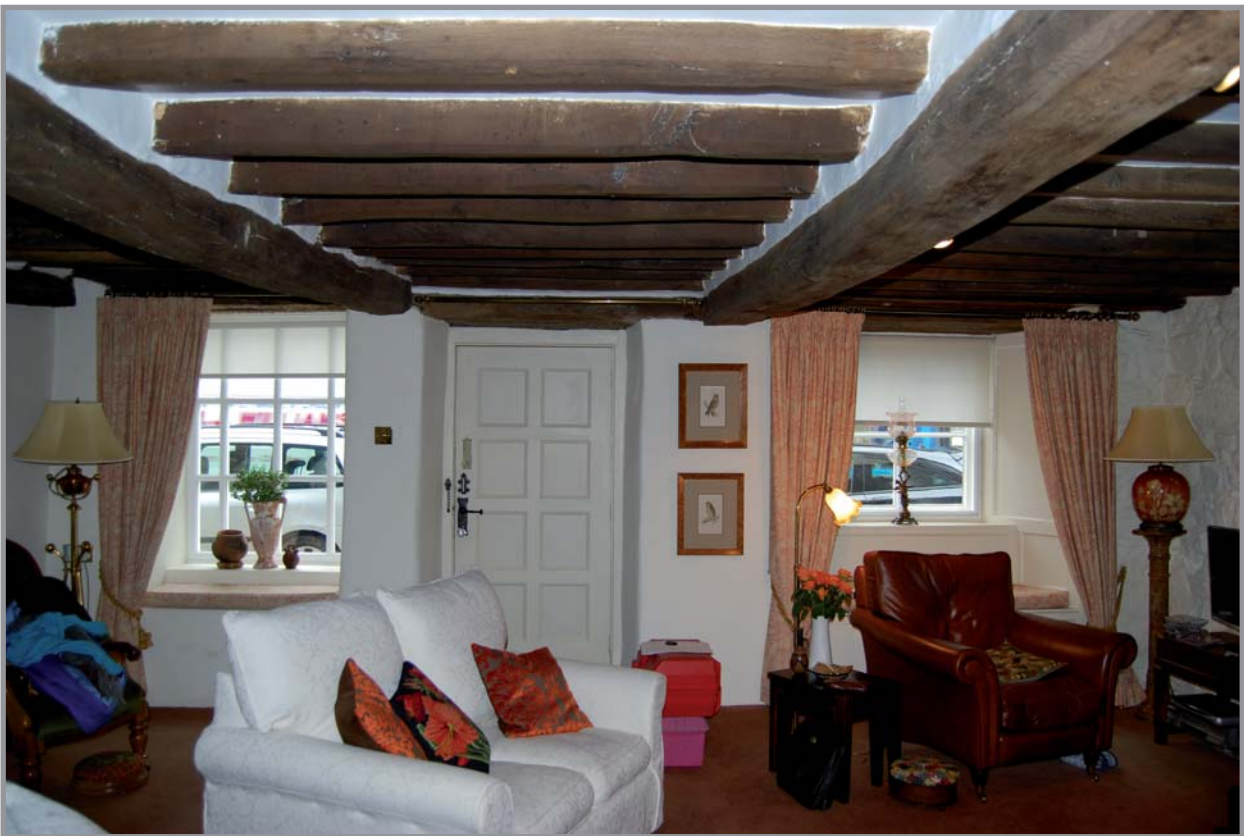
Plate 2: Ground floor living room, showing frontdoor. Facing south-east

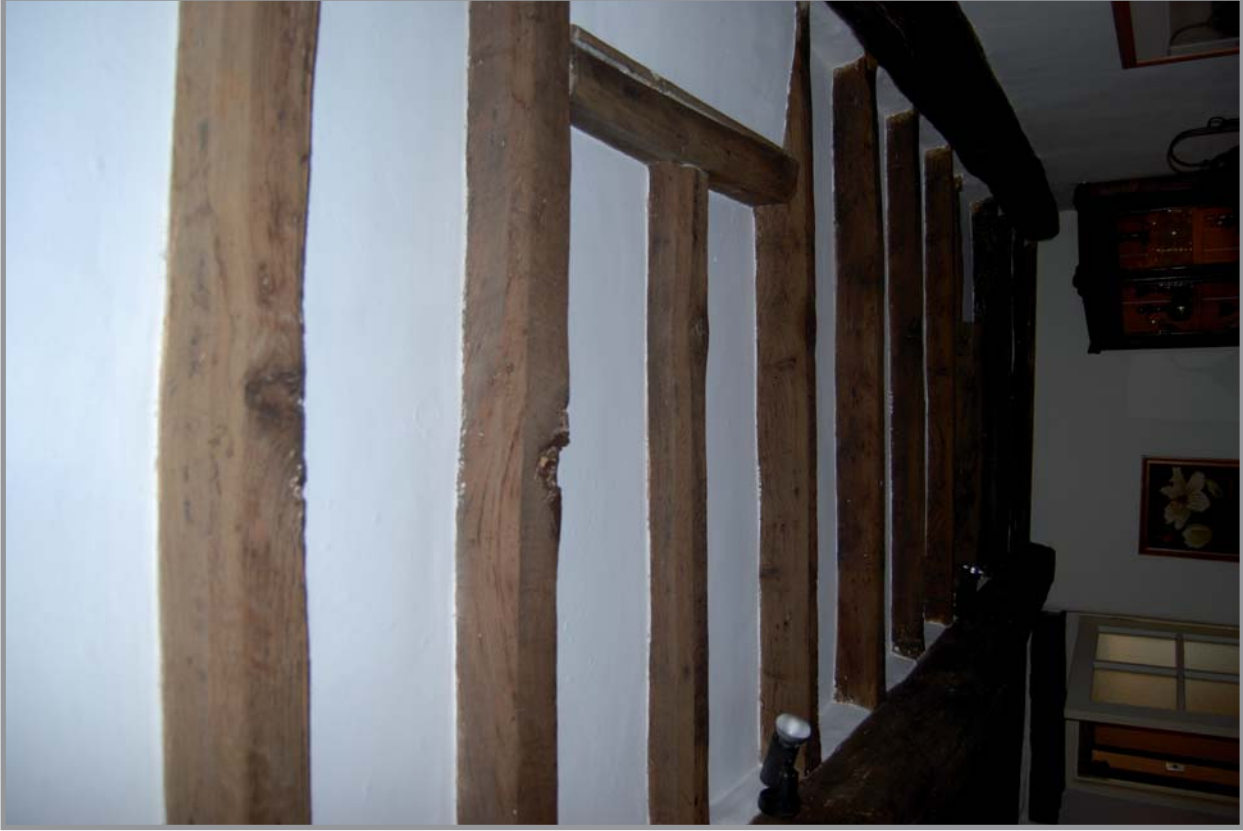
Plate 3: Ground floor living room, showing ceiling timbers. Facing north-west

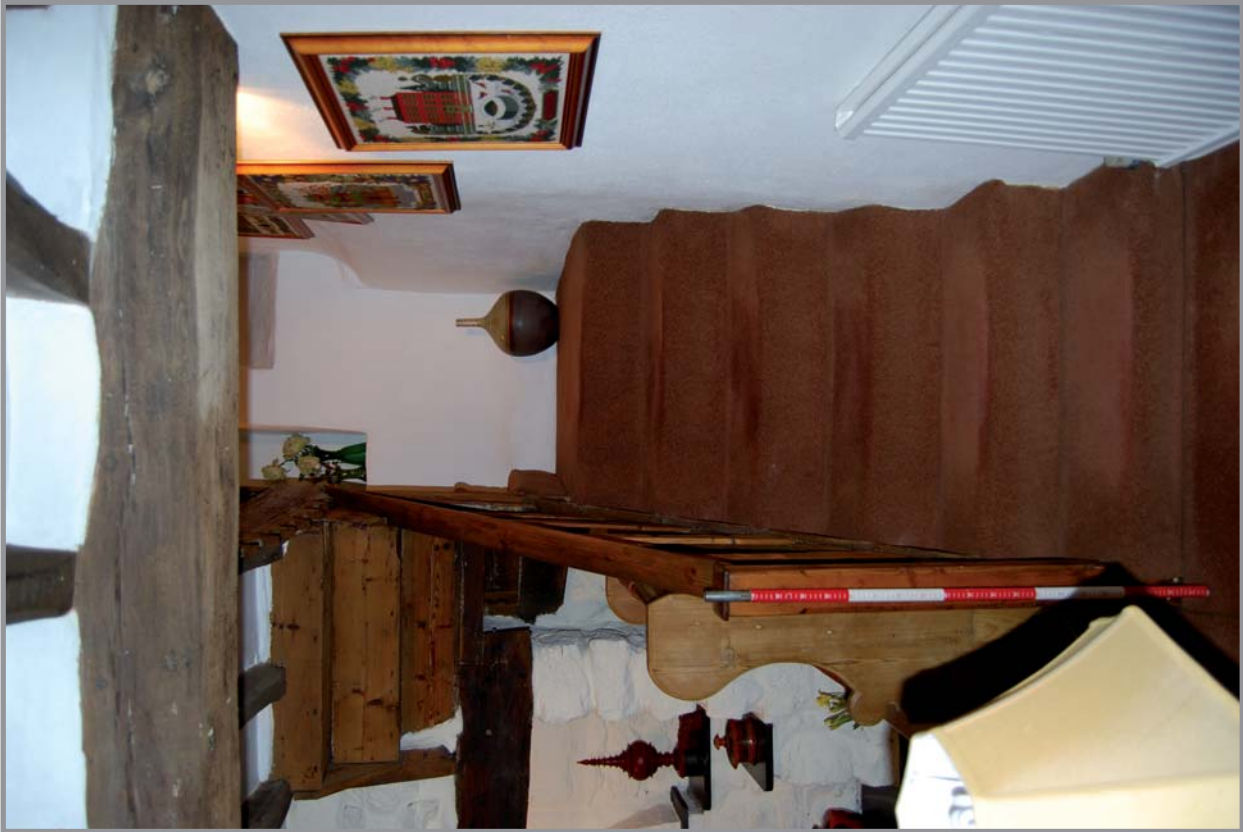
Plate 4: Ground floor living room, showing staircase to first floor. Facing south

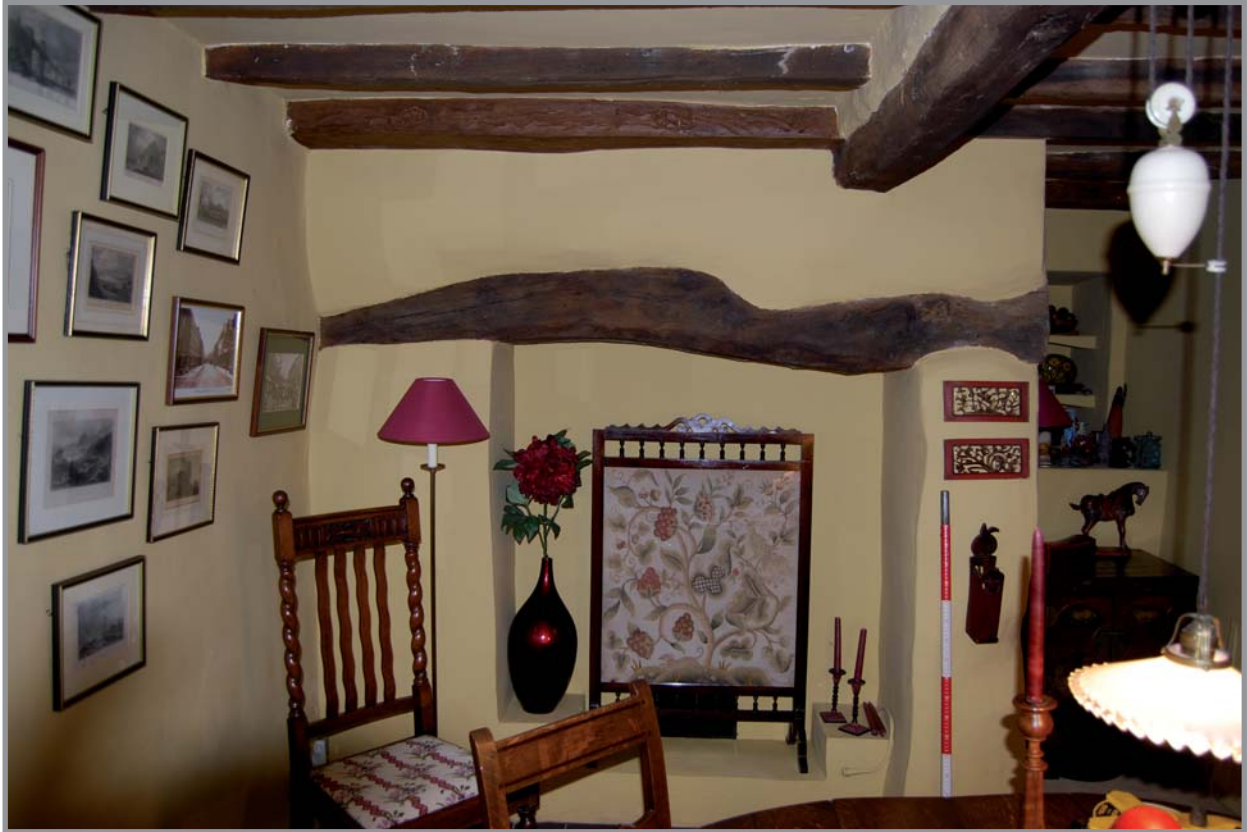
Plate 5: Ground floor dining room, showing fireplace. Facing north-west

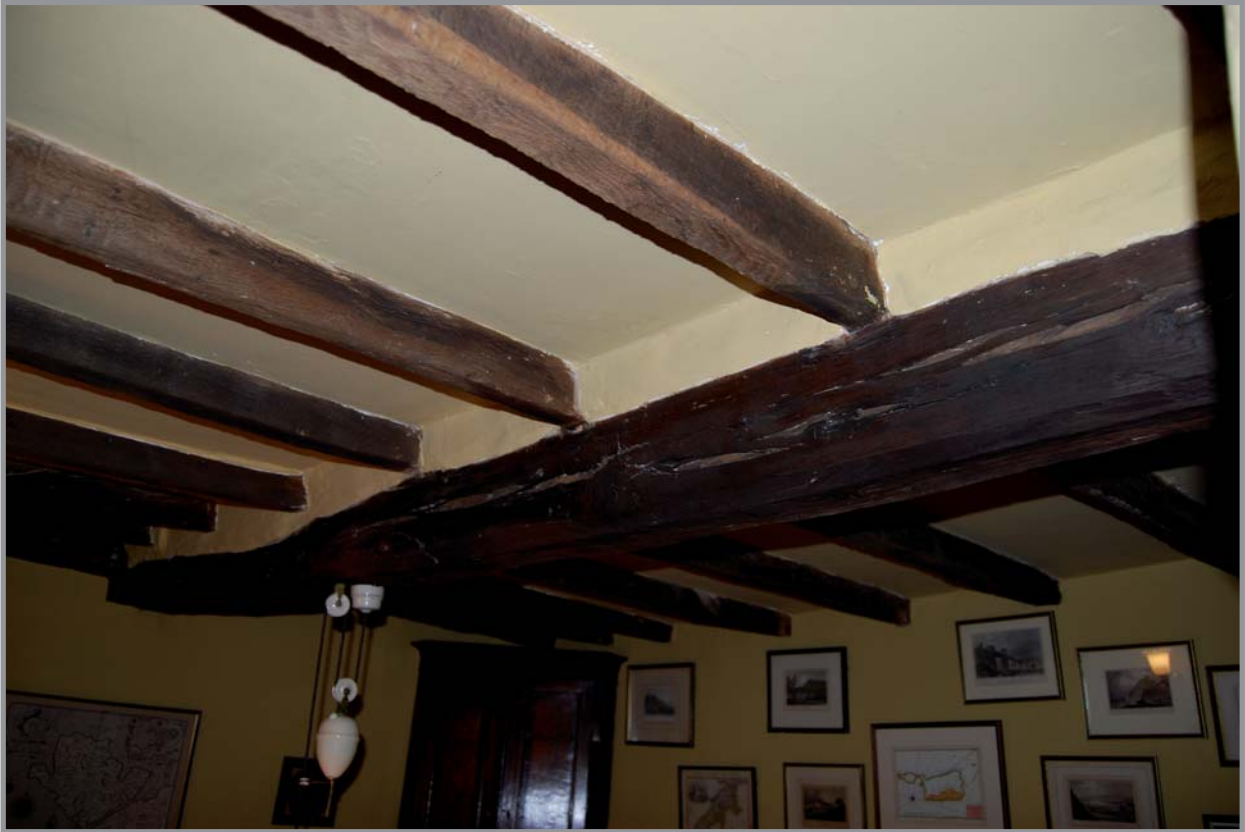
Plate 7: Ground floor dining room, showing ceiling timbers. Facing south-east

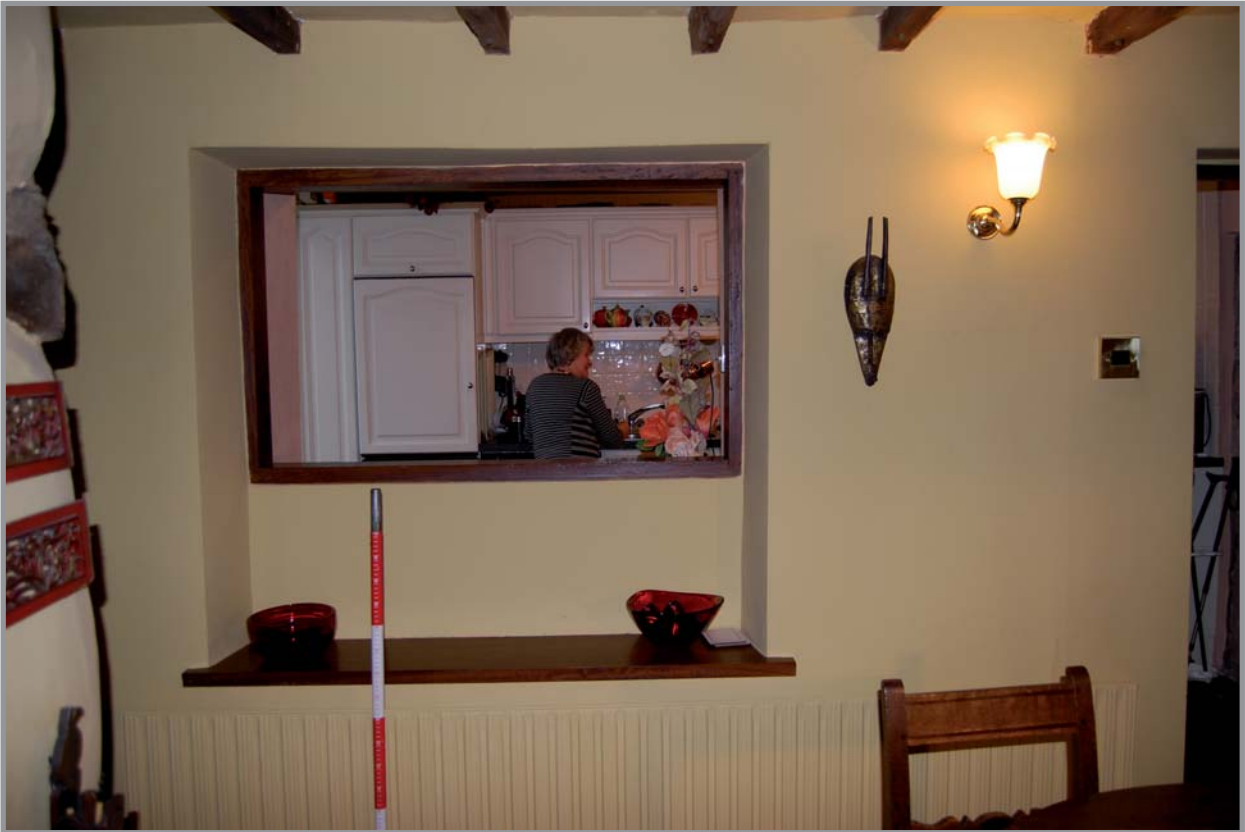
The rear wing is reached from the present kitchen. It is a small wing, divided longitudinally into two bays by a single large chamfered beam which supports squared joists. A large fireplace lies at the north-west end of the room, with a narrow space alongside that might formerly have led to a door. A large modern opening or window pierces the wall between this wing and the present kitchen.

Plate 8: Ground floor dining room. Showing replacement window through to kitchen. Facing north-east

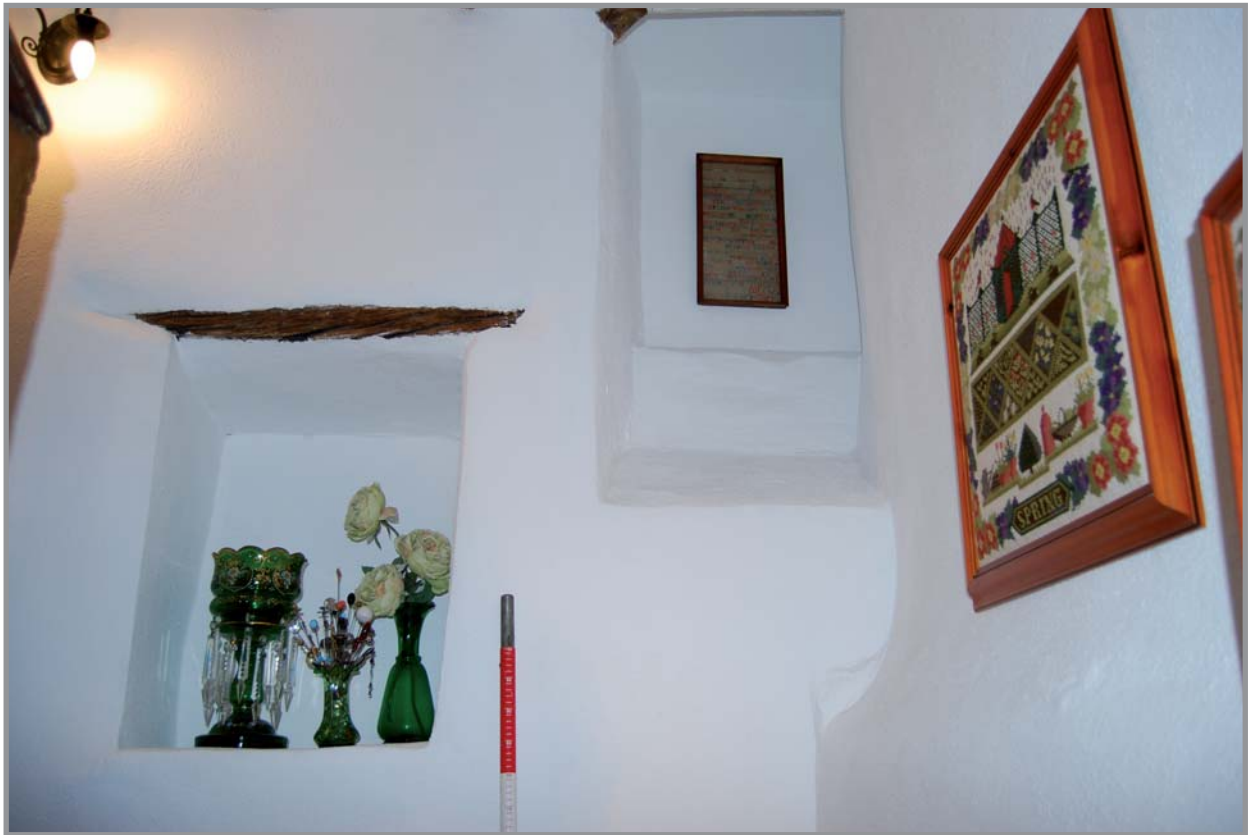
A blocked window and possible door are visible in the south-west wall off the first stair landing. The first floor is essentially two large bays divided by a chamfered beam. Squared rafters run between these and the two walls – a chamfered beam supports the joists on the inside of the north-east wall, as on the ground floor. The north-west rafters appear to be largely supported by the fireplace lintel, though all is blocked up here so it is difficult to be sure of this. In the south corner of the room is an alcove alongside the project stack – this may be a blocked door also.

Plate 9: Stairway, showing blocked window. Facing south-west

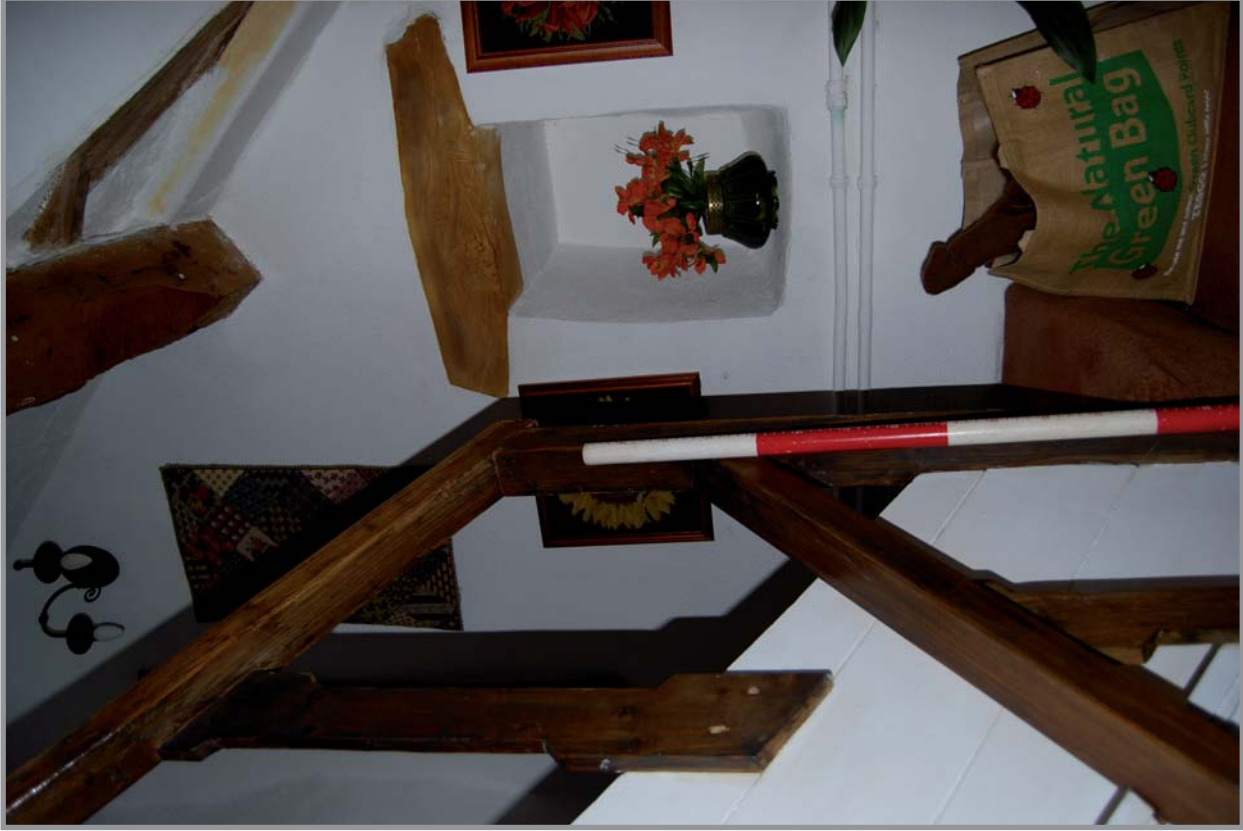
Plate 17: Staircase leading from first floor to second floor, showing blocked window. Facing south-west

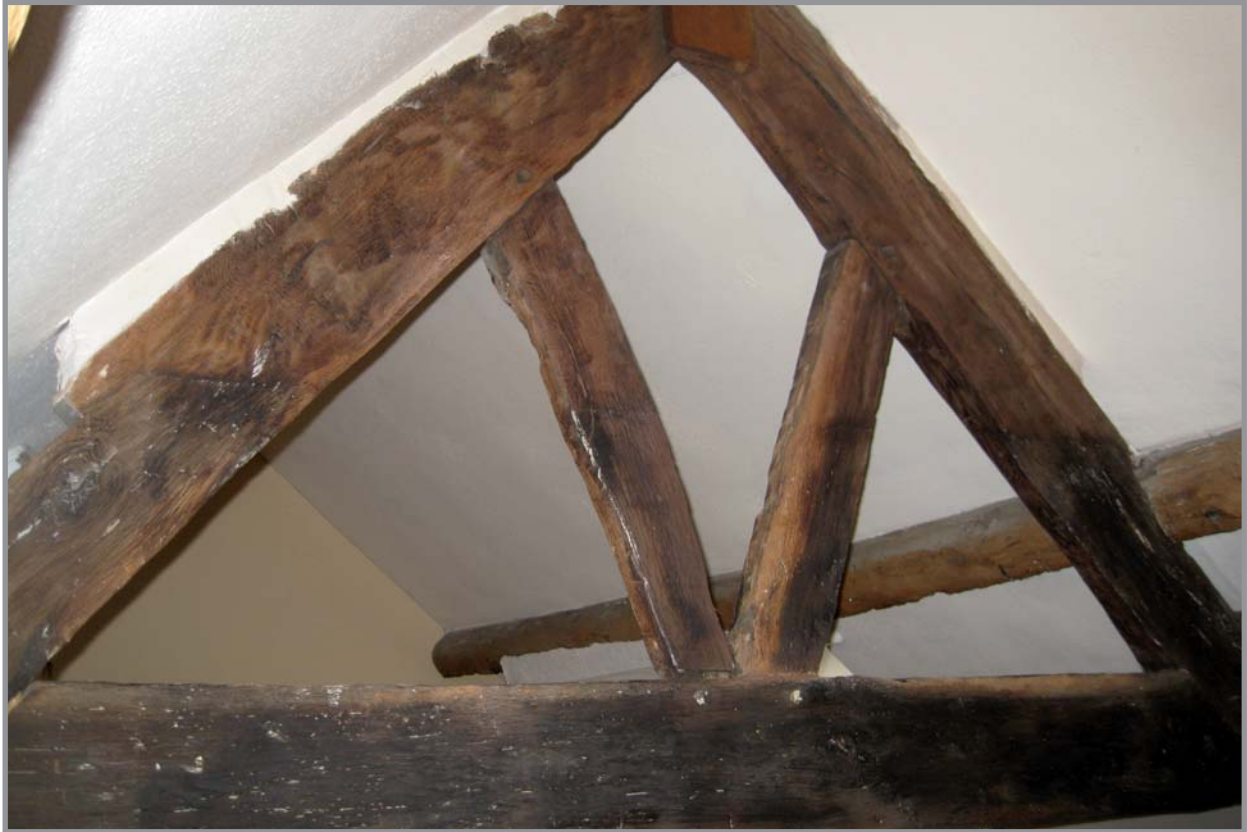
Plate 19: Truss 1 in second floor front room. Facing east

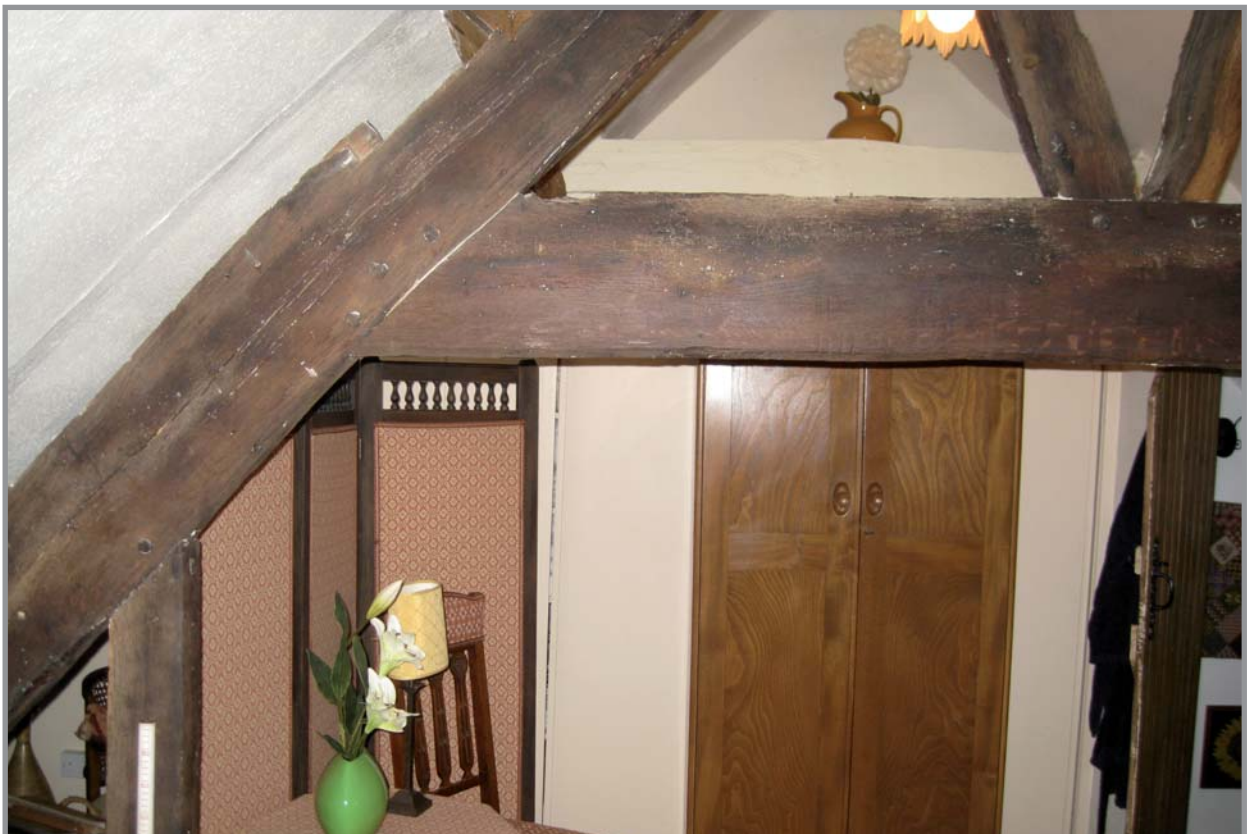
Plate 20: Truss 1 detail in second floor front room. Facing east

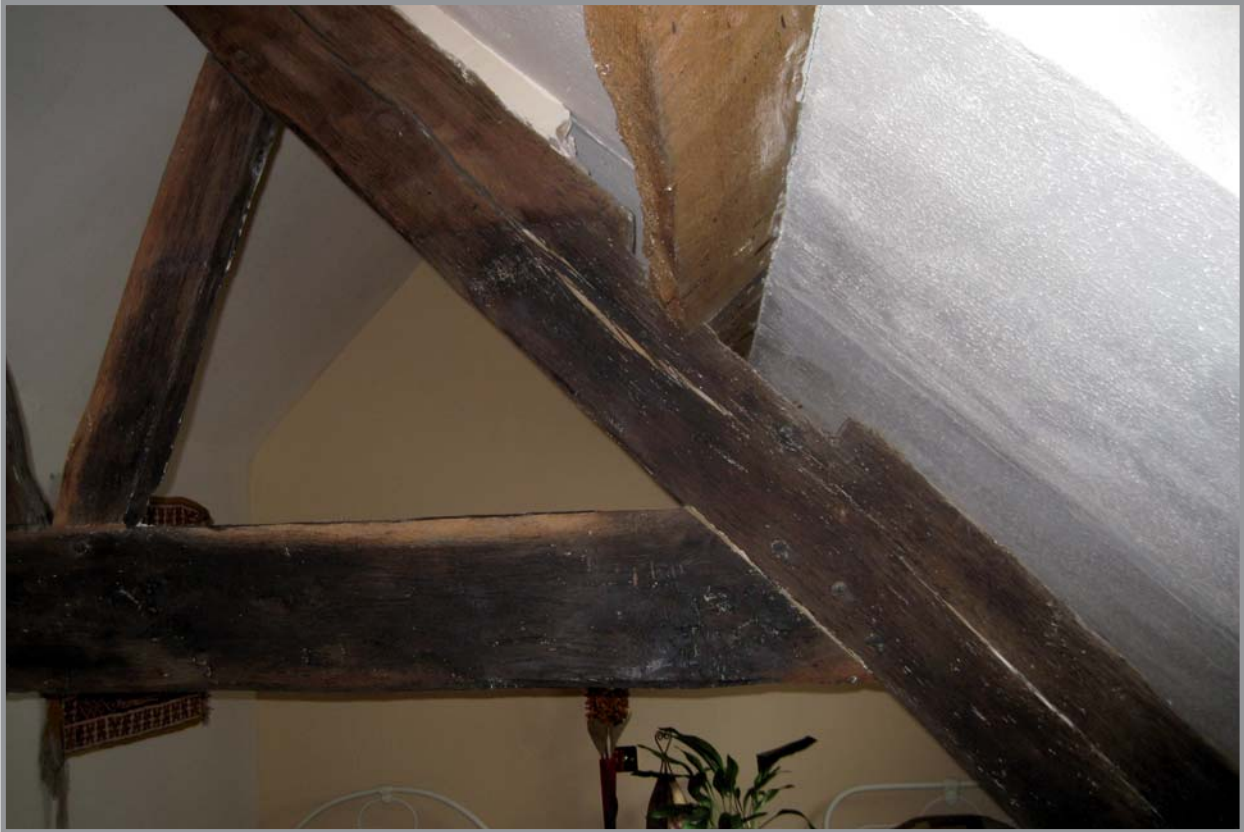
Plate 21: Truss 1 detail in second floor front room. Facing west

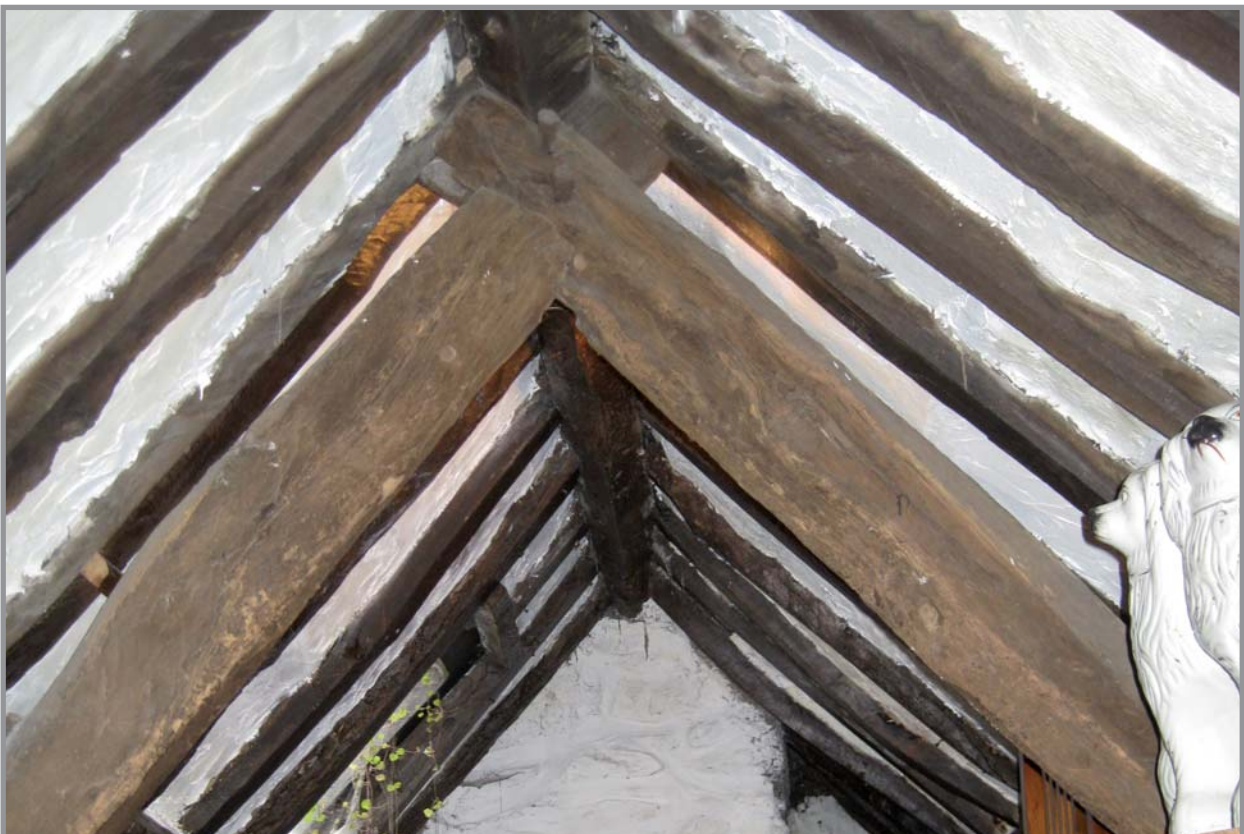
Plate 22: Truss 2 in attic room. Facing south-west

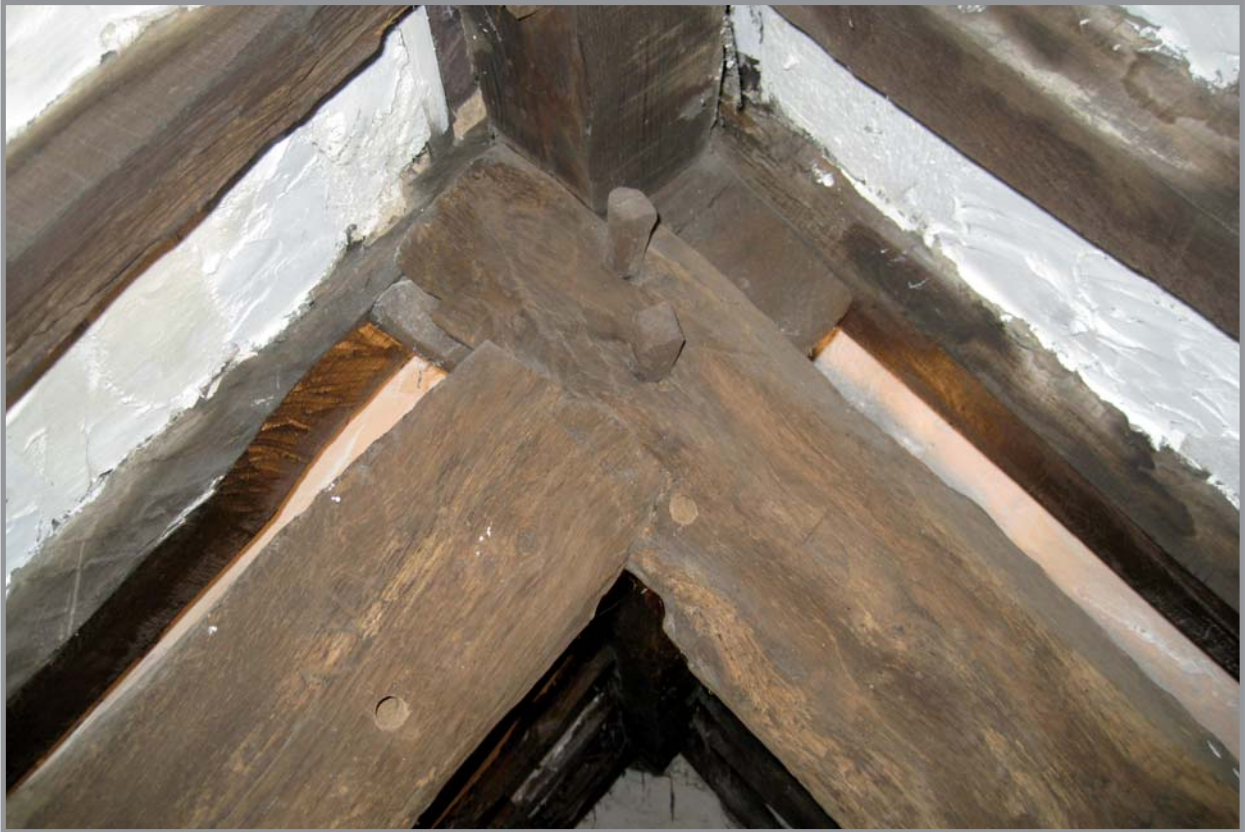
Plate 23: Truss 2 detail of the collar beam truss ridge beam, Facing north-west
