# Survey of the Wreck of the *Thor*

Cardiff BSAC 0590

BSAC Expedition BEGS-08-05

October 2008

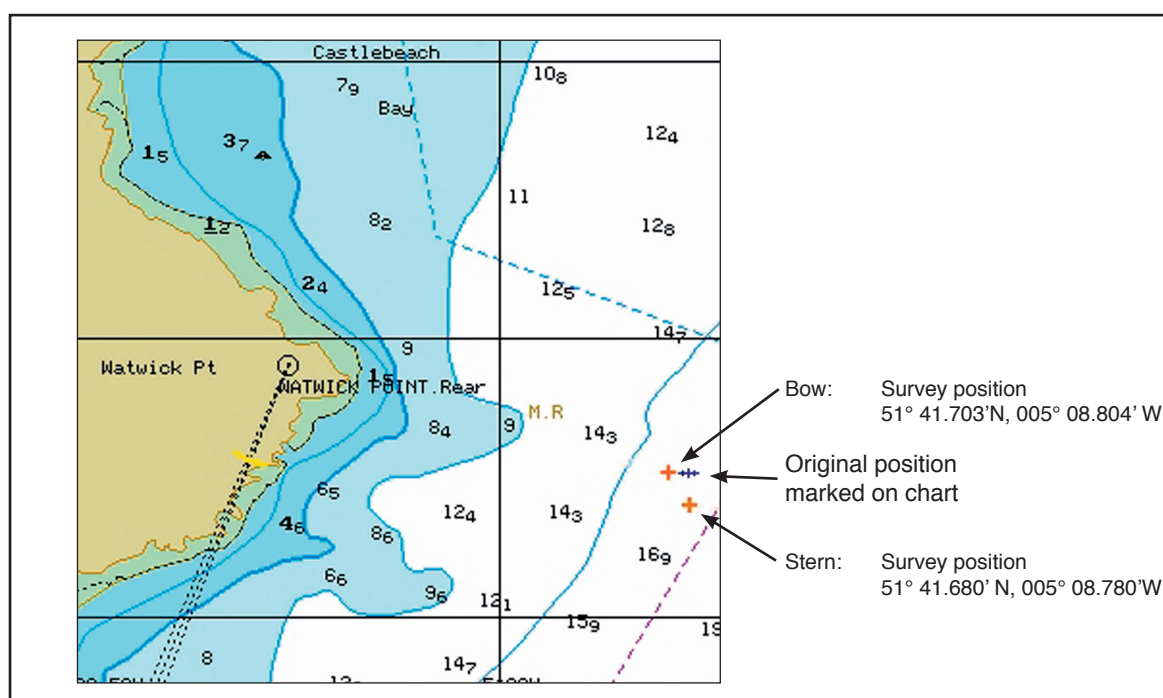
Fig. 4.1: Chart extract showing the charted position of the *Thor* and the positions of the bow and stern marked during the survey

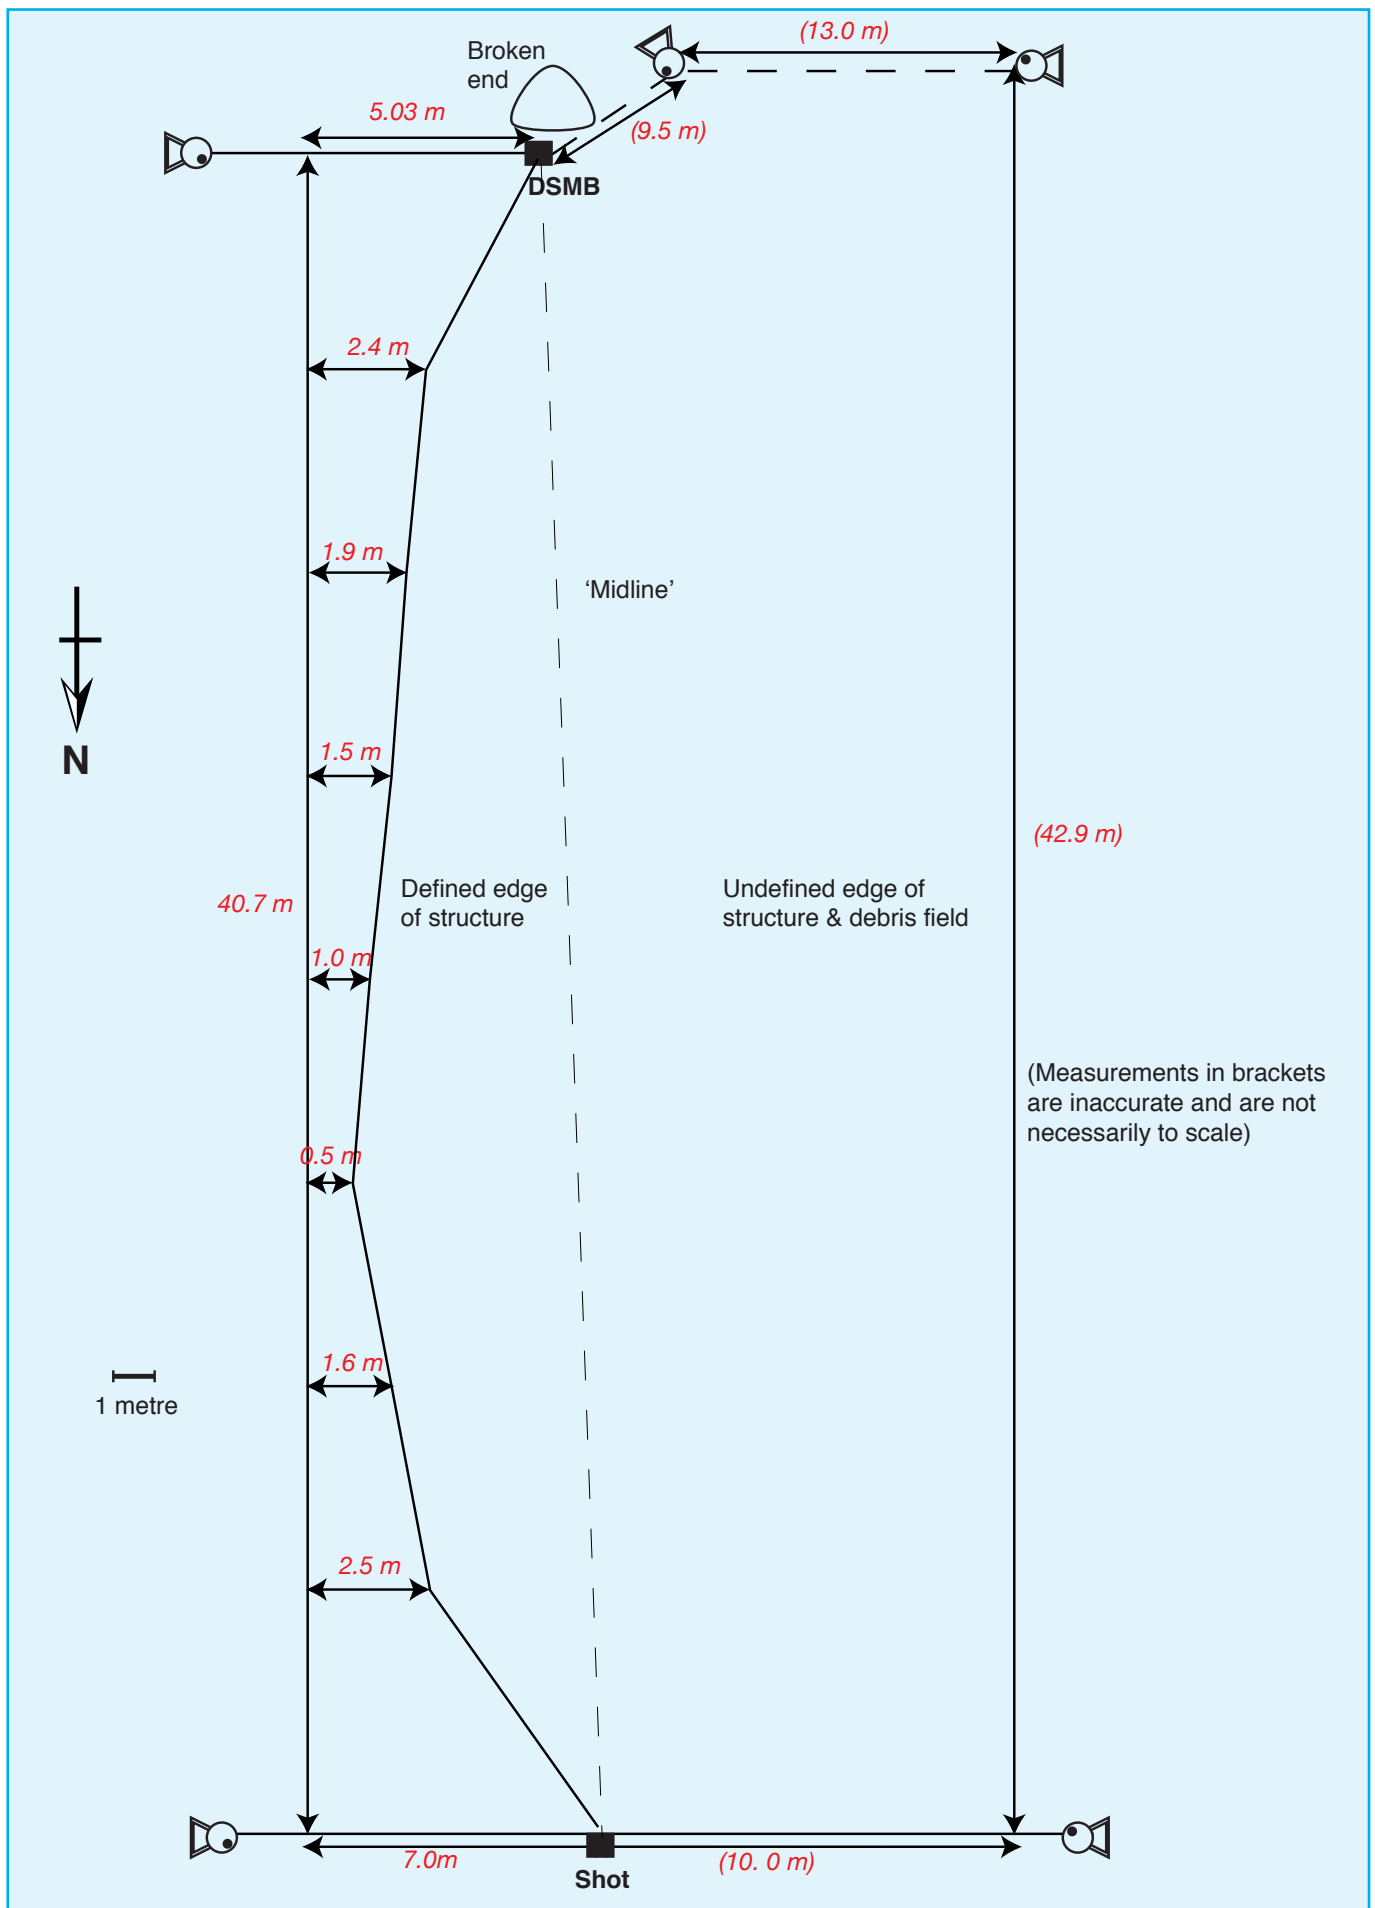
Figure 4.3: Schematic of wreck, drawn to scale from survey results

- The overall length of the wreck has been determined  
*Approximately 43 m from bow to stern*
- The maximum width of the wreckage area has been determined  
*No more than 17 m across the widest section*
- A general area has been defined within which all of the debris can be found
- The height of the wreck off the seabed was determined relative to the defined edge of the hull on the seabed (Figure 4.4)  
*Up to 3 m off the seabed at the stern*

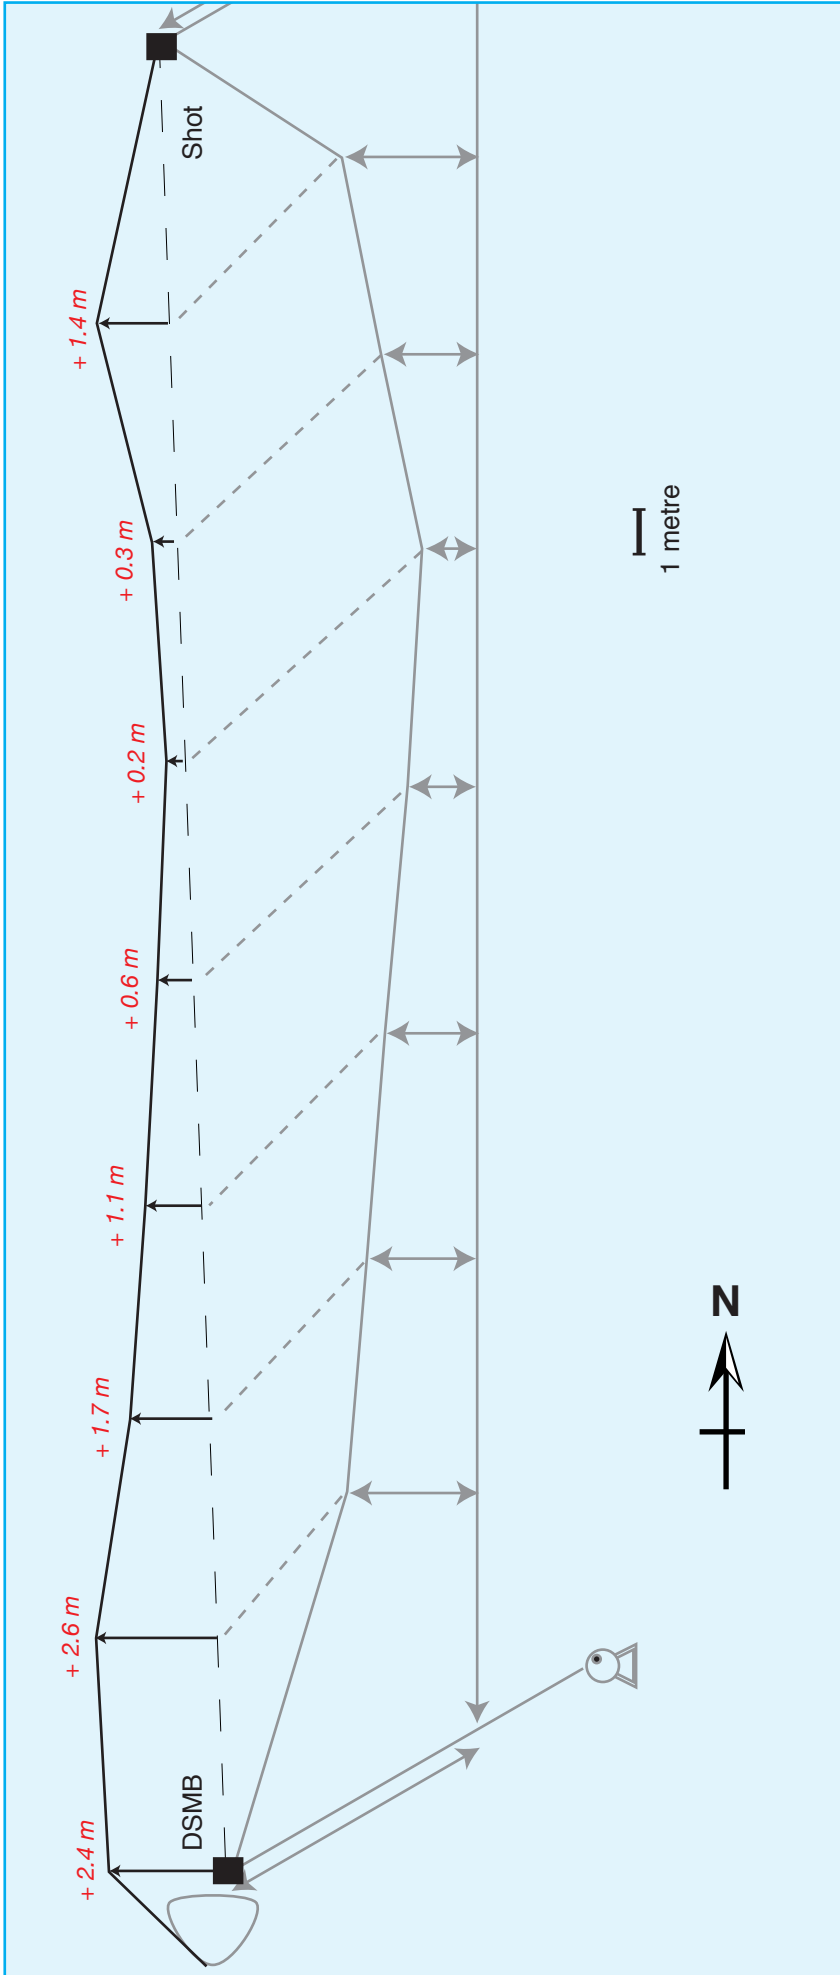
Figure 4.4 (above): Schematic of wreck, drawn to scale from survey results, showing the height contour along the hull relative to the defined edge measured previously

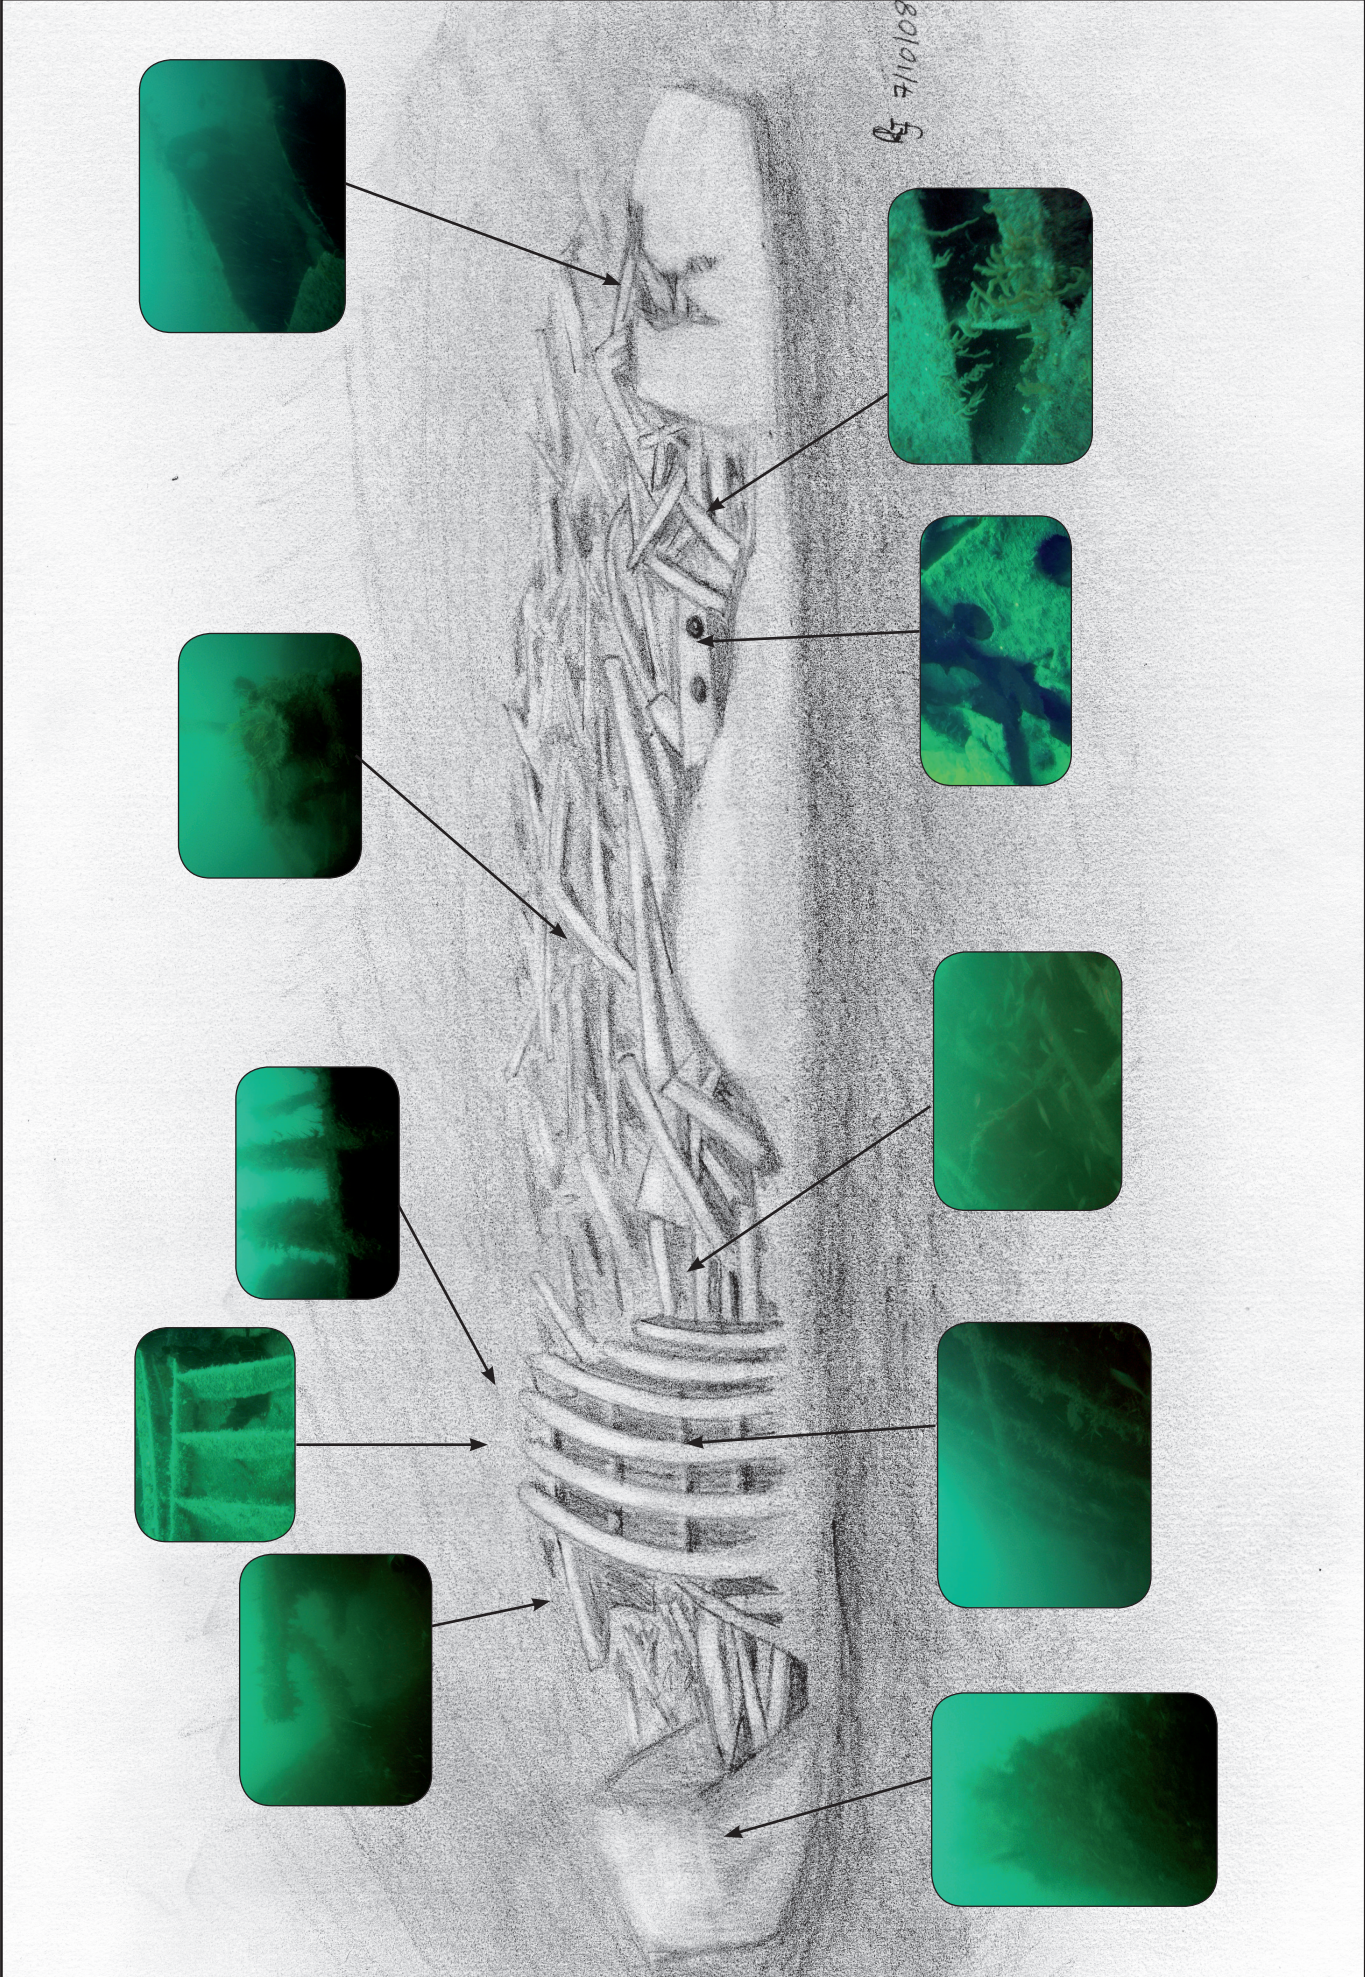
Figure 4.5 (below): Illustration of the wreck with photographs related to various points around the site. Illustration is drawn to the same scale as the schematics in Figures 4.3 & 4.4.
