REPORT OF AIRCRAFT ACCIDENT

(1) Place RAF Llanbedr, Wales (2) Date 3 September 1944 (3) Time 08:12
AIRCRAFT: (4) Type and model B-17F 290 (5) A. F. No. H-23105 (6) Station AAF Station 238
Organization: (7) 8 AFCC 8 AF (8) 2nd C. G. R. C. (9) Hq. & Hq. Sqdn.
(Command and Air Force) (Group) (Squadron)

Report on Crash of B-17 (N23105) on Sunday, Sept. 3, 1944 at RAF Llanbedr, Merioneth

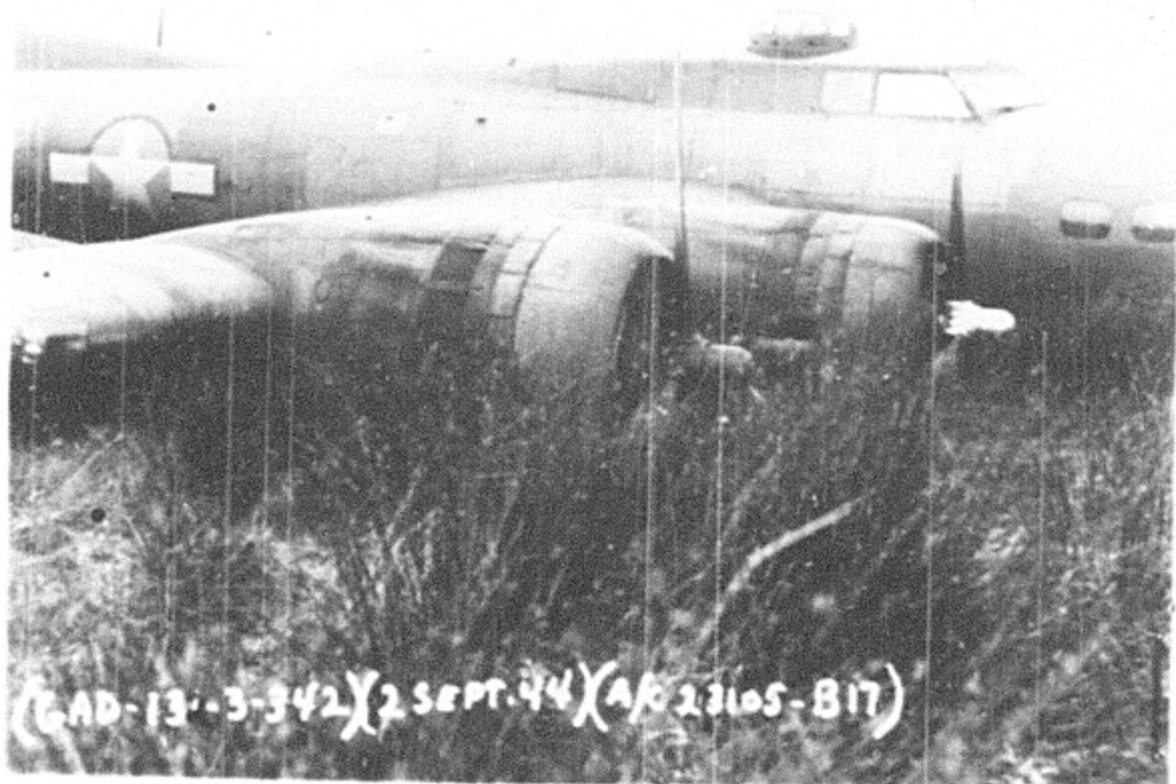
(GAD-13-3-342) (2 SEPT. 44) (A/C 23105-B17)

(56) Nature of accident Pilot landed long, brakes failed to function properly, aircraft ran off end of runway and wired down in soft ground.

(57) Cause of accident Long landing and faulty brakes.
