## Bryn Gwylan Threshing Barn, Llangernyw, Conwy

Level 3: Archaeological Building Survey

Report No. 1640

January 2018

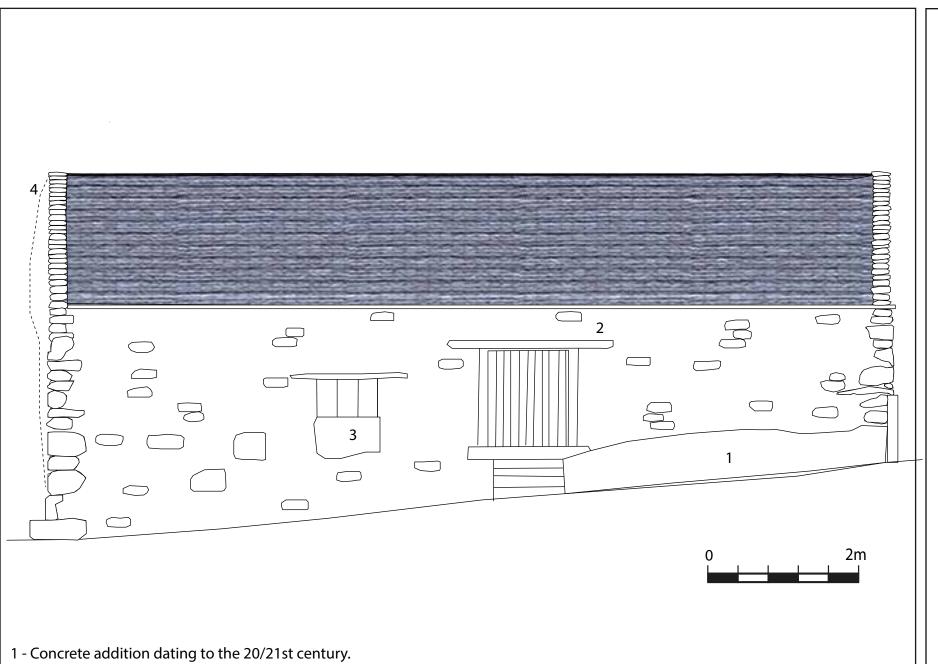
Figure 7. Existing front elevation.

- 2 Re-used timber lintel.
- 3 Mortar addition dating to 20/21st century previously an entrance.
- 4 Severe bulging to gable.

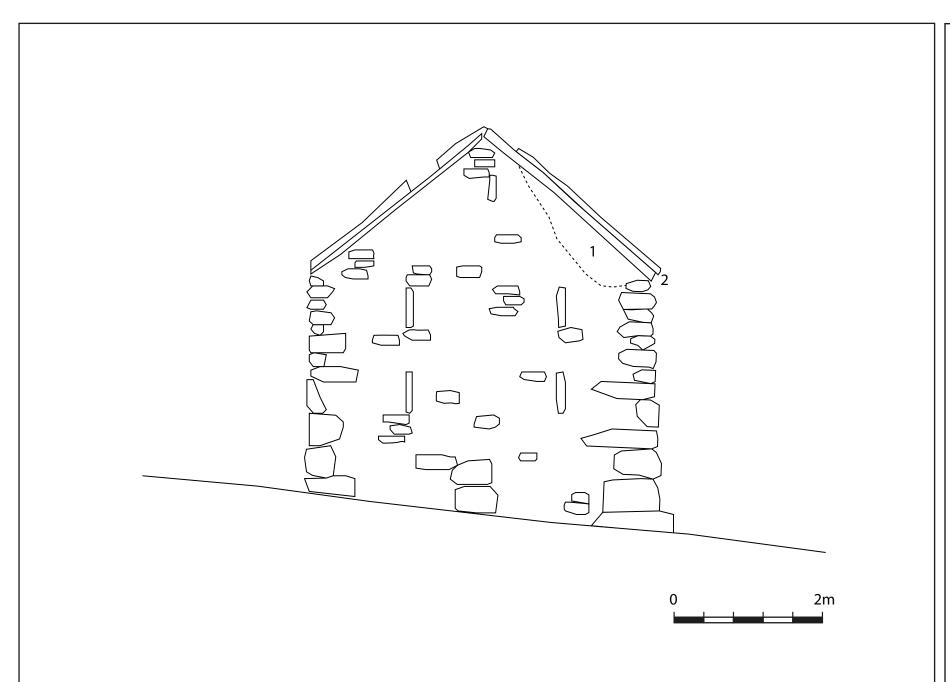
Figure 8. Western side elevation.

- 1 20/21st century repair.
- 2 20/21st century repair timber frame replaced by layer of mortar.

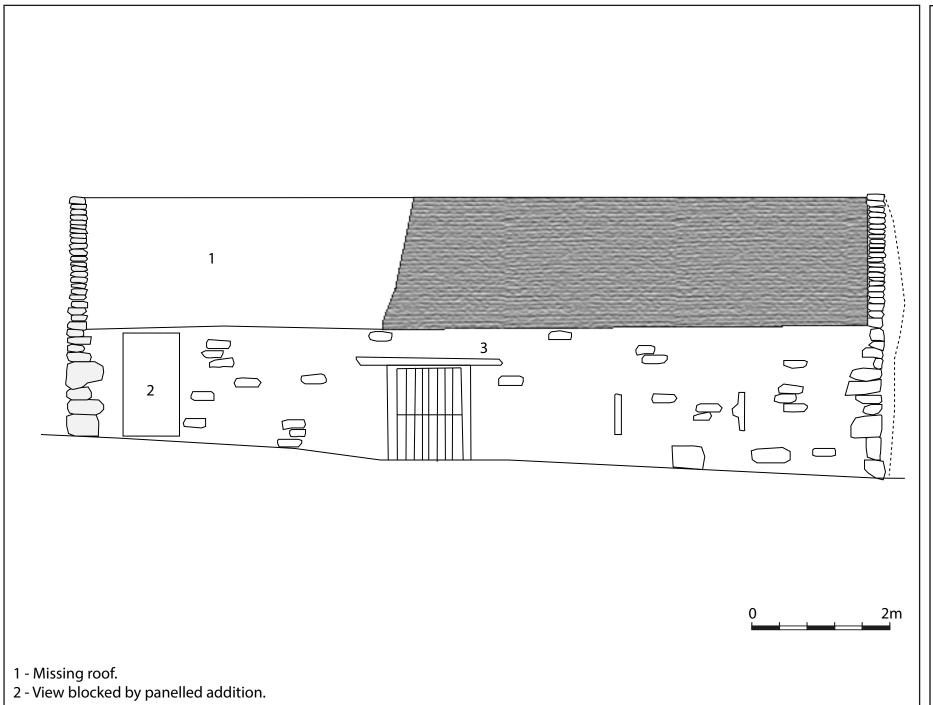
Figure 9. Rear elevation.

- 3 Concrete lintel.

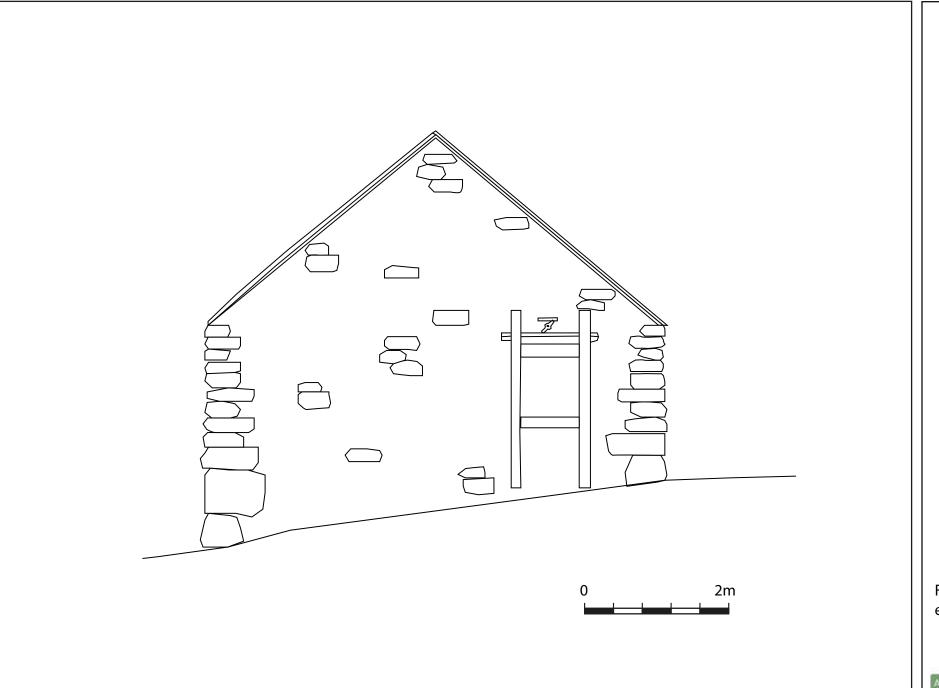
Figure 10. Eastern elevation.

This elevation is damaged by a central fracture and it is bulging outward. Some of the stone used for its construction have fallen and are currently located at its base.

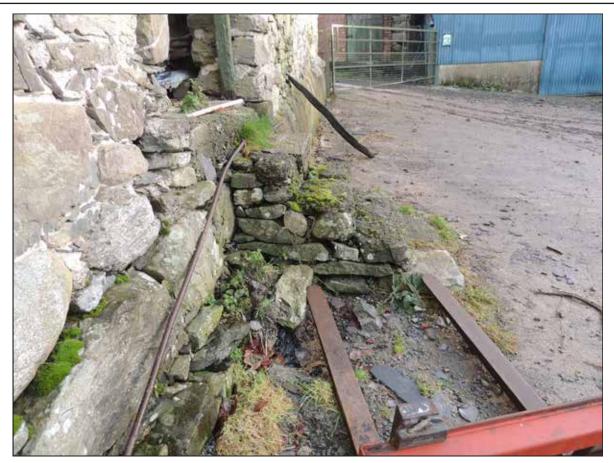
The four steps leading to the entrance door appear to have been originally constructed using local stone. However, they are nowadays reinforced by a layer of concrete, similar to that observed at the base of this elevation (see below).

Plate 5 (above): Detail of steps with concrete layer, looking E.

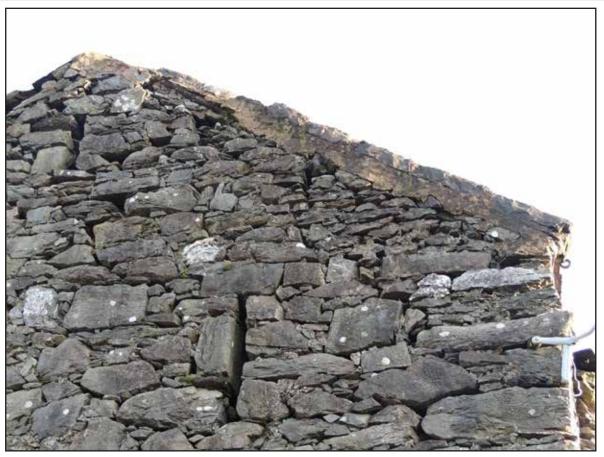
Plate 15 (above): Detail of repair, rear elevation.

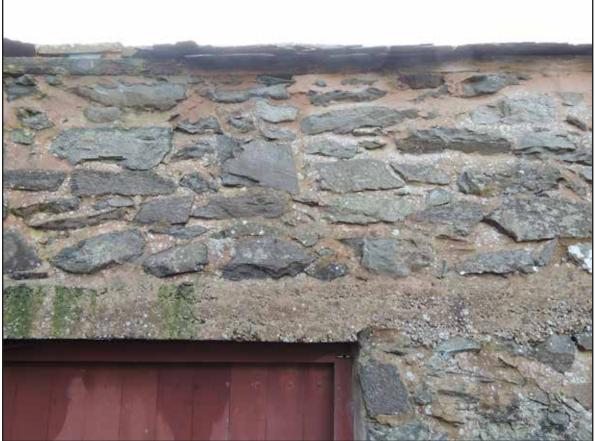
Plate 20 (below): Detail repair - rear evelation.

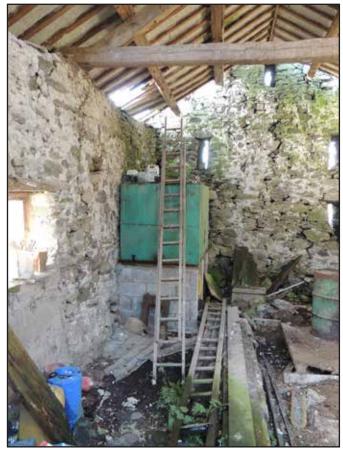
- **Plate 29-30, 39, 41:** Physical evidence of the power used to propel the engine is limited to a series of deposits derived from an oil powered engine located in the NE addition and dating to the 1920s (Vaughan pers. comm). A minimax fire extinguisher still found within the barn, dating to the first half of the 20<sup>th</sup> century. During the second half of the 20<sup>th</sup> century, the barn was used for chaffing straw, grinding corn and slicing turnips for the animals. During the summer, it was used for shearing sheep (A. Vaughan pers comm). It is therefore possible that some of the tanks located within the barn were used to carry out some of these activities.

Plate 29 (above): Deposit located on the corner between the SW and the W elevation -interior.

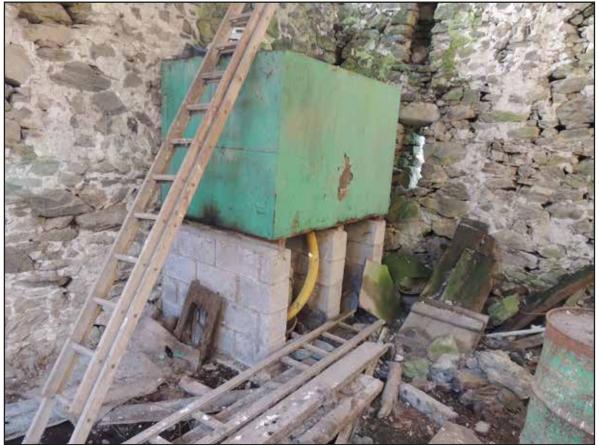
Plate 30 (below): Detail of deposit located on the corner between the SW and the W elevation -interior.
