STANAGE PARK, KNIGHTON, POWYS
 OUTLINE BRIEF AND SPECIFICATION FOR REINSTATEMENT OF ORNAMENTAL LAKE

STANAGE PARK, KNIGHTON, POWYS
OUTLINE BRIEF AND SPECIFICATION FOR WORK IN
RELATION TO THE SILTED UP LAKE TO BE EXECUTED AS PART OF A
GLASTIR AGREEMENT

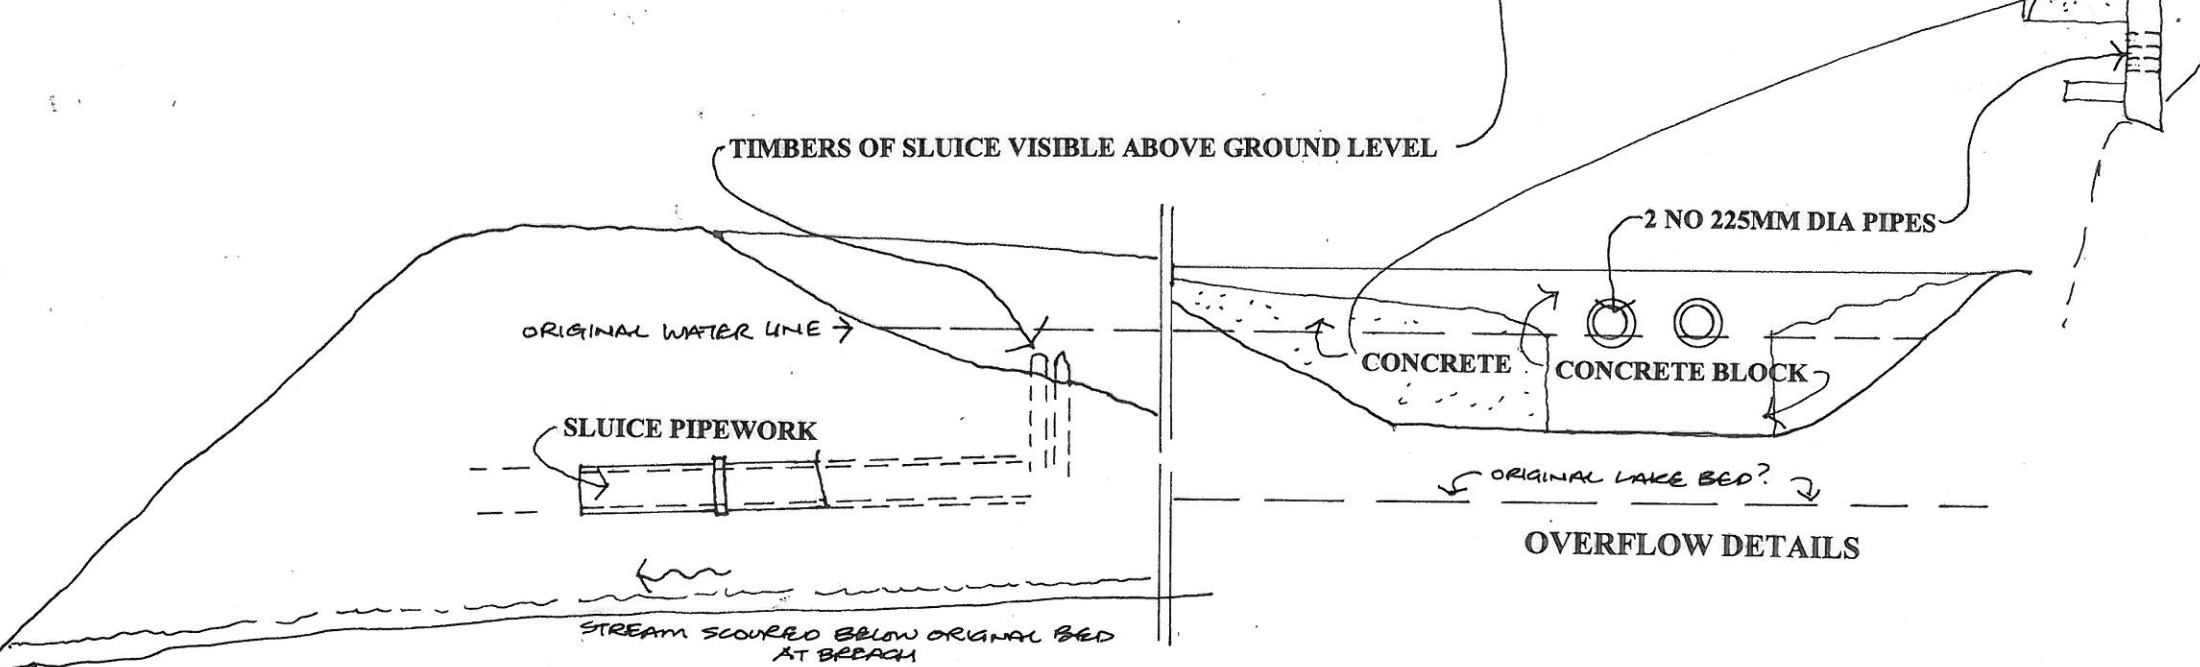
OVERFLOW DETAILS

TIMBERS OF SLUICE VISIBLE ABOVE GROUND LEVEL

2 NO 225MM DIA PIPES

CONCRETE CONCRETE BLOCK

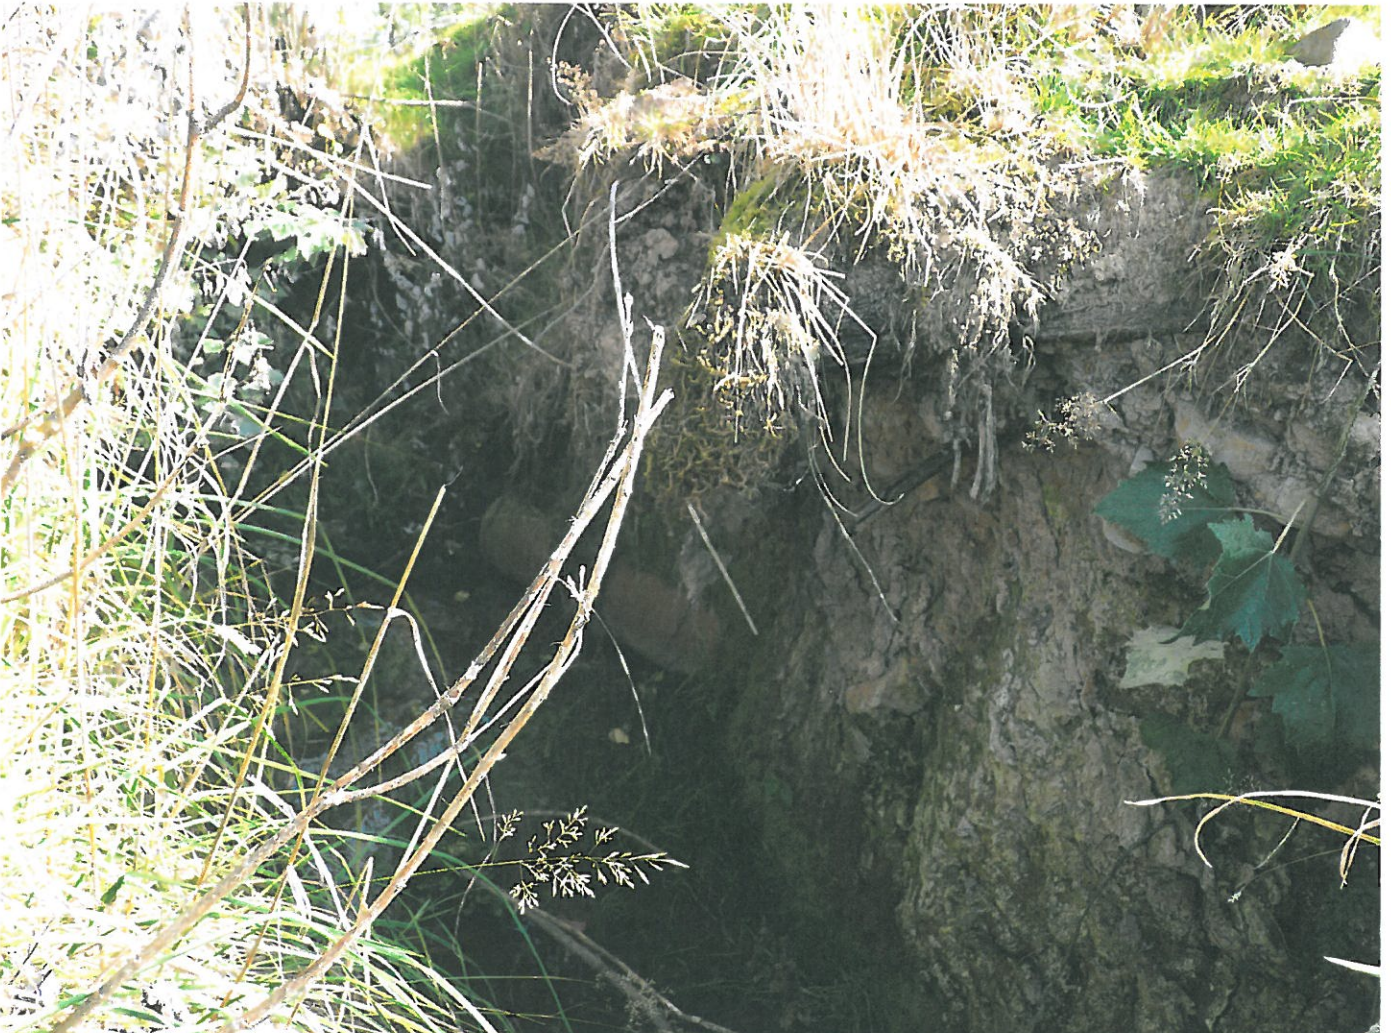
4530 Stanage Park Lake – Dam & Sluce

←
SLUCE

- 3.2 The dam is largely intact and stands to its original height. However it has been breached due to water undermining the sluice pipework so that the stream now flows 600mm below the sluice invert. It is extremely likely that the stream has eroded through any clay lining to the lake at this point. Tree roots have also invaded the dam structure and wind forces on the trees will weaken the dam structure as they grow taller.

- 4.3 Archaeologically excavate the sluice structure to inform the repair strategy
- 4.4 Archaeologically investigate the north end of the dam for any evidence of an overflow structure

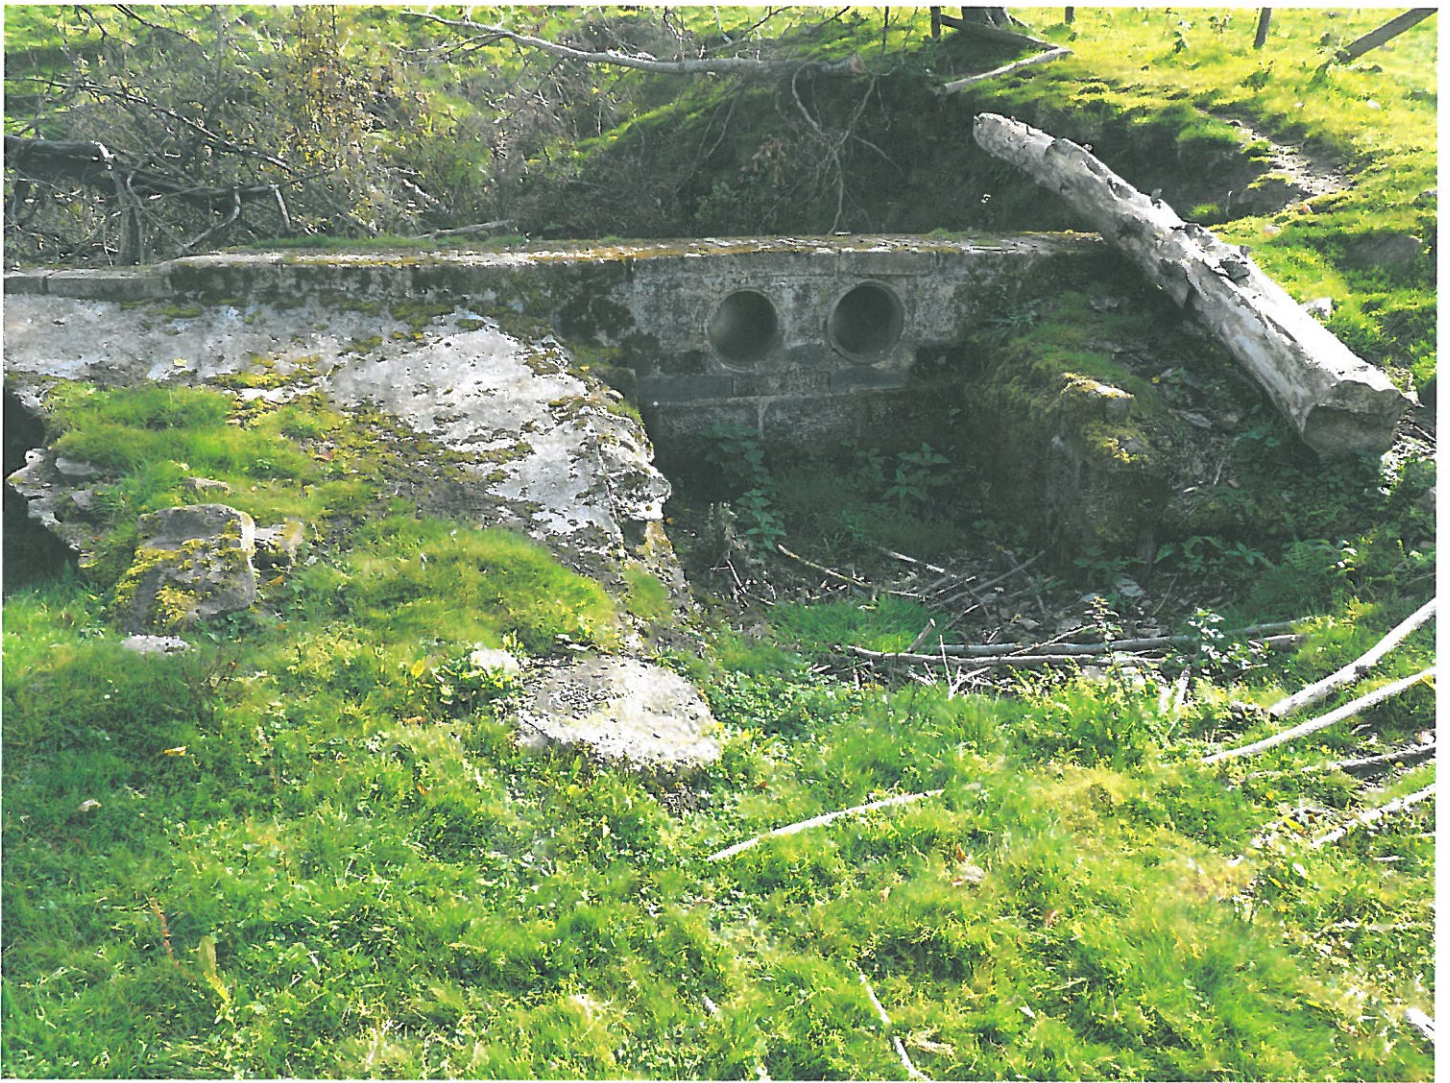
4530 Stanage Park Lake – Lake Overflow

- 3.3 The concrete block overflow structure is in poor condition. The blocks at the base of the outlet channel are disintegrating but the upper blockwork is relatively sound. The two 225mm diameter concrete pipes are inadequate to accommodate sudden downpours. Water has eroded under the blockwork at the east end of the overflow structure. Larger volumes of uncontrolled overflowing water at this point have deeply eroded the bank and the south end of the dam

- 4.5 Clear the vegetation and archaeologically examine the south overflow for any evidence of an earlier structure
- 4.6 At the same time an ecological appraisal will be undertaken by others based on CIEEM Guidelines. This will involve a desktop Data Search, Phase I habitat survey, identified and mapping invasive weeds, protected species assessment, habitat descriptions and target notes to identify areas of concern.
