Photographic Schedule of North Wales Hospital

Denbighshire County Council,
Smithfield Road,
Denbigh,
LL16 3RJ

Ref: 168119/Chapel Elevation B

Date of Inspection: 28th Sep 2018

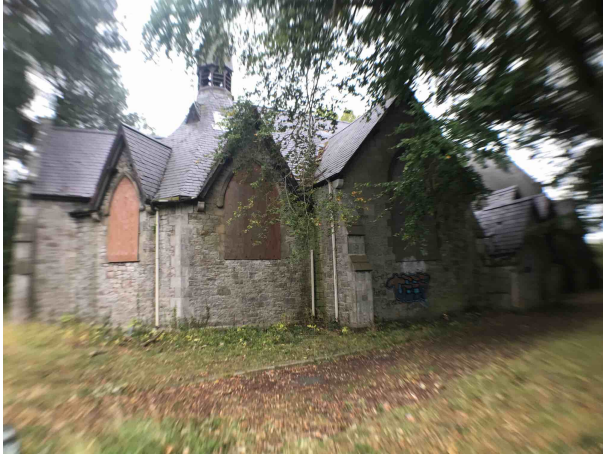
A wide-angle, slightly blurred photograph of the chapel building, showing its stone walls, gabled roof, and a small tower. The building is surrounded by trees and a grassy area.	Elevation B. 5 bays
2

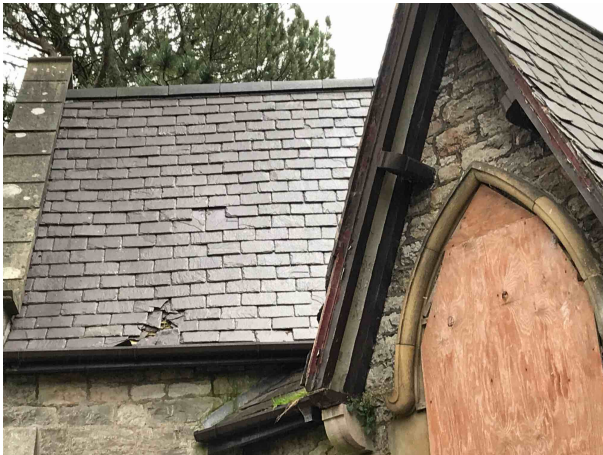
A close-up photograph of the chapel's roof and a wooden door. The roof is made of slate tiles, and there is a noticeable gap or missing slate near the door.	Bay 1 missing slate

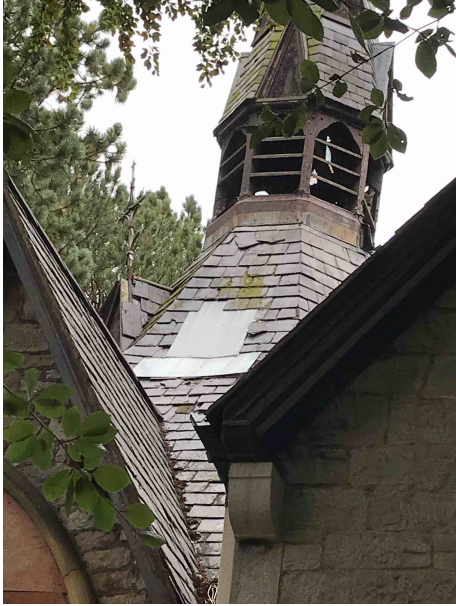
Bay 2 missing slate
6

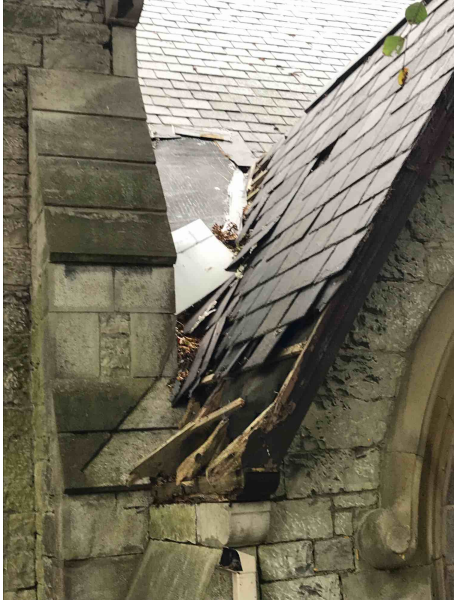
Bay 4 left side valley stripped.
9

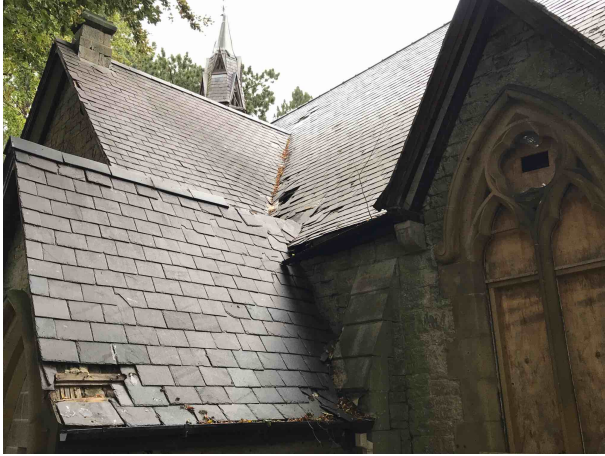
Slate missing bay 4 & 5
11
