**A.P.A.C. Ltd.**

**ARCHAEOLOGICAL  
WATCHING BRIEF  
WB/AT/17**

**The Anchor Inn, Tintern, Monmouthshire**

**Planning Application No: DC/2016/01428**

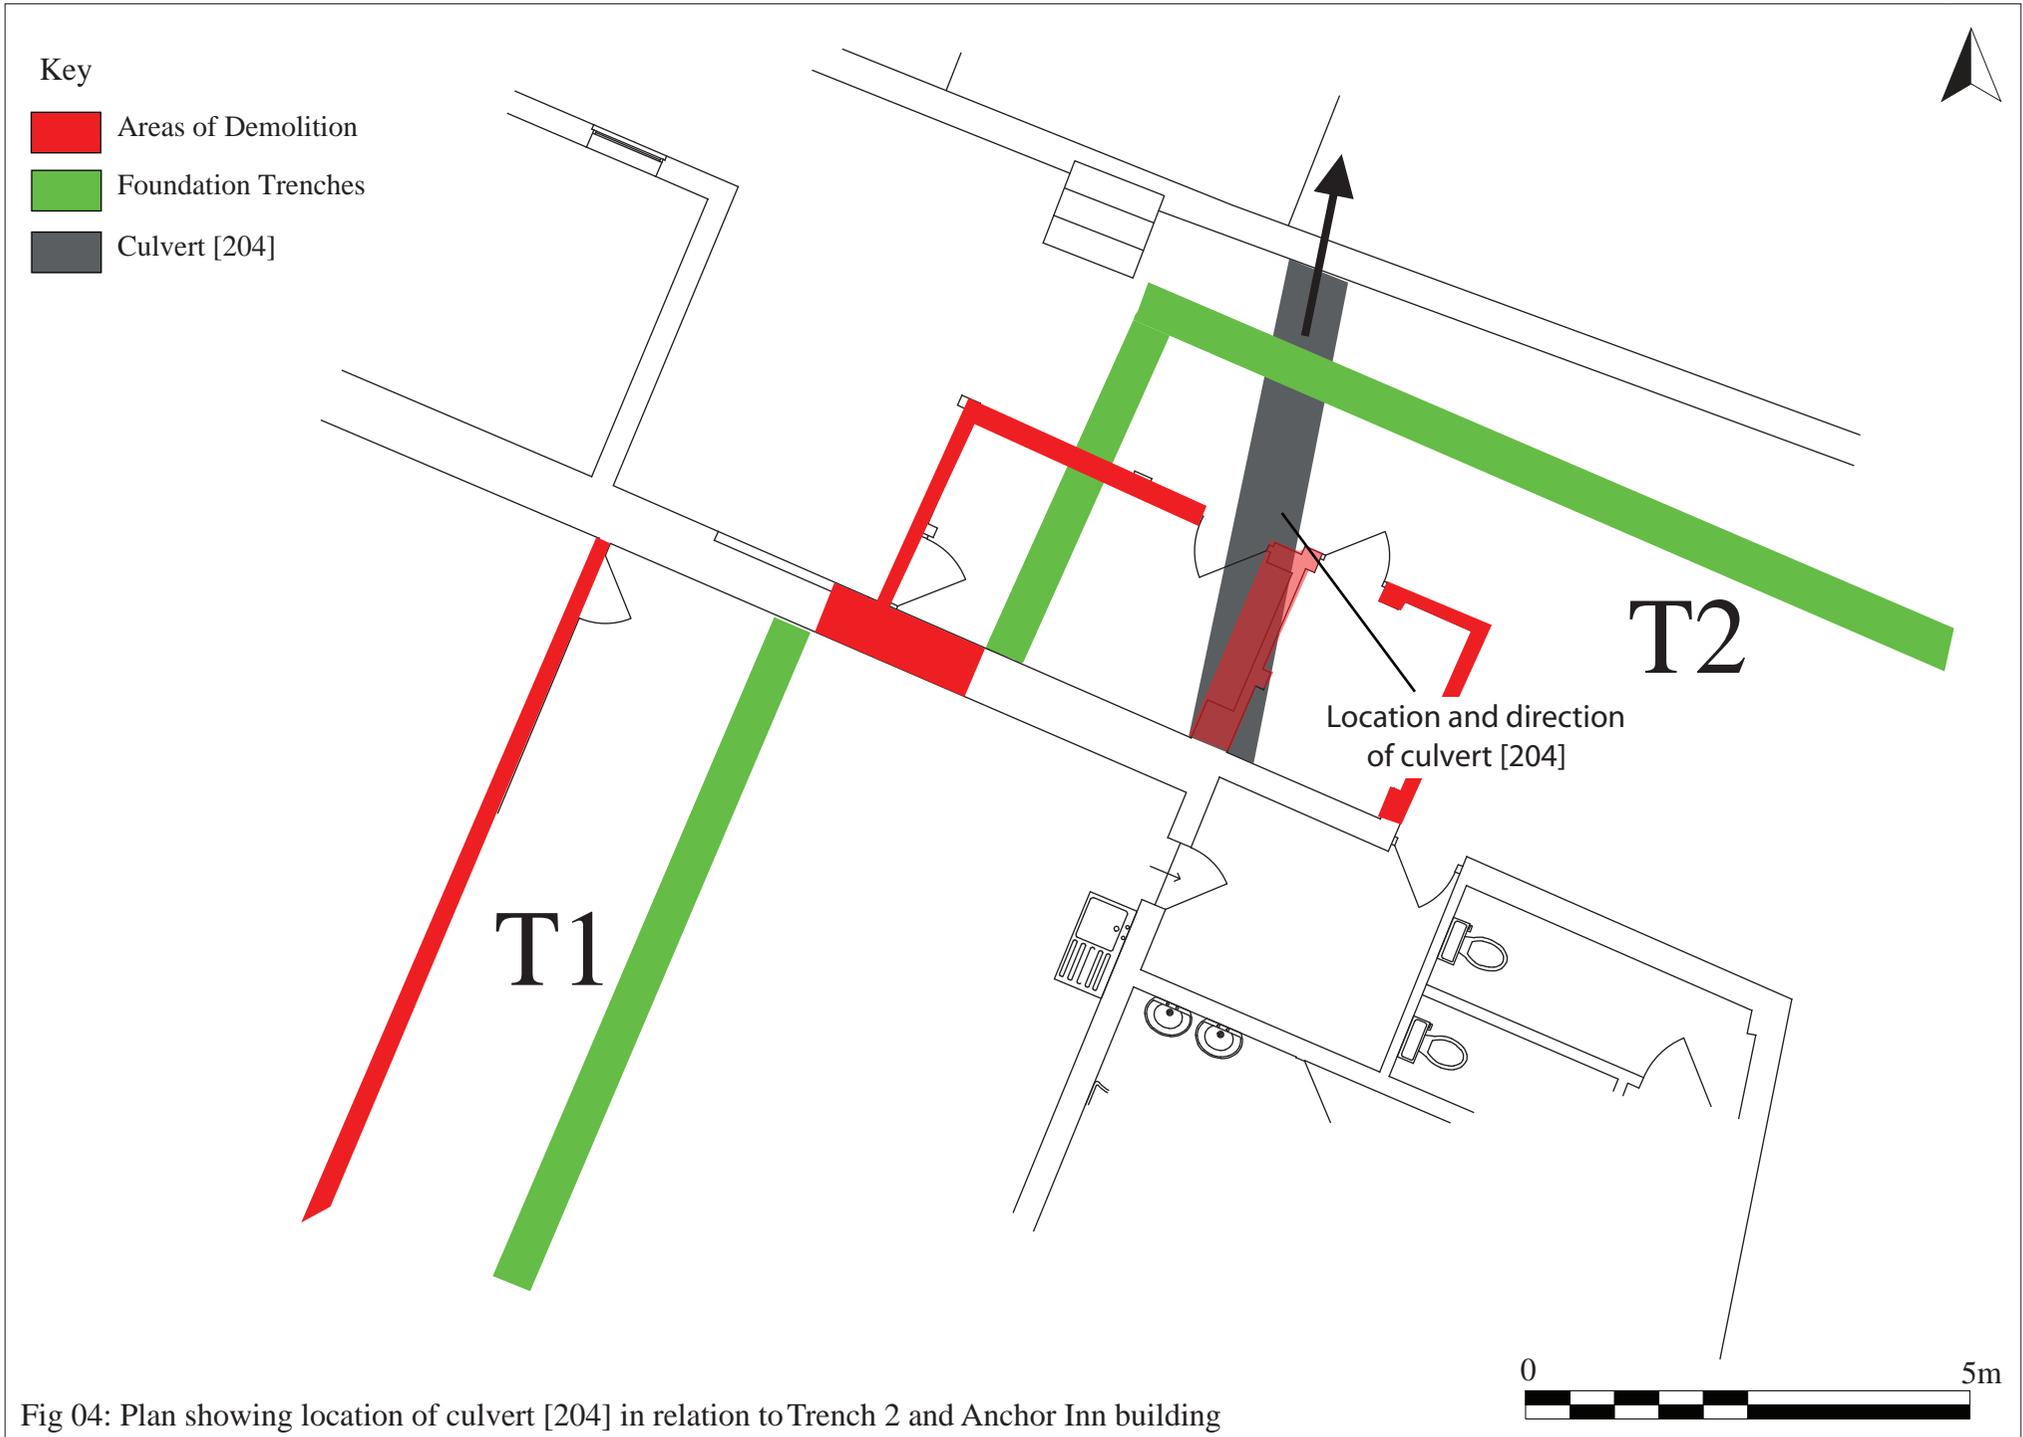
Fig 04: Plan showing location of culvert [204] in relation to Trench 2 and Anchor Inn building

At the north-western end of this trench a stone built culvert [204] was located. It was partially exposed in plan (in order that a modern service above it could be reinstated – Plate 13) before it was cut through by the foundation trench excavation (Plates 14&15). It was observed to be located within a cut [205] made into clay horizon (202); was rectangular in section and measured approximately 0.8m wide by 0.3m deep. It had a flat stone base with stone walls bonded in lime mortar and a flat stone capping. It contained a waterlogged, loosely compacted, dark brown/black silt fill visibly rich with organic remains but evidently heavily contaminated with hydro-carbons. Further investigation of the culvert feature was hampered by the depth and instability of the foundation trench and the contaminated and waterlogged ground conditions.

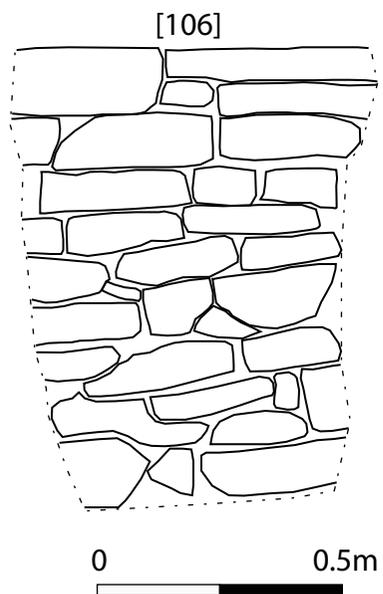
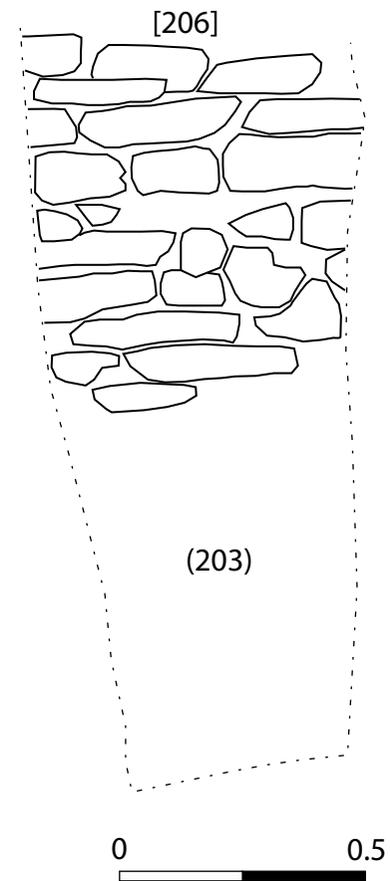
Fig 5: Illustrations showing face of wall [106/206] detail within trenches 1 and 2

Wall [106/206], exposed in the ends of trenches 1 and 2, is likely to be medieval in date, though the upper courses are seemingly later additions. The south-west face of the wall showed a marked outward batter towards its base compared to the flush north-eastern face. It is felt likely that this increase in width towards the base is likely to represent wider foundations rather than be indicative of an external face.

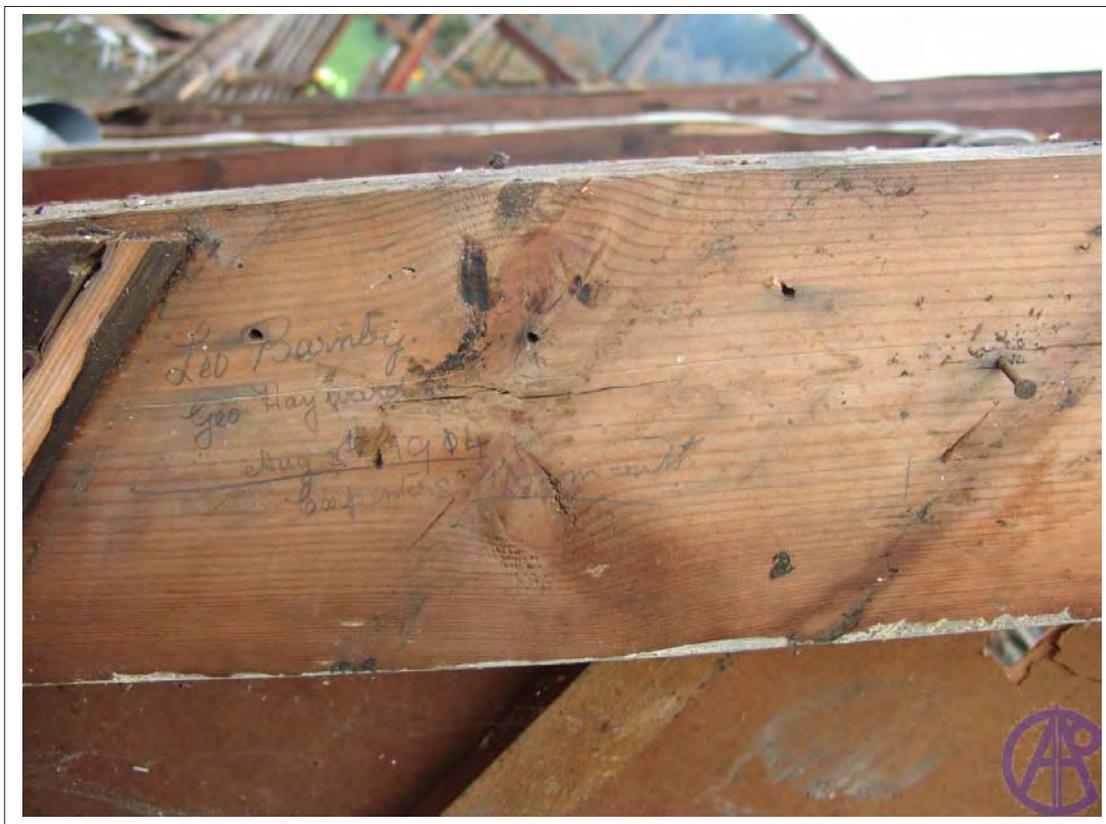
Little of archaeological merit was noted during this process although a timber beam inscribed with the carpenters names and a date (Barnaby & Hayward 1904) was noted and retained (Plate 4).

Plate 4: View of carpenters signatures and date on pavilion timber

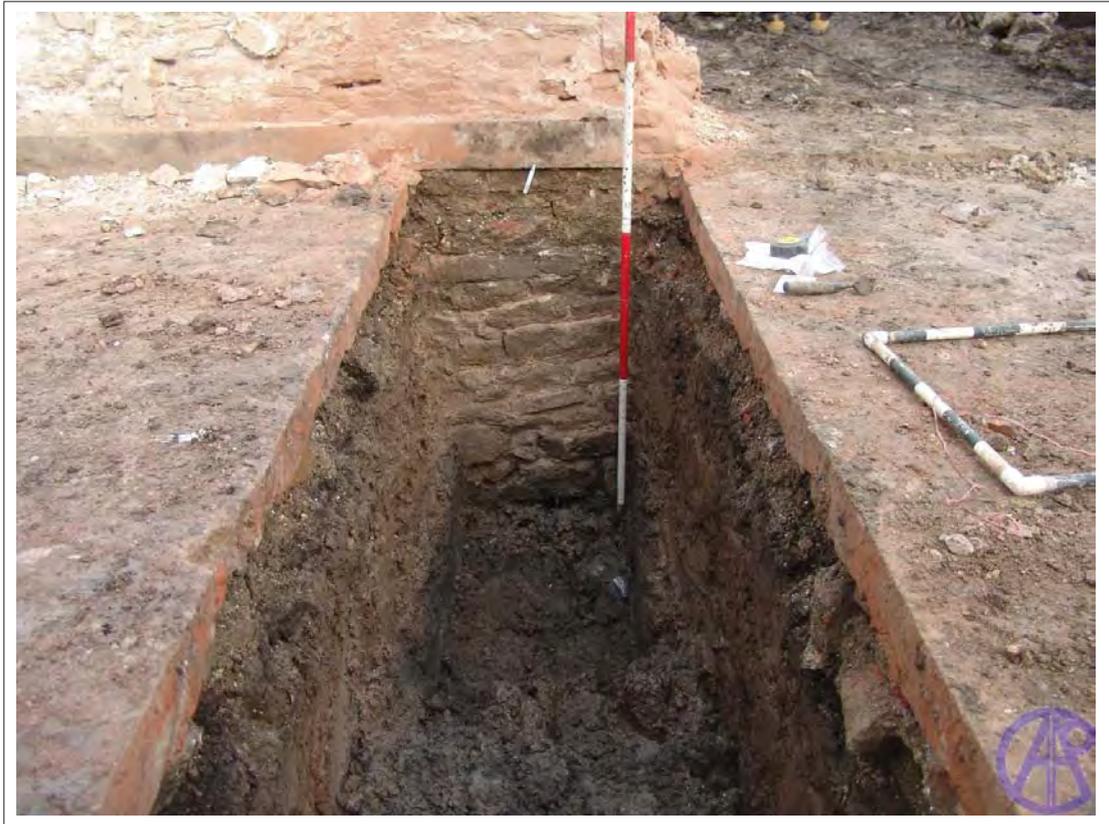
At the north eastern end of trench 1 the foundations of the aforementioned extant wall [106] extended to a depth of 1.3m below the current ground surface (Plate 9). The stones of the wall appeared to be randomly sized though all laid lengthwise and tightly bonded in lime mortar. The face of the foundations was battered outwards (towards

the south-west) giving the lower courses of the wall a thicker width than that visible above ground. Although no foundation cut was visibly evident, the wall was butted by grey clay horizon (105). This deposit also continued below the wall suggesting that a foundation cut for the wall was made into clay (105). The upper courses of the exposed foundation were also butted by deposit (104), overlying the basal grey clay (105).

Plate 9: Post-excitation view of wall [106] within trench 1, scale 1x2m

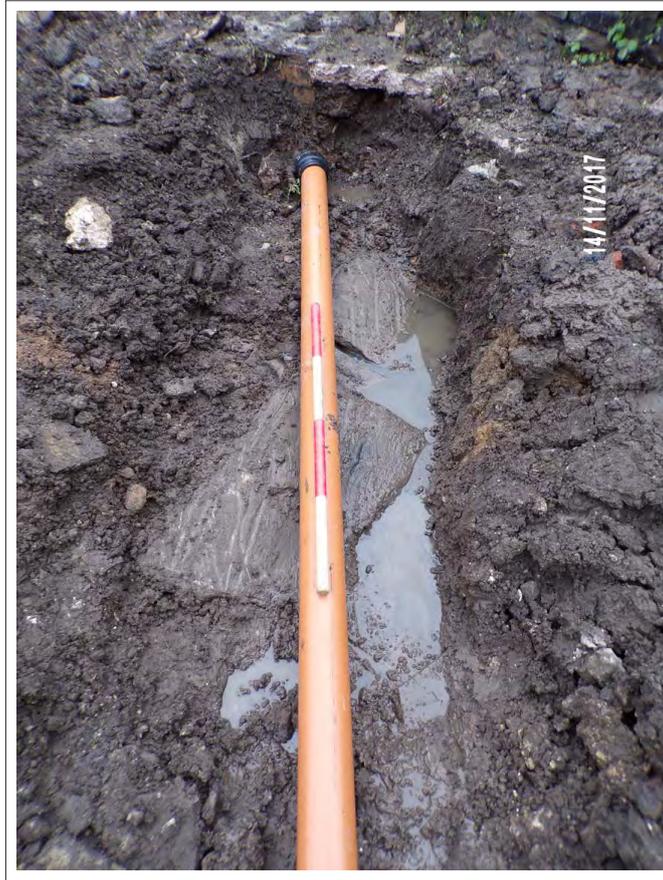
Plate 13: View of culvert [204] in plan beneath modern service. Scale 1x1m

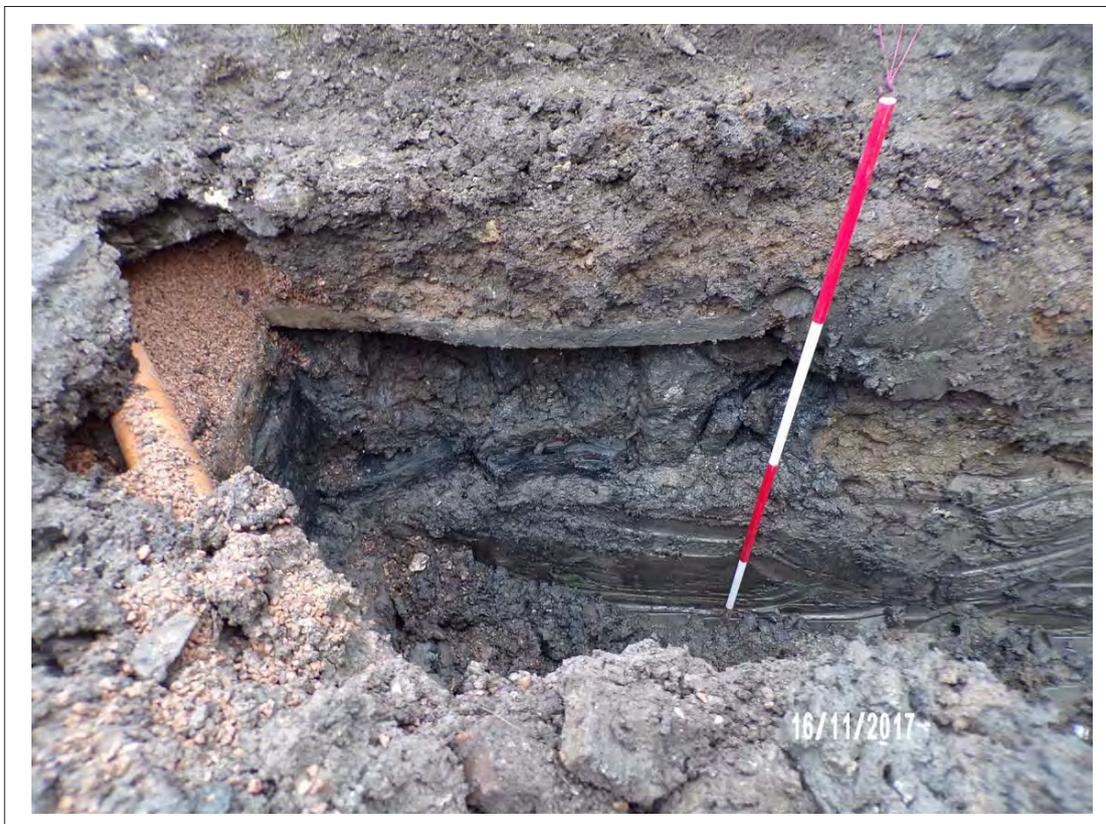
Plate 14: View of section through culvert [204] within trench 2. Scale 1x2m

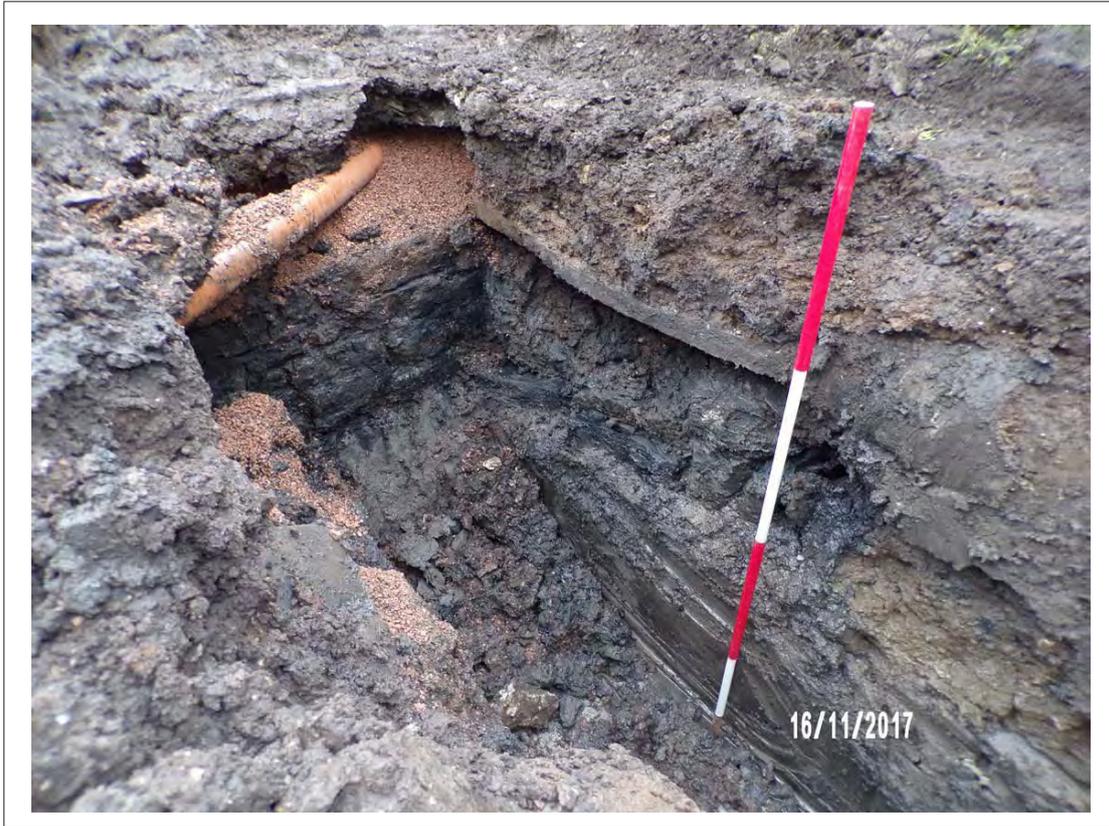
Plate 15: Oblique view of section through culvert [204] within trench 2, Scale 1x2m

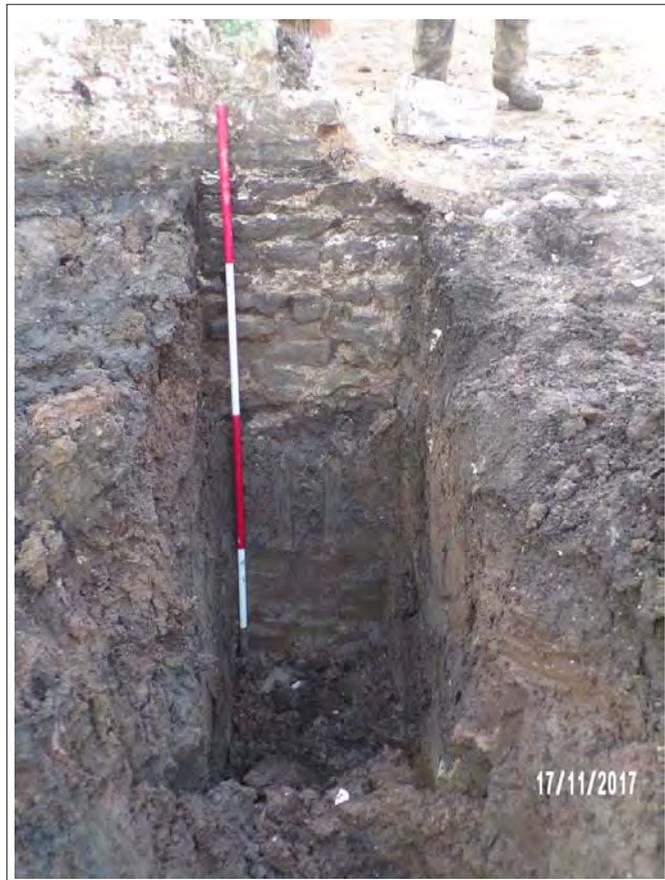
The lower courses of the wall appeared different in the two areas it was exposed. Whilst the south-western face was battered outwards giving a wider base, the north-eastern face was flush with the above ground section. The north-eastern face also appeared less well finished with bigger and seemingly more randomly placed stones; being not so tightly mortared.

Plate 16: View of wall [206] and deposits beneath exposed in trench 2. Scale 1x2m

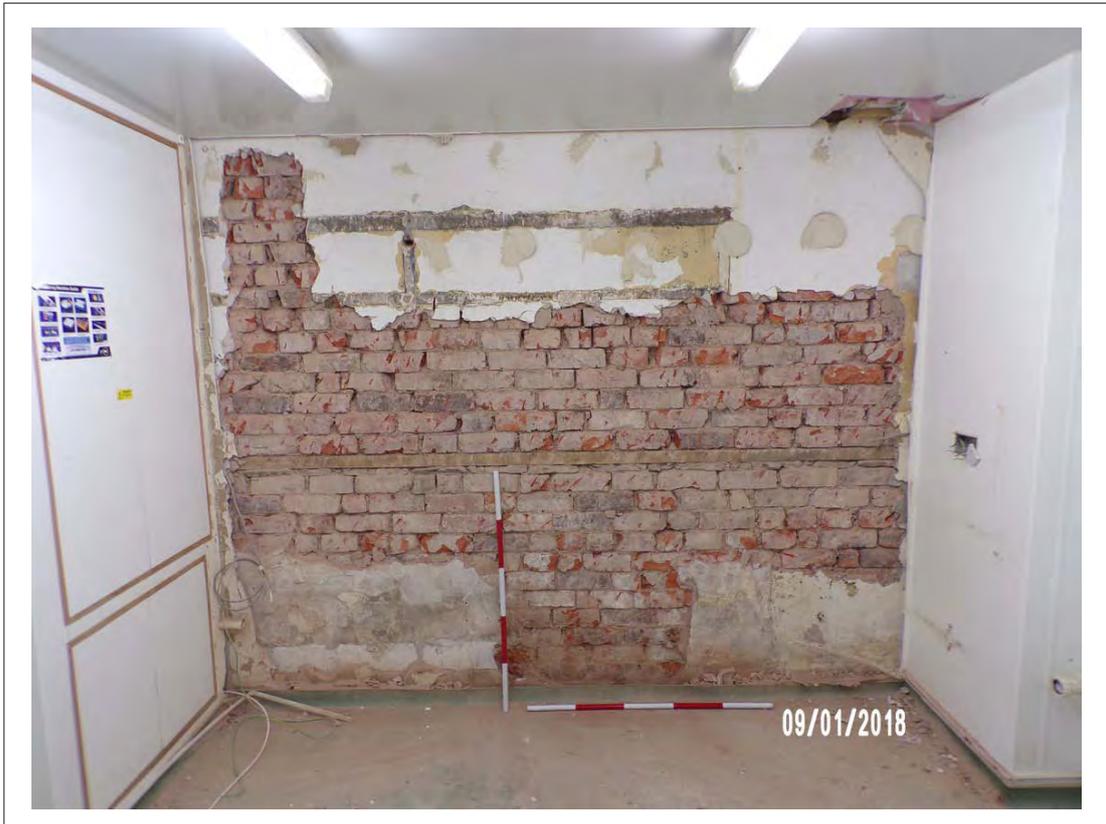
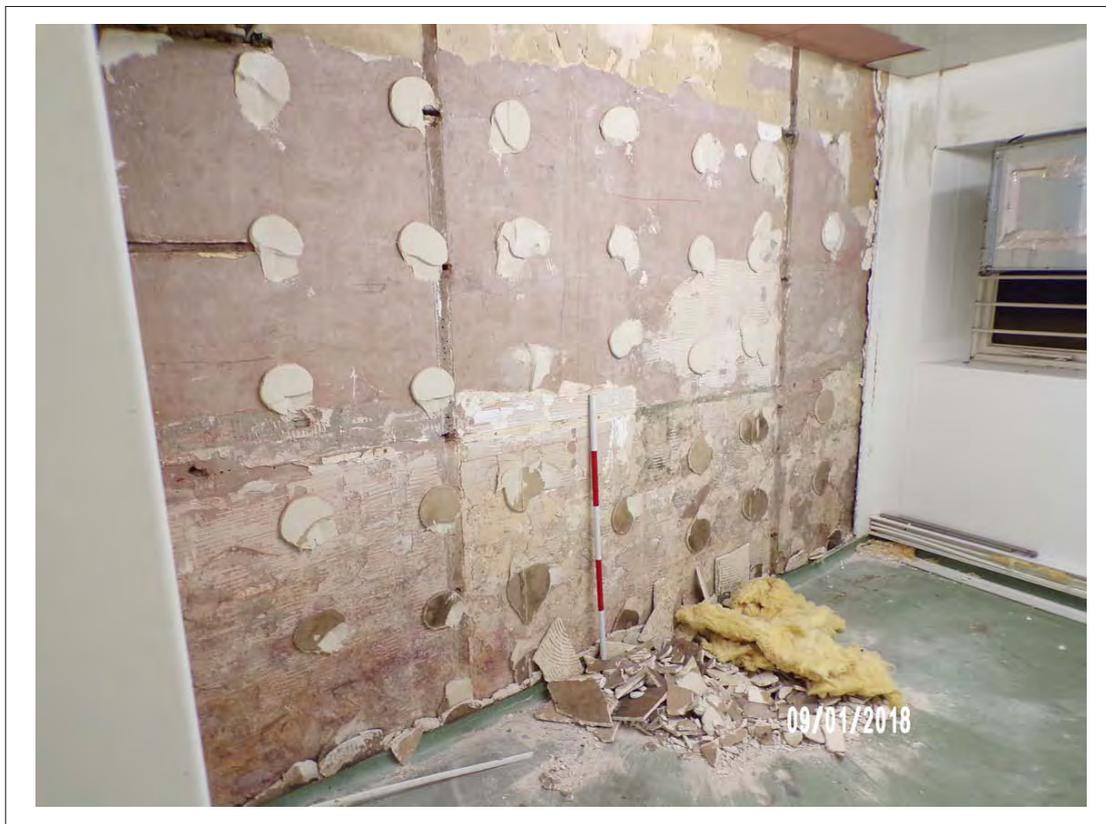
Plates 17&18 show the western and eastern faces of the brick built internal partition wall, a three metre length of which was to be removed as part of the redevelopment program. Removal of ceramic tiles and cement render from the western wall face showed the partition to be constructed of unfrosted red bricks, uniform in size and bonded with cement. The bricks themselves are likely to have been reused from elsewhere. The internal partition wall itself is likely to be a comparatively modern (20<sup>th</sup> Century) insert into the 18/19<sup>th</sup> century kitchen structure.

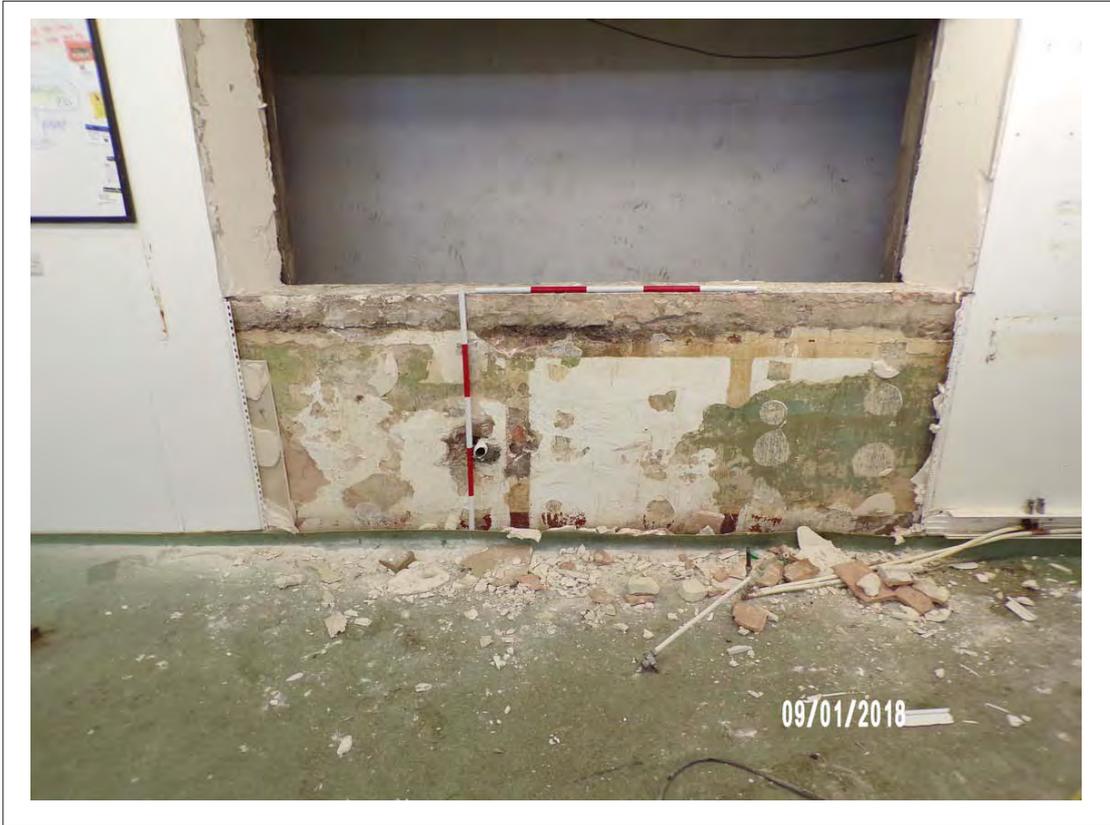
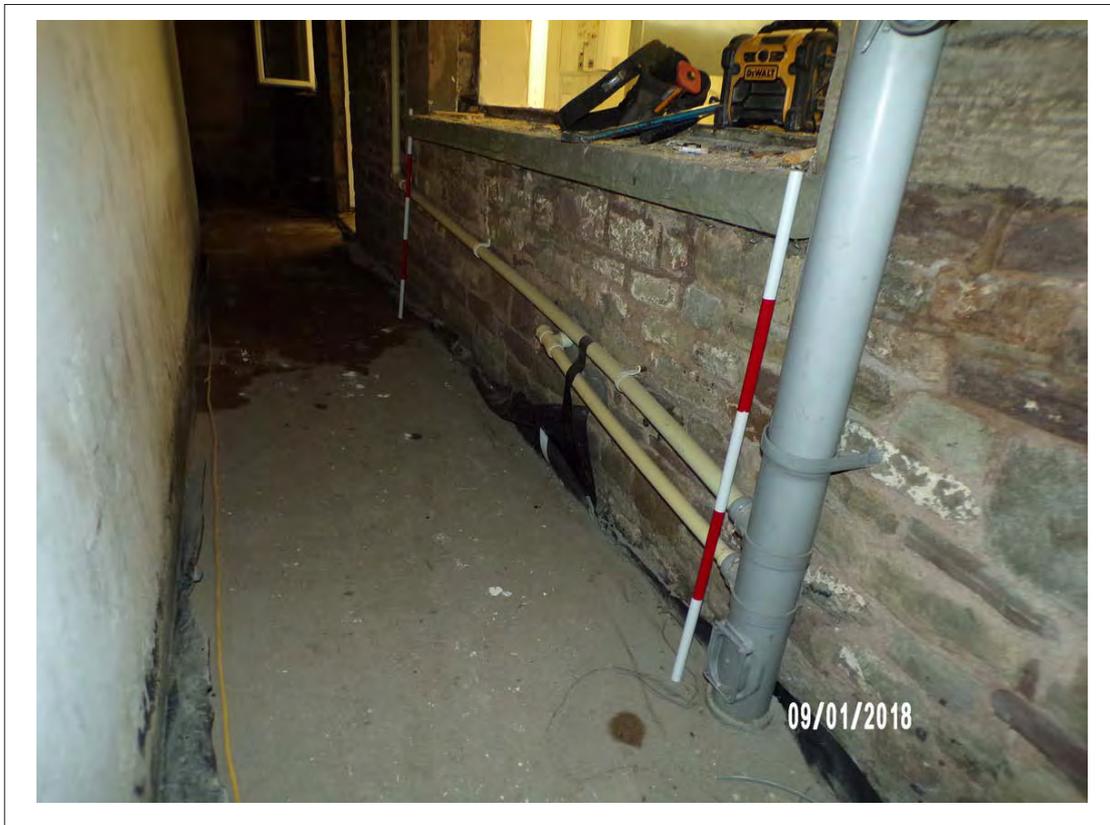
Plates 19&20 show the western and eastern faces of the area of kitchen wall beneath the window opening which was also to be removed as part of the redevelopment program. Removal of plasterboard showed the eastern, internal, face of the wall to be constructed of brick with a cement skin. The western, external, face of the wall was constructed of roughly coursed, faced stone blocks forming the original wall of the 18/19<sup>th</sup> century kitchen structure. The brick skin was butted against the external stone layer

and likely represents a later (20<sup>th</sup> century) addition to the kitchen; possibly contemporary with the insertion of the brick partition wall described above.

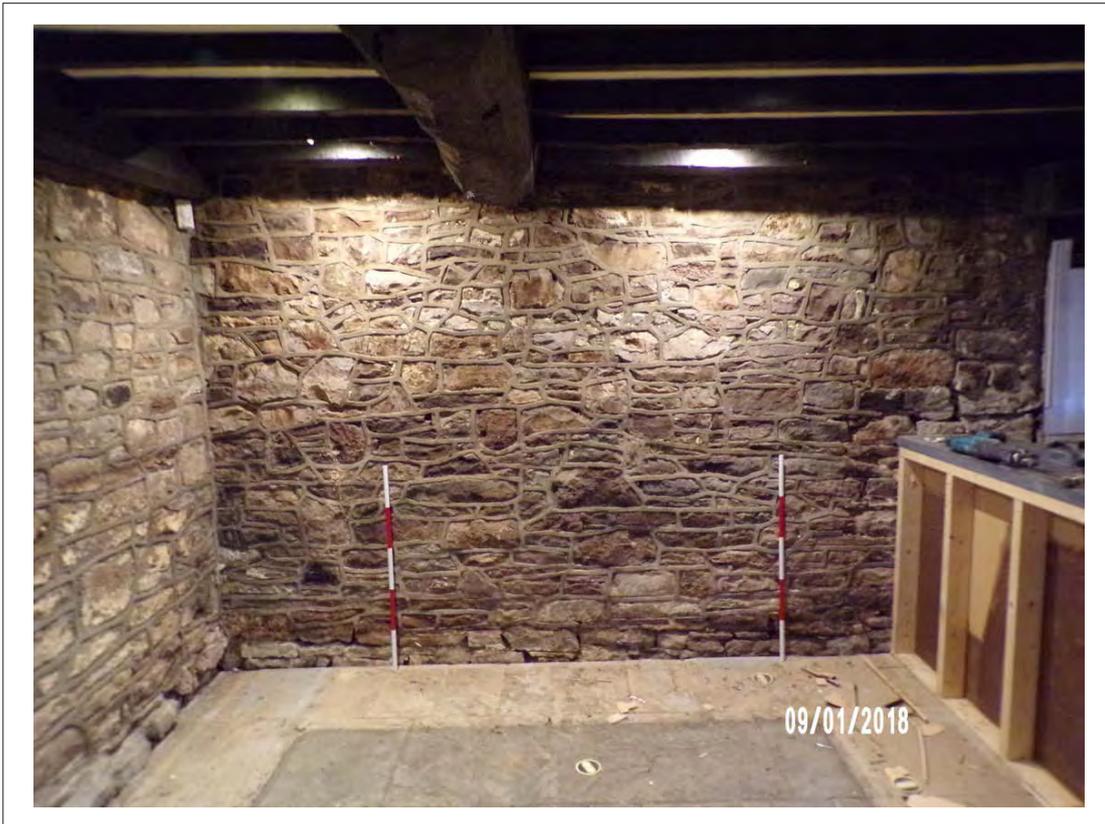
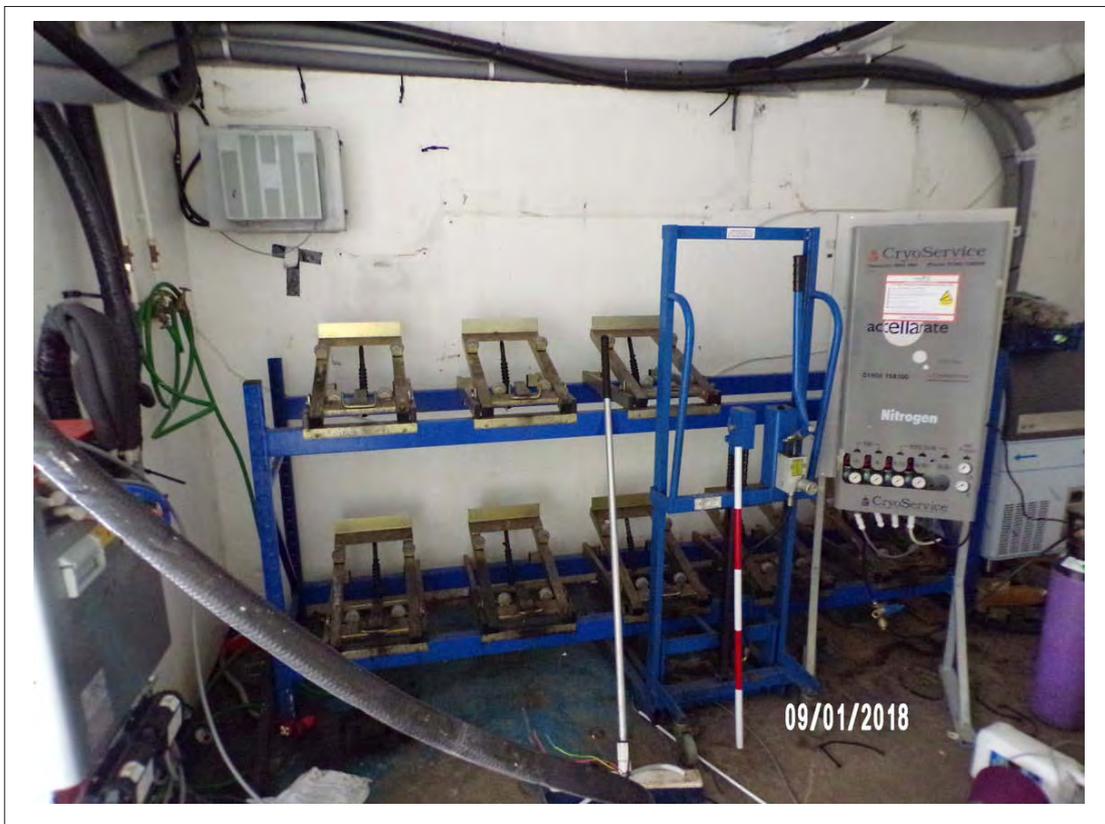
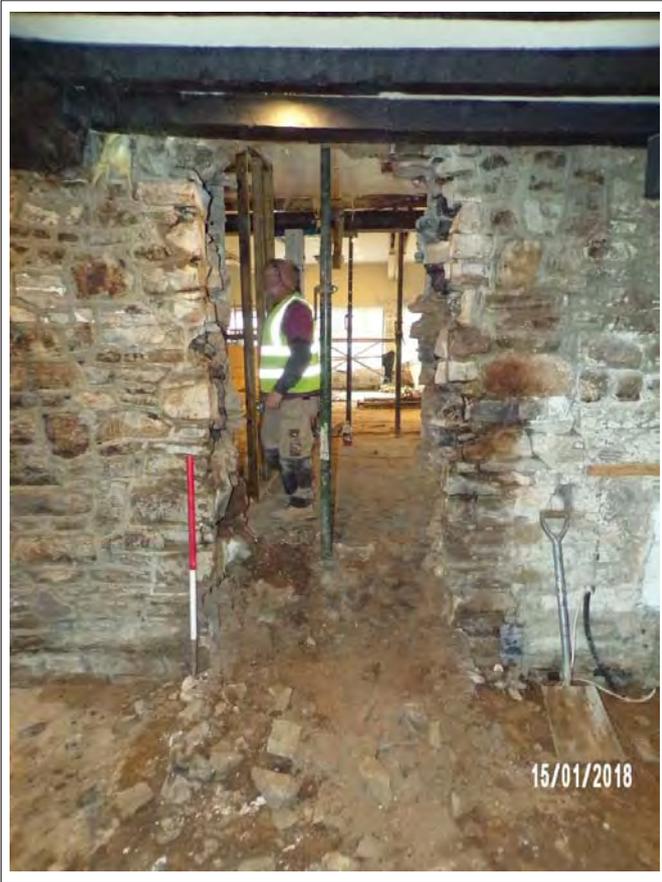
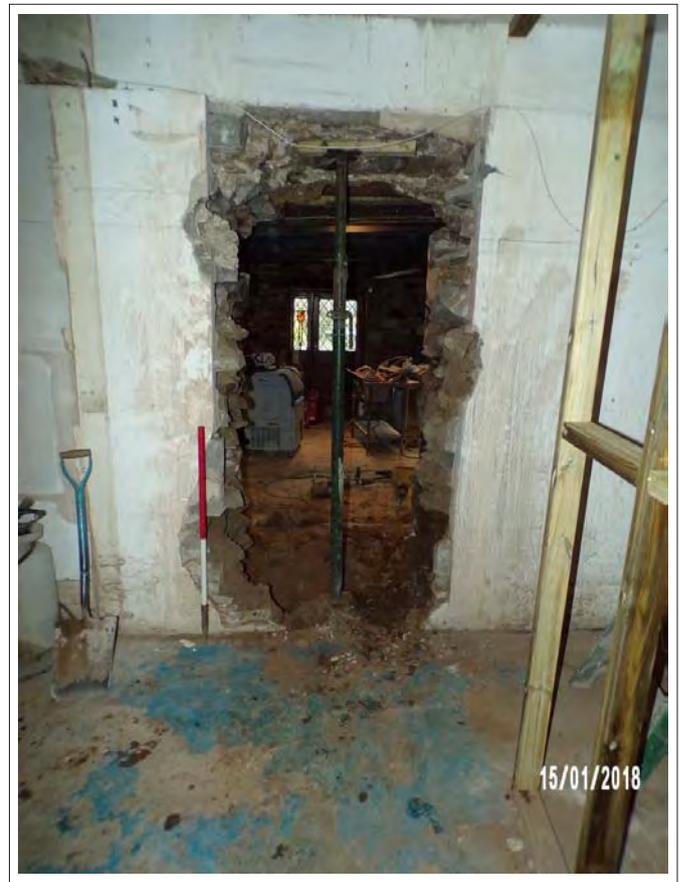
Plates 21-24 show the eastern and western faces of the bar area wall both before and after alteration (insertion of a new doorway opening). The watching brief undertaken during the formation of this opening noted that the wall consisted of two facing courses with an internal rubble core. The internal rubble core was roughly bonded in dried mud. Contained within the core of the wall was a largely intact small mill/quern stone (Appendix 3). This is likely to be contemporary with the construction of the wall and thus be of approximate eighteenth century date.
