Photographic Record

York Hotel - St Mary Street, Cardiff

November 2017

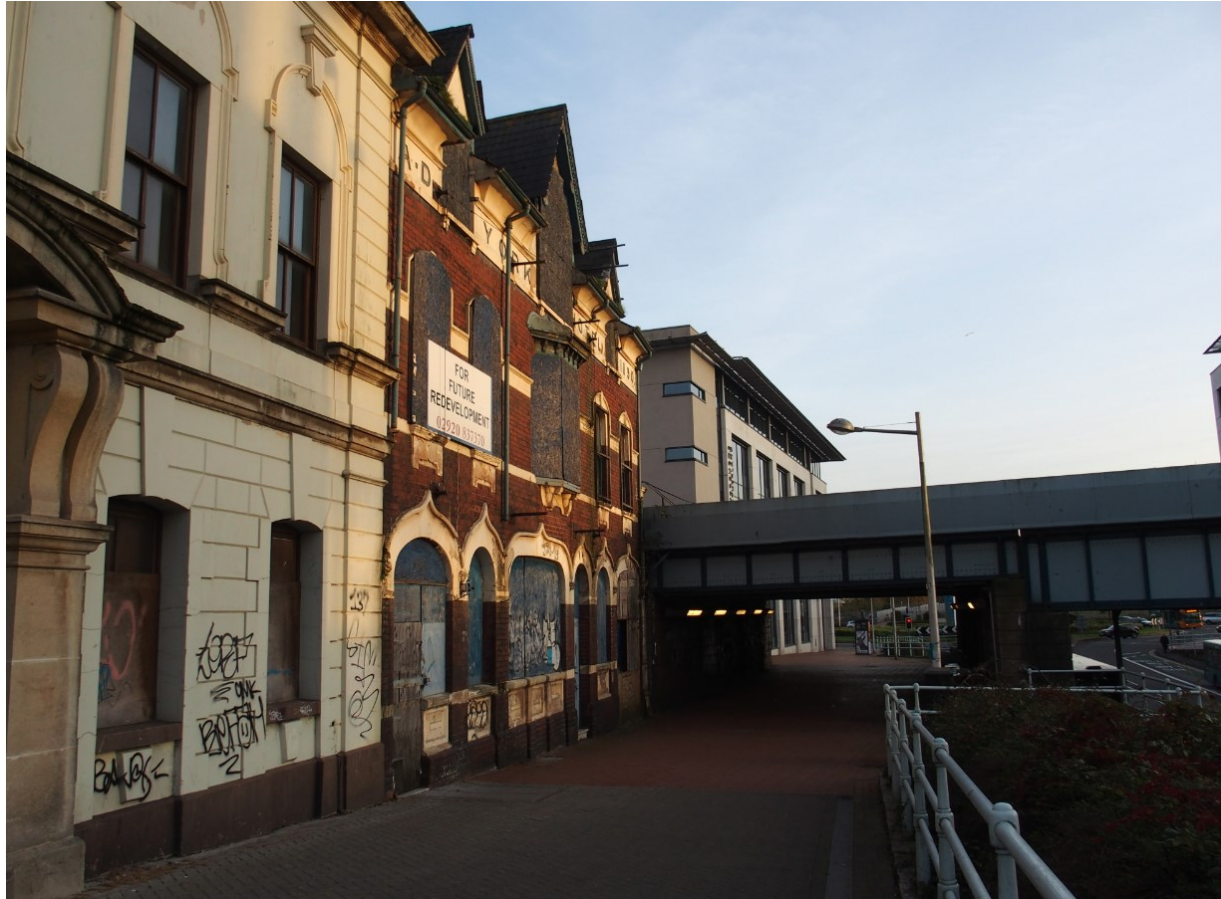
Photo ref	01
Photo Location	West Elevation.
Details	Three storey building, as viewed from the north west corner of the Site, showing the principal front elevation. Frontage is comprised of red brick, with stucco details, and a pitched slate roof. There are six ground floor openings, 4 windows at first floor level with a shallow canted bay window centrally placed at first floor level, and 3 gabled dormers at roof level, covered in slate tiles.

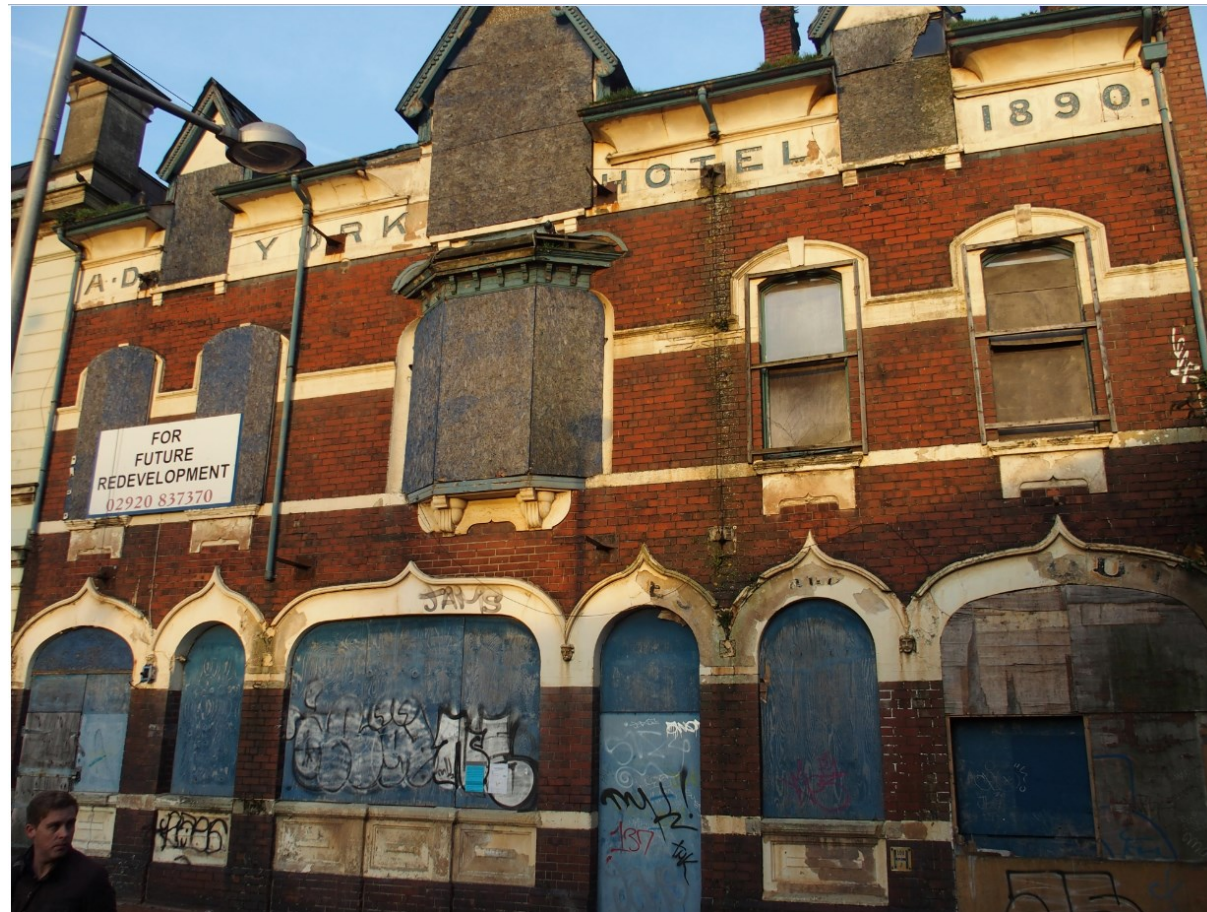
Photo ref	02
Photo Location	West elevation.
Details	View of the western elevation of the building, from the south east. View shows the coved eaves cornice with name and date in plaster work, and second floor level. Two pairs of timber sash windows are visible at first floor, with a canted bay window placed centrally between them. Red brick stucco ornamentation. At ground floor, openings are contained in ogee arches /surrounds with mask consoles and spandrel panels.

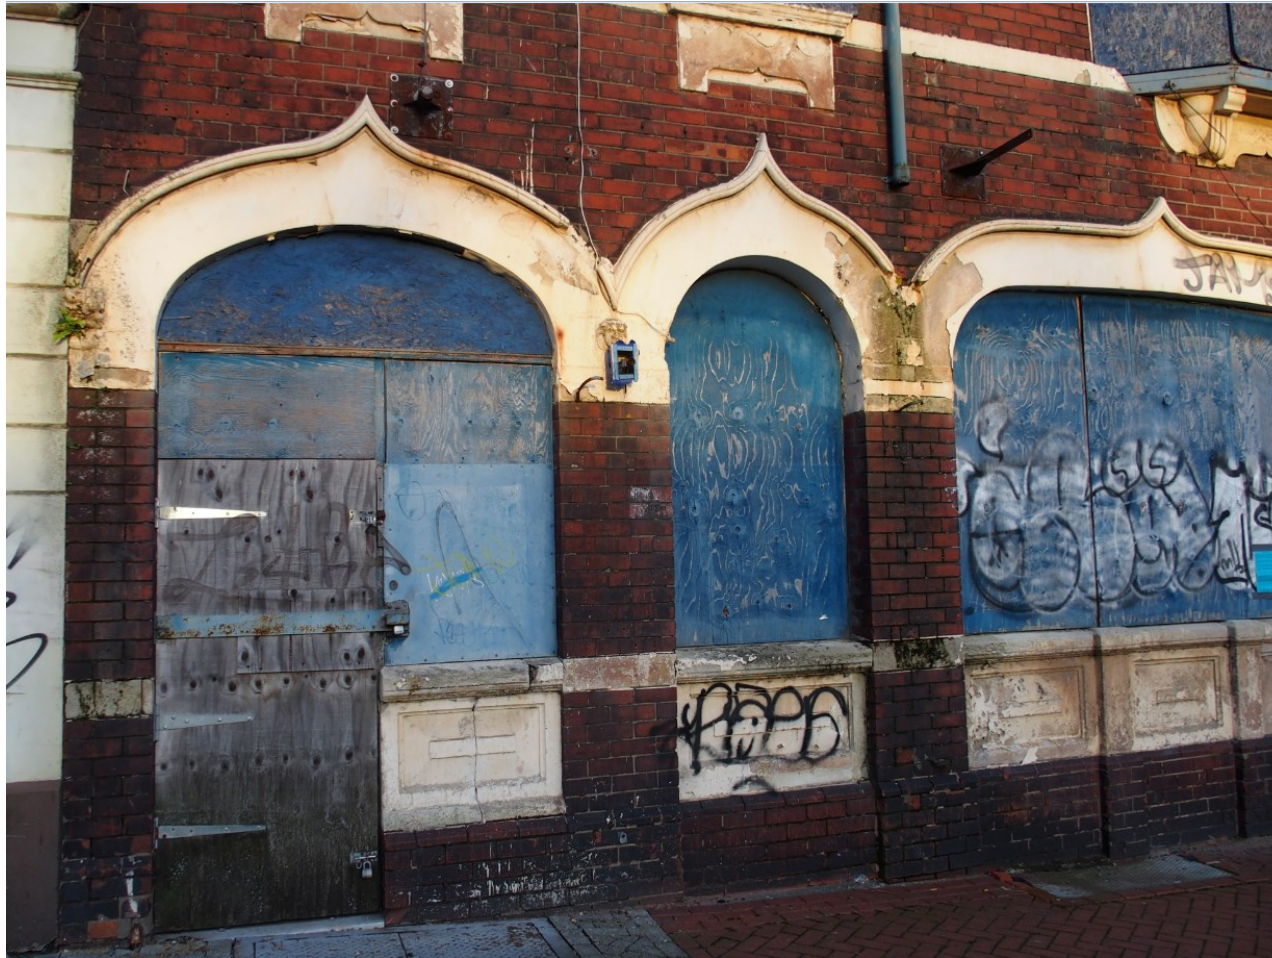
Photo ref	03
Photo Location	West elevation: ground floor openings on the west side of the front elevation.
Details	Ground floor opening vary in size, but are each have ogee arched heads/windows/door surrounds. Below each of the windows is a stone cill, which ran across the brick work but has been damaged in some places and lost. Decorative rectangular aprons are seen below the cills.

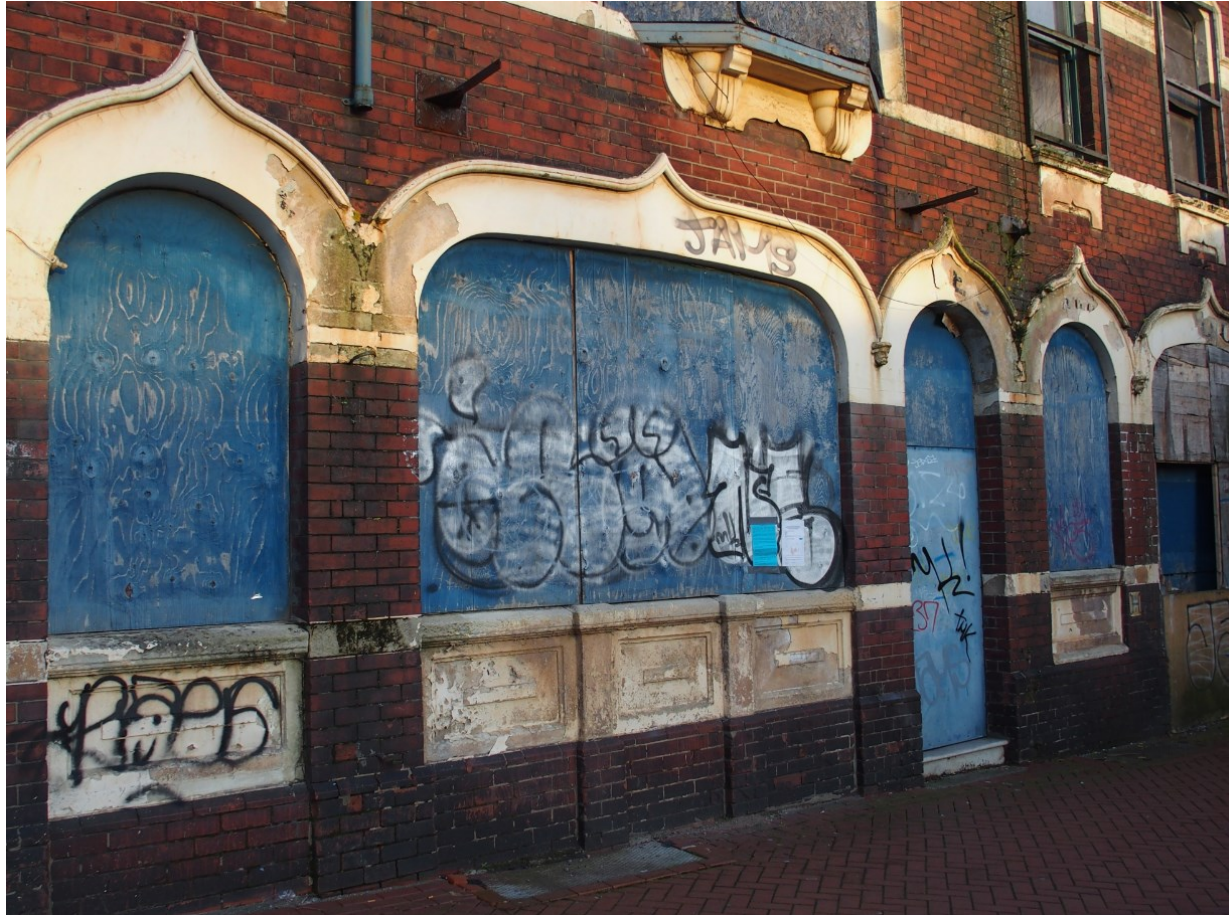
Photo ref	04
Photo Location	Exterior west elevation: ground floor openings looking towards the centre/east side of the front elevation.
Details	Openings are irregular in size. Each opening is topped with an ogee arch. A single doorway is shown, in this view, with a stone entrance step, whilst the windows have stone cills and aprons beneath. Two long metal pegs extend from the wall above the widest window and may have been used for hanging signage or for lighting.

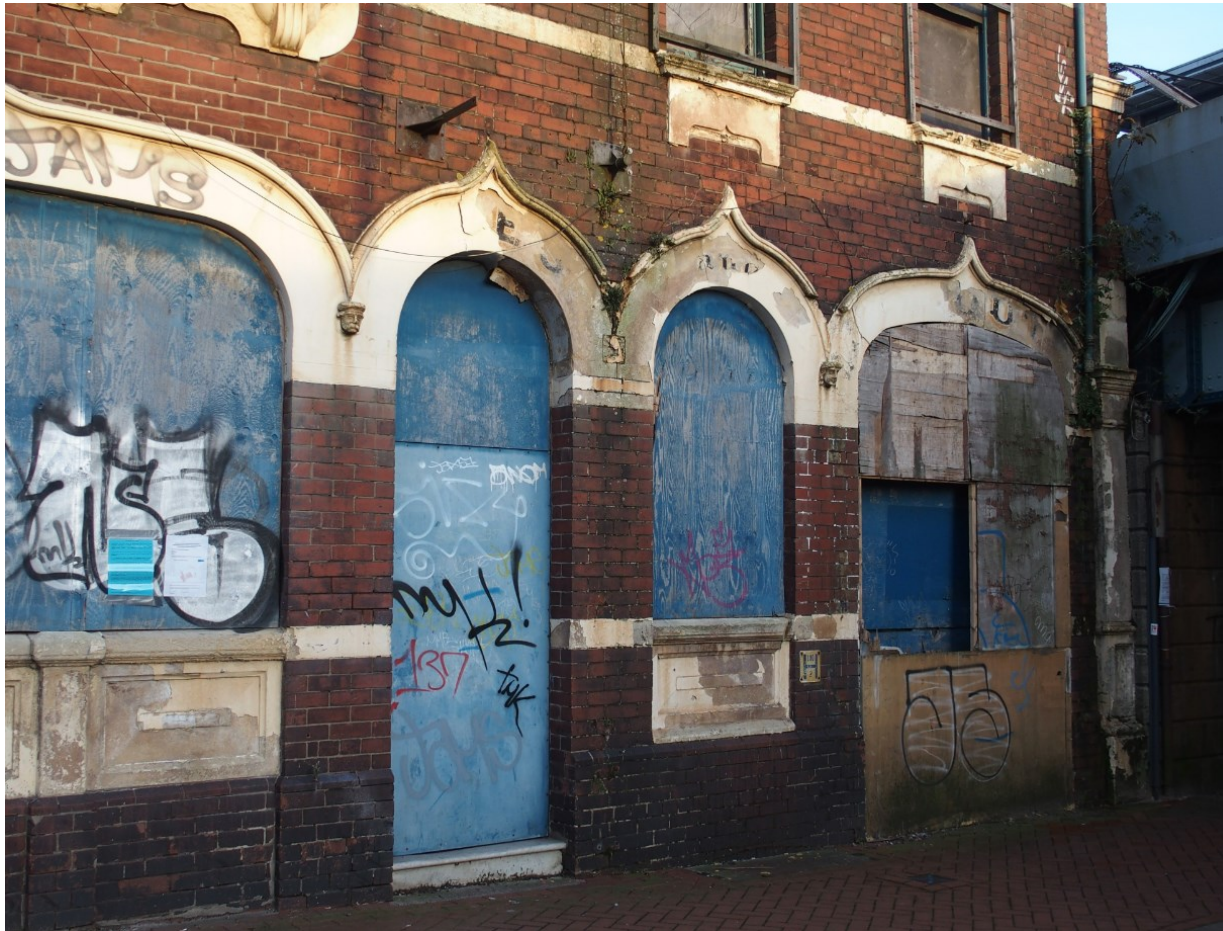
Photo ref	05
Photo Location	Exterior west elevation: ground floor openings on the east side of the front elevation.
Details	Two entranceways are located on the east side of this elevation, with a small window situated in-between. The doors and window are topped with ogee arches, and the window has a stone cill below with a decorative apron.

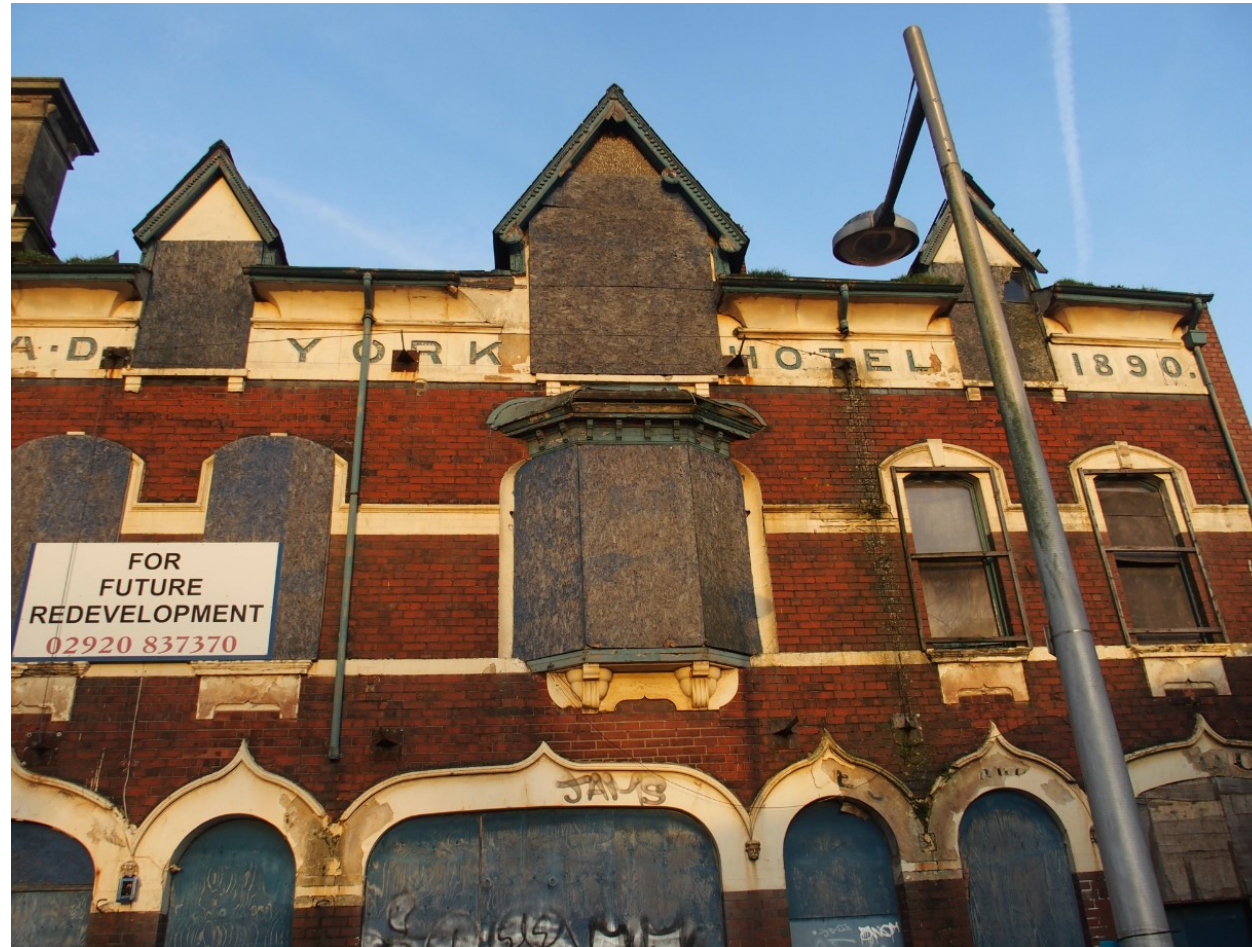
Photo ref	06
Photo Location	West Elevation: first floor level.
Details	View of central cambered window supported by moulded plaster console brackets, and flanked by two pairs of smaller windows. Window surrounds have central stylized keystone and aprons with ogee motifs. The windows are joined together by plaster detailing to form a string course. The eaves band is marked: 'AD YORK HOTEL 1890.', seen at roof level.

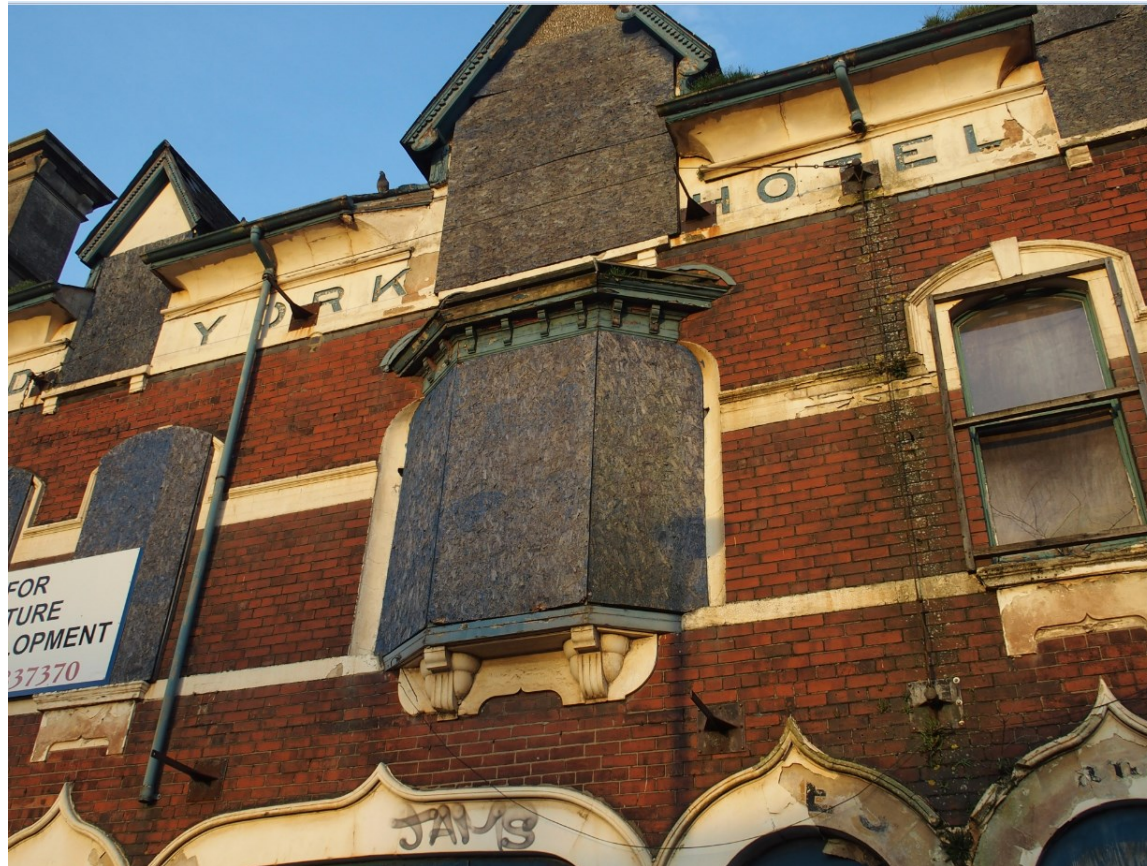
Photo ref	07
Photo Location	West Elevation: first floor.
Details	Cambered central window with a dentilled cornice above. Below are two rounded console brackets (a type of S-shaped corbel). The windows either side are framed by gentle depressed stone arches and central keystones. All three windows have aprons, which echo the ogee arches below. The window surrounds are also linked to form a string course.

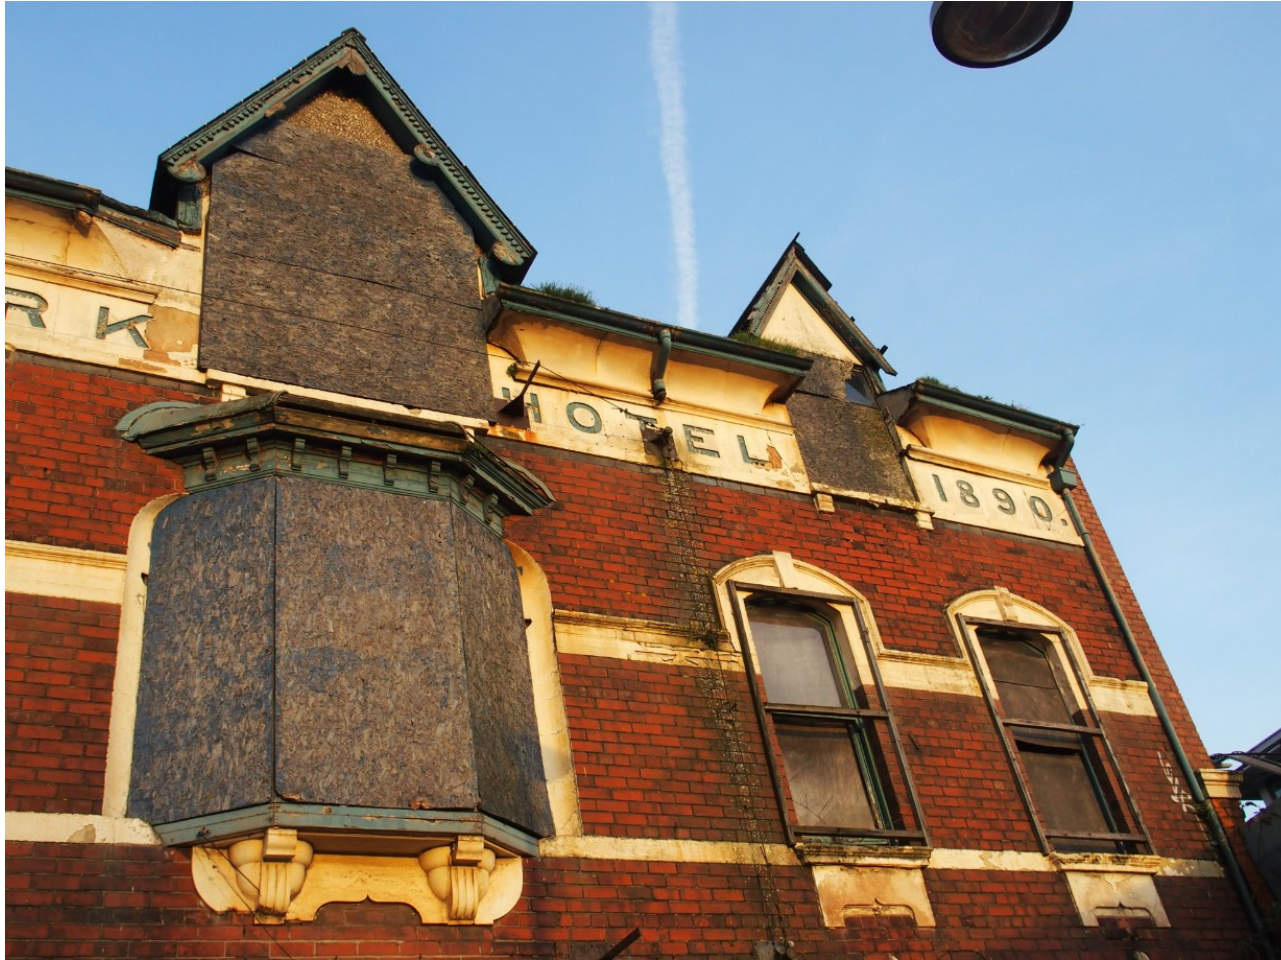
Photo ref	08
Photo Location	Exterior West Elevation: first floor windows.
Details	View of the central cambered window and smaller flanking windows on the east side of the front elevation. Cambered window and the two smaller flanking windows are connected by a string course, and all three have aprons below. A down pipe is situated to the right of the two smaller windows. The left downpipe has been lost.

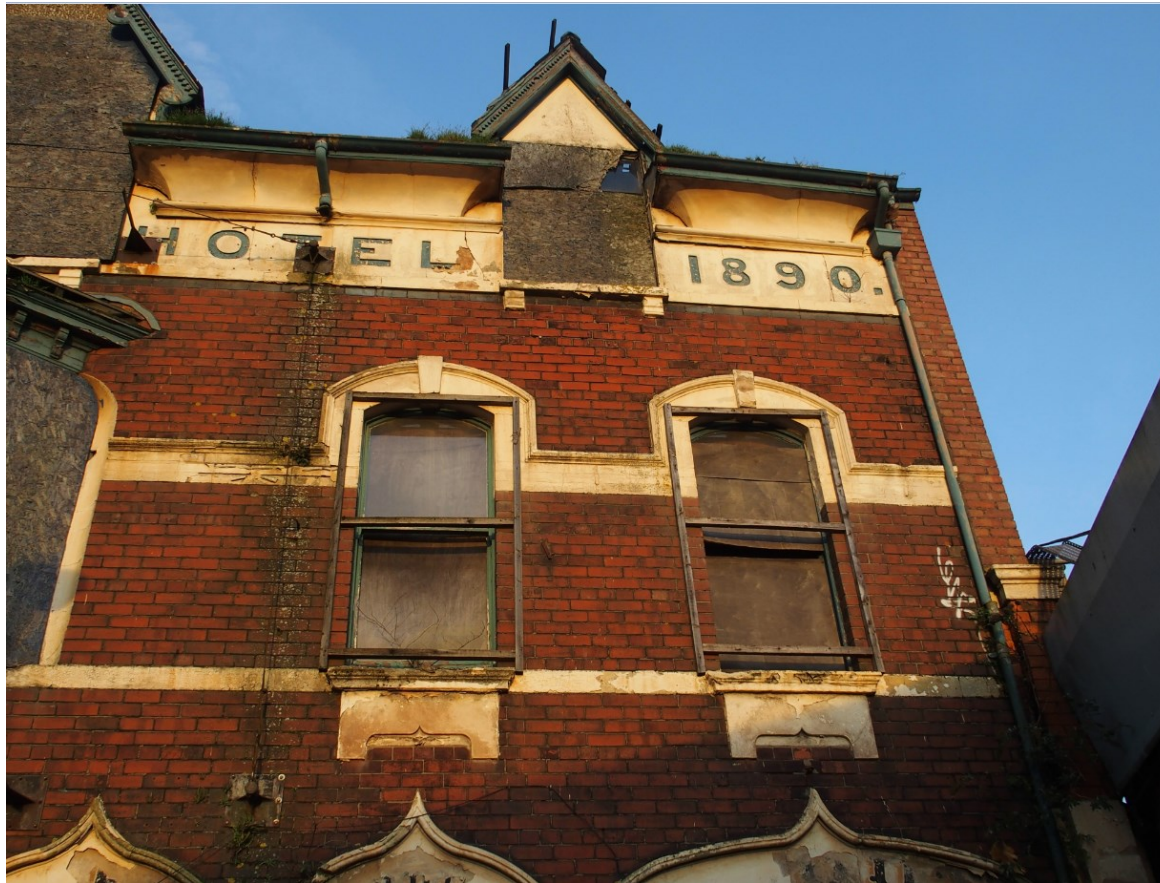
Photo ref	09
Photo Location	West Elevation: first floor.
Details	View of the first floor flanking windows on the east side of the west elevation. The windows are 2 over 2 timber sash windows, framed by gentle depressed stone arches, which run into the string course, and central keystones. Below the windows are aprons which echo the ogee arches at ground floor level. Metal frames are also seen on the exterior of the windows. A down pipe is situated to the right of the windows. The left hand downpipe has been lost , but the imprint is still seen in the brick work.

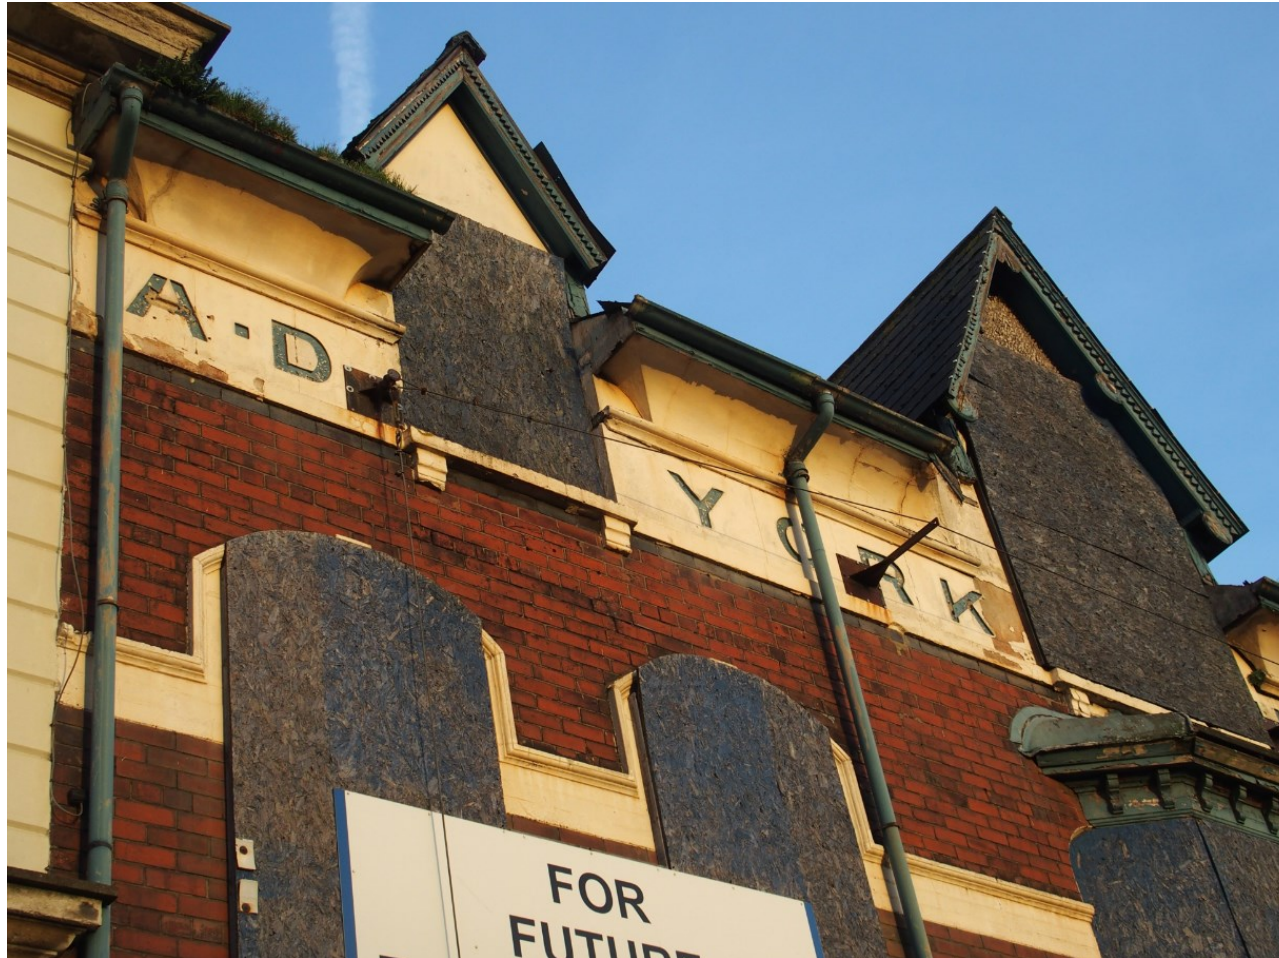
Photo ref	10
Photo Location	Exterior west elevation: second floor.
Details	Dormer windows at roof level are seen, with patterned barge board gable, of rough cast render. The eaves band is marked: 'AD YORK HOTEL 1890.', and is seen to run through the lower section of the dormer windows. Below the windows are two squared console brackets .

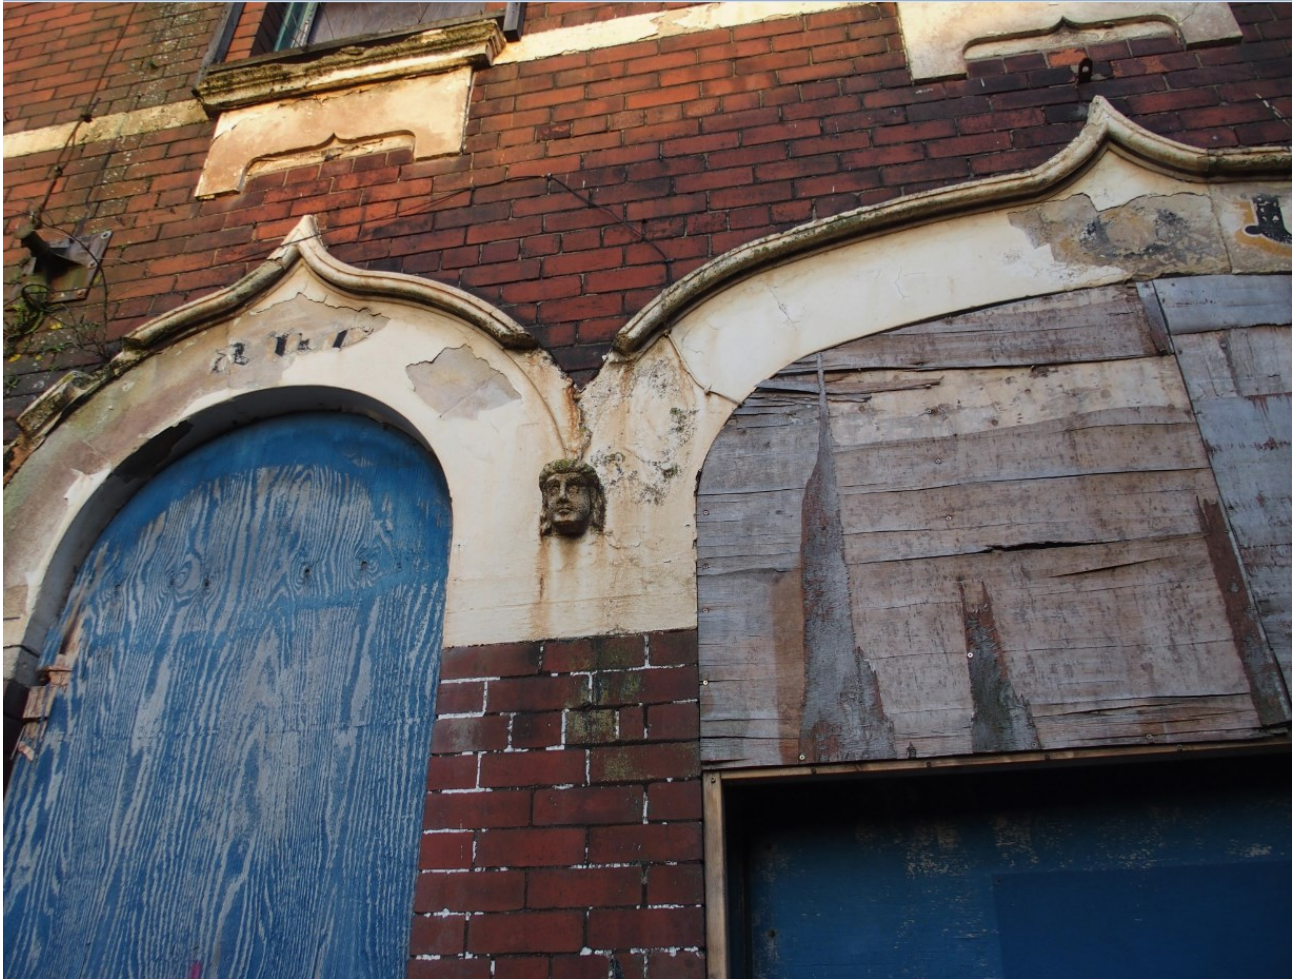
Photo ref	11
Photo Location	West Elevation: architectural detail.
Details	View of the stucco ogee arch and decorative corbel head, ground floor. The corbel is made of sandstone, which is eroding.

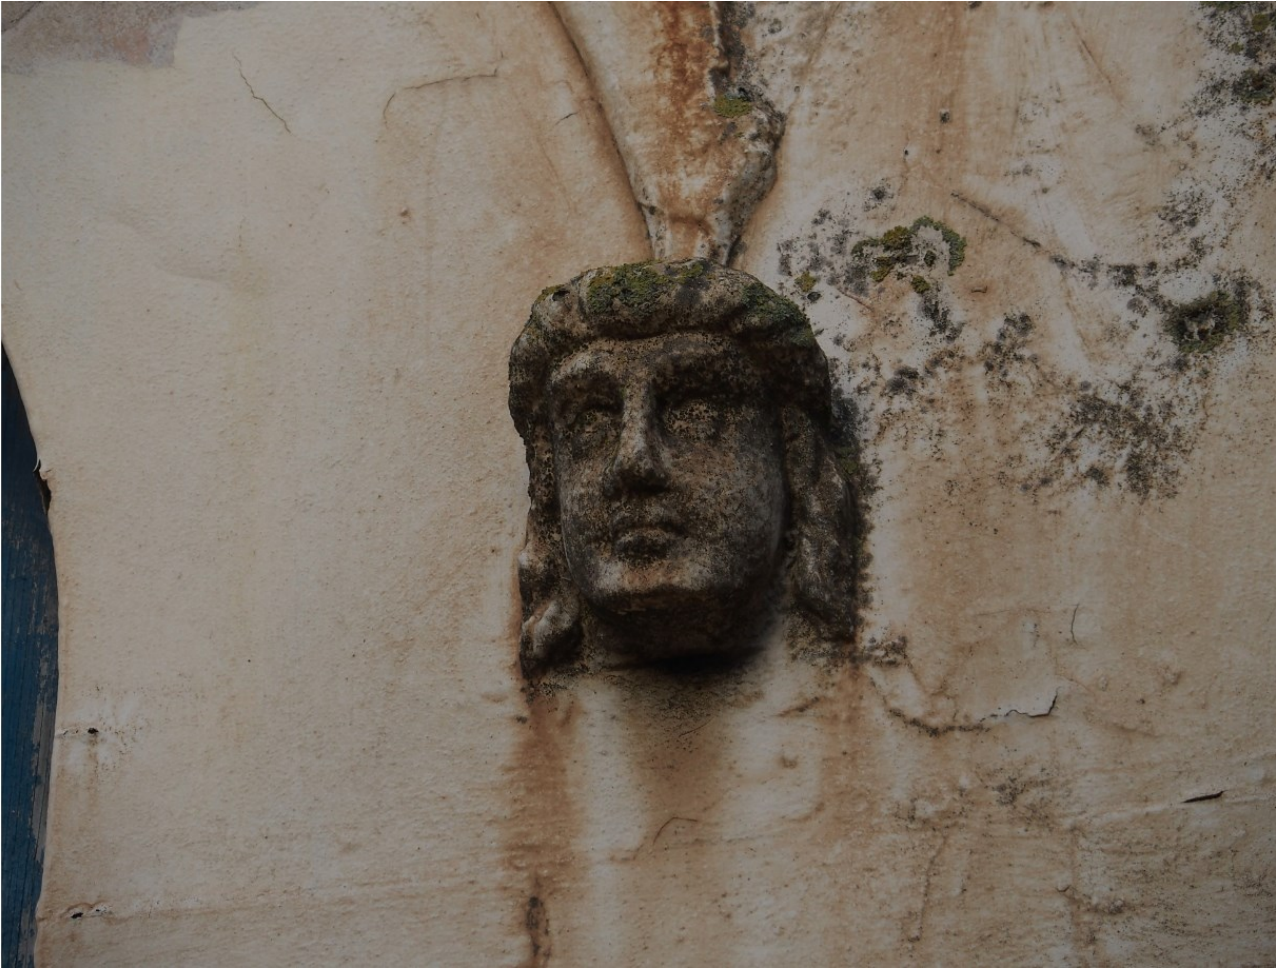
Photo ref	12
Photo Location	West elevation.
Details	Decorative stone corbel head, ground floor.

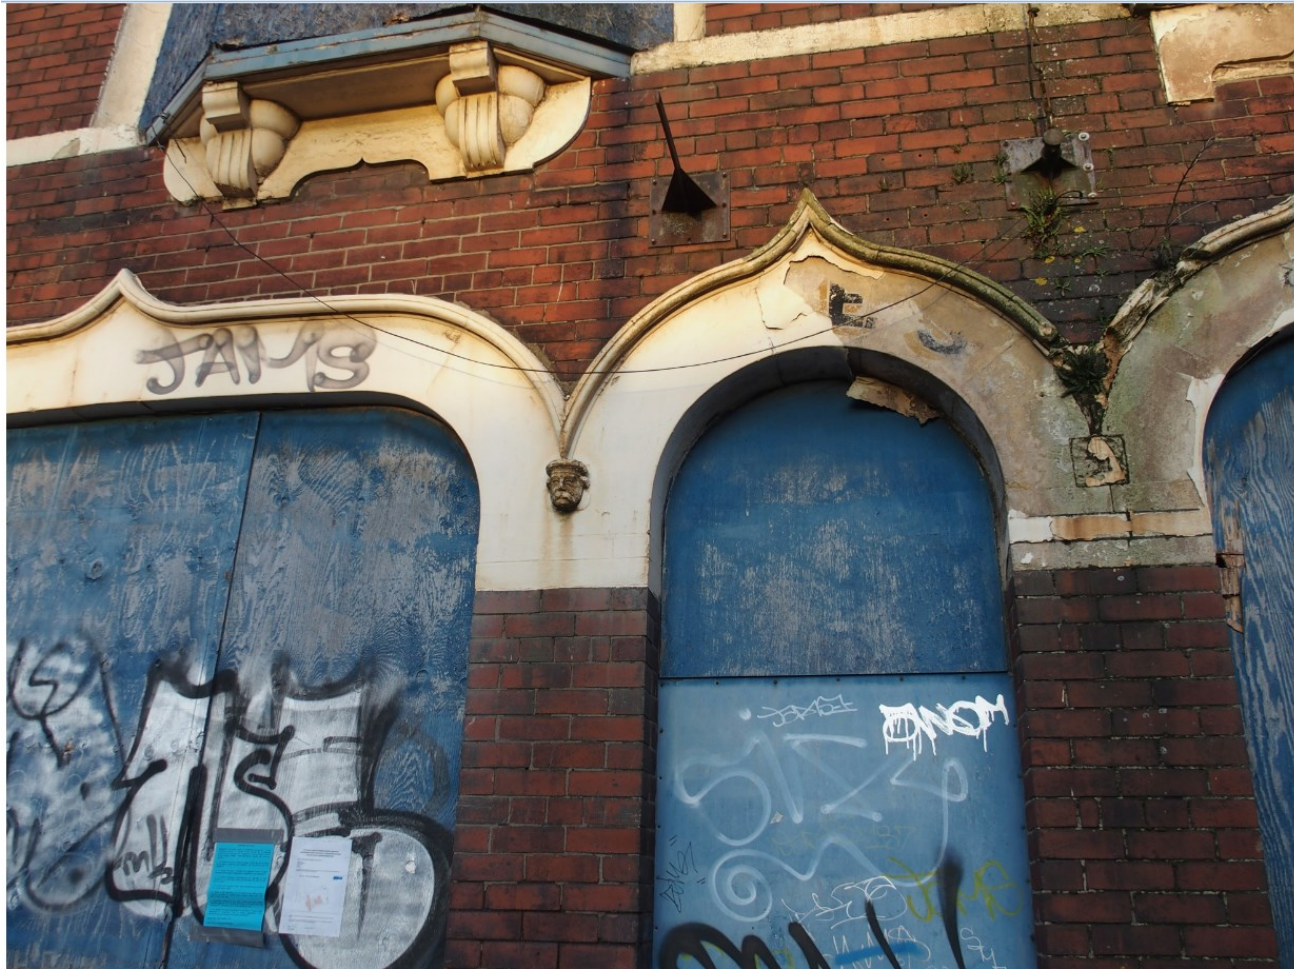
Photo ref	13
Photo Location	West elevation: architectural detail.
Details	View of stucco ogee arch, with one intact and one lost, decorative corbel head, ground floor.

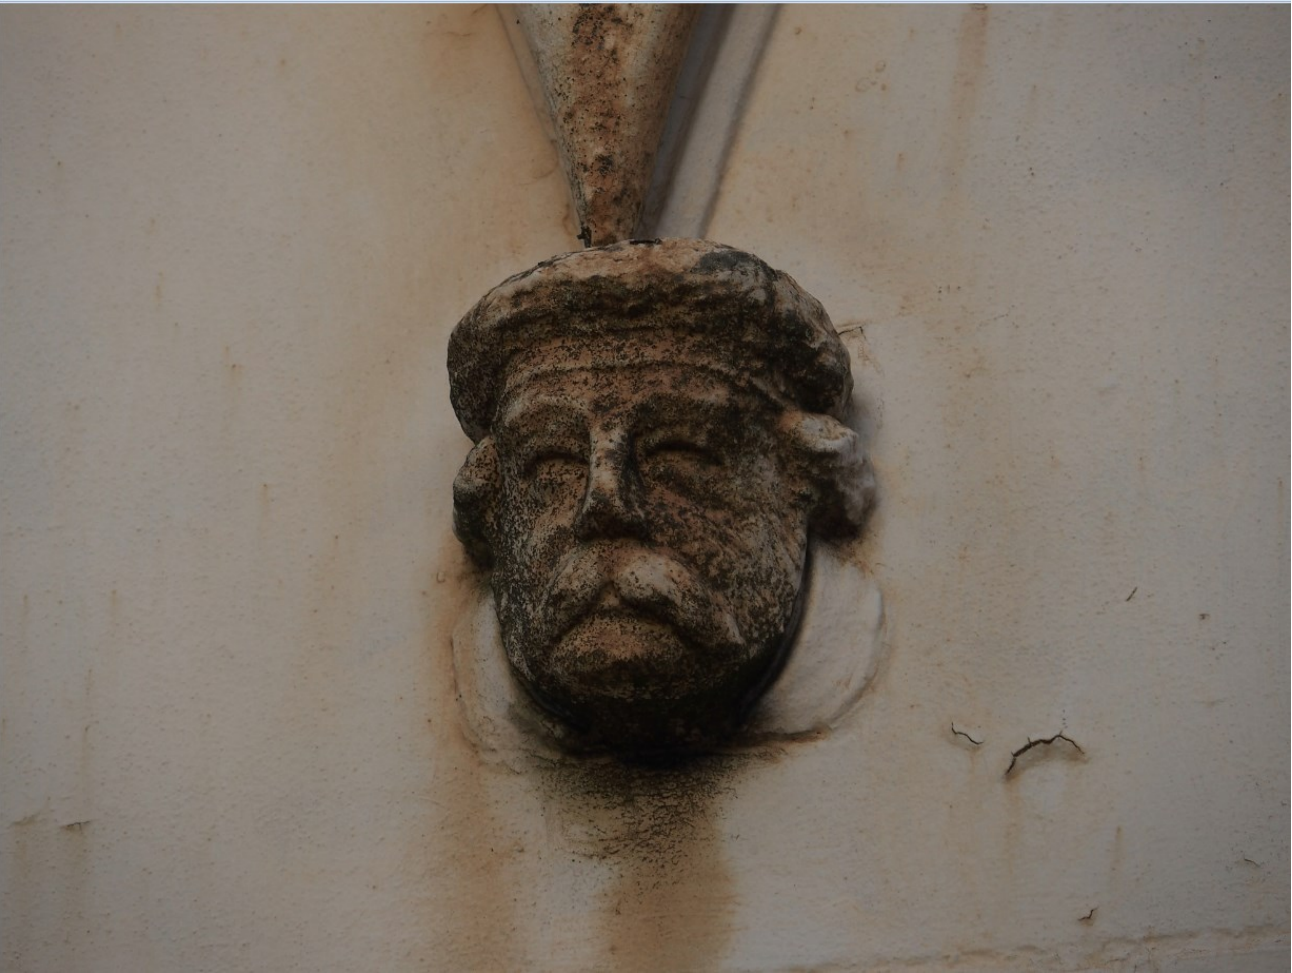
Photo ref	14
Photo Location	West elevation: architectural detail.
Details	Decorative stone corbel head, showing a heavily moustached man, with shoulder moulds , ground floor.

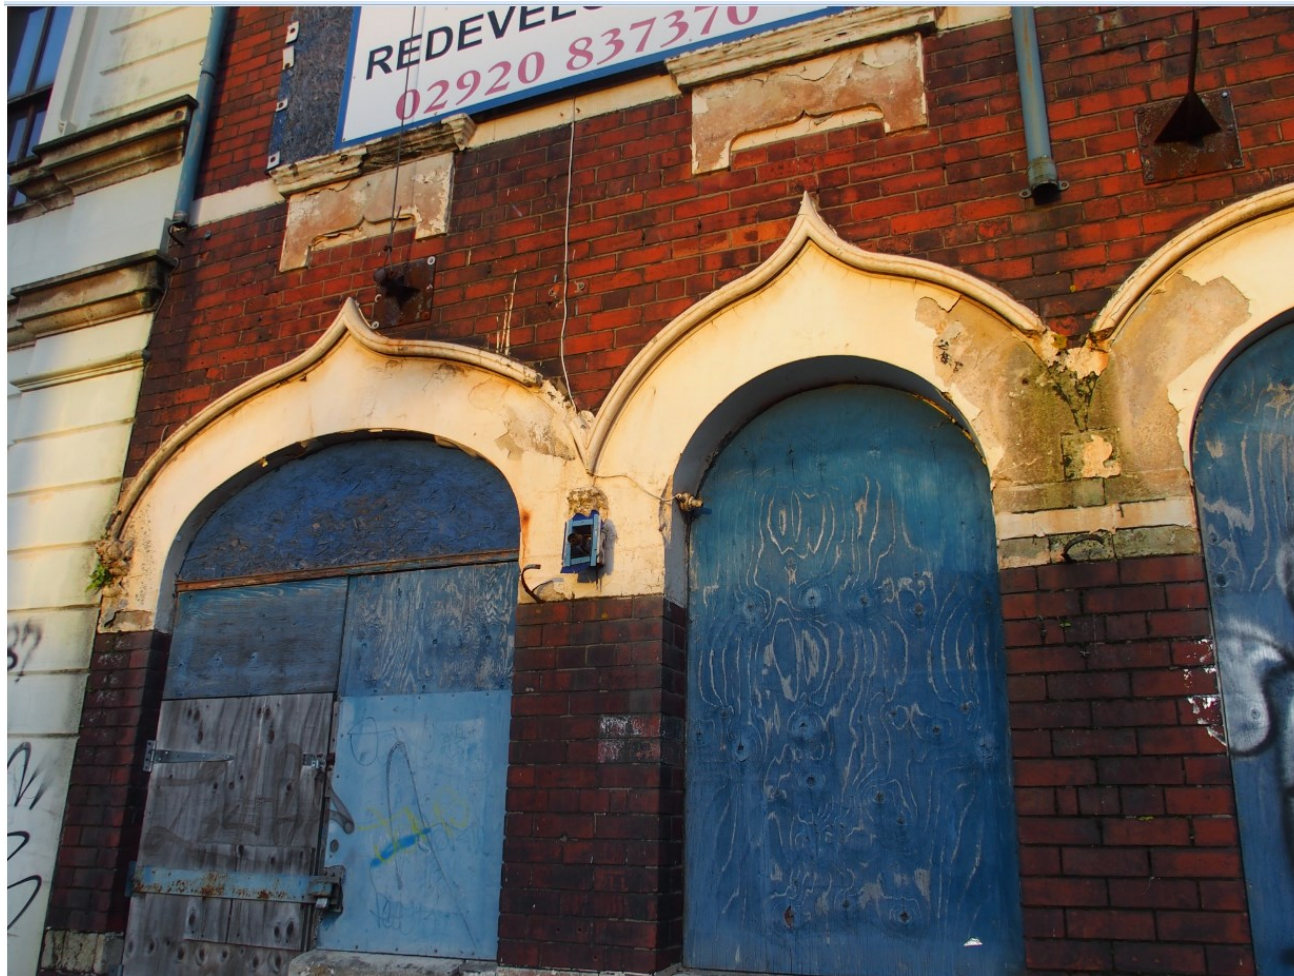
Photo ref	15
Photo Location	West elevation: architectural detail.
Details	Irregular stucco ogee arches, and intact decorative corbel head.

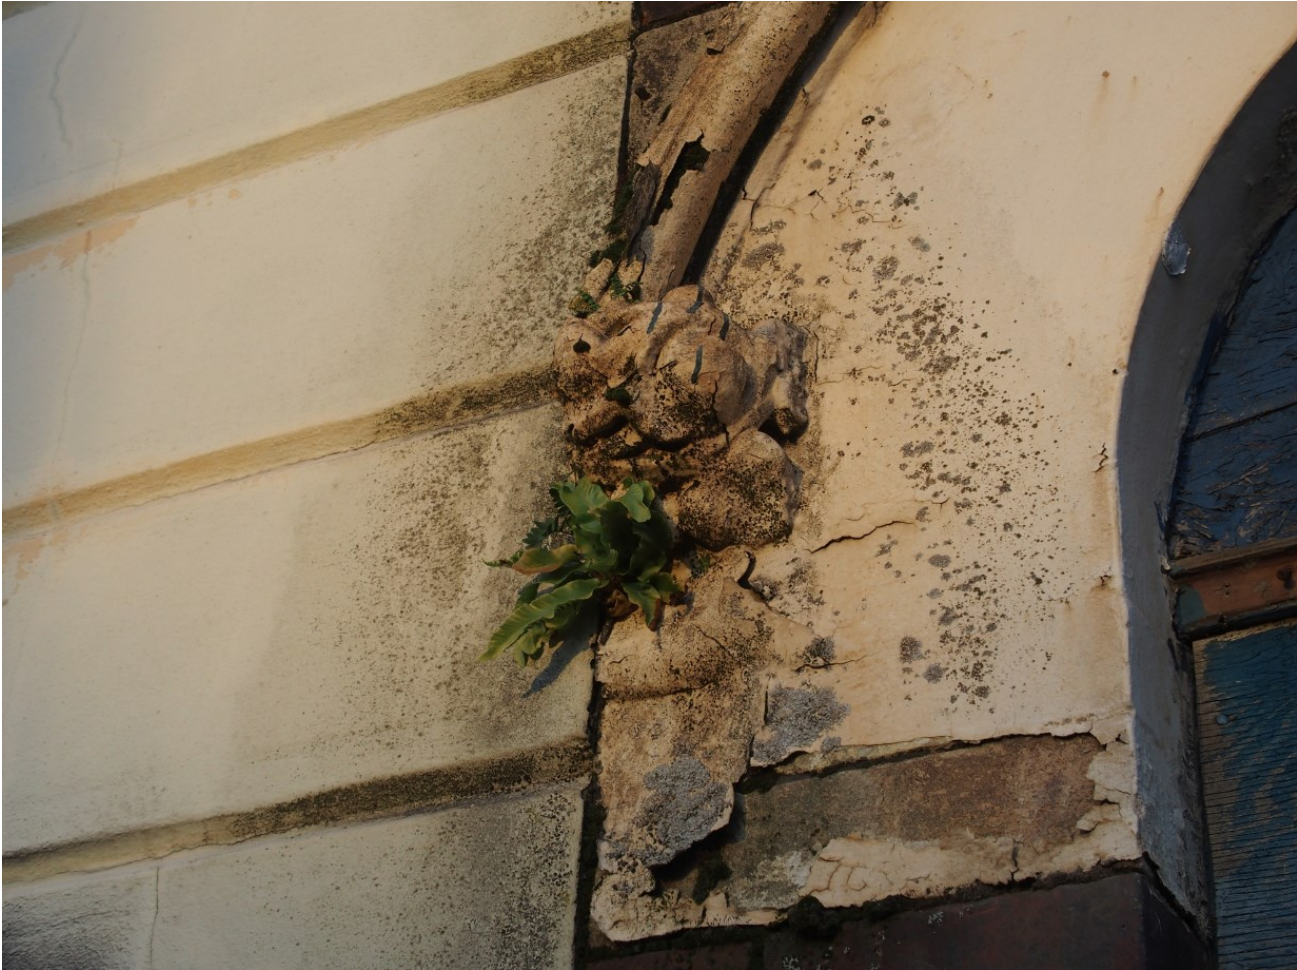
Photo ref	16
Photo Location	West elevation: architectural detail.
Details	Damaged stucco corbel on the western most arch, ground floor.

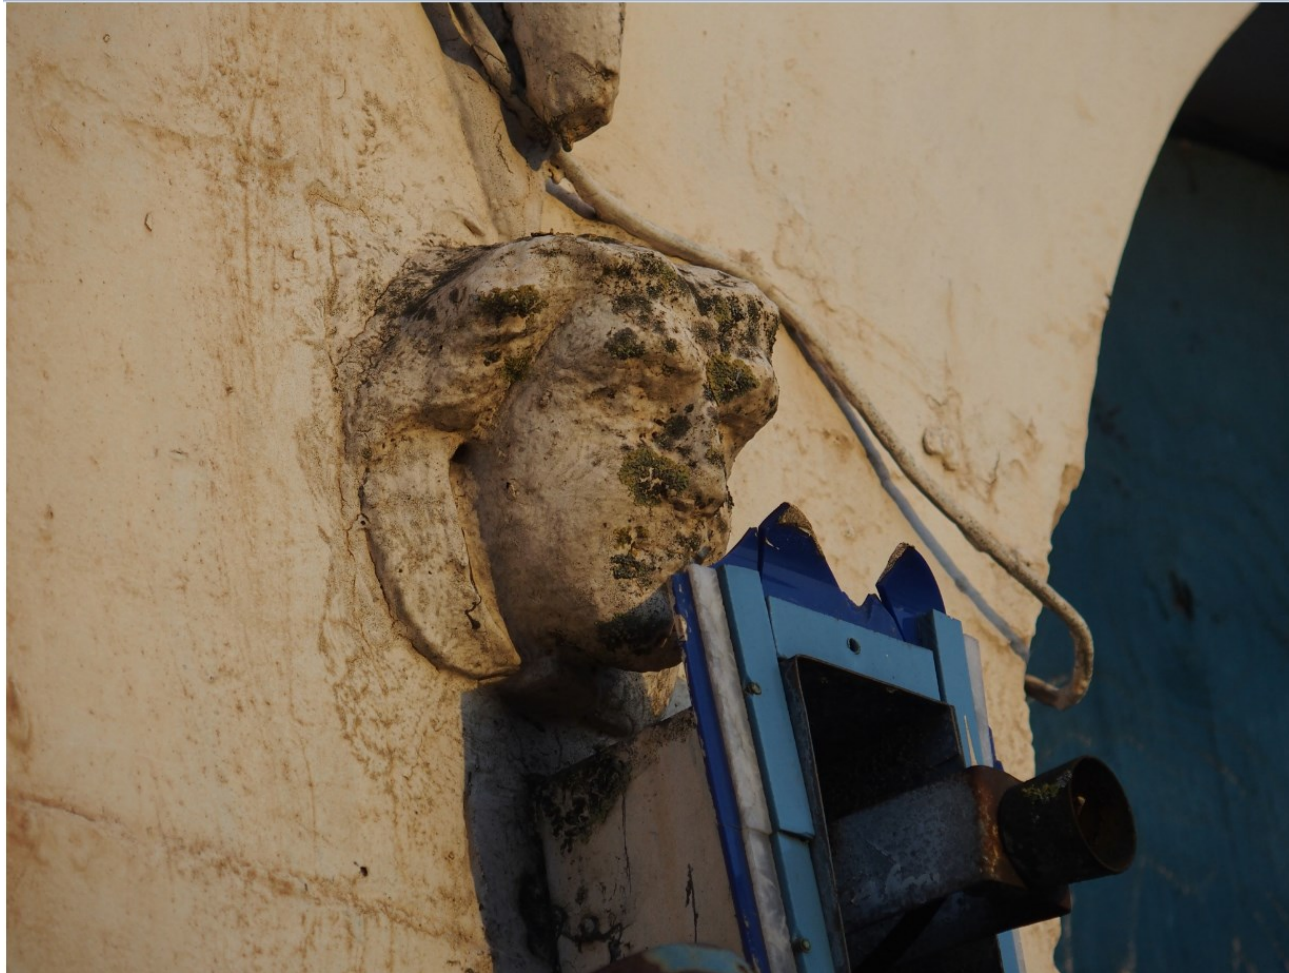
Photo ref	17
Photo Location	West elevation : architectural detail.
Details	Decorative corbel, head with shoulder mould, at ground floor. Sandstone material is eroding. Modern security camera situated directly below.

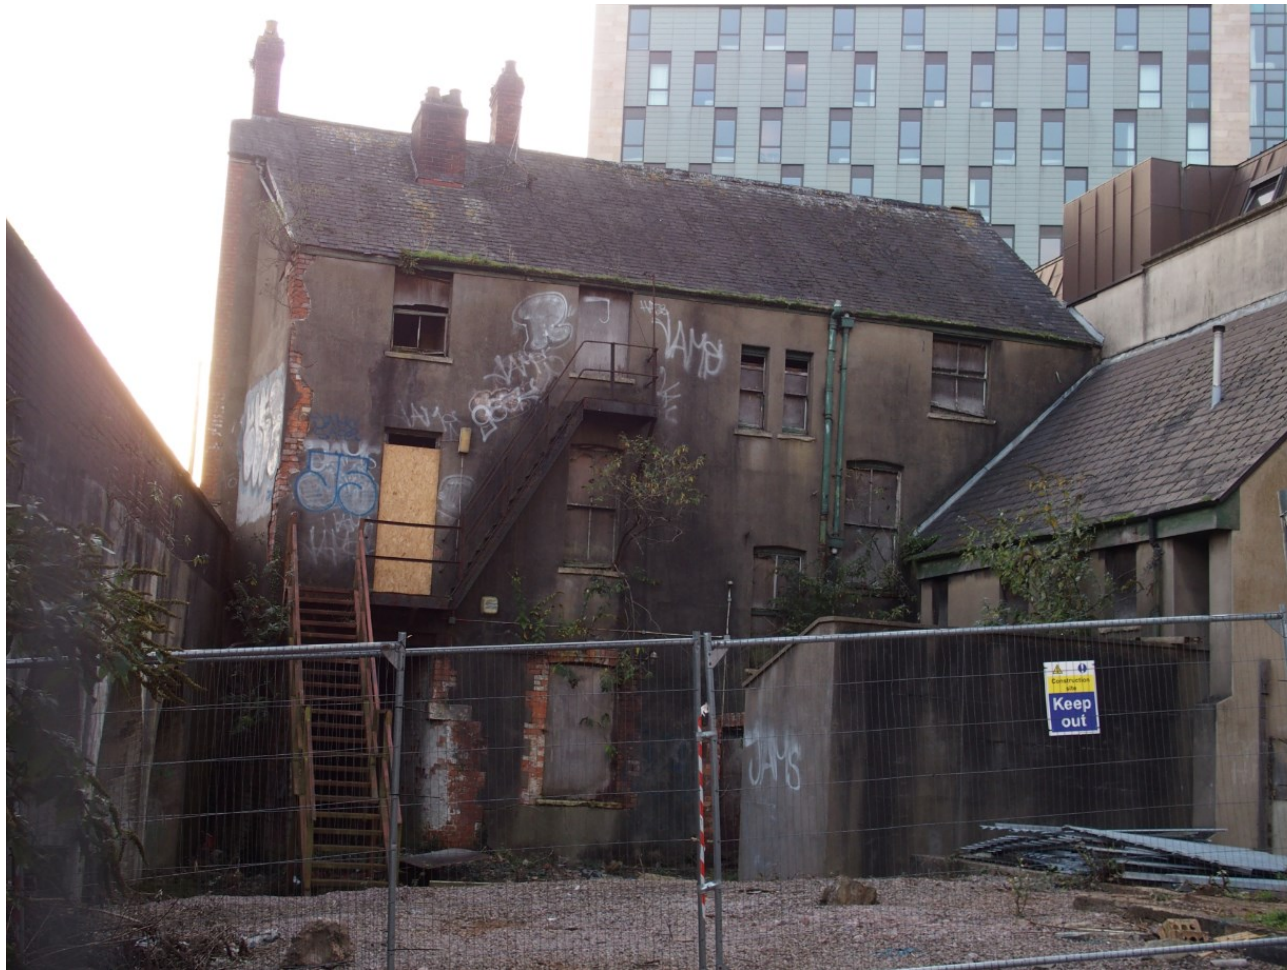
Photo ref	18
Photo Location	East Elevation.
Details	View of the rear elevation of the building comprised of plastered/rendered, with an irregular fenestration pattern of varied timber sash windows. Remains of foliage are seen on this elevation. A 20th century metal staircase is situated on the left side of the elevation, which leads up to the third floor. The pitched slate roof can be seen, with three remaining brick chimney stacks. The wing of the building is also situated on the eastern side of the rear. It is a two storey rendered structure, with a mono-pitched roof.
