Photographic Record

York Hotel - St Mary Street, Cardiff

November 2017

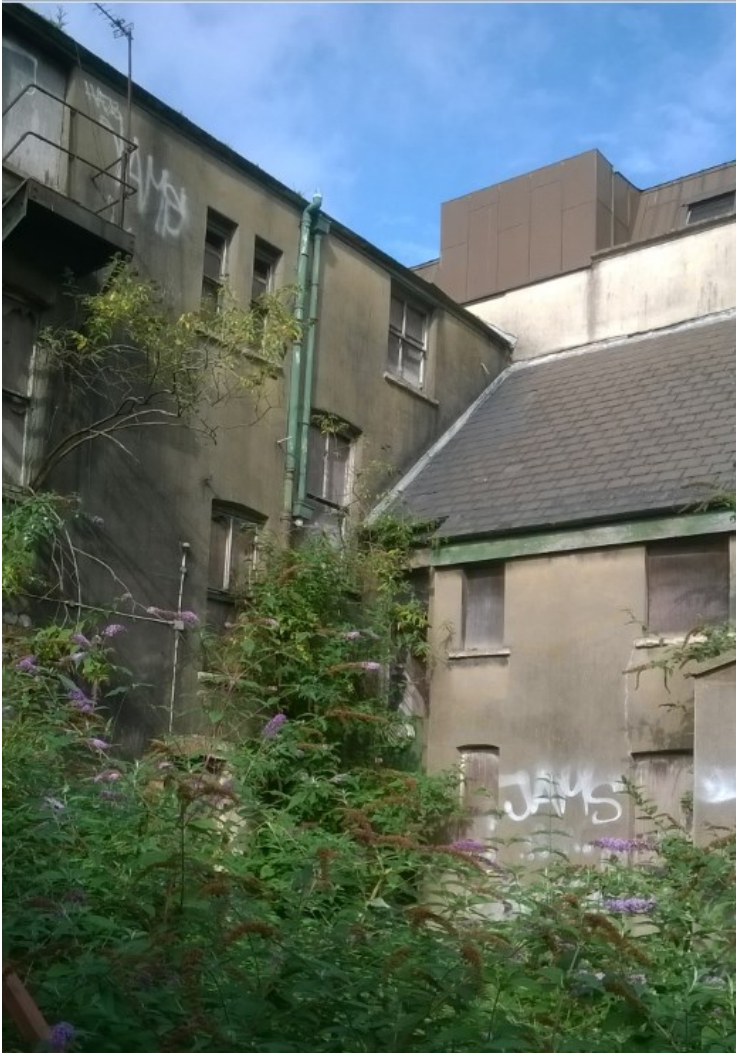
Photo ref	19
Photo Location	East Elevation
Details	View of the wing adjoining the main section of the hotel. Slate roof can be seen on the wing and part of the irregular fenestration pattern.

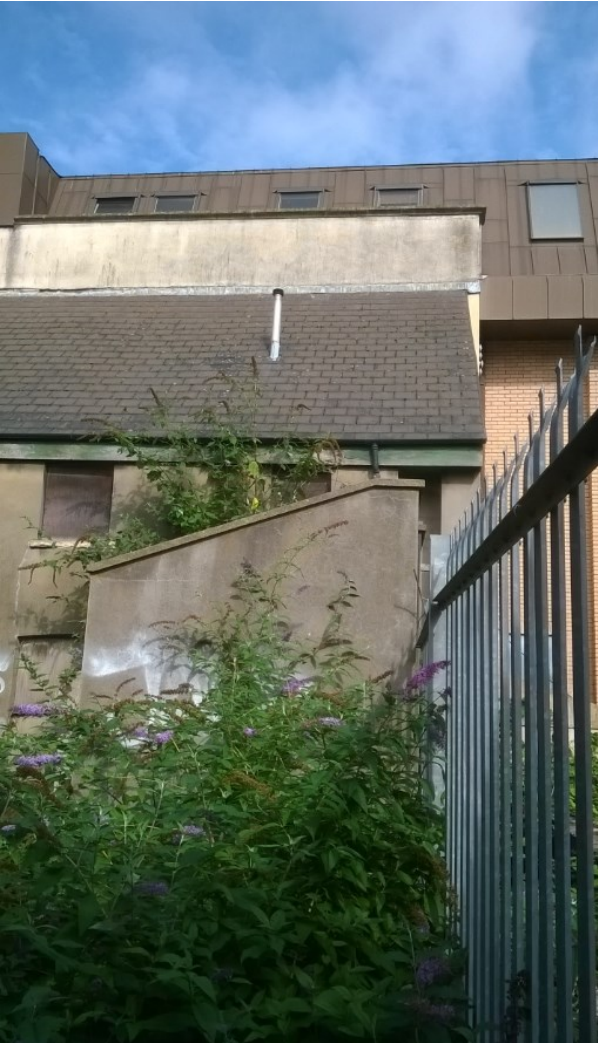
Photo ref	20
Photo Location	East Elevation.
Details	End of the wing showing slate tiled roof and ancillary structure.

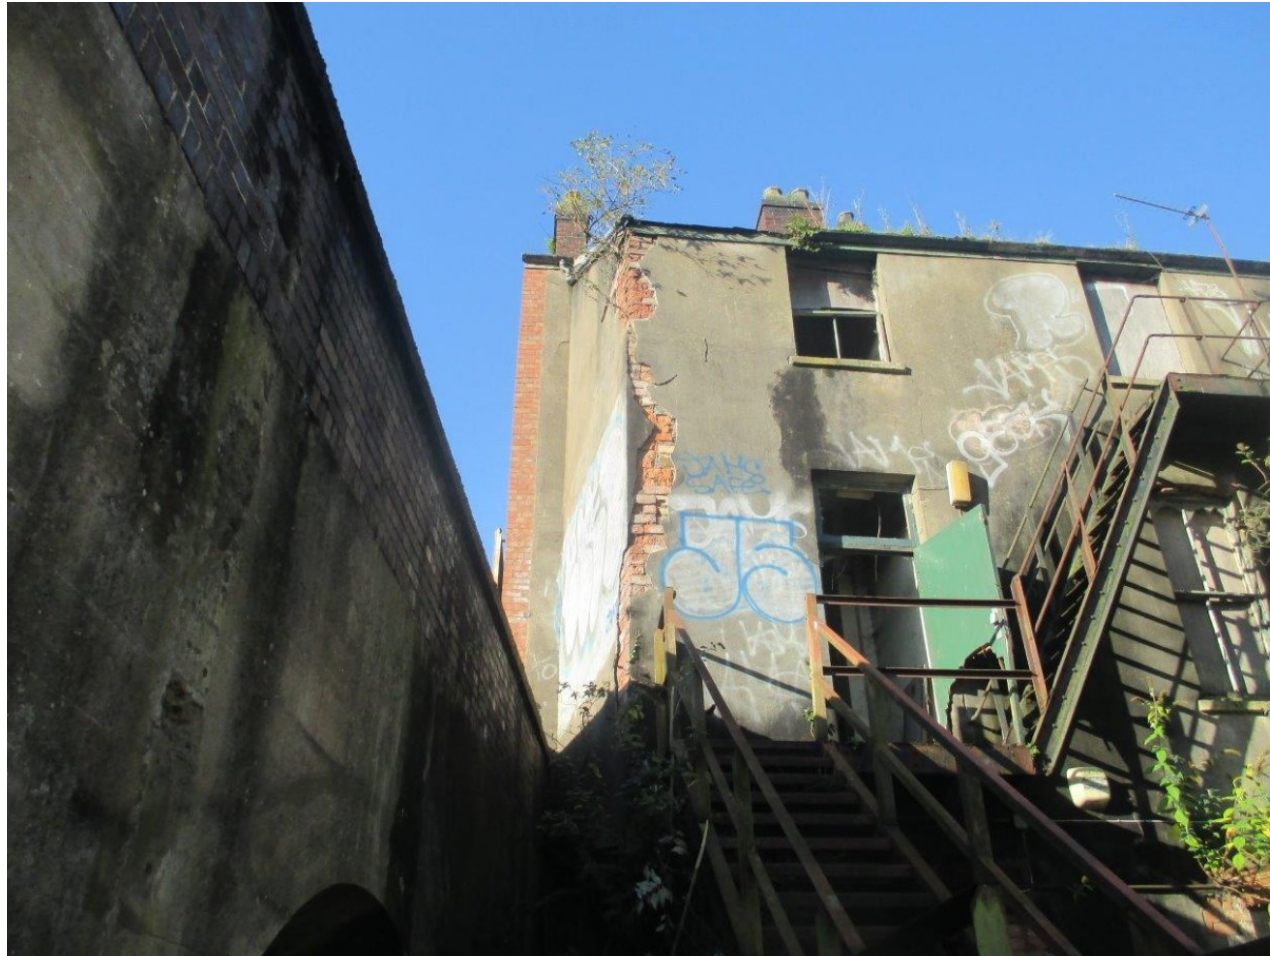
Photo ref	21
Photo Location	East elevation.
Details	Partial view of the southern elevation of the building rising above the viaduct. Red brick chimney stack is shown.
