WL08.01 East elevation, displaced stonework

WL08.02 South elevation

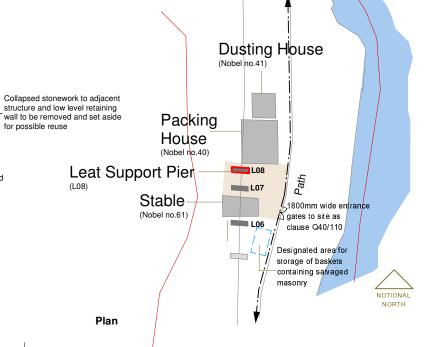
WL08.01 East elevation

Unstable and leaning leat wall in danger

of imminent collapse
Carefully record all stonework as clause

C41/140 and dismantle complete as C41/121 Rebuild as C41/125

Structural cracks

for possible reuse
