**A Community Archaeology Project at the Glyn Neath  
Gunpowder Works, Pontneddfechan, South Wales.**

**SAM-BR230**

**Herefordshire Archaeology Report No. 382**

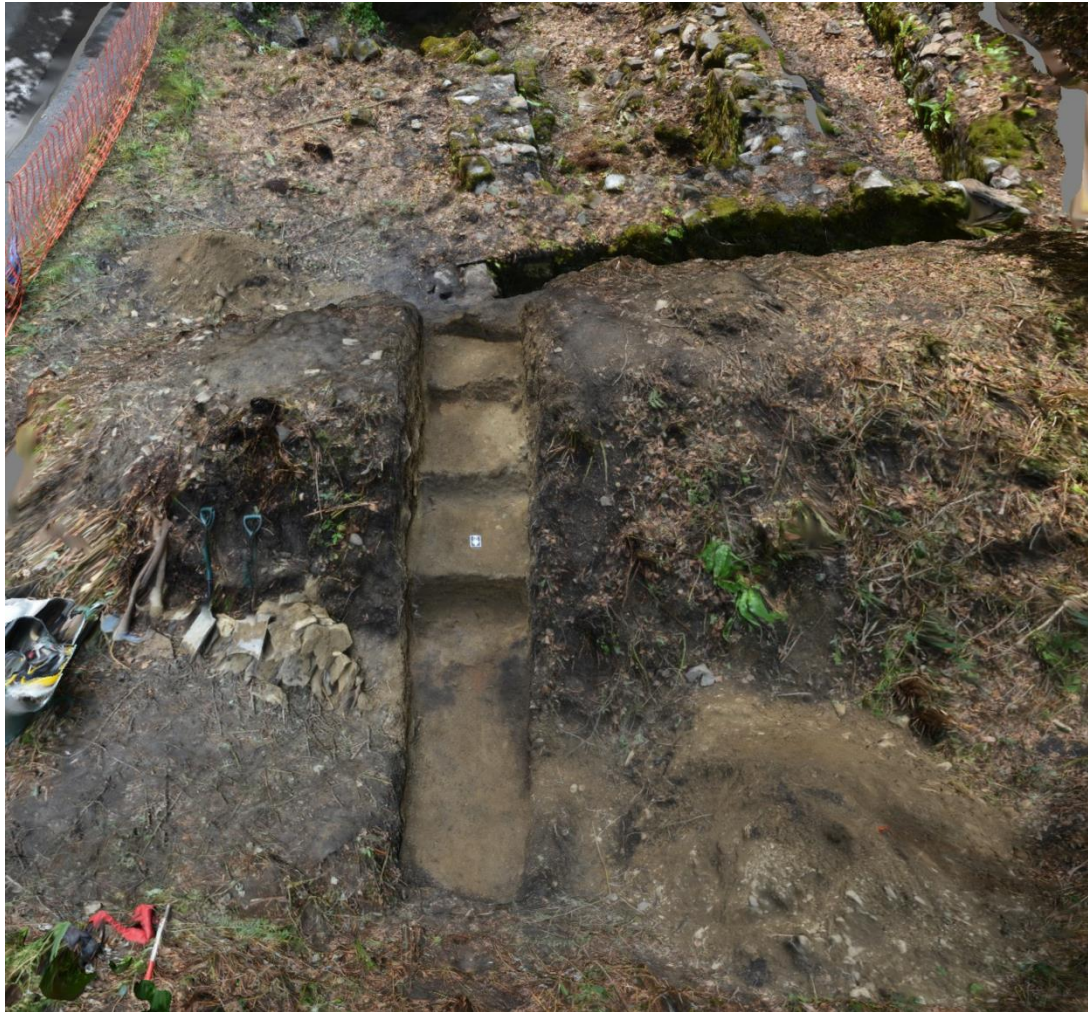
*Plate 2: Showing the trench in relation to the eastern wall of the surviving Cake Press House.*

It would appear that the earthen bank was constructed as a blast wall rather than a wall line. It's revetted face on the northern side presumably there to keep damp out of the stone built Cake Press House. This suggests that if there was damage to the original Cake Press House, it was rebuilt on its existing wall footings rather than immediately to the north/west and that the earthen bank investigated was constructed as a protective bund presumably to deflect blast. No artefacts were recovered from this excavation making the dating of its construction difficult.

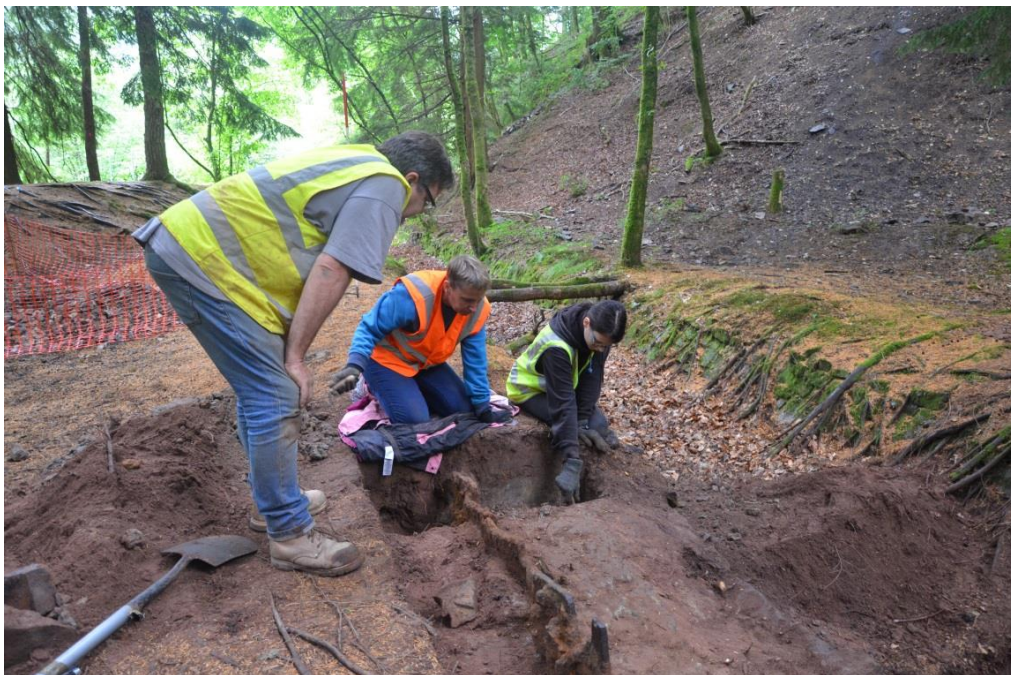
Located on the south side of the leat a larger area was excavated in order to investigate the protruding iron plate, the trench measured 1.00m by 2.05m, the stratigraphic sequence was similar to that observed on the north side of the leat apart from the iron plates (207).

(207) comprised of a series iron plates laid vertically and running parallel to the line of the leat. The iron plates contained evidence for various corroded fittings or bolts (See Plates. 9, 10 & 11), suggesting that they had been reused. The plates were on average 0.035m to 0.04m thick with an average width of 0.35m.

*Plate. 3 Overview of excavation of Trench 2, showing iron plating.*

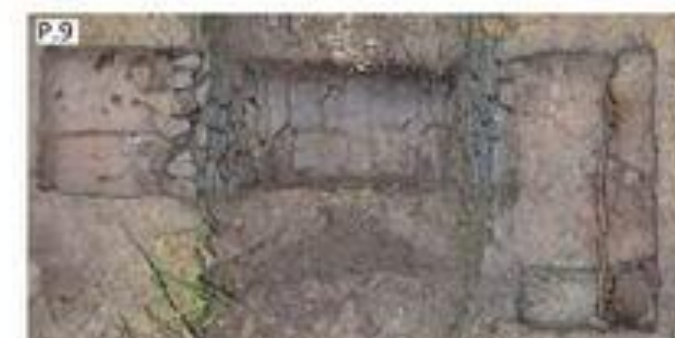
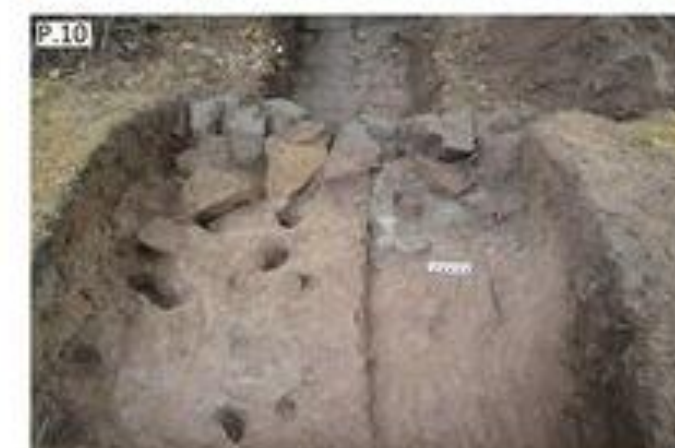
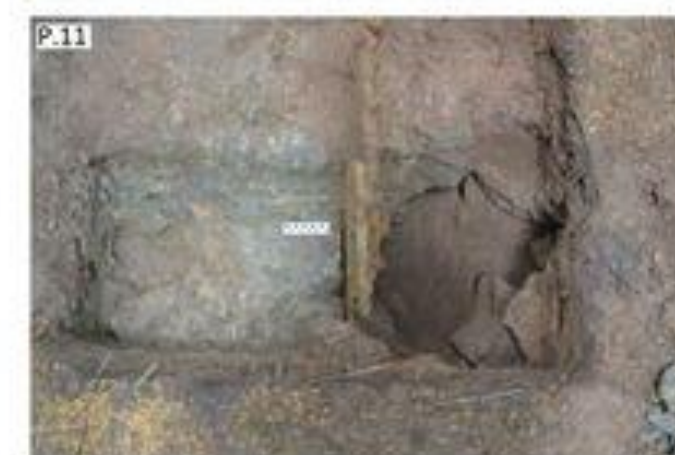
Plate. 9 Top Down view showing leat excavation.

Plate. 10 Detail showing clay layer (206) bonding leat wall.

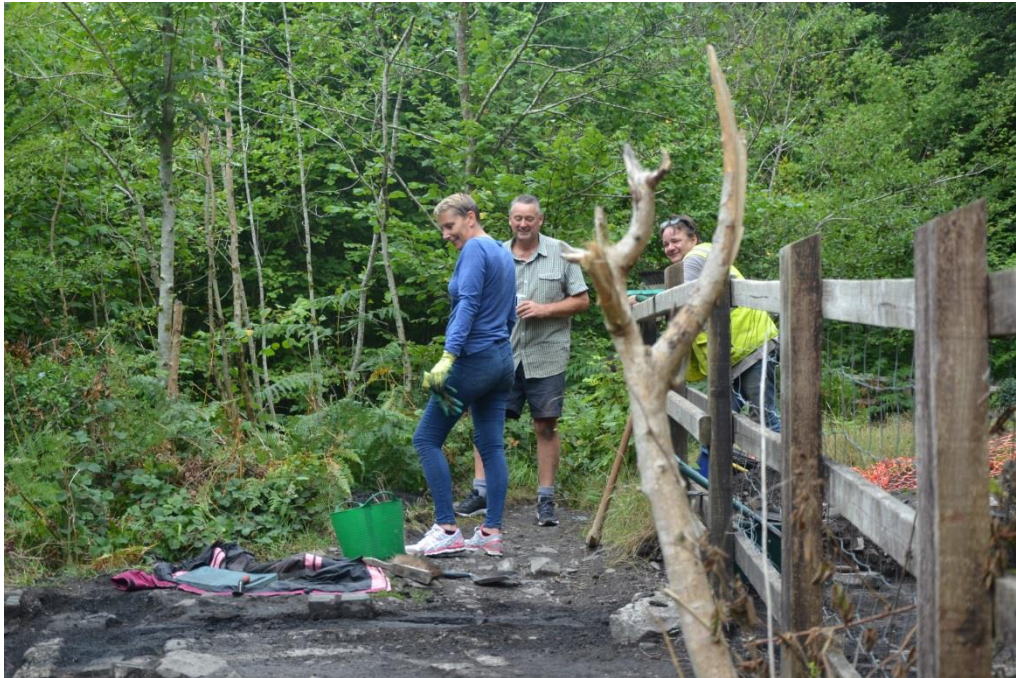
*Plate. 4 Overview of Area 3 cleaning and recording.*

The Pump Hose floor investigation consisted of a section of the Pump House floor being cleaned of loose debris to expose the surface, as the area is subject to heavy footfall it is clear from the area investigated that significant damage is being done to the structures exposed during the clearance, the brick work is generally loose and weathered and the open area surfaces are cracking and breaking away.
