ARCHAEOLOGICAL

WATCHING BRIEF REPORT

Chapel House Culvert Bridge, Angiddy, Tintern

Monmouthshire County Council: Highways C954

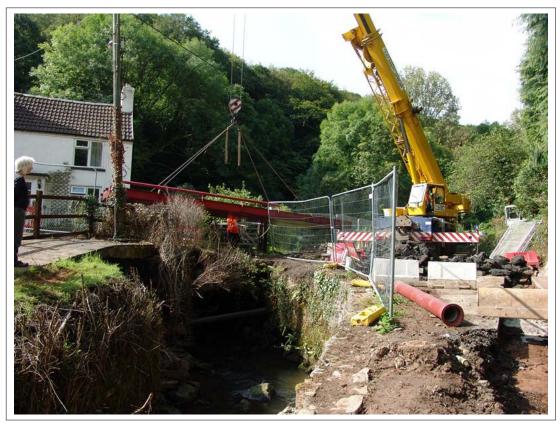
The demolition of the stone bridge began with the removal of the temporarily installed steel plate forming the roads surface (Plate 1). This was located above a 0.4m deep stone chippings hardcore deposit (001) containing live services and modern plastic debris (Plate 2). Hardcore (001) was removed by mechanical excavator and was found to immediately overlie the stones (002) forming the archway of the bridge (Plate 3). No original road surface was located.

Plate 1: View of temporary steel plate road surface removal. Looking south

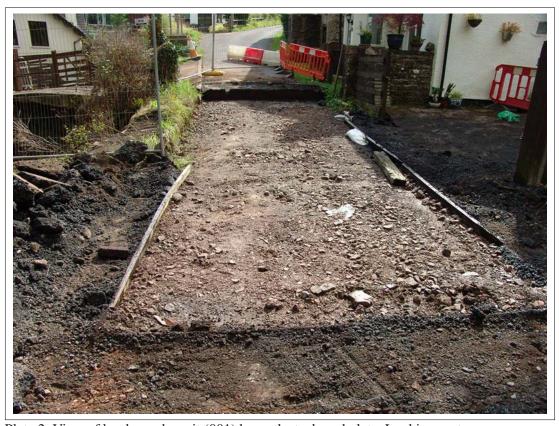
Plate 2: View of hardcore deposit (001) beneath steel road plate. Looking east

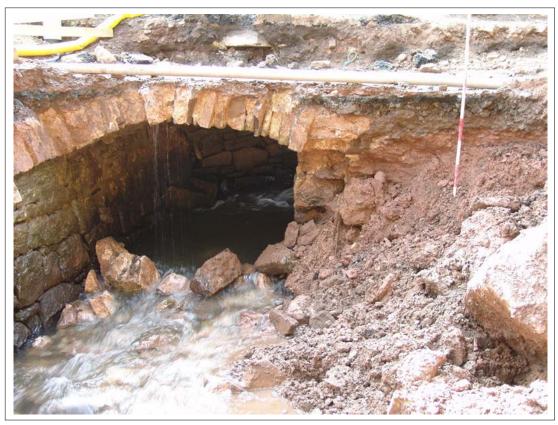
Plate 3: View of bridge arch stones with hardcore (001) above. Scale 1x2m. Looking south

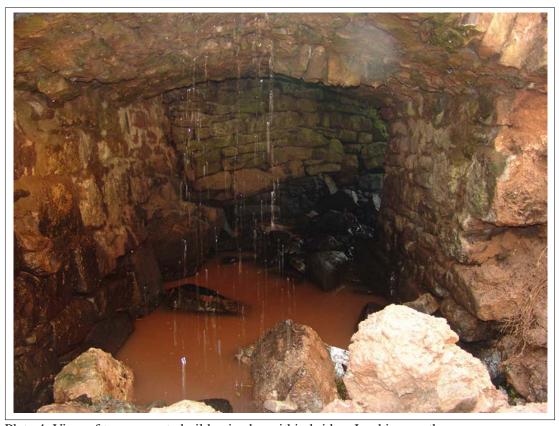
The bridge itself measured approximately 5m in width with a span of 2m. It appeared kinked halfway along its length reflecting two separate construction phases (Plate 4). The stones forming the arch (002) were composed of

The bridge itself was found to have two phases to its build. Work on the top of the bridge arch revealed no original road surface. It is possible that the bridge was intended to carry a narrow gauge railway.

Plate 4: View of two seperate build episodes within bridge. Looking south

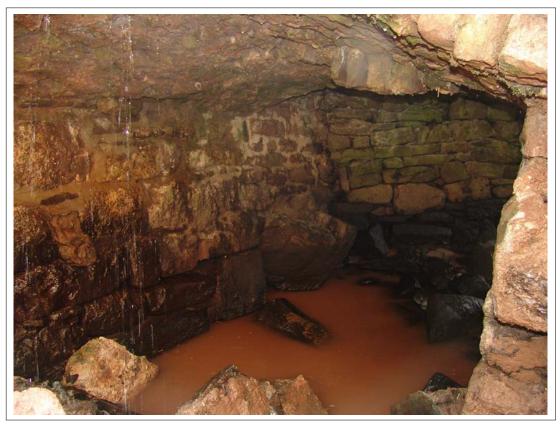
roughly faced, rectangular sandstone blocks up to 0.4m in length and 0.2m wide. No original bonding material was apparent though some areas of the stonework had been subject to later, modern, repointing in cement (Plate 5).

Plate 5: View of unbonded bridge stonework with later cement pointing. Looking south east

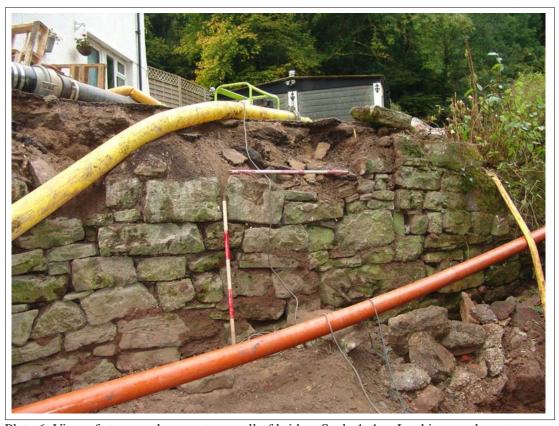
Plate 6: View of stonework on eastern wall of bridge. Scale 1x1m, Looking south east

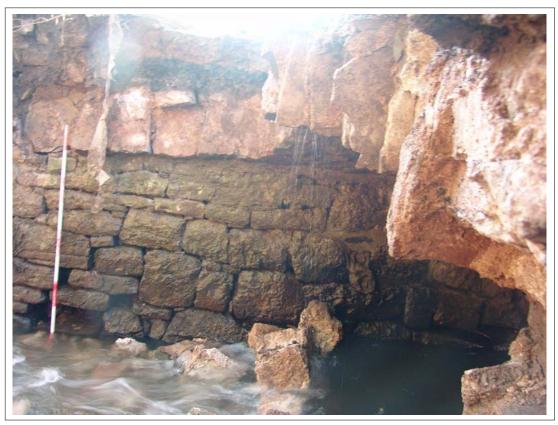
Plate 7: View of bridge stonework of western wall. Scale 1x2m, Looking west

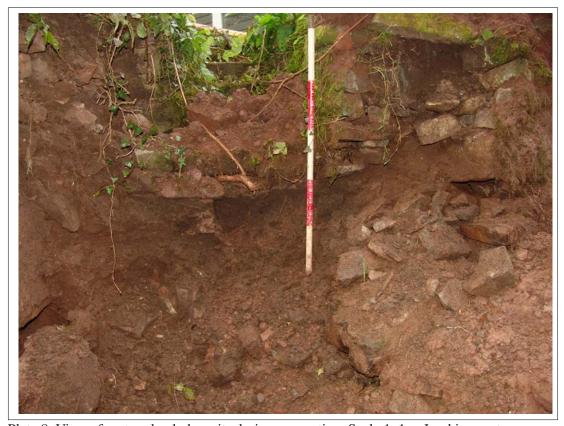
After removal of the eastern wall (003) of the bridge, and in order to house the new culvert, the eastern bank was cut into and the resultant spoil material removed (Plate 8). Excavation in this area showed the soil sequence to be composed of a 0.3m deep topsoil material (005) located above a red/orange silty clay subsoil (006). With the exception of a set of extant 19th century stone steps (007 – Plate 9) affording access to the stream, no archaeological features were disturbed during work in this area

Plate 8: View of eastern bank deposits during excavation. Scale 1x1m, Looking east

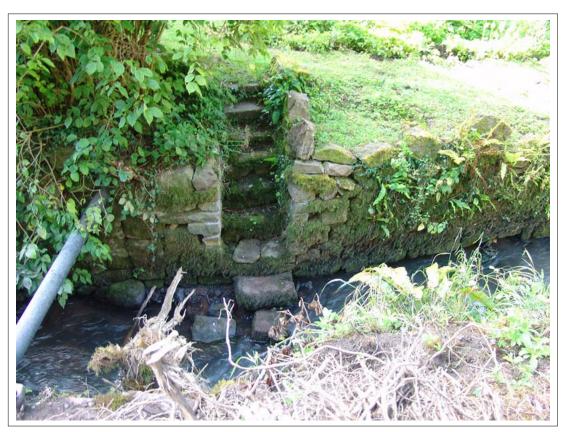
A set of stone steps offering access to the stream, located on the eastern bank and removed during the course of the works, were likely domestic in nature and associated with a property close to the stream bank.

Plate 9: View of set of stone steps within eastern bank adjacent to Chapel House. Looking east

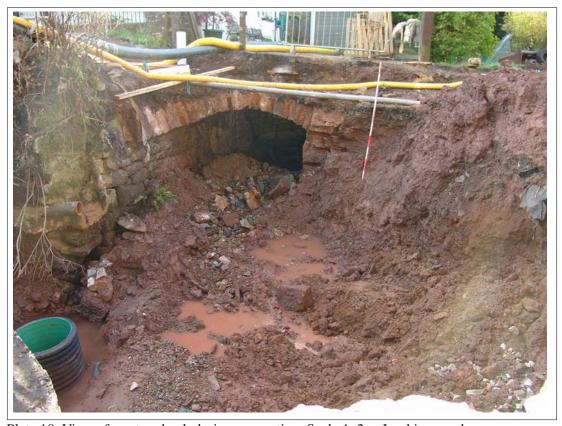
As with the excavation on the eastern bank, material was removed from the western bank (Plate 10) in order that the new culvert was sited correctly.

Plate 10: View of western bank during excavation. Scale 1x2m, Looking south

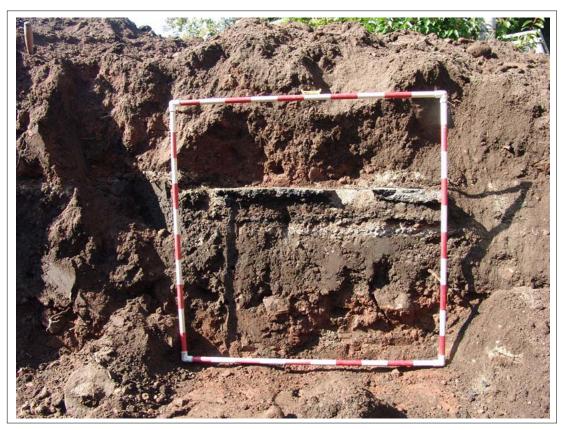
Excavation of the west bank, after removal of the western wall of the bridge (004), showed two earlier road surfaces (008 & 009 – Plate 11), both tarmac and buried beneath a redeposited subsoil horizon (010). No further features of archaeological significance were noted.

Two earlier road surfaces were located on the western bank though both were tarmac. Thus they are unlikely to be earlier than mid-20th century in date. A plethora of live and defunct services on the eastern bank and crossing the bridge is testament to the amount of recent disturbance to the area.

Plate 11: View of two tarmac road surfaces within western bank. Scale 1sqm Looking west $\,$

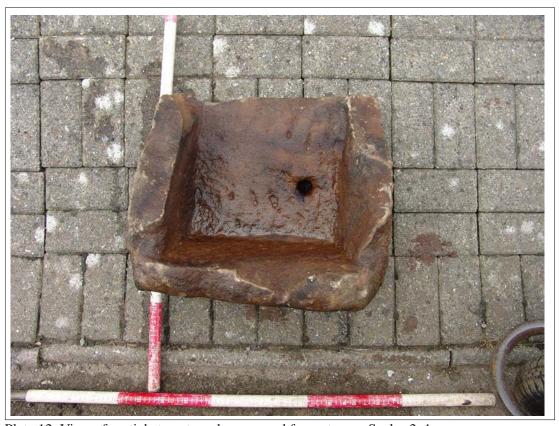
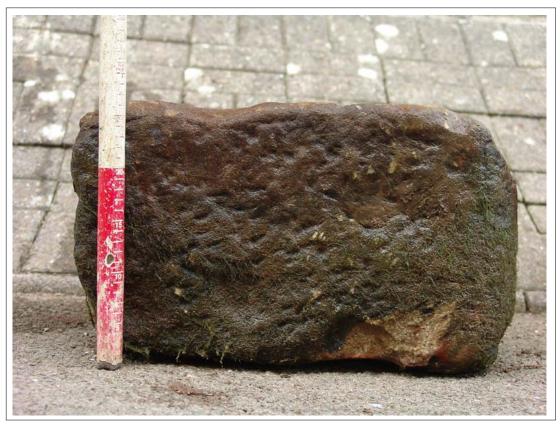
A partial worked stone trough was located within the stream itself (Plates 12&13) as was a single narrow gauge rail (Plates 14&15).

It is possible that the worked stone trough is medieval in date and was moved from the Abbey in nearby Tintern. The onset of industry within the Angiddy valley from the 16th century onwards coincided roughly with the dissolution of the monasteries, thus rendering Tintern Abbey as a good source of worked stone. Other examples of reused Abbey stone are prevalent within structures still extant along the valley.

Plate 12: View of partial stone trough recovered from stream. Scales 2x1m

Plate 13: Profile view of stone trough showing tool marks. Scale with 0.2m increments

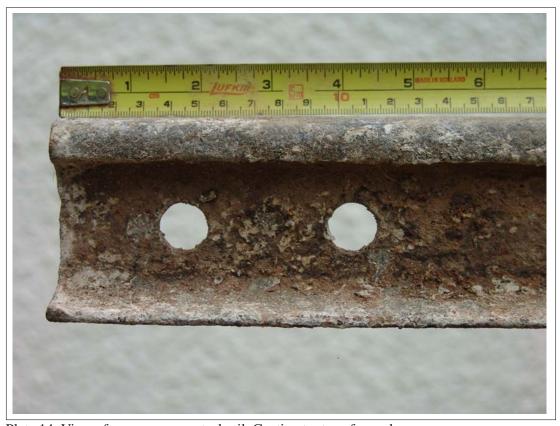
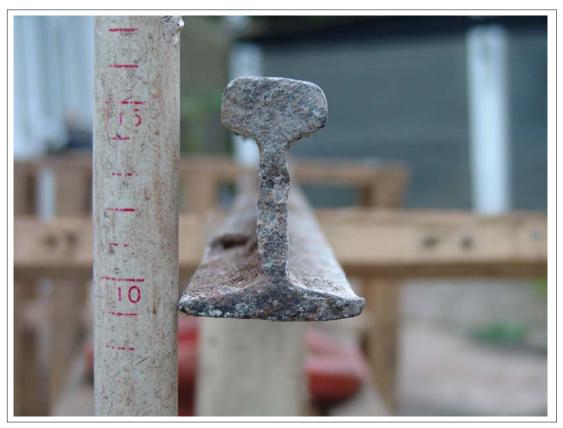
The narrow gauge steel rail recovered during the course of the watching brief may suggest that the bridge, at one time, carried a light railway/tramway.

Plate 14: View of narrow gauge steel rail. Centimetre tape for scale

Plate 15: Profile view of steel rail. Scale with 0.2m increments
