# Prepared for: Nigel May and Stephanie Kruse Project No: N/A

# Barn 2, Court House Farm, Cascob, Powys

Historic Building Record

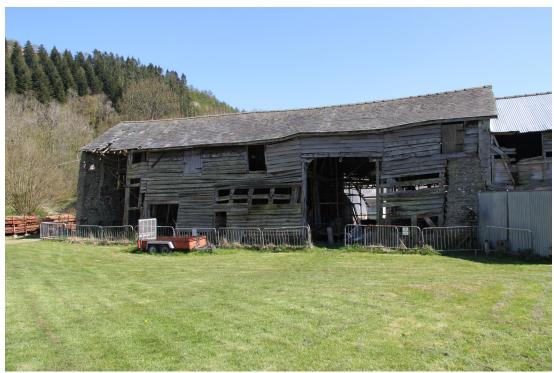
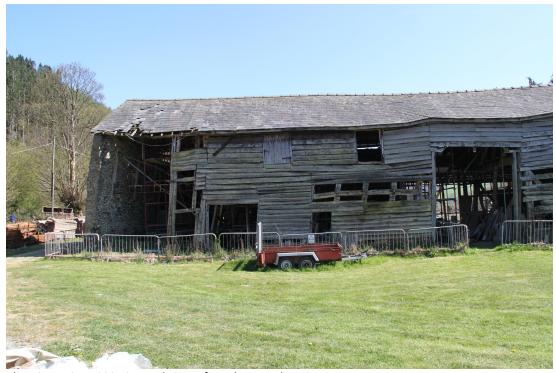
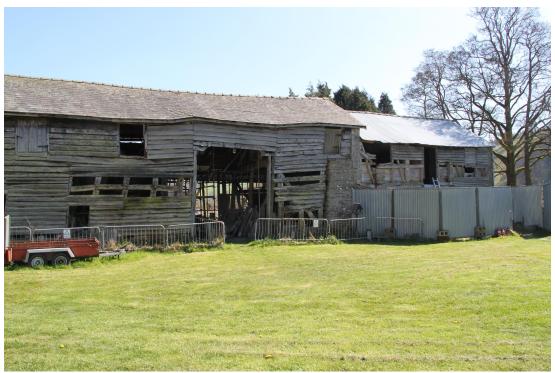
5.3.1 The **north west** elevation (**Plates 1-3**) is predominantly comprised of oak weatherboarding, with a small element of stone wall between the barn and cart shed, and a low stone and brick plinth from which the building rises. The weather boarding rises into a slate roof, which is finished with concrete ridge tiles.

In parts the weatherboarding has become loose and in parts gone completely, which has exposed the square panelling of the timber frame which it conceals.

The north-east gable has subsided, with its apex *circa* 1000mm out of plumb, causing the rest of the barn to rack.

Plate 1 - AD011\_001: General view of north-west elevation; Barn.

Plate 2 - AD011\_002: General view of north-west elevation.

Plate 3 - AD011\_003: General view of north-west elevation; Barn, and Cart Shed and Granary.

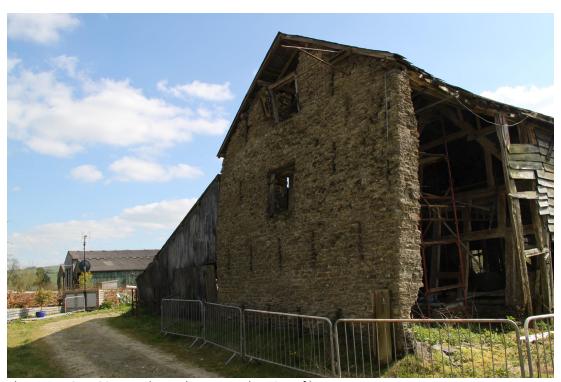
- 5.3.2 The **north east** elevation (**Plate 4**) is comprised of the barns gable end and the later tin lean-to extension. The gable is constructed of a local limestone with lime mortar and houses 13 ventilation slits and two square windows. The corrugated tin lean-to has a single doorway, which abuts the stonework of the gable. Severe subsidence has caused considerable damage to the elevation, with the apex of the gable missing.

Plate 4 - AD011\_004: North-east limestone elevation of barn.

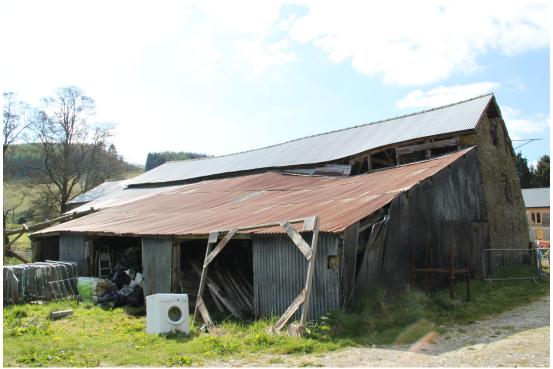
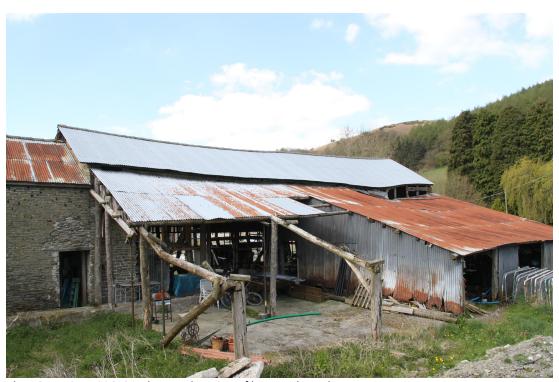
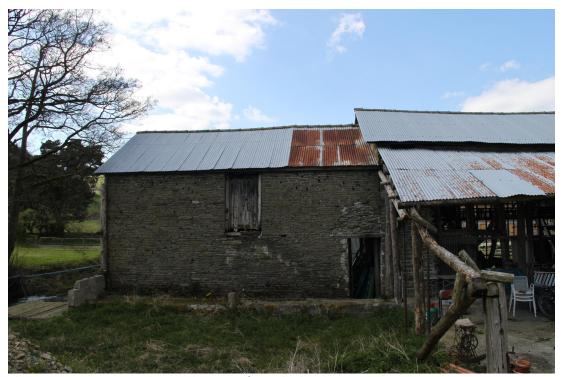
- 5.3.3 The **south east** elevation (**Plates 5-7**) is formed of the tin lean-to along the length of the main barn, which rises to the eaves of the main barn, and a stone elevation to the cart shed and granary/hay loft; this has a single doorway to the first bay at ground floor and a single doorway at firth floor to bay 2. The roofing material is comprised solely of corrugated tin sheets.

Plate 5 - AD011\_005: ¾ view of north-east and south-east elevations or barn and lean-to.

Plate 6 - AD011\_006: South-east elevation of barn and rear lean-to.

Plate 7 - AD011\_007: South-east elevation of cart shed and granary.

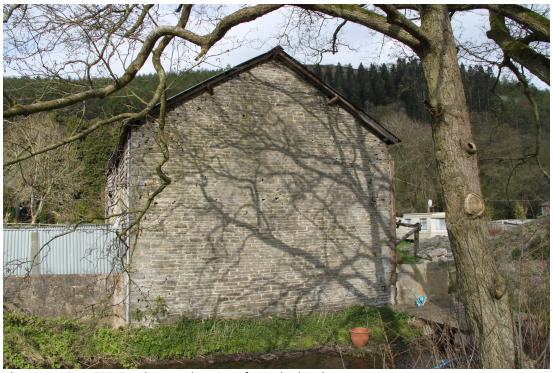
- 5.3.4 The **south west** end (**Plate 8**) is formed of a plain limestone gable to the cart shed and granary/hay lofty.

Plate 8 - AD011\_008: South-west elevation of cart shed and granary.

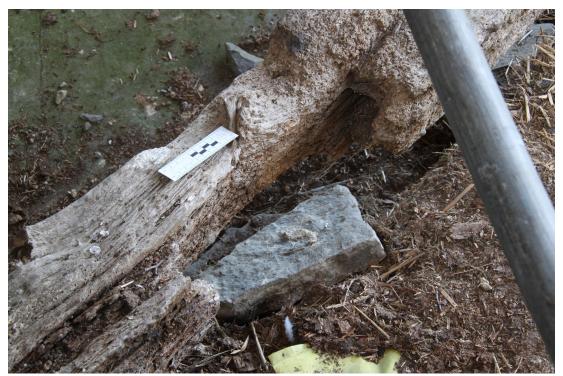
Plate 37 - AD011\_037: Deteriorated mortice in sill beam.

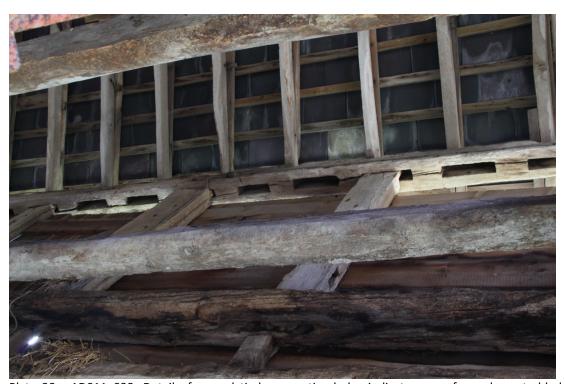
Plate 38 - AD011\_038: Detail of reused timber; mortice holes indicate reuse from close studded building.

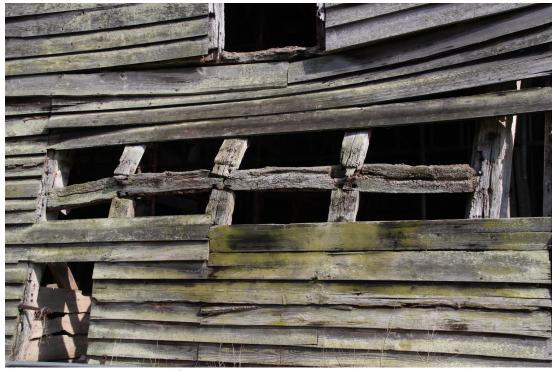
Plate 53 - AD011\_053: Exposed framing on north-west lateral wall, showing weather damage.

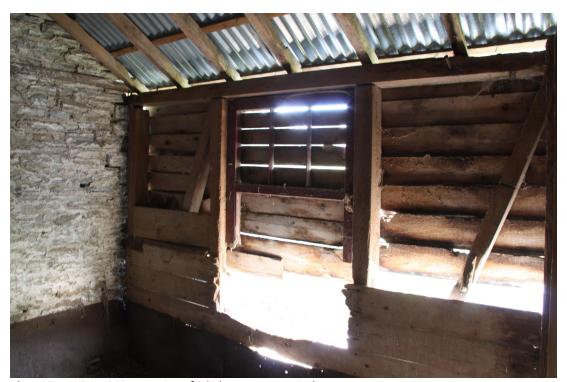
Plate 62 - AD011\_062: Remains of 9 light casement window.
