St Cadog's Church, Llangadog, Carmarthenshire

Archaeological Watching Brief

Report No. 650

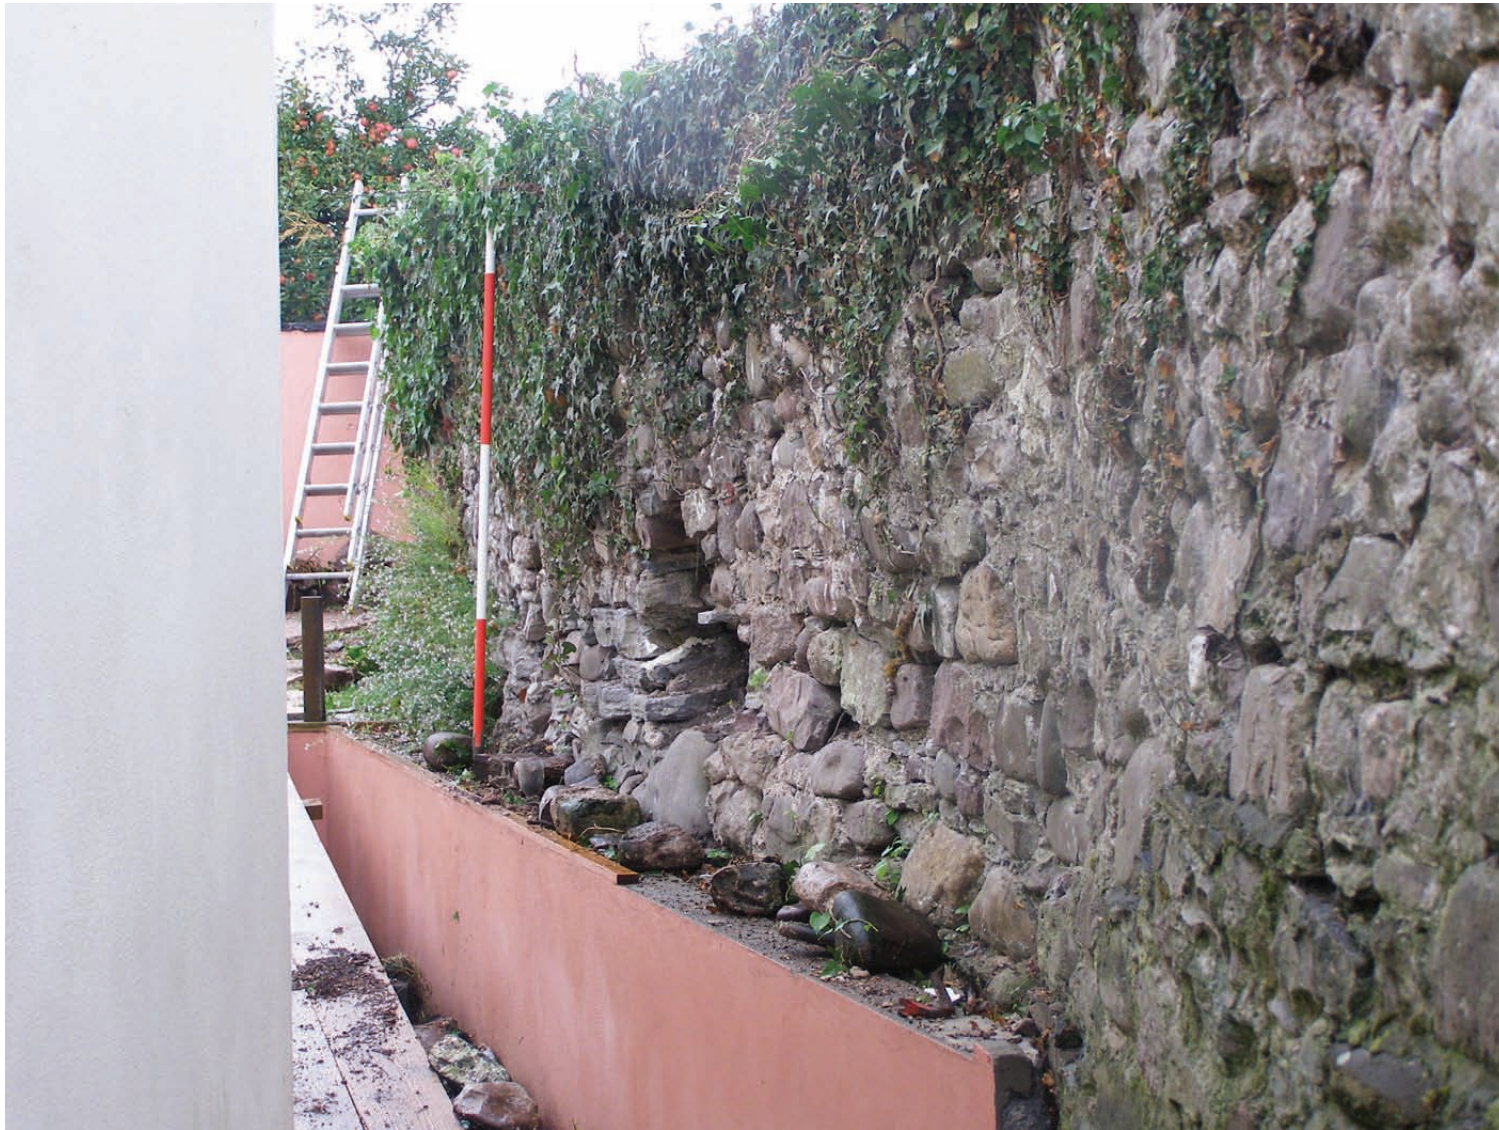
Prior to the demolition of the wall, a photographic survey was carried out to record its existing structure. Unfortunately, the eastern end of the wall had been partially demolished prior to the archaeologist being called to site by the contractor. However, as much as possible of the original wall was photographed (fig. 2 and fig. 3).

In total, 9m of existing graveyard wall was removed and rebuilt. The wall was 0.7m thick and 2m high and constructed using rounded pebbles and lime mortar. At the eastern end the wall was built directly onto the shale bedrock, however, the western 5m had been constructed on a concrete foundation.

Fig. 2
Western end of
wall prior to
demolition.

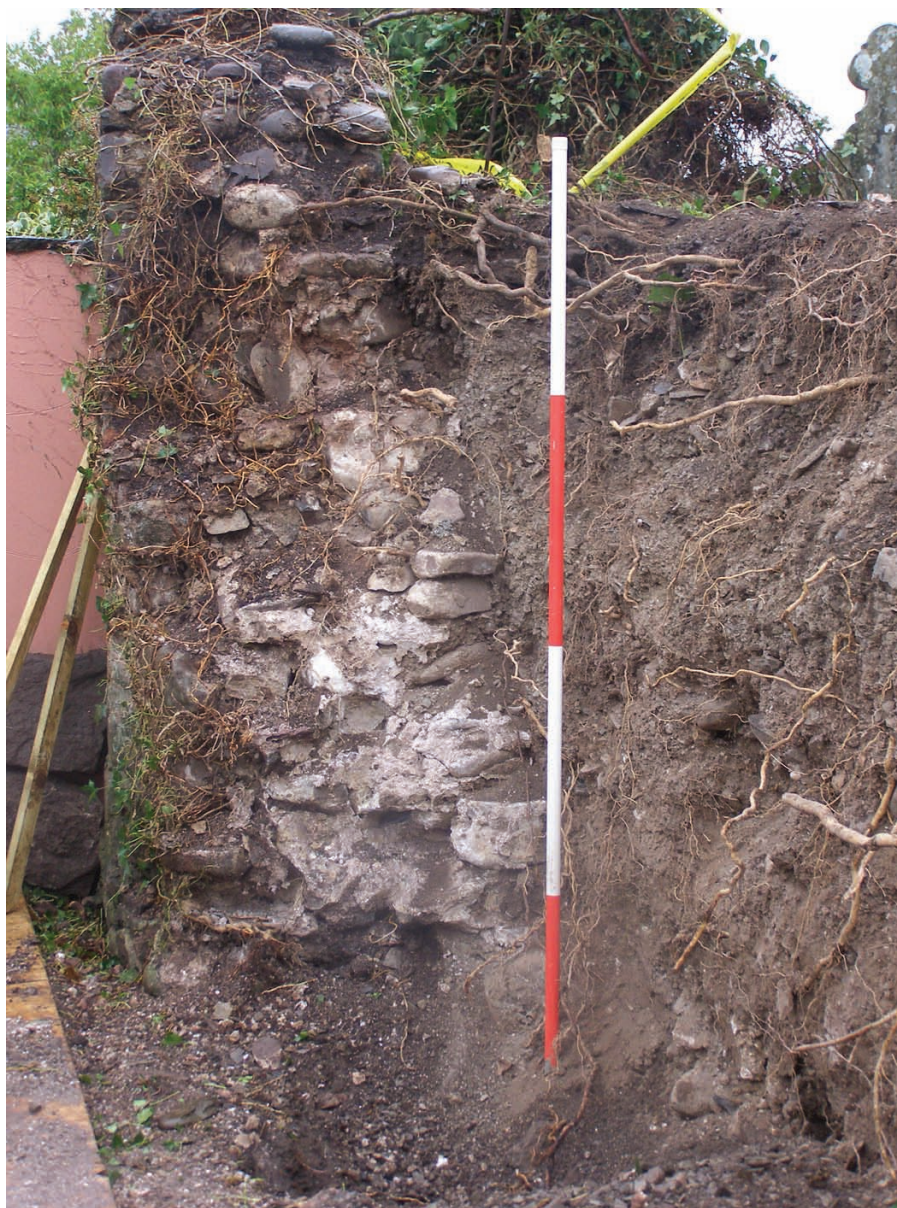
Fig. 3
Eastern end of
wall demolished
prior to arrival of
archaeologist

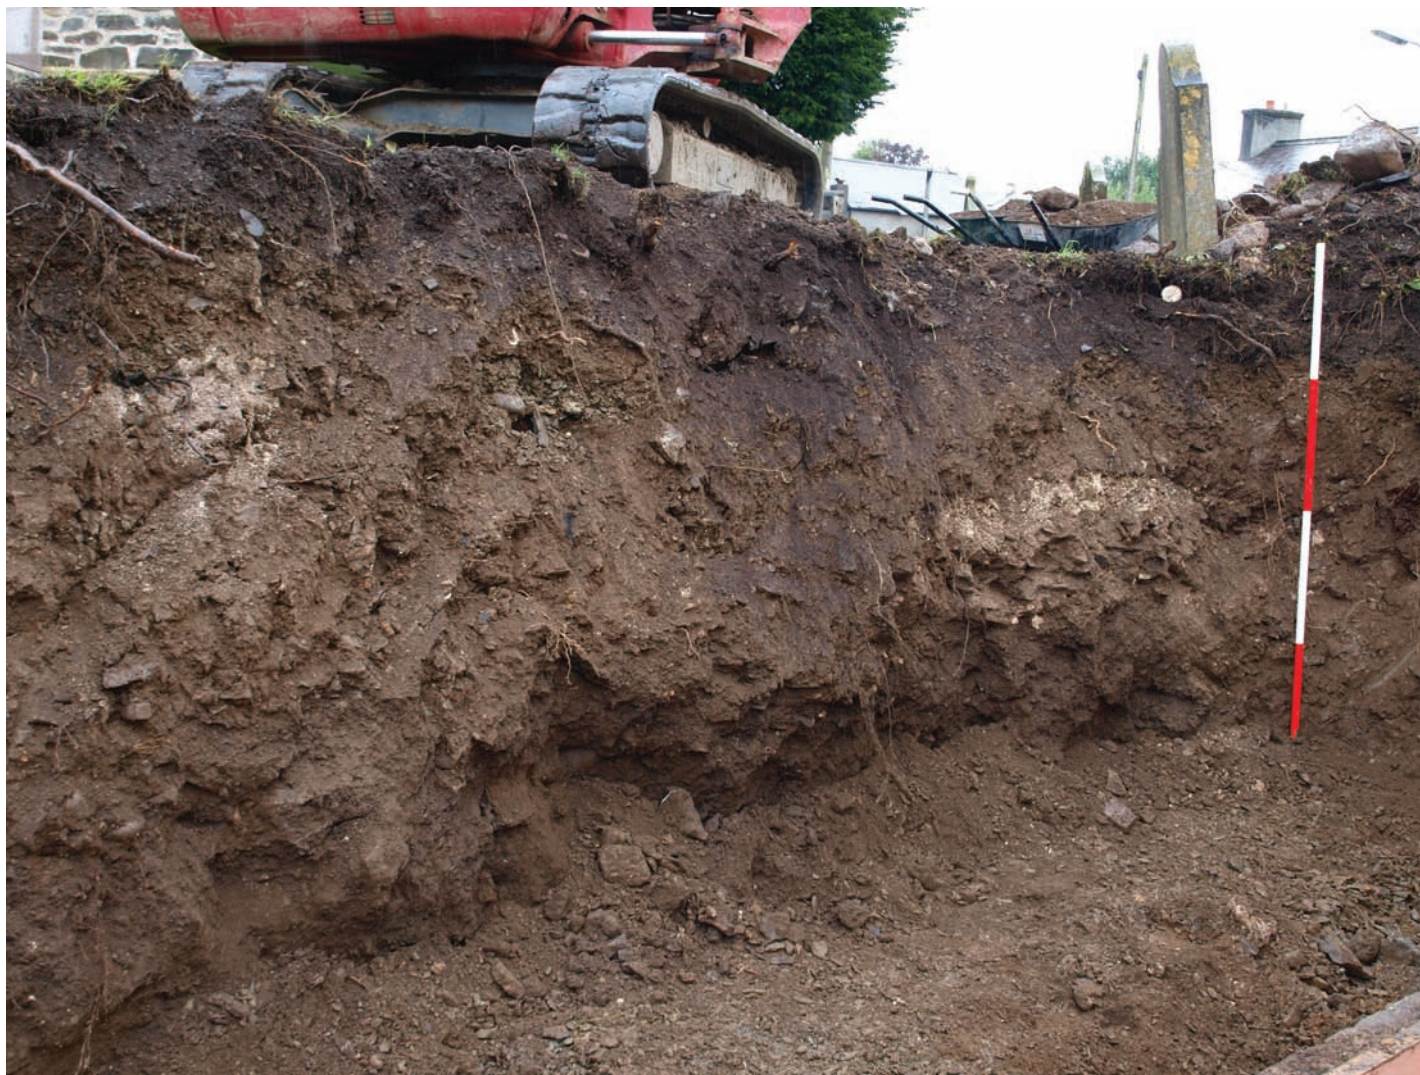
The wall was built as a retaining wall to support the ground level of the graveyard, which is around 1.8m higher than the surrounding land. A profile was cut through the graveyard deposits immediately behind the wall during the works (fig. 4), which revealed that the ground comprised a layer of turf and topsoil (001), a thick layer of redeposited material (002). At the eastern end of the wall the redeposited material overlay a layer of disturbed natural (003), while the western end of the wall overlay the concrete foundation.

The topsoil (001) was 0.3m in depth and overlay the layer of redeposited material (002). This layer, (002), was 1.2m deep, but comprised layers and lenses of different material including mortar, rubble and redeposited natural. A single 19th century glass bottle was identified within the redeposited material (not retained). This layer was assigned a single context number as it was evidently the result of a single depositional event. Within this redeposited layer, a large number of disarticulated bones were identified, predominantly long bones, together with several skulls and skull fragments (fig. 5). None was found within a grave cut. Some of the long bones and the skulls were found within discrete pockets within the redeposited material, with the skulls seemingly deliberately collected together and buried up against the inner surface of the wall. Underlying the redeposited material at the eastern end of the wall was the disturbed natural (003). This was 0.5m thick and comprised the natural yellow clay silt intermixed with brown clay silt, frequent stones and occasional fragments of bone.

Fig. 4
Profile through
graveyard
deposits behind
eastern end of
wall

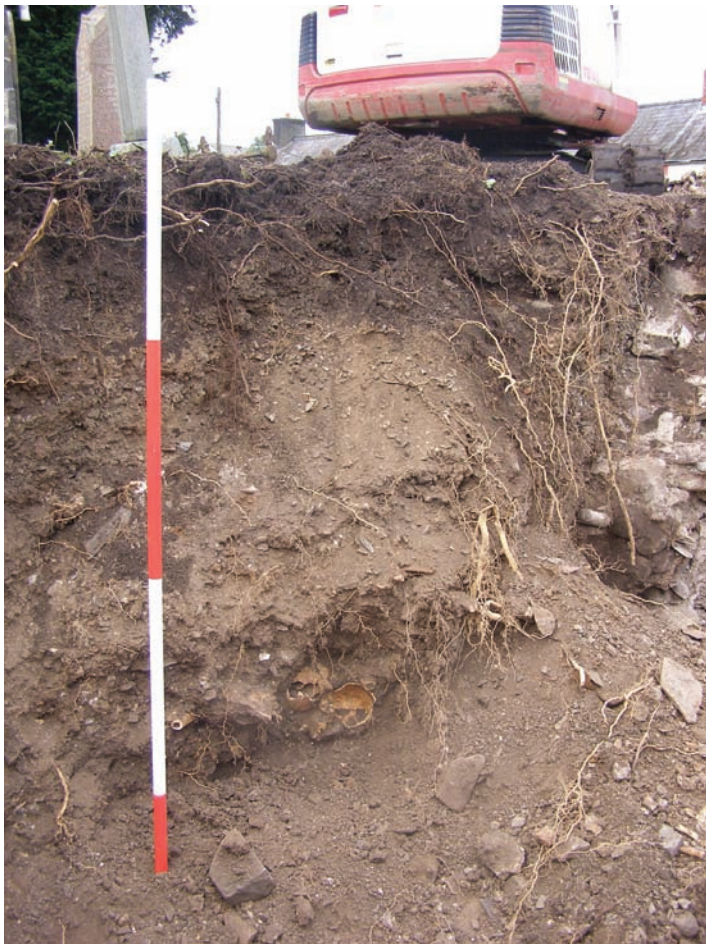
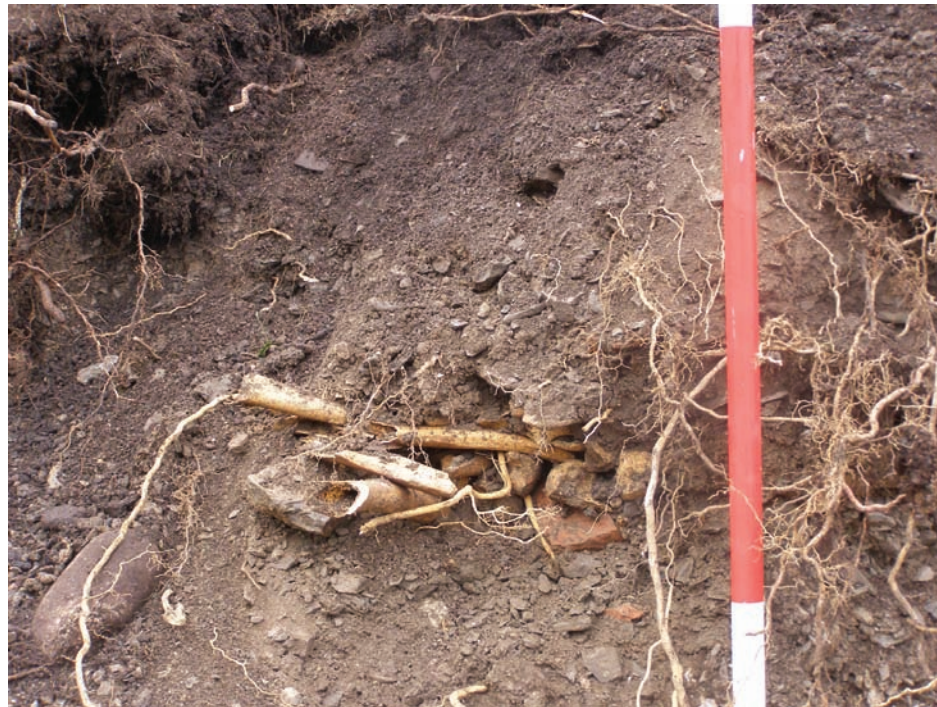
No grave cuts or structural remains were identified within the area of works. All bones revealed during the excavation were handled respectfully and reburied as close to their original position as possible.

Fig. 5
Skulls and
disarticulated bones
within the made
ground of the
graveyard

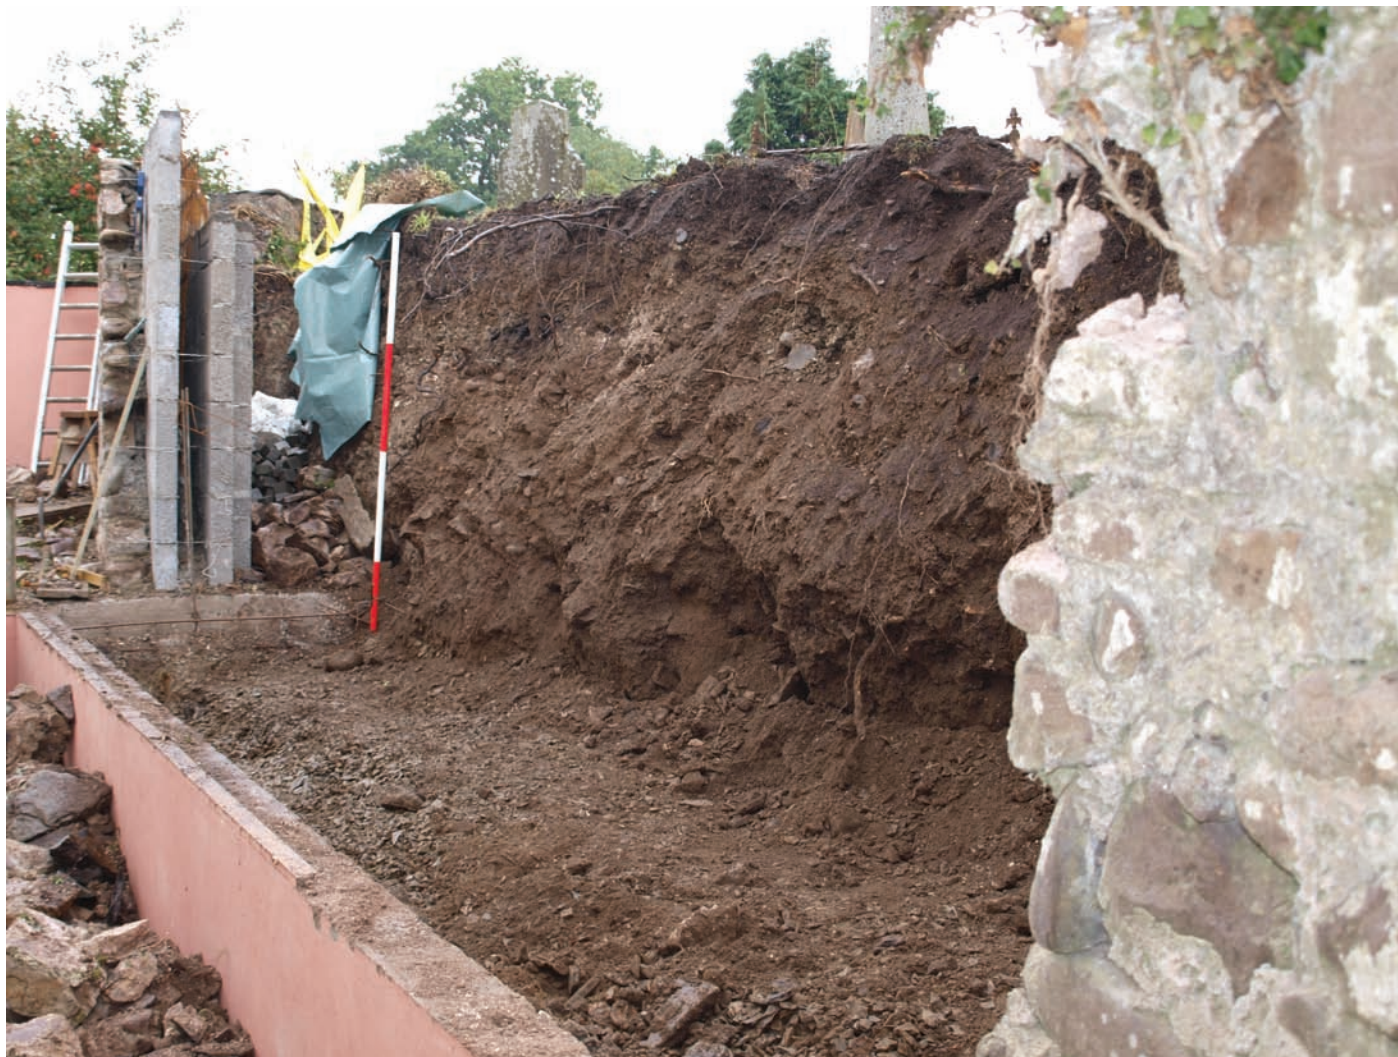
The works associated with the wall demolition and reconstruction (fig. 6) have revealed interesting details about the history of the graveyard. It is clear that the ground level on the site was artificially raised, probably during the 19th century when the Church was remodeled. The ground was probably raised to facilitate further burials within the graveyard, which is likely to have been full following its many centuries of use. Indeed, the quantity of disarticulated bone, skulls and bone fragments attests to the disturbance of burials during the digging of later graves.

Fig. 6
Wall repair works
underway with
reconstructed
eastern end to the
left of the picture,
the groundworks
underway in the
middle and the
old wall to the right
