Llanwrin Church, Machynlleth, Powys, 2011

Archaeological watching brief

Prepared for: Llanwrin PCC

Date: 18 September 2011

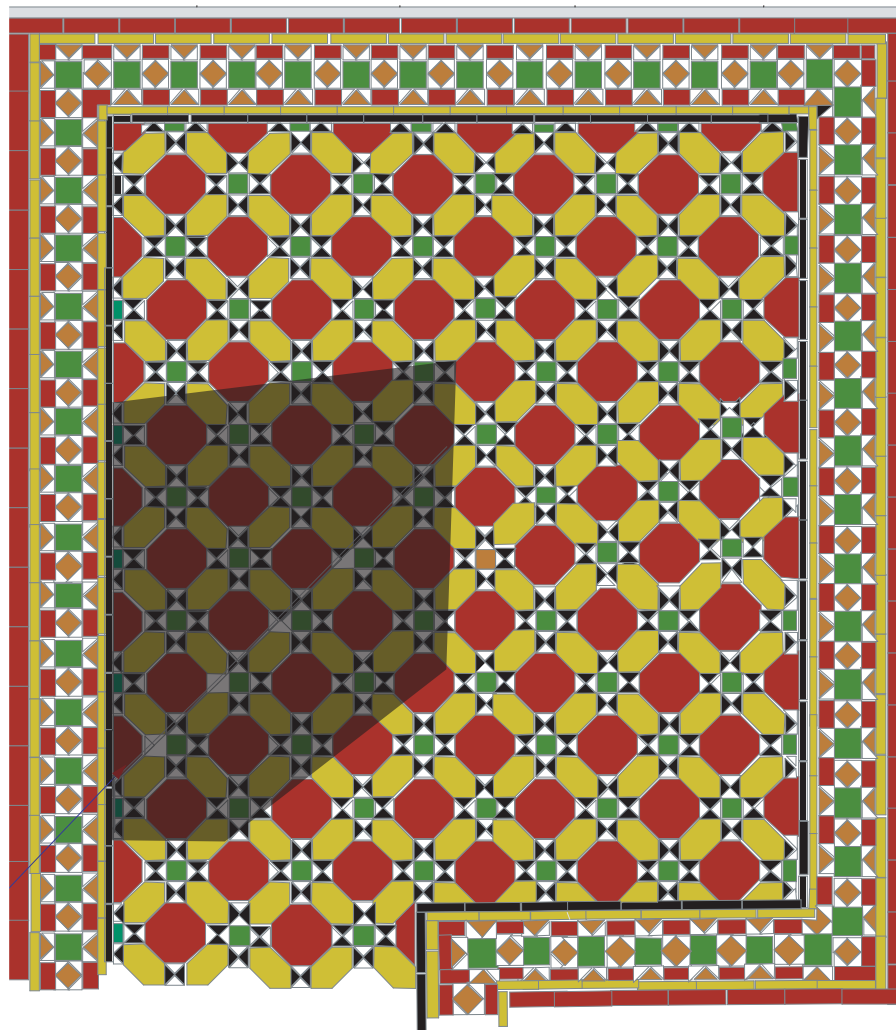
FIG 2: Location of excavated area in sanctuary
(Cambrian Archaeological Projects, on Charles Cowan base plan)

- 4.2.2 An area of sanctuary floor tile was lifted carefully by hand and the underlying deposits recorded (for area of work see FIG 2). The tile floor (layer 1) is of 1864 date and this was found to have been bedded on a 1cm thick layer of red cement (layer 2). The tiles lifted cleanly off this bedding layer. Below the bedding was a 7cm thick bed of local gravel and sand (layer 3) used to level the area before the bedding mortar was laid (PLATE 1). Below the levelling layer was a make-up layer of compacted sand and gravel (layer 4), which was not excavated (PLATE 2). The cracks in the floor penetrated both the floor surface and the underlying cement bedding, but not further down. This implies that the cracking was due to water penetration and freezing of the floor over the cold winter of 2010, not (as thought originally) by subsidence into an underlying vault.

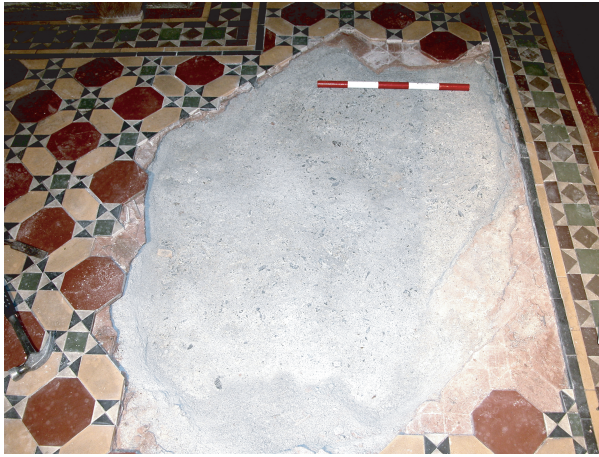
PLATE 1: Sanctuary area excavation, looking south.
Scale 0.5m

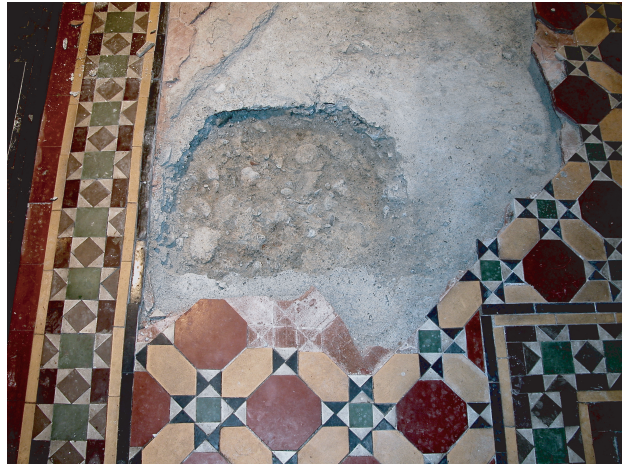
- 5.1.1 Work on the 1864 sanctuary floor indicates that no collapsing vaults lay below the floor and that cracking was due to recent frost damage. Similar damage is also evident in the choir adjacent to the choir stalls.
- 5.1.2 The external area adjacent to the west and north walls of the church have been excavated in the past, probably when the church was restored in 1864. The current cement render on the west wall and brickwork below the north-west corner probably relate to 20th century work on the church.
- 5.1.3 Investigation of the internal render on the west wall and recording of the external face of the west wall when the render is taken off will be the subject of an additional note when this work is completed. This is not part of the originally agreed faculty watching brief, but will inform a decision about internal render replacement.

PLATE 2: Sanctuary floor after excavation below floor, looking north.

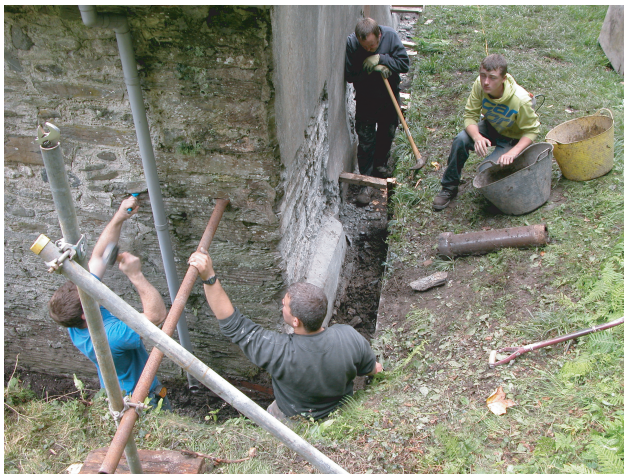
- 4.2.3 The area along the west and north walls of the church were reduced by up to 0.9m (see FIG 1 and PLATE 3). The material removed contained 20th century rubbish and had evidently already been excavated during the 1864 restoration of the church. The upper 20cm of material was of dark brown soil and stone waste

(layer 5), overlaying a cleaner stony material (layer 6) 20cm thick, which cleaned down (in the north-west corner) onto a shale and clay deposit (layer 7). All three layers were disturbed and probably post 1864 in date.

PLATE 3: Ground reduction work around west and north walls, looking south.

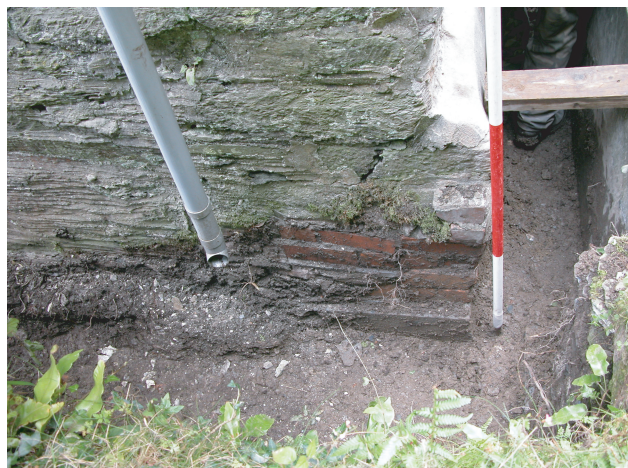
- 4.2.4 A reddish mortar on the lower face of the west wall indicates that this may relate to the 1864 work, and that the current cement render on the external face of the west wall, and some bricks at a low level below the north-west corner (PLATE 4), may relate to 20th century work on the church.

PLATE 4: Brick underpinning below north-west corner of church, of 20th century date, looking south.
Scale in 0.5m divisions
