# NEUADD, LLANON, CEREDIGION, BUILDING RECORDING & COMMUNITY ARCHAEOLOGICAL EXCAVATION 2013

## VOLUME I

RHIF YR ADRODDIAD / REPORT NO. 2013/57  
RHIF Y PROSIECT / EVENT RECORD NO. 105803

Medi 2013  
September 2013

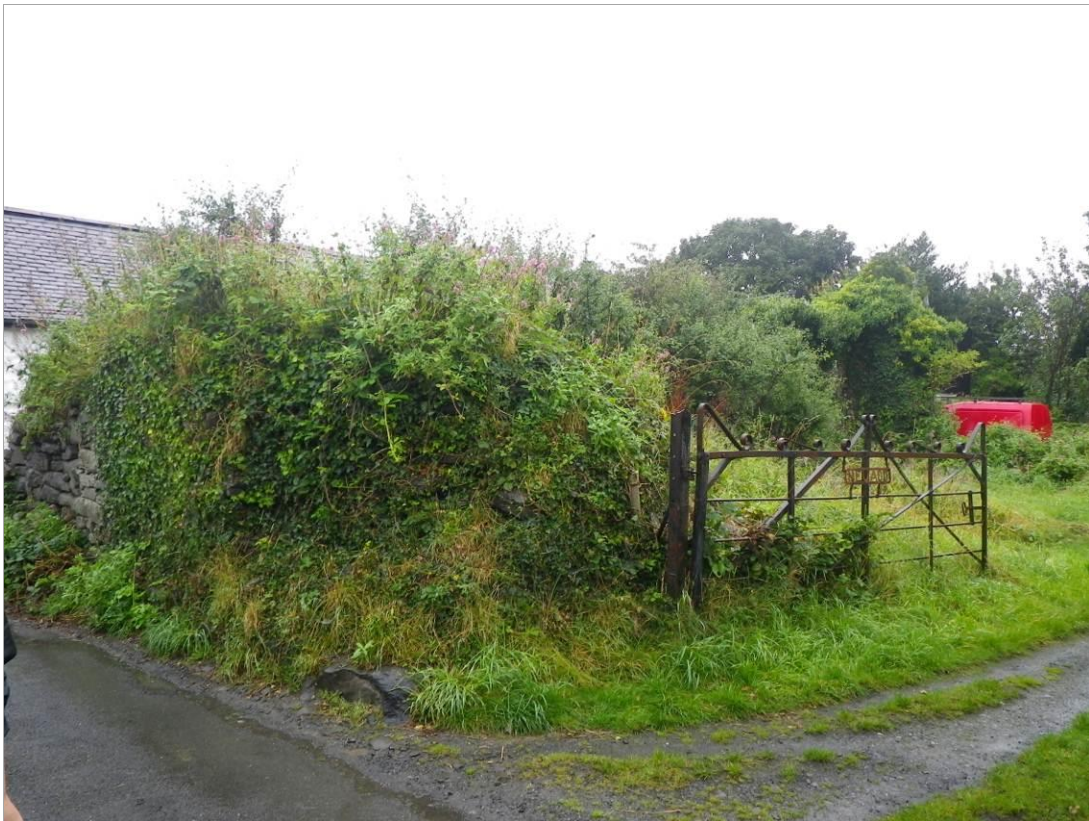
**Photo 1:** View of the overgrown ruined Neuadd in 2013 from Heol Non.

- 2.2.1 At the beginning of 2013 the ruins were extremely overgrown and it was very difficult to judge the condition of the masonry (Photo 1).
- 2.2.2 Small trees and shrubs were growing out of the walls and ivy covered the majority of the masonry (Photo 2).

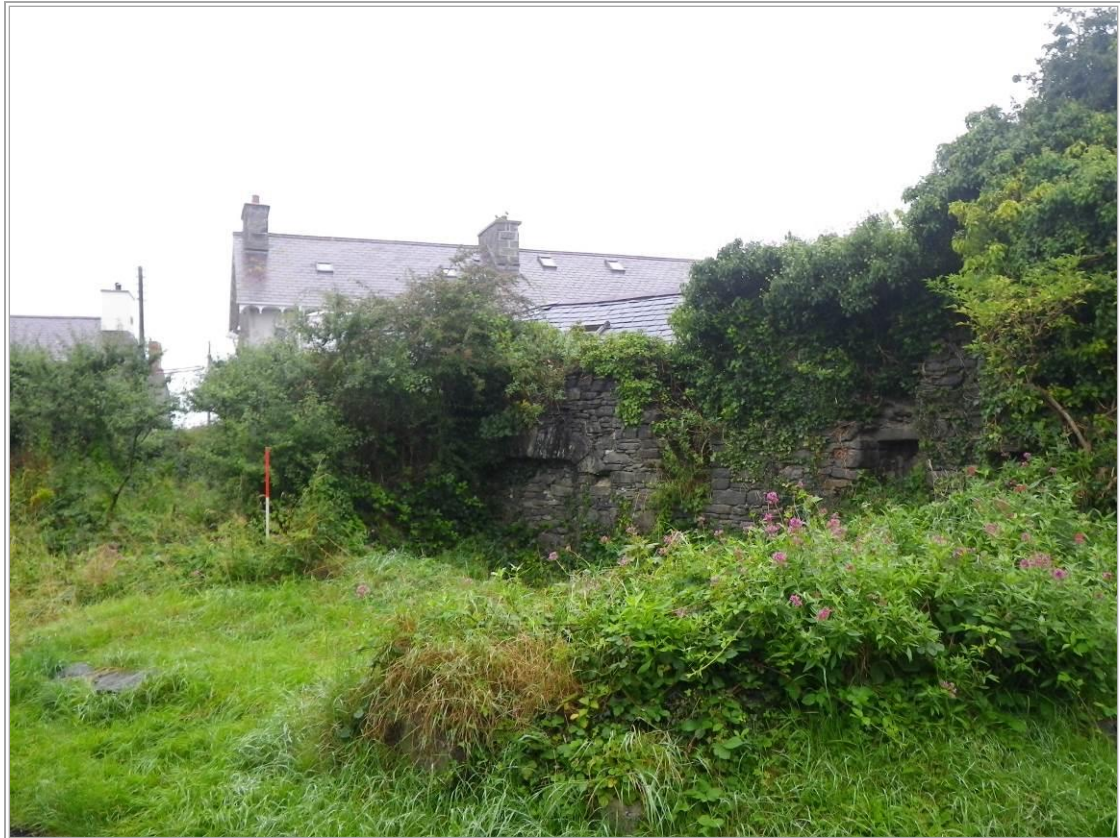
**Photo 2:** *View of the ruined Neuadd in early 2013 looking southwest.*

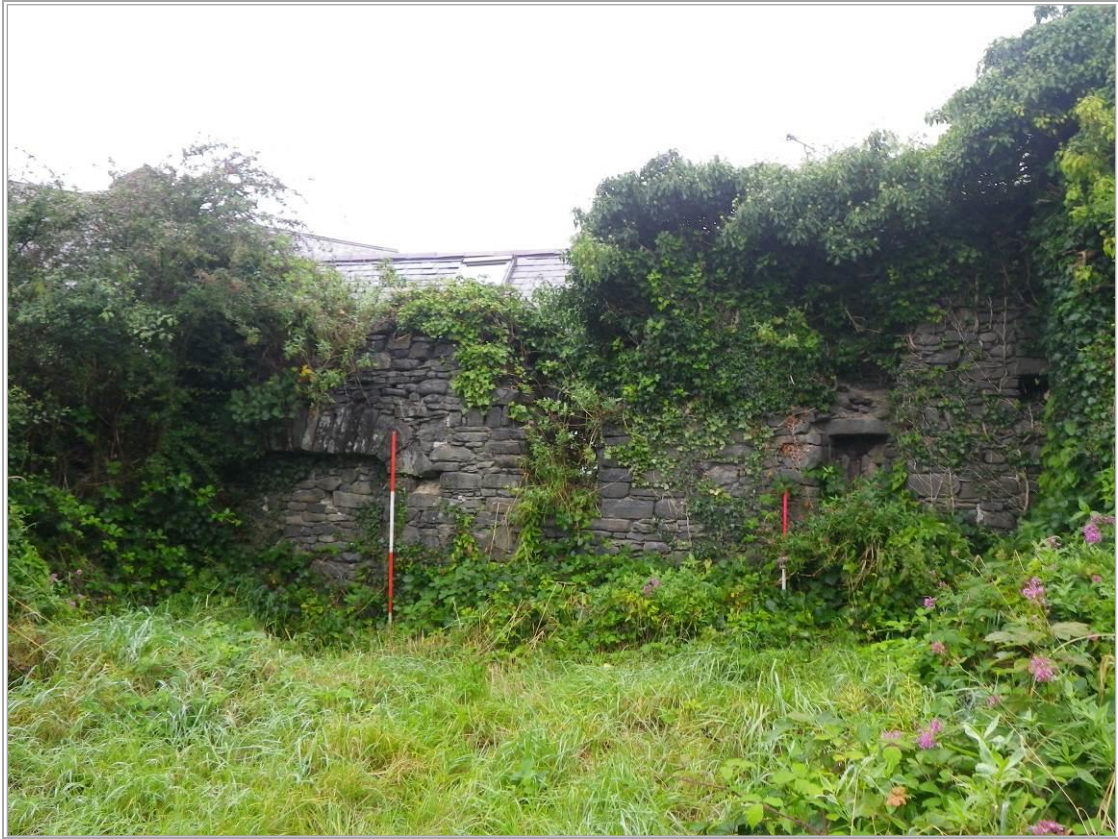
**Photo 3:** above. View of the ruined north wall of the Neuadd in 2013, showing the blocked fire place to the left and to the right of the shorter 1m ranging rod is the second lower splayed window. Detail shown in photo below

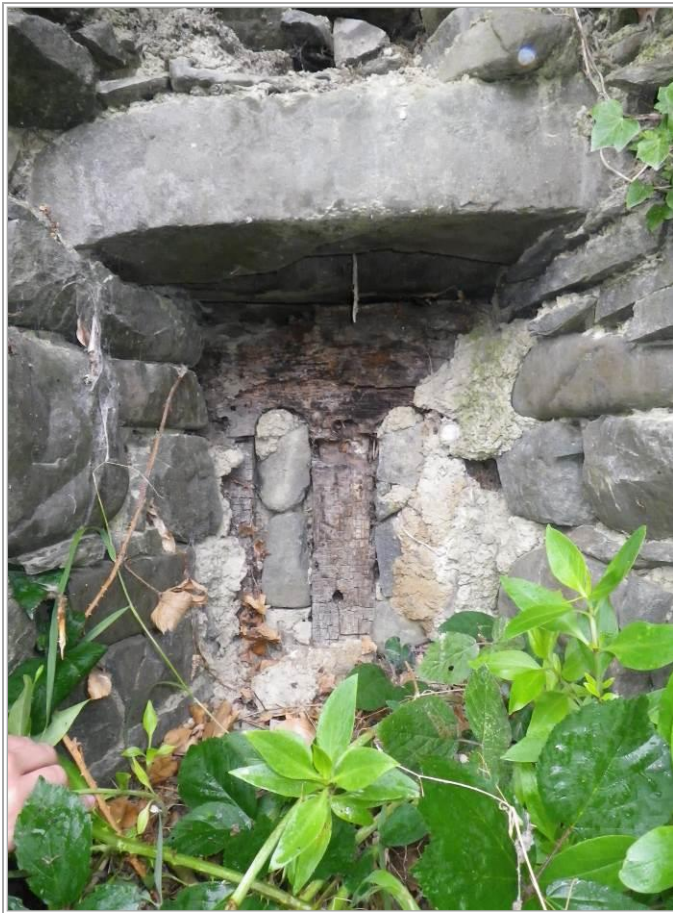
- 2.2.3 The line of the southern wall was not visible as it was covered in overburden and vegetation.
- 2.2.4 It was clear that the vegetation obscured how much overburden had accumulated over the site. This appeared to be greater towards the western end of the building's interior.
- 2.2.5 Some architectural features were visible, including the blocked lateral fire place (Photo 3).
- 2.2.6 A lower splayed window found towards the northeast corner of the Neuadd in the north wall was also visible. Remarkably the inserted wooden window frame had survived (Photo 4).

**Photo 4:** below. Detail of the splayed window in the north wall, showing the inserted wooden window frame that has in later years been filled with blocking stones.

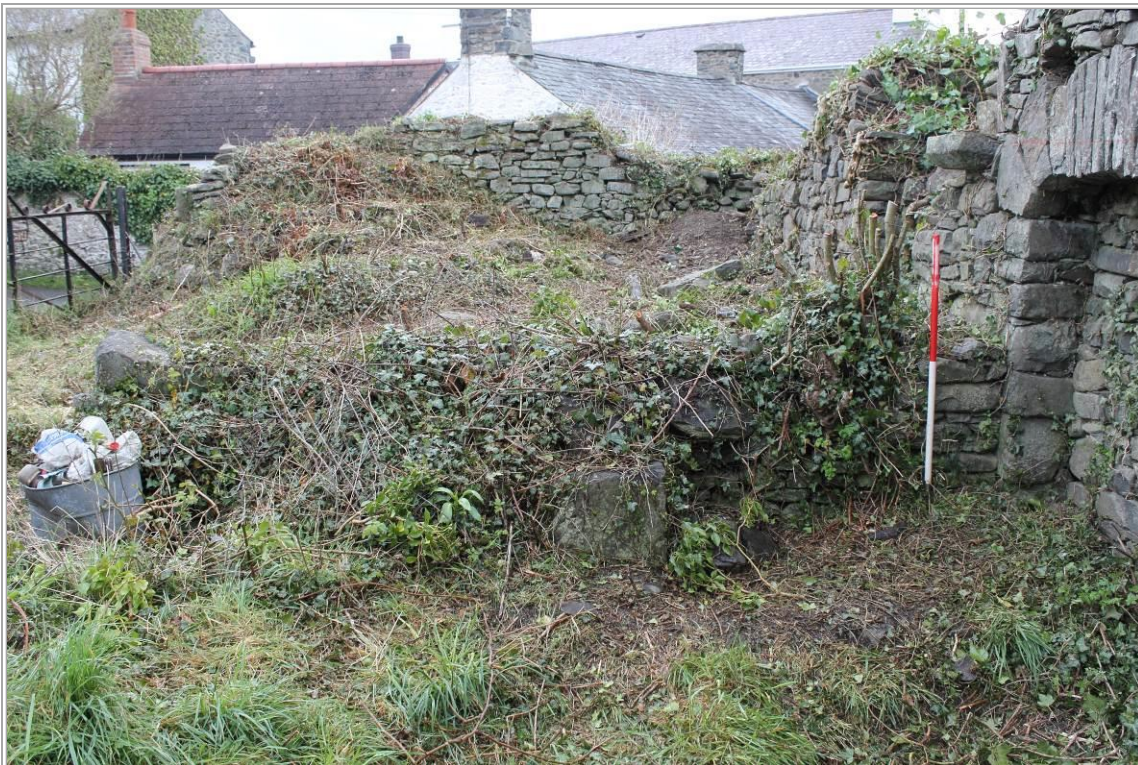
- 7.1.2 As soon as it became possible the first phase of the building recording was started. Volunteers worked with Trust staff to record the main details of the stonework before conservation work began (Photo 12).
- 7.1.3 Upon the removal of the vegetation it became apparent that the walls were in a worse condition than had originally been thought. In particular the southwest and northeast corners of the building were in a poor state.
- 7.1.4 The clearance work also revealed the amount of rubbish dumped within the ruin, as well as the very large quantity of overburden that existed, predominantly at the western end of the building (Photo 13).

**Photo 13:** *Looking west after much of the vegetation has been cleared from Neuadd. Note the large amount of overburden at the western end of the building.*

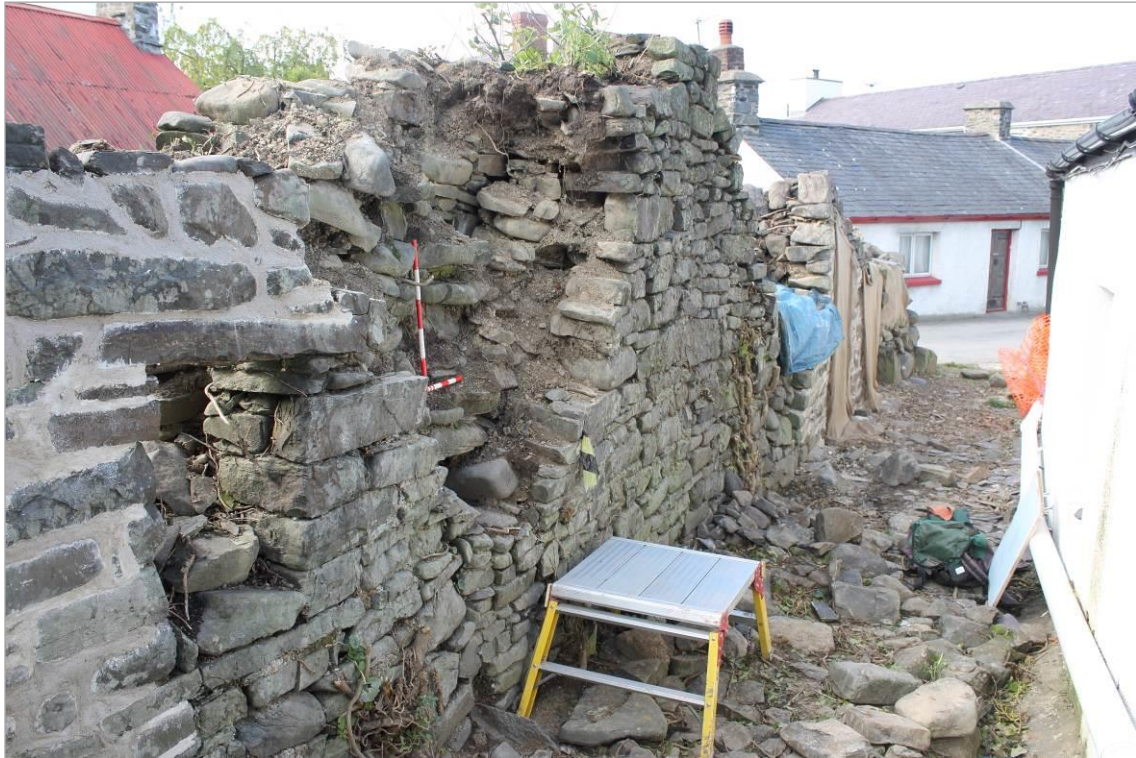
- 7.1.5 The conservation building team continued the removal of the vegetation when they began work in early May. During this process the poor state of the walls became obvious and much detailed work had to be carried out to make the walls safe. In places the walls had to be rebuilt (Photo 14). Trust staff worked closely with the conservation building team, using their records to make sure that walls were rebuilt as closely as possible to the original design.

**Photo 14:** *The north face of the north wall of Neuadd during conservation work.*

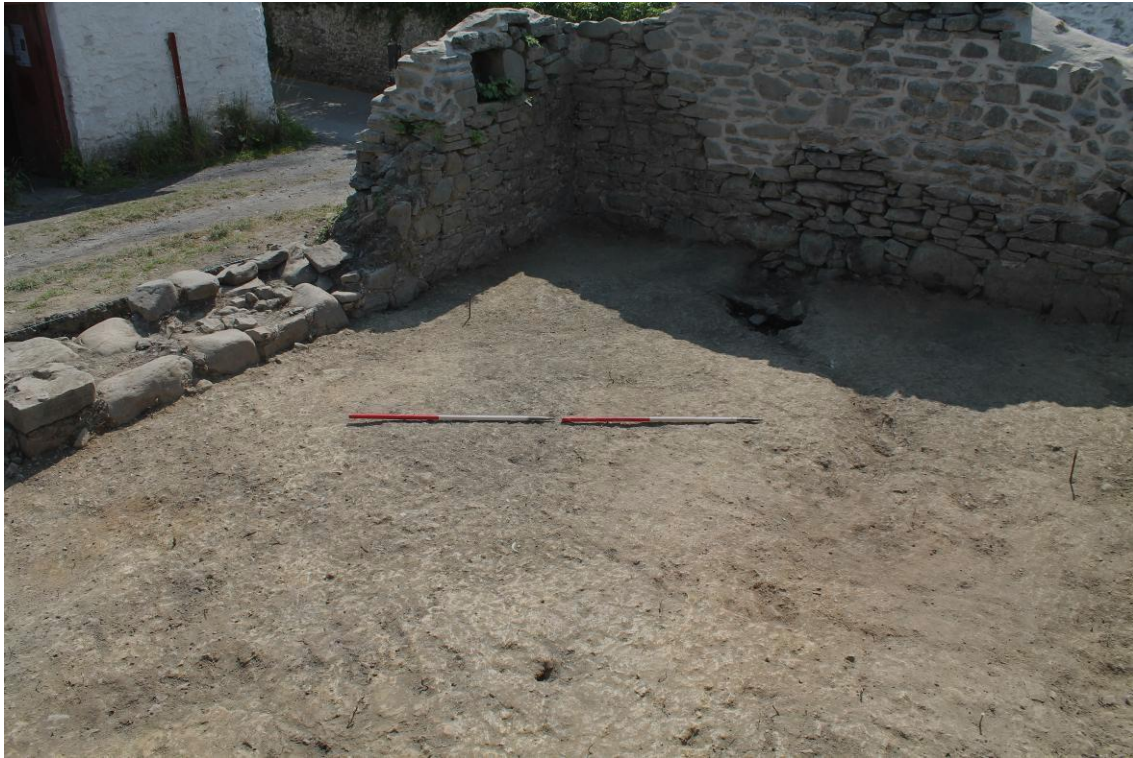
**Photo 19:** Looking southwest across the Neuadd west room showing the clay floor surface [1003]. The dark feature seen towards the west wall has been caused by the roots of a former tree.

- 7.3.6 As with [1002] this floor layer [1003] faded towards the east side of the room becoming cleaner with far fewer stones. It is possible that this change indicated an internal north-south division across the room but because of the extremely hot weather during the excavation such slight changes in soil colour were near impossible to plan.
- 7.3.7 It was decided that the excavation would stop at this floor surface [1003] but two narrow trenches (Figure 9) were excavated at right angles to each other through [1003] to look at underlying archaeological layers.
- 7.3.8 The stone walls of Neuadd are constructed from a locally derived stone. As can be seen in Photo 19 above the foundation stones are very large rounded boulders, some as wide as the wall itself; c. 0.70-1.0m wide. Some of the stones have been worked and are faced and there are traces of a residual lime mortar in places.

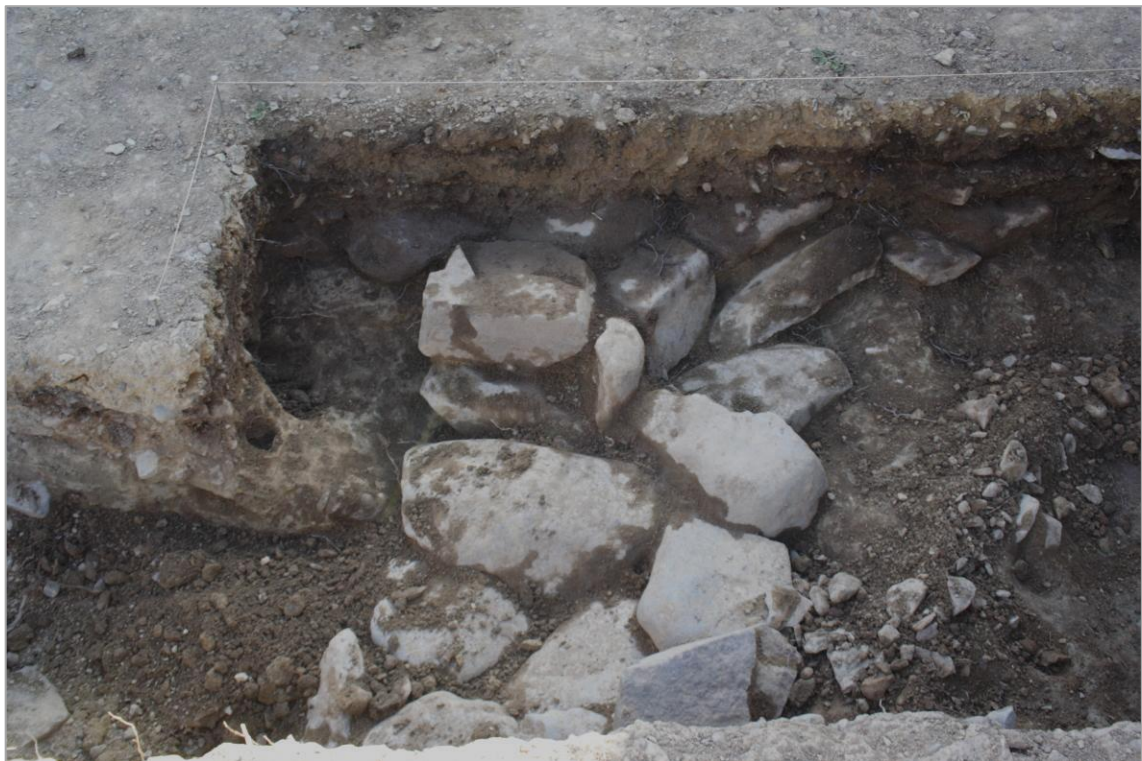
**Photo 20:** The base of a wall [1007] revealed in the narrow trench excavated below floor surface [1003].

7.3.9 Although the wall was not excavated it appeared to sit within a shallow foundation cut within the natural boulder clay.

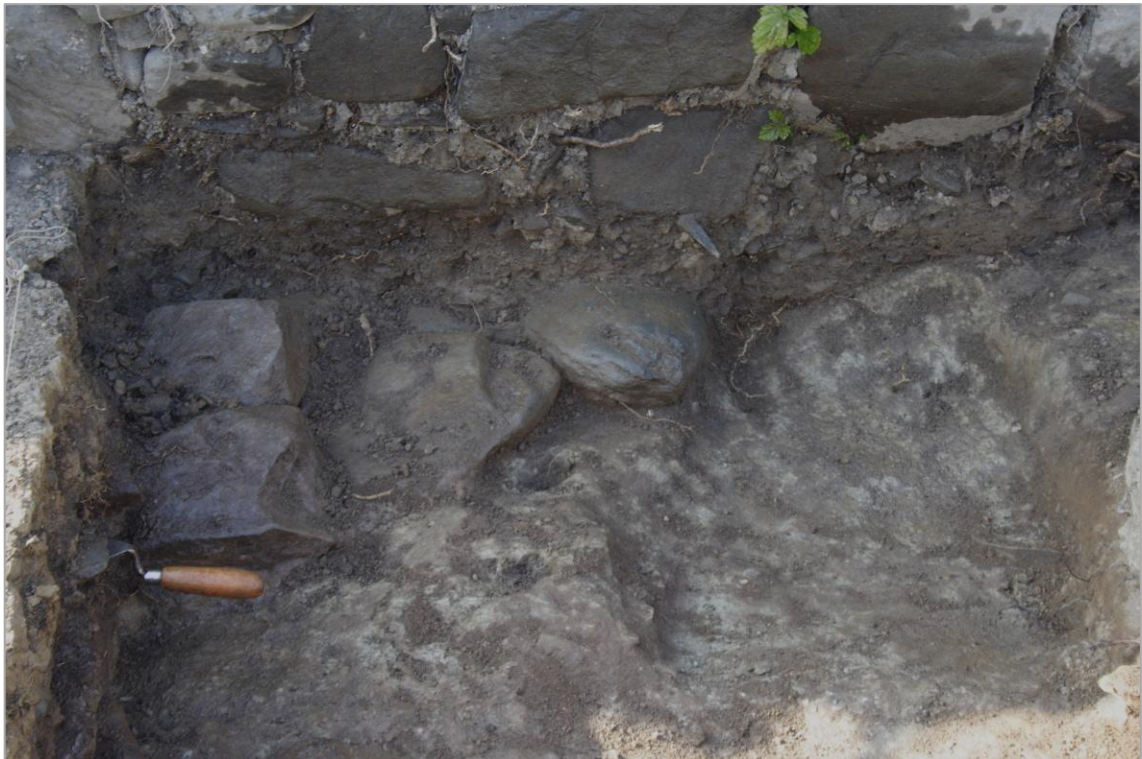
7.3.11 The photograph below shows how the foundations of the Neuadd north wall sit on layer [1006] that lies above the spread of stone [1009], proving that the stones are of earlier date than the construction of Neuadd.

**Photo 21:** Taken facing north this photograph shows how the foundations of the Neuadd north wall are constructed upon layer [1006]. The lower spread of stones [1009] sits on the natural boulder clay [1008].

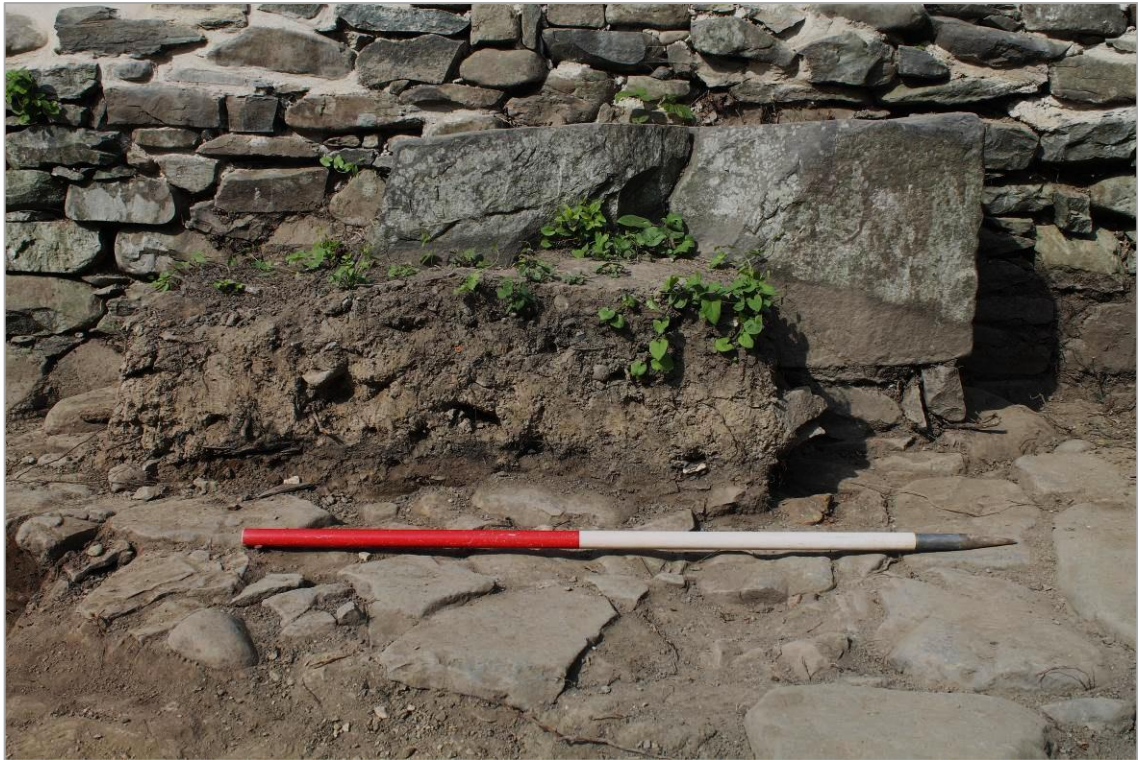
- 7.4.6 Partially covered by [2006] was an area of crudely laid flag stones of various sizes. These flags ran underneath a large stone block[2008] (Figure 8 & Photo 24). Around the eastern edge of the stone flags was a worn depression that was filled by layer [2006] (Photo 25).

**Photo 24:** Photograph taken facing west showing the stone flags [2007] beneath the large stone block[2008]. Note the small stones that have been used to level the stone block (seen on the right). The earth block surrounding most of the stone was left in place because the stone block was unstable and starting to crack.

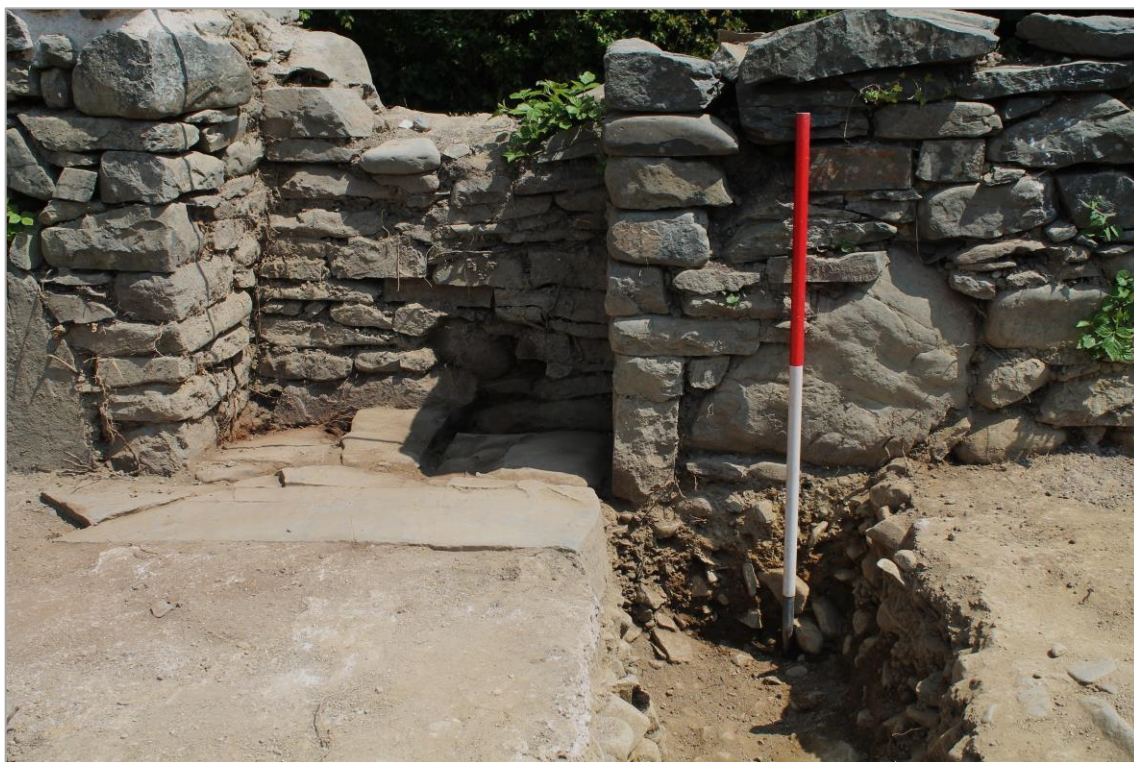
- 7.4.10 The removal of [2001] also revealed the hearthstone in front of the east wall fireplace (Figure 8 & Photo 27).

**Photo 27:** Taken facing east this photograph shows how the foundations of the Neuadd east wall sit directly upon the natural gravel [2013].

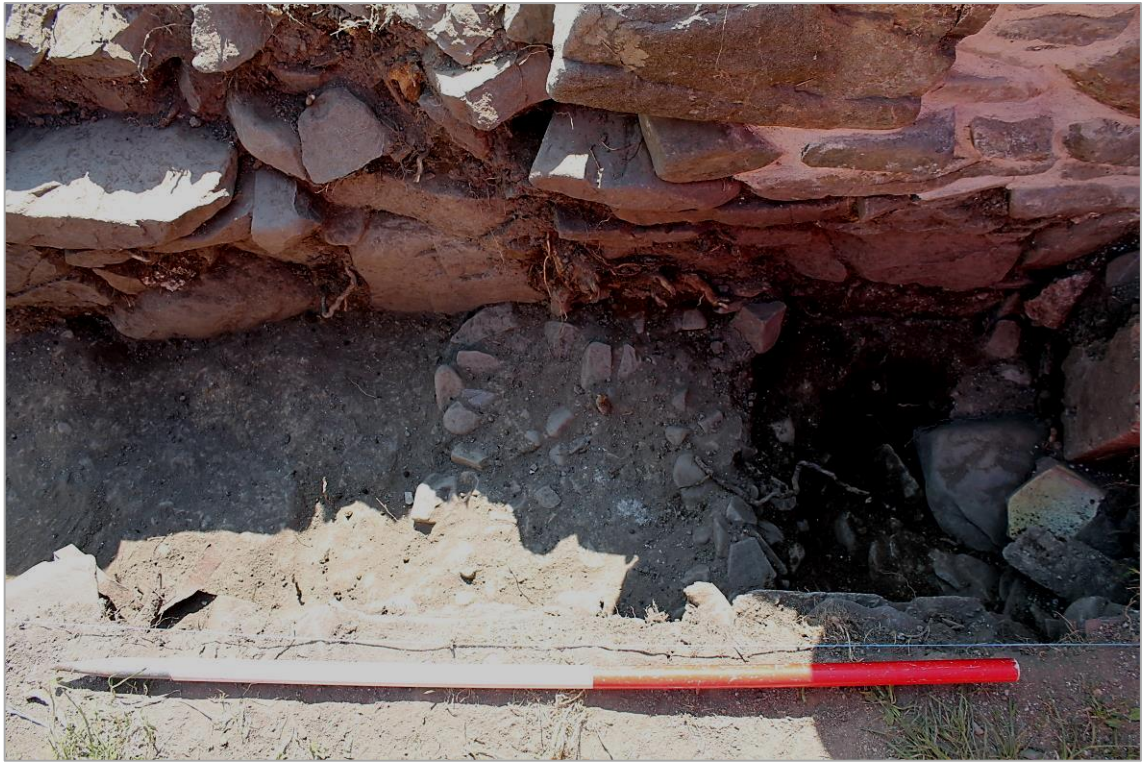
- 7.5.3 Below the tumble a foundation for a narrow wall [2005] was discovered (Figures 9 & 11, Photo 29). The clay and stone foundation measured roughly 0.40m wide and ran eastwards from the Neuadd east wall that it abutted.
- 7.5.4 To the north of this foundation wall was evidence of a pit (Photo 29). It was not possible to fully excavate this pit.
- 7.5.5 The length of the trench could not be extended to the south far enough to investigate whether a parallel wall to [2005] existed.

**Photo 29:** *Looking west at the narrow trench (E-F) excavated along the exterior of the Neuadd east wall. The photograph shows the foundations of a wall [2005] running east at right angle to the east wall and evidence of a pit to the north of the wall foundation that was not fully excavated.*

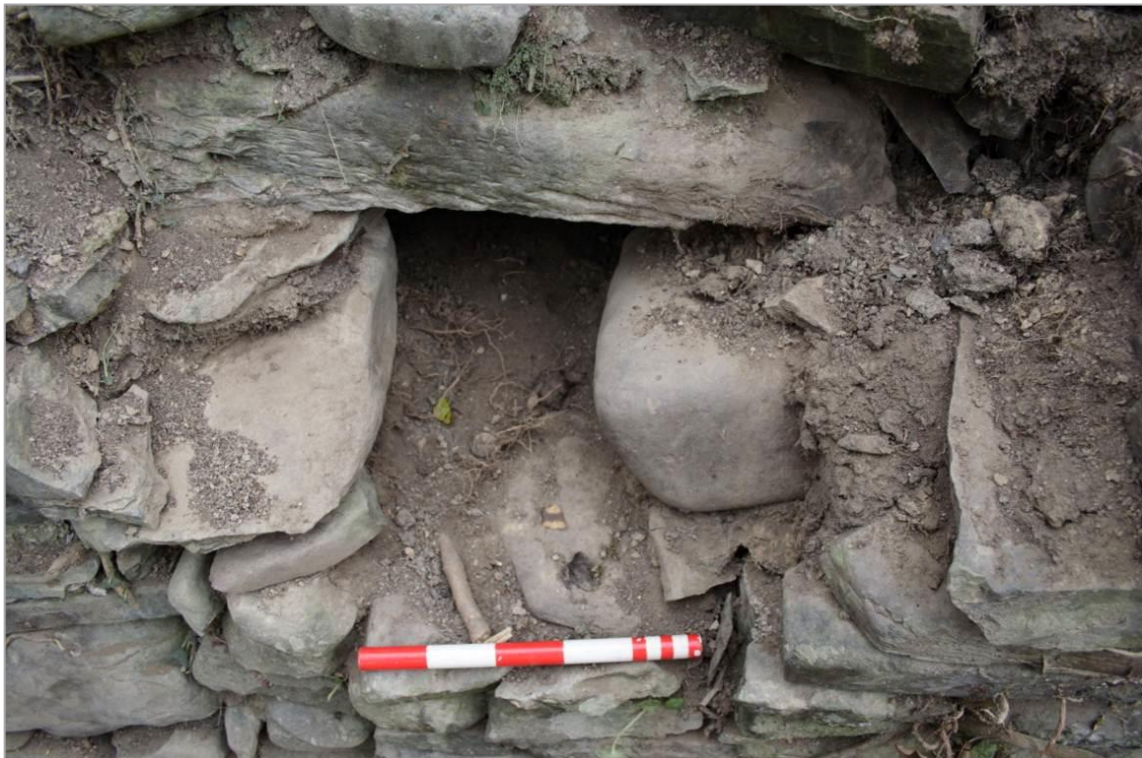
**Photo 32:** The oven (prior to conservation) revealed in the north face of the north wall after vegetation clearance.

- 8.6 The oven discovered behind the fireplace in the north wall confirms the domestic nature of the building.
- 8.7 However, Neuadd is not the first development on this site, as evidence was found for an earlier structure. The foundation of a stone wall and the spread of stone that surrounds it discovered below Neuadd in the west room are sealed by a deposit that the Neuadd foundations sit upon. They are of unknown date but one flint flake was found close by at the same level indicating possible prehistoric activity in the area.
