CPAT Report No. 1753

Caersws Water Main Repair, Powys

Archaeological Watching Brief

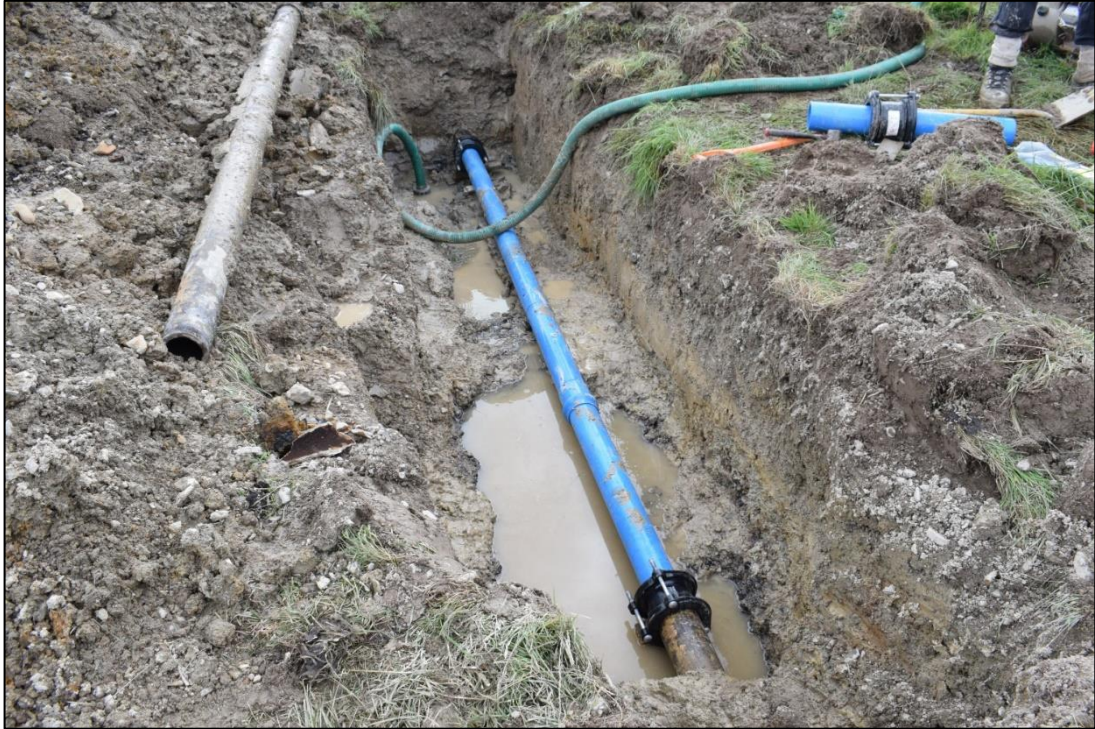
- 3.2. The water main in which the leak occurred runs from a larger main that follows the line of the main A470 Carno road. This branch is an asbestos cement pipe which starts at approximately NGR SO 0286 9207 and runs north-east, feeding stock water supplies in the two scheduled fields. The trench was initially excavated to 2m by 1m in size, slightly wider than the original trench in which the pipe was laid, but the poor condition of the pipe meant that a complete section had to be removed. This resulted in the final excavation covering an area of 5m north-east/south-west by up to 1m wide (Fig. 3).

Fig. 3: The final excavation, showing the replacement pipe, from the north-east. Photo CPAT 4782-0008

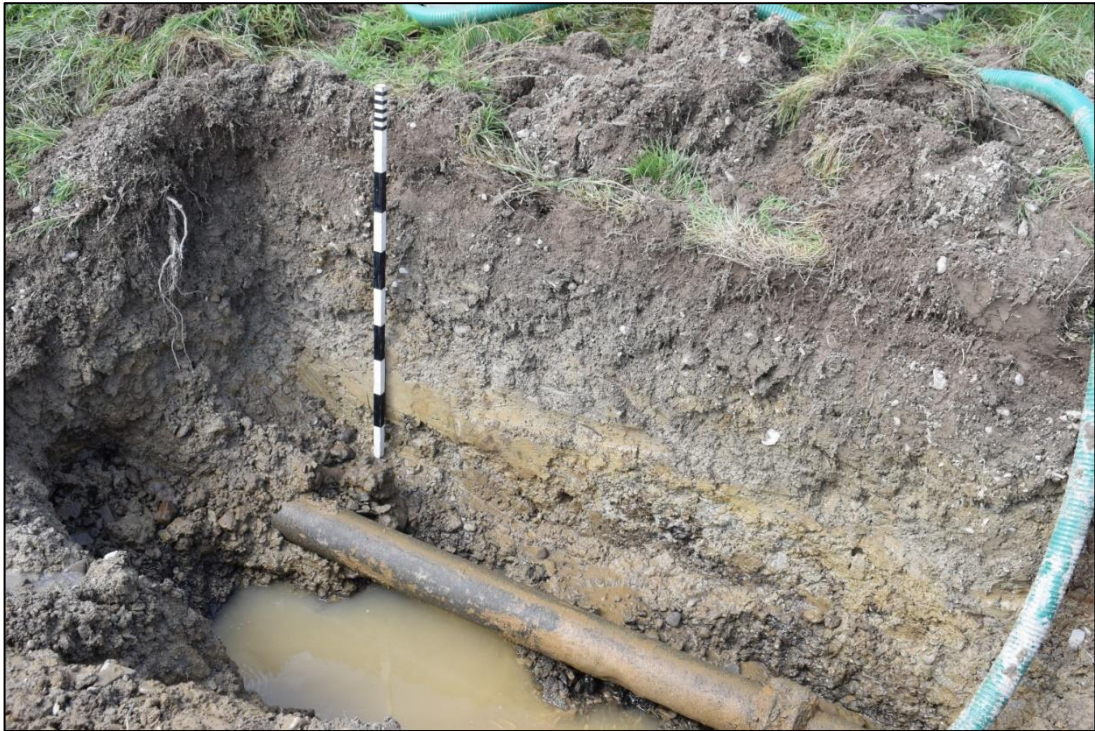
- 3.4. The natural subsoil was revealed at a depth of between 0.5m and 0.6m below the surface, continuing to the base of the trench at approximately 1.0m in depth. These natural soils comprised manganese-panned gravels covered with sticky yellow clay. Above these was a layer of grey gravelly silt, between 0.3m and 0.4m in thickness, which contained some Roman material and probably denotes the contemporary ground level; it did not appear that the gravel included any surface metalling, but it was not seen in plan so this is difficult to gauge with certainty. The Roman material comprised two sherds of highly abraded coarse pottery and was not retained. The overlying surface soil was a grey-brown silty topsoil, 0.2m in thickness.

Fig. 4: The section through the deposits at the site location, from the east. Photo CPAT 4782-0005

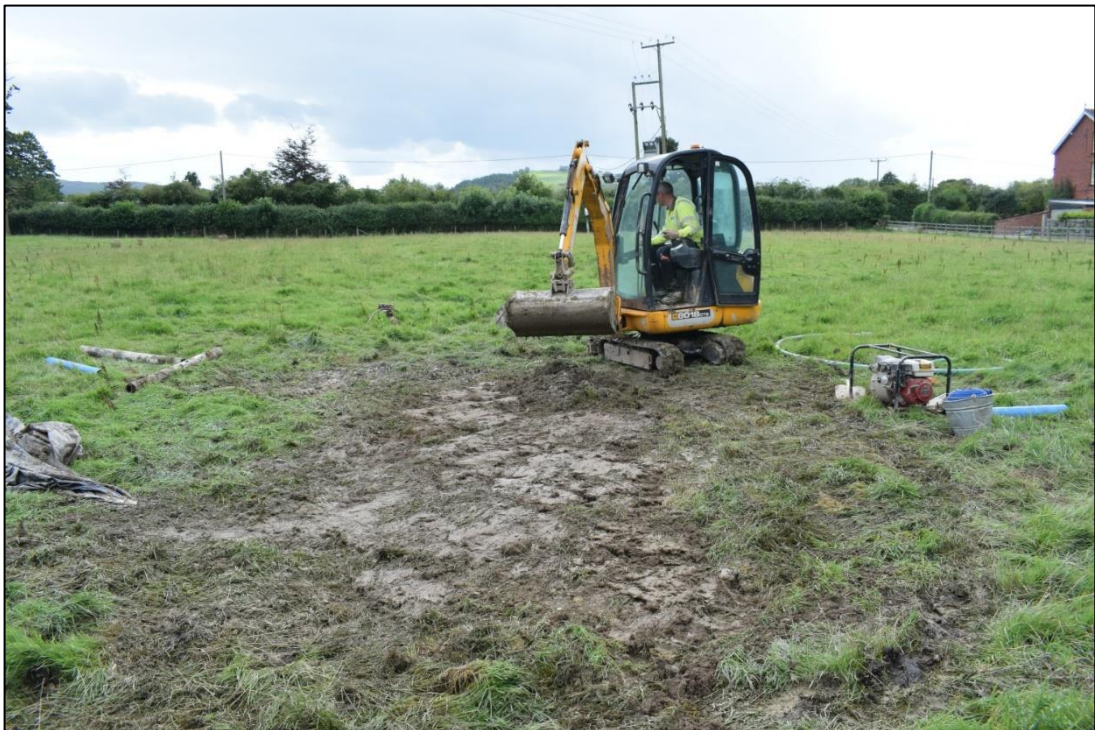
- 3.5. Once the pipe had been repaired (see Fig 3), the excavations were reinstated by machine (Fig. 5). This returned the area of the leak to its previous surface appearance.

Fig. 5: The area of the leak following its reinstatement. Photo CPAT 4782-0010
