ARCHAEOLOGICAL MONITORING DURING RESTORATION WORKS ON THE CEFN FLIGHT OF FOURTEEN LOCKS

*for Newport City Council in partnership with the Monmouthshire,
Brecon and Abergavenny Canals Trust Ltd (MBACT)*

August 2011

HA Job no.: CFOL10

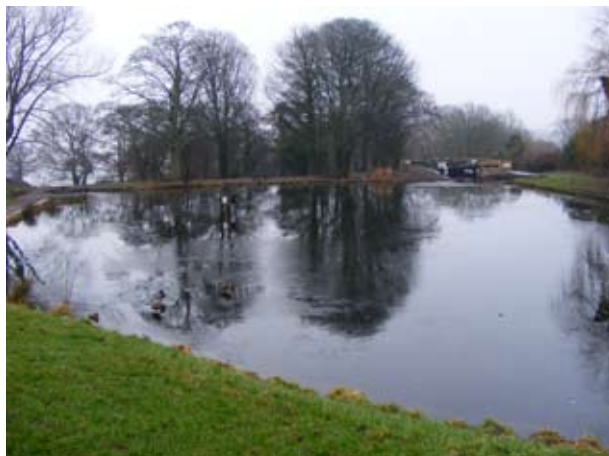
1.1

| Repairs: | Sloping brick lined bottom, modern stone edging and slipway |

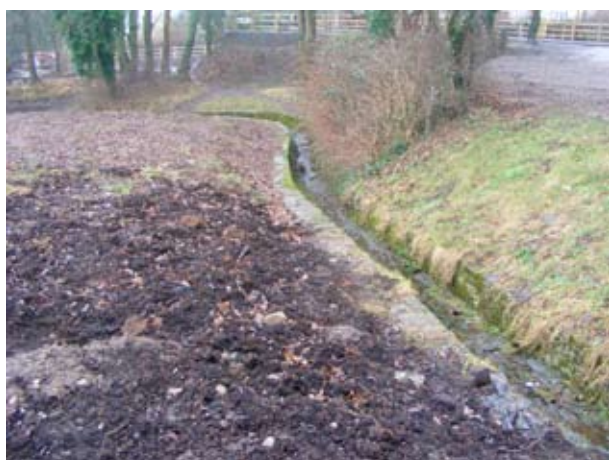
1.2

| Detail: | Spill weir, repaired with modern fabric; feeds stone culvert. Vertical edge to a semi flat stone lined base. The east end splays out as it enters lock 19 pond |
| Repairs: | Some evidence of 20th century brick repairs and modern re-pointing |

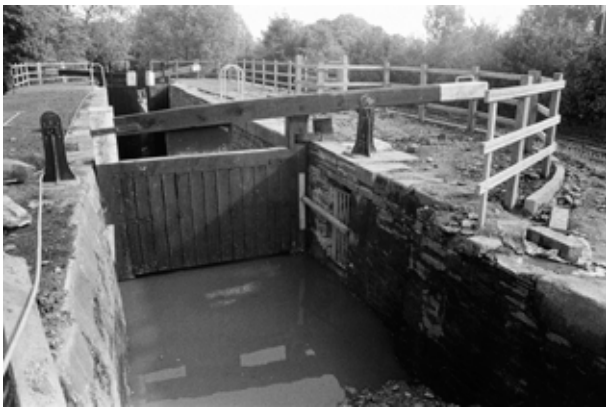
1.3

- Group: Lock 20–19 pair
- Structure: Lock 20
- Element: Lock
- Description: Ashlar sandstone constructed lock chamber with stone lined concave base. Two sluices (Paddles), sluice gate, and gate recesses .Mitre block (previous replacement). Lower pound at east end leading to lock 19. There was evidence for two roundabouts associated with the lower gates, although these appear to be associated with a 20th century phase of consolidation works on the locks.

- Dimensions: Avg – 21.1 x 3.10m
- Fabric: Local sandstones with the addition of 20th century / modern red and white ceramic bricks
- Detail: This chamber is fed from the winding hole above. It is constructed from local red and yellow sandstone. The two sluices (paddles) were blocked by modern blocking .No paddle mechanisms survived. Use of mixed red brick patching throughout the chamber and in particular in the gate recesses. A mitre block was present however, this was a later replacement as they are often replaced with the gates. A number of the coping stones have been removed or broken. The base is a sandstone lined concave floor. The roundabouts (tread stones) were also constructed from sandstone. The roundabout on the south wall (CFOL10-20-RS) survived in better condition than on the north wall (CFOL10-20-RN/RRW), although examination of the fabric revealed modern concrete in the makeup suggesting a later embellishment or reconstruction (suggested date indicates works conducted in the 1970s). A possible beam socket was observed on the coping of the north wall to the east of the lock gates (CFOL10-20-NW-17, 21, 22).

- Repairs: The use of mixed red and white ceramic brick may have been part of the original construction but likely, it is an indication of repairs in weaker areas where the face stones have pulled away from the core work. The sluices (paddles) have been blocked and the mitre block may be a replacement. There was evidence of more modern repairs on the south roundabout. A retaining wall for the north roundabout is evident and may have been constructed in the mid 20th from salvaged stones. There were also some modern wing wall remains.

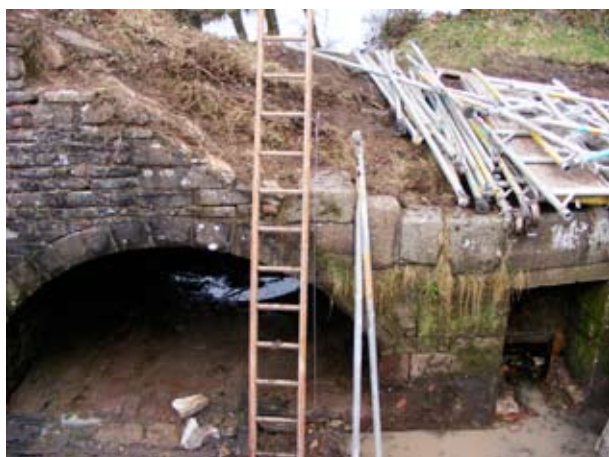
1.4

Description: The area between the locks that holds water at a constant level. Copingstones missing.

Repairs: Ares of the chamber showed signs of re-pointing

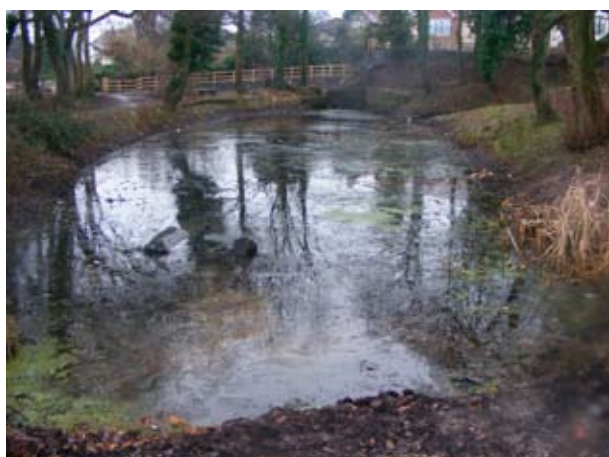
1.5

Repairs: Some re-pointing of the stones

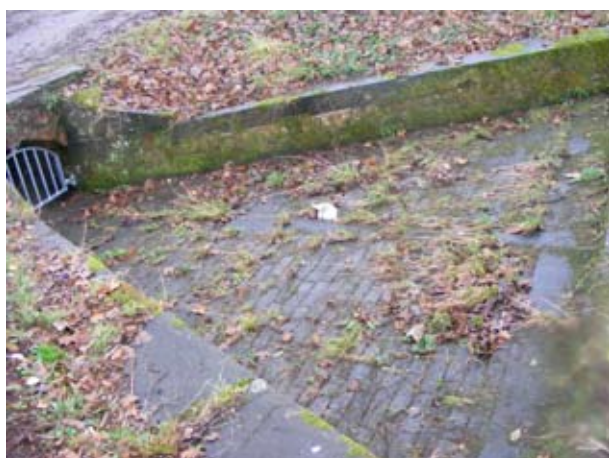
1.6

Repairs: Some re-pointing of the original sandstone

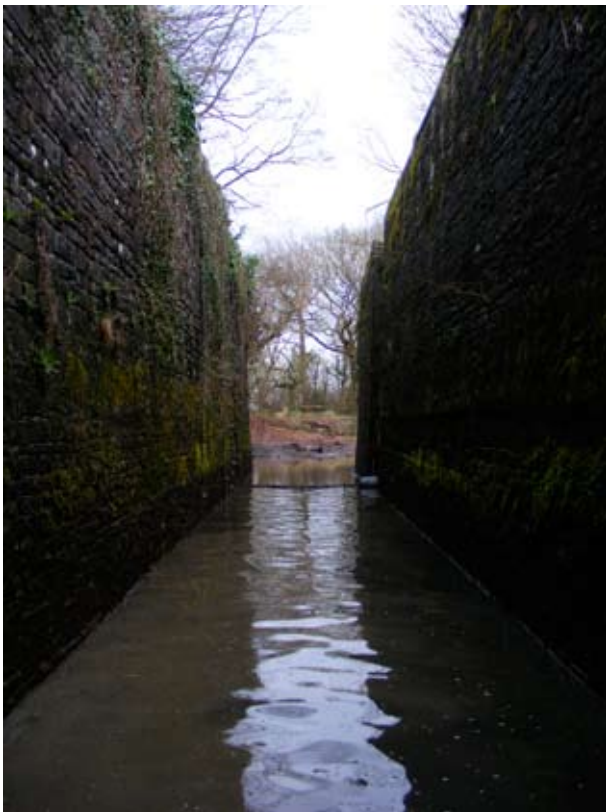
1.7

| Repairs: | The use of red and white ceramic brick may have been in the original construction but likely it is as a result of latter repairs in weaker areas. The sluices have been blocked and the existing mitre block may be a replacement. |

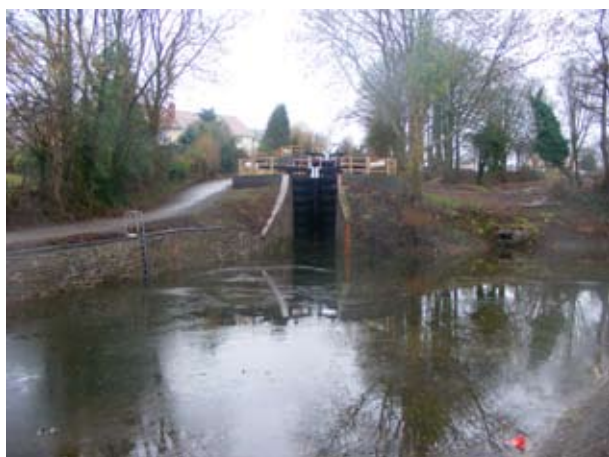
1.8

| Detail: | Open-faced arched culvert from balancing pond 19 is visible on the west. The retaining wall on the south is in poor condition. Some of the coping stones are missing and there is evidence of repair using red ceramic brick. There are few visible signs of a wall on the north side of the pond. A circular spill weir set, into a repaired wall at the northeast feeds water through a sloping stone lined culvert into the balancing pond for lock 17. This weir has had extensive modern repairs. A wall runs from this weir joining it to Lock 18. |
| Repairs: | Modern re-pointing and ceramic red brick |

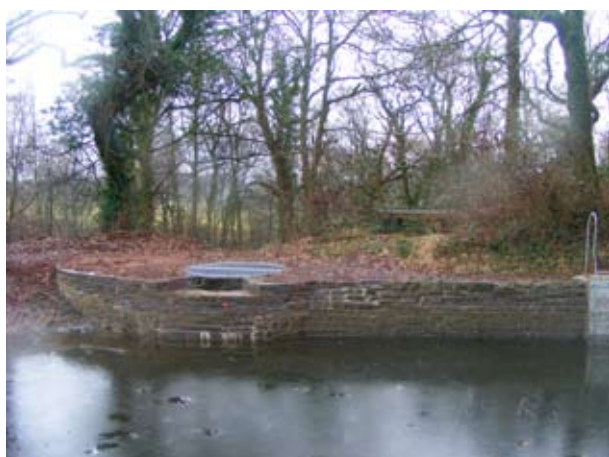
1.9

| Repairs: | Some evidence of modern re-pointing. |

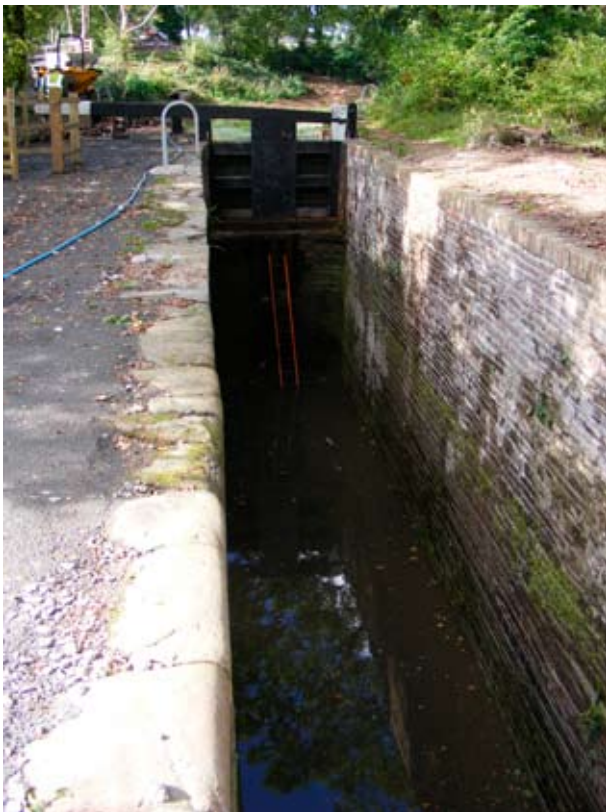
1.10

- Group: Lock 18–17 pair
- Structure: Lock 18
- Element: Lock
- Description: Stone lock chamber with stone lined concave base. Two sluices, sluice gate, and gate recesses. Mitre block (with modern repairs) *in situ*. Evidence of roundabout grips but no solid structure suggesting cosmetic re-construction, possibly associated with latter works. Leads pound between locks 18/17.

- Dimensions: Avg – 18.0 x 3.10m
- Fabric: Local yellow and red sandstones with the addition of 20th century / modern red and white ceramic bricks
- Detail: This chamber is fed by water from 19/18 winding hole. It is constructed mainly from local red and yellow sandstone. The two sluices were blocked. No paddle mechanisms survive. The reinforcing steel plates in front of the sluice gate remain *in situ*. Again as previously seen, there are areas of brick patching throughout the chamber, in particular in the gate recesses indicating latter repairs. A mitre block was present however; this may be a later replacement. A number of the copingstones have been removed or broken on both side of the lock in some areas. The base is a stone lined concave floor. The stones are predominantly sandstone again with the addition of red brick patches. The partial remains for the north roundabout were revealed with some grips still *in situ* (later removed). Some modern (1970s) graffiti appears on the upper section of the north wall (CFOL10-18-GF).

- Repairs: Red brick repairs, evident on the wall sections particularly in the gate recesses. Traces of 20th century re-pointing still remaining on the chamber walls.

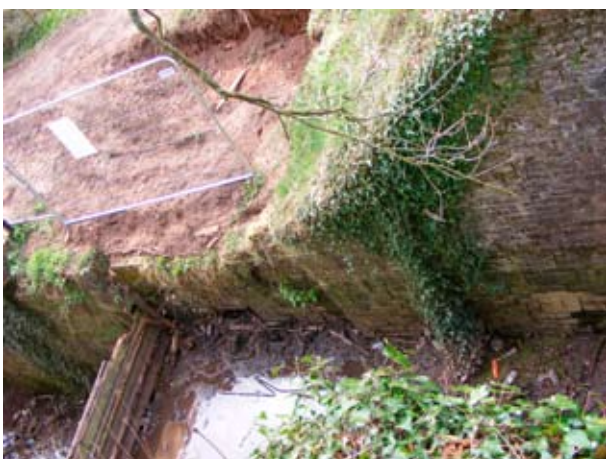
1.11

- Group: Lock 18–17 pair
- Structure: Pound between Lock 18–17
- Element: Pound
- Description: The area between the locks that holds water at a constant level. Copingstones missing. Distinctive feature include an arched culvert in north wall and a circular culvert on south wall.

- Fabric: Local sandstone
- Detail: Semi-circular arched culvert leading to lock 17 balancing pond. This has been partially blocked by re-used stones. Only 60% of the face of the circular culvert remains. The culvert is stone lined with a mixture of sandstone and red brick. It leads to the overflow spill weir feeding lock 17/16 winding hole.

- Repairs: The blocking of the semicircular culvert appears to have re-used other stones from the lock including coping stones and was probably an attempt to make the area safe.

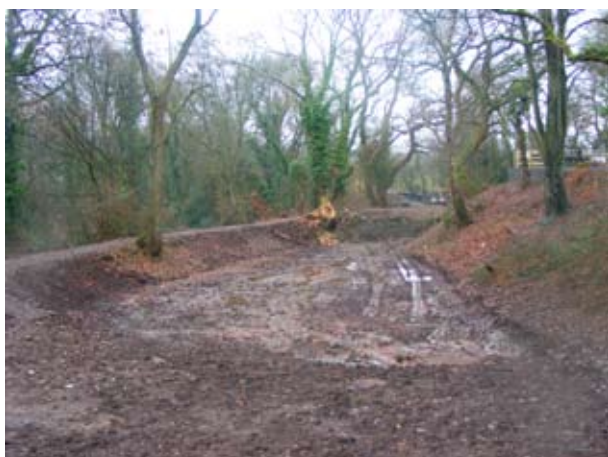
1.12

Group: Lock 18–17 pair
Structure: Lock 18 balancing pond
Element: Pond
Description: Balancing pond that is fed by a circular spill weir and culvert from Lock 19/18 winding hole. An arched culvert at the south leads to the pond between locks 18 and 17.
Dimensions: Approx 48m x 13m
Fabric: Local sandstones
Detail: The area had dense vegetation that obscured much of the pond however; the remains of a lower sandstone retaining wall are visible beneath the vegetation on the northeast edge. The base was most likely clay lined
Repairs: No visible evidence
Related photos: CFOL10-18-BP

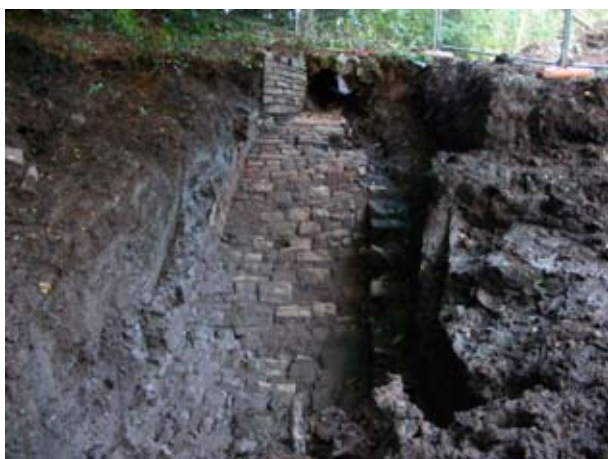
1.13

Continuous monitoring of the ground works allowed the opportunity to record the spill weir uncovered and excavated between locks 18 and 17 (Appendix 1.13). This feature had been backfilled and its entrance from the pound bricked up as a past safety measure. Examination of the associated finds gave an indication that this had been some time in the 1960'S. The spill weir was exposed for recording and reinstated using plastic piping and was then backfilled again. During the excavation of the spill weir, it was noted that the lower pond was edged in stone forming a small secondary pond as seen on the Great Western Railway map of Fourteen Locks (Illus 6).

The overflow spill from the locks 18/17 pound to below Lock 17 uncovered during the remediation works (Appendix 1.13) is again not illustrated by Davies but appears with a small secondary pond on the Great Western Railways map. Brickwork relating to this secondary pond was observed during the 2010 works. If this feature was added to the system during or after construction it may indicate that it was a response to poor water management in this part of the system, possibly caused by the undersized winding hole below Lock 17.

Group: Lock 18–17 pair
Structure: Lock 17–18 pound overflow spill weir
Element: spill weir and holding ponds
Description: A circular culvert from the pond between locks 18/17 feeds this spill weir. The weir is of a red and yellow sandstone construction. It is a "u" shaped enclosure with a small pond and attached funnelled spill weir leading to a steep declined open channel. This feeds a walled oval holding pond that is then converted to feed Lock 17/16 winding hole.
Fabric: Local mixed Sandstone blocks.
Detail: The u shaped enclosure is a sandstone construction and opens out to a small holding pond, which is walled on the east side. This leads to a stone spill weir that is the same as those at locks 19 and locks 16/15 balancing ponds which funnel water to a steeply declined stone channel. This channel leads to a partially walled oval pond that is then channelled beneath the towpath to feed locks 17/16 balancing pond.

Repairs: No evidence of later repairs and the walls were in a poor state of repair. Very poor state of preservation on the walls
Related photos: CFOL10-18-CULVERT; CFOL10-17-EXOFSP; CFOL10-17-OFSP; CFOL10-OFSP-PRE; CFOL10-17-PP-6

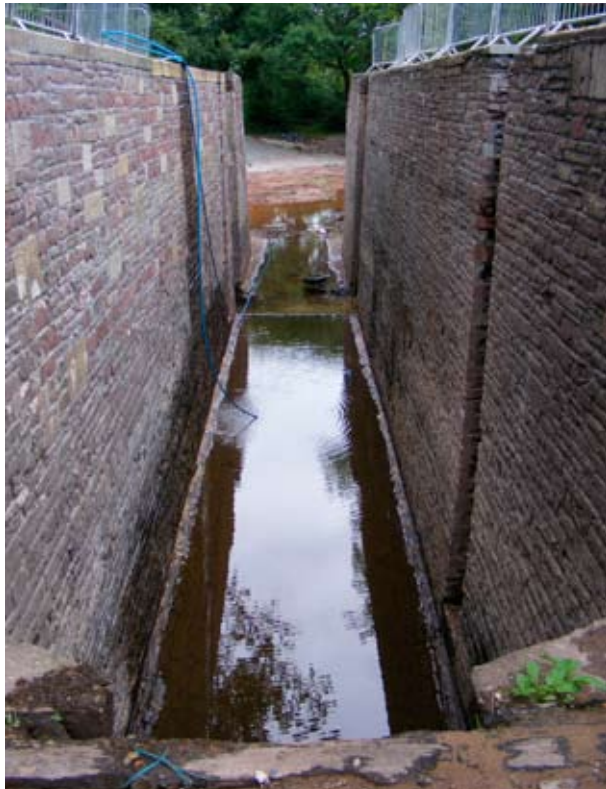
1.14

Group: Lock 18–17 pair
 Structure: Lock 17
 Element: Lock
 Description: Stone lock chamber with stone lined concave base. Two sluices, sluice gate, and gate recesses. Mitre block (modern) still *in situ*. Leads out to lock 16 balancing pond. No evidence indicating the existence of the roundabouts was visible within the area.
 Dimensions: Avg 19.00 x 3.01m
 Fabric: Local sandstones with the addition of 20th century / modern red and white ceramic bricks
 Detail: This chamber is fed by lock 18 and connecting side pond. It is constructed mainly from local red and yellow sandstone. The two sluices, as in the other chambers were blocked with modern rubbish. No paddle gear survived. As in all the chambers the use of brick as a method of repair was evident throughout the chamber. During the clearance a mitre block was observed. The base is of the same design as the other chambers. There are signs of 1970s graffiti on the upper chamber walls.

Repairs: The use of red and white ceramic brick may have been part of the original construction but likely, it is later repairs in weaker areas. The sluices have been blocked and the mitre block may also be a replacement. The 1970s graffiti may suggest a program of repairs at this time as evidenced by the large amount of red brick within this chamber.
 Related photos: CFOL10-17-CW; CFOL10-17-EXW ; CFOL10-17-F; CFOL10-17-HW; CFOL10-17-GEN; CFOL10-17-GF; CFOL10-17-GR; CFOL10-17-NWNR; CFOL10-17-NWR; CFOL10-17-SWNR; CFOL10-17-SWR.

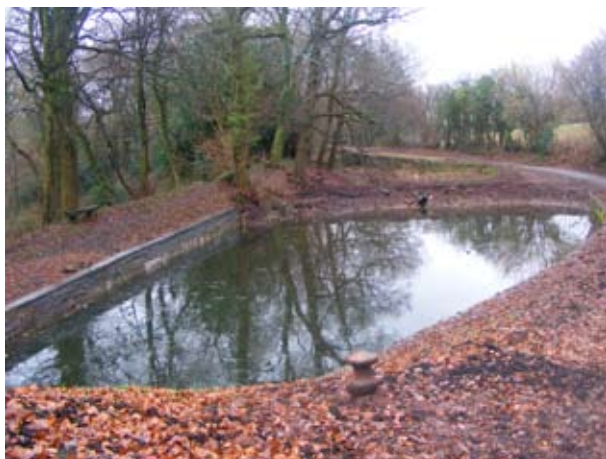
1.15

Group: Lock 18–17 pair
 Structure: Lock 17 winding hole
 Element: Pond
 Description: This is the winding hole for locks 17/16. It is more constrained than the winding holes for locks 21/20 and 19/18, being more a widened section of canal than a large pond. This may explain the presence of the overflow spill-weir and holding pond leading from the pound of locks 18/17 – probably necessary in order to store sufficient water to operate lock 16.
 Dimensions: Approx 73 x 30m
 Fabric: Sandstone and clay
 Detail: The pond is bunded half-way along its length, preventing water from entering the lower lock system. Feeds lock 16/15 balancing pond via a spill weir.
 Repairs: No evidence although this may be due to the overgrown nature of the pond.
 Related photos: CFOL10-17-WH-(0-6)

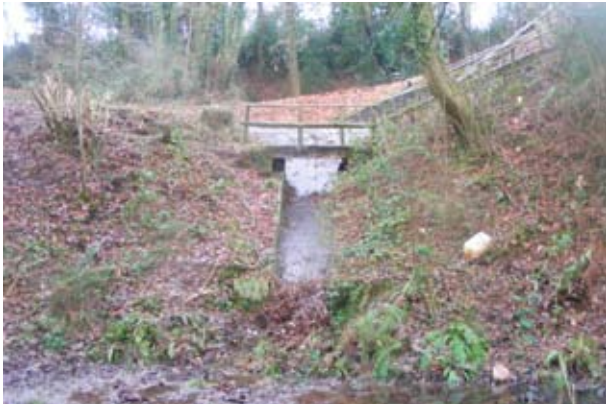
1.16

Group: Lock 18-17 pair
Structure: Lock 16 balancing pond
Element: Spill weir to Lock 16 balancing pond
Description: Funnelled sandstone spill weir from Lock 17/16 winding hole to Lock 16 balancing pond. Has a coursed sloping base, narrowing towards its base.
Fabric: Sandstone
Detail: Vertical edges to a sloping base leading to the culvert. Stone lip at the south controls the volume of water entering the spill weir.
Repairs: Not evident
Related photos: CFOL10-17-SPLP
CFOL10-17-WH-2
