Mount Pleasant Baptist Church, The Kingsway, Swansea

Level 2 Historic Buildings Record

Project No.: AD124

Date: October 2022

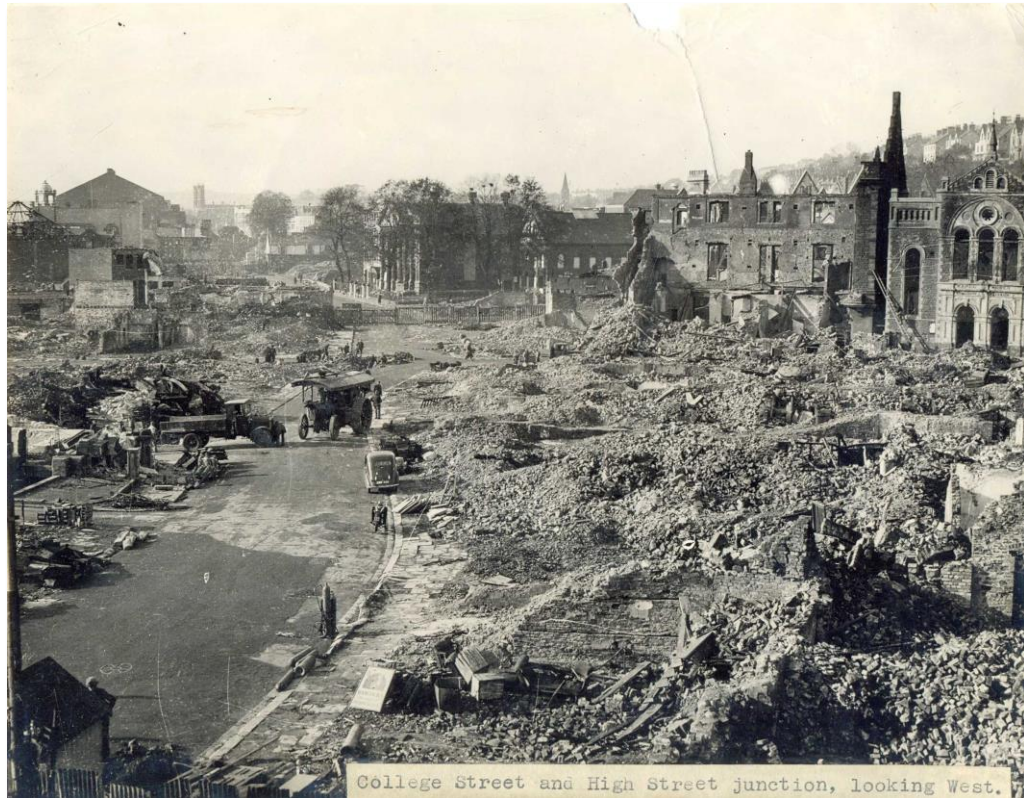
Fig. 8 – Bomb damage surrounding Mount Pleasant, WWII, 1941.

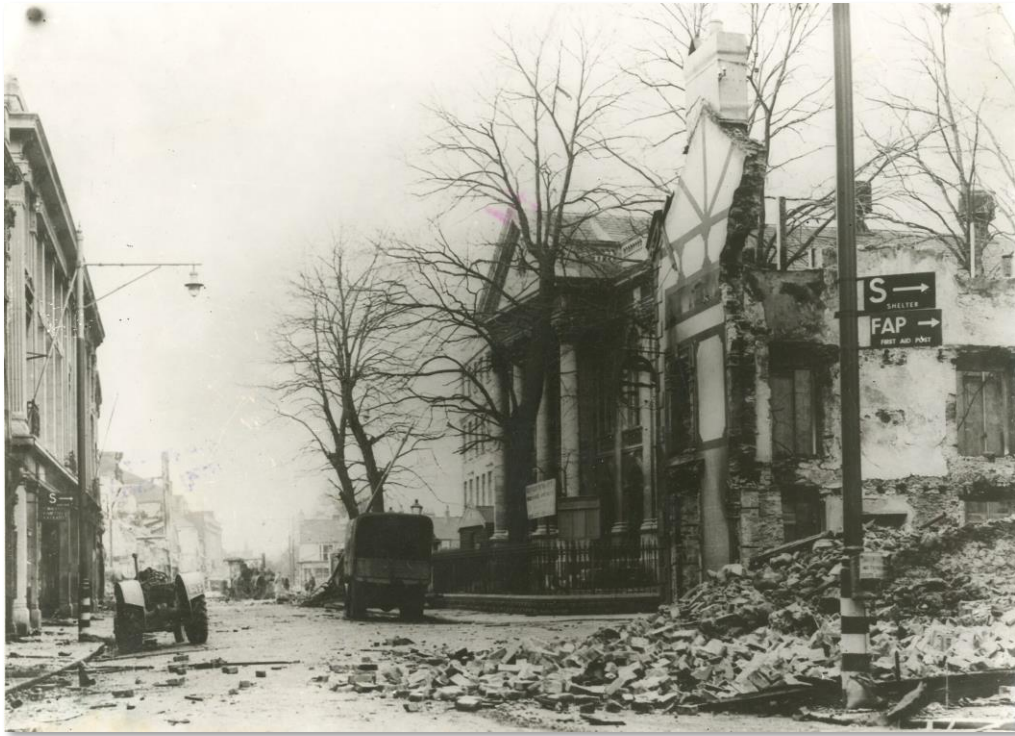
Fig. 9 – Bomb damage around Mount Pleasant, WWII, 1941. N.B. Ventilation cowls to roof.

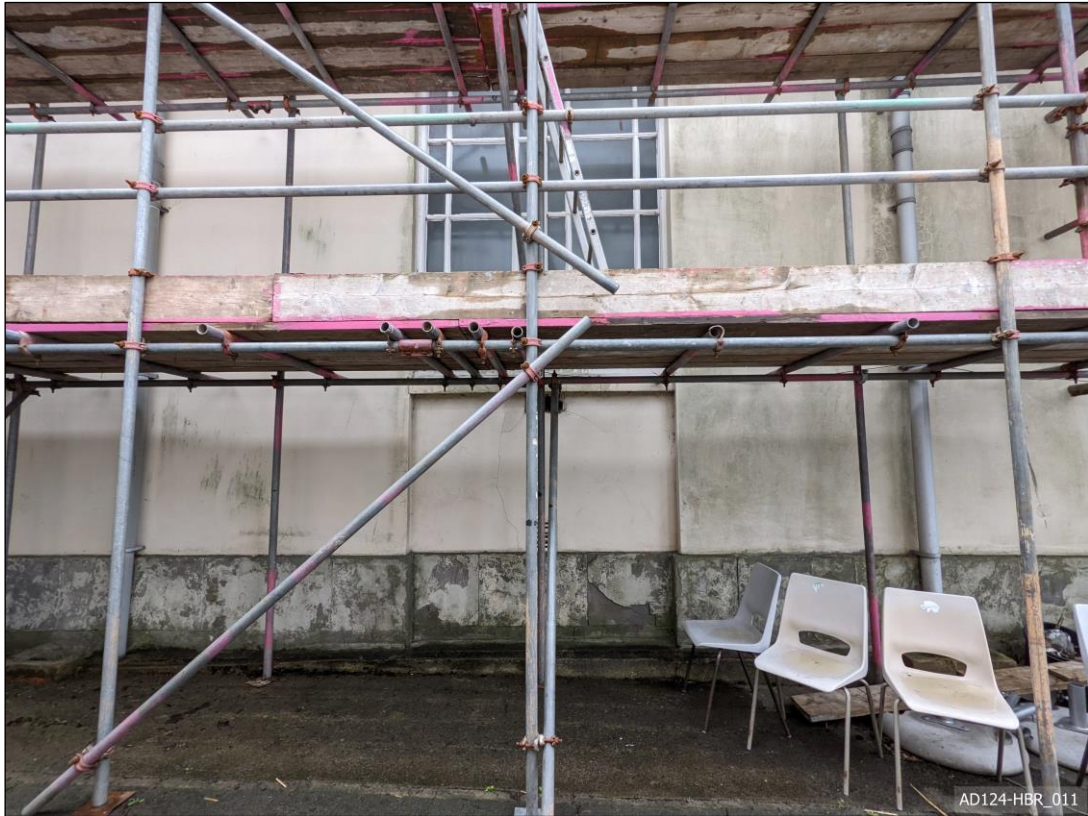
Plate 11 – View east, showing location of new disabled access (through window).

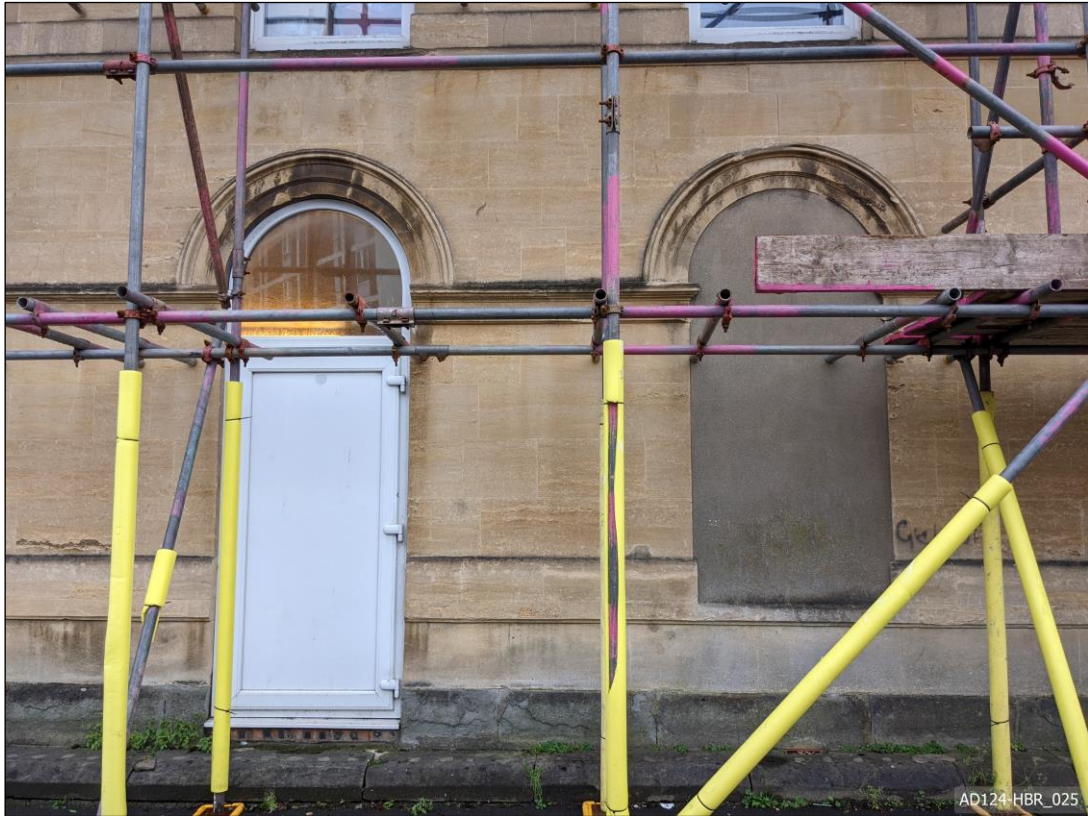
Plate 25 – View west, showing doorway and blocked window in east elevation of lecture hall.

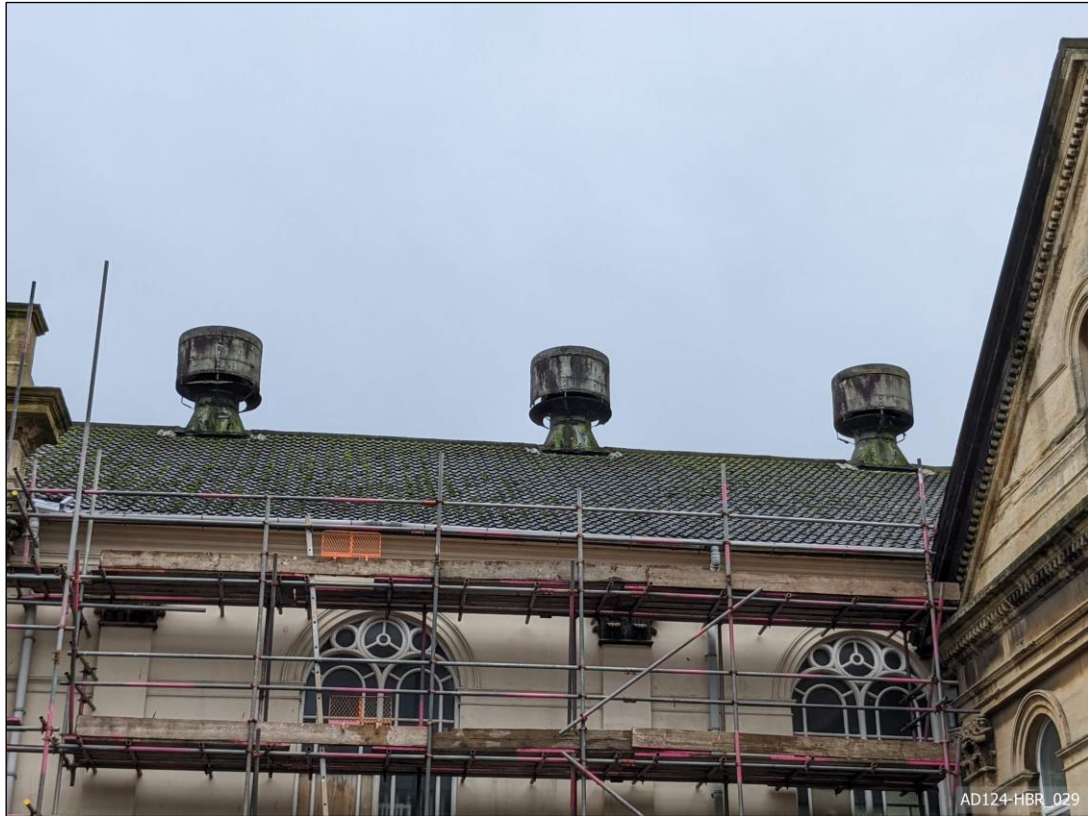
Plate 29 – View west, showing ventilation cowls to roof of main chapel.

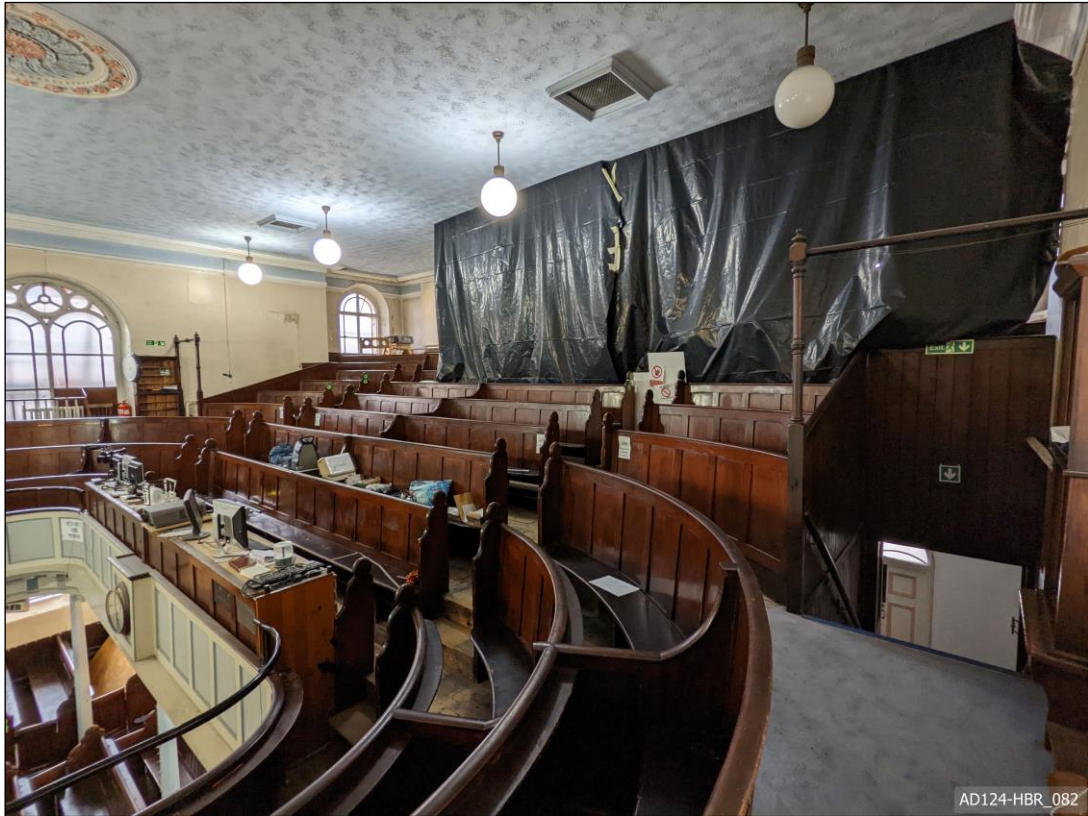
Plate 82 – View south-west, showing gallery and area of ceiling damage.
