Doorway Unblocking at
Plas Machen,
Lower Machen, Newport

Level 2 Historic Buildings Record

Date: December 2022

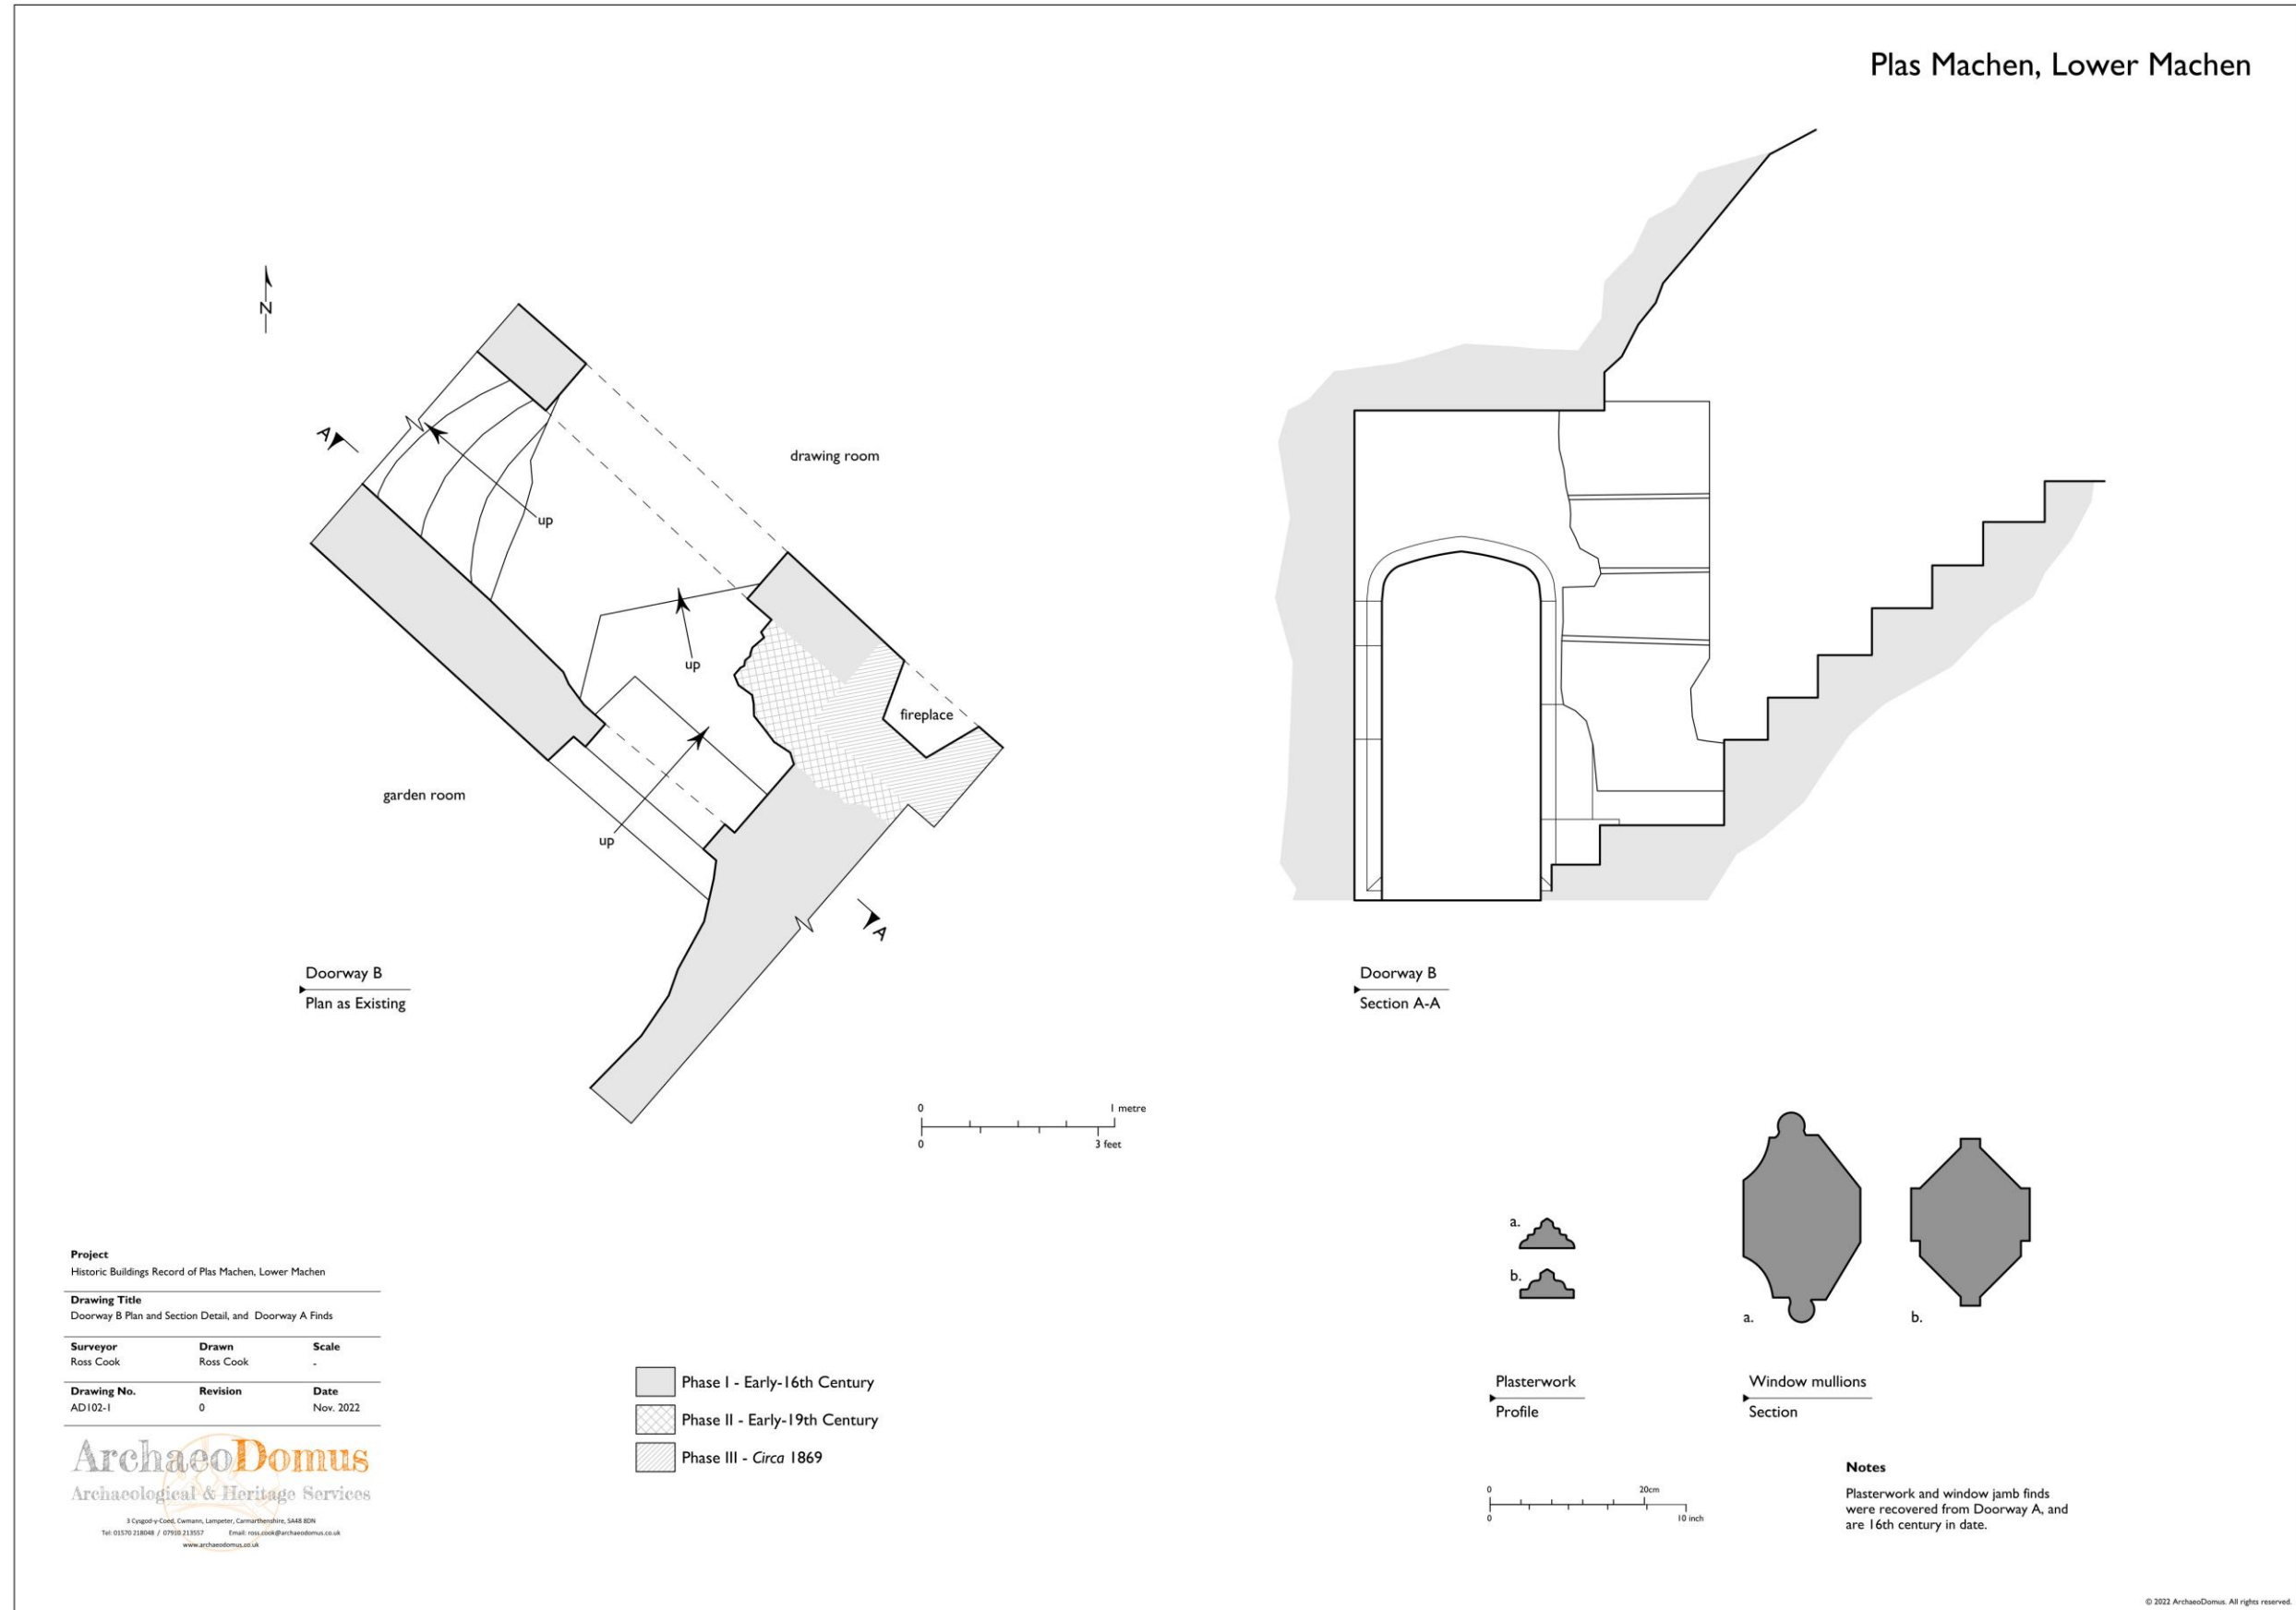
Fig. 11 – Doorway B plan and section, and doorway A finds.

- 6.4.3 Dressed and moulded window mullions and jambs were recovered from doorways A and B, the mullion profiles have been recorded (**Plates 28-32; Fig. 11 – a. and b.**). These represent two different moulding types: sunk chamfer and hollow chamfer with bead. Each type have glazing rebates.

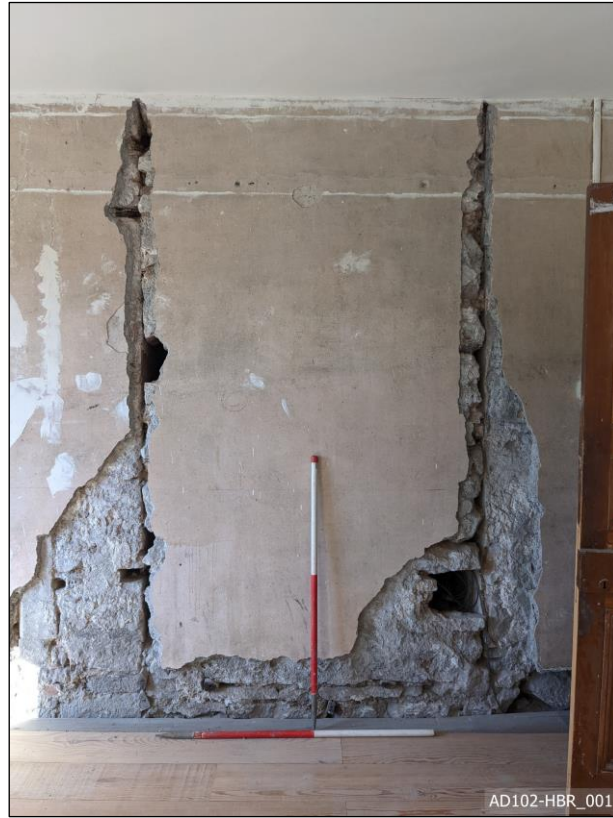
Plate 1 – Doorway A – View south-west, showing north-east elevation.

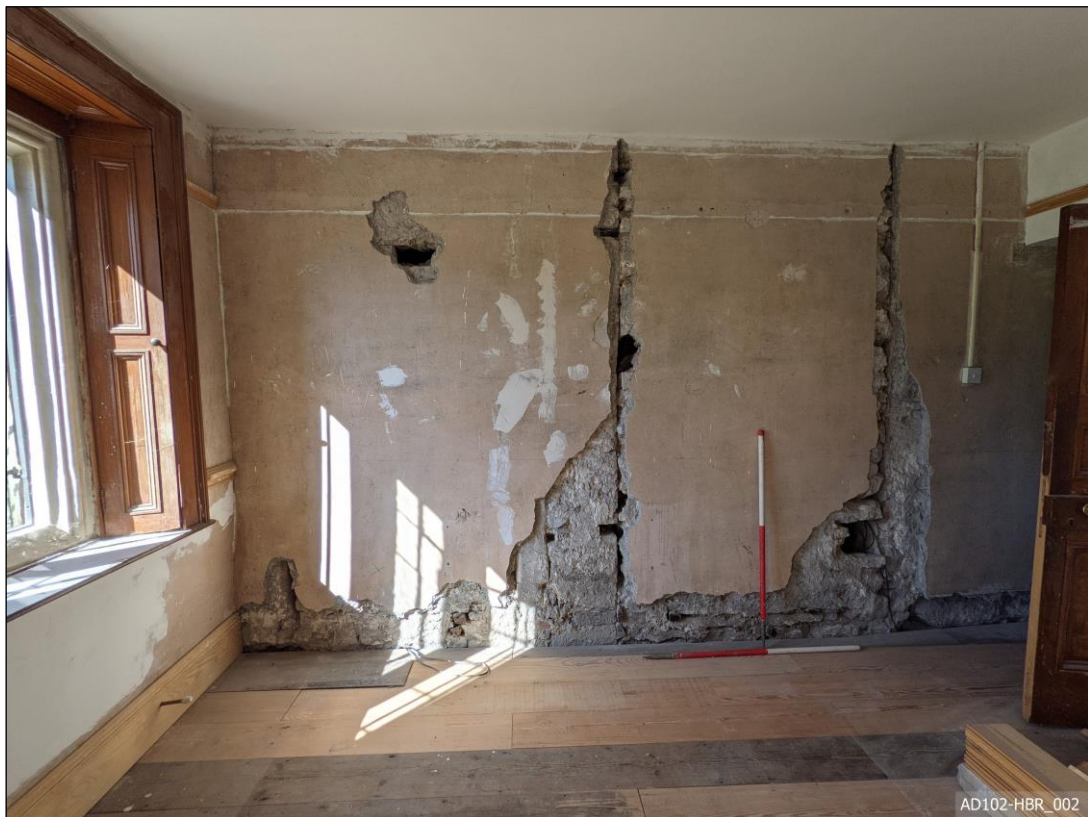
Plate 2 – Doorway A – View south-west, showing north-east elevation.

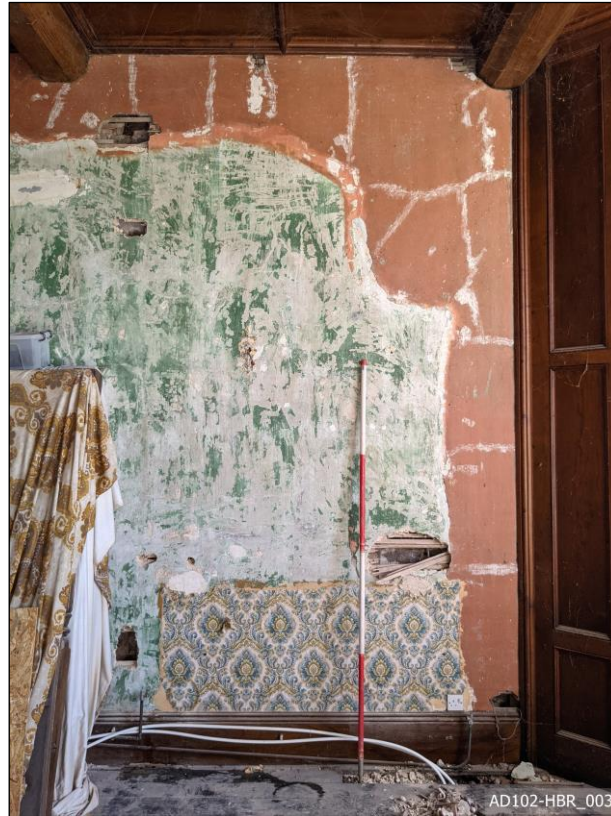
Plate 3 – Doorway A – View north-east, showing south-west elevation.

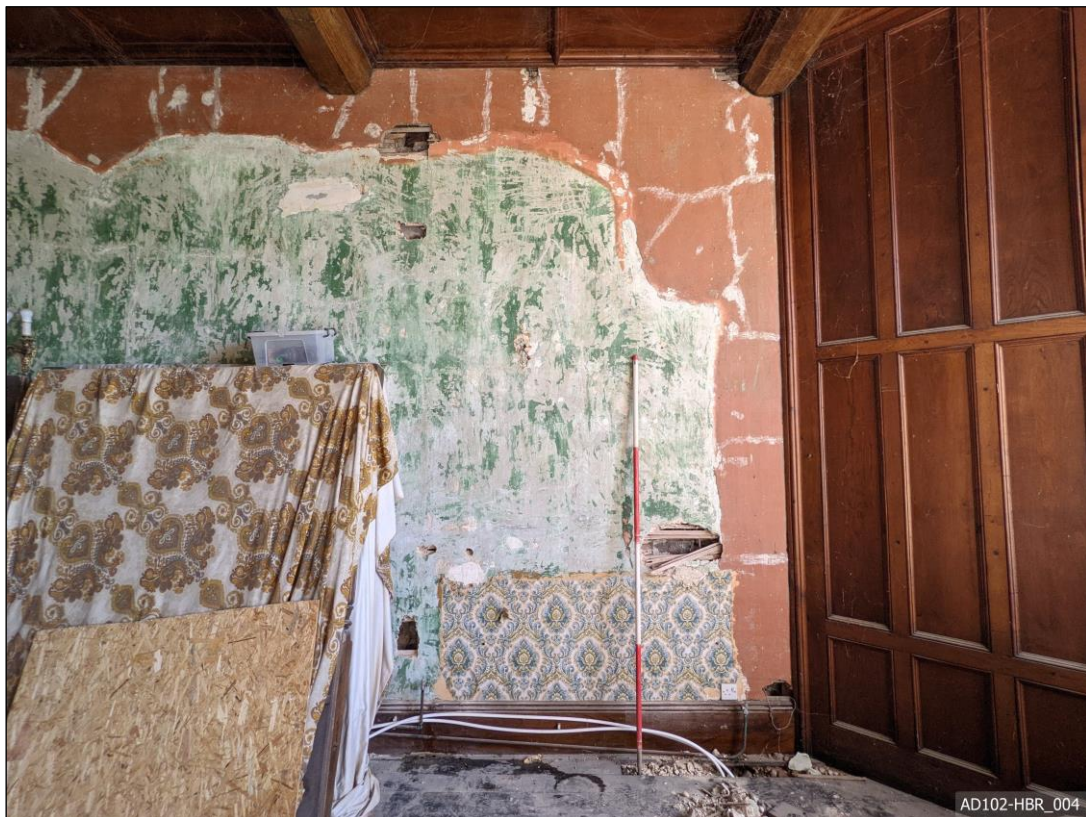
Plate 4 – Doorway A – View north-east, showing south-west elevation.

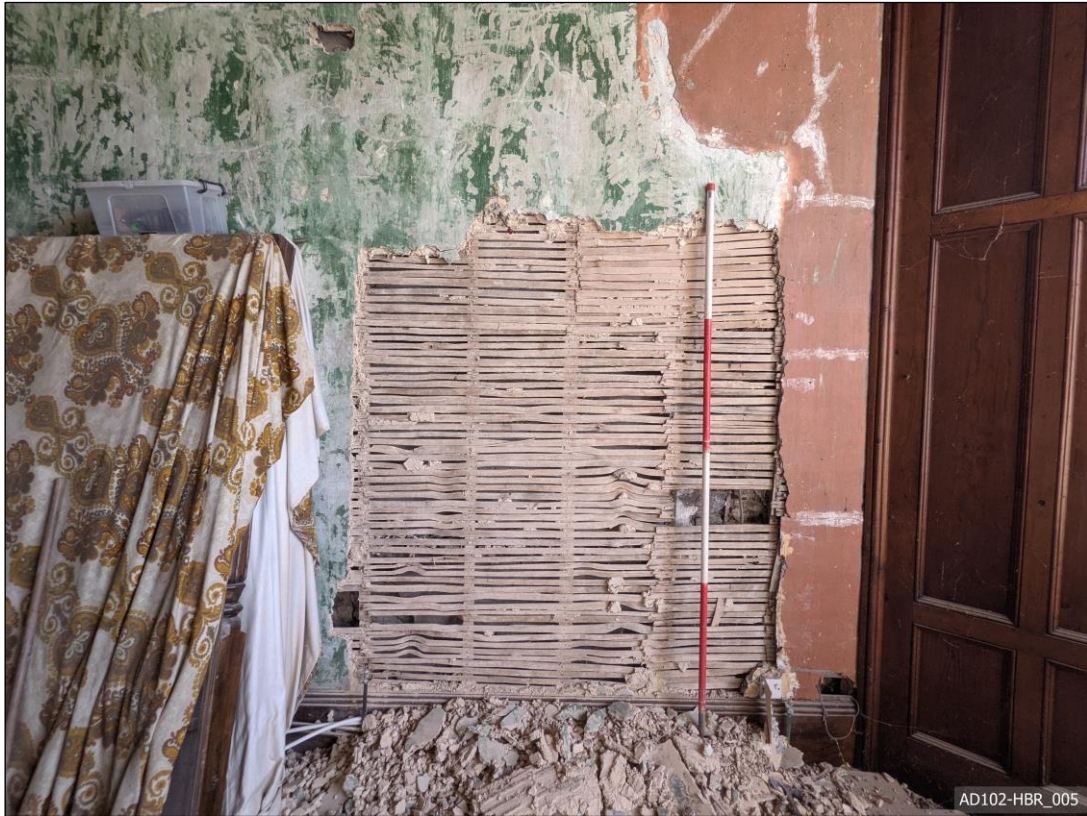
Plate 5 – Doorway A – View north-east, showing laths on removal of plaster.

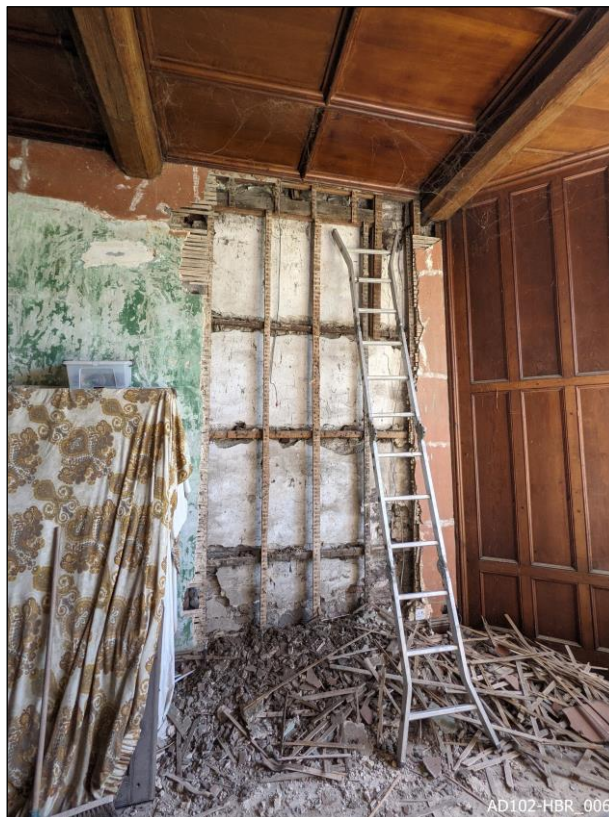
Plate 6 – Doorway A – View north-west, showing removal of lath-and-plaster.

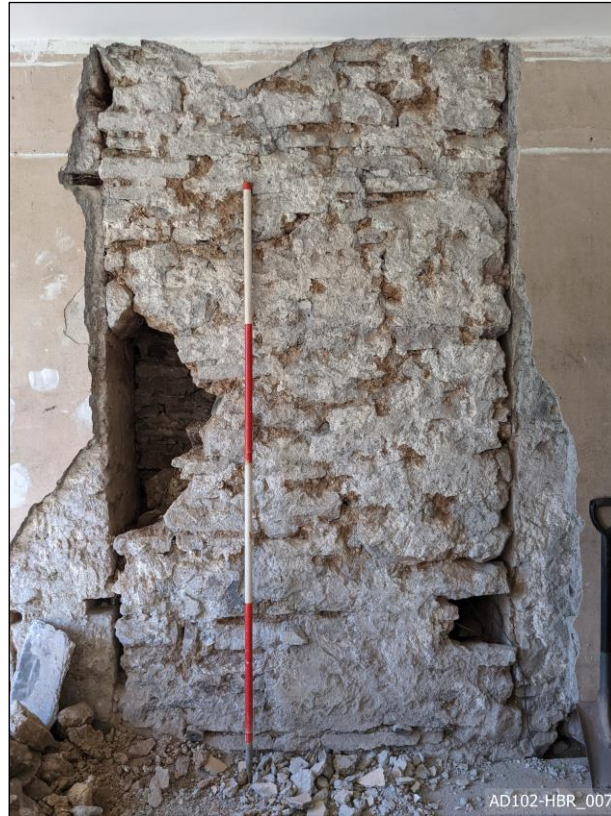
Plate 7 – View south-west, showing removal of plaster.

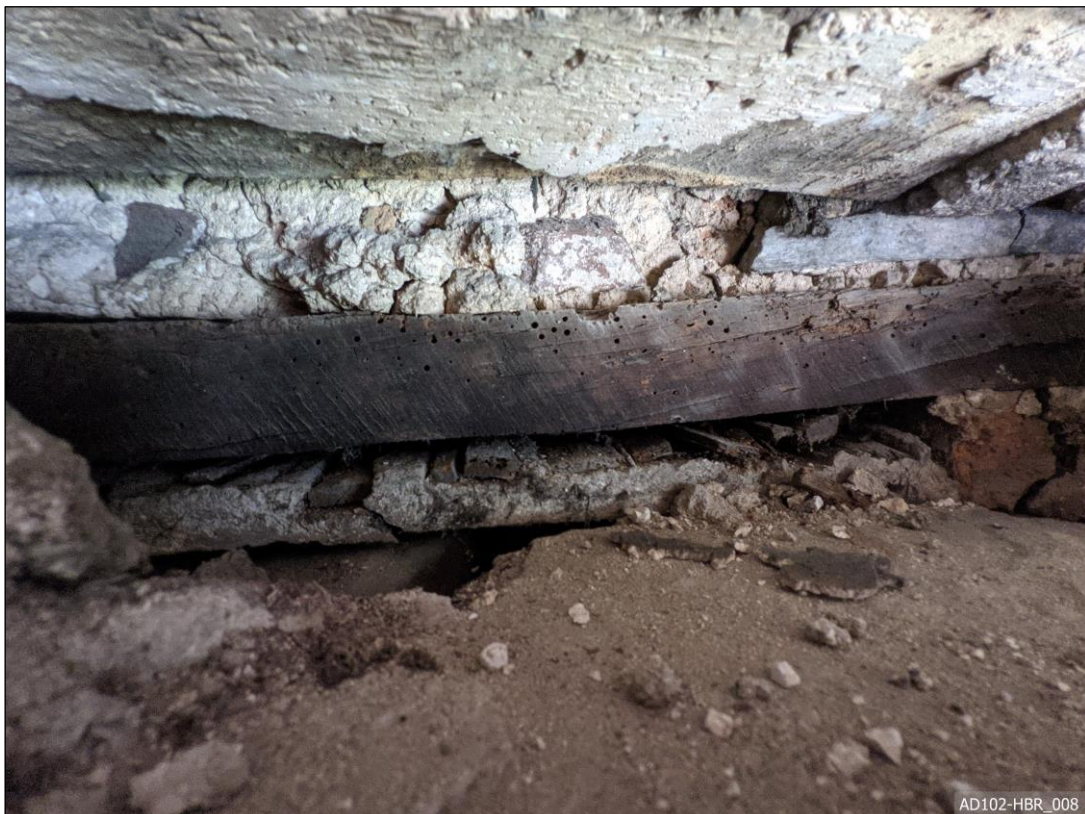
Plate 8 – Doorway A – View north-east, showing early-19th century lath-and-plaster of door passage head.

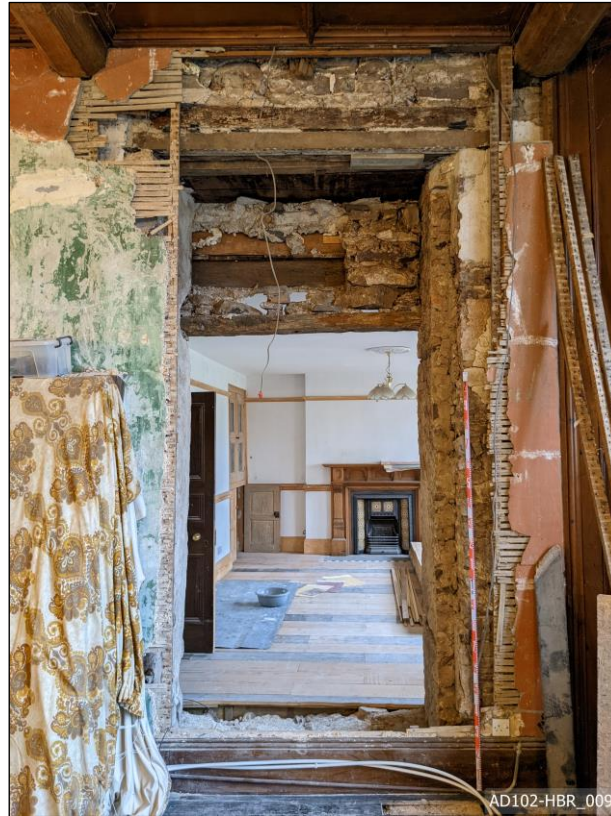
Plate 9 – Doorway A – View north-east, showing opened doorway.

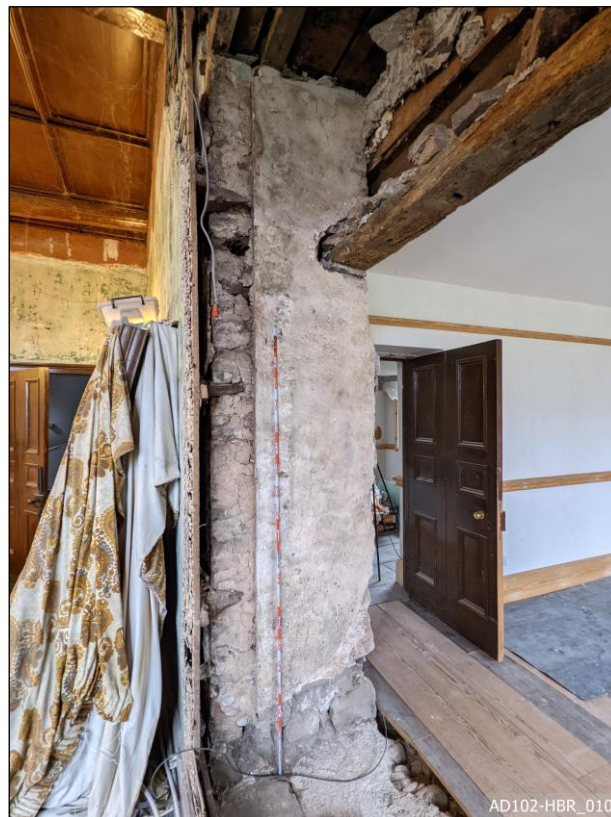
Plate 10 – Doorway A – View north, showing north reveal of doorway.

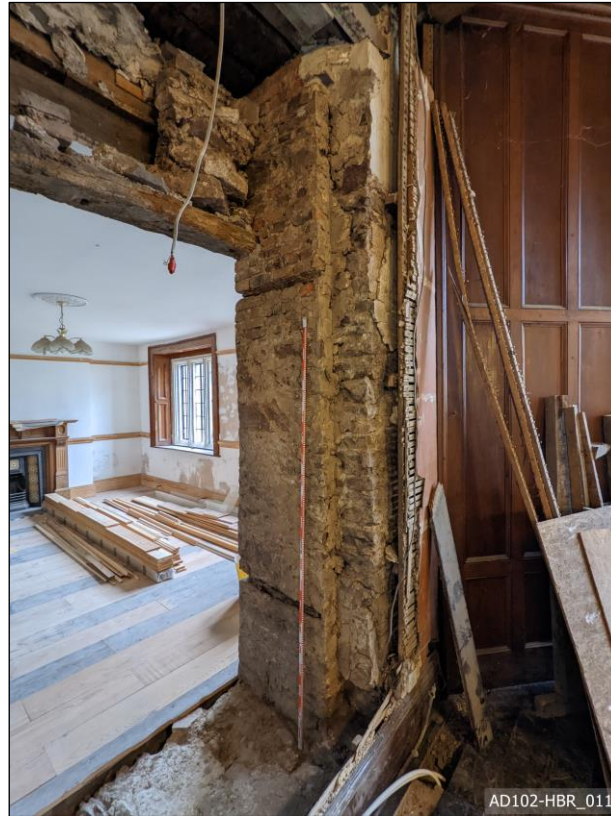
- 6.2.4 **Phase II – 1800-1850** – the doorway was narrowed with a skin of brickwork built up against the south reveal, this also supported a new lower lintel for a door head on the sitting room side.

Plate 11 – Doorway A – View south, showing south reveal of doorway with brick lining.

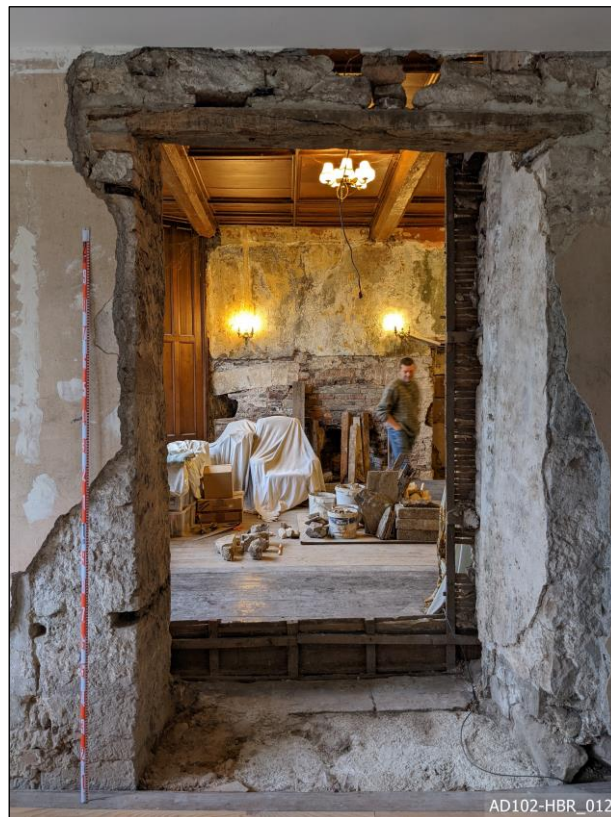
Plate 12 – Doorway A – View south-west, showing opened doorway with lower head.

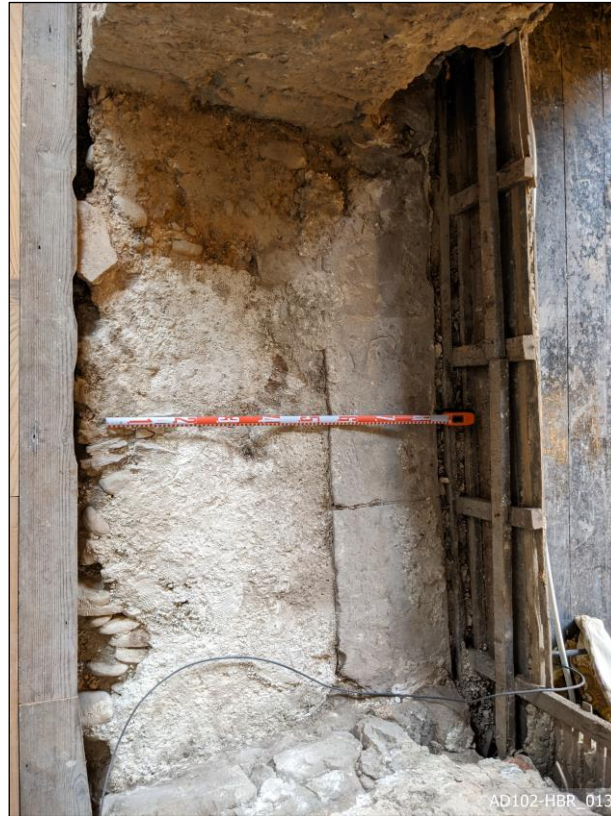
Plate 13 – Doorway A – Threshold of doorway.

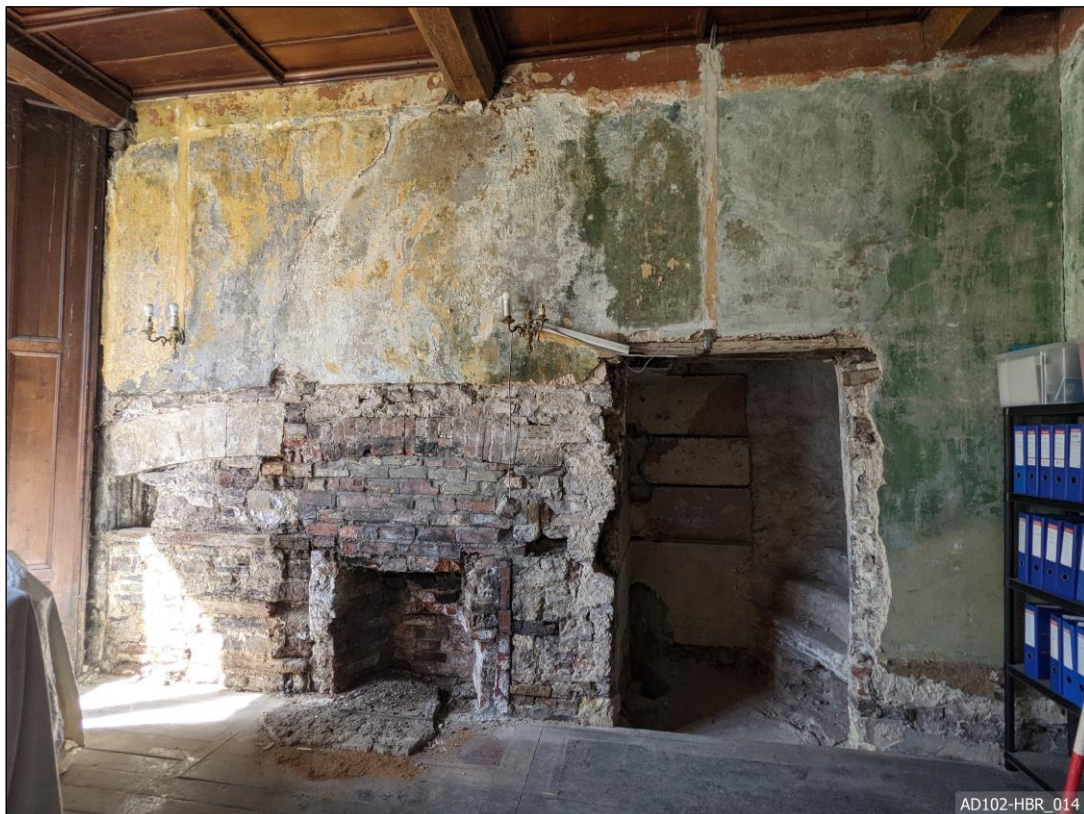
Plate 14 – Doorway B – View south-west, showing north-east elevation.

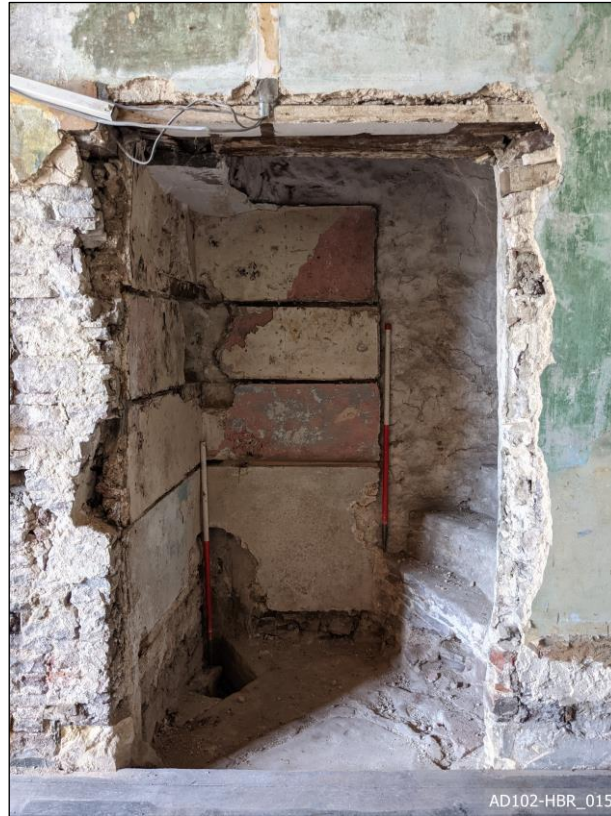
Plate 15 – Doorway B – View south-west, showing north-east elevation.

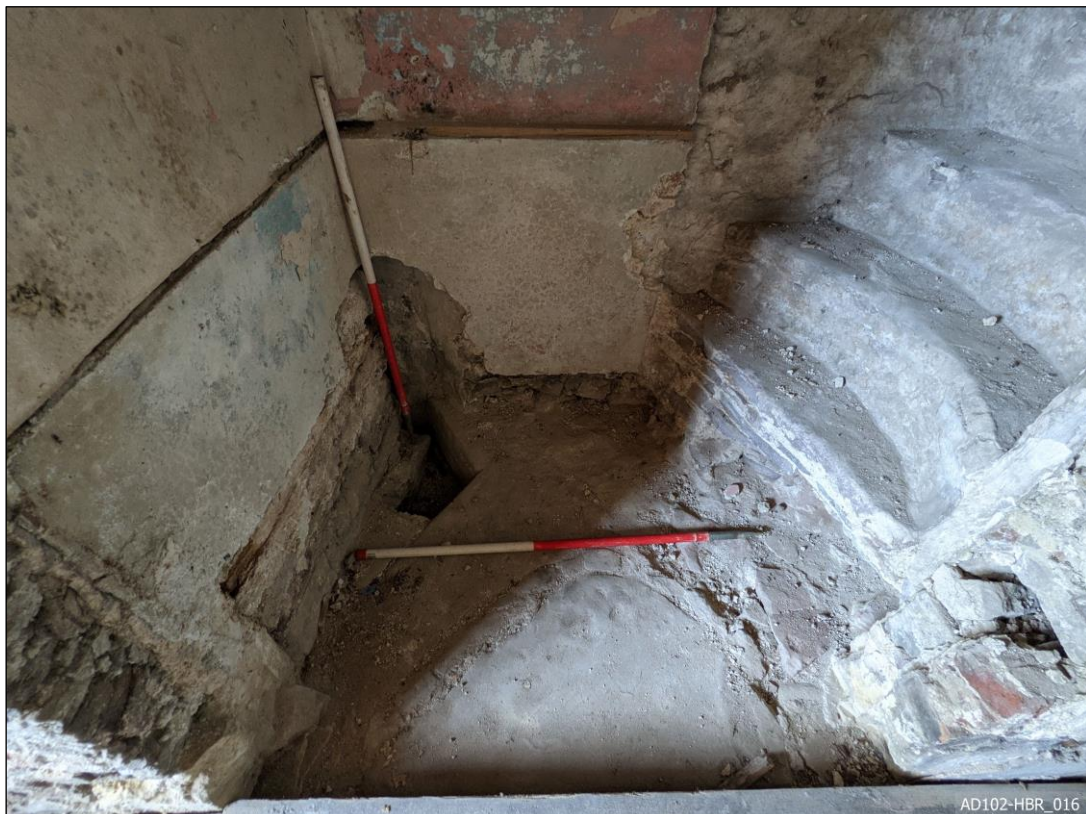
Plate 16 – Doorway B – View south-west, showing intermural steps and stair.

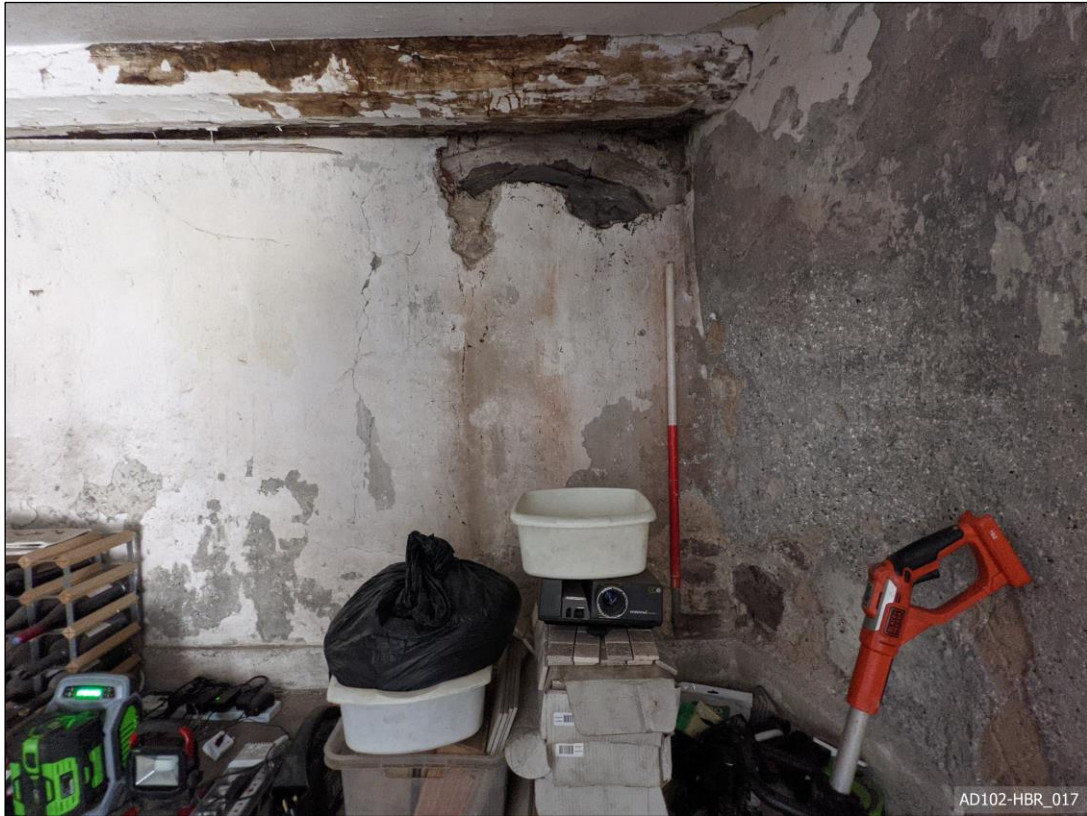
Plate 17 – Doorway B – View north-east, showing south-west elevation.

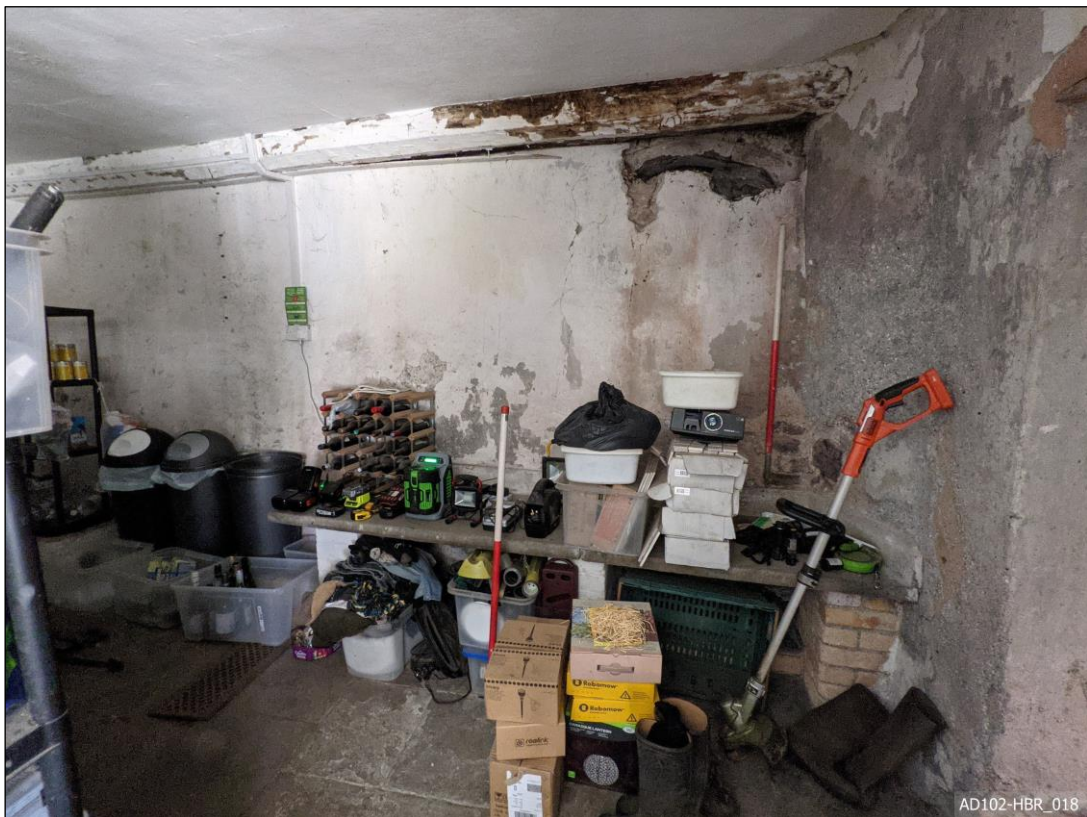
Plate 18 – Doorway B – View south-east, showing south-west elevation.

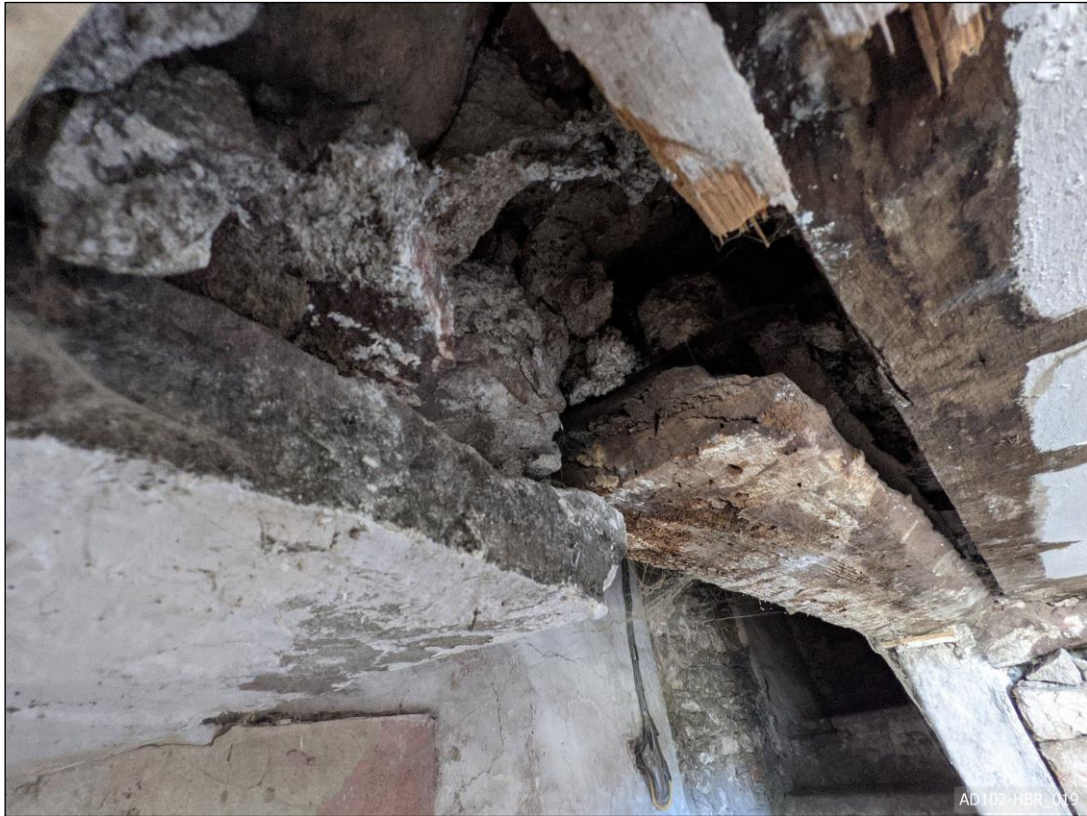
Plate 19 – Doorway B – View north, showing reused screen head as lintel in doorway from drawing room.

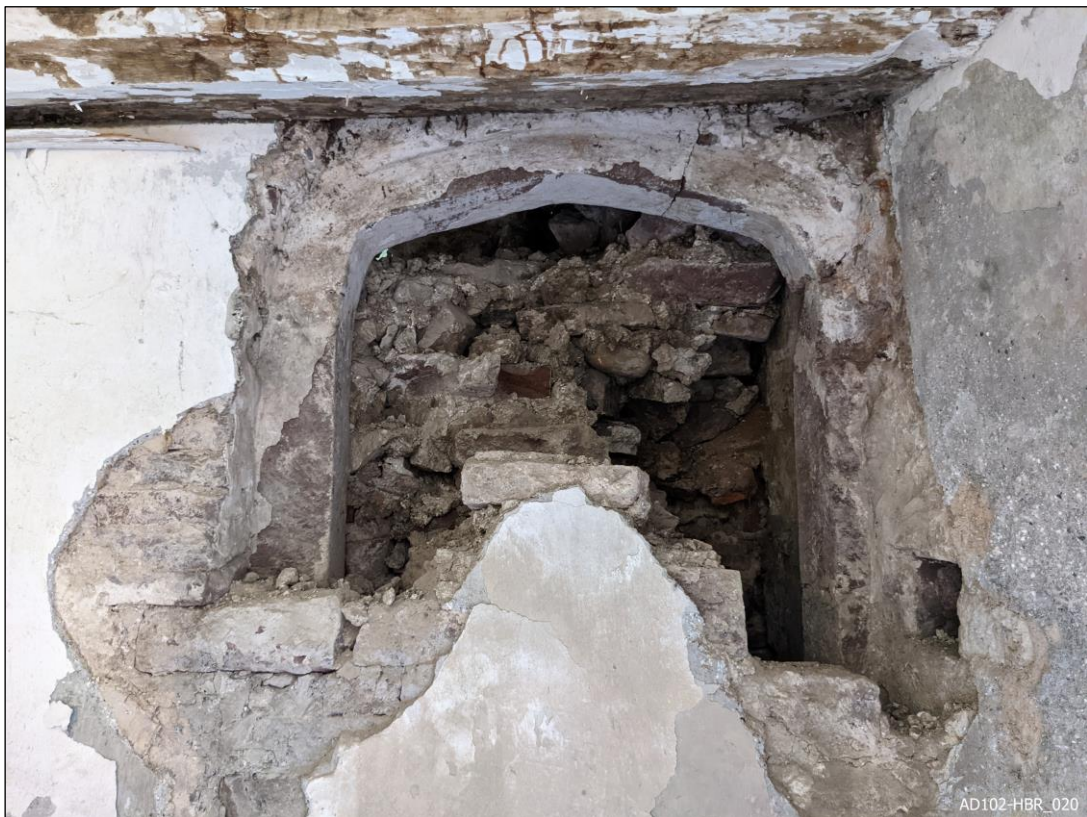
Plate 20 – Doorway B – View north-east, showing doorway unblocking.

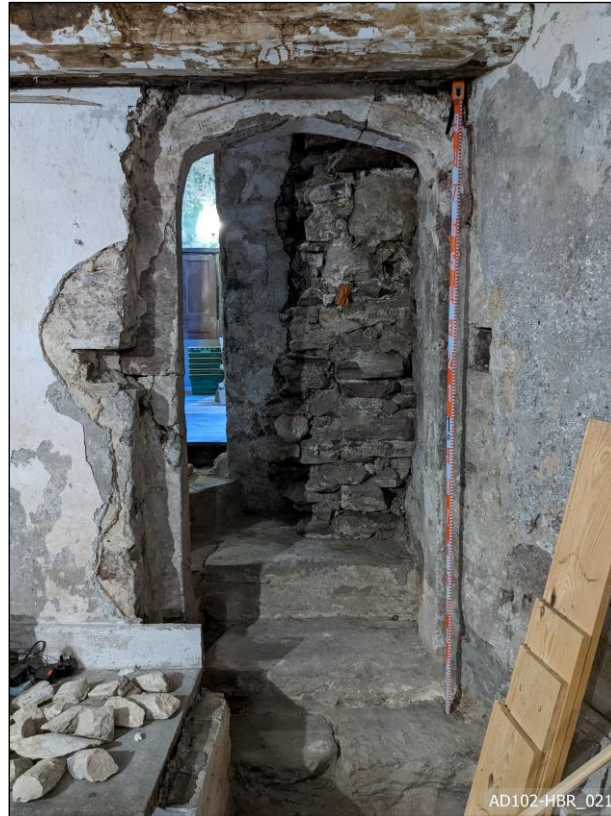
Plate 21 – Doorway B – View north-east, showing doorway reopened.

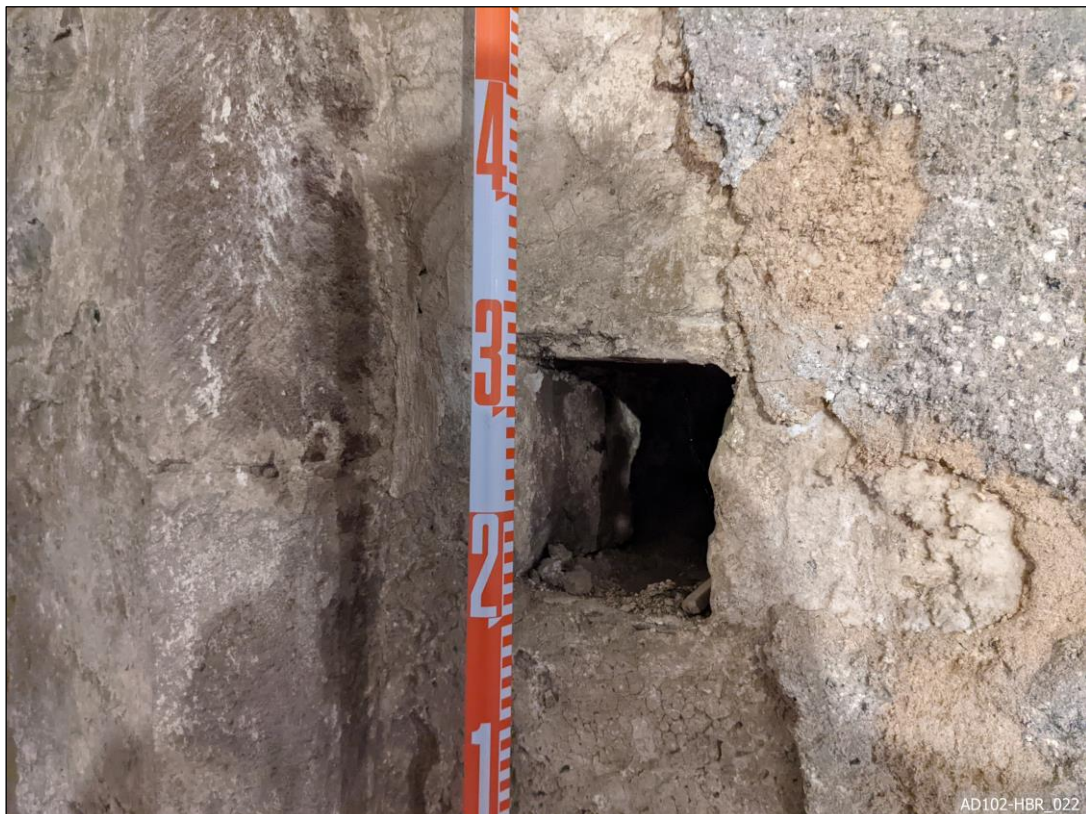
Plate 22 – Doorway B – View south, showing draw bar socket.

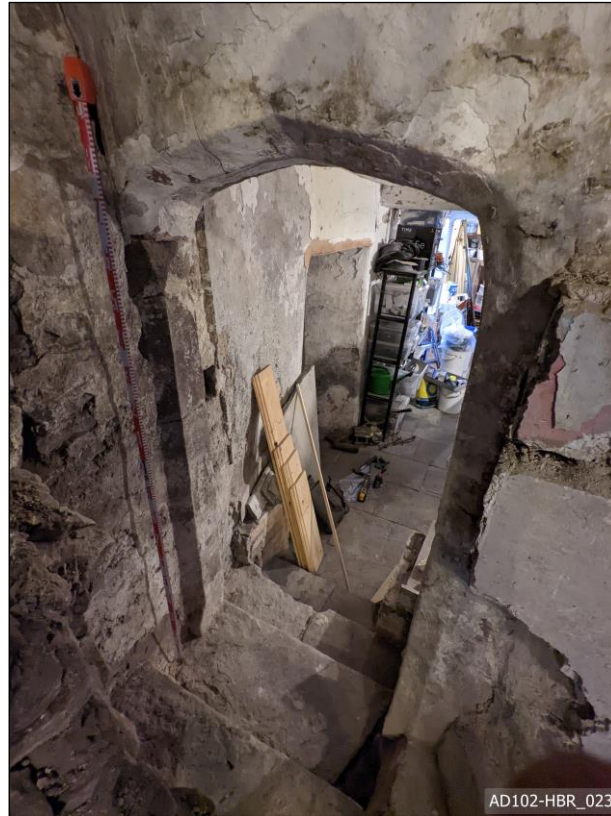
Plate 23 – Doorway B – View south-west, showing north-east elevation of unblocked doorway.

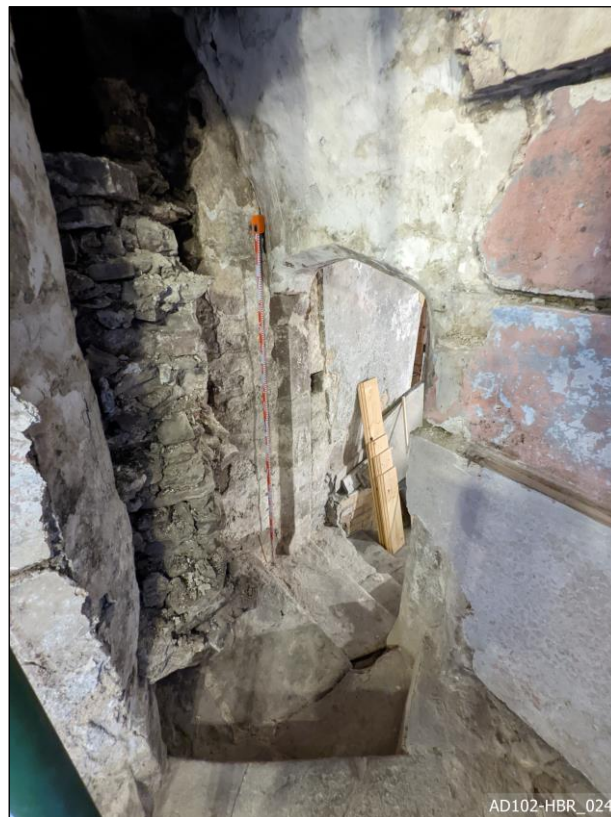
Plate 24 – Doorway B – View south, showing intermural stair passage.

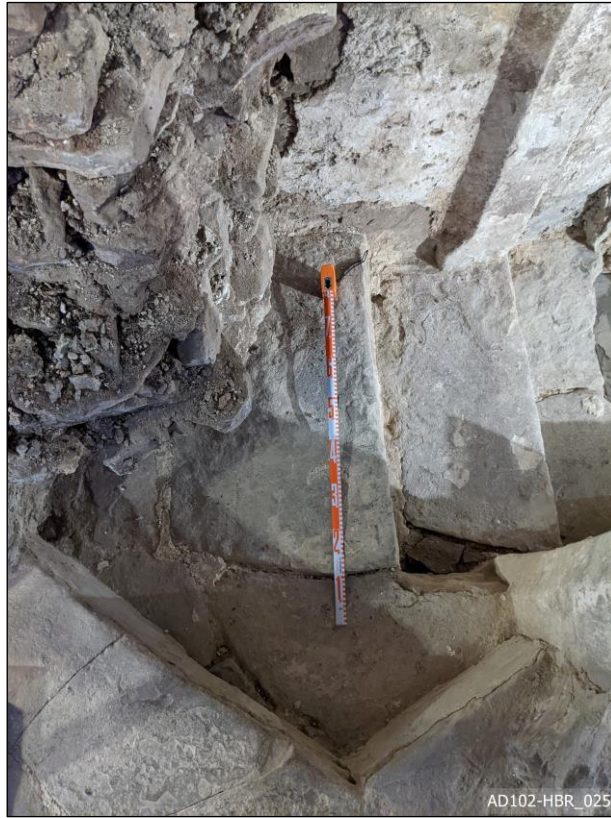
Plate 25 – Doorway B – View showing steps.

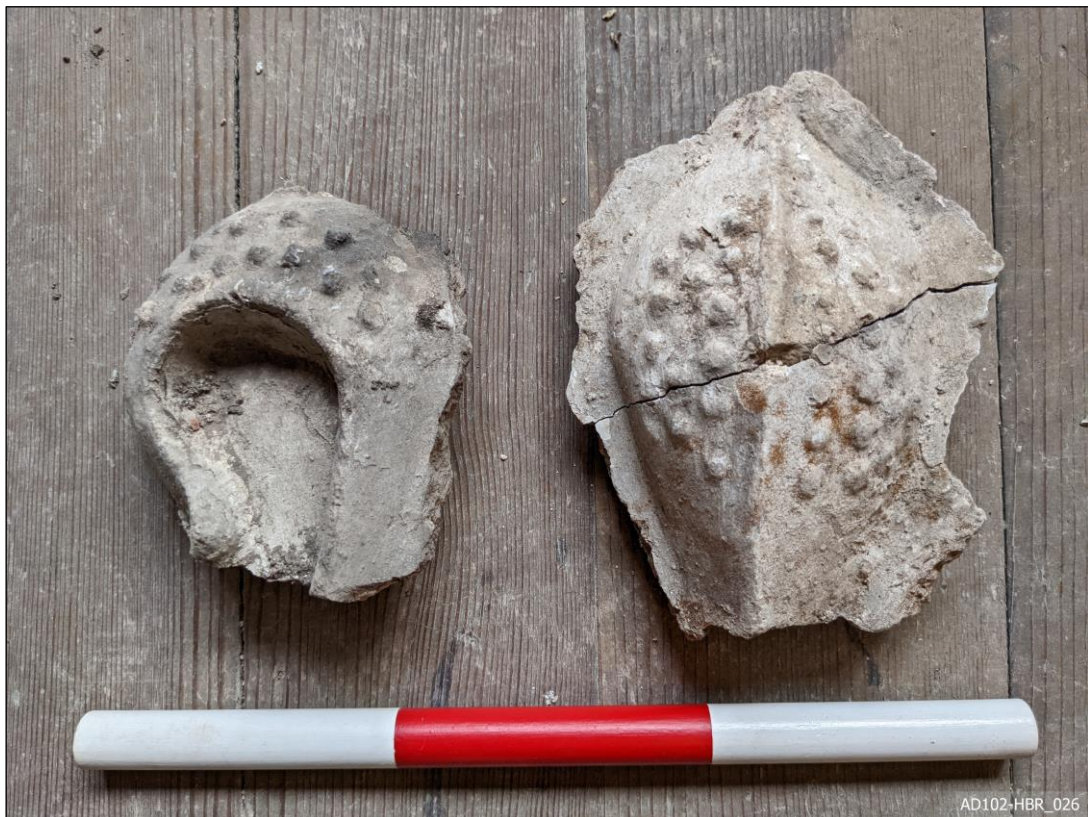
- 6.4 Small Finds (Plates 26-32)**
- 6.4.1 All finds were retained on site and will form a part of the client's own archive.
- 6.4.2 Plasterwork items relating to a geometric ceiling were recovered from doorway A, their profiles have been recorded (**Plates 26-27; Fig. 11 – a. and b.**). The scheme incorporated a studded fleur de lis (**Plate 26**).

Plate 26 – Doorway A – Recovered plasterwork fleur de lis.

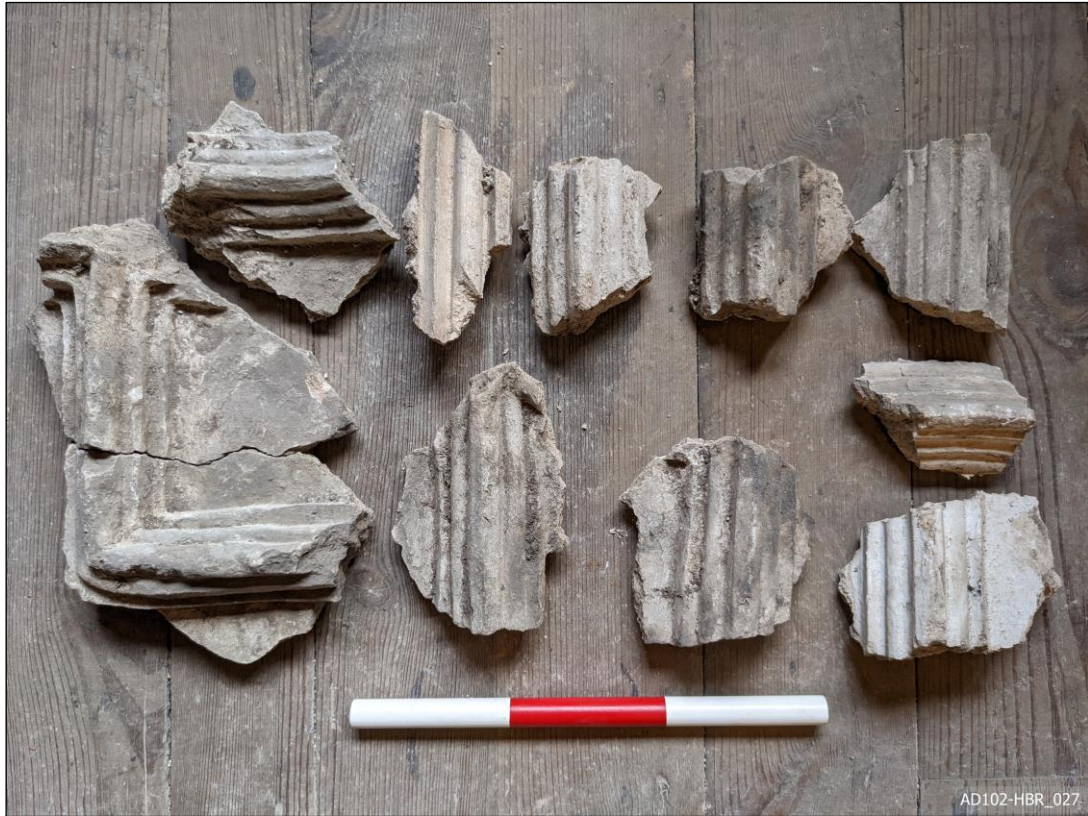
Plate 27– Doorway A – Recovered moulding from geometric ceiling.
