Doorway Unblocking at
Plas Machen,
Lower Machen, Newport

Level 2 Historic Buildings Record

Date: December 2022

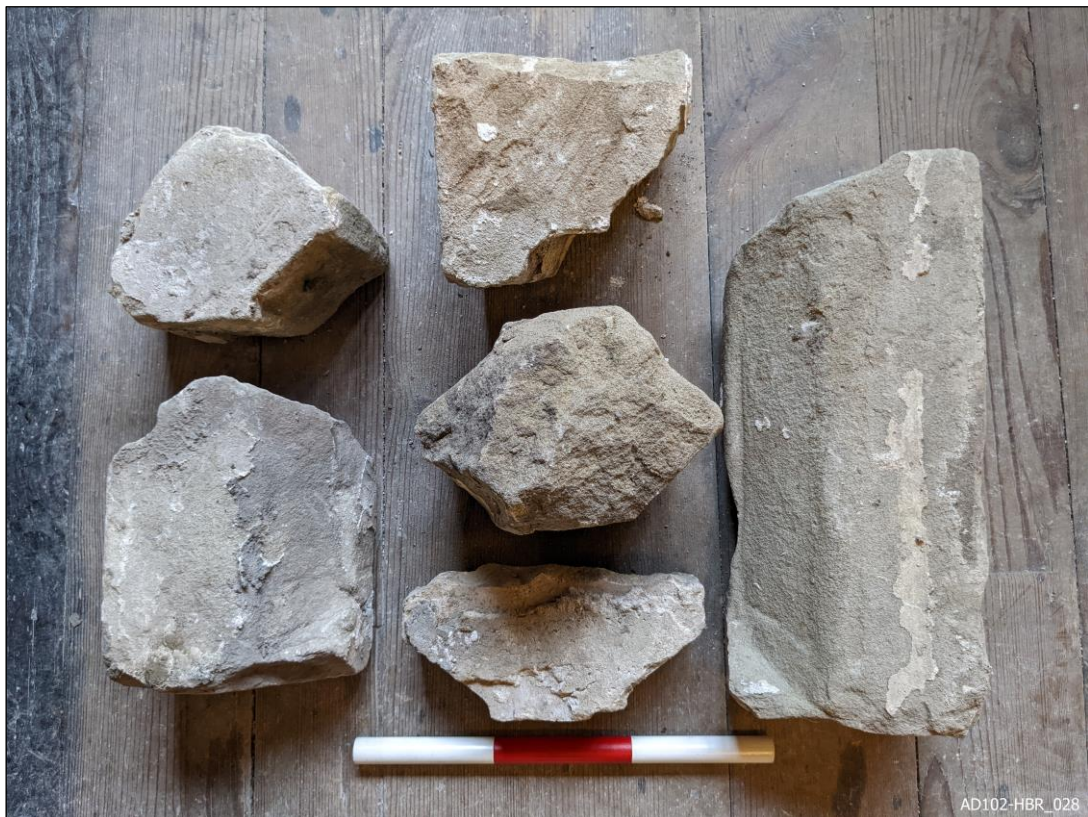
- 6.4.3 Dressed and moulded window mullions and jambs were recovered from doorways A and B, the mullion profiles have been recorded (**Plates 28-32; Fig. 11 – a. and b.**). These represent two different moulding types: sunk chamfer and hollow chamfer with bead. Each type have glazing rebates.

Plate 28 – Doorway A – Recovered window mullions and jambs.

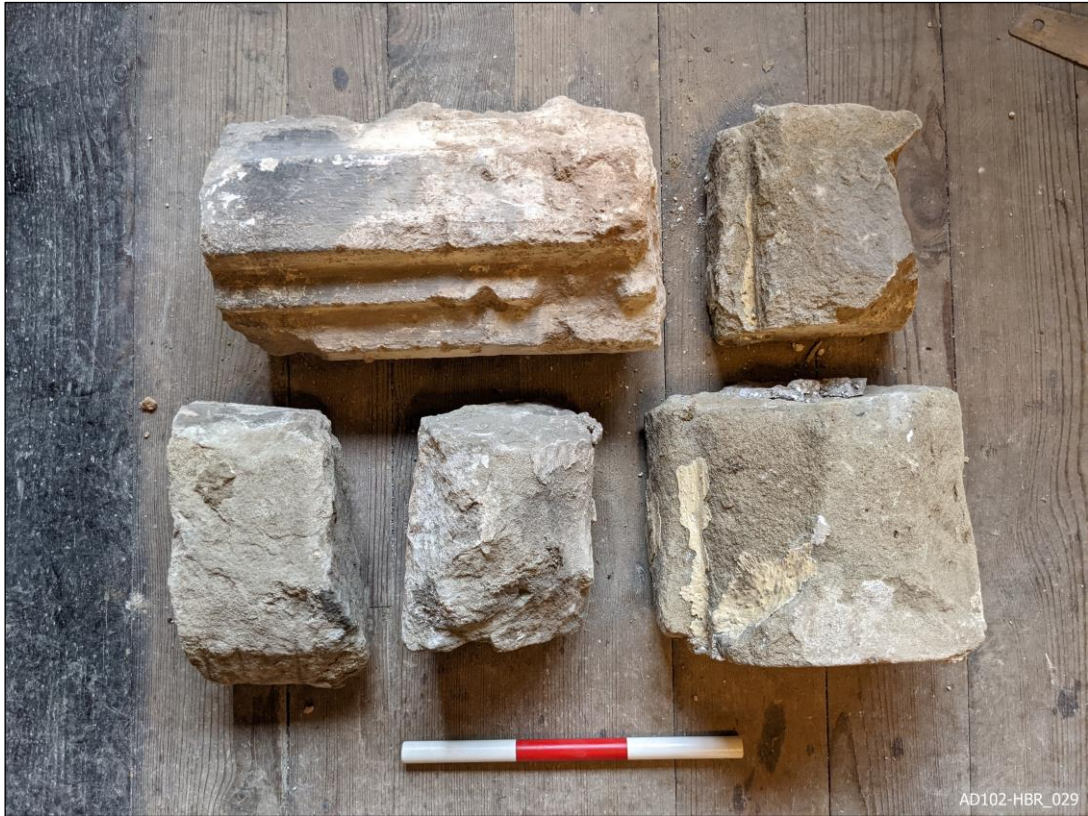
Plate 29 – Doorway A – Recovered window mullions and jambs.

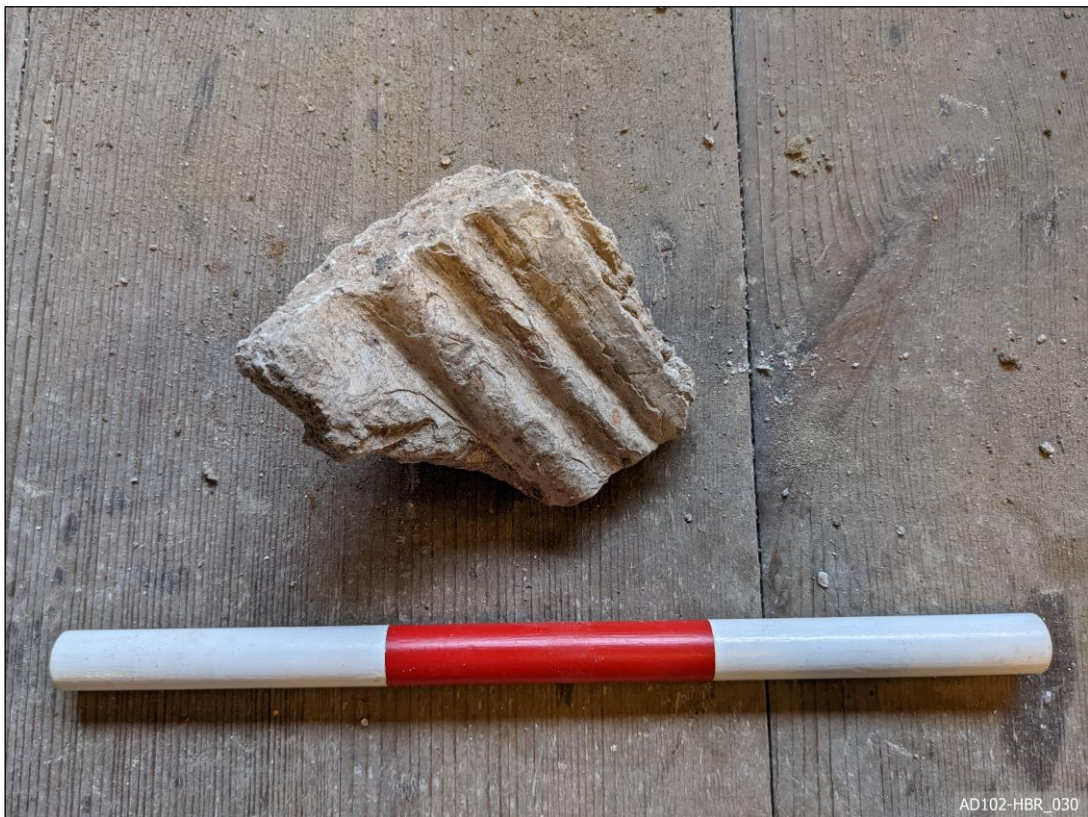
Plate 30 – Doorway B – Recovered architectural moulding from window or hearth.

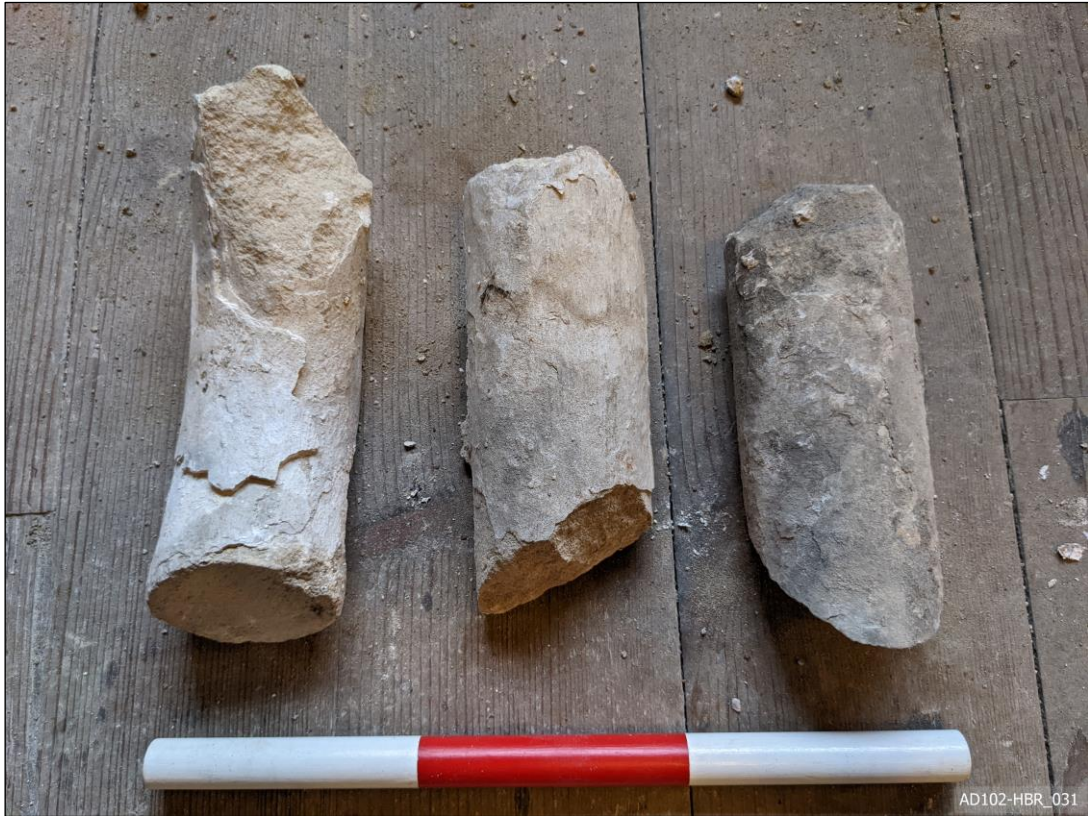
Plate 31 – Doorway B – Recovered roll moulding, possibly from window.

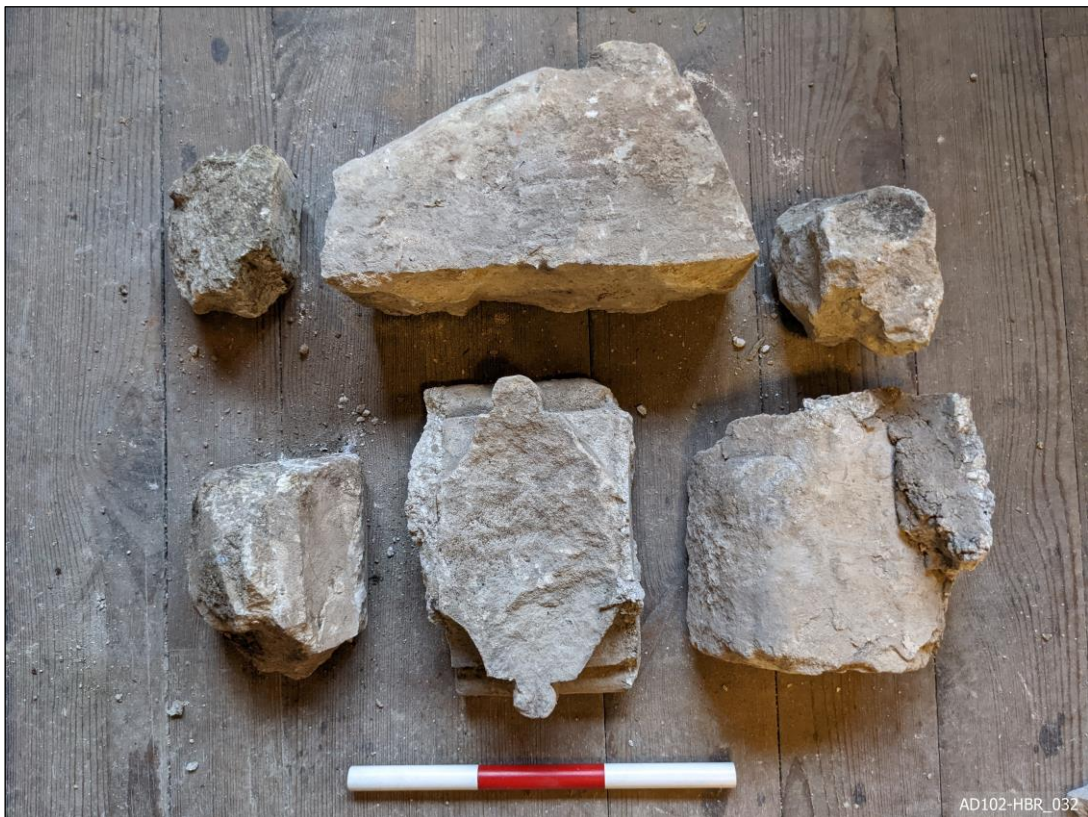
Plate 32 – Doorway A – Recovered window mullions and jambs.
