# Gelli Cefn y Rhos, Cwmdu, Carmarthenshire

## Level 3 Historic Buildings Record

Project #: AD100

Date: May 2021

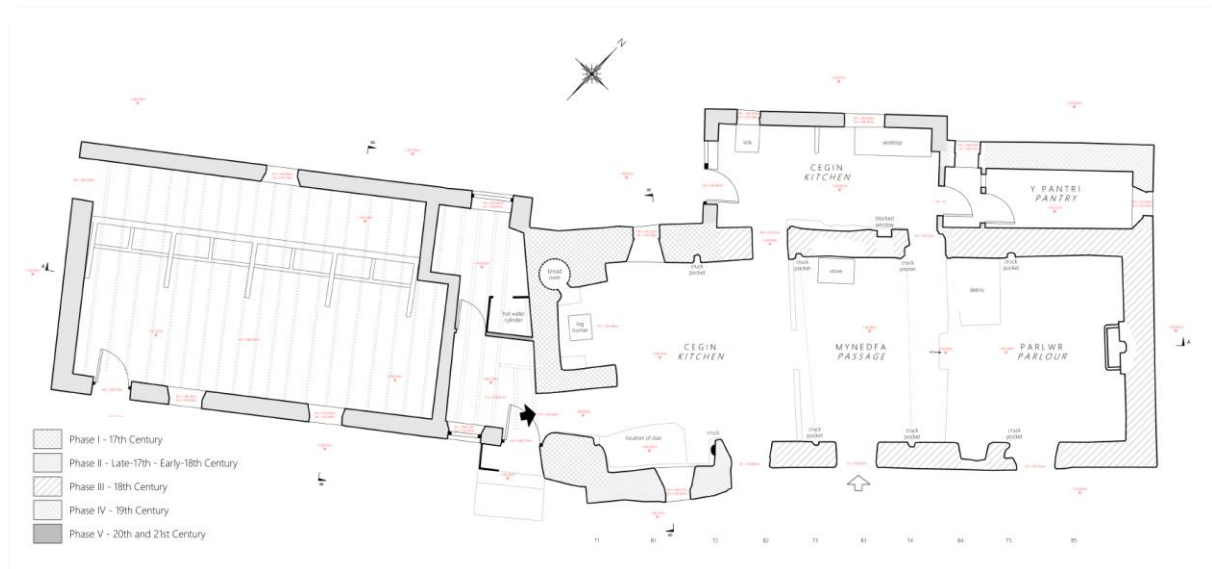
*Fig. 6 – Phased ground floor plan.*

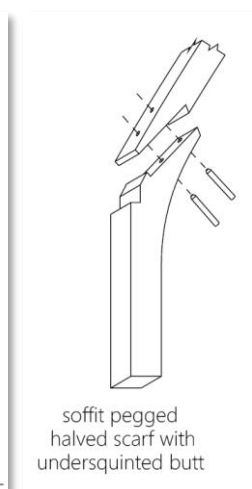
*Fig. 8 – Scarf joint detail.*

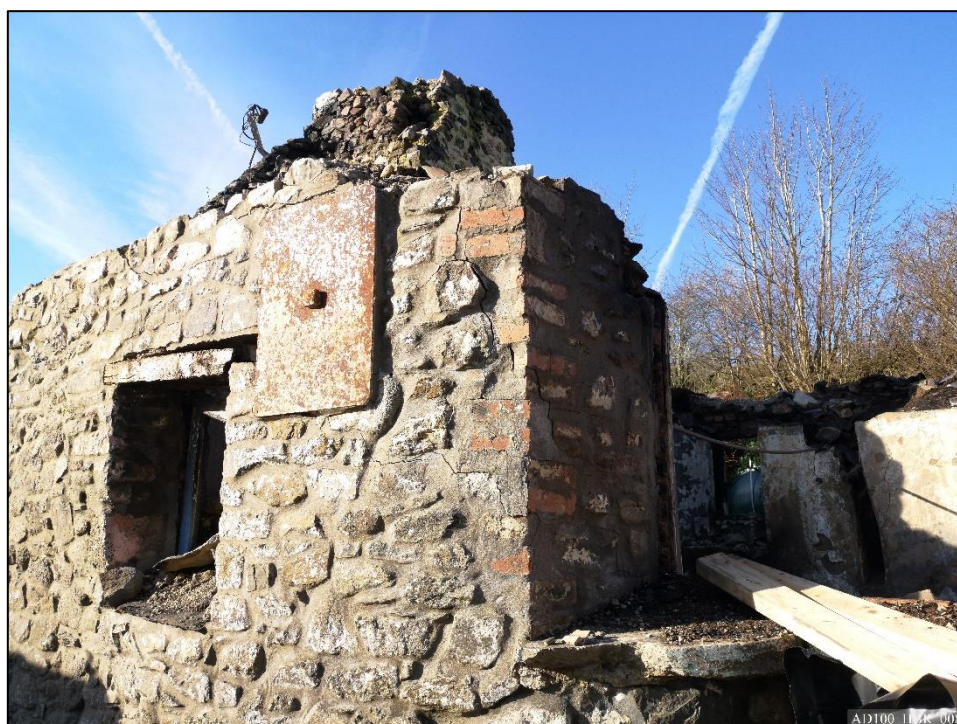
Plate 8 – East elevation, showing rebuild window reveal in red brick.

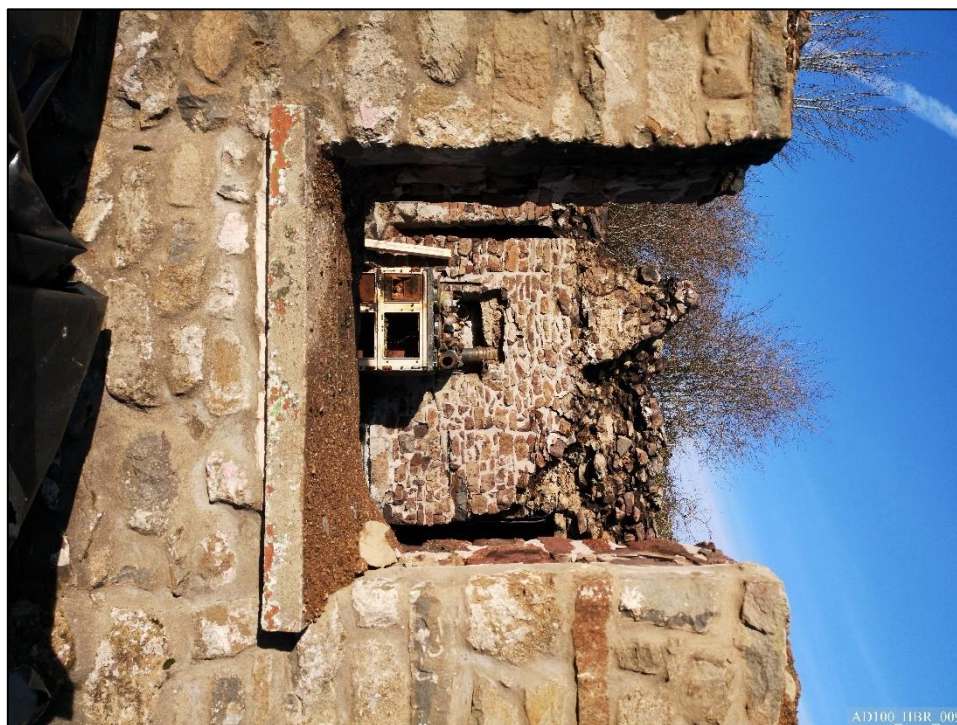
Plate 9 East elevation, showing window formed from 18<sup>th</sup> century doorway.

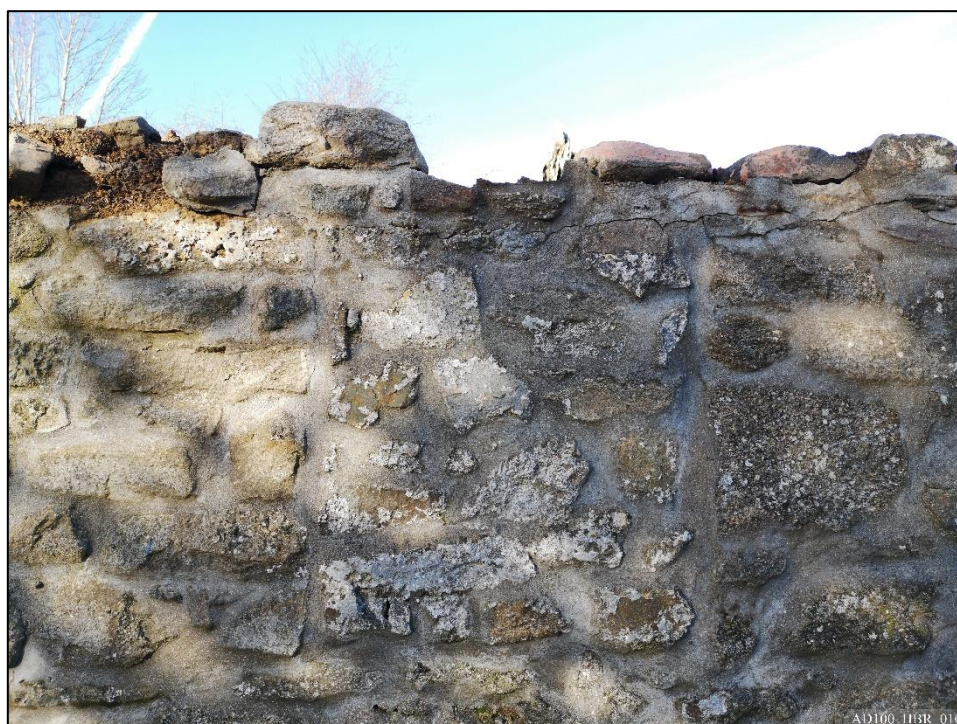
Plate 10 – East elevation, showing blocked window.

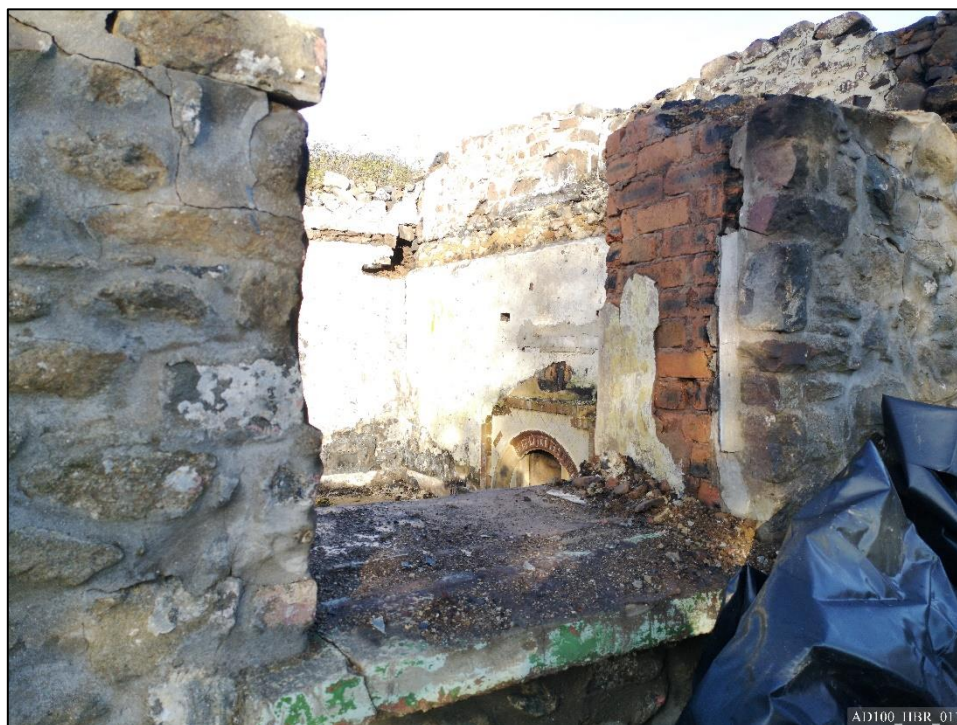
Plate 11 – East elevation showing enlarged window to parlour.

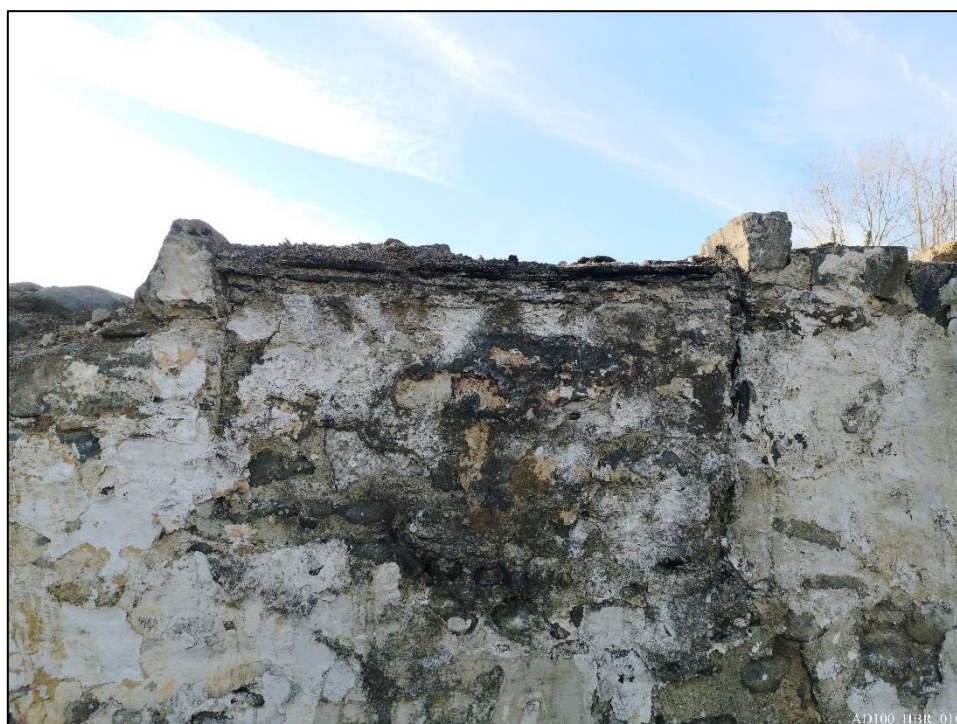
Plate 16 – North elevation, showing joints in masonry from first floor doorway.

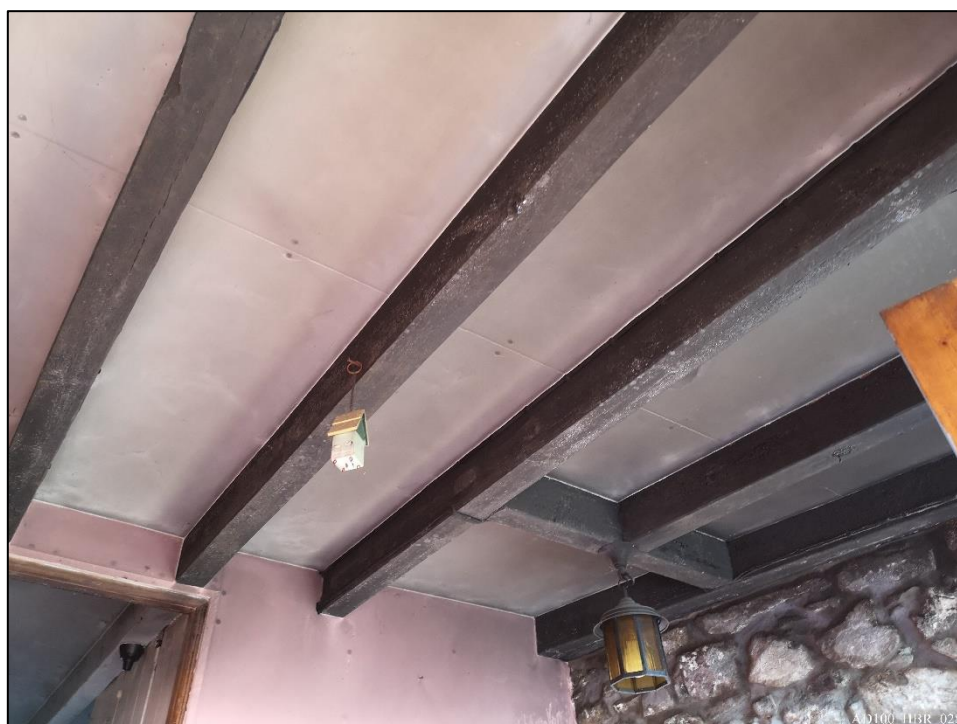
Plate 28 – Lobby, showing ceiling with trimmer for a former stair.

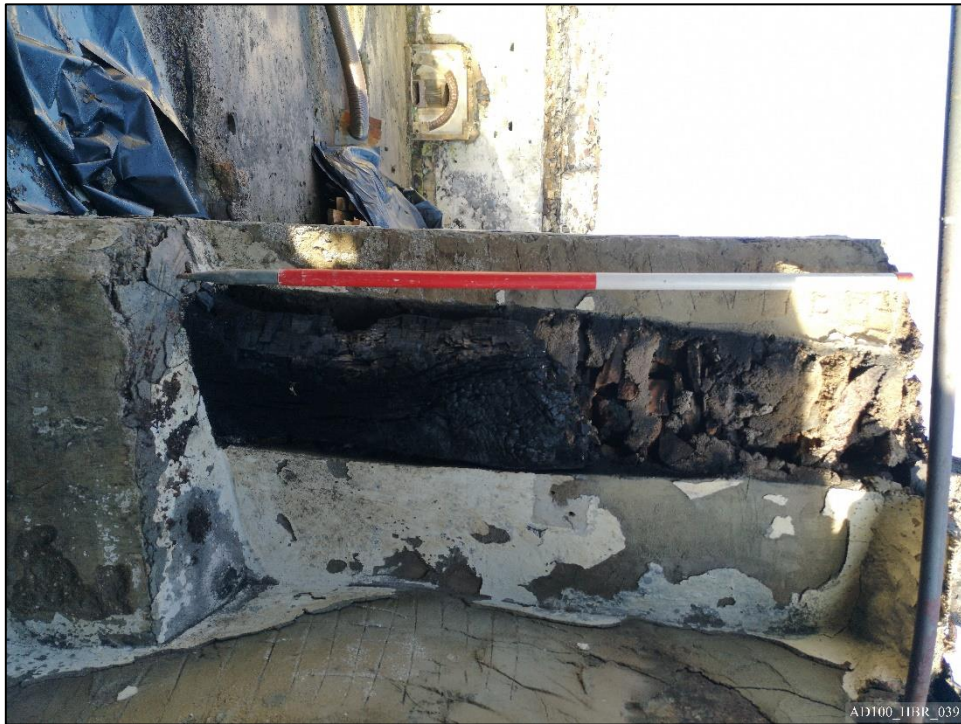
Plate 39 – Remains of cruck T2 to east lateral wall.

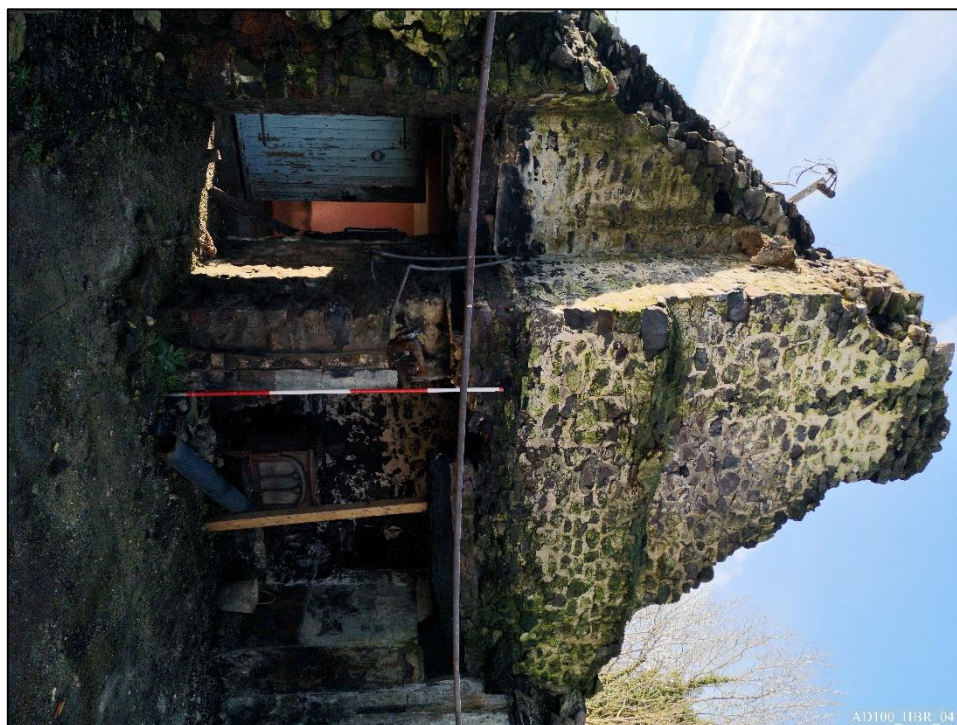
- 7.4.2 Even with fire damage, the form of the building, with its large chimney (**Plates 41 & 44**) and low eaves, stands as a good example of a Carmarthenshire vernacular farmhouse with origins in the 17<sup>th</sup> century. At this time, the entrance was made through the south gable of the house, alongside the large fireplace and where it is today. It may have been the case that this entrance was originally accessed via a byre, in the classic longhouse form. However, evidence for a byre at this phase has not been observed and was probably a later addition to the farmhouse.

Plate 41 – Chimney and fireplace.

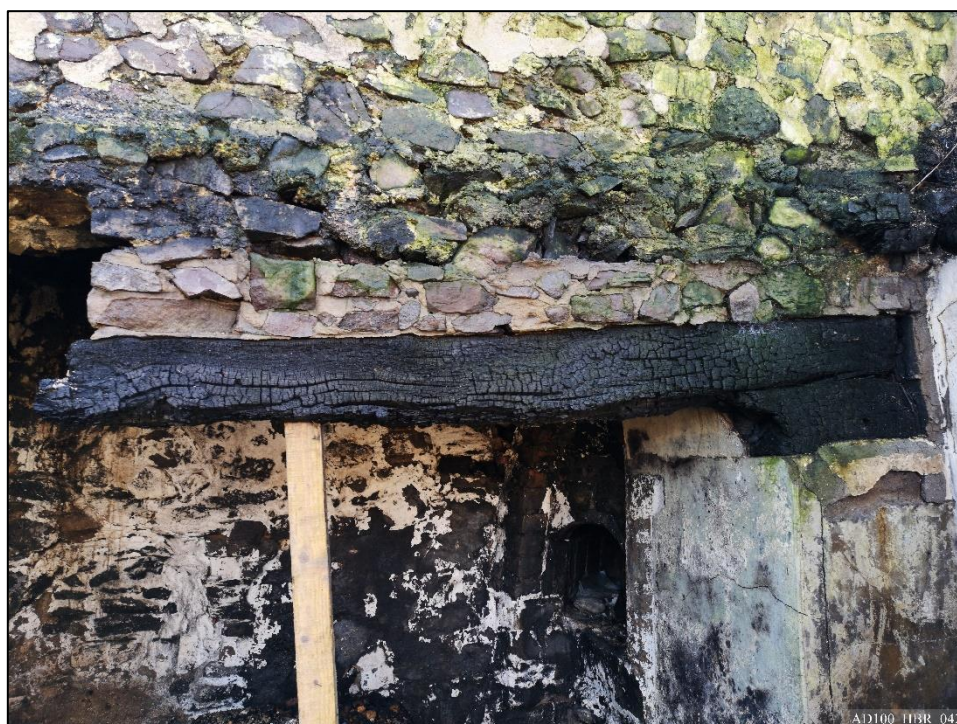
Plate 42 – View south, showing remains of fireplace bressummer and transverse beam over.

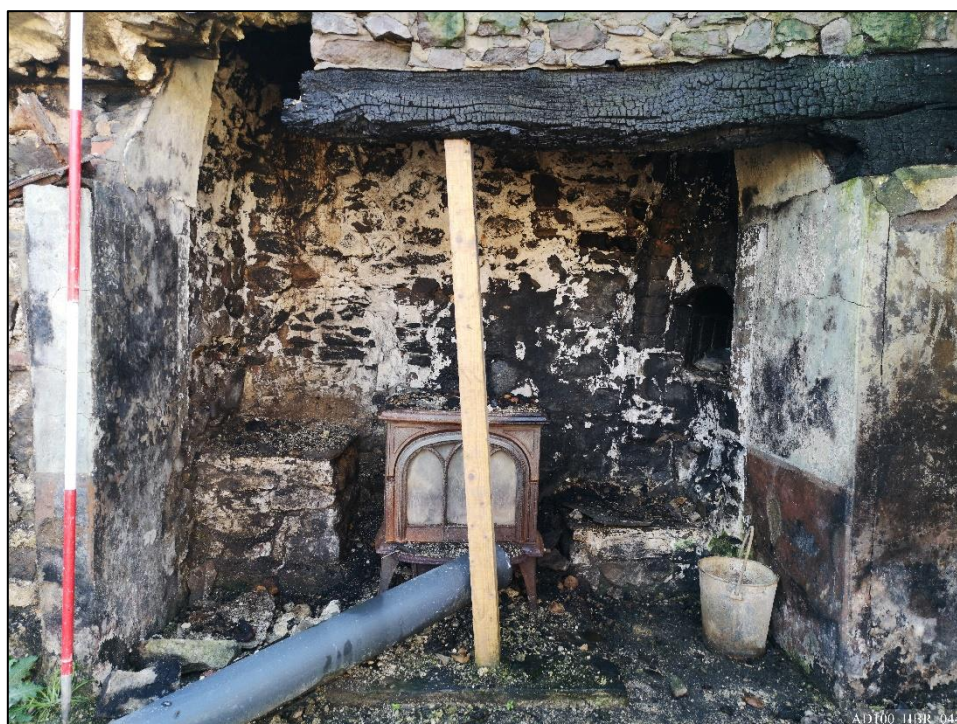
Plate 44 – View south, showing fireplace.

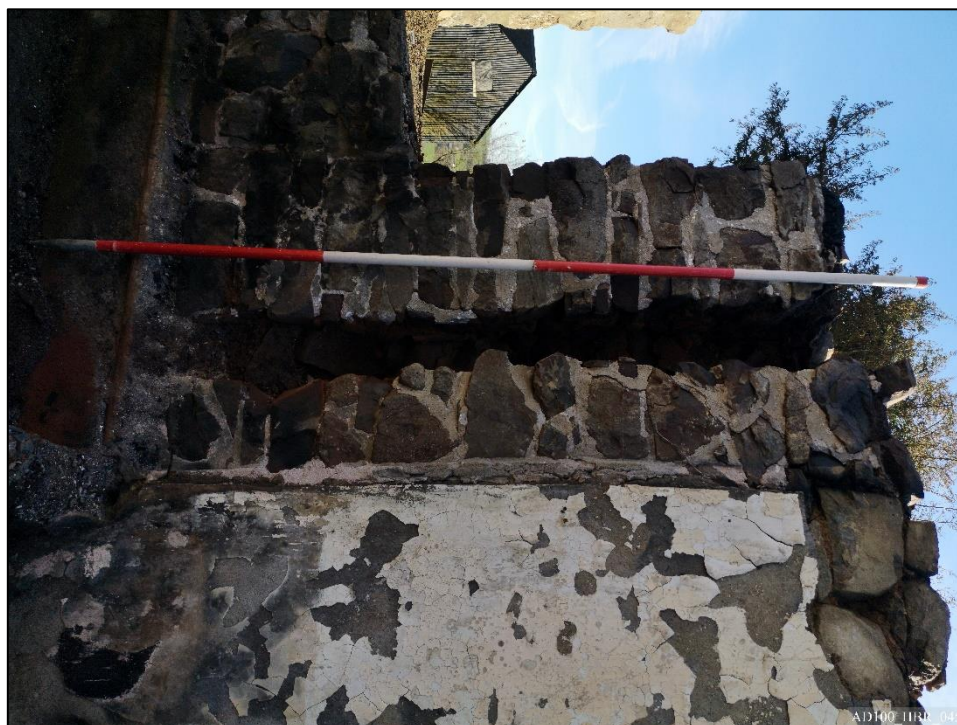
Plate 45 – Cruck pocket for T3 to east lateral wall.

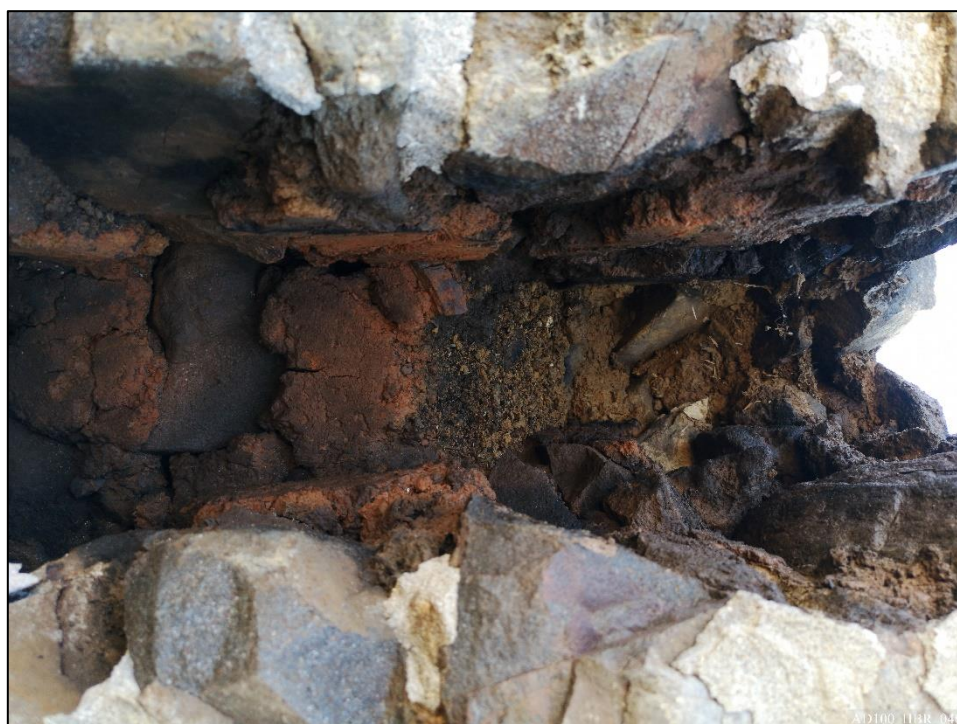
Plate 46 – View inside of cruck pocket T3, showing clay-earth mortar.

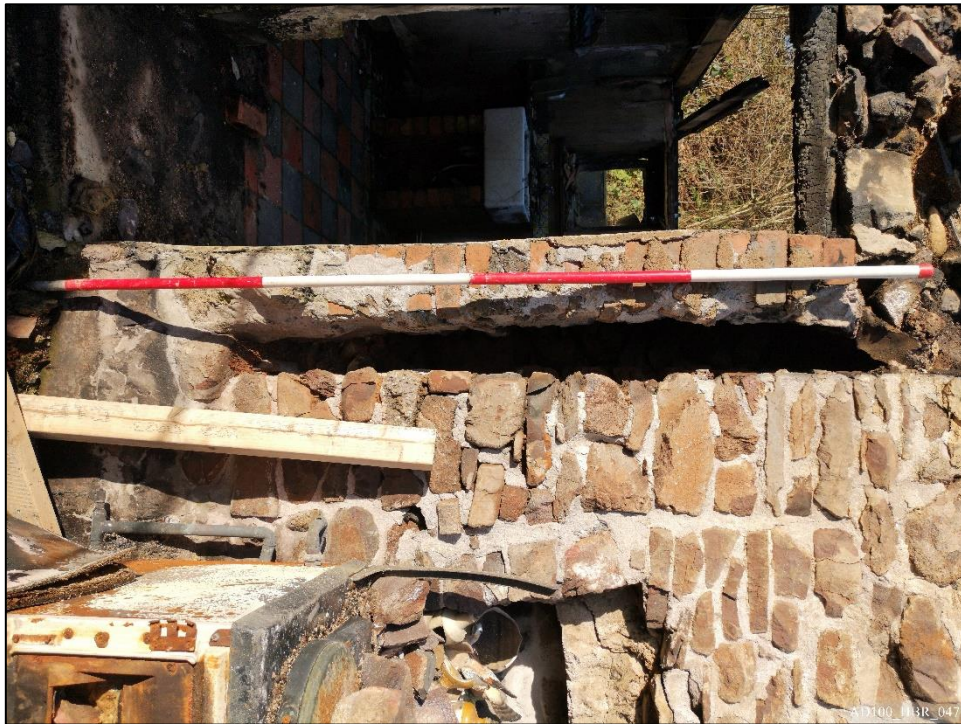
Plate 47 – Cruck pocket for T3 to west lateral wall.

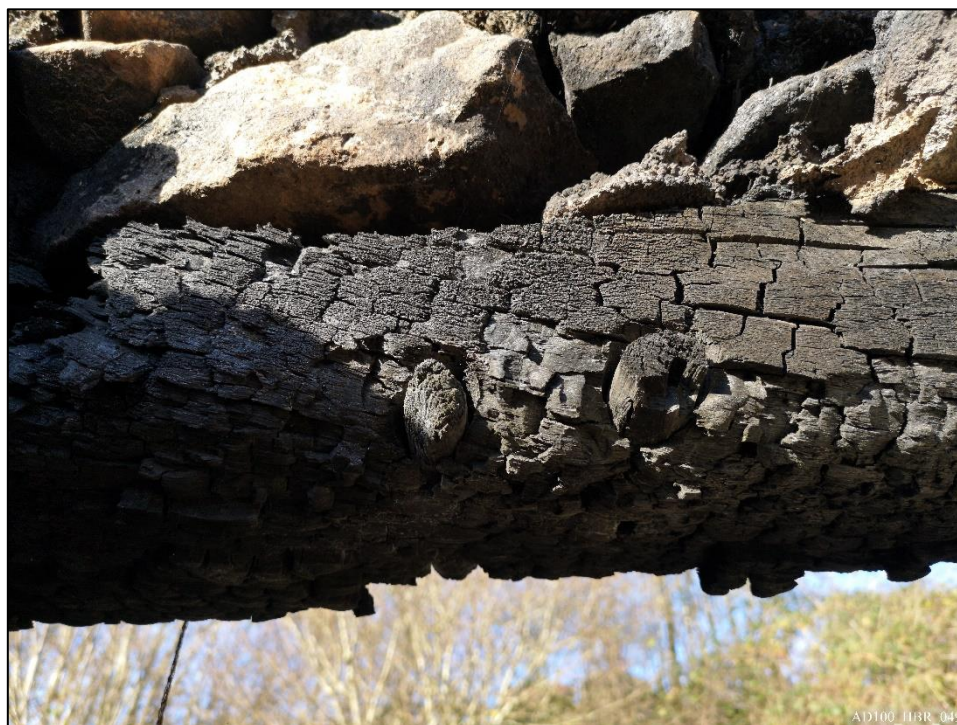
Plate 49 – Reused timber lintel, showing pegs in situ.

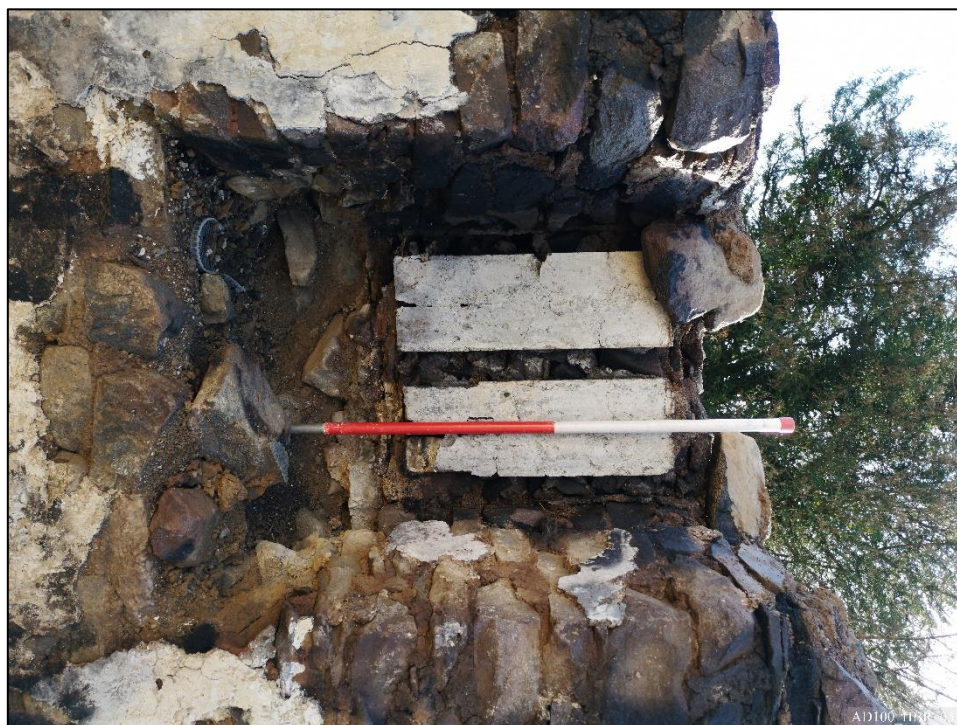
Plate 55 – View east, showing blocked window.

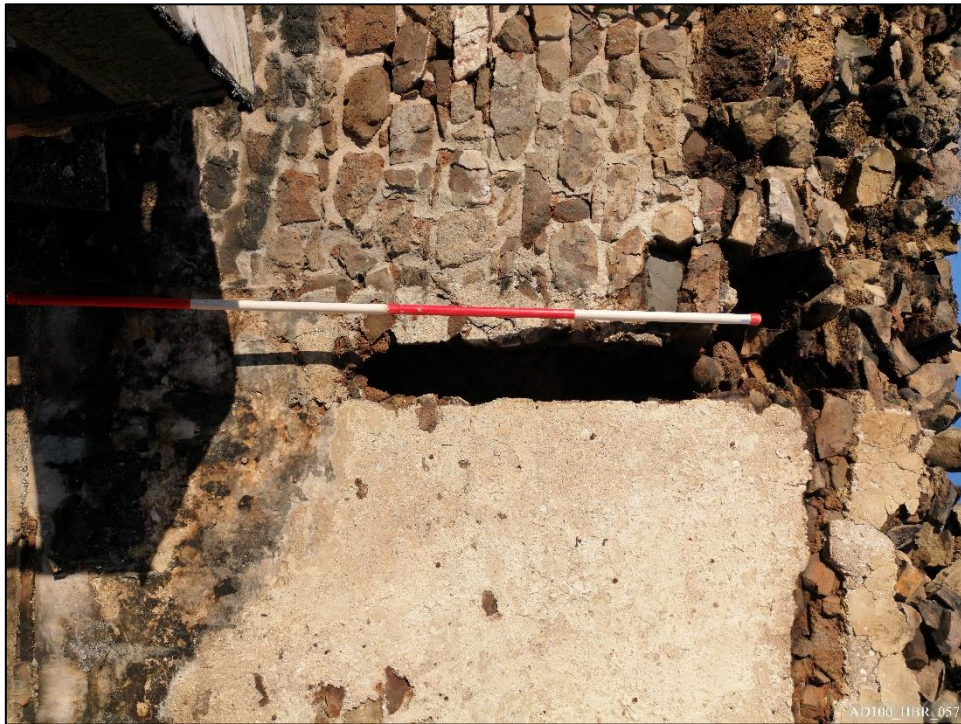
- 7.5.5 The transverse beams were not framed with the crucks, but instead they sat in pockets in the masonry to the front of each frame (**Plate 57**), a common configuration with scarfed cruck buildings in the region. Further indication that these were integral with Phase II are two vertical lines in the masonry of the north elevation, which indicate where a doorway once provided access to the first floor (**Platess 16 & 59**). It is not clear what this provided access to or for what it was used.

Plate 57 - Cruck pocket for T5 to west lateral wall.

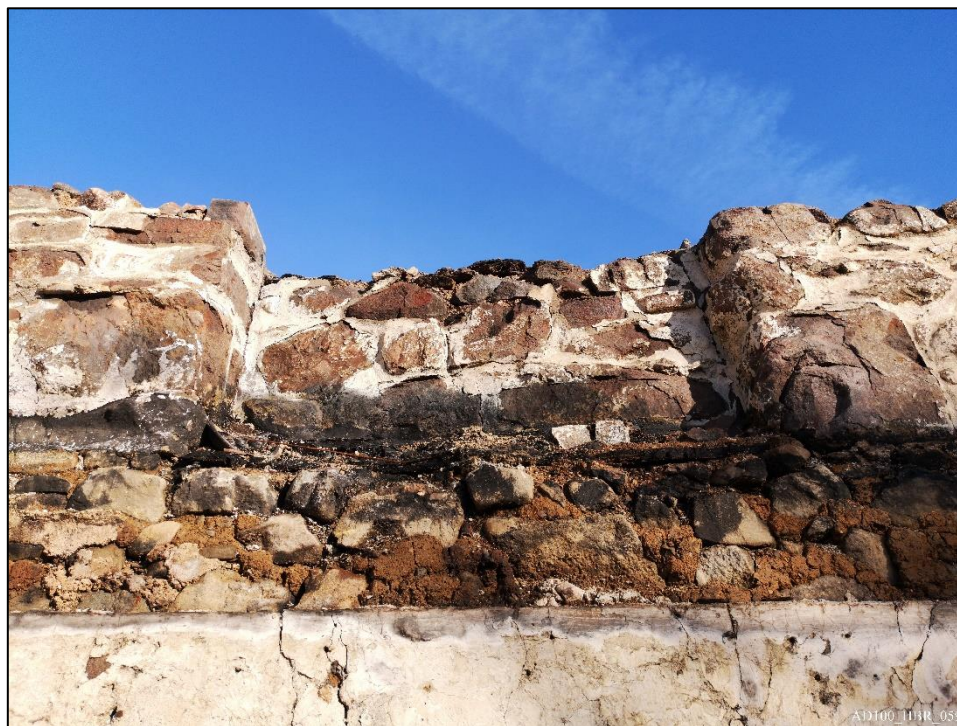
Plate 59 – View north, showing blocked doorway to first floor and first floor level.

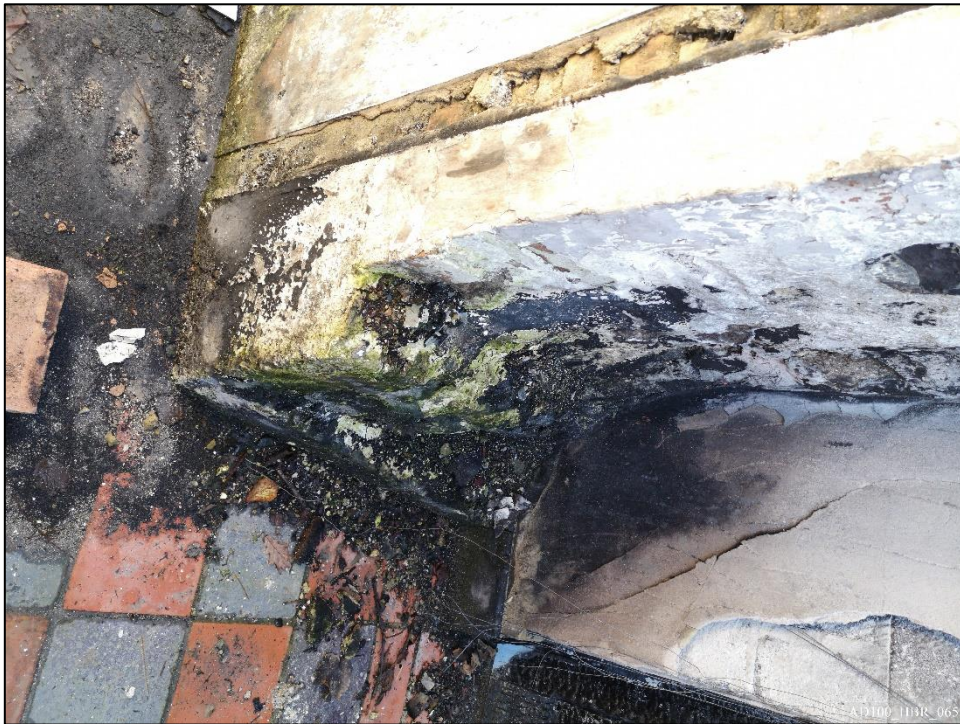
Plate 65 – Detail showing plinth to west lateral wall, demonstrating original thickness of Phase I.

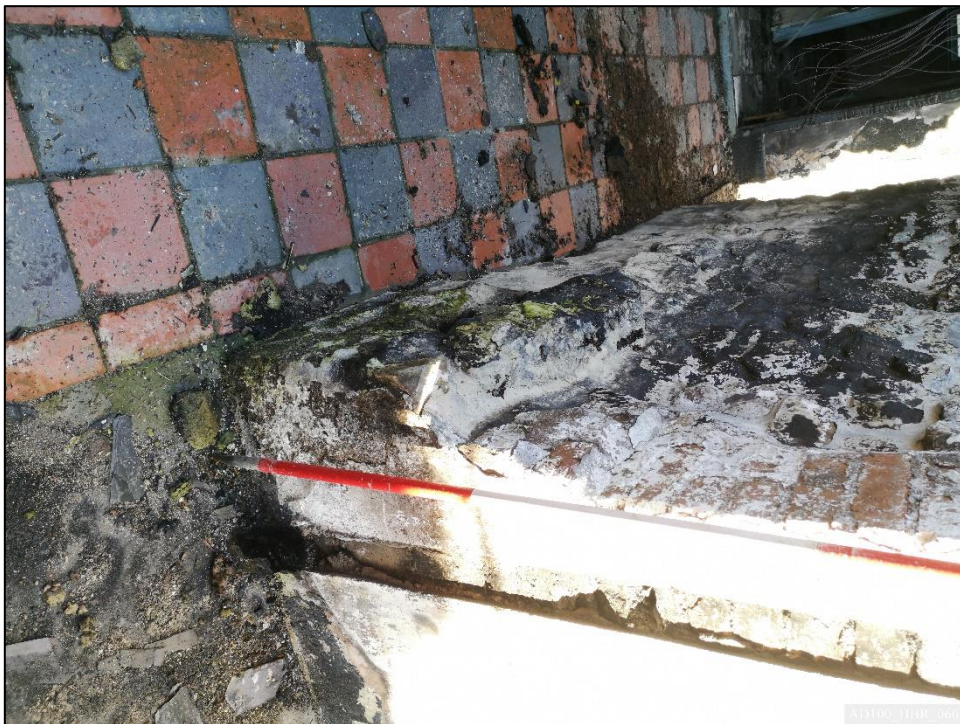
Plate 66 – Detail showing plinth to west lateral wall, demonstrating original thickness of Phase I.

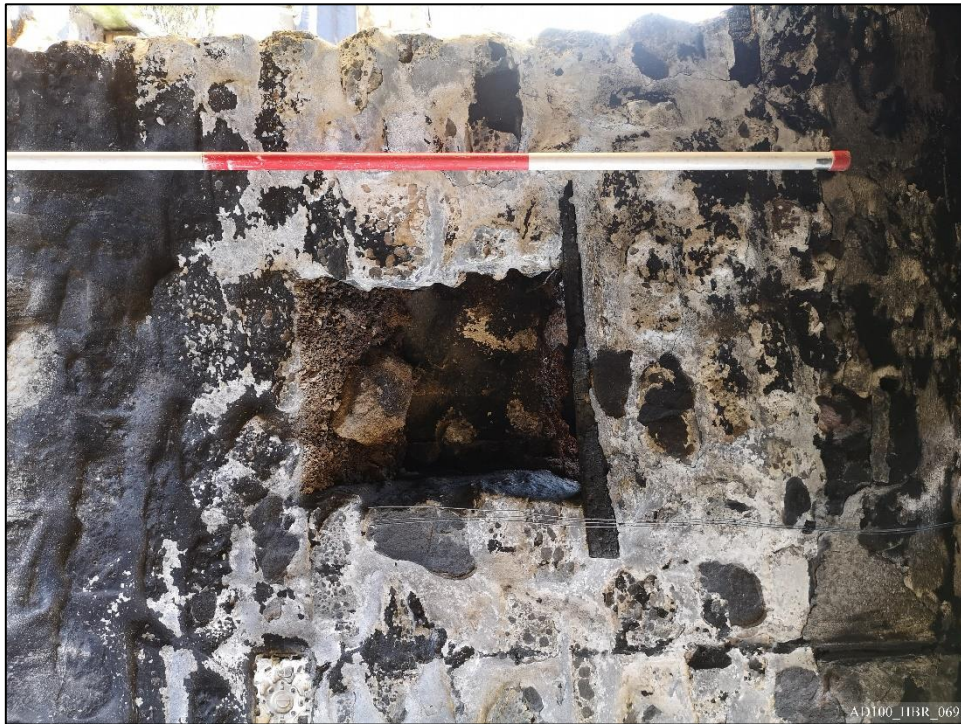
Plate 69 – Blocked window to west lateral wall.

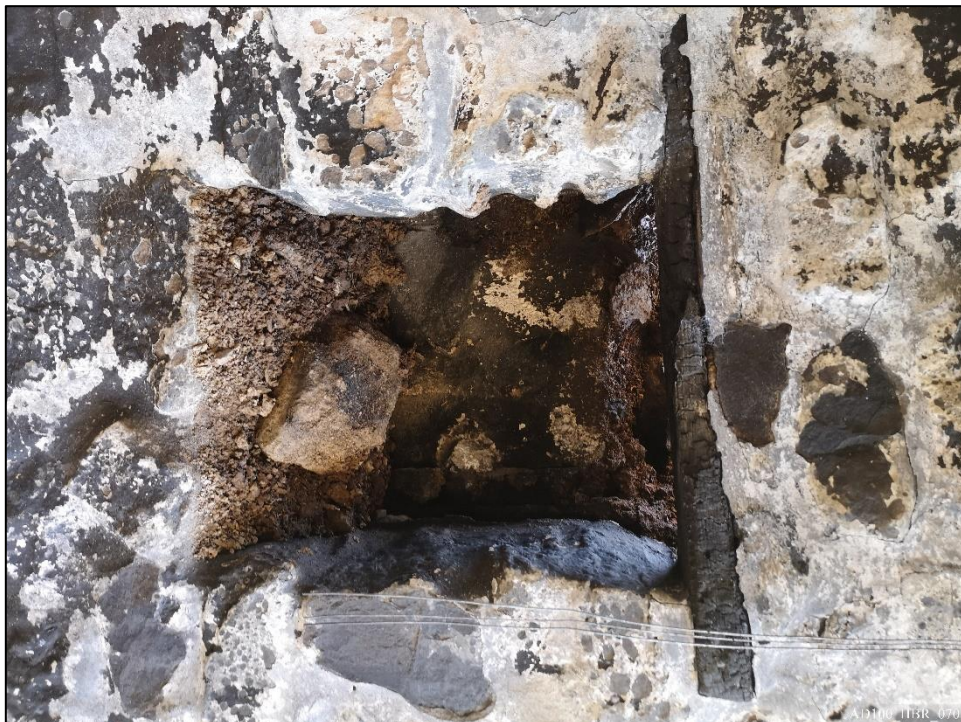
Plate 70 – Blocked window to west lateral wall.
