# Vivian Engine House, Hafod-Morfa Copperworks

## Archaeological Watching Brief & Building Record

**City and County of Swansea**

**- BLACK MOUNTAINS ARCHAEOLOGY -  
- ARCHAEOLEG MYNYDD DU -**

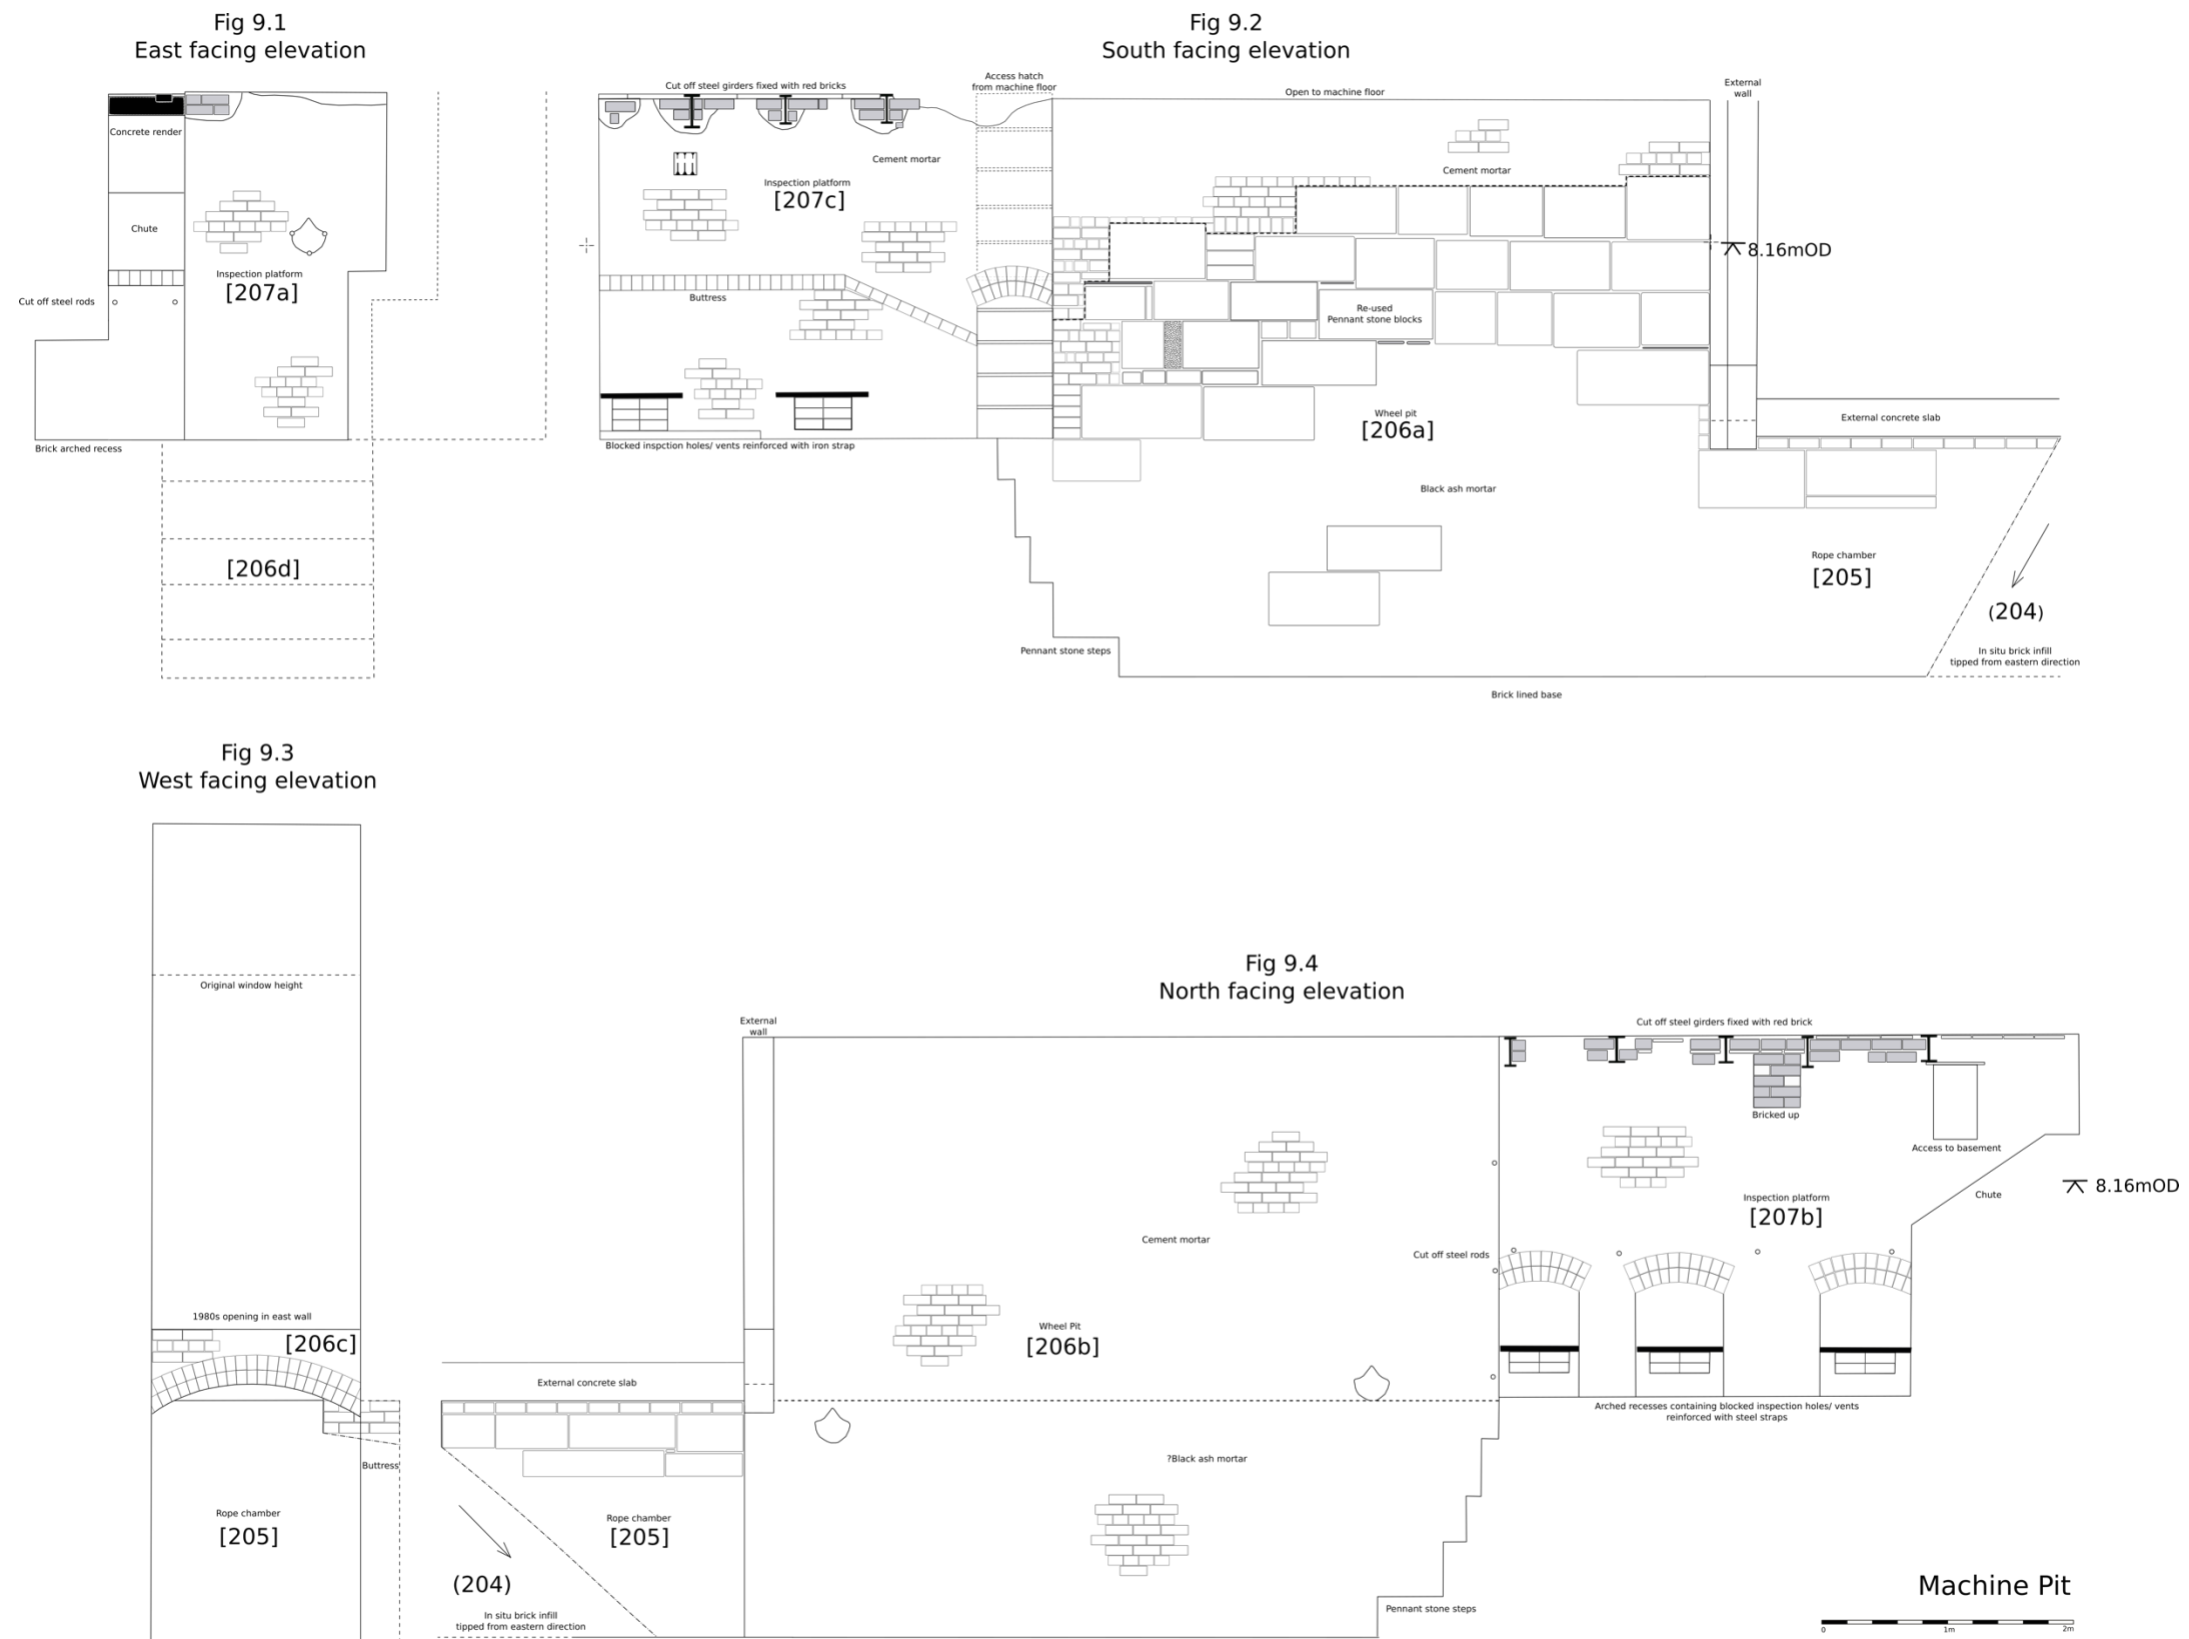
Figure 9. Elevation drawing record of the Vivian Engine House Machine Pit showing the Wheel Pit [206], Inspection Chamber [207] and Rope Chamber [205].

4.1.12 The opposite wall of the wheel pit the ash brick wall [206b] appears to have black ash mortar up to the level of the inspection platform and could tentatively be described as Phase 2 up to this level. However, the coursing is identical to the brickwork above, which has grey cement mortar and is dated to Phase 3 in the 2002 survey. Due to the poor conditions at this lower level due to water ingress and oil contamination detailed inspection was not possible. A more detailed mortar analysis would be helpful to study this further.

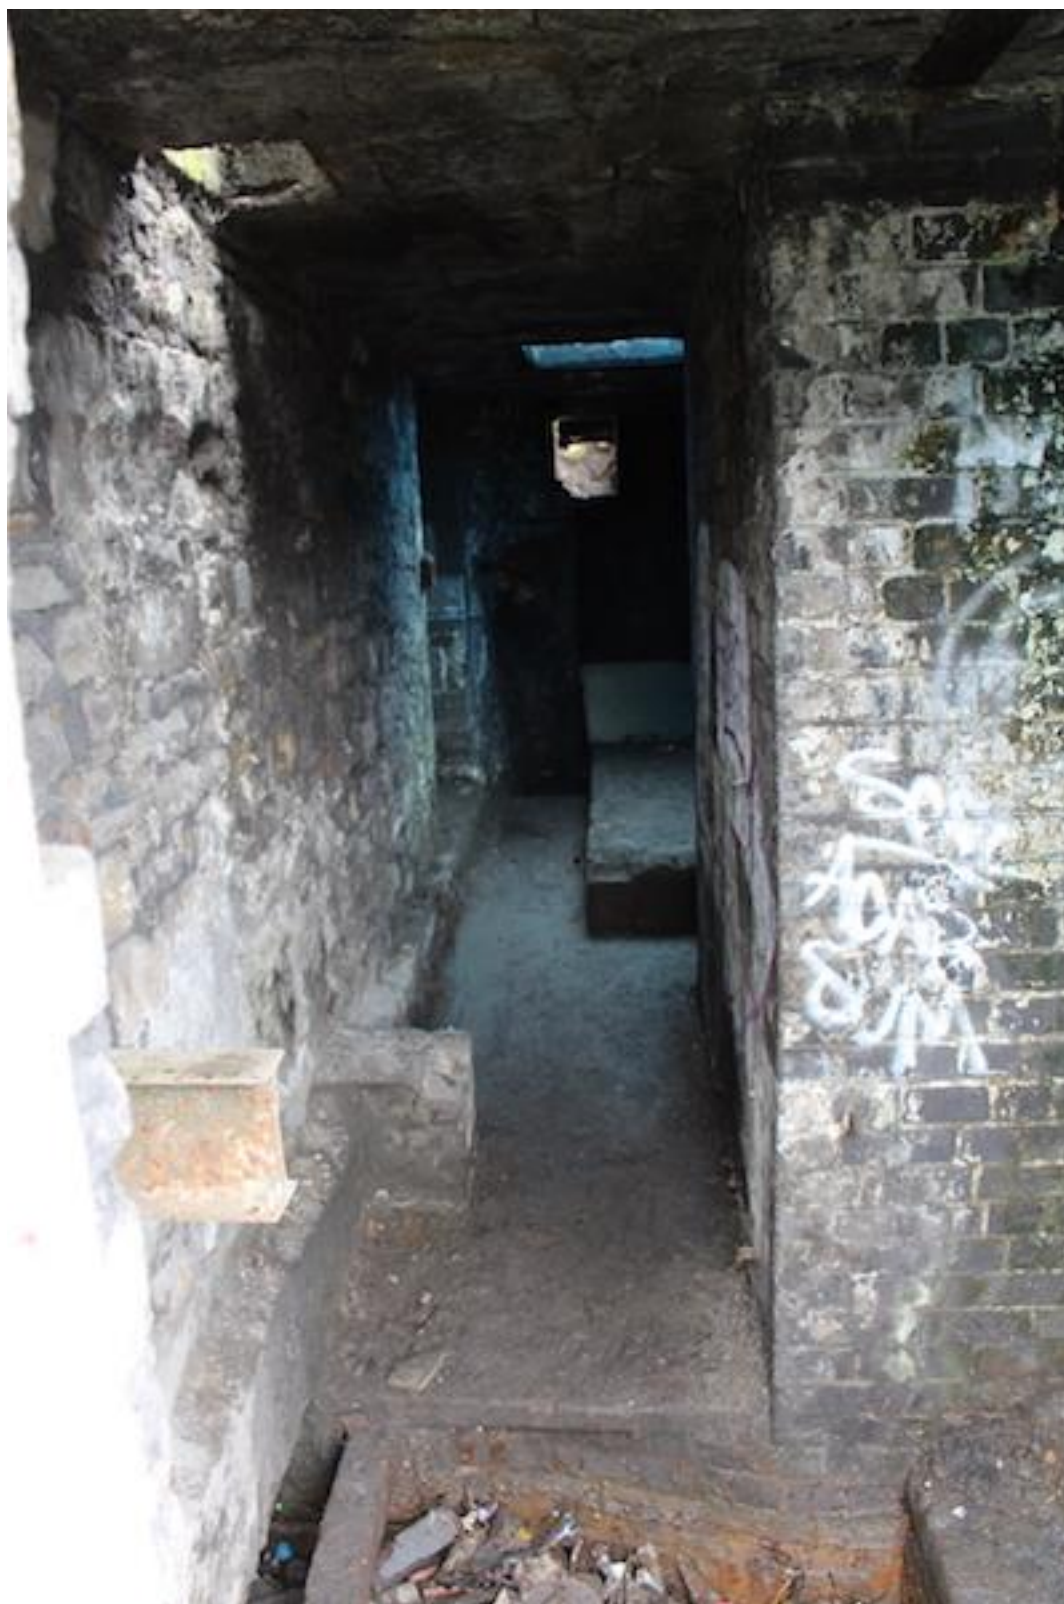
Plate 11. West facing post-excavation photo of main basement [105] showing sump [103] in foreground.

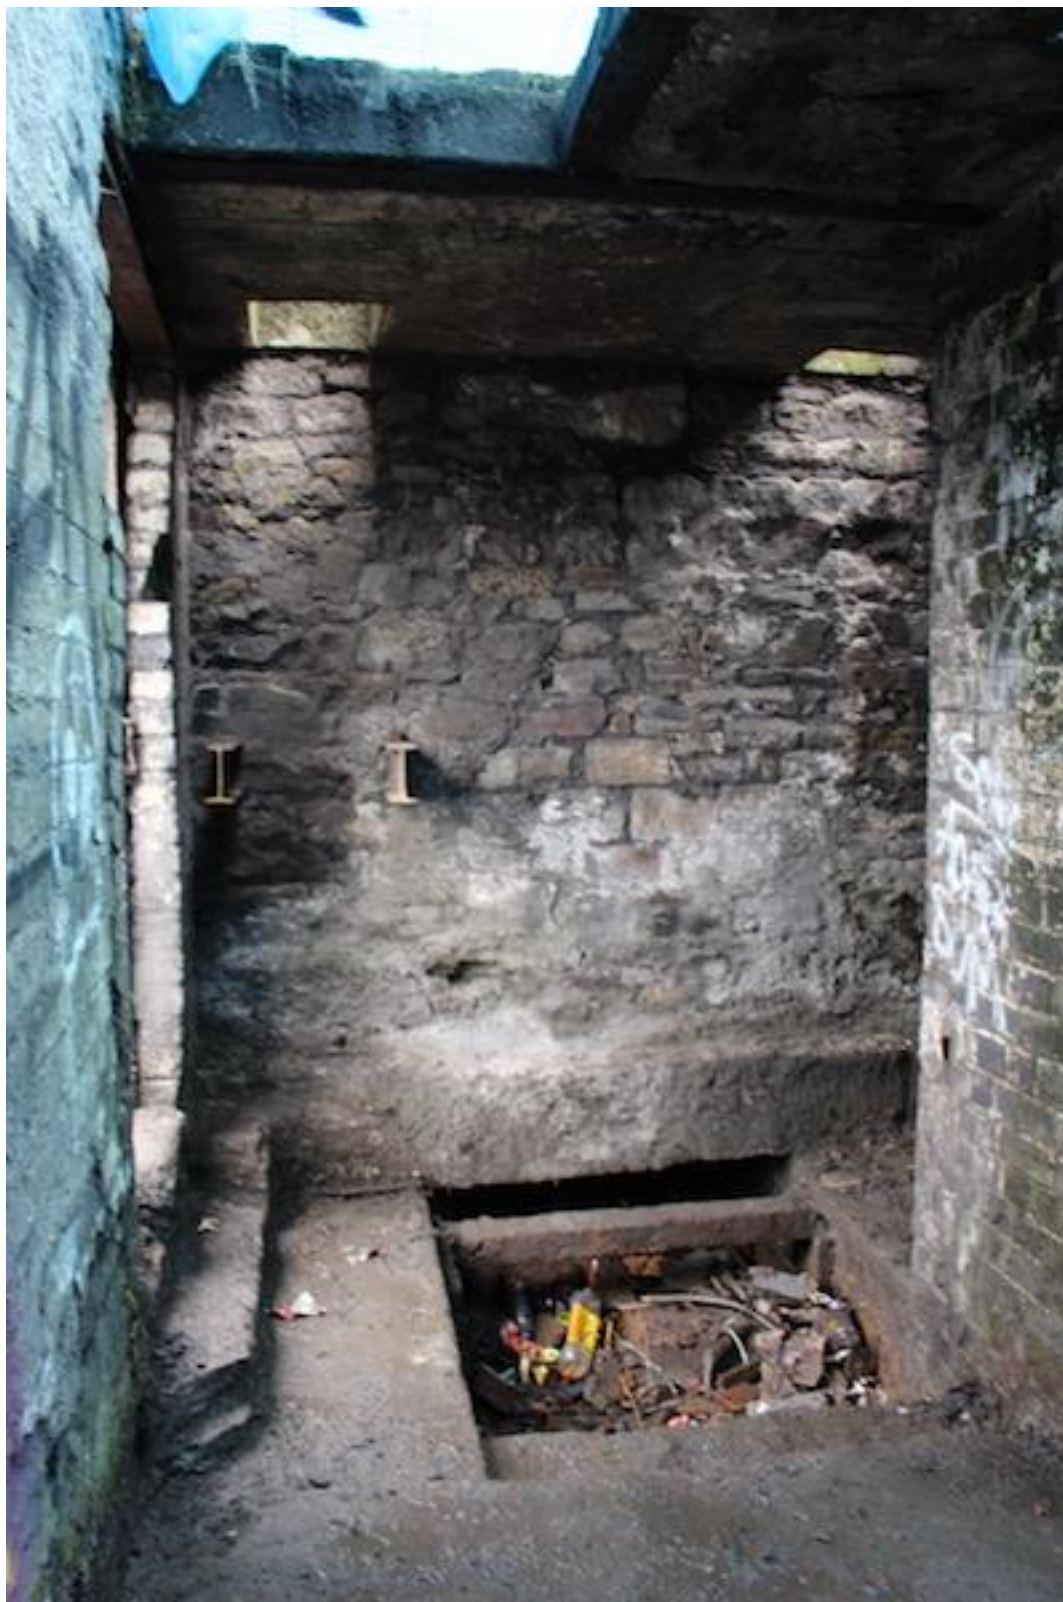
Plate 12. South facing post excavation photo of basement [105] showing sump [103].

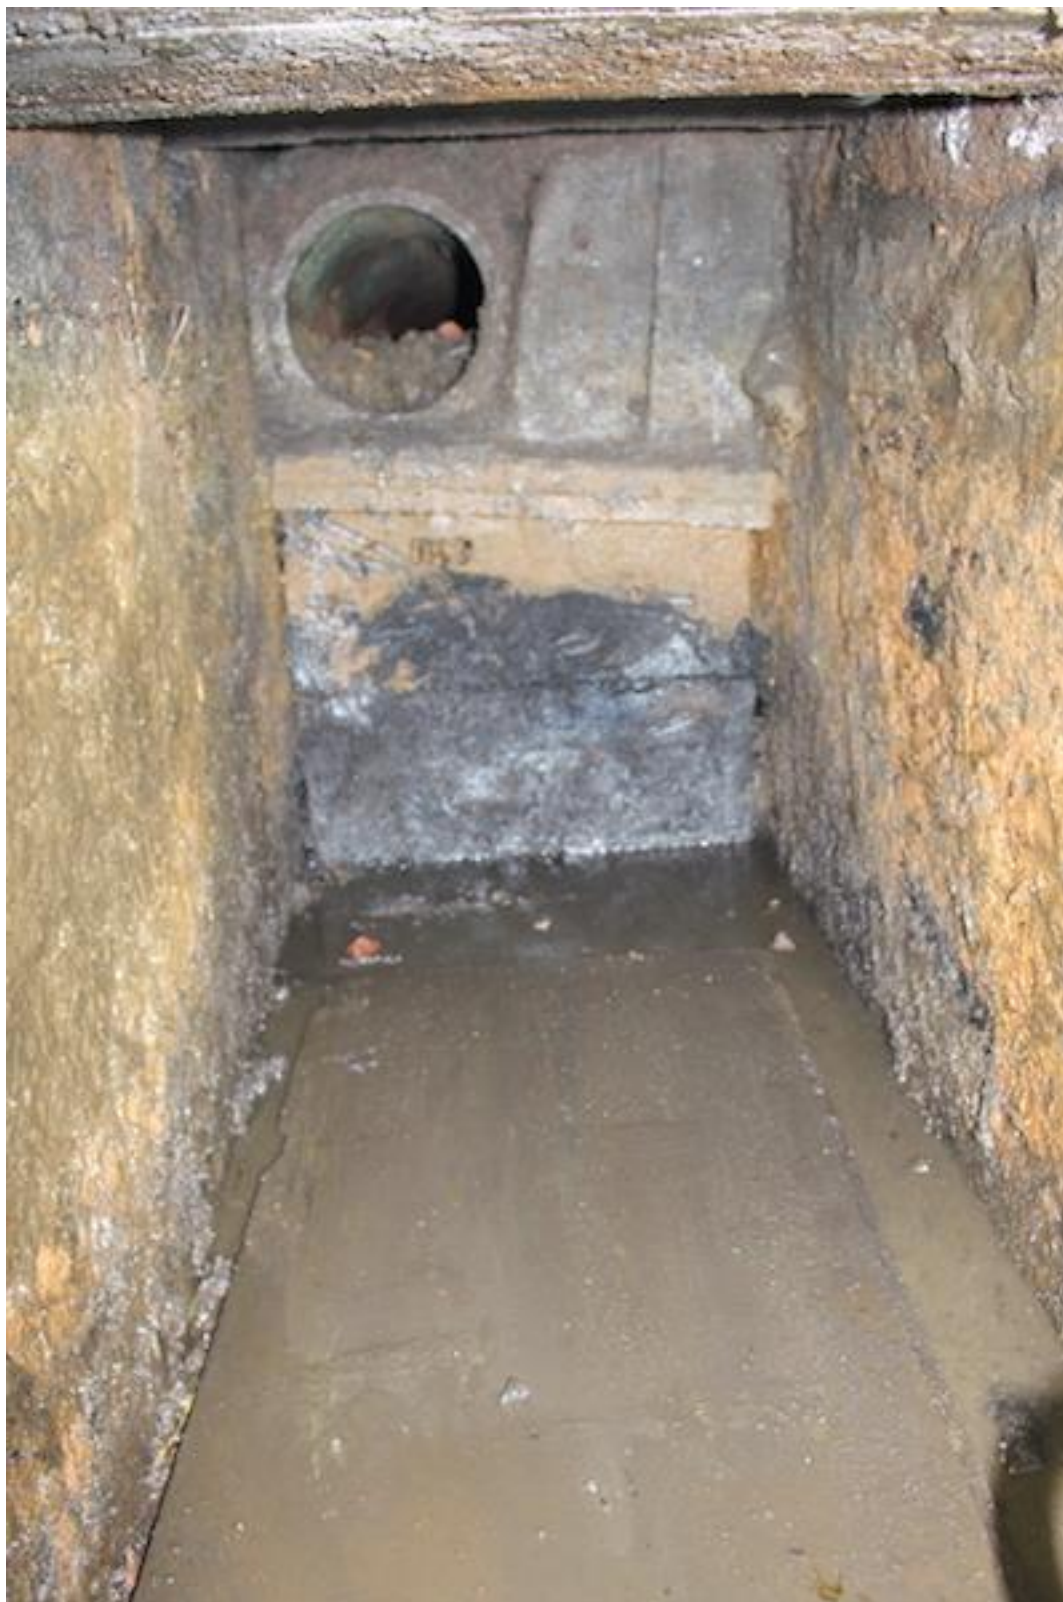
Plate 17. East-facing post-excavation photo of culvert [104], which is partially blocked with timber and laid with a land drain.

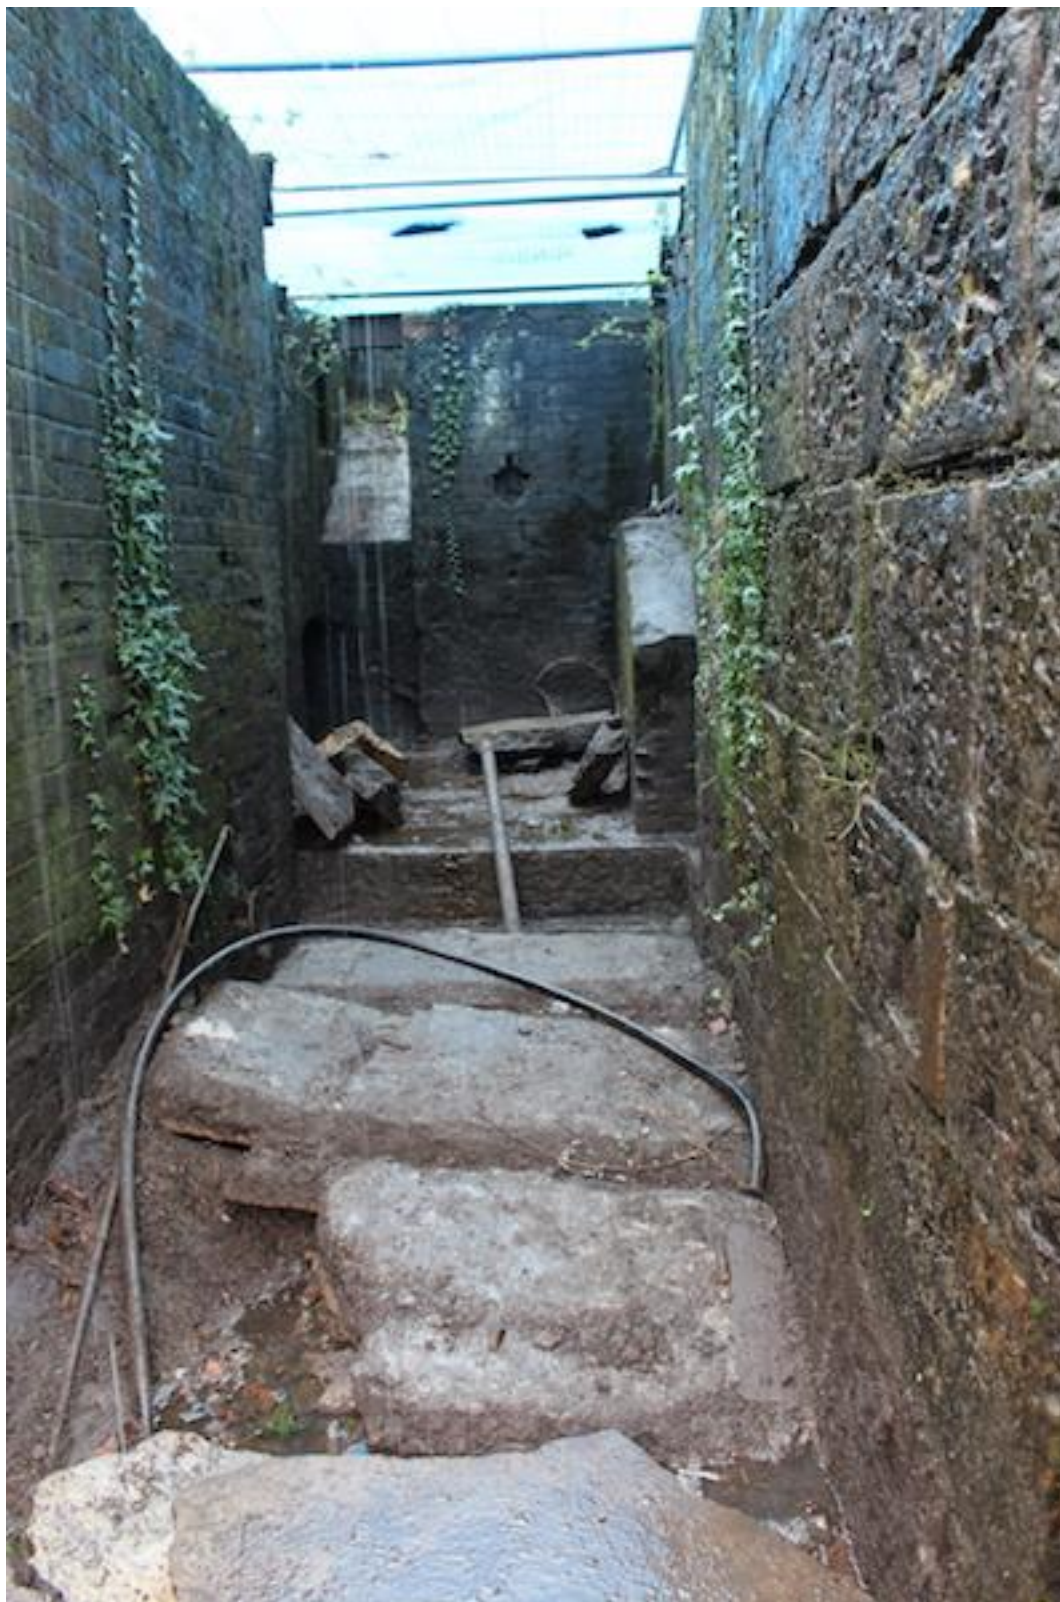
3.1.19 The slabs were not laid as a surface; they were upside-down, broken up and clearly re-deposited. It was initially thought that they might have originated from the roof of the inspection platform, where steel girders, now cut out, are clearly visible (Figure 9; Plates 32-34). However, the construction of the slabs, with iron rails running through as a means of reinforcement do not match the dimensions of the inspection platform. Alternatively, a slab above the wheel pit itself was considered, however, there is no evidence for girders or joist hangers on the walls of the wheel pit. The slabs are therefore believed to have been backfilled into the wheel pit from elsewhere on site.

Plate 19. West facing photo showing re-deposited concrete slabs (202) within wheel pit [206].

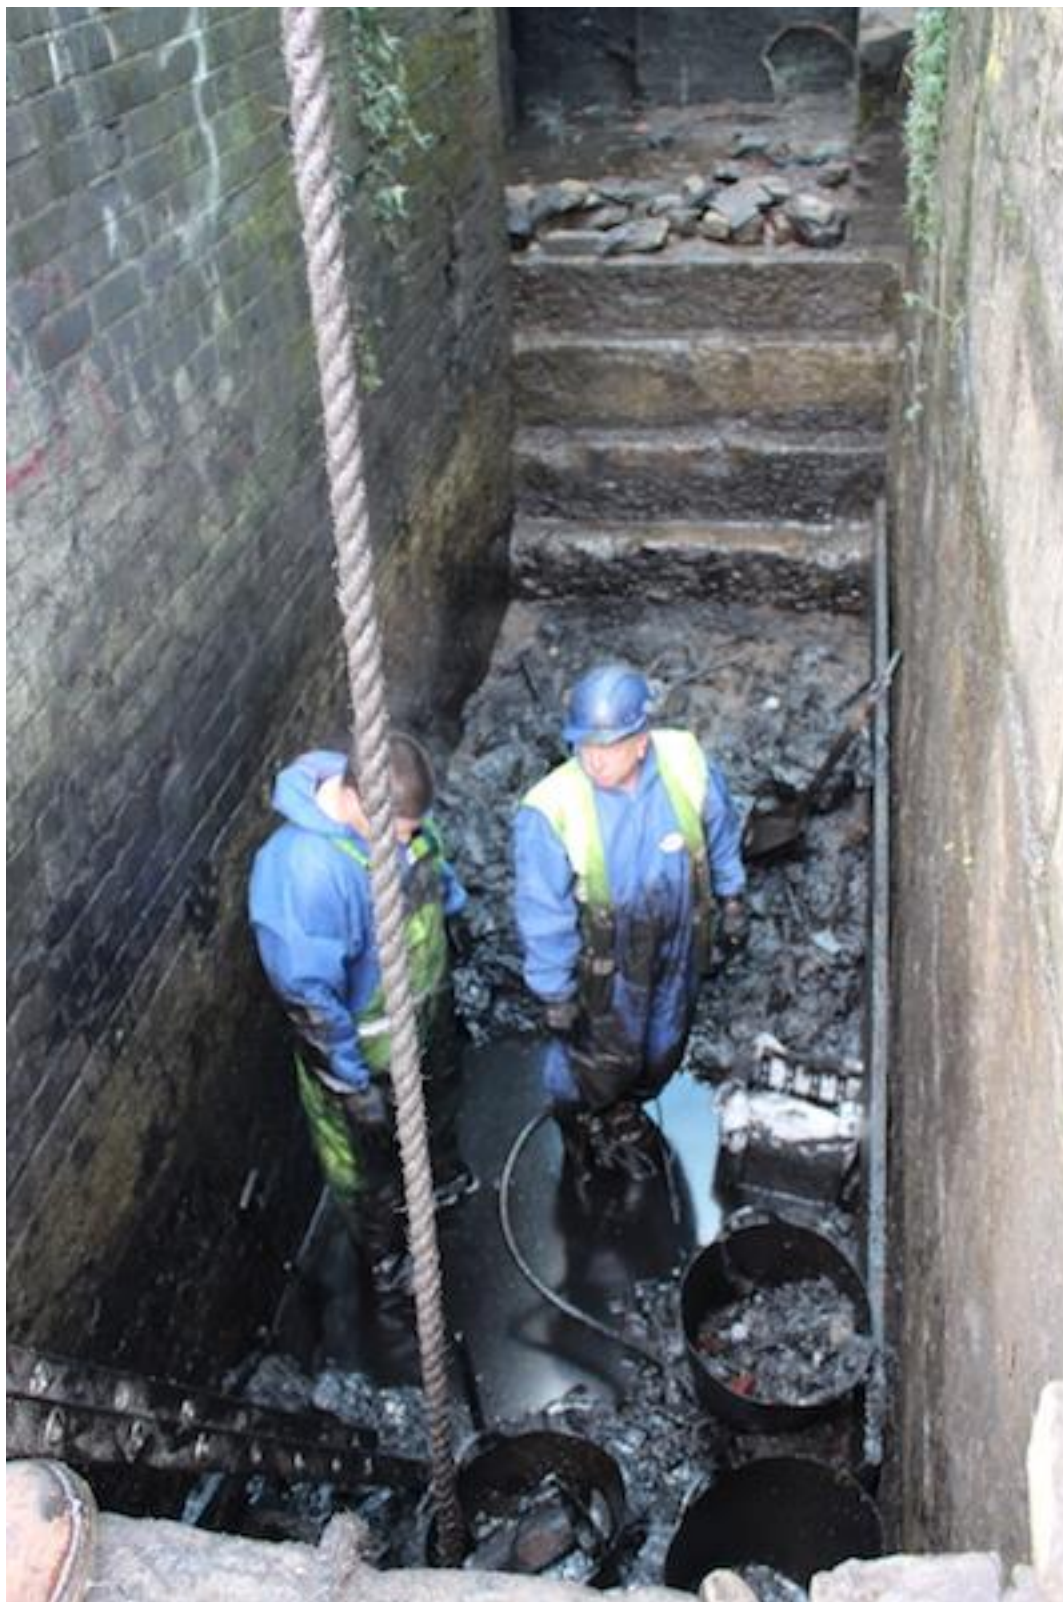
Plate 24. Working shot during excavation of wheel pit [206] showing oil contamination of lower deposit (203).

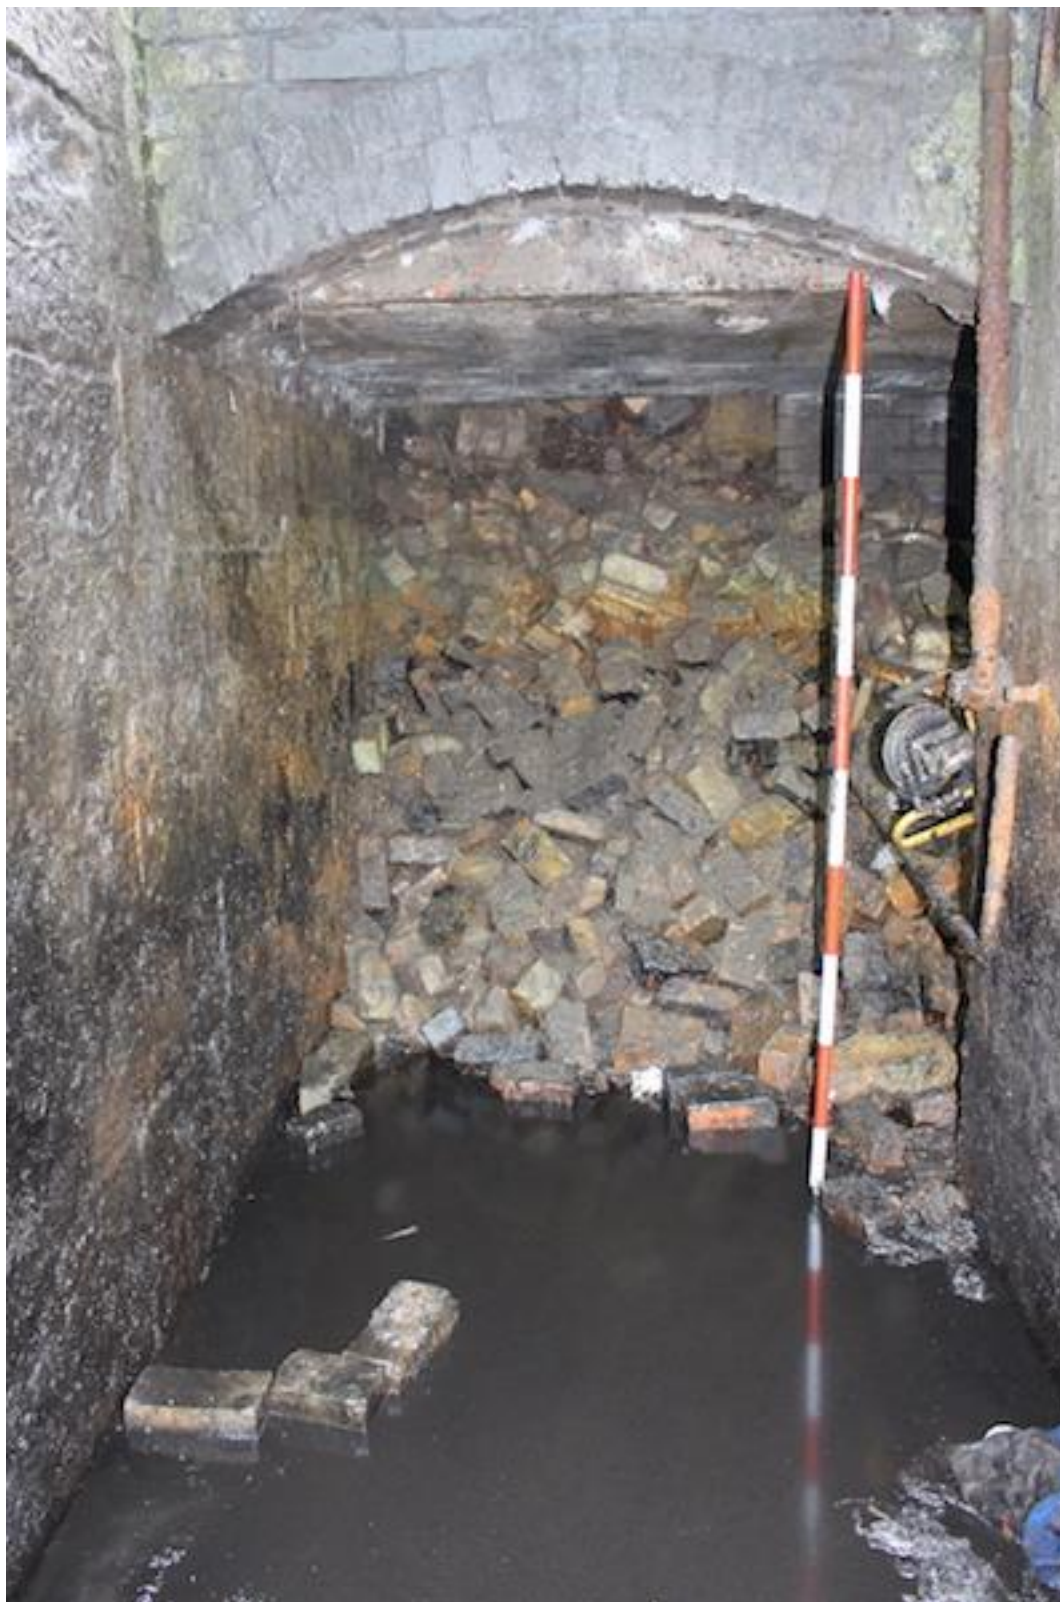
Plate 27. East-facing post –excavation photo showing rope chamber [205] extending east from the base of wheel pit [206]. Brick backfill (204) was not fully removed due to concerns about subsidence.

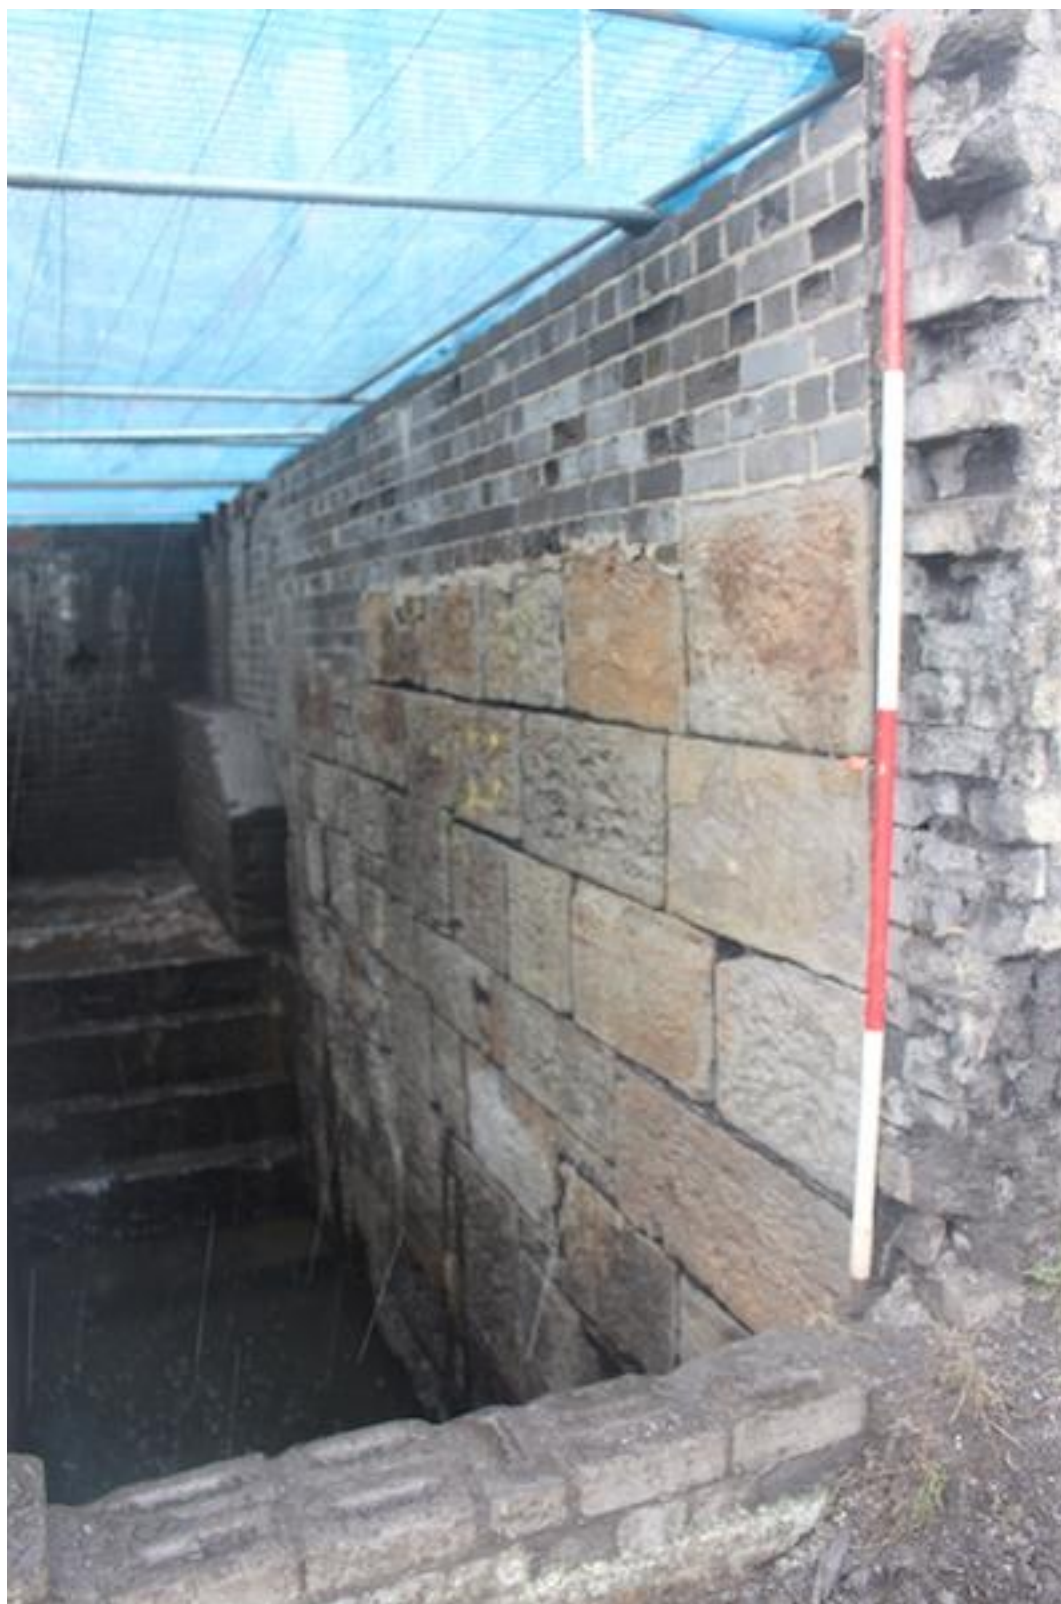
Plate 30. West-facing photo showing pennant stone north wall of wheel pit [206]. The wall is extended up to machine floor level with Vivian ash brick.

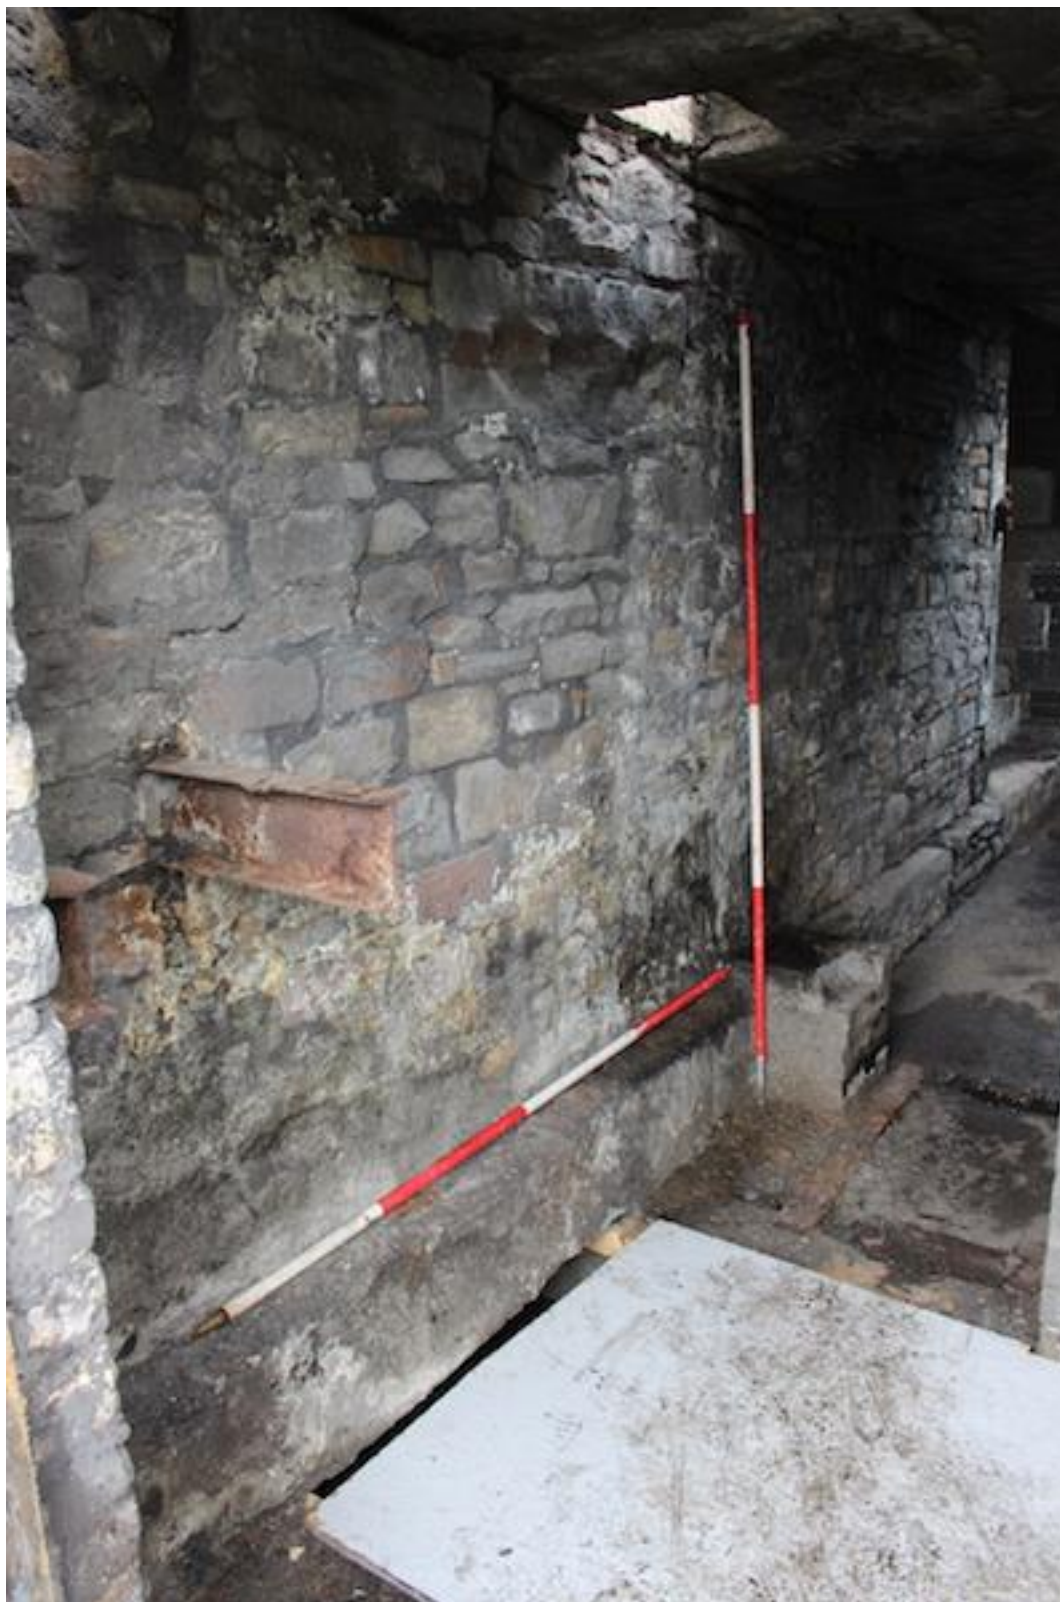
Plate 37. West-facing photo from east doorway showing the south wall of main basement [105]. The pennant stone lintel of sump [103] is visible in the foreground.

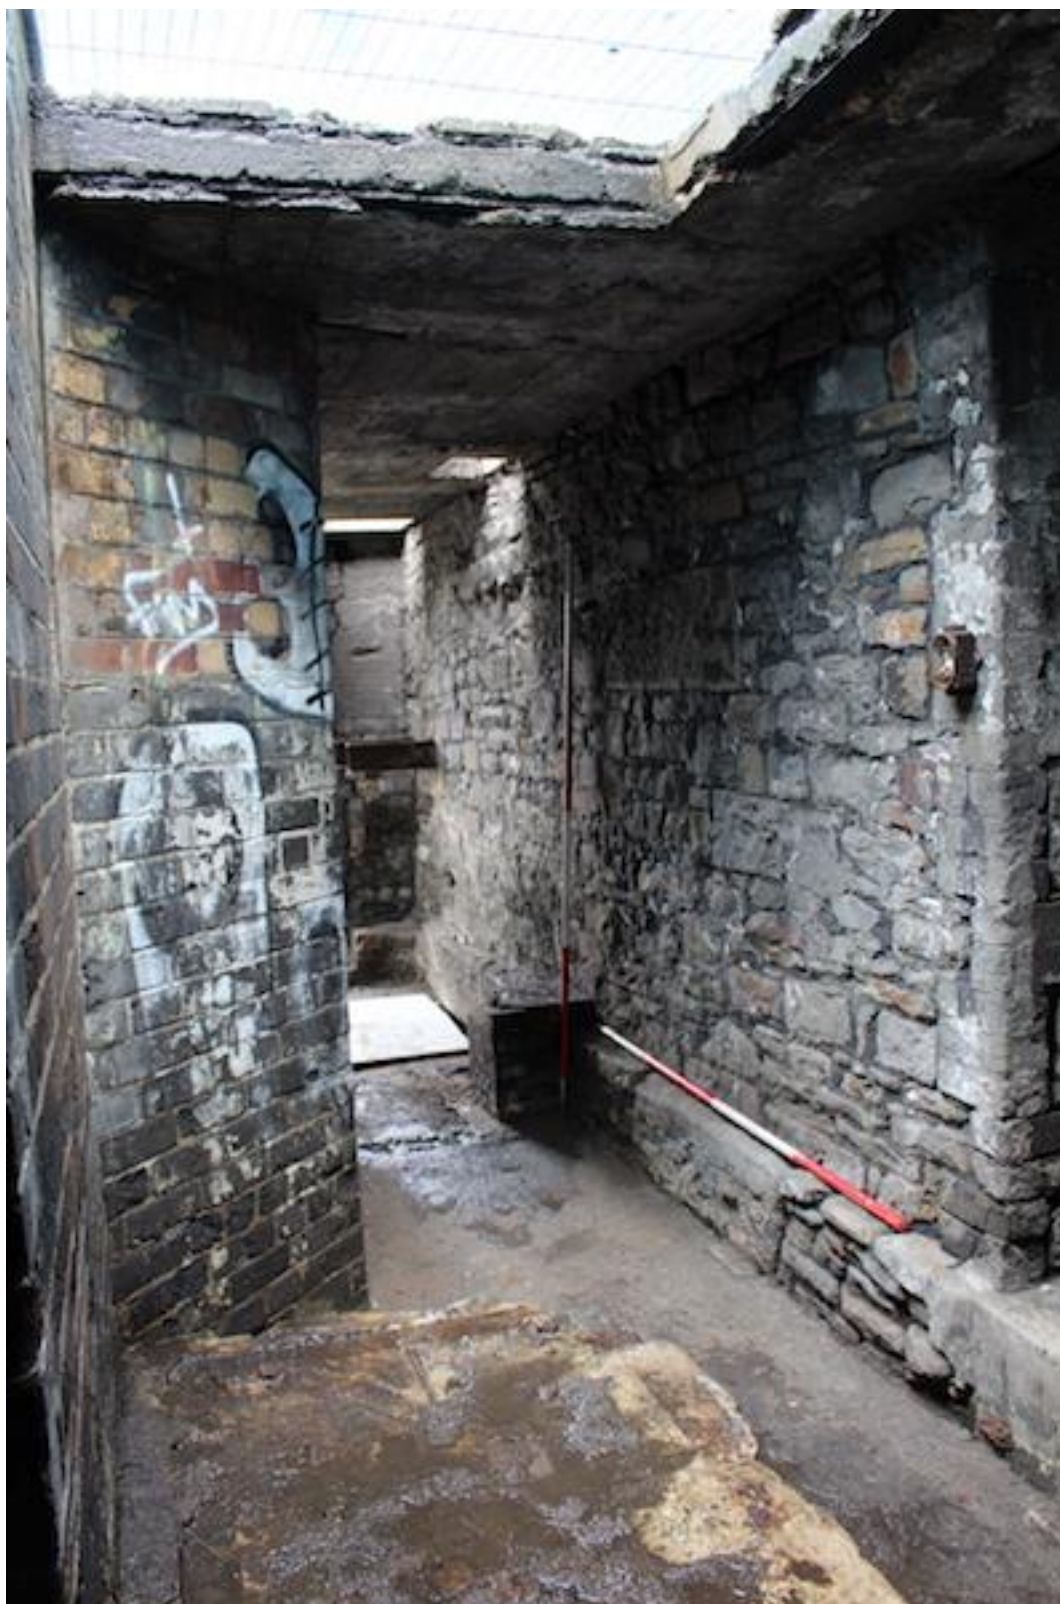
Plate 38. East-facing photo showing main basement [105] showing the south rubble stone wall and ash brick north wall with later red/ yellow brick infill.

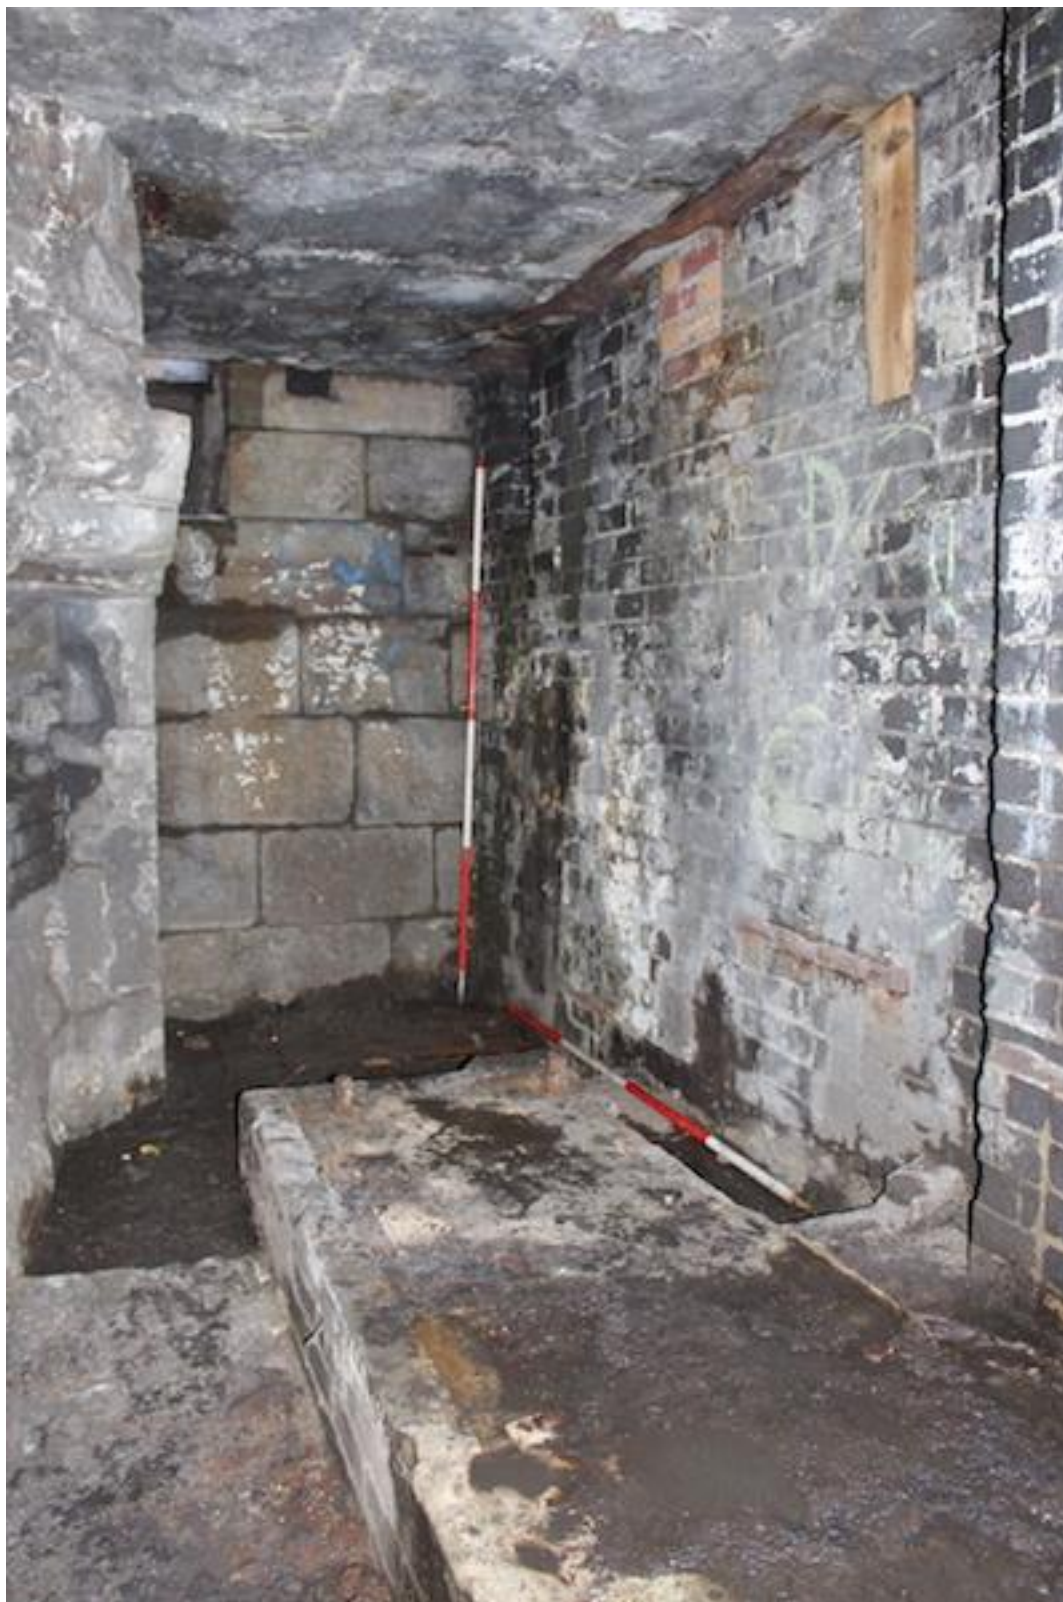
Plate 39. West-facing photo showing the pennant stone west wall of main basement [105] and ash brick north wall with later red/yellow brick infill.

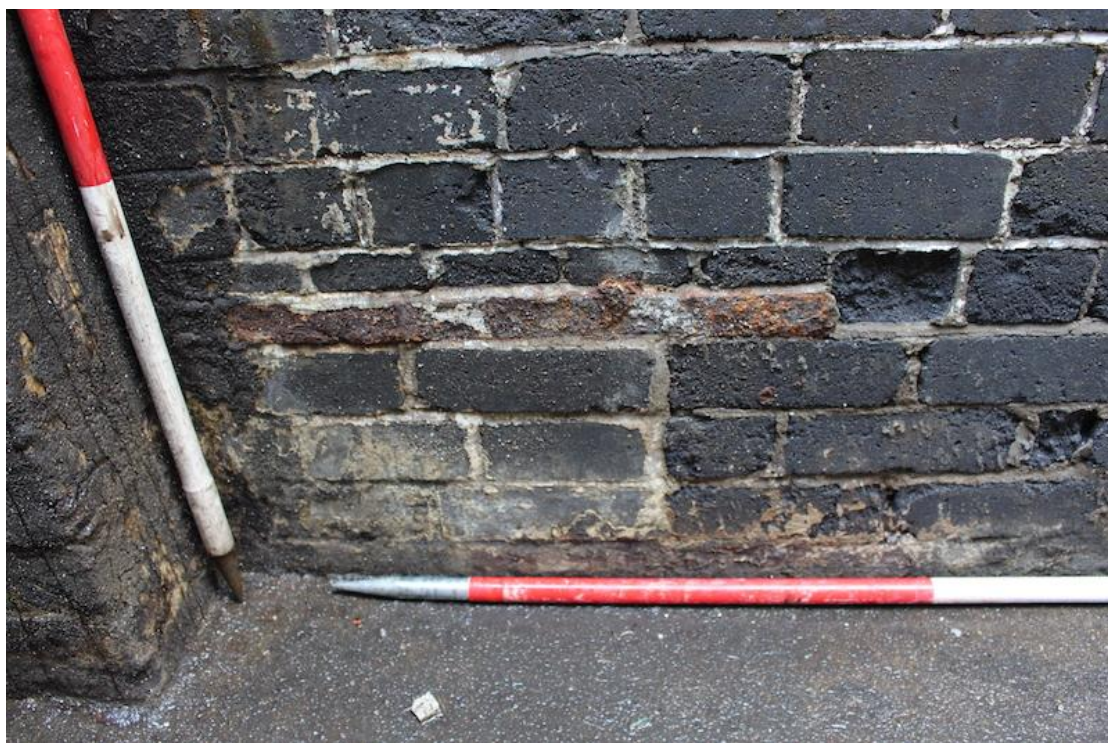
Plate 41. One of a number of blocked inspection hole/ vents. This one is located in stairwell [106].
