# Vivian Engine House, Hafod-Morfa Copperworks

## Archaeological Watching Brief & Building Record

**City and County of Swansea**

**- BLACK MOUNTAINS ARCHAEOLOGY -  
- ARCHAEOLEG MYNYDD DU -**

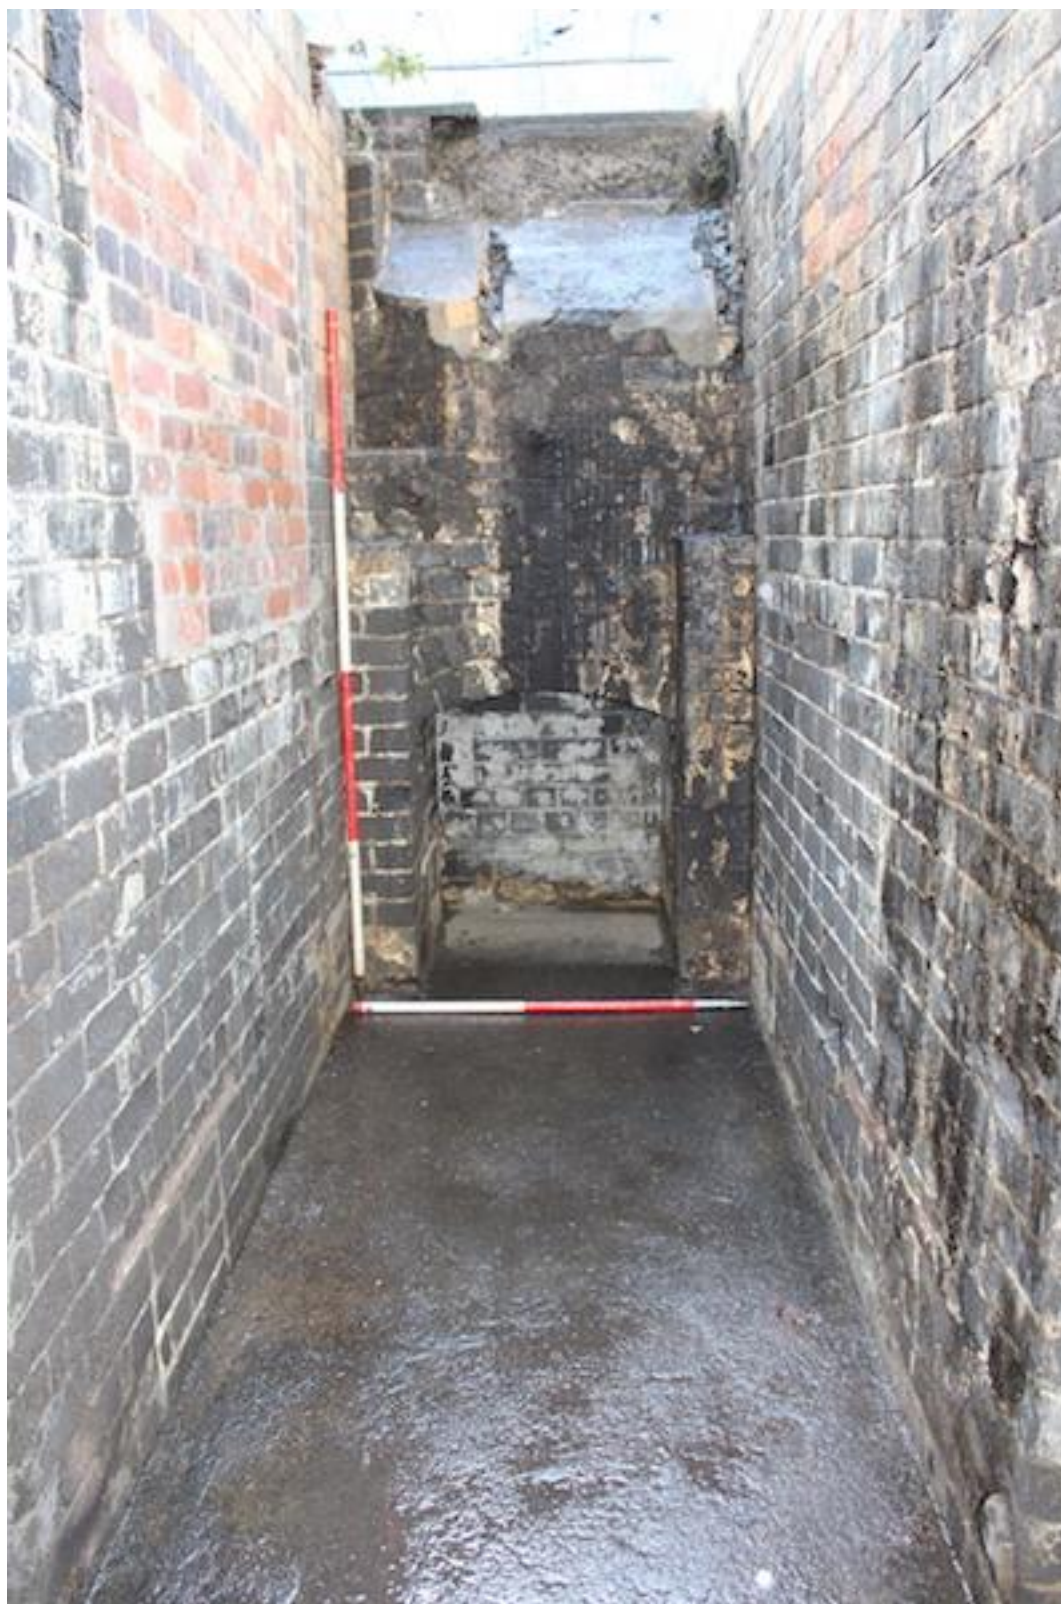
Plate 42. West-facing photo of stairwell [106] showing brick arched recess at base of stairwell and later inserted slots to carry stairs. Later red/ yellow brick infill in the north and south walls of the stairwell is also visible.

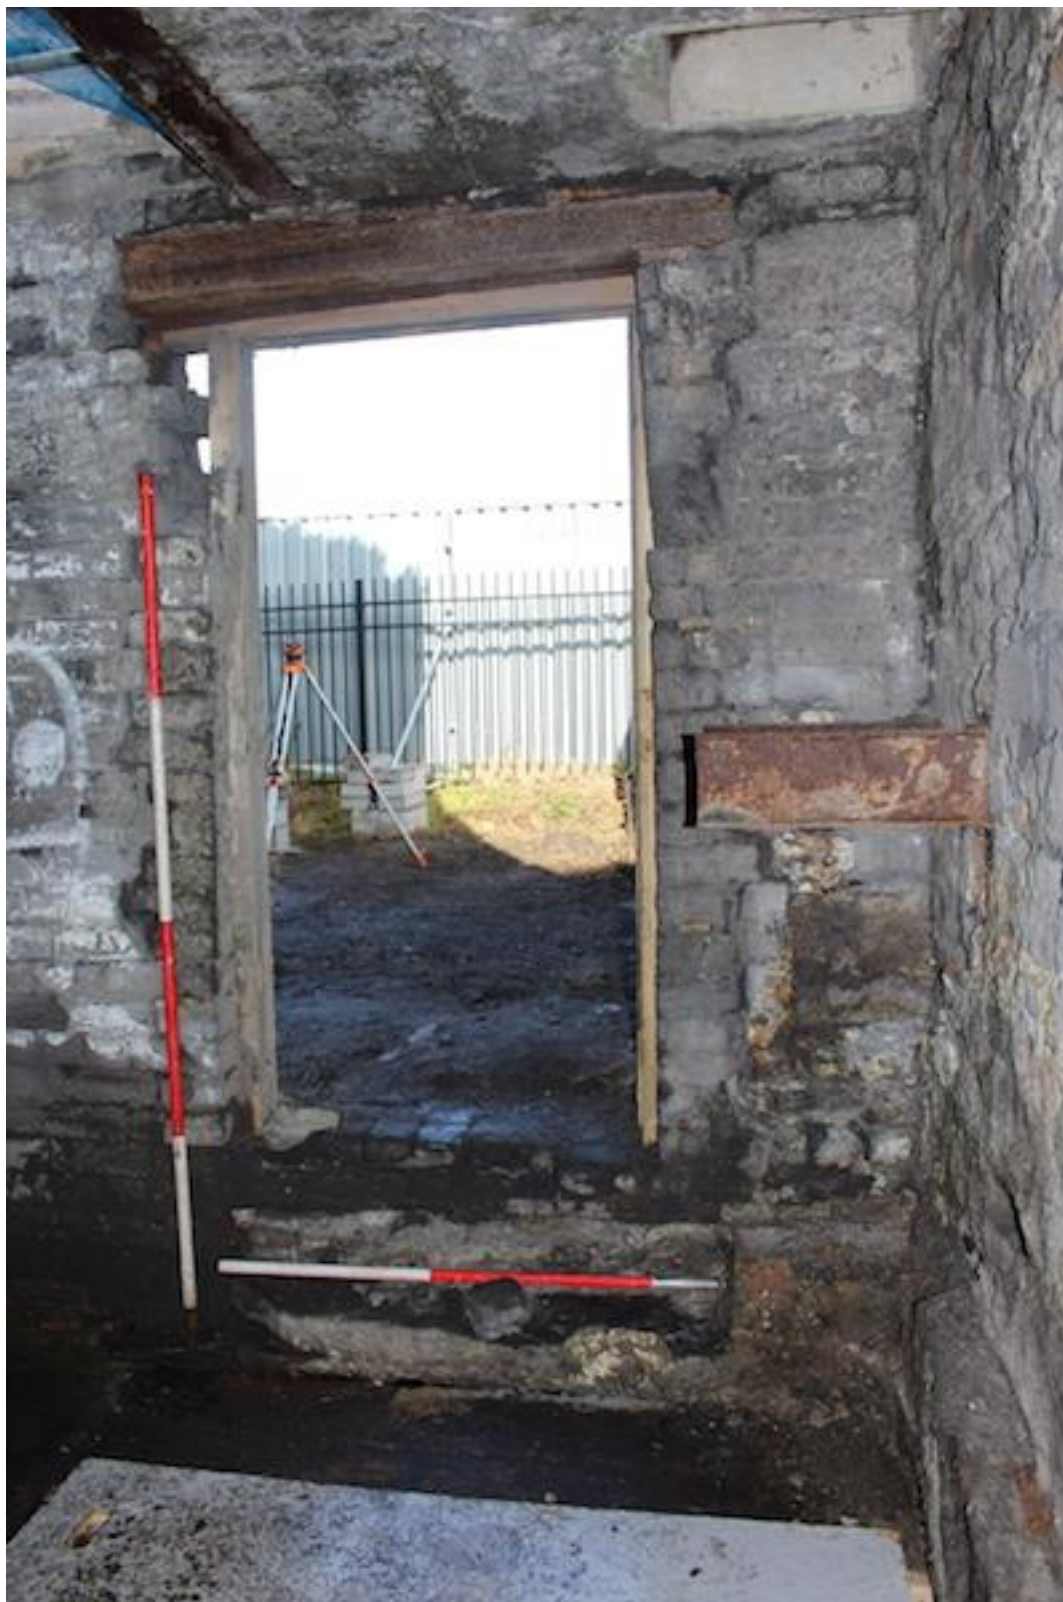
Plate 44. East-facing photo from main basement [105] showing east doorway and the pennant stone threshold stone that acts as the lintel for culvert [104].
