CPAT Report No. 1761

Bryn Eglwys, Dylife, Powys

Building Survey

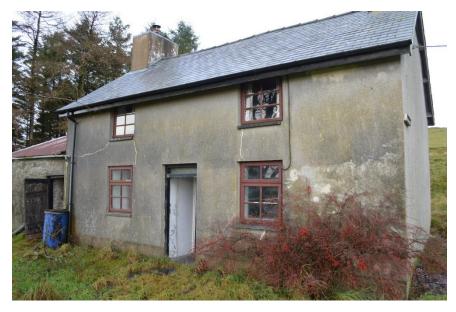
5.3. The exterior of the house was in good repair, with rendered walls, slate roof and ceramic ridge tiles. The render masked any structural details. All of the windows were modern replacements, although the doors to the house and byre may be original (Figs 5-8).

Fig. 5 The south-eastern elevation

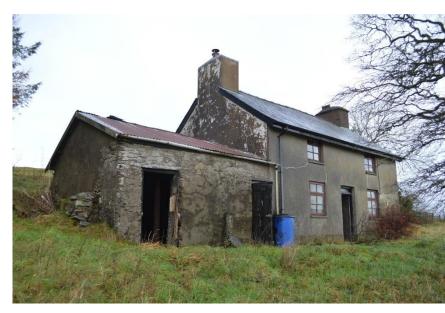
Fig. 6 The south-eastern elevation and byre

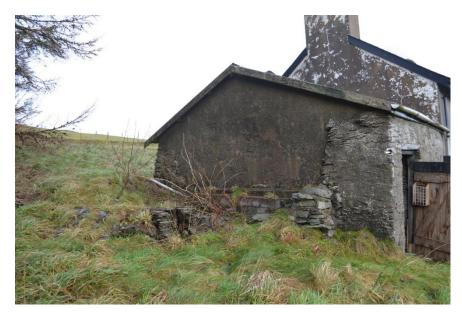
Fig. 7 The south-western end of the byre and site of outbuilding

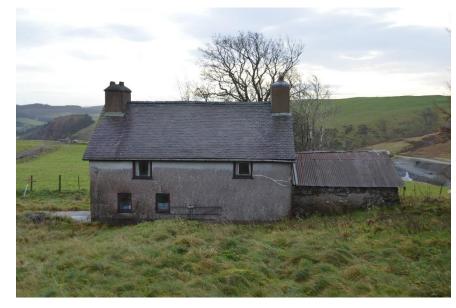
Fig. 8 The north-western elevation

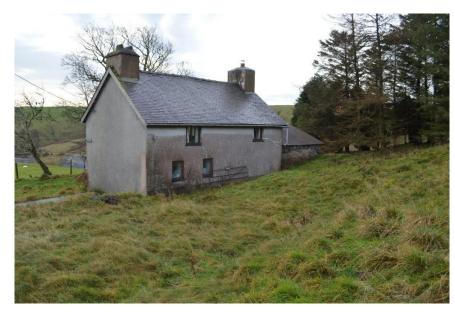
Fig. 9 The north-western elevation showing platform for barn

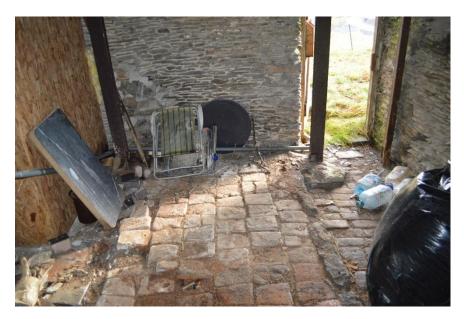
5.10. A small byre had been added to the south-west end of the house, with two doors, one for the stalls and the other for the feeding passage. Much of the original brick-paved floor survived (Fig. 10), although all of the stalls had been removed. The south-western wall had collapsed and been rebuilt using blockwork, while the roof timbers were modern, supporting corrugated iron.

Fig. 10 Brick floor in the byre

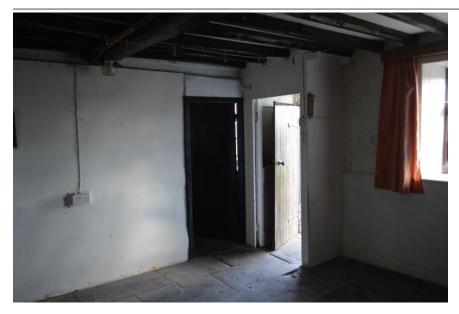
- 5.4. The house was accessed through a central door in the south-east elevation which opened into a small entrance hall, a modern insertion created by partitioning the main hall (Fig. 11). A wooden coat rack, probably original was attached to the wall just inside the door.

Fig. 11 The hall showing entrance and kitchen door

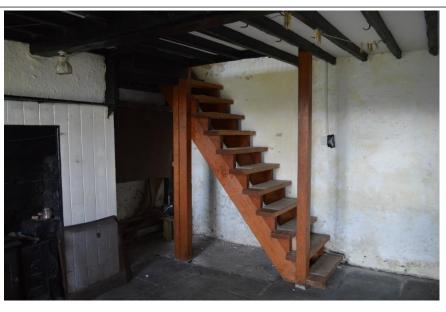
- 5.5. The hall retained the original slate floor and part of the original cast-iron range, although the central section had been removed to insert a wood stove (Fig. 12). The original winding stairs had been replaced, although their position and form were apparent from scars in the plasterwork and the absence of slate flagstones from what would have been a cupboard beneath the stairs (Fig. 13).

Fig. 13 The hall showing new stairs

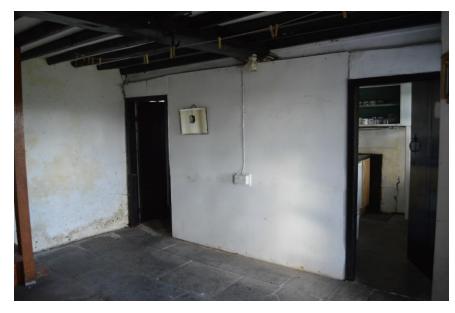
- 5.6. Doorways in the partition at the north-east end of the hall gave access to a kitchen and pantry (Fig. 14). The kitchen (Fig. 15) was a later repurposing of a room which may previously have been a small sitting room, cooking having originally been done using the range in the hall. There was a projecting chimney breast in the kitchen with a central fireplace, now blocked.

Fig. 14 The hall showing doors to kitchen and pantry

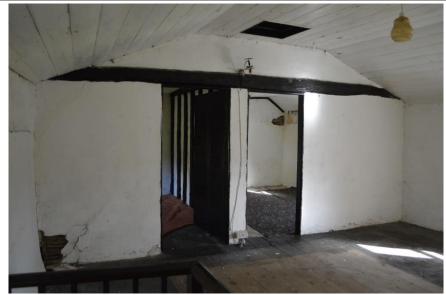
5.8. The stairs from the hall led to a large landing bedroom which would originally have had a fireplace, now blocked (Figs 17-18). Two further bedrooms were accessed via doors in the timber and lath and plaster partition. The larger room would also have originally been heated (Fig. 19), although the smaller room was not. The later had exposed posts demonstrating the structure of the partitions (Fig. 20).

Fig. 18 Landing bedroom

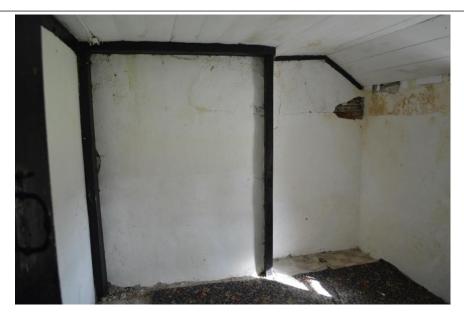
Fig. 19 Bedroom two showing chimney breast

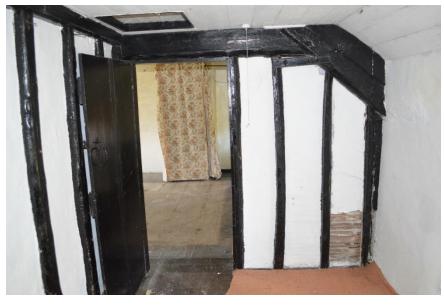
Fig. 20 Bedroom three showing timber and lath and paster partition

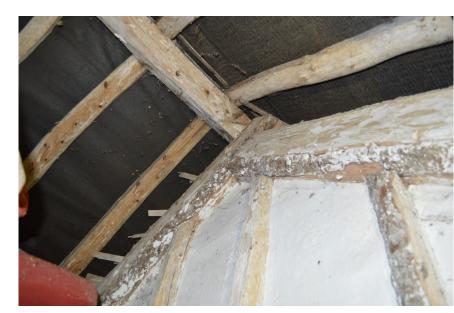
5.9. The roof space was not accessed in full, although could be viewed through two trap doors in the ceiling. The roof was supported on double purlins which rested on a roof truss incorporated into the partition dividing the main rooms (Figs 21-22). The truss had a collar below ceiling level, but no tie-beam (Fig. 26).

Fig. 21 Apex of roof

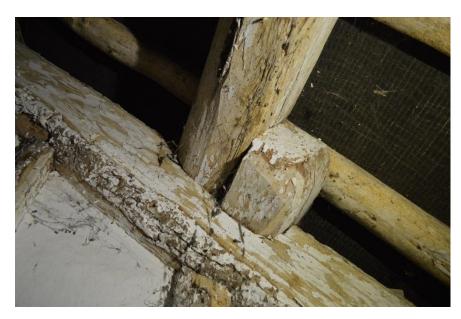
Fig. 22 Roof truss showing purlins
