Resurgam
Rhyl, North Wales

Designated Site Assessment

Archaeological Report

Ref: 53111.03ss

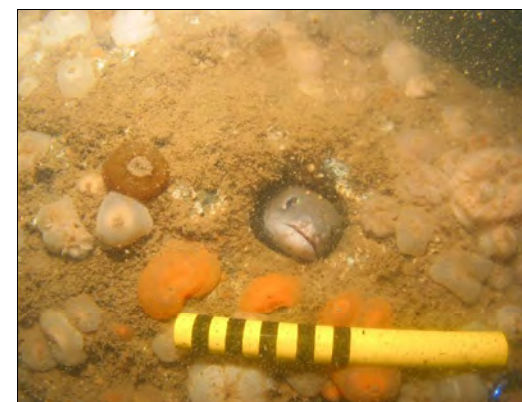
- 5.4.7. The actual bow cone is almost completely obscured by anemones but in general it appears to be in good condition with no obvious signs of damage. On top of the bow cone there is a small hole measuring approximately 0.06m in diameter. This feature had the appearance of being engineered and probably was an original designed feature, although it doesn't appear on any of the original plans. It is possible that this may represent the position of a removed deadlight but may equally be a free flooding hole. This hole is depicted in **Figure 3**.

- 5.4.9. Also just behind the bow cone there is a small, sub-rectangular hole in the pressure hull. This is situated just aft of the bow cone bulkhead and just forward of the internal dividing section, in an area that formed a small hold likely have been the coal bunker. This hole measured approximately 0.8m by 0.65m and had extremely delicate edges, which showed signs of relatively recent corrosion, see **Figure 3**.

Hole in bow section

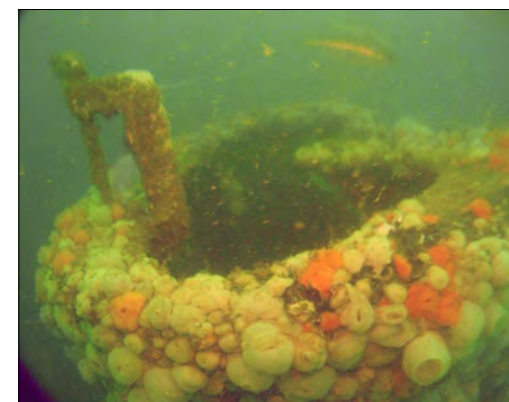
- 5.4.14. In the stern facing section of the conning tower there is an obvious 'V' shaped dent to the top of the tower. This damage was present prior to the 1997 surveys and may even have occurred when the *Elphin* came along side the *Resurgam* to take the crew off (Peter Holt pers. comm.). This damage appears to have corroded since 1997 to such an extent that previously joined sections of the conning tower rim that had been bent inwards have now corroded apart. This deterioration in the condition of the conning tower can be seen by comparing the 1997 SubMap photograph (**Plate 4**) with the photograph taken during WA's 2006 survey (**Plates 5-8**).

- 6.1.2. The wreck, while largely intact, has suffered some damage in the past. The V-shaped dent in the conning tower appears to be deteriorating; previously joined sections of the conning tower rim that had been bent inwards have now corroded apart.

Damage to conning tower as observed by WA in 2006

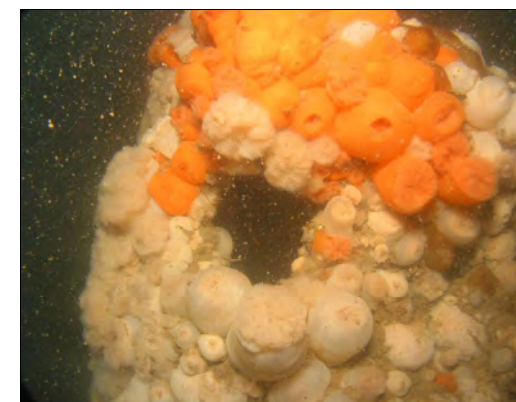
- 5.4.15. Garrett sent Cochran & Co a letter outlining the required specifications for the boat, included in which was the number and placement of '...lookouts in each of the four cardinal points...' (Bowers 1999: 106). This refers to the portholes that would have allowed the helmsman to navigate whilst on the surface but closed down. None were observed during the WA diving inspection; all that remain are the holes from which they have been removed, an example of which is shown in **Figure 3**.

- 6.1.7. All the portholes in the conning tower have been either dislodged or deliberately removed. While the location and condition of two of these portholes are known, the fate of the other two portholes is not. The conning tower's manhole cover is also missing. It is likely that the conning tower hatch became detached during the wrecking event and has either become completely buried or has corroded away. In any case, even with the help of Uri Geller, it has never been relocated.

Missing porthole in conning tower

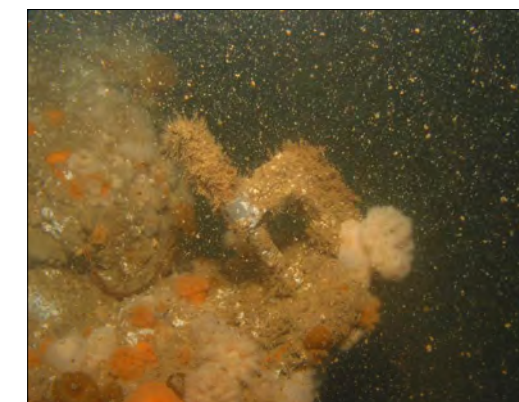
- 5.4.19. Two anodes were observed along the line of the casing remains. These are attached via 'G' clamps and all appear to be working well. However, one had eroded almost completely while the other appears to have been reduced by 50%.

Anode clamp on remains of prop blade

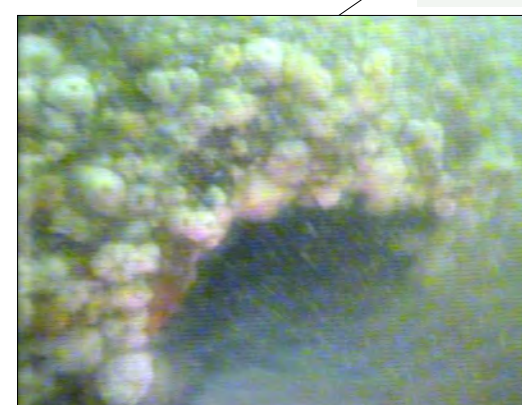
- 6.1.4. There is a large hole on the port side of the bow section. The metal around the edges of this hole is exposed and very delicate; in some areas lacking in marine growth which might help to protect it from further corrosion. Though not quite large enough for a diver in full diving gear to enter comfortably, it may not deter a diver from trying to enter and further damaging the wreck in the process.

Hole on port side

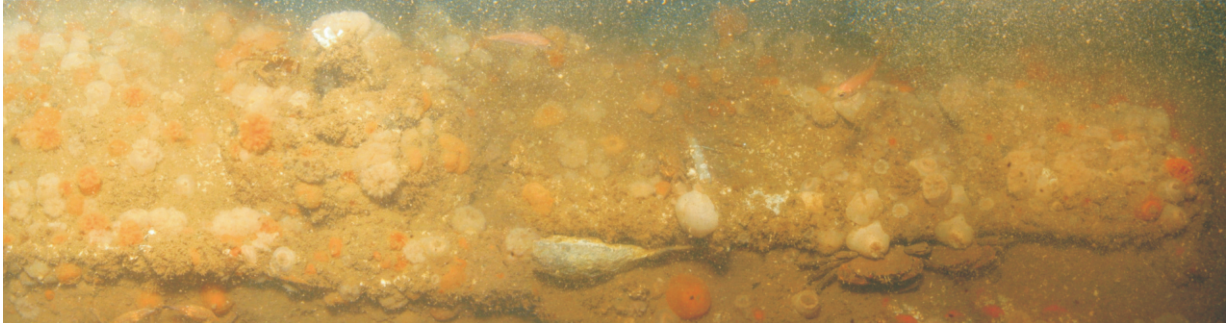
Plate 1. Remains of casing and smoke escape valve

- 5.4.4. Initial inspection of the wreck also showed that a large portion of the upper casing has either become detached or has corroded away, see **Plate 1**. This casing is the free flooding upper works that was attached to the pressure hull on top of the vessel. Within this casing the exhaust system toward the stern would have been protected. The casing is clearly illustrated in the contemporary photograph of *Resurgam* as it sat in Birkenhead dockyard prior to launch, see **Plate 13**.

- 5.4.5. The upper casing was made from a lower grade of steel than the pressure hull as it was designed to be free flooding and therefore not subjected to pressure when submerged. As a result it is to be expected that it will corrode at a faster rate than the steel making up the pressure hull.

- 5.4.18. The remains of the casing are visible at the stern of the vessel. This free flooding casing would have protected the smoke escape valve or exhaust (**Figure 3**). The casing itself has largely corroded away but there are remnants still attached to the hull, but nothing is upstanding more than 0.1m. There is nearly enough of the base of this casing in the stern area to trace the outline of the casing as it would have looked prior to its loss.

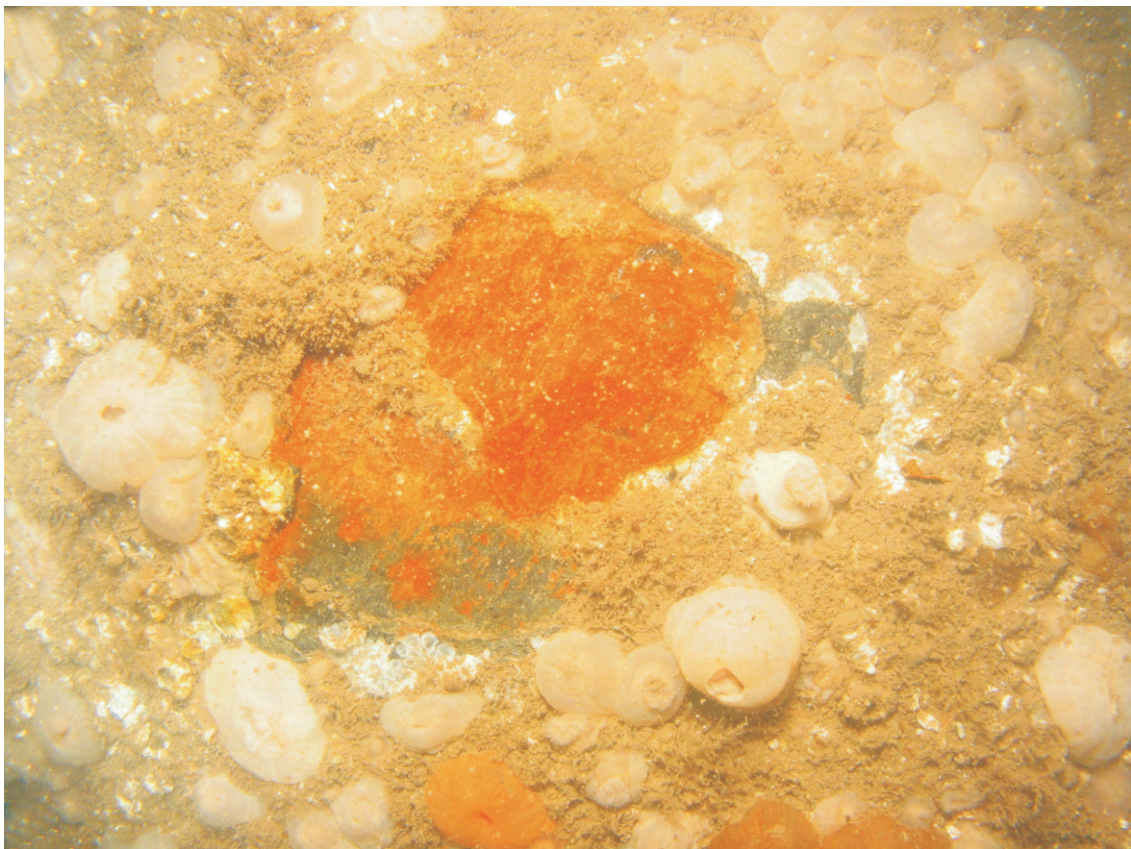
Plate 2. Fresh corrosion on starboard side, forward section

- 5.4.11. Between the bow cone and the upstanding air intake/snorkel a small patch of fresh corrosion was located on top of the pressure hull, just starboard of the centreline. This can be seen in **Plate 2**. It measured 0.12m by 0.07m and was roughly oval in shape.
- 5.4.12. The air intake/snorkel is located 0.76m forward of the leading edge of the conning tower. It is upstanding by 0.8m and is cylindrical. On top of the intake an amorphous concretion is attached. This is likely to be the counter balance to the automatic shut down valve. If the submarine was running on the surface with the hatch closed and

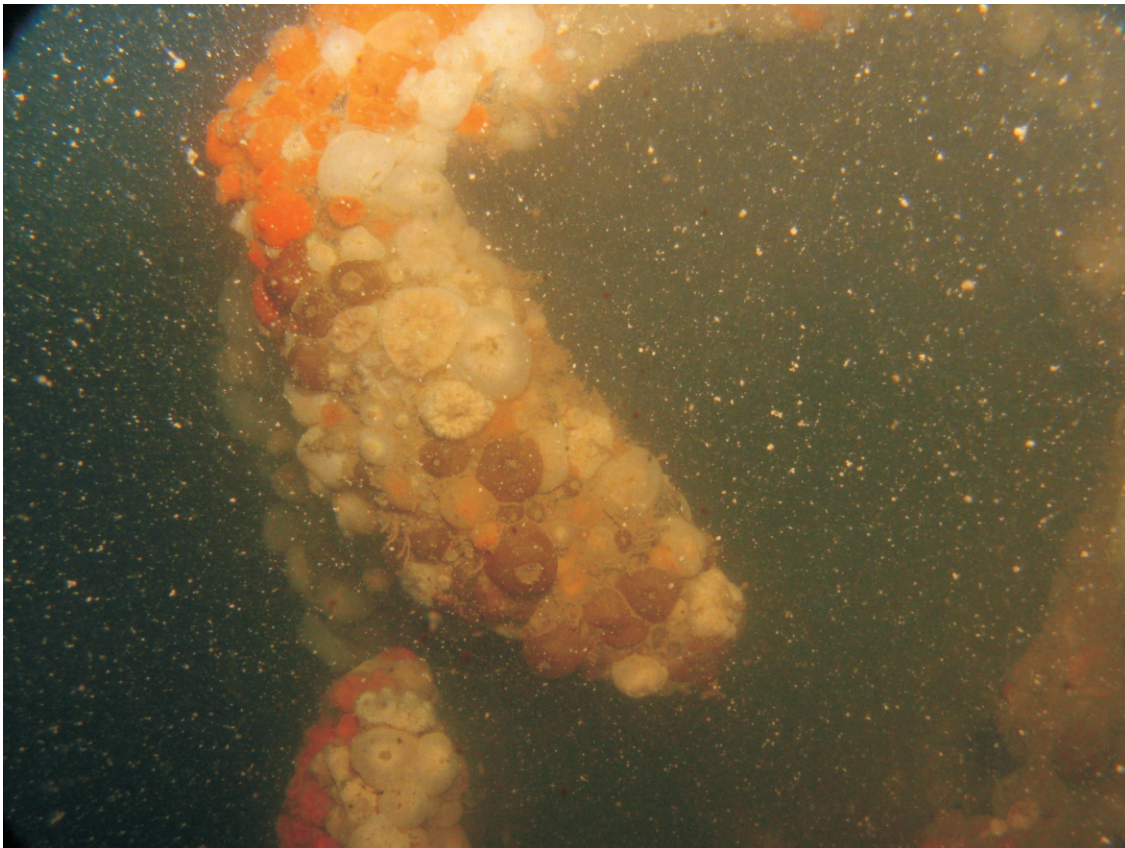
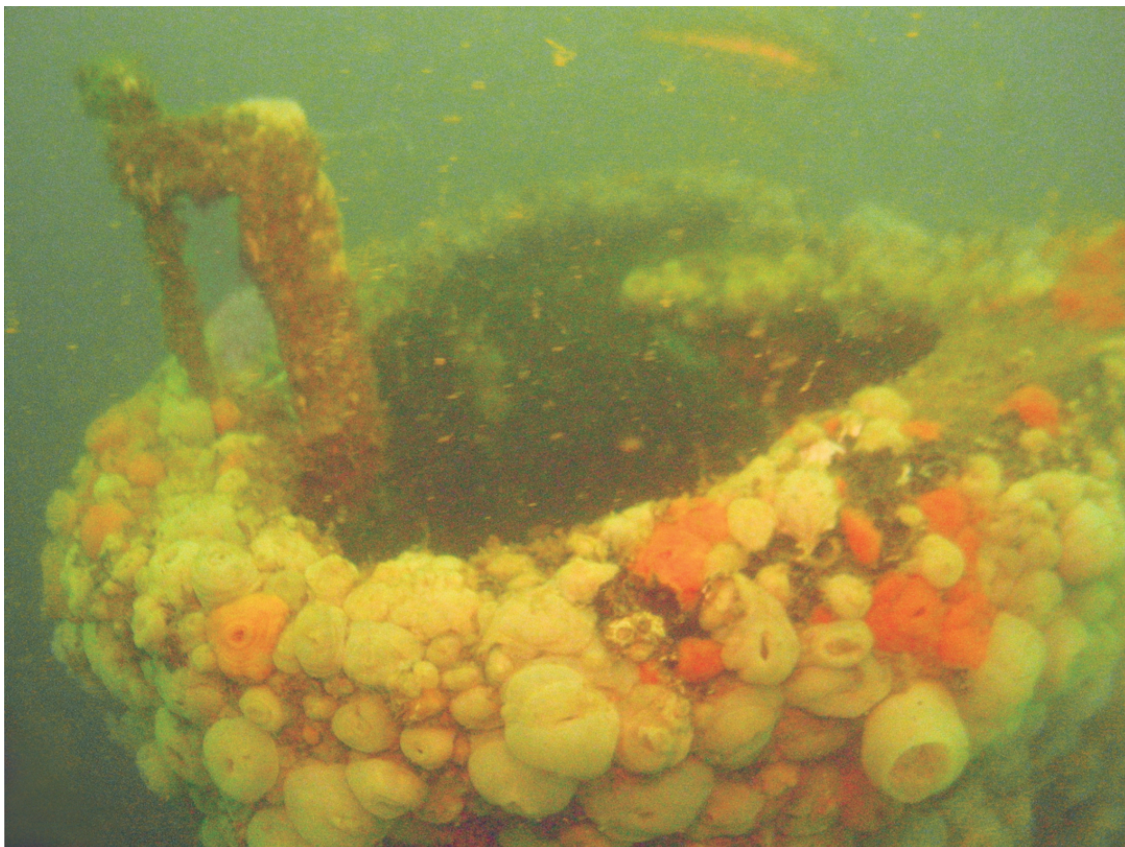
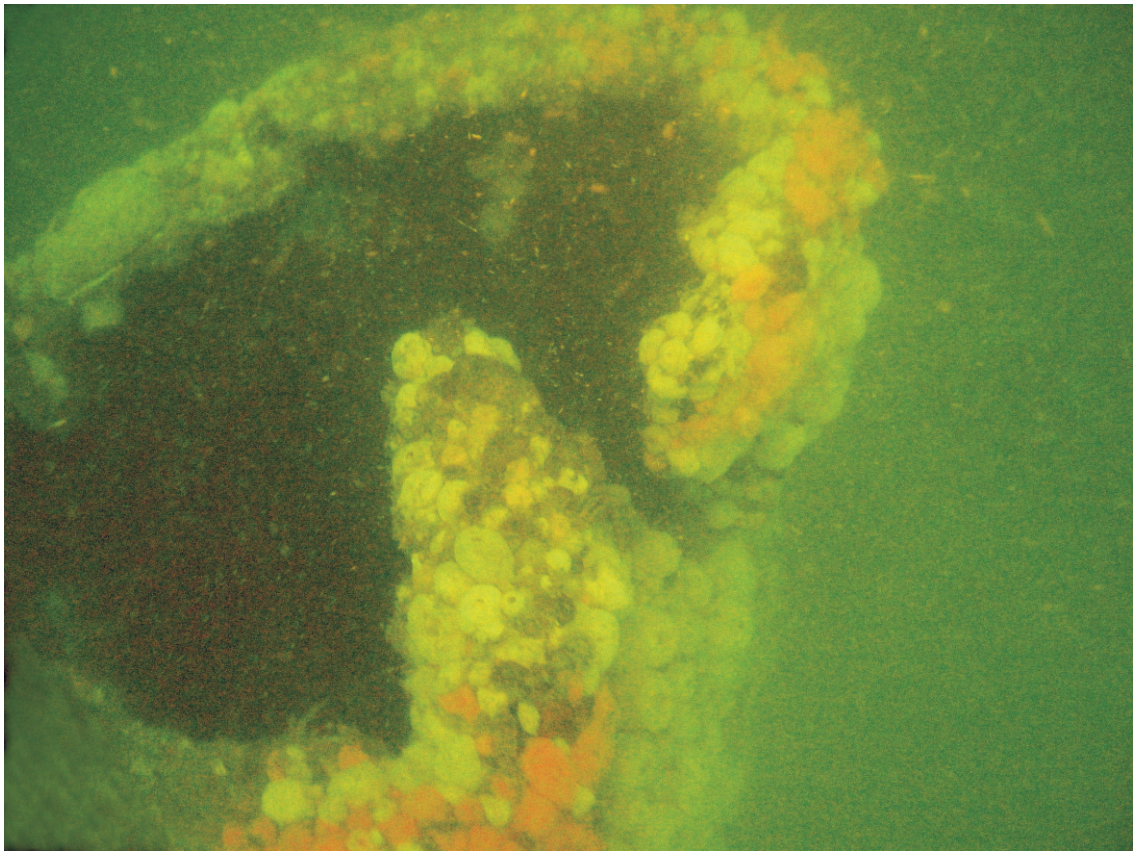
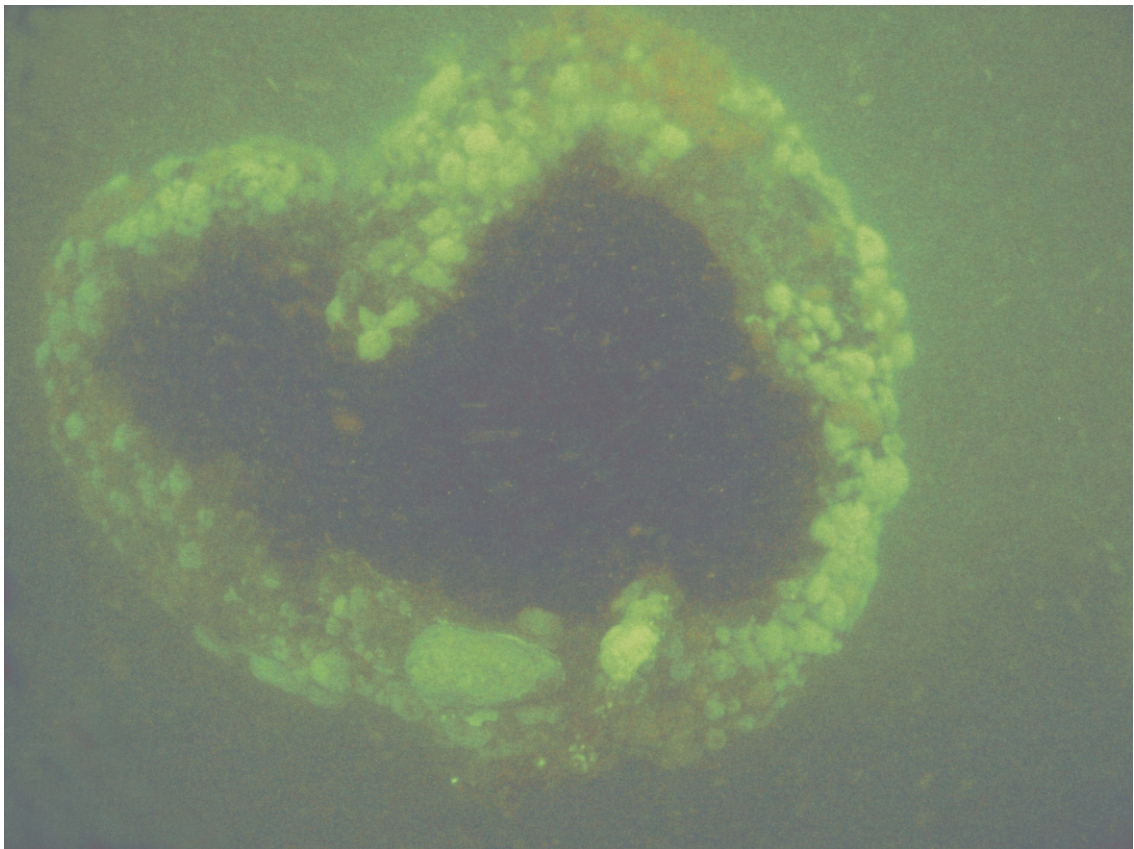
Plate 5. Damage to conning tower as observed by WA in 2006

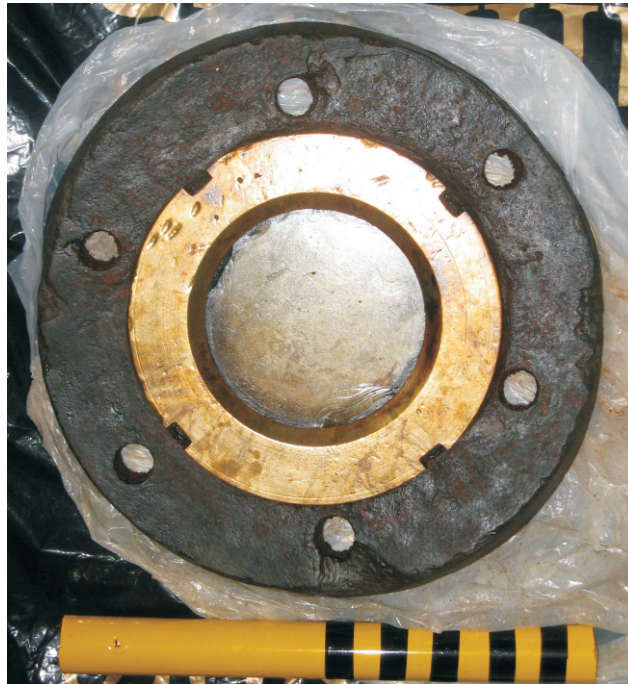
- 5.5.3. The porthole undergoing conservation in the Royal Navy Submarine Museum, Gosport was inspected by WA staff prior to the commencement of diving operations. The conservation effort appeared to be progressing well (though this is not the assessment of a trained conservator), it was photographed by WA staff and its condition is illustrated in **Plate 9**.

Plate 9. Porthole from conning tower, now in the Royal Naval Submarine Museum, Gosport

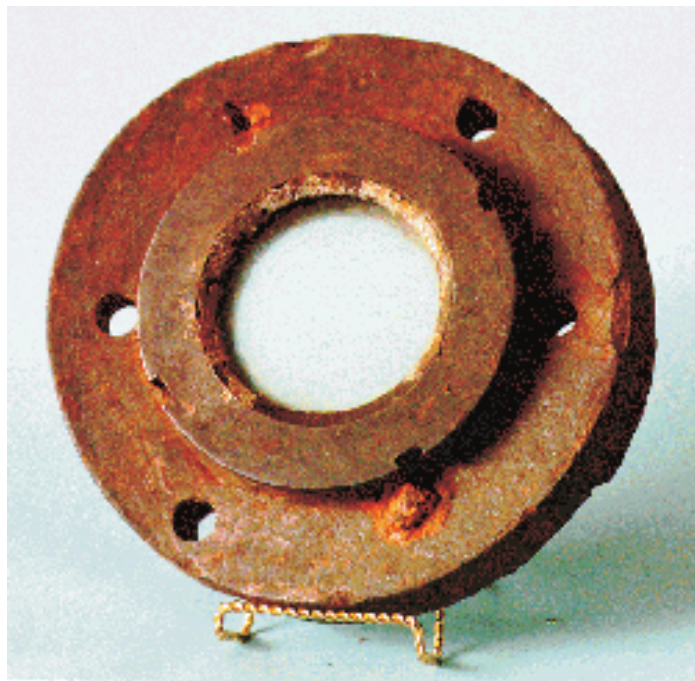
- 5.5.4. Bill Garrett was contacted by email regarding the porthole in his possession (**Plate 10**). Mr. Garrett replied that the porthole is kept in a solution of sodium carbonate in a stable low light area, and that this solution is changed every six months. This was recommended to Mr. Garrett by Martin Dean when he first received the porthole (Bill Garrett pers. comm.).

- 5.5.5. Mr. Garrett described the porthole as having visible cracking of the cast-iron flange, which was evident when he first received it into his possession, although those cracks are now wider than they were in 1996. There is evidence of a thin layer of the

hull of the conning tower (approximately 0.01m thick) adhering to the face of the cast iron flange, with evidence of a gasket between this layer and the casting. No change was reported in the condition of the brass retaining rings and glass, the glass remaining clear and transparent. Mr. Garrett also noted evidence of a gasket between the glass and the brass retaining rings.

Plate 10. Porthole from conning tower in the possession of Bill Garrett, as photographed in 1996
