Historic Building Recording at

**LOWER FARM
BOWLING BANK**

Client:	Tony Walsh
Local Authority:	Wrexham County Borough Council
NGR:	340913, 350545
Planning App:	P/2021/0604
Author(s):	E Ellis
Doc Ref:	LP4028C-HBR-v1.1
Site Code:	LP4028C / PRN 166988
Date:	September 21

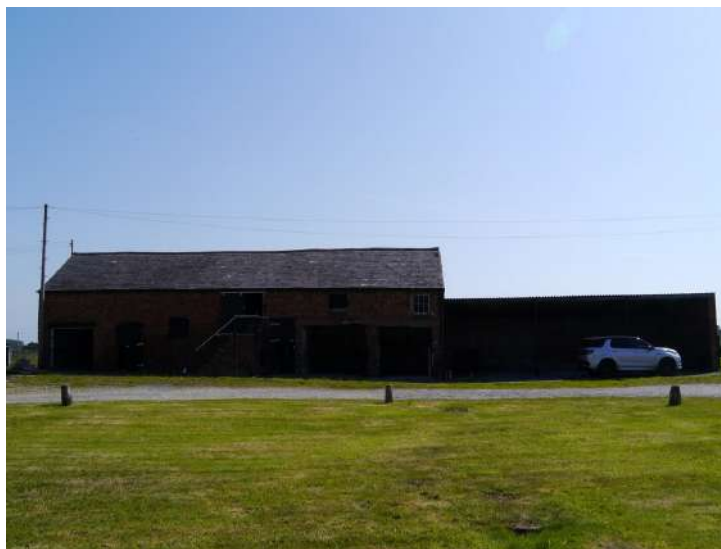
Plate 3 - South-west elevation

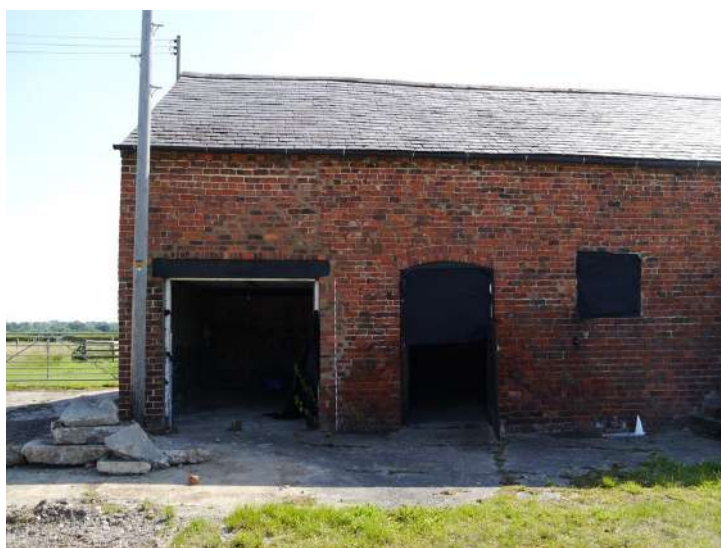
6.3.6. The north-west entranceway functioned as an access point into room B5, comprising of a timber frame, and solid timber beam lintel. There was a clear indication of restoration work to the surrounding fabric of the threshold, with an interruption to the brick bond arrangement which had been chased by a discolouration in mortar (PLATE 5). This may have potentially been the result of a later alteration phase to widen an original stable doorway.

Plate 5 - Room B5 threshold

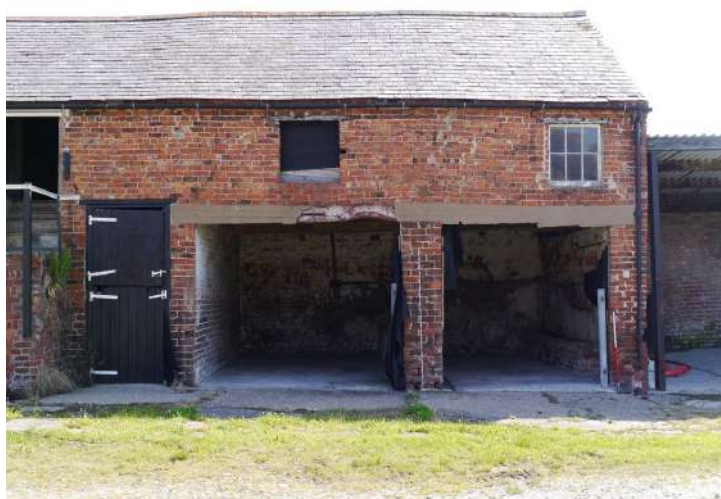
6.3.7. The two much wider entrance points situated on the far south-east elevation, comprised of solid timber beam lintels which were coated in etched plaster so to resemble a stretcher brickwork bond. B8 was marginally wider than the adjacent room B9 to the south-east (PLATE 6).

Plate 6 - Threshold of room B8 (left) and B9 (right)

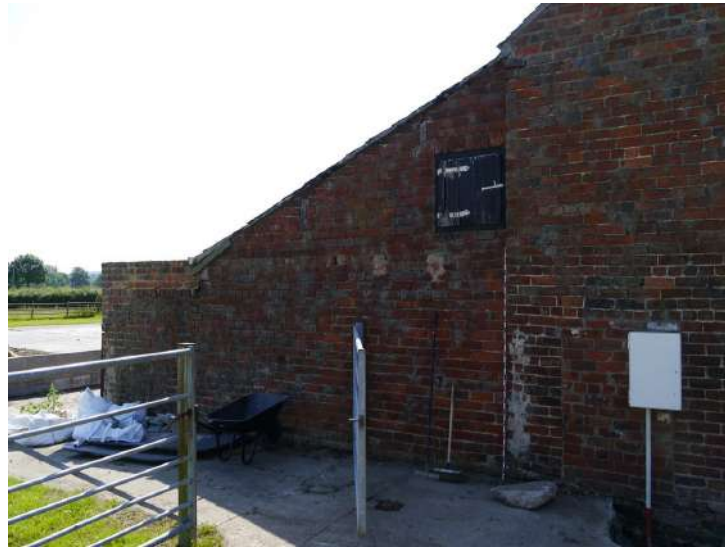
Plate 10 - Sealed feature

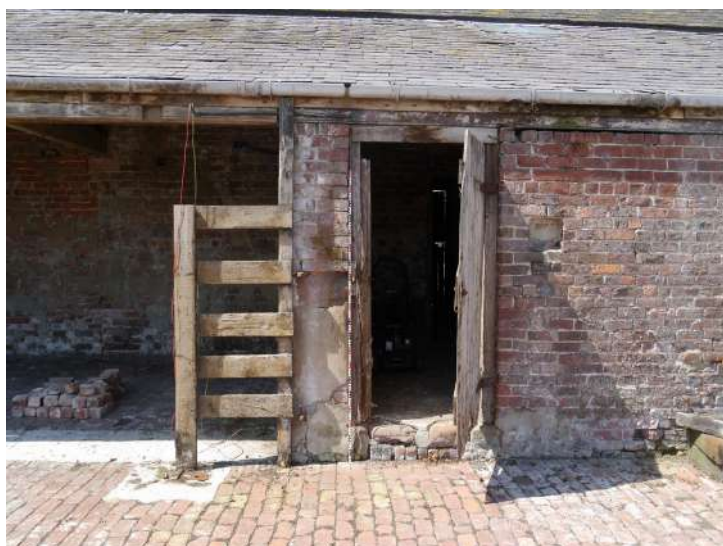
- 6.3.28. Situated directly north-west of B4, a doorway entrance leading into the internal B3 room. Extending from a stepped sandstone threshold above a row of brick headers, to the timber joist directly beneath the roofline, complete with a timber lintel (PLATE 13).

Plate 13 - Room B3 threshold

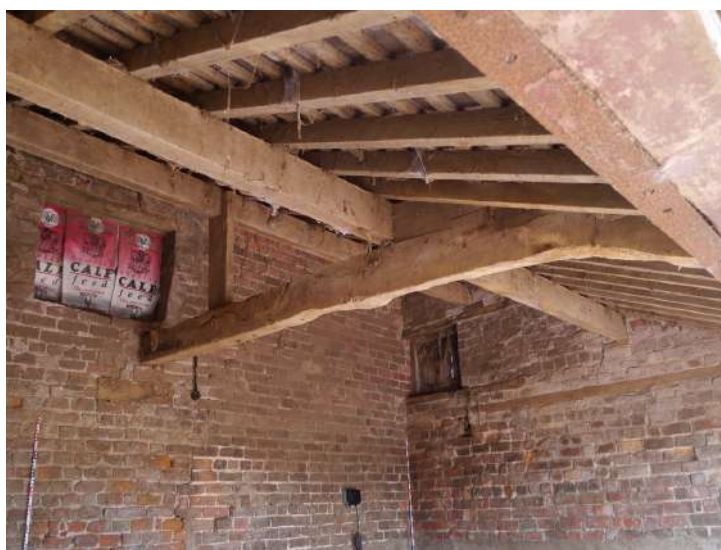
- 6.4.4. A small square pitching hole was positioned in the corner of the upper north-west wall, directly adjacent the south-west wall (PLATE 15). A horizontal timber blank lintel and sill was evident. Parallel to the opening on the south-east elevation wall was another pitching opening in similar dimension, complete with a horizontal timber blank lintel and sill fussed into the brick fabric, which would have created an opening into the adjacent Room 2. Features likely associated to an air ventilation system.

Plate 15 - Air ventilation window north-west wall room B1

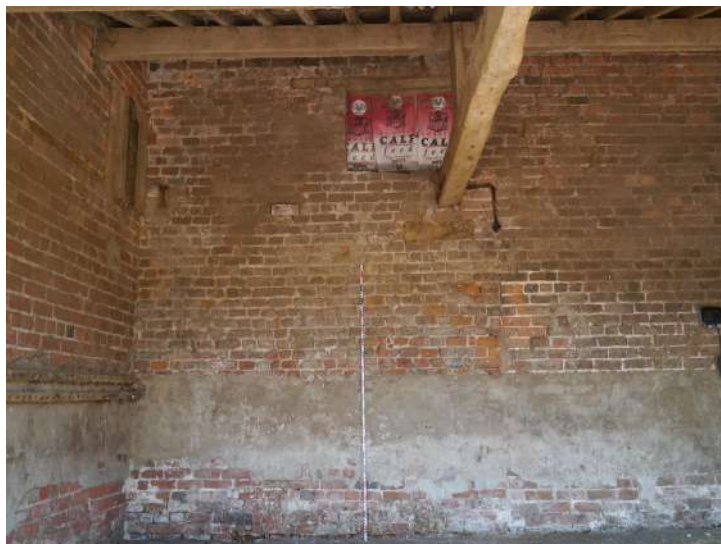
Plate 16 - South-west reconstruction wall room B1

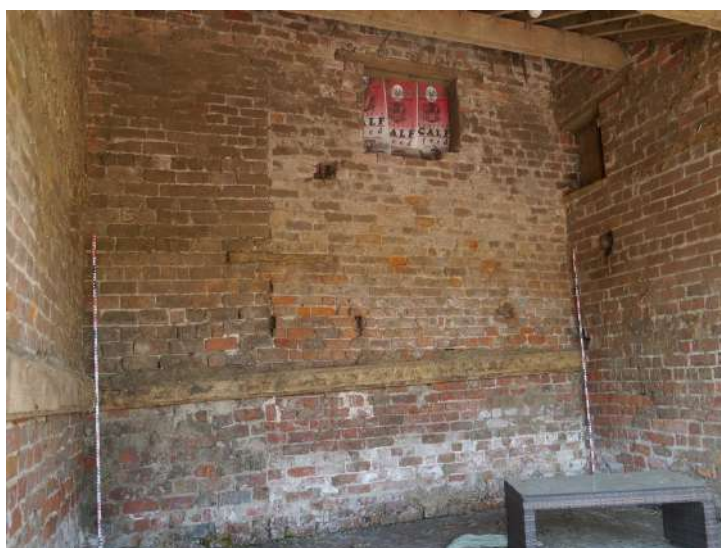
6.4.12. A reconstruction phase was evident as a clear vertical division score within the south-west brick fabric, distinguishable from the dissimilarity in brick colour and a break in bonding from the foundation to the roofline (PLATE 17). The later phase of brickwork extended from the centre of the wall to the north-west wall. Most likely associated to the similar feature seen in room B1 which would have probably been an original wide open Bay into room B6.

Plate 17 - South-west reconstruction wall room B2

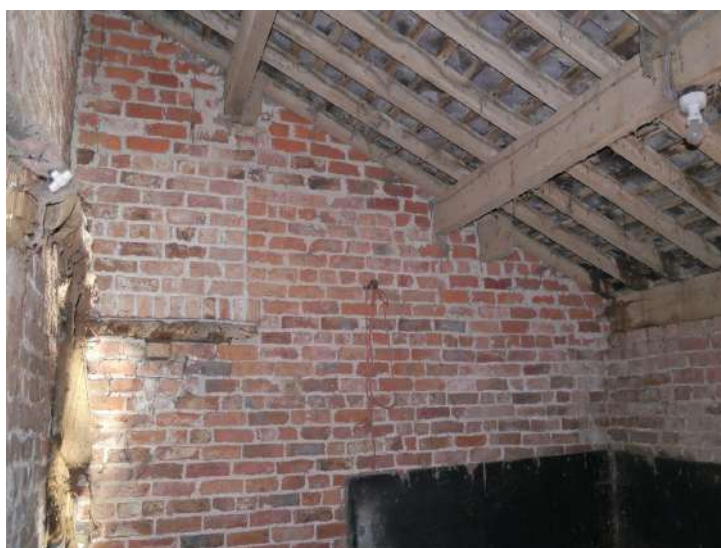
Plate 19 - Sealed air ventilation window north-west elevation room B3

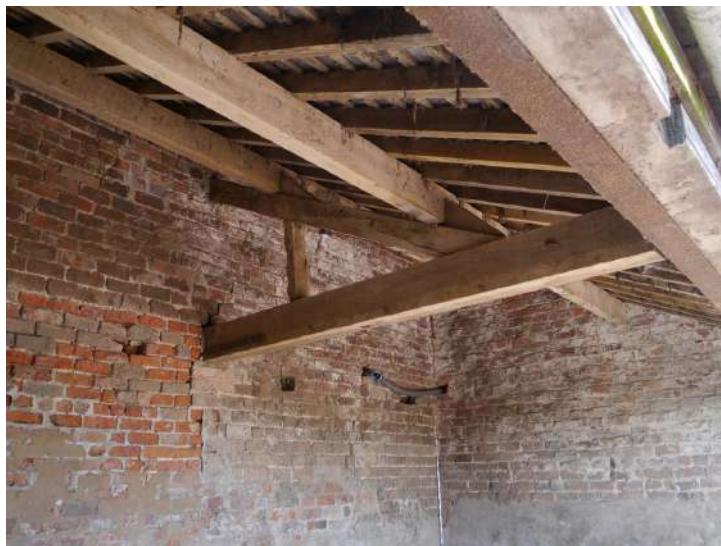
the north-west elevation wall (PLATE 21). Two purlins sat above the tie beam which were fused into the north-west and south-east walls. A series of common rafters rested above the purlins, extending in a declining fashion from the south-west wall to the steel joist of the north-west access point.

Plate 21 - Open roof with steel joist room B4

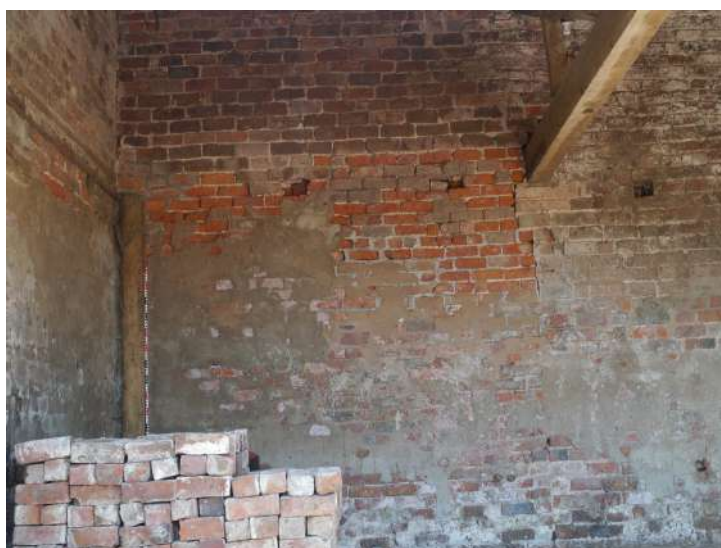
Plate 22 - South-west reconstruction wall room B4

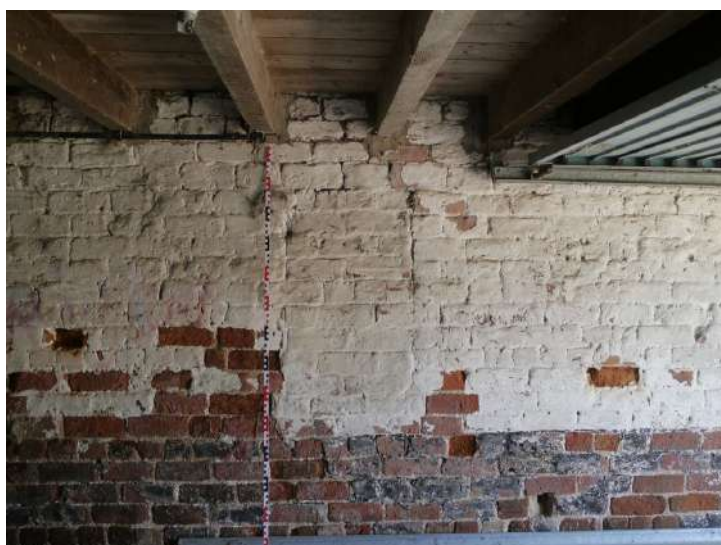
Plate 24 - Sealed air ventilation feature north-west elevation room B5

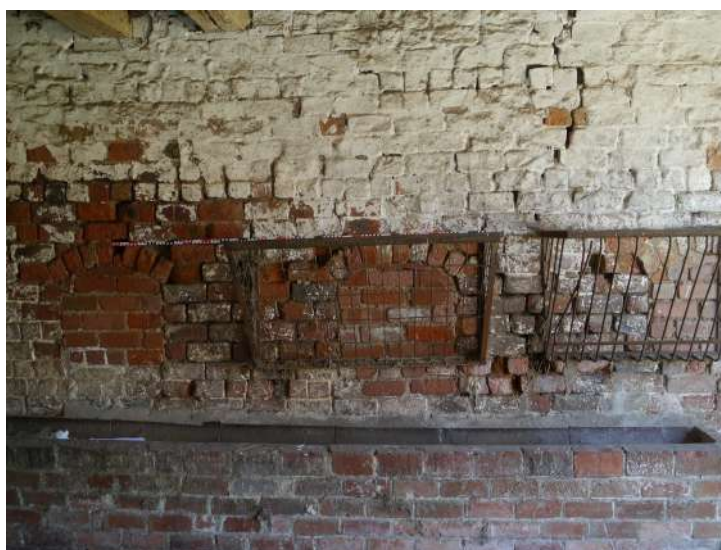
6.4.53. Three flat romanesque styled arched air ventilation windows were evident in a consecutive horizontal fashion along the centre of the south-east wall. Originally, the features would have formed an opening between room B8 and adjacent room B9, although, all three air ventilation windows were blocked in brick at a later phase (PLATE 30).

Plate 30 - Three sealed air ventilation features on the south-west wall in room B8
