Historic Building Recording at Springfield Farm Marford Hill

Report No. 22/4602C

A level 2 building survey was carried out at Springfield Farm, Marford Hill, Marford, LL12 8TD in December 2022 by Ethan Ellis and John Baker of MOLA on behalf of the client Blueprint Architectural Services Ltd.

The survey was requested by Clwyd Powys Archaeological Trust (hereafter CPAT) prior to the conversion of the barn into office buildings and took the form of a photographic and drawn survey in line with Historic England best practice and an agreed methodology, as laid out in a written scheme of investigation (Ellis 2022).

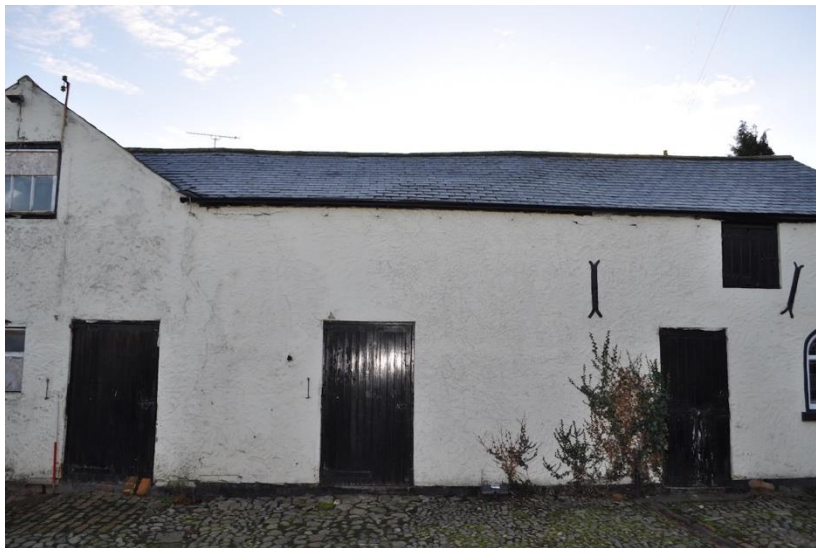
Plate 1 - North West Facing Elevation

6.2.1. The north west facing elevation the external façade is covered in a white render which obscures the brickwork (Plate 1). There is a slate roof which, according to the owner, was replaced in the 1980's. Towards the north east there is a single story lean to extension (Plate 2). Towards the south west, there is a single story cart shed which forms a further extension to the building (Plate 3).

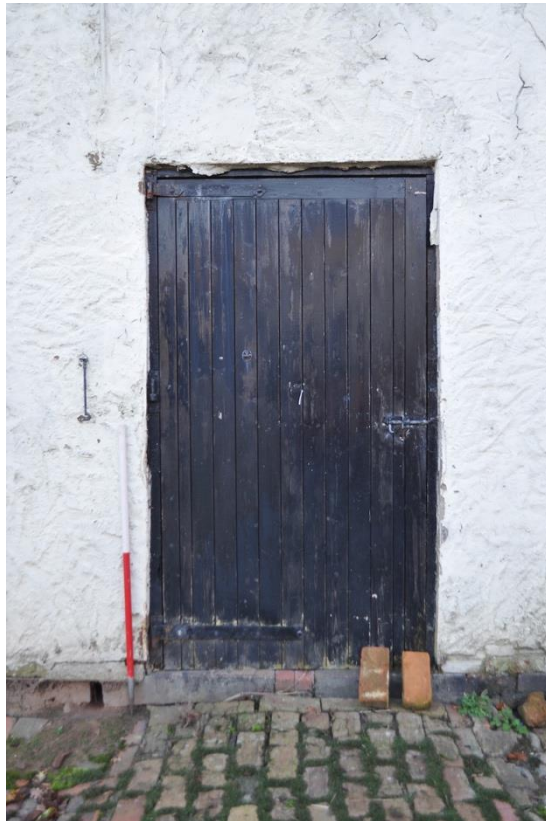
Plate 9 - Batten Door, North West Facing Elevation

6.2.3. There are five doors present on this elevation. From the north east side, the first three doors are constructed of wood in the batten style (Plate 9). With iron half barrel hinges and iron fittings (Plate 10). Towards the south west end of this elevation, the fourth door is again of wooden construction and split in the Dutch style (Plate 11). The fifth door is currently a modern metal garage style door covering a substantial opening in what was the cart shed for the farm (Plate 12).

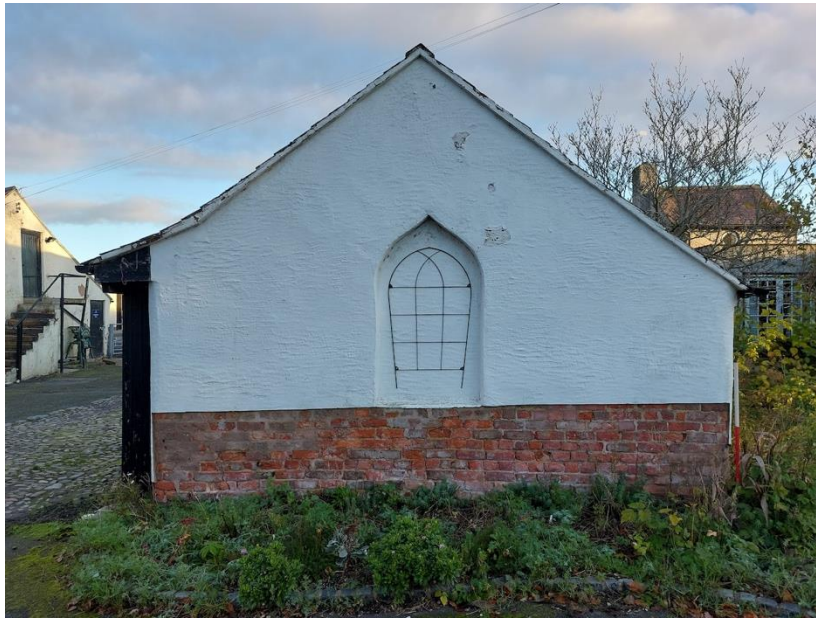
Plate 16 - South West Facing Elevation

- 6.3.1. The south west facing elevation has been covered in a white render which obscures most of the brick work (Plate 16). The roof observed is identical to the slate roof described above – new blue grey shingles. The shingles themselves were measured on the cart house roof, they have a width averaging 0.25-0.26m.

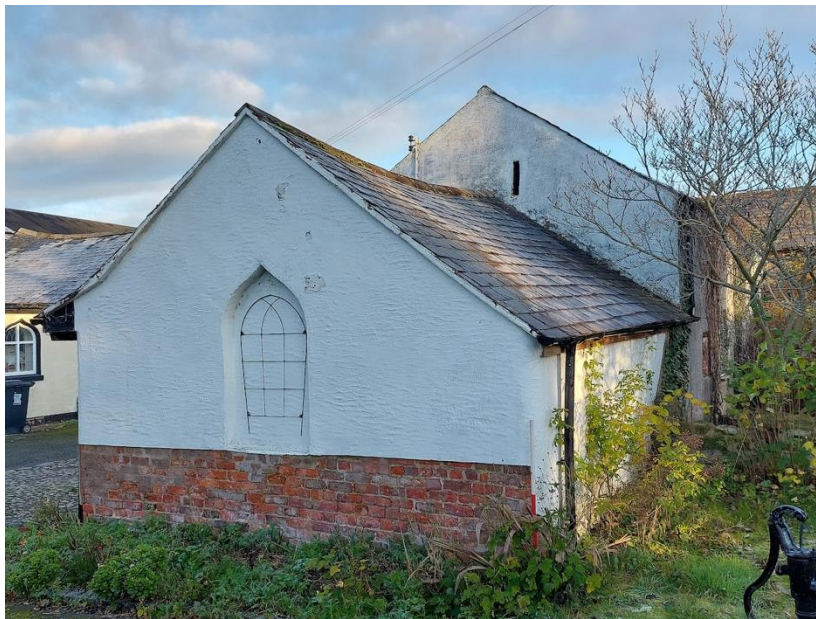
Plate 17 - South West Facing Elevation Showing Air Vent

6.3.2. The gable end of the main bulk of the building has a single air vent on the south east side, this suggests that the first floor may have once been utilised as a hay loft (Plate 17).

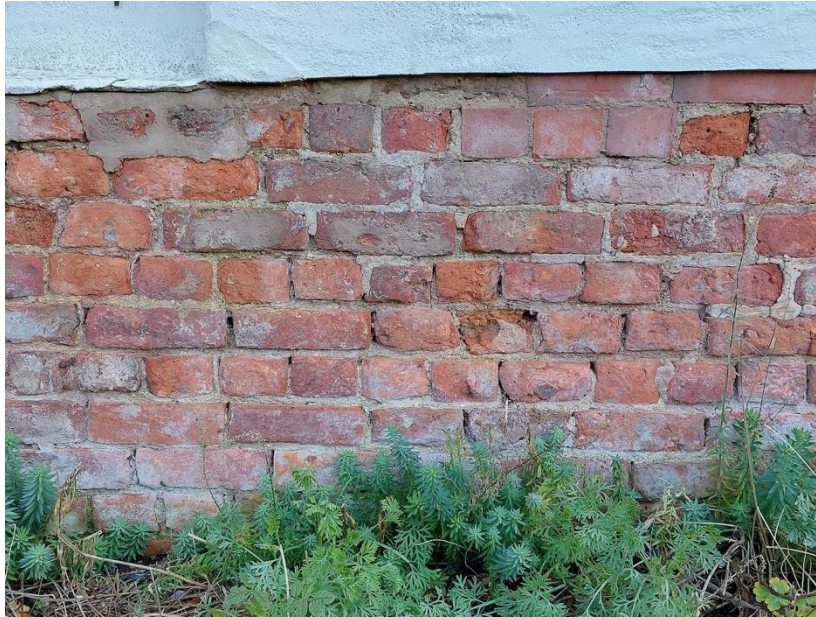
Plate 18 - Detail Shot of Brickwork on South West Facing Elevation

6.3.3. The gable end of the cart house is covered in the same white render but for the lower ten courses of brickwork (Plate 18). The bricks themselves are handmade with large inclusions of pebble and stone evident, suggesting a pre 19th century date of construction. The dimensions are 0.27m L x 0.07m D x 0.11m W and they are laid in an irregular bond. There is some evidence of repair work with modern machine made brick on this elevation (see Plate 18).

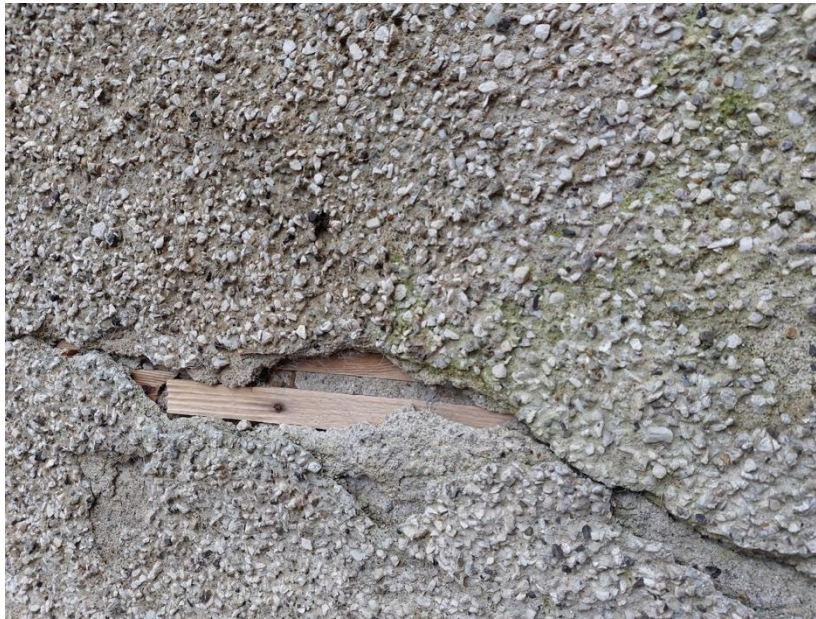
Plate 20 - Detail Shot Showing Lath and Plaster Render on South West Facing Elevation

this portion of the building. The render is attached using a lath and plaster technique (Plate 20).

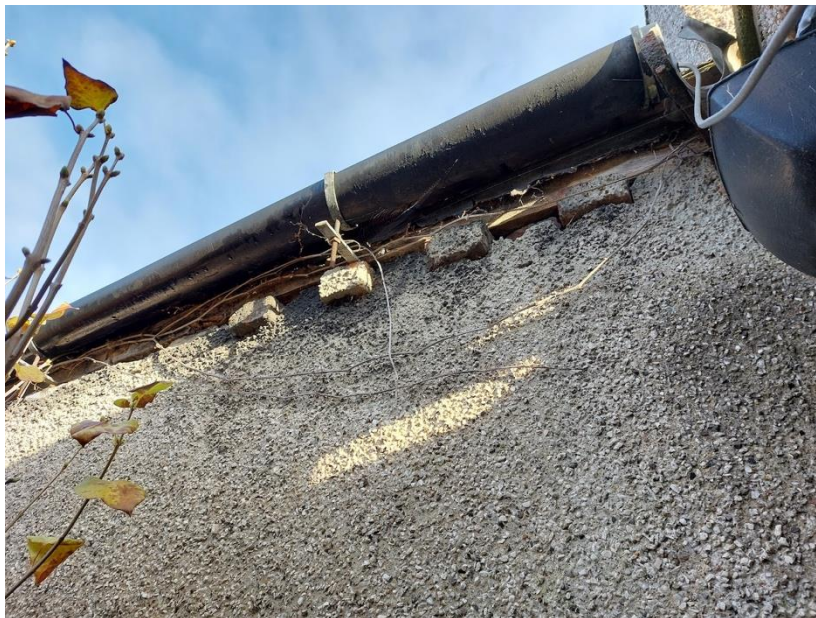
Plate 23 – Dental course brickwork on South West Facing Elevation

6.3.7. There is also dental course brickwork towards the roofline on the far south east of this elevation. This motif was not observed elsewhere in the building but is evident on the adjoining cottage (Plate 23).

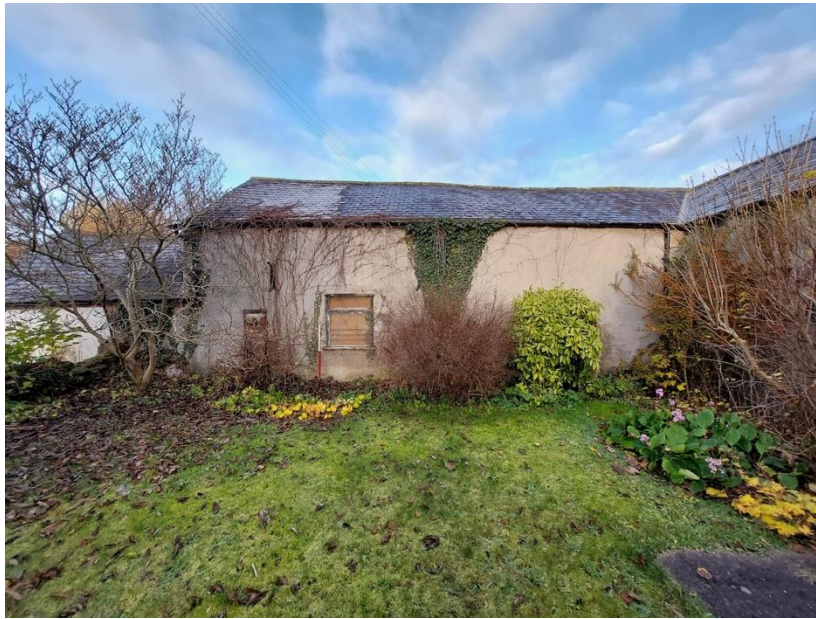
Plate 24 - South East Facing Elevation

6.4.1. On this elevation, towards the south west, the white render continues to wrap around the rear of the cart house (Plate 24). This then stops and is replaced with the pebbledash render described in 6.3.5 above. These renders obscure

the brickwork with the exception of the lower ten courses on the cart house as described in 6.3.3.

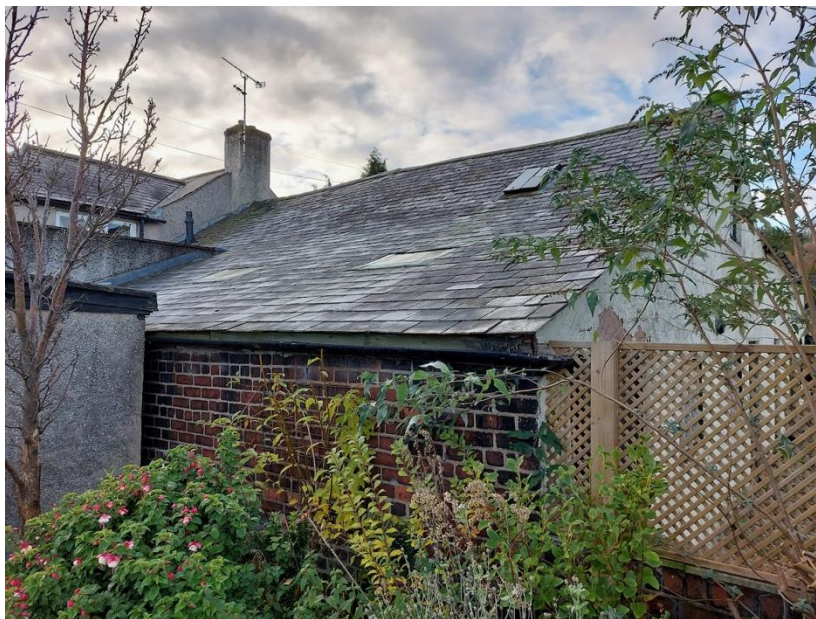
Plate 28 – North East Facing Elevation

6.5.1. The north east facing elevation is entirely taken by the lean to extension and it's roof. The gable roofline of the building is continued by the shed roof of the extension. Three skylights are visible, one in the gable roof and a further two in the shed roof of the extension. All are metal framed and single glazed (Plate 28).

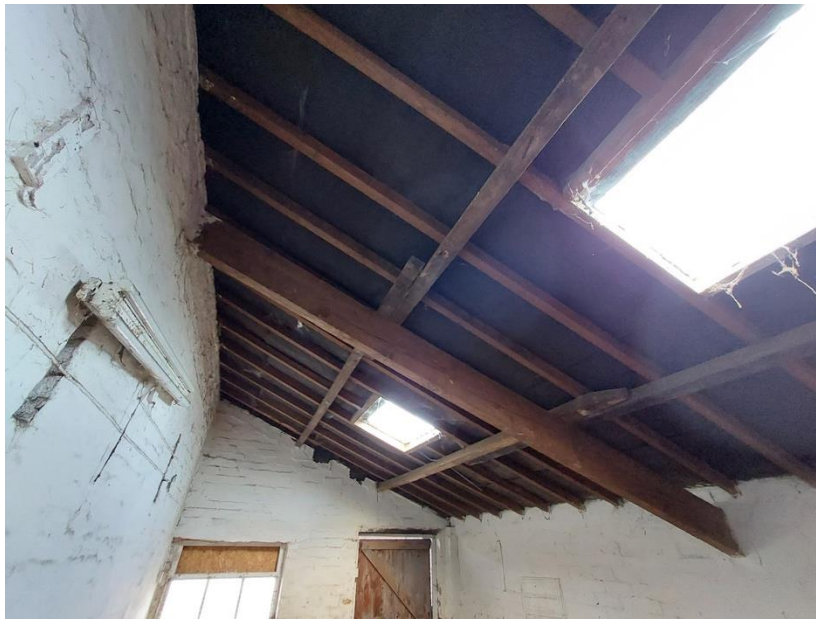
Plate 29 - Exposed Roof in Room G1

- 6.6.1. Room G1 is the lean to extension on the north east end of the building. The exposed ceiling in room G1 shows the roof construction (Plate 29). The timber which makes up the superstructure of the roof of this room is modern and saw cut – saw marks were evident on the timber framing, the purlins and rafters are exposed, and a waterproof membrane is also visible.

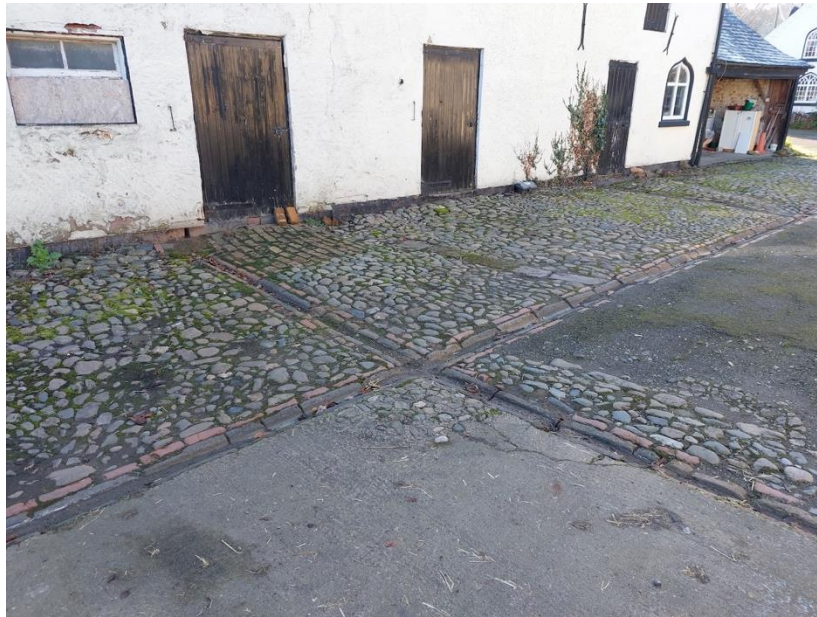
Plate 30 - Exposed Cobbled Surface in Front of North West Facing Elevation

- 6.6.2. The floor is made up of a layer of concrete. In front of the north west elevation, there is a cobbled surface (Plate 30), it is possible that the floor in rooms G1-5 were also once cobbled.

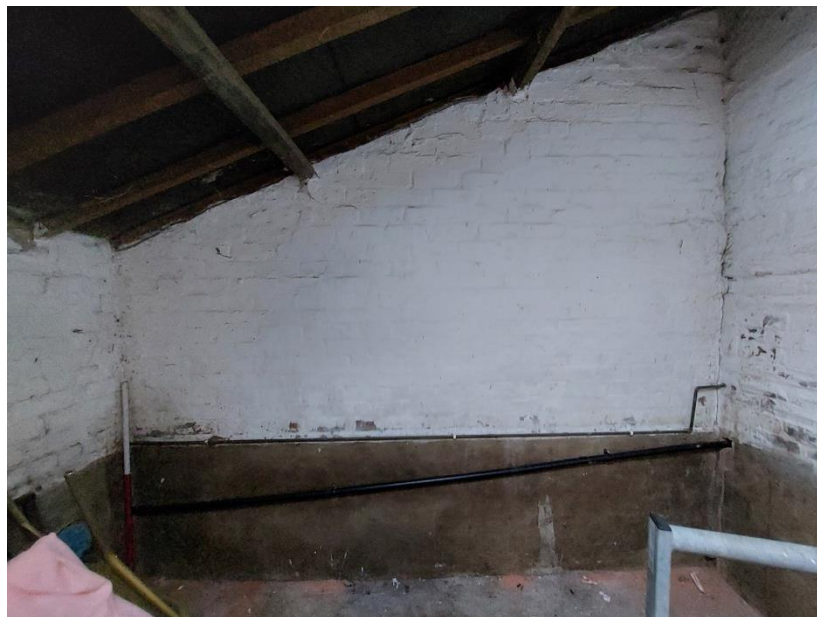
Plate 31 - North West Facing Elevation of Room G1

6.6.3. The north west facing elevation of this room is of brick construction. At the mid point of the elevation to the floor level, there is a render that is designed to protect the brickwork from livestock. The upper portion of the elevation, the brickwork has been whitewashed (Plate 31).

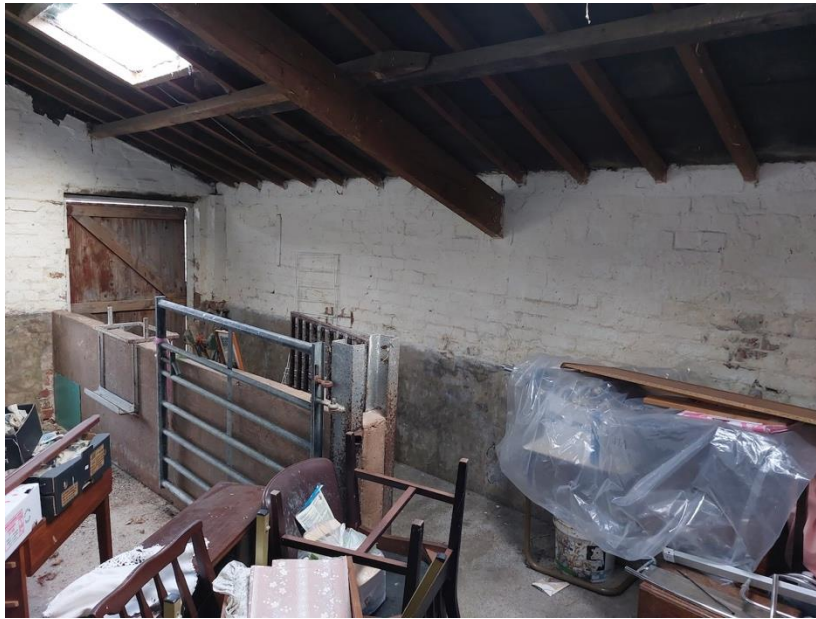
Plate 32 - South West Facing Elevation of Room G1

6.6.4. The south west facing elevation is much lower in height owing to the sloping shed style roof. The lower portion of the wall has been covered in render and the upper exposed brickwork has been whitewashed (Plate 32)

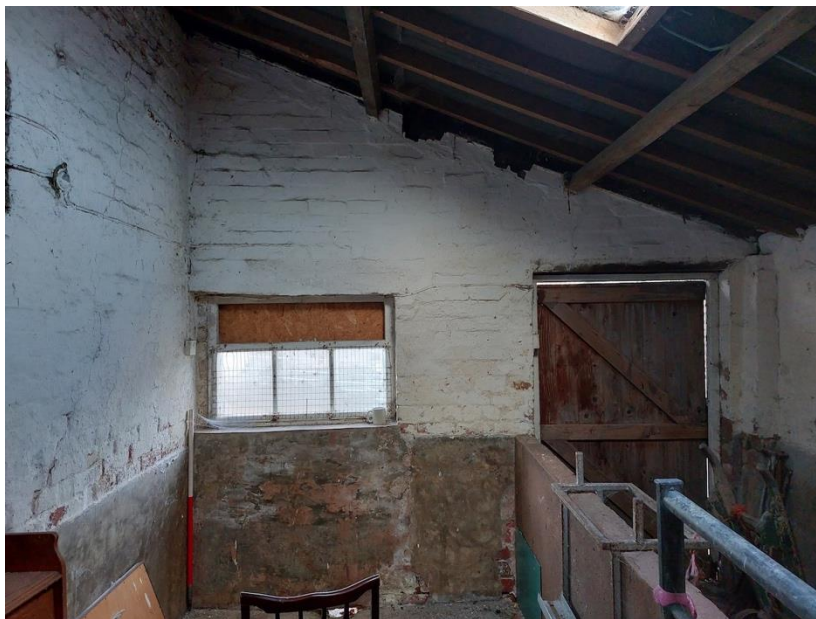
Plate 33 - South East Facing Elevation of Room G1

6.6.5. The south east facing elevation similarly has been covered in a combination of render and white wash. There is also a timber framed window (as described in 6.2.2) with a concrete and brick sill. A door is present in the north east side of this elevation. It is of a batten construction and the wood appears to be modern and saw cut (Plate 33).

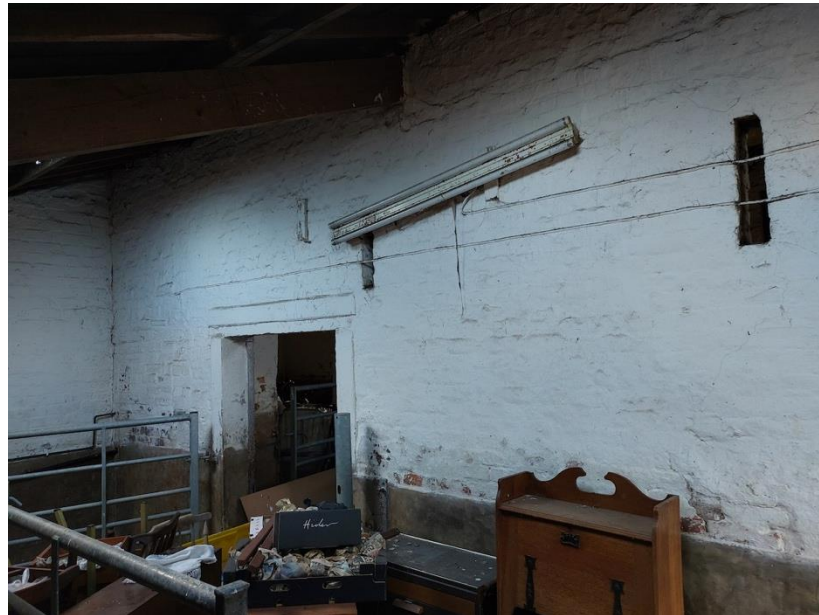
Plate 34 - North East Facing Elevation of Room G1

characterised by smaller brickwork in a less regular coursing. The higher courses of this elevation also appear to be made from machine made brick, suggesting that the roof may have been raised at some point since the middle of the 19th century. Towards the south east side of this elevation there is a low doorway capped with a wooden lintel. In the lower corner of the south east side, there is a disused gate hinge which likely served an external gate when this elevation was the external face of the building (Plate 34).

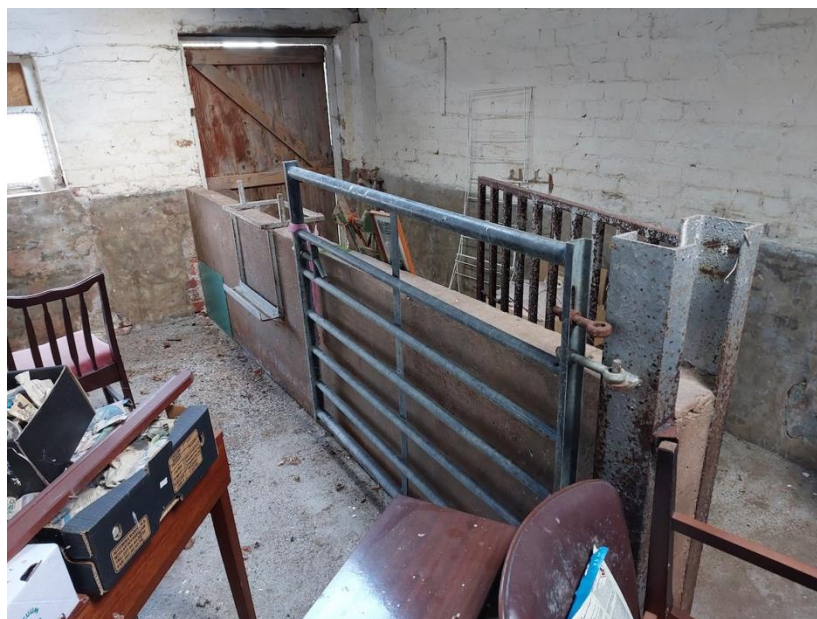
Plate 35 - Livestock Pens Room G1

6.6.7. Within the room there are livestock pens for cows constructed of metal (aluminium and steel) and concrete (Plate 35). These look to be of a modern design.

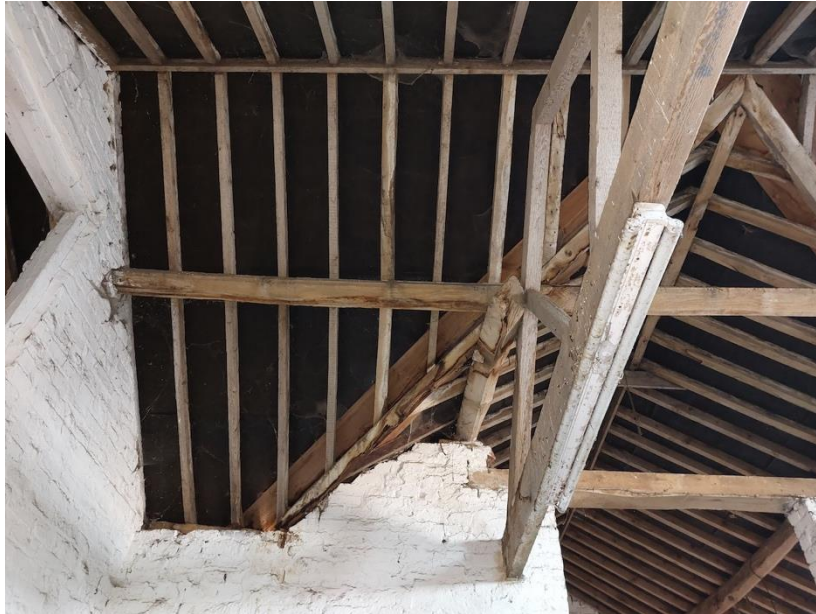
Plate 36 - Exposed Roof in Room G2

6.7.1. The roof of room G2 is exposed and the structure can be clearly seen. The structure as a truss frame. Some of the exposed wood appears to be new and machine cut, other pieces appear much older and were likely recycled when the roof was repaired in the 1980s (Plate 36). The upper courses of brickwork also appear to be more modern which would suggest that the roof may have been raised at some point in its life, likely since the middle of the 19th century, given the brick type.

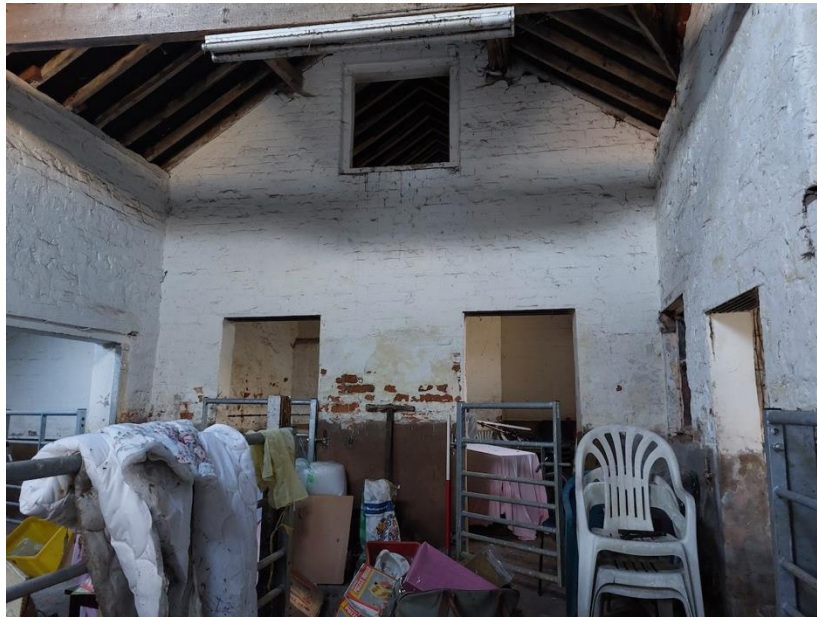
Plate 37 - North West Facing Elevation of Room G2

6.7.3. The north west facing elevation is double height with two low doorways in the north east and south west ends (Plate 37). The doorways have been accommodated in the brickwork, though have new metal reinforcements above (Plate 38). The doorways are higher than the beam slots described below (6.7.6) so were likely a later modification. Each doorway has a metal gate suggesting a one way system for cattle. These doorways lead into room G3. In the upper half of the elevation there is a single square opening with a timber frame. The elevation is of handmade brick construction – the upper portion of which has been white washed, and the lower has been rendered.

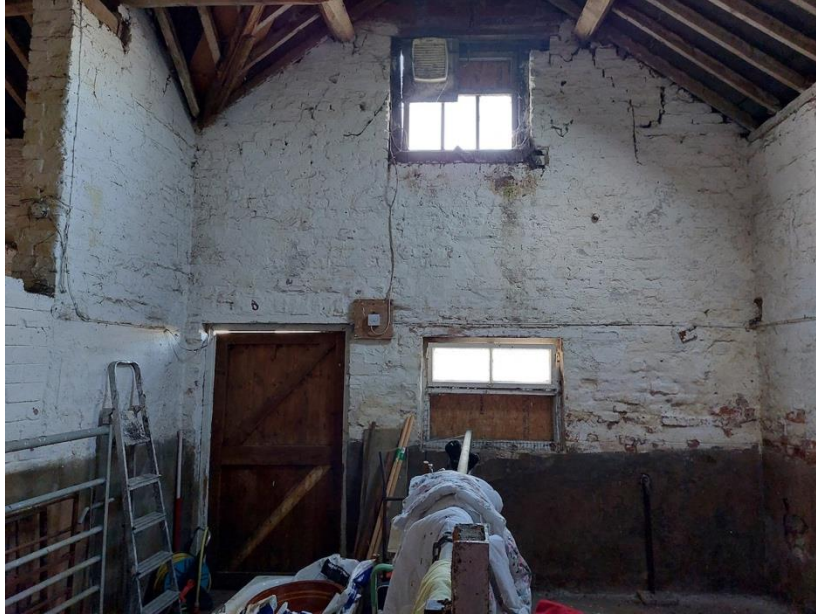
Plate 41 - South East Facing Elevation of Room G2

wood. Below and off centre towards the north east is a further window which is of timber construction. It is single glazed and of a similar construction to the window above. To the south west of this elevation, there is a wooden door of batten construction matching the one seen in room G1, which leads to the outside (Plate 41).

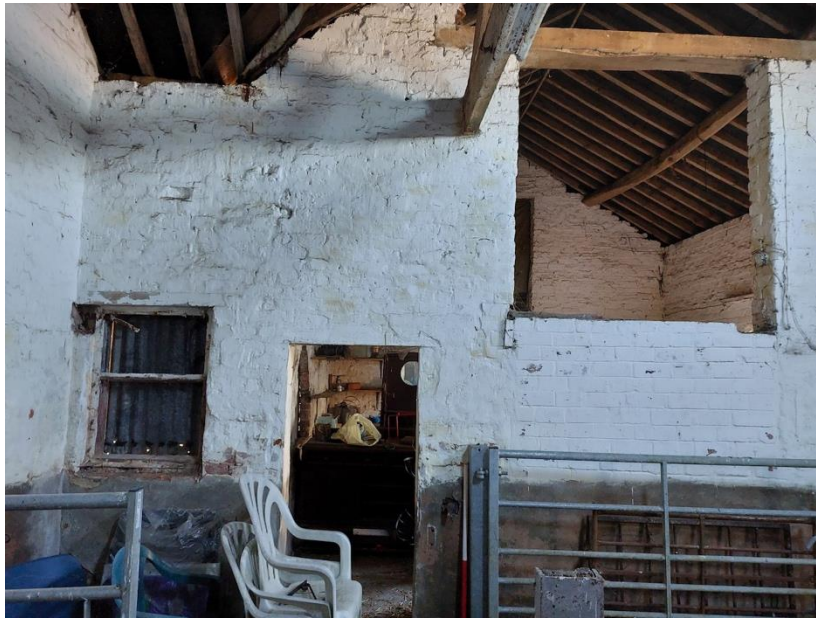
Plate 42 - North East Facing Elevation of Room G2

6.7.6. The north east facing elevation is double height and of handmade brick construction. The elevation has been whitewashed in the upper portion and rendered in the lower. In the centre of this elevation there is a large opening. This opening is accommodated in the brickwork so would have been an original feature. This likely permitted access between rooms G2 and G4 in the hay loft. The brickwork directly below this gap appears to have been replaced with more modern material. The whitewash covering makes it difficult to determine. The dimensions of the bricks below the opening are identical to those seen in the rest of the construction of rooms G2, G3 and G4 (i.e. 0.23m L x 0.07m D x 0.12m W). There is a doorway in the south east corner of this elevation allowing access into room G4. The doorway is also shorter than those on the north west facing elevation and below the level of the beam slots suggesting that this opening is original which accommodated the ceiling height. Next to this there is a window of timber frame construction with a stone sill which has been boarded up (Plate 42).

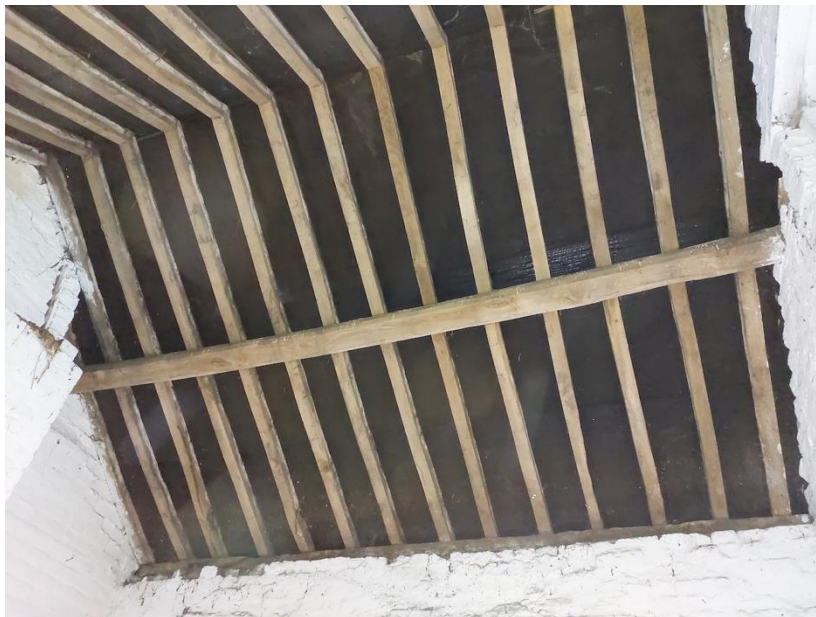
Plate 43 - Exposed Roof in Room G3

6.8.1. The ceiling is entirely exposed in room G3, it is of a timber truss construction and the superstructure and waterproof membrane are clearly visible (Plate 43).

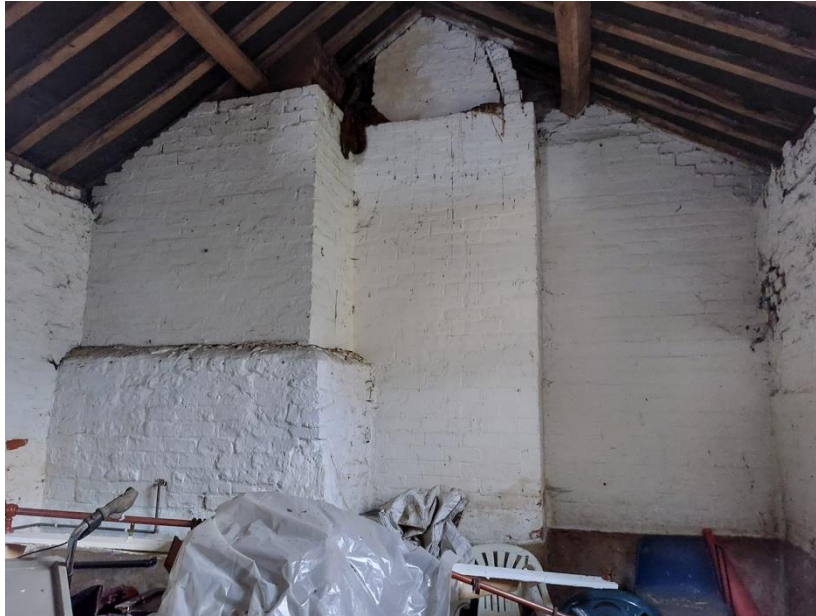
Plate 44 - North West Facing Elevation of Room G3

Cottage (Plate 44). The brickwork has been whitewashed and rendered in an identical way to the elevations seen in rooms G2 and G1 again suggesting that this was utilised for livestock.

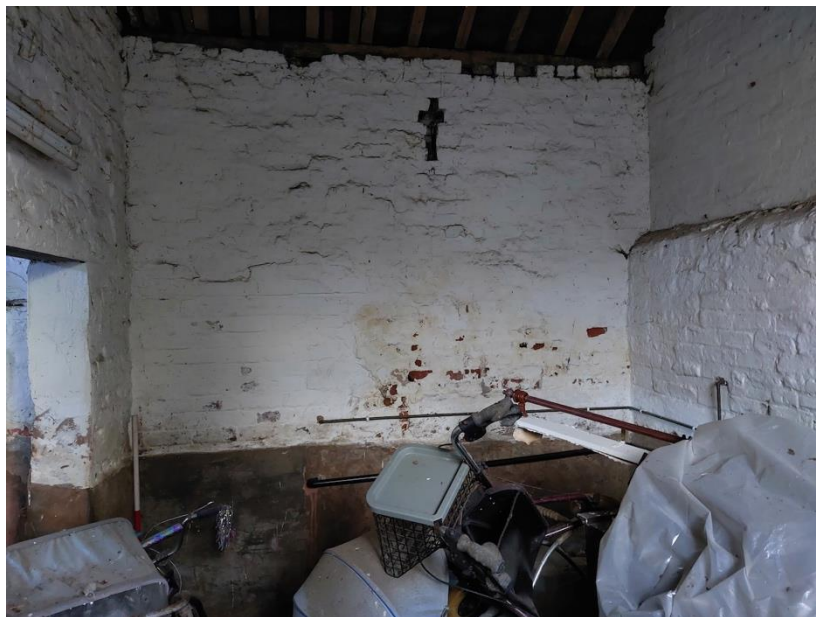
Plate 45 - South West Facing elevation of Room G3

6.8.4. The south west facing elevation is of handmade brick construction which has been whitewashed and rendered (Plate 45). Off centre and towards the roofline of this elevation, there is a cruciform opening (Plate 46). This is typical of the surrounding architecture in the village of Marford and a common distinctive marking of the surrounding buildings (along with the ogee windows and white external render).

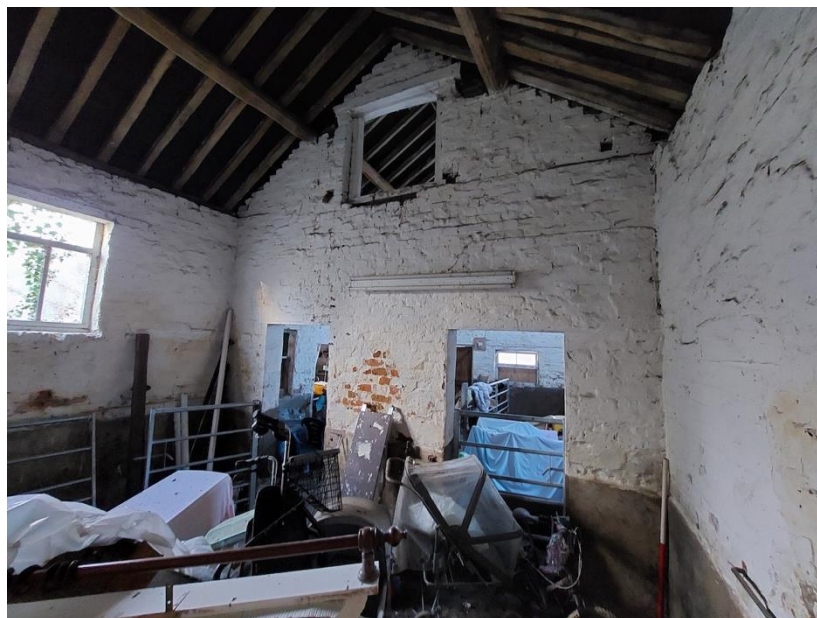
Plate 47 - South East Facing Elevation of Room G3

6.8.5. The south east facing elevation of room G3 is covered in white wash and render in the fashion previously described. There is a square upper window into the pitch of the roof and two lower doorways (as described in 6.7.3) (Plate 47).

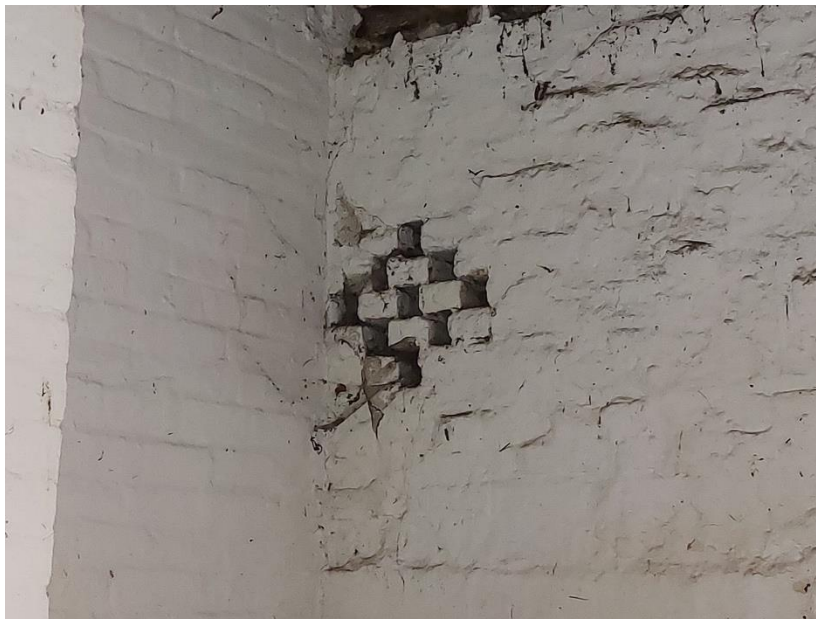
Plate 49 - Detail Shot of Air Vent on North East Facing Elevation of Room G3

there is brick air vent. This may suggest a storage purpose for this room or that it was used to house livestock – the vent would regulate heat produced by the animals and encourage air flow (Plate 49).

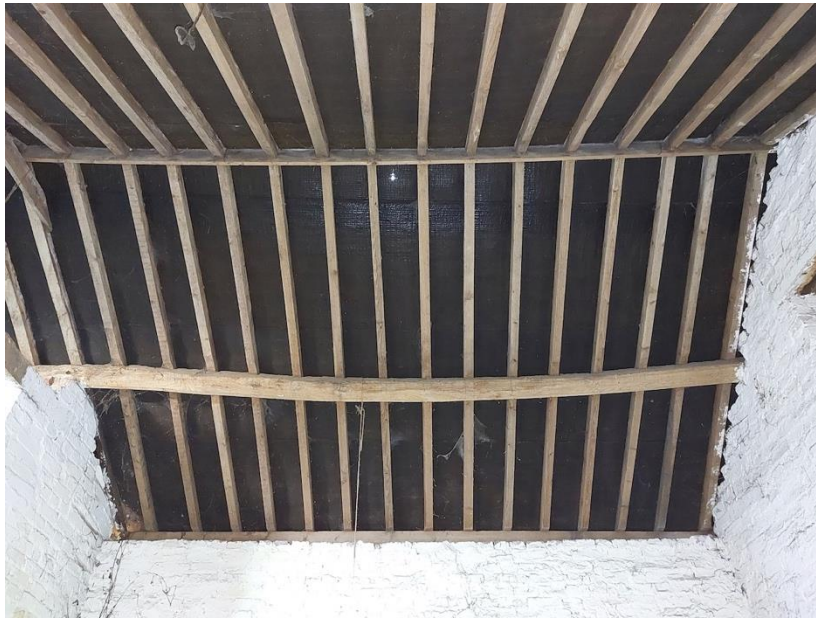
Plate 50 - Exposed Roof in Room G4

6.9.1. The roof of room G4 is a continuation of that seen in G2, the structure is visible as is the waterproof membrane. There is a mix of machine cut timber and older recycled wood that makes up the structure (Plate 50).

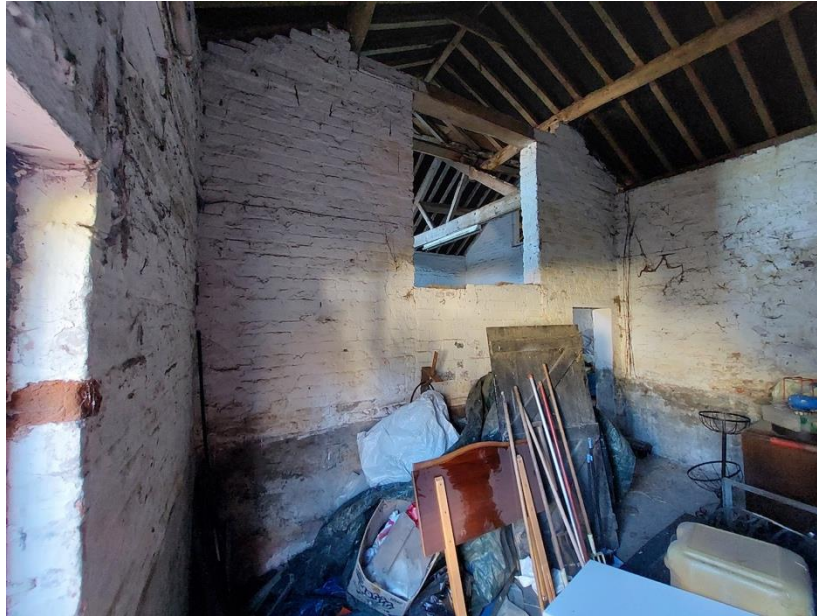
Plate 52 - South West Facing Elevation of Room G4

where the first floor would have been, allowing access into room G2. There is also a doorway to the south eastern end of this elevation (doorway and hay loft opening described in detail in 6.7.6) (Plate 52)

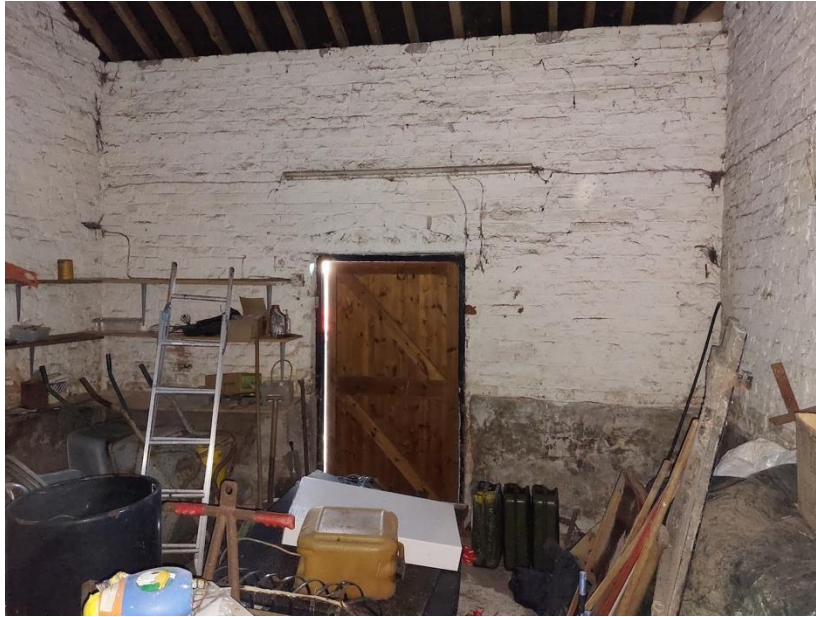
Plate 53 - South East Facing Elevation of Room G4

6.9.5. The south east facing elevation of G4 is built of handmade brick and has been covered in white paint and render on the lower portion (Plate 53). There is a central batten door which matches those seen in rooms G2 and G1. This doorway is a later amendment to the original design. Above the current doorway, there is a flat archway wider than the current entrance (Plate 54). Modern brick has also been cut and inserted either side of the door to narrow the entrance and accommodate the current doorway (Plate 55). The original, taller, wider, arched entryway was likely constructed for ease of access for livestock or horses.

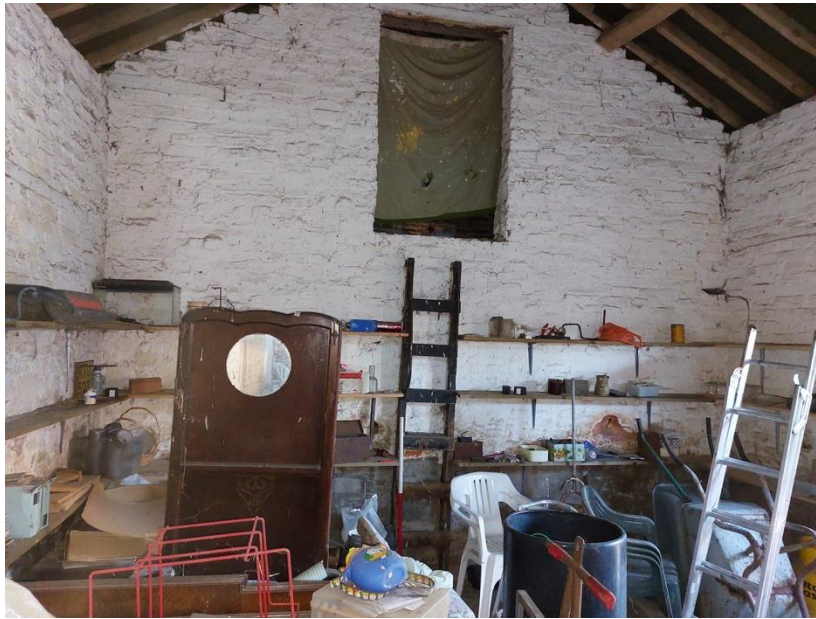
Plate 56 - North East Facing Elevation of Room G4

6.9.6. The north east elevation is of handmade brick construction and is covered in a combination of white wash and render. In the centre of this elevation is a rectangular opening not dissimilar from that seen on the south west elevation. However, this opening is smaller and begins two courses of brickwork higher up. The surrounding brickwork for this opening also appears to have been damaged suggesting that this opening was a later addition permitting an extension of the hay loft above rooms G1-4 through to room F1. This would suggest that room F1 initially had a different purpose that was not necessarily connected to the storage of fodder (Plate 56).

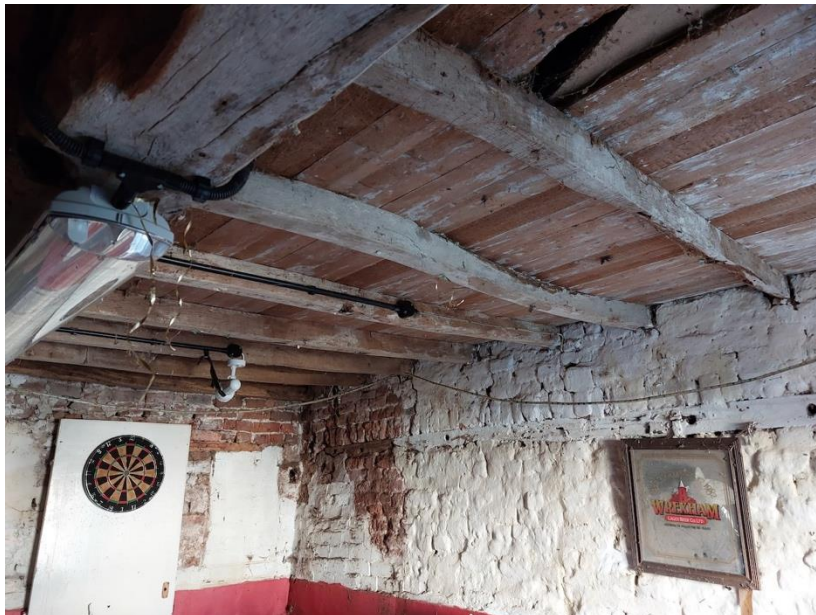
Plate 57 - Ceiling in Room G5

6.10.1. The ceiling of room G5 looks to be original (though see 6.10.4 and 6.10.6 below). The thick wooden beams are not machine saw cut and the floor-boards look to be contemporary (Plate 57). Towards the east corner of the room, there is a section of the floor above which has been replaced by a modern piece of compound wooden board (Plate 58). This may indicate the presence of a previous access to room F1 above.

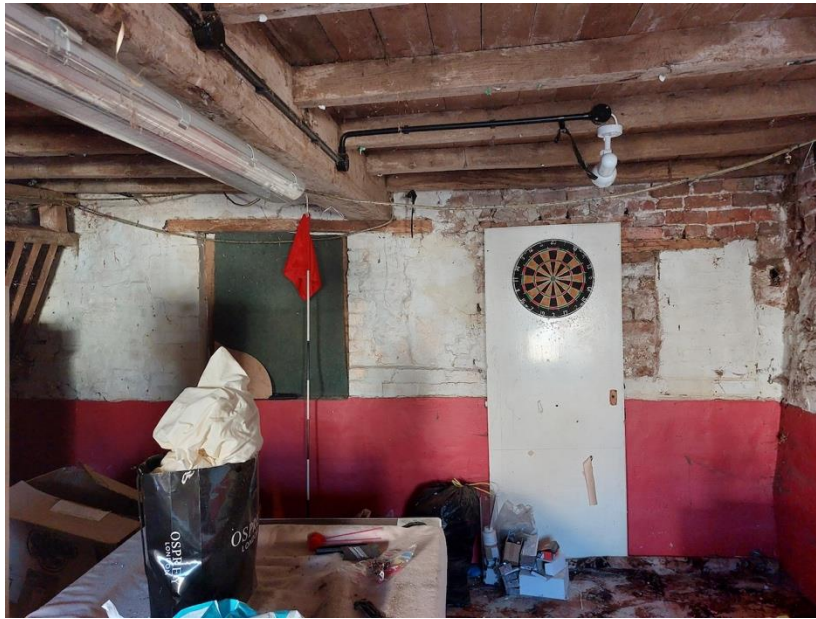
Plate 59 - North West Facing Elevation of Room G5

- 6.10.3. The north west facing elevation of room G5 is of brick construction, the brick is handmade with clear large inclusions (0.23m L x 0.08m D x 0.13m W). The upper half of the brickwork has been mostly whitewashed though the lower half covered in a cement render which has been painted red. The render, along with the concrete floor would strongly suggest that G5 was once used to house livestock (Plate 59). Towards the north east side, there is a large boarded up window with a wooden frame and lintel (Plate 60). The brickwork around this window is modern and so this is likely a later insertion. Behind where there is currently a dartboard and white wooden support, there is a bricked up window, though a clear image was difficult to attain given the dart board and surrounding wooden support affixed to the brickwork. Next to this and towards the south west, there is a further bricked up small window. The wooden lintel is still extant though the sill appears to have been replaced with brick of the same type that is currently blocking it (Plate 61). This series of smaller windows along this elevation may allude to the room's use as horse stalls.

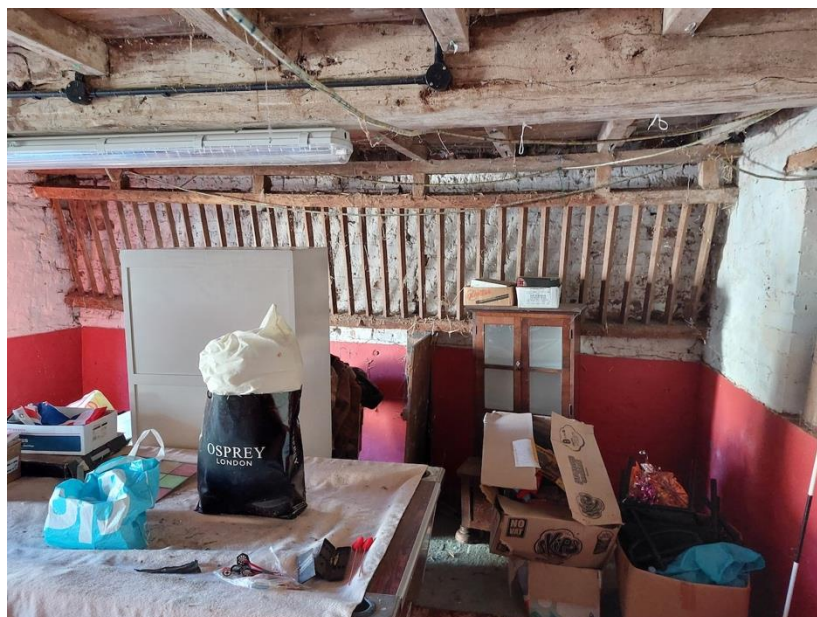
Plate 62 - South West Facing Elevation of Room G5

6.10.4. The south west elevation is largely obscured by a hay feeder that is still attached to the wall (Plate 62) again suggesting that the room was once used to house cattle or horses. The elevation is of brick construction, handmade and identical to that seen elsewhere in G5. In this elevation the brickwork is exposed but for the lower half which is covered in a cement render. There are also four beam slot holes (two along this elevation and two along the north east) which suggests that the ceiling was raised at some point.

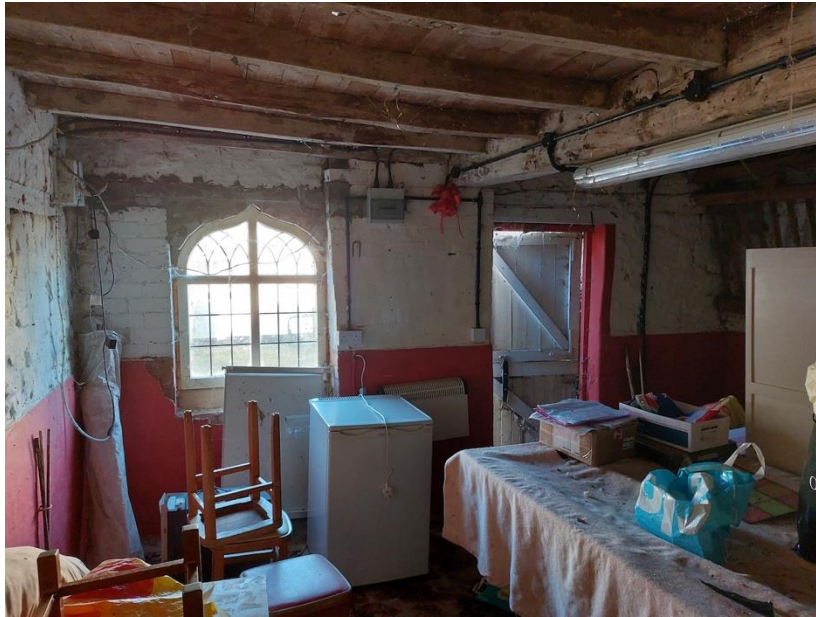
Plate 63 - South East Facing Elevation of Room G5

6.10.5. The south east facing elevation of room G5 is made up of brick which has been painted white on the upper half, and rendered and painted red on the lower (Plate 63). Towards the north eastern side, there is a split Dutch style door of timber construction. The lintel above is made of wood and outside in front, there is a drain with a maker's mark of 'Hancock and Co' (Plate 64). To the south western edge, there is the ogee window. From the inside there is evidence that this was a later addition. Modern builder's block makes up the support for the ogee arch, and expanding foam has been used to bridge the gap between the window and the brickwork (Plate 65).

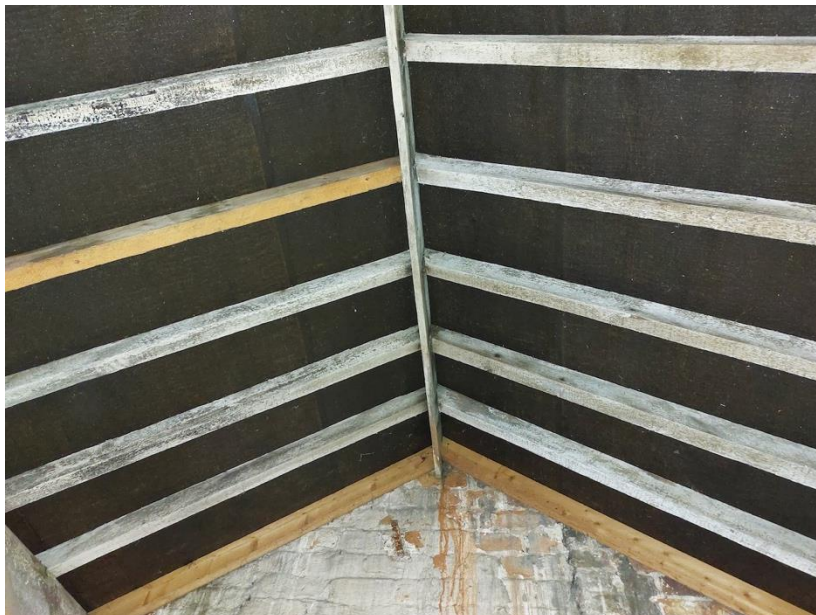
Plate 67 - Exposed Roof in Room G6

6.11.1. Room G6 comprises of what was the cart shed, with the modern garage door opening. The ceiling in room G6 looks to have been replaced in it's entirety. All of the visible timber is new and machine cut, likely this was done in the 1980s with the rest of the roof repair for the building (Plate 67).

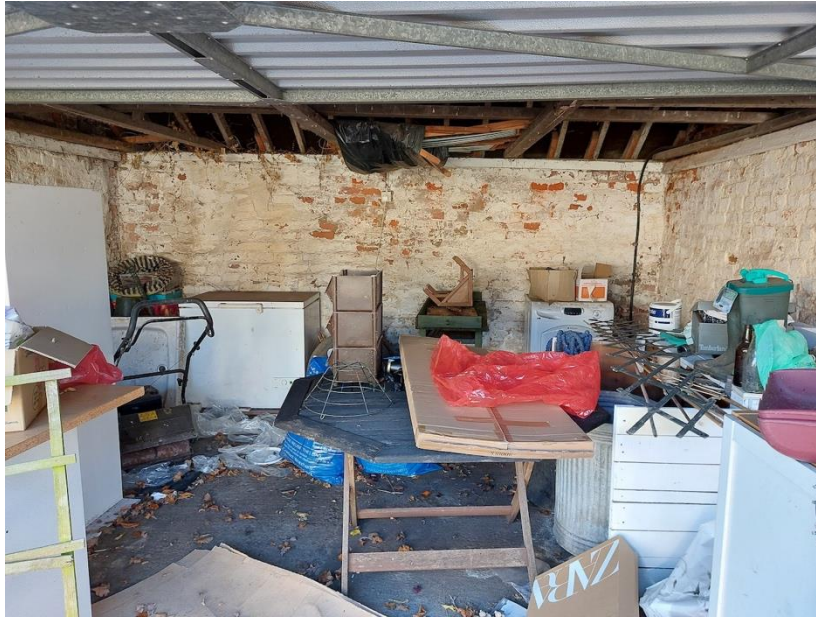
Plate 68 - North West Facing Elevation of Room G6

6.11.3. The north west facing elevation of G6 is of handmade brick the brick wall has been whitewashed from floor to ceiling (Plate 68).

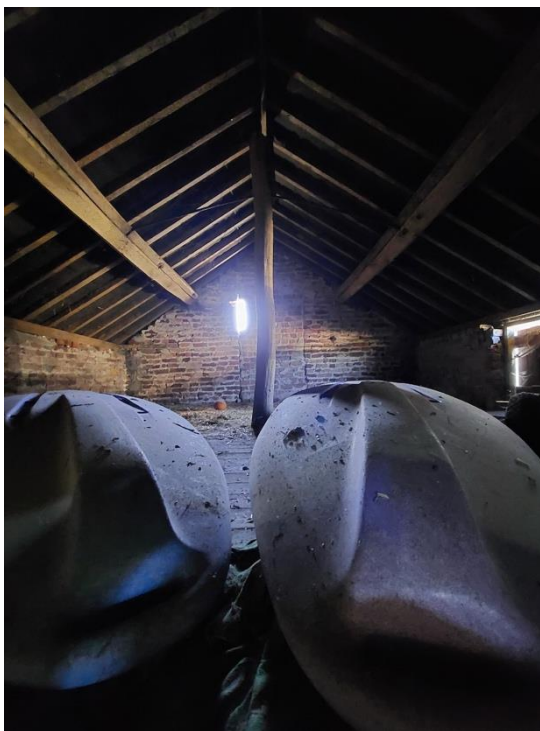
Plate 73 - General shot of Room F1, Facing South West

6.12.7. The north east facing elevation is of exposed handmade brick. In the centre there is a void that has been bricked up. This was likely the main access point to F1 prior to the access made through from the hay loft in G4. When this was blocked up, a vent was incorporated to better control the humidity and airflow (Plate 73).
