# **GREEN FARM HIGHER KINNERTON**

Historic Building Recording at

Client:	Daniel Rowland
Local Authority:	Flintshire County Council
NGR:	333761, 361094
Planning App:	064050
Author(s):	E Ellis and J Baker
Doc Ref:	LP4509C-HBR-v1.3
Site Code:	LP4037C / PRN 213811

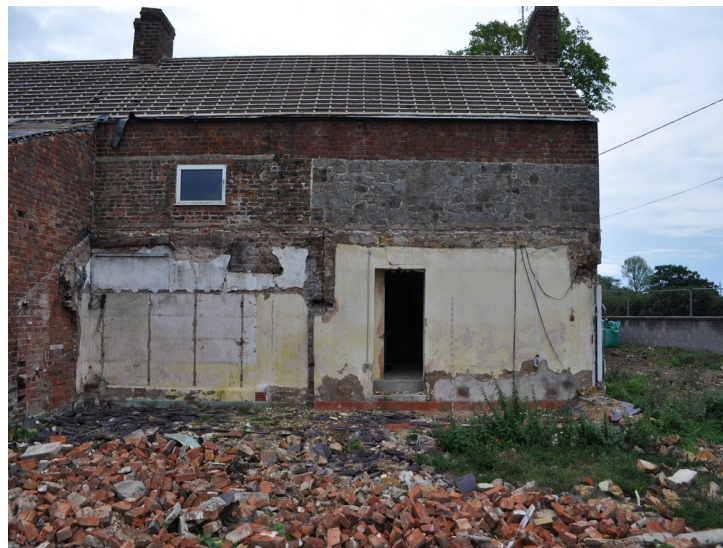
Plate 1 - Northwest Facing Elevation

6.2. Upon the northwest facing elevation (PLATE 1), there are five distinct phases. Phase 1 is the original body of the building constructed from irregular blocks of grey limestone from North Wales – seen on the north west corner of the external northwest facing elevation. The lower half of which is now covered in a pale render and may be of local origin.

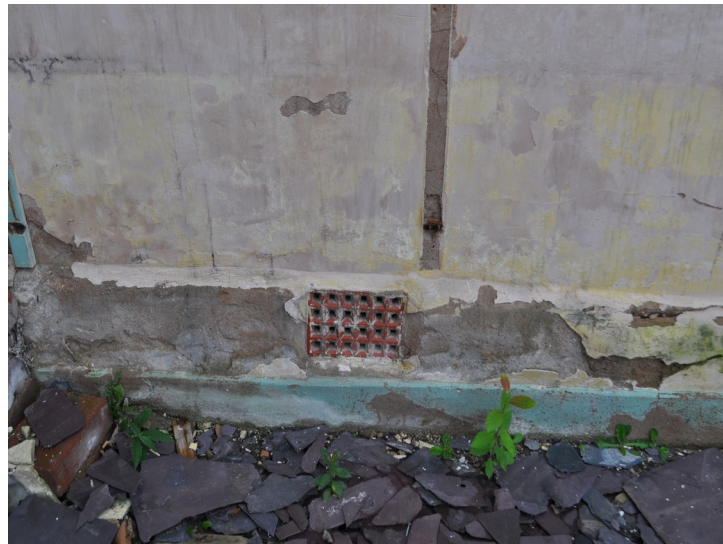
*Plate 2- AirVent Brick on Northwest Facing Elevation*

- 6.4. Ceramic air ventilation tiles were inserted at a latter stage along the base of both phase 1 and 2 in a horizontal fashion, which were likely a 20<sup>th</sup> century addition (PLATE 2).
- 6.5. A window feature is evident on the upper northeast section of the phase 2 elevation, comprising of a contemporary UPVC window. Yet, the original brickwork either side of the feature does not appear to be disturbed. However, machine made brick is evident directly above and below, indicating a later insertion. Thus, it is likely that an original window had once occupied the area but the fabric was altered marginally at a later stage to accommodate the contemporary UPVC.
- 6.6. Plaster render along the lower northeast elevation concealed the wall beneath. Thus, a detailed analysing of the buildings skeletal fabric was unsuccessful.

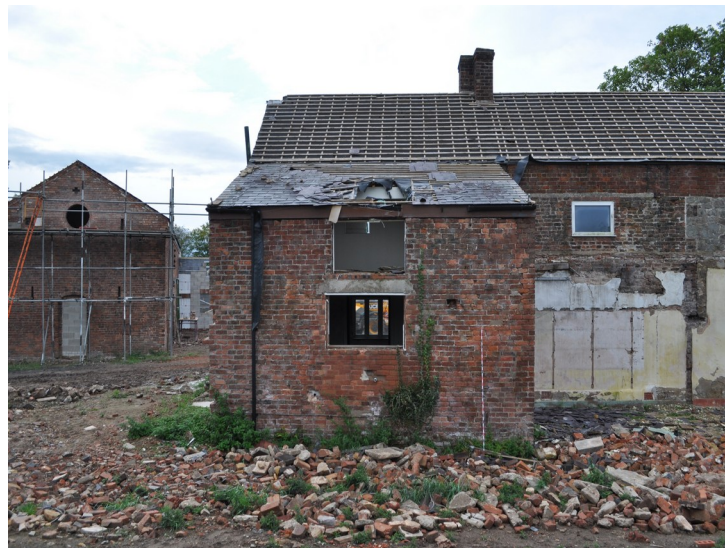
*Plate 3 - Northwest Facing Elevation*

6.9. The extension has a slate roof following the pitch of the main structure. Two windows were included in this phase of construction. The lower appears to have been contemporary. The upper window appears to have been added at a later date – the surrounding brickwork is disturbed and has been repointed, and the two windows are of different sizes. A concrete lintel was fitted between the two likely for additional support when the new window was added.

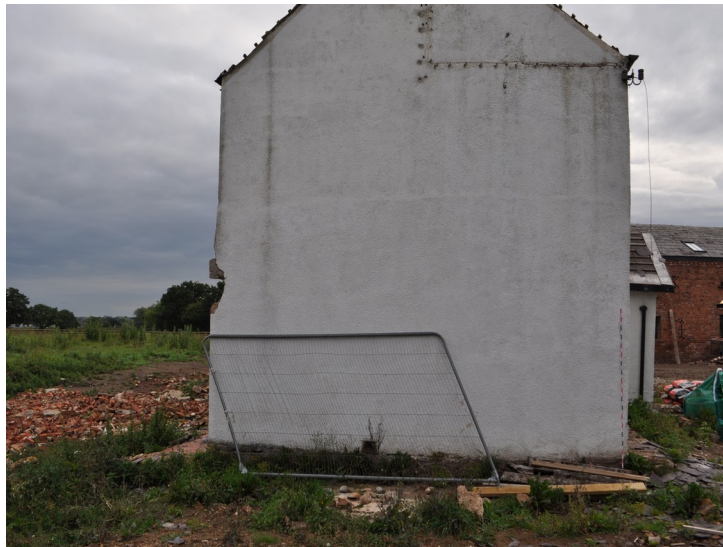
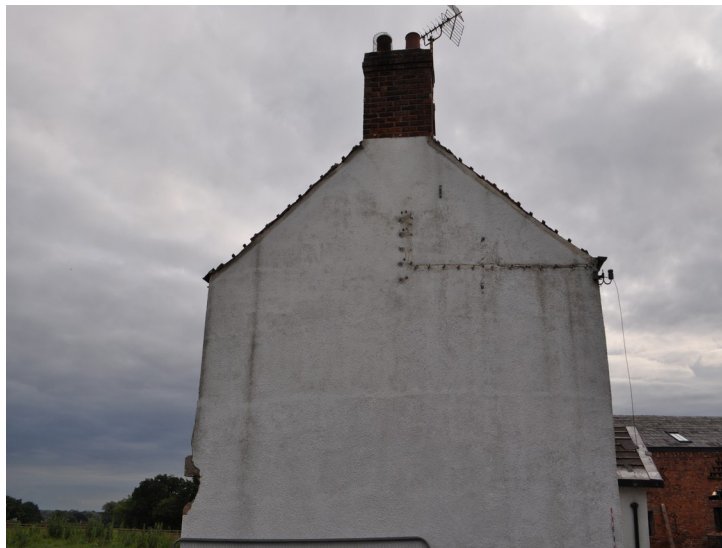
6.12. The southwest gable end elevation is almost entirely covered in a white wash render (PLATE 4, 5). The lower two courses show a stone construction (PLATE 6), which would indicate that this was part of the original body of the cottage. However, there is evidence of brickwork which may be associated to later repair works. A chimney stack consisting of machine made brick was aligned with the elevation.

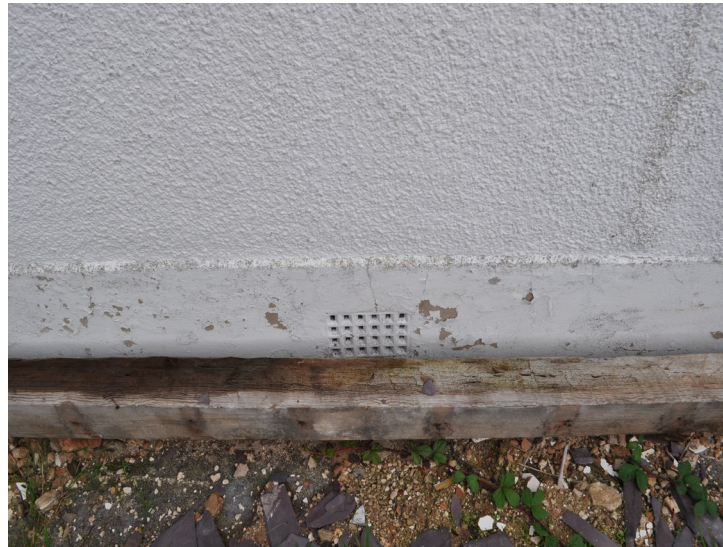
Plate 8- Air vent brick

6.14. There are also ceramic air ventilation bricks towards the northwest side of the elevation (PLATE 8). These match those seen on the northwest elevation in dimension and location points along the lower elevation, indicating a possible contemporary phase.

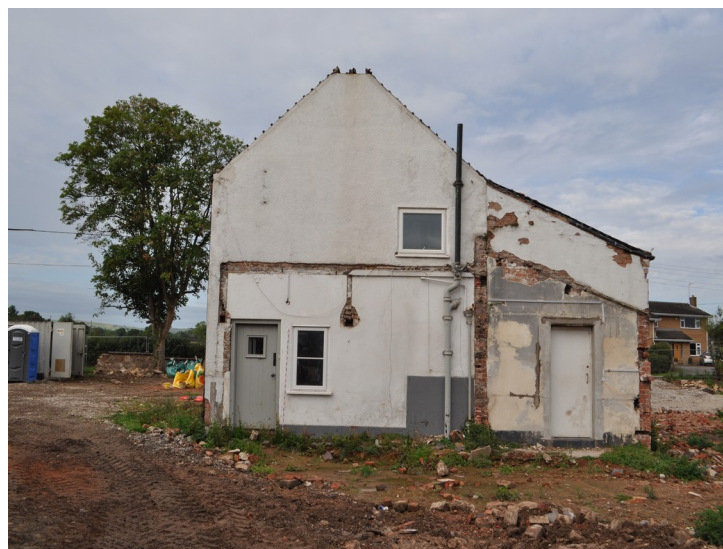
Plate 9- Northeast Facing Elevation

6.22. The doorway on the northeast corner of this elevation looks to be internal and may have been a later addition to allow access to the now demolished extension, the render surrounding the doorway makes an analysis of this difficult to determine.

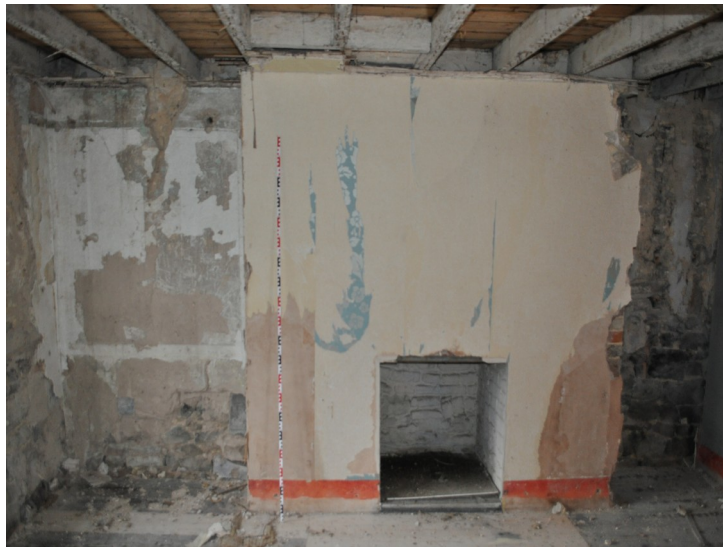
Plate 10- Room G1, Northeast Facing Elevation

6.23. The exposed ceiling in room G1 (PLATE 10) located on the ground floor, southeast most side, is a timber construction. A load bearing timber beam extended on a northwest-southeast alignment in the centre of the ceiling, with a series northeast-southwest aligned joists resting above. Modern timber floorboards of the first floor sit above the series of (PLATE 12).

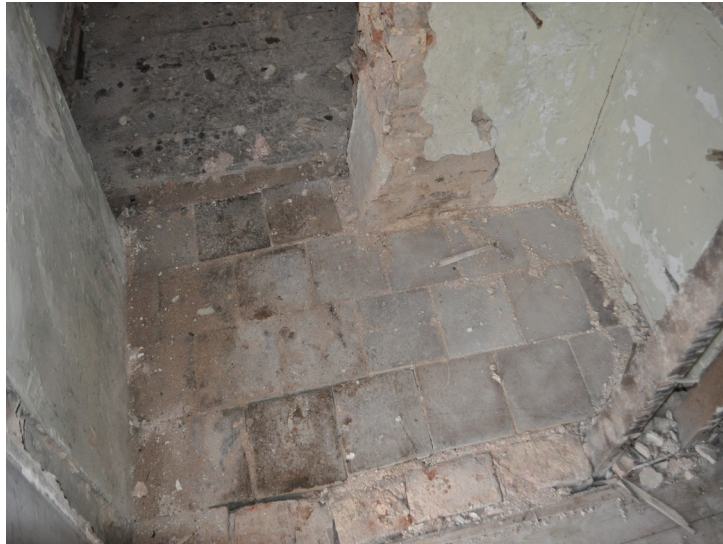
*Plate 11 - Tiled Floor in Room G1*

6.24. The floor is also made of timber floor boards, and there are floor tiles present on the threshold joining room G1 and G2, behind the staircase in the north east corner of the room (PLATE 11).

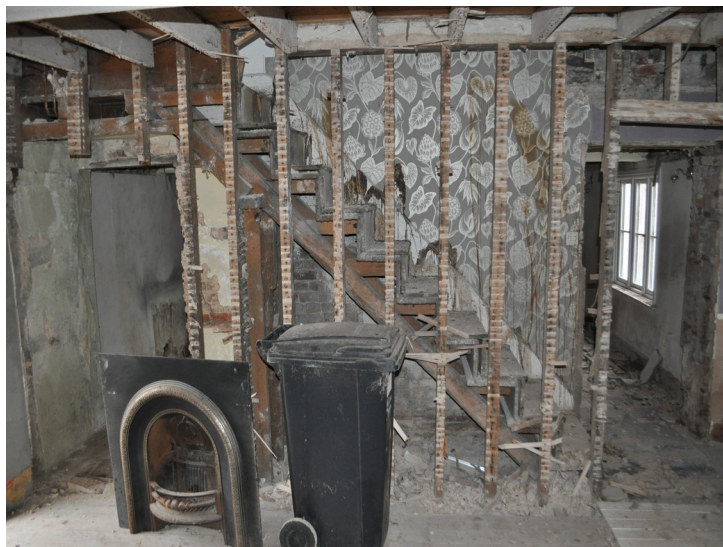
Plate 13- Southwest Facing Elevation of Room G1

6.27. The southwest facing elevation of room G1 comprises of the timber frame of a former stud wall, behind which the staircase to the first floor is visible. The wall behind the staircase is of brick construction. The brick appears to be modern, machine made and in a common bond. The southeast corner of this elevation houses a doorway which grants access to the foot of the staircase and entry to the porch and into room two on the ground floor. Located on the northeast corner of this elevation there is an additional doorway giving access to room G2 (PLATE 13).

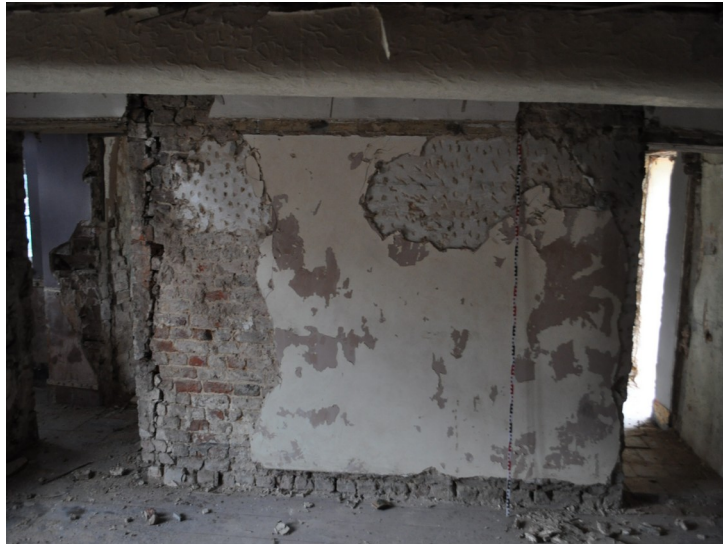
Plate 15- Northeast Facing Elevation of Room G2

6.30. The northeast facing elevation is of a machine made brick, with a common bond construction. There are two doorways on the southwest and northwest ends of the elevation which presented access into room G1 (PLATE 15).

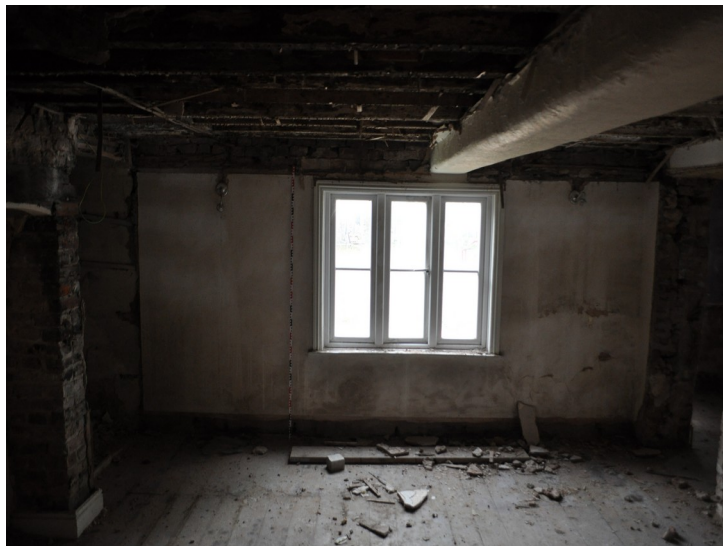
Plate 16- Northwest Facing Elevation of Room G2

6.31. The northwest facing elevation is of a brick construction identical to that of the northeast facing elevation – modern machine made brick in a common bond. The majority of the wall is covered in plaster. There is a central UPVC window, the surrounding plaster means that it is not possible to determine if this was contemporary to this phase of construction (PLATE 16).

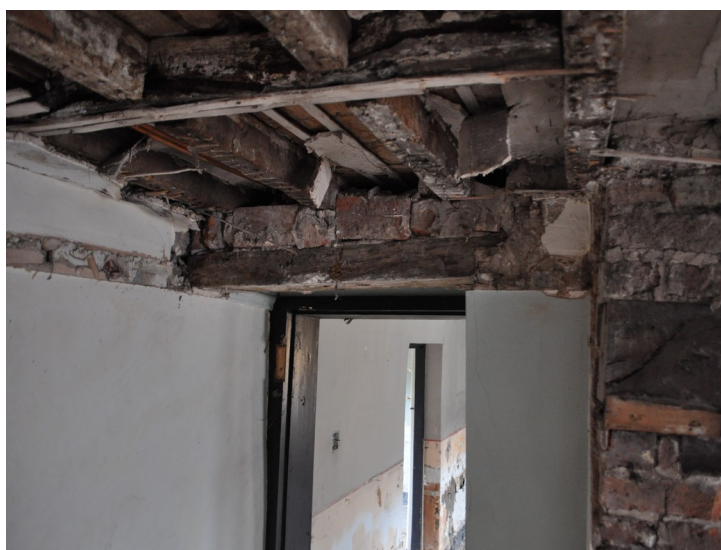
Plate 18-Wooden Lintel Above Doorway on Southwest Facing Elevation of Room G2

lintel, the surrounding brickwork is undisturbed so this is likely contemporary to this building phase (PLATE 18).

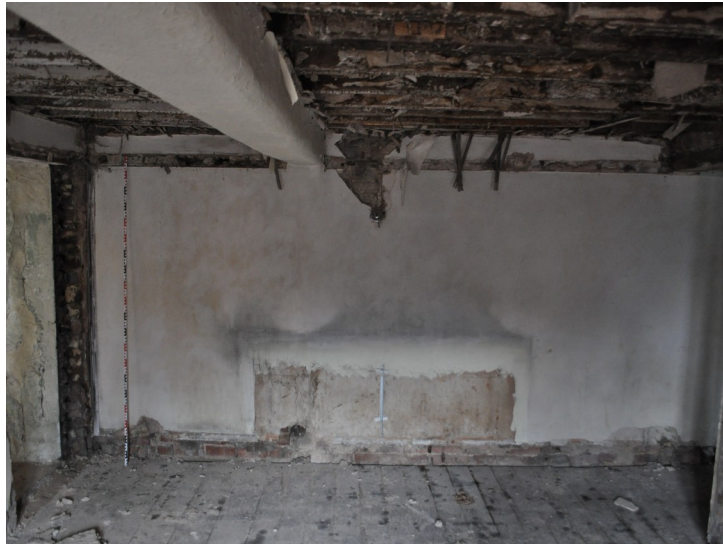
Plate 19- Southeast Facing Elevation of Room G2

6.33. The southeast facing elevation is of brick construction. The bricks are machine made and modern, the bonding is indeterminable as only two courses are visible on the lowest portion of this elevation – the rest of the wall is covered in plaster (PLATE 19).

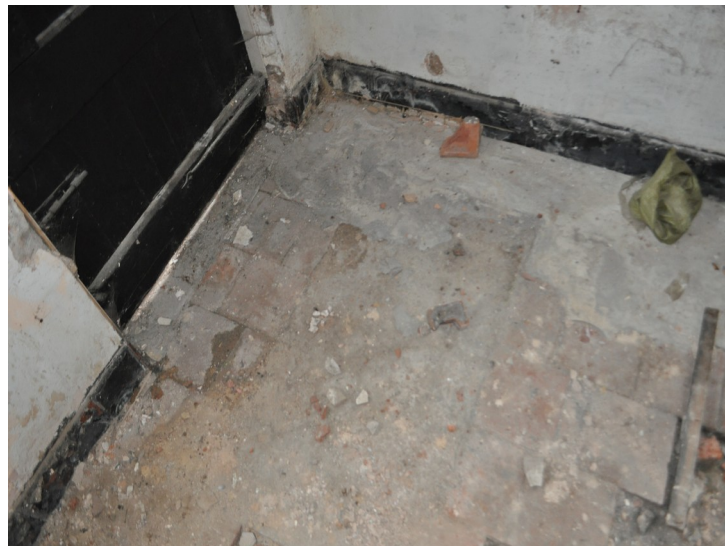
Plate 22 - In Situ Tiles in Southeast Corner of Room G3

6.34.1. The floor is made up of timber floorboards and tiles, which are present in-situ in the southeast corner of the room (PLATE 22). The same tiles have been lifted in the centre of the room which appear to be modern from the fabric and the stamp on the obverse side (PLATE 24).

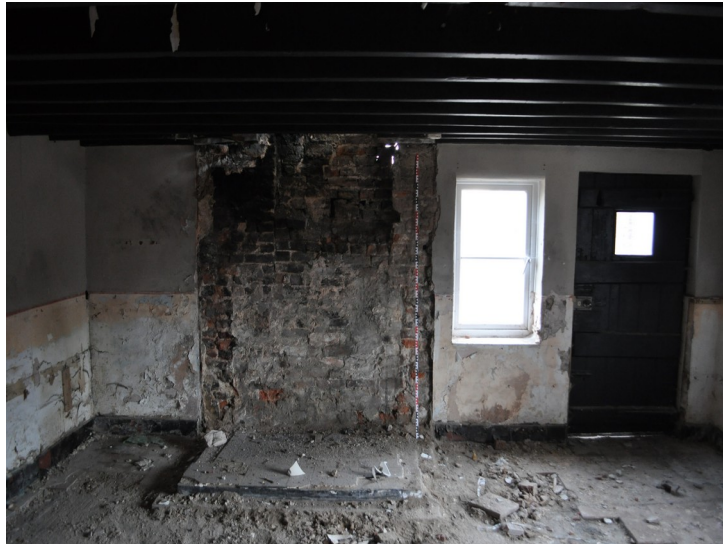
Plate 26- Southwest Facing Elevation of Room G3

6.37. The fabric of the southwest facing elevation of room G3 was largely obscured by the plastering. There is a section of exposed brickwork and a tiled hearth where a fireplace and chimney were once housed (PLATE 25). The bricks are machine made and in a common bond design (PLATE 26).

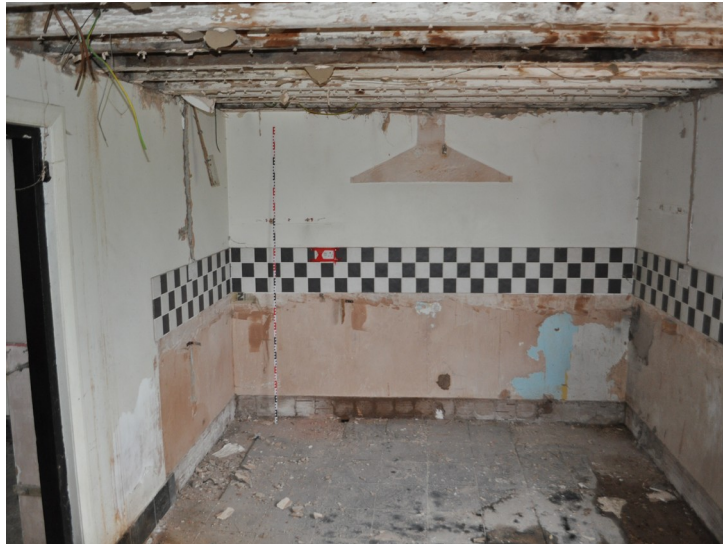
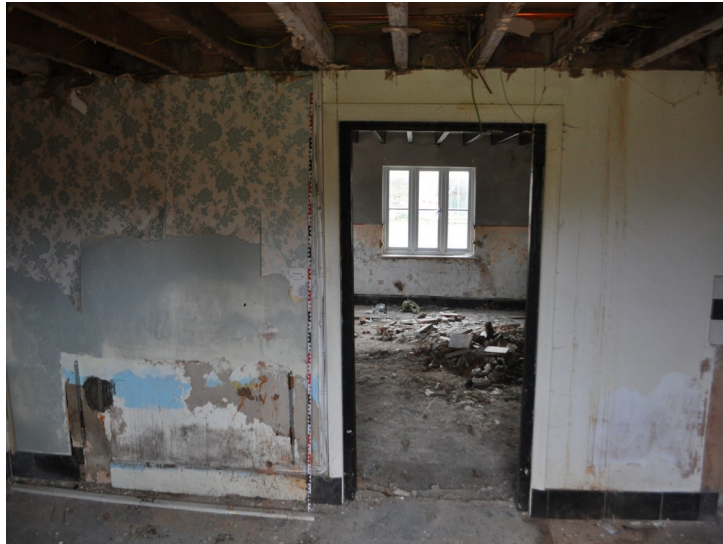
6.40. The ceiling of room G4 consisted of exposed joists which run along the same alignment as seen in room G3. Any other plasterwork or boarding has been removed, though the fixings are still existent in the timber (PLATE 27, 28).

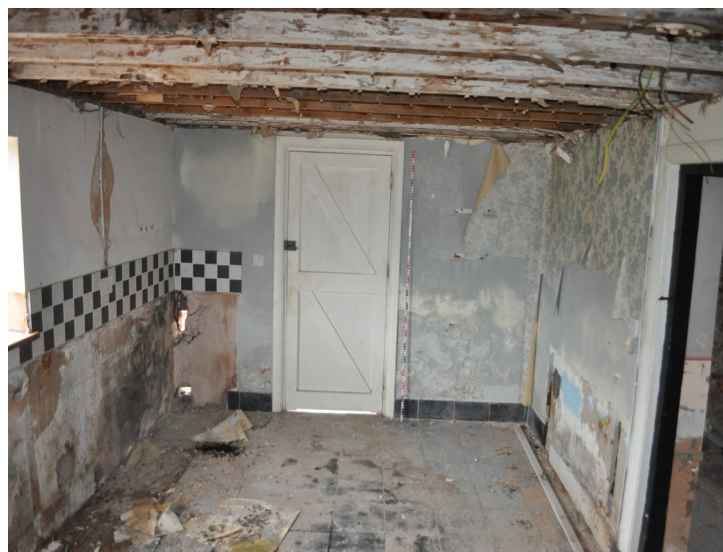
Plate 29- Southwest Facing Elevation of Room G4

6.44. The southwest facing elevation is also plastered. The same course of black tiles which run the entire periphery of the base room G4 are visible. The three courses of decorative black and white kitchen tiles were present on this elevation on the north east edge. There was a wooden door towards the centre of the elevation, leading to the outside (PLATE 29).

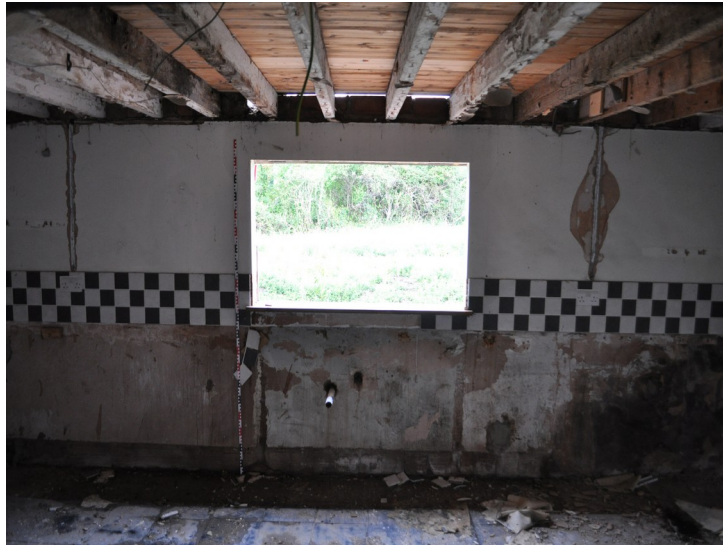
Plate 30 - Southeast Facing Elevation of Room G4

6.45. The southeast facing elevation of room G4 was covered in plaster, the fabric of the elevation cannot be seen. The course of black tiles had been removed at the base of this elevation, though the silhouette of them is visible. The three courses of black and white tiles which extend in horizontal fashion along the centre of the elevation run the entire width, with a partial interruption from the central window (PLATE 30).

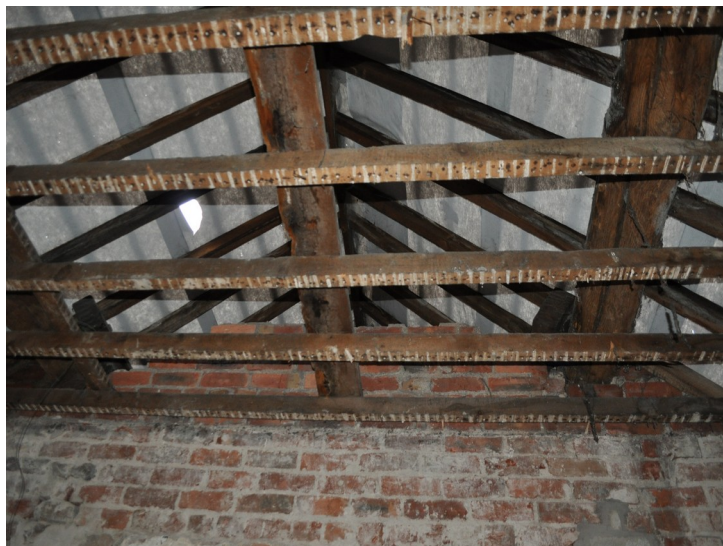
Plate 31 - Ceiling in Room F1

6.46. On the first floor, the ceiling in room F1 was pitched to follow the line of the roof. Two load bearing timber beams extended northeast to southwest and rested on the northeast elevation wall and the southwest elevation wall. The load bearing beams appeared to be recycled, characterised by cut marks of previous fixtures. The rafters were visible as was the waterproof membrane and the ceiling joists, which were modern (PLATE 31).

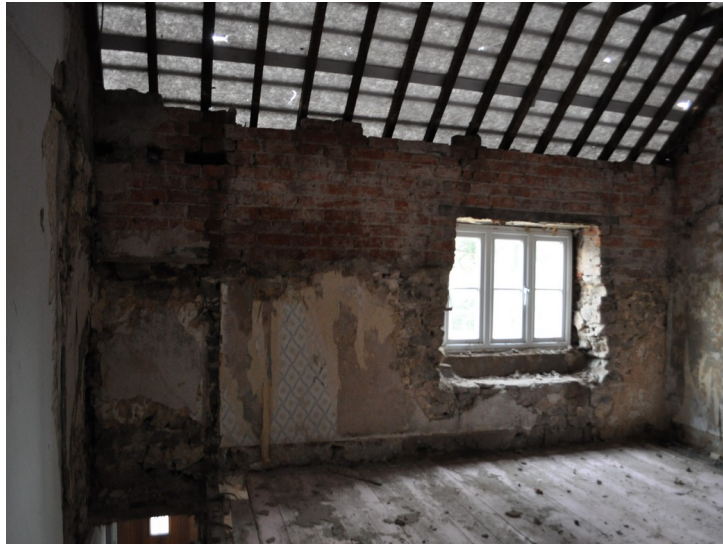
Plate 33- Northwest Facing Elevation of Room F1

6.49. The north west facing elevation is similarly a mixed fabric of stone and mortar and machine made brick. The brickwork is in a common bond. There is a modern UPVC window offset towards the southwest of the elevation. The stone fabric comes half way up the window and the upper half is accommodated by five courses of brickwork. The stonework looks to have been disturbed to accommodate this window, the brickwork looks to be contemporary. There is a wooden lintel above the window which also looks contemporary. Located on the southeast side of this elevation, there is a silhouette of an internal wall which separated off the gap for the stairway (PLATE 33).

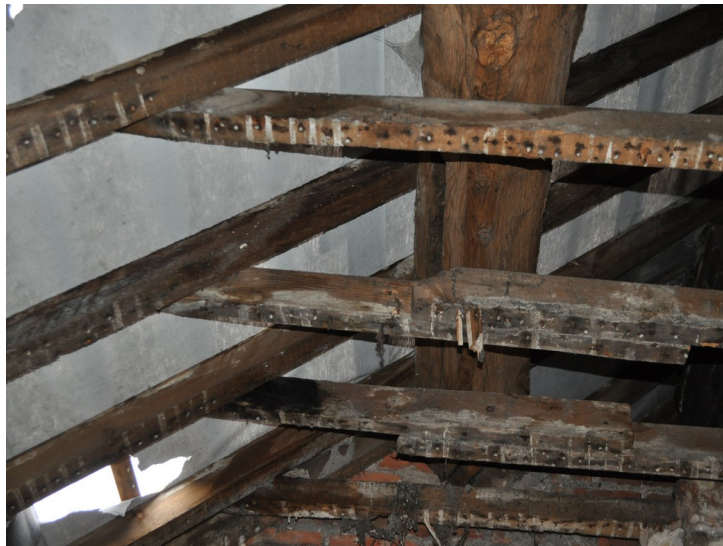
Plate 36- Ceiling in Room F1

6.53. The ceiling of room F2 is identical to that of room five, as is the makeup of the floor (PLATE 36, 37). The northeast-southwest support timber beam had evidently been repurposed, as there were defunct slots cut in the centre of the timber (PLATE 36).

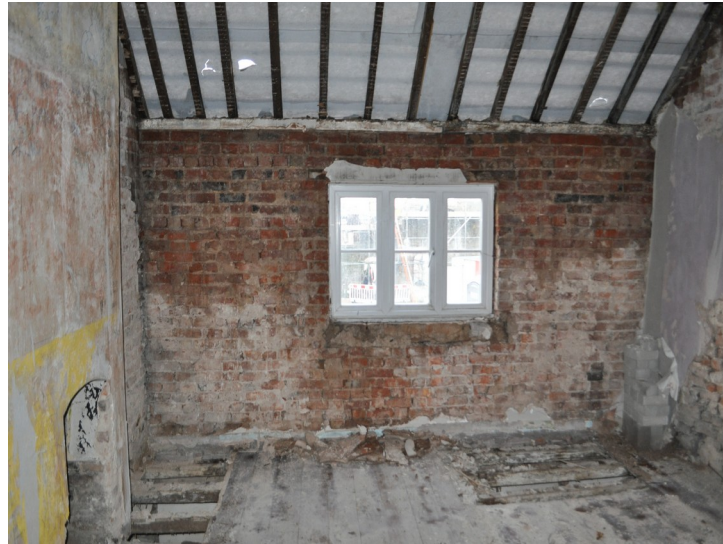
Plate 37- Northwest Facing Elevation of Room F2

6.55. The northwest facing elevation is made entirely of machine made brick in a common bond. There is a central UPVC window, with a stone lintel below. The brickwork encompassing the feature appear to accommodate the window space, indicating a contemporary window space that was later fitted with a modern window (PLATE 37).

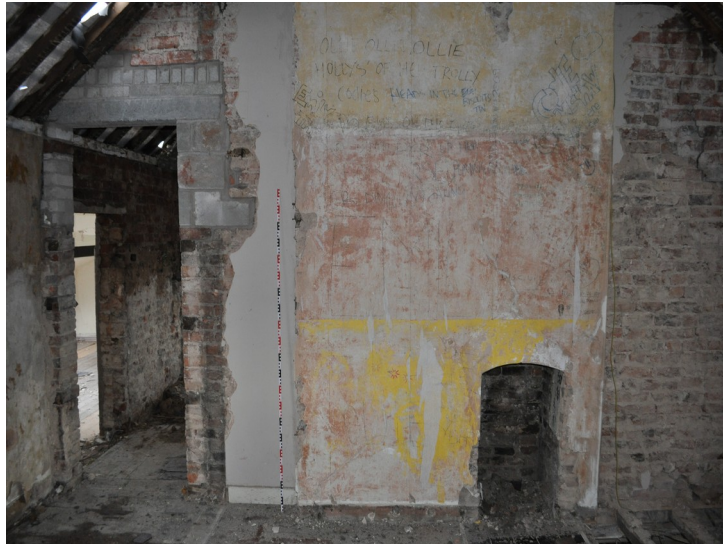
Plate 38- Southwest Facing Elevation of Room F2

6.56. The southwest facing elevation of room F2 is dominated by a central chimney breast and fire place. The outside of the chimney is plastered. The brickwork inside the fireplace is exposed – it is machine made and in a stretcher bond. Either side of the chimney, the elevation is constructed of machine made brick in a common bond. A doorway was located on the northeast side of the elevation which presented access to room F3. Similarly to the opposing doorway described above (6.50), this has been reinforced with modern blockwork as part of the present works on the building (PLATE 38).

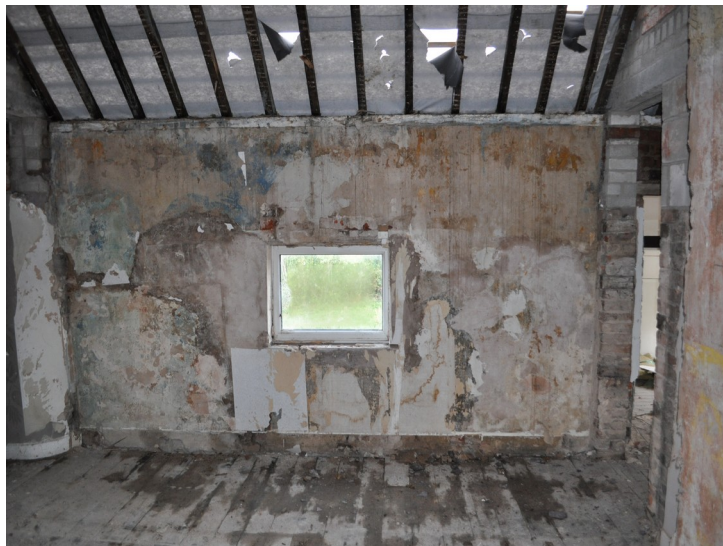
Plate 39- Southeast Facing Elevation of Room F2

6.57. The southeast facing elevation is largely covered with plaster, with a central modern UPVC window. Due to the surrounding render, the fabric beneath was obscured for detailed analysis. Just above the window was a partial course of red brick which were machine made although, the bond is not able to be determined (PLATE 39).

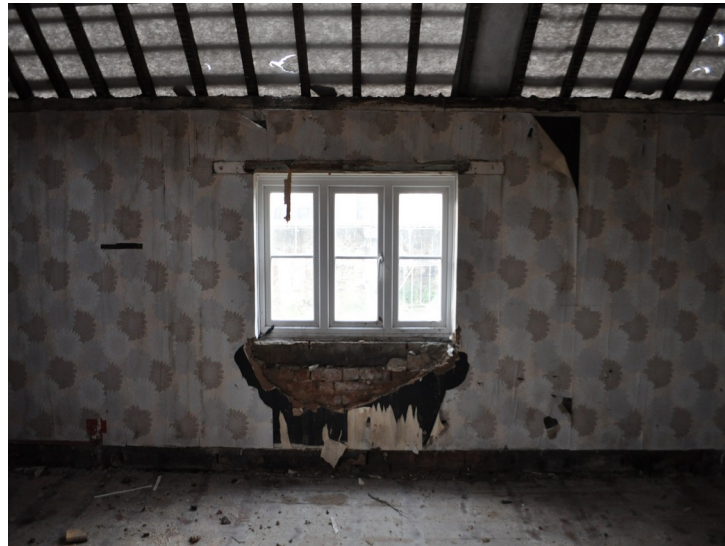
Plate 42- Northwest Facing Elevation of Room F3

6.60. The northwest facing elevation is covered with plaster. There is a central UPVC window, above which there is a timber lintel and stone sill. Three courses of brickwork were exposed below the window. The bricks were machine made, the bonding is indeterminable (PLATE 42).

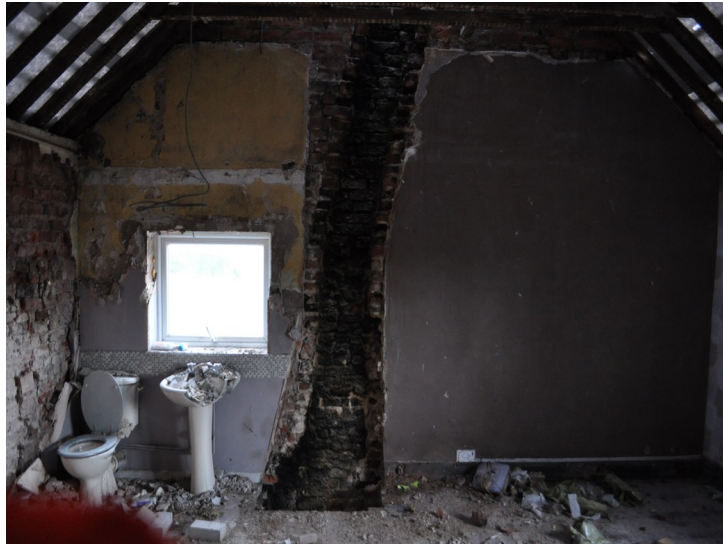
Plate 43- Southwest Facing Elevation of Room F3

6.61. The southwest facing elevation of this room was covered largely in plaster so the fabric is difficult to determine. There was a central chimney which lead from the southwest facing elevation fireplace, in room G3 below. On the northwest side of this elevation, there was a toilet and sink, elluding that this area functioned as a bathroom. Above the sink is a modern UPVC window – the surrounding fabric is obscured by plaster (PLATE 43).

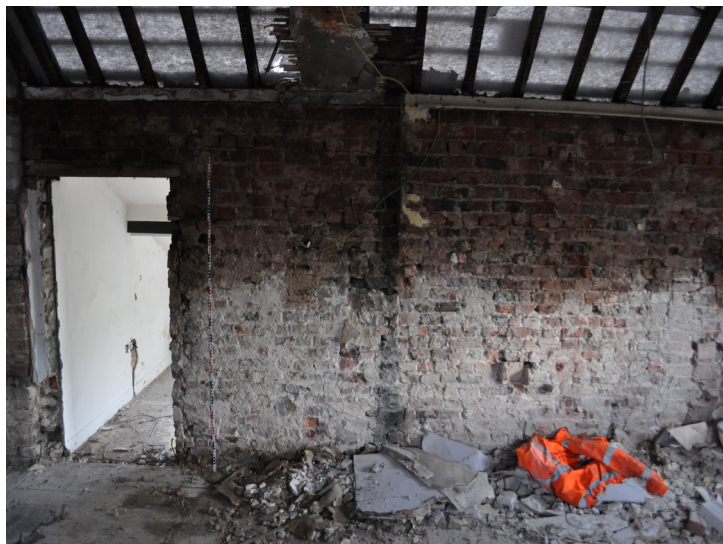
Plate 44: Southeast Facing Elevation of Room F3

6.62. The southeast facing elevation of room F3 is largely of exposed brick. The brick appeared to be a single phase of construction, machine made and in a common bond. In the centre there was a shadow of a now demolished partition wall for the bathroom. Towards the southwest side, there was a doorway which lead into room F4. The doorway was supported by a concrete lintel, and the surrounding brickwork appeared to have been disturbed so to accommodate the doorway. This suggests that the doorway was a later addition to this phase of construction, possibly during the construction of phase 4 (PLATE 44).

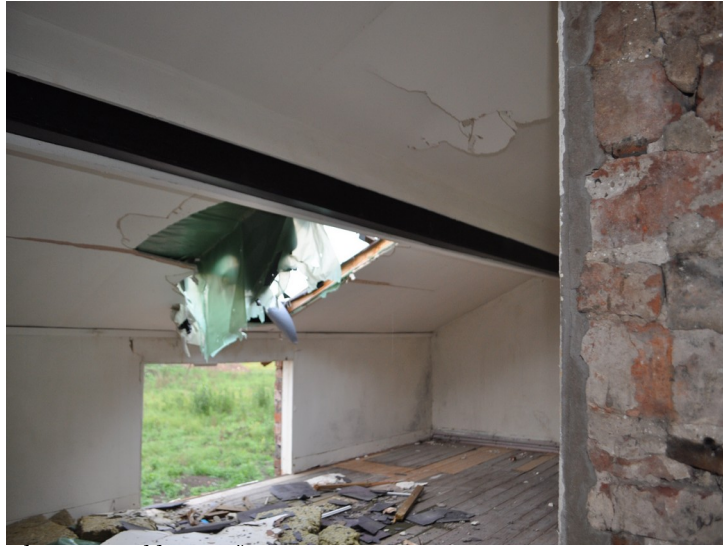
Plate 45: Oblique of Room F4

6.63. The floor of room F4 was deemed hazardous and so the images and analysis are limited. The floor is made up of timber floor boards running perpendicular to those in rooms F1, F2 and F3. The ceiling is low and has a single modern timber beam running across it (southwest – northeast). There is a space in the centre of the ceiling for a sky light. The rest of the ceiling is plastered (PLATE 45).
