THE GREEN FARM BARN

Author Ethan Ellis MA

Client: Rowlands Contracting

Doc Ref: LP4037C-HBR-v1.4

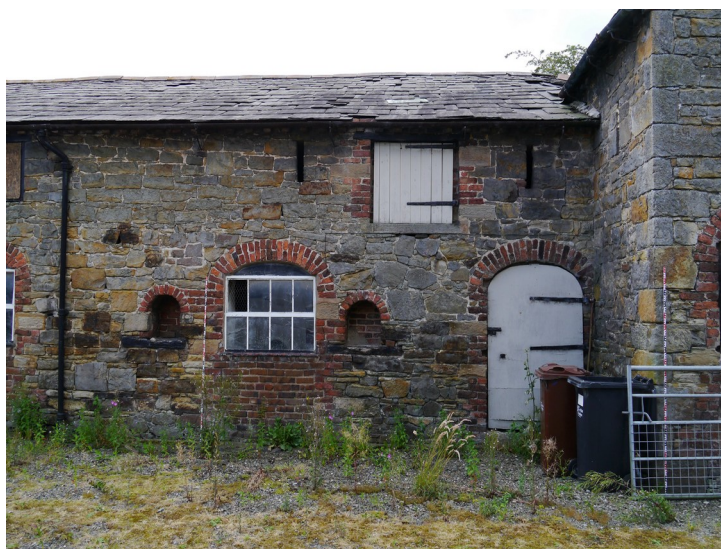
6.4.3. The three central previous doorways of Phase 1, and the singular doorway on Phase 2, were bricked from the foundation to the centre of the doorway, which created a rectangular void positioned above. Identically fashioned, with thirteen course high brick in english garden wall bond, three stretchers below a row of headers on the lower area, four stretchers to a row of headers in the centre, and three stretchers below the top course of headers. The three central doorways of Phase 1 were complete with contemporary eight pane windows, whilst the Phase 2 doorway had a fixed swing gate. The two outer doorways of Phase 1 functioned as entrance points into the building, the north west most doorway consisted of an external sliding door, and south-west doorway fused with a swing gate (PLATE 3).

Plate 3 - South-west most doorway of Phase north-west elevation

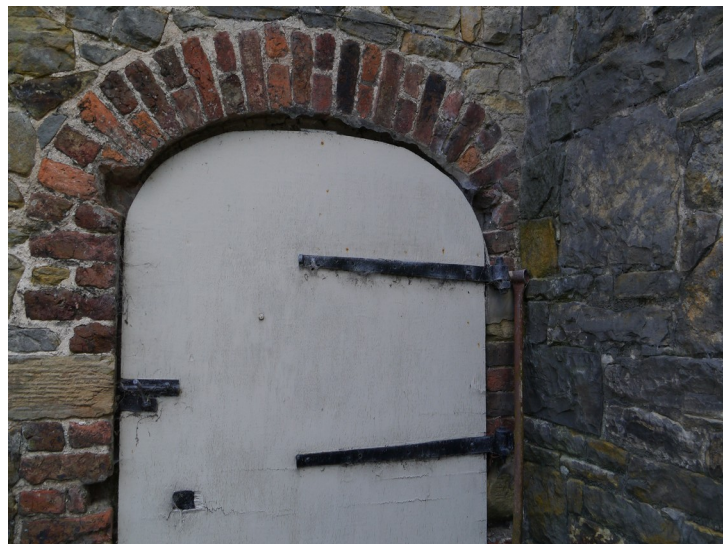
Plate 4 - Phase 2 truncating Phase 1 doorway

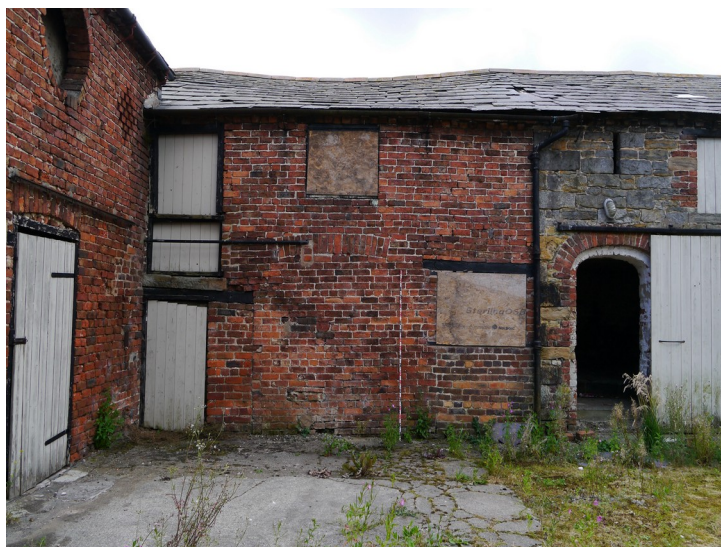
6.4.18. The rooftop consisted of large slate of various dimensions with a row of ceramic tiles forming the ridge line. The centre of the ridge was slumped.

Plate 6 - North-west elevation of Phase 4

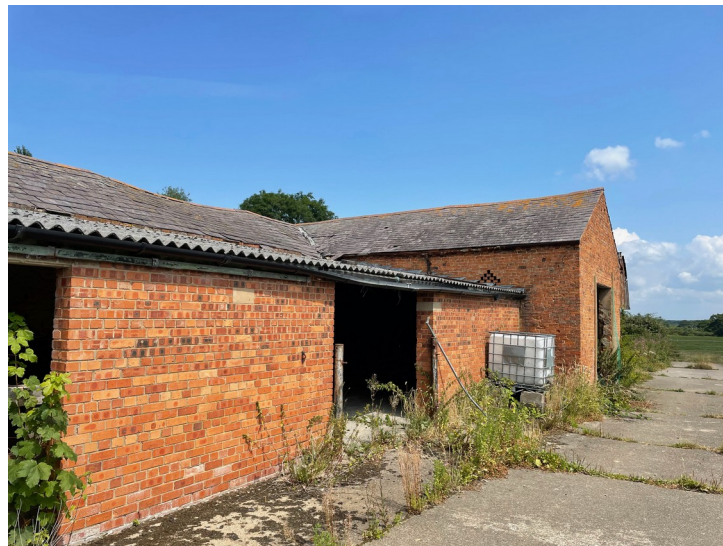
6.4.39. A partial seven course diamond shaped air ventilation feature was visible which had been truncated by the roofline of Phase 7 (PLATE 12). The feature was identical in dimension and design to those seen on the south-west elevation of Phase 5.

Plate 12 - South-west elevation of Phase 6

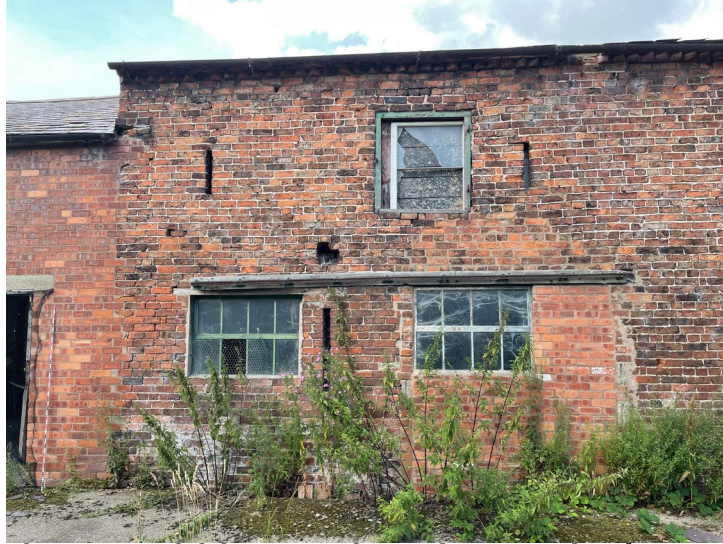
contrary to the modern material used to seal the doorway. An attempt was made to continue the english garden bonding style. A narrow doorway similar to that seen on the south-west elevation, may have originally occupied the area before the wide doorway bay was inserted, following the parallel fashion of both the north-east and south-west elevation of Phase 5.

Plate 17 - Sealed doorway and two adjacent window features, north-east elevation of Phase 5

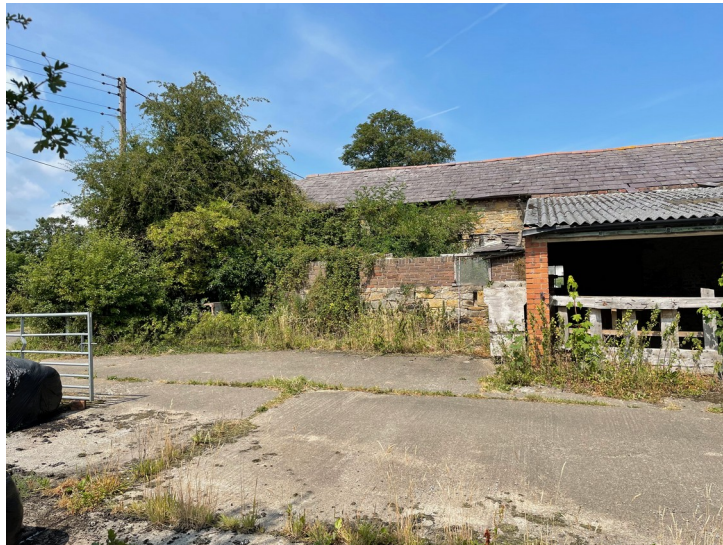
6.4.60. Undergrowth concealed the extent of the south-east elevation of the Phase 2 building during the time of survey, which made it impossible to interpretation the building wall (PLATE 21).

Plate 21 - Vegetation concealing the South-east elevation of Phase 2

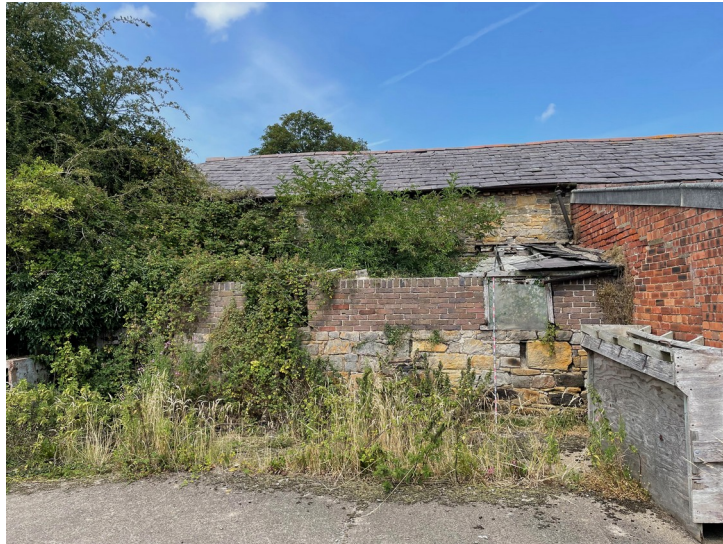
which made interpretation difficult. However, it was possible to detect a lower stone foundation with an eight course stretcher bond brick wall, complete with a row of headers positioned above the lower stone material. The roof had collapsed but the reminiscence of slate material above a timber joist were evident (PLATE 22).

Plate 22 - South-east elevation of Phase 3

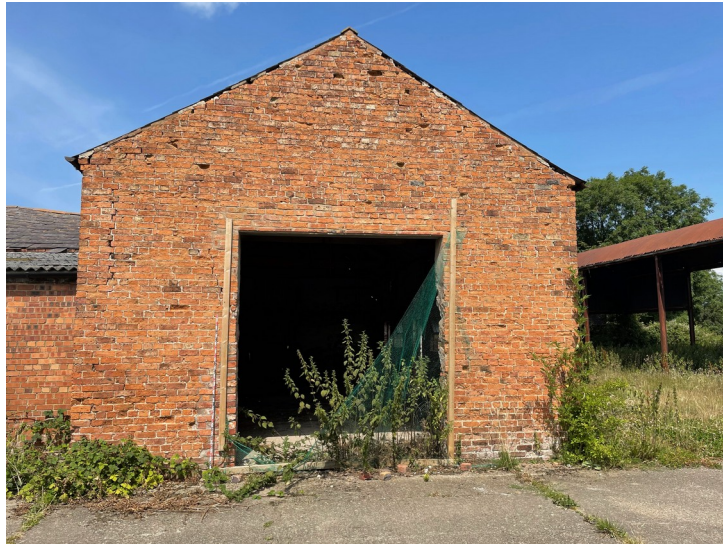
6.4.62. The south-east elevation of building Phase 6 was a gable end wall which comprised of bricks and mortar in english garden wall bonding style. A large wide doorway occupied the central area of the elevation wall which appeared to have been a later insertion. As the brickwork on the north-east most edge of the doorway had broken brick ends, and the reconstructed south-west edge consisted of modern brick scored by a darker shade of mortar (PLATE 23).

Plate 23 - South-east elevation of Phase 6

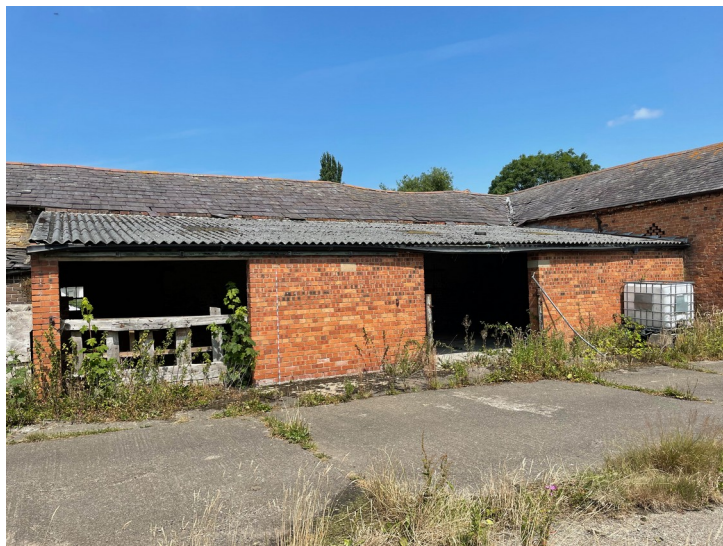
6.4.63. Modern brick and mortar formed the fabric of the south-east elevation which had been fashioned in english garden wall bonding (PLATE 24). The brick material resembled that of the north-east elevation of Phase 6 both in colour and dimension. Phase 7 appeared to butt against Phase 6.

Plate 24 - South-east elevation of Phase 7

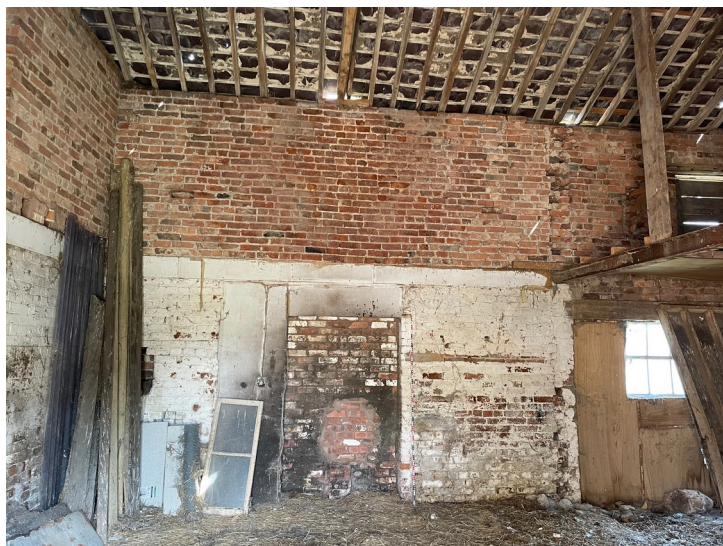
Plate 46 - North-east elevation Room B6

6.5.56. Situated south-east of the doorway along the north-east wall, a clear vertical disturbance to the original fabric was evident, two brick end wide from the foundation to the top course. The brick and mortar was damaged and did not comply with the surrounding coursing bond of the main fabric. Evidently, the vague disturbance outlined the location of the former south-east division wall.

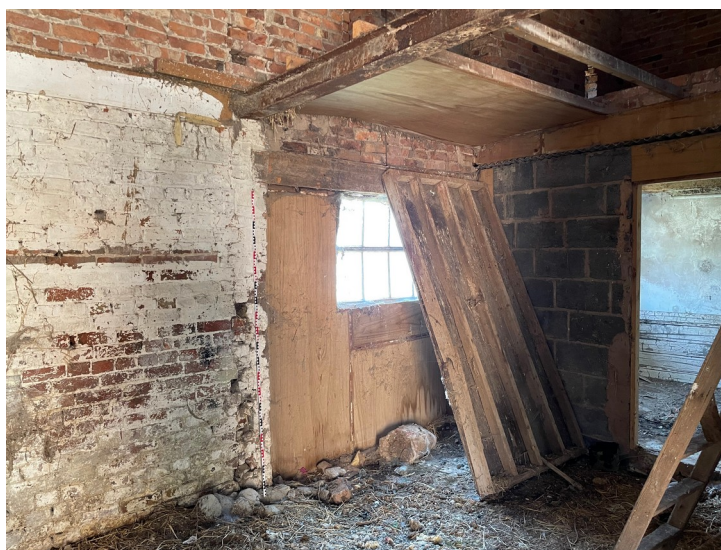
6.5.58. Modern breeze blocks sealed the lower area of the original wide brick doorway, and replaced with a rectangular 8 pane sash window, which bore a timber lintel.

Plate 47 - North-east elevation Room B6 extended opening
