**LEVEL 3 BUILDING RECORDING OF
A FORMER BARN AT
LLAN Y NANT, LLANISHEN,
TRELLECH GRANGE, NP16 6QN
PLANNING APPLICATION:
DM/2019/00998 (Monmouthshire)**

April 2021

Trysor Project No. 2020/746

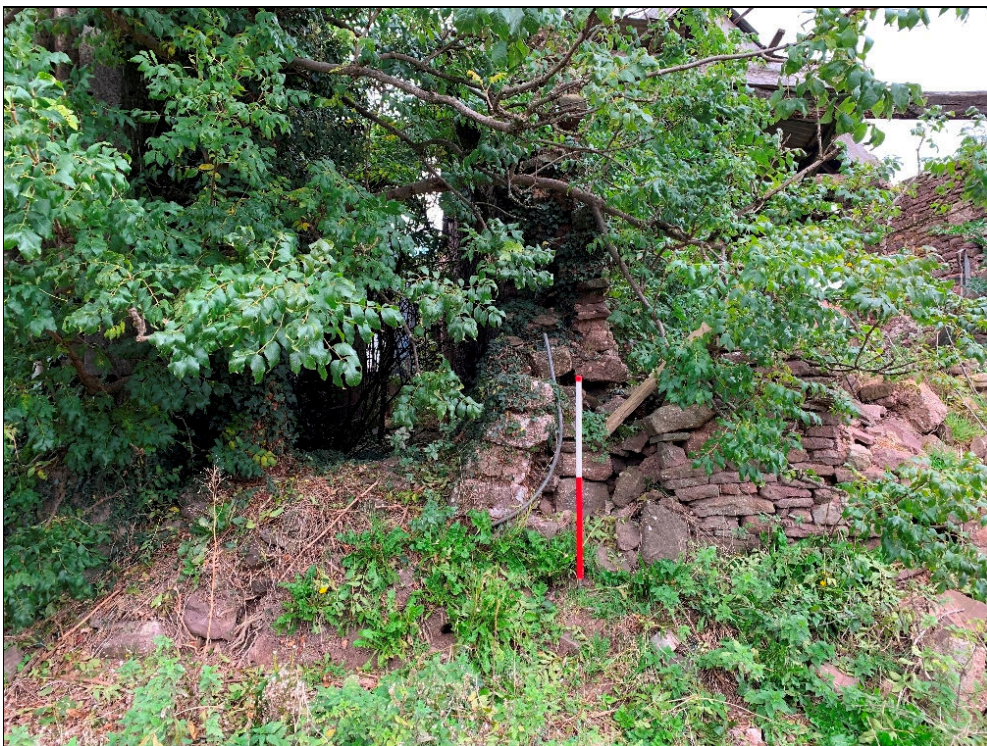
Plate 4: LLN2020_004 - A view of the southwestern corner of the barn, which seems to show that there was a rip joint where the western and southern walls met, suggesting that the original southern gable wall had been replaced at some time. Looking north.

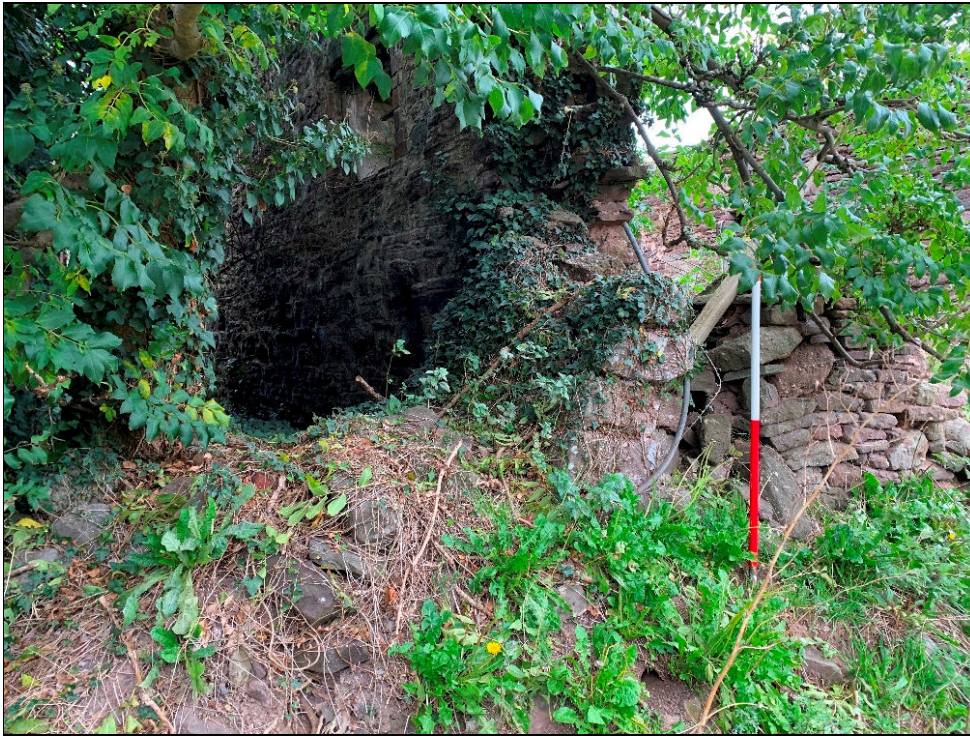
Plate 5: LLN2020_005 - Another view of the southwest corner of the barn, showing the break between the western and southern walls. Looking northeast.

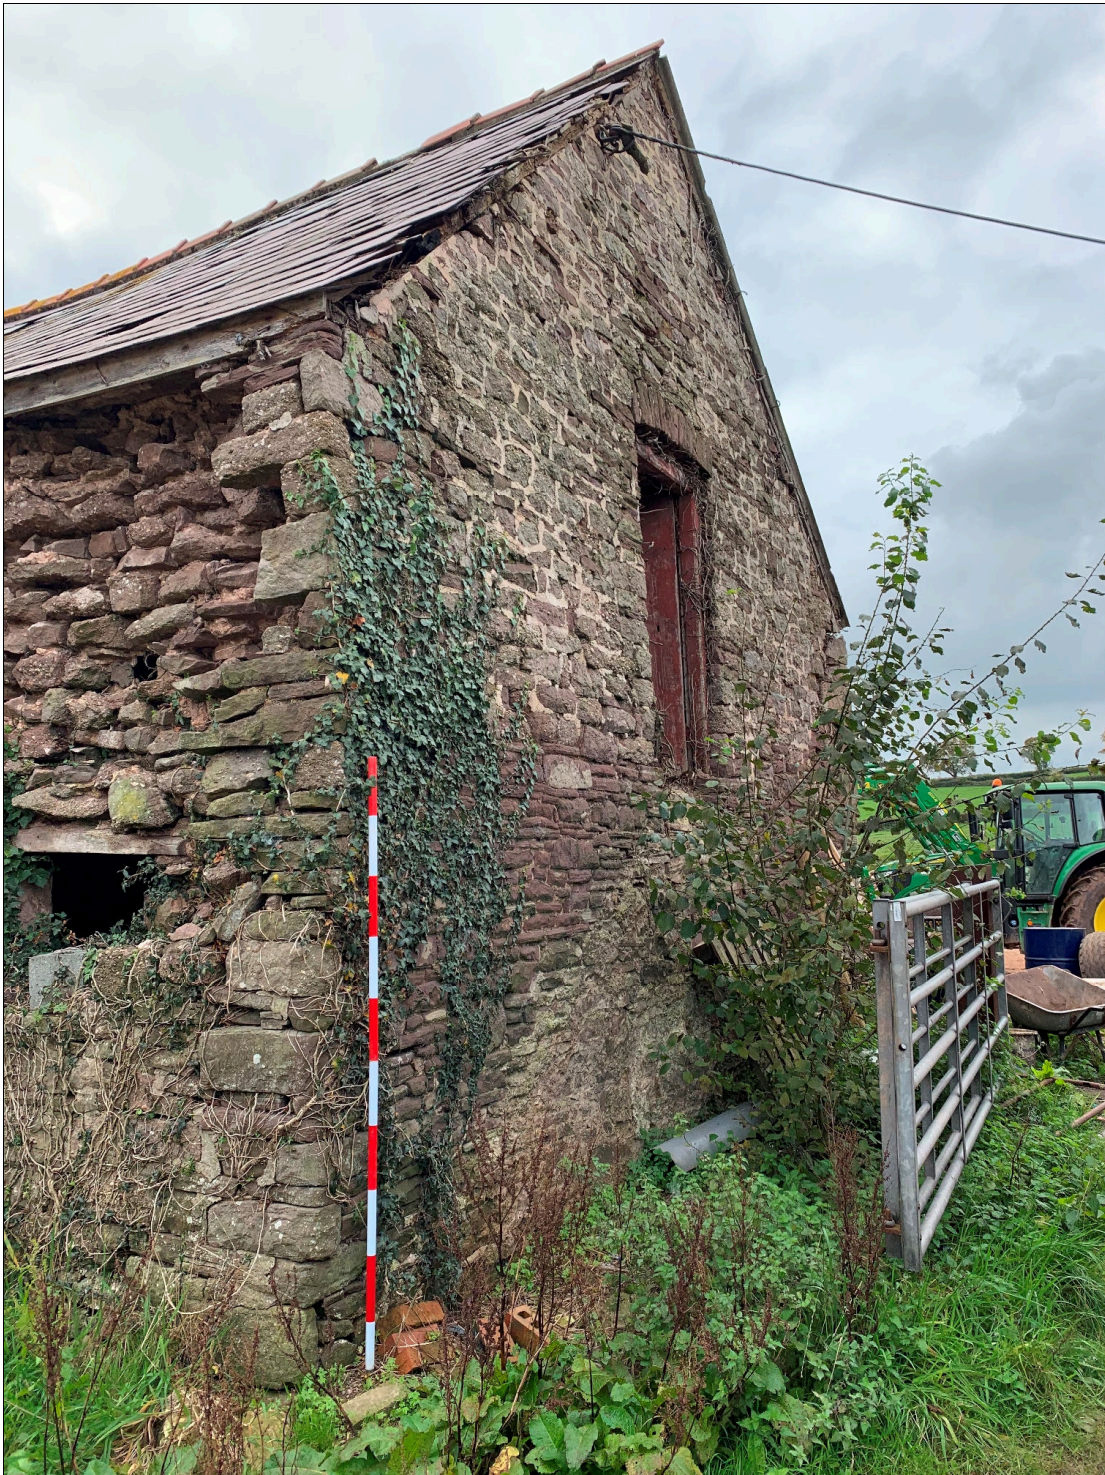
Plate 21: LLN2020_0021 - A view of the northern gable end of the cow house. The stair to the doorway in the upper floor has been removed but the scar of the structure is still visible on the wall. Looking west-southwest.

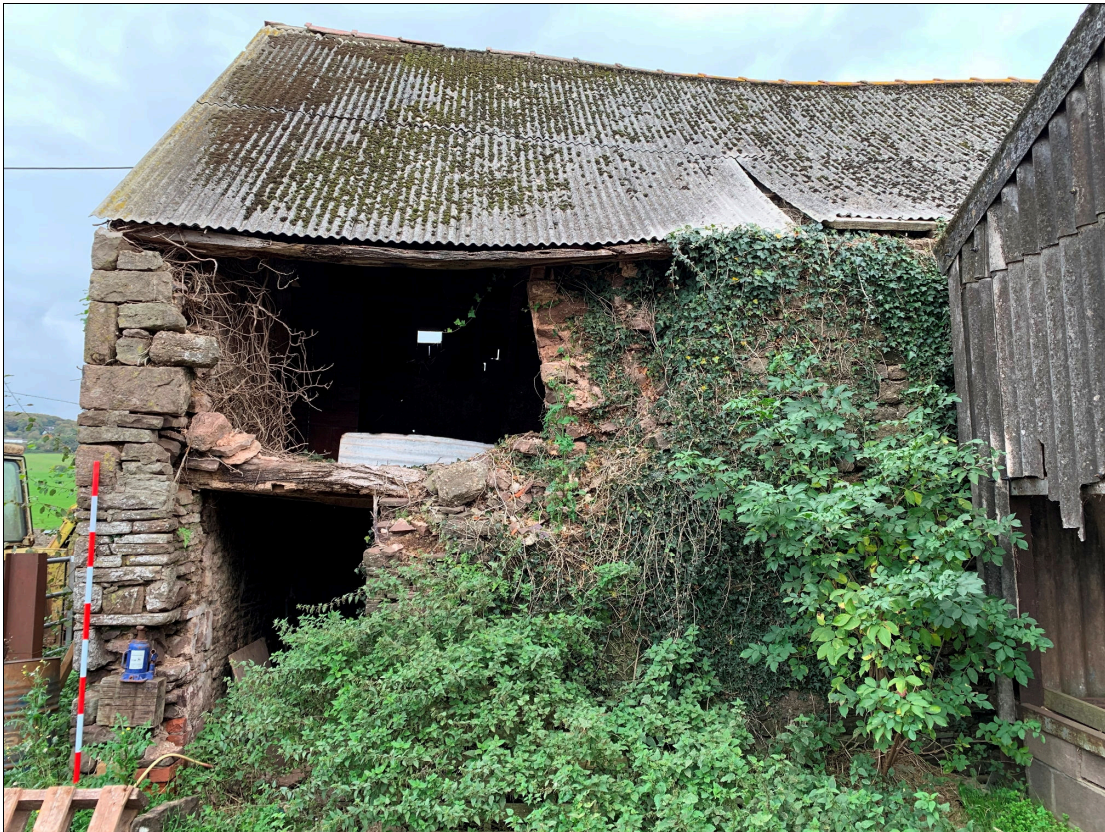
Plate 27: LLN2020_0027 - A view of the western elevation of the cow house, showing the collapsed section of wall in the upper floor above the doorway. The reveal of a window is seen to the right of the missing section. A blocked up central doorway is present on the ground floor, behind the vegetation to the right of centre. The northern end of the modern agricultural shed built alongside the barn and cow house is seen to the right of the image. Looking east.

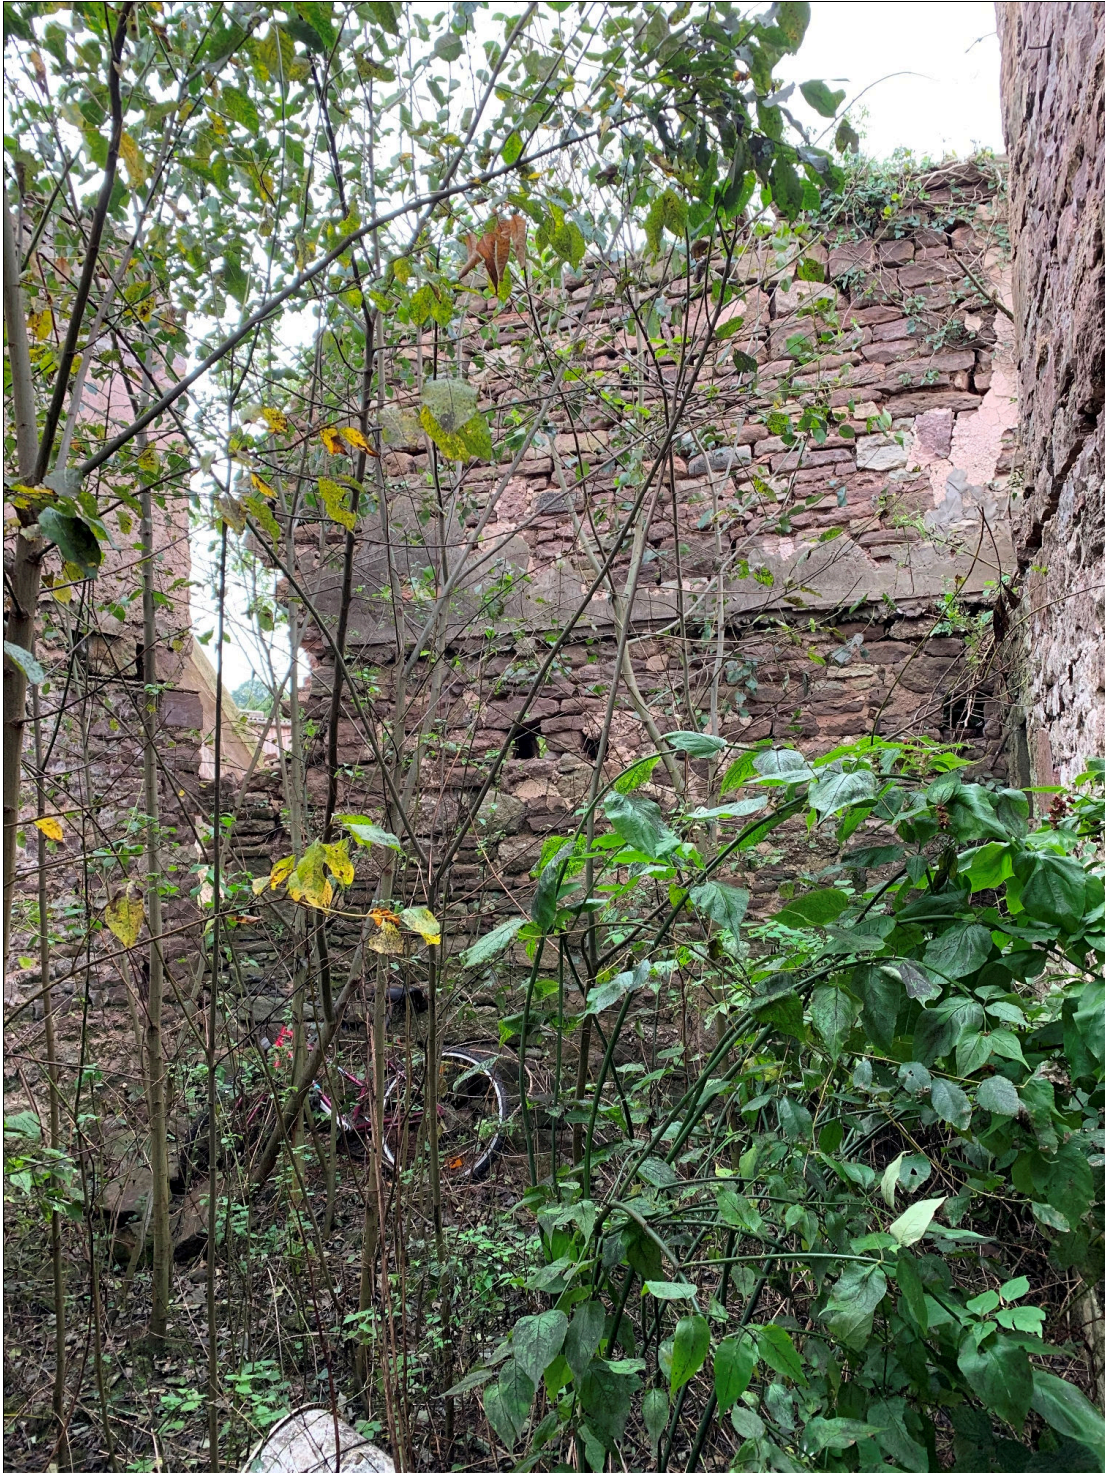
Plate 31: LLN2020_0031 - A view of the western wall inside the eastern annexe. The wall is the eastern wall of the earlier barn. The gap to the left has been caused by the collapse of the southern gable wall of the barn. Looking west-southwest.

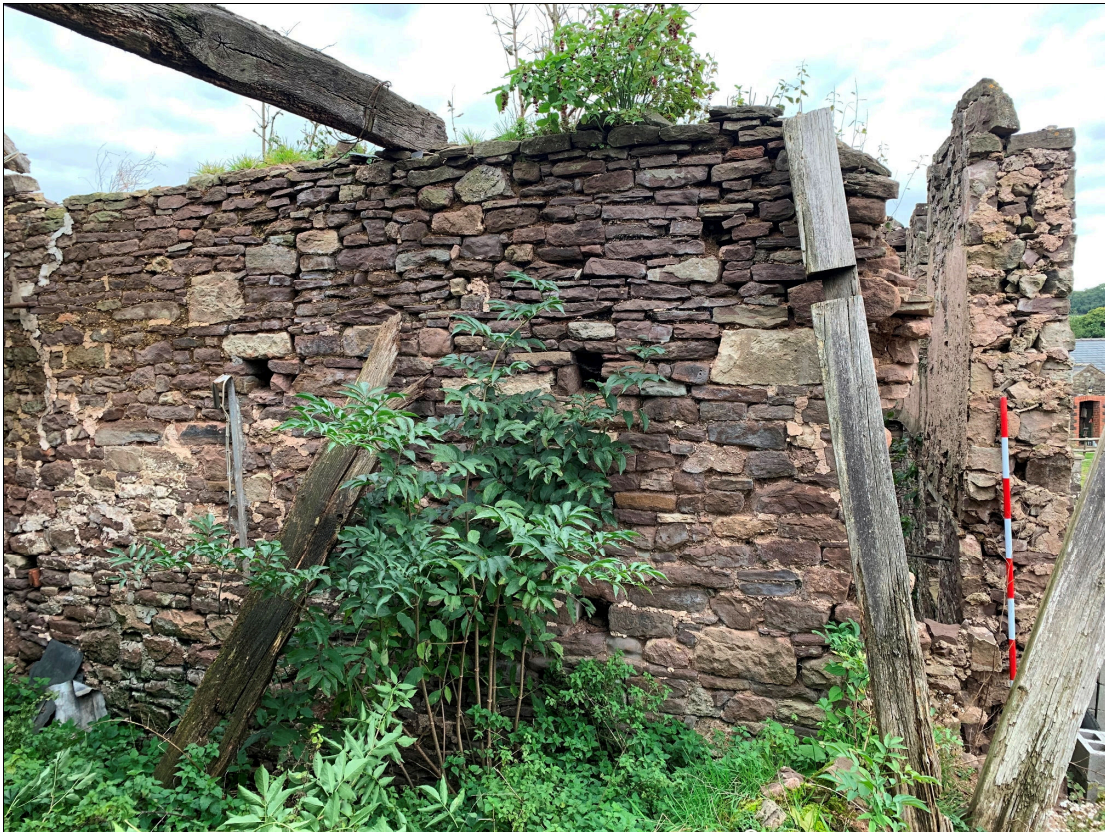
Plate 47: LLN2020_0047 - A view of the eastern wall inside the barn, showing the break in the southern end of the wall to the right, caused by the loss of the southern gable wall. This has exposed the end of the southern wall of the eastern annexe, which would have formerly been attached to the barn wall. Looking east.

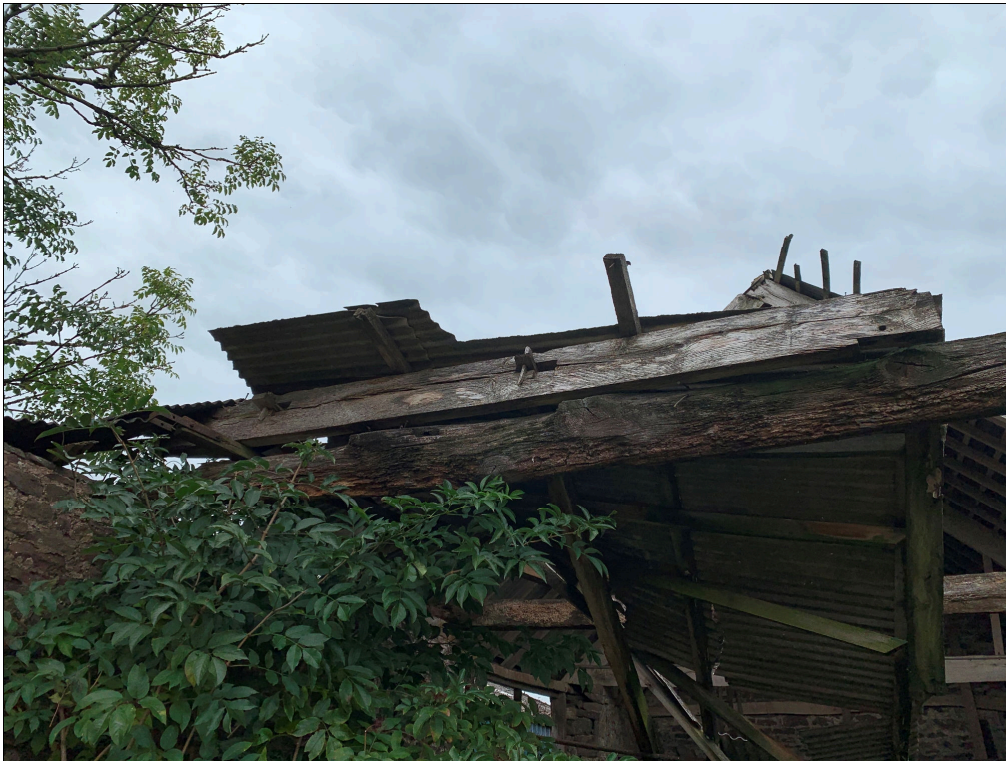
Plate 49: LLN2020_0049 - A view of the timbers of a broken roof truss at the southern end of the barn. Looking north.

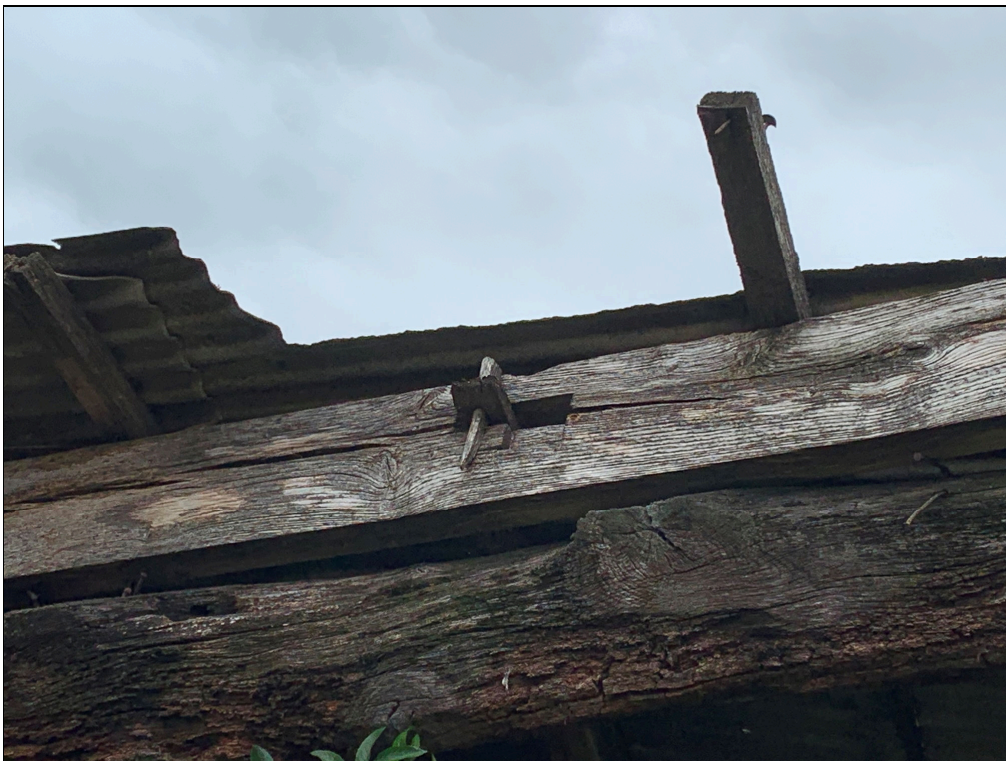
Plate 50: LLN2020_0050 - A view showing more detail of the broken roof truss, which had wooden pegs connecting the timbers. Looking north.

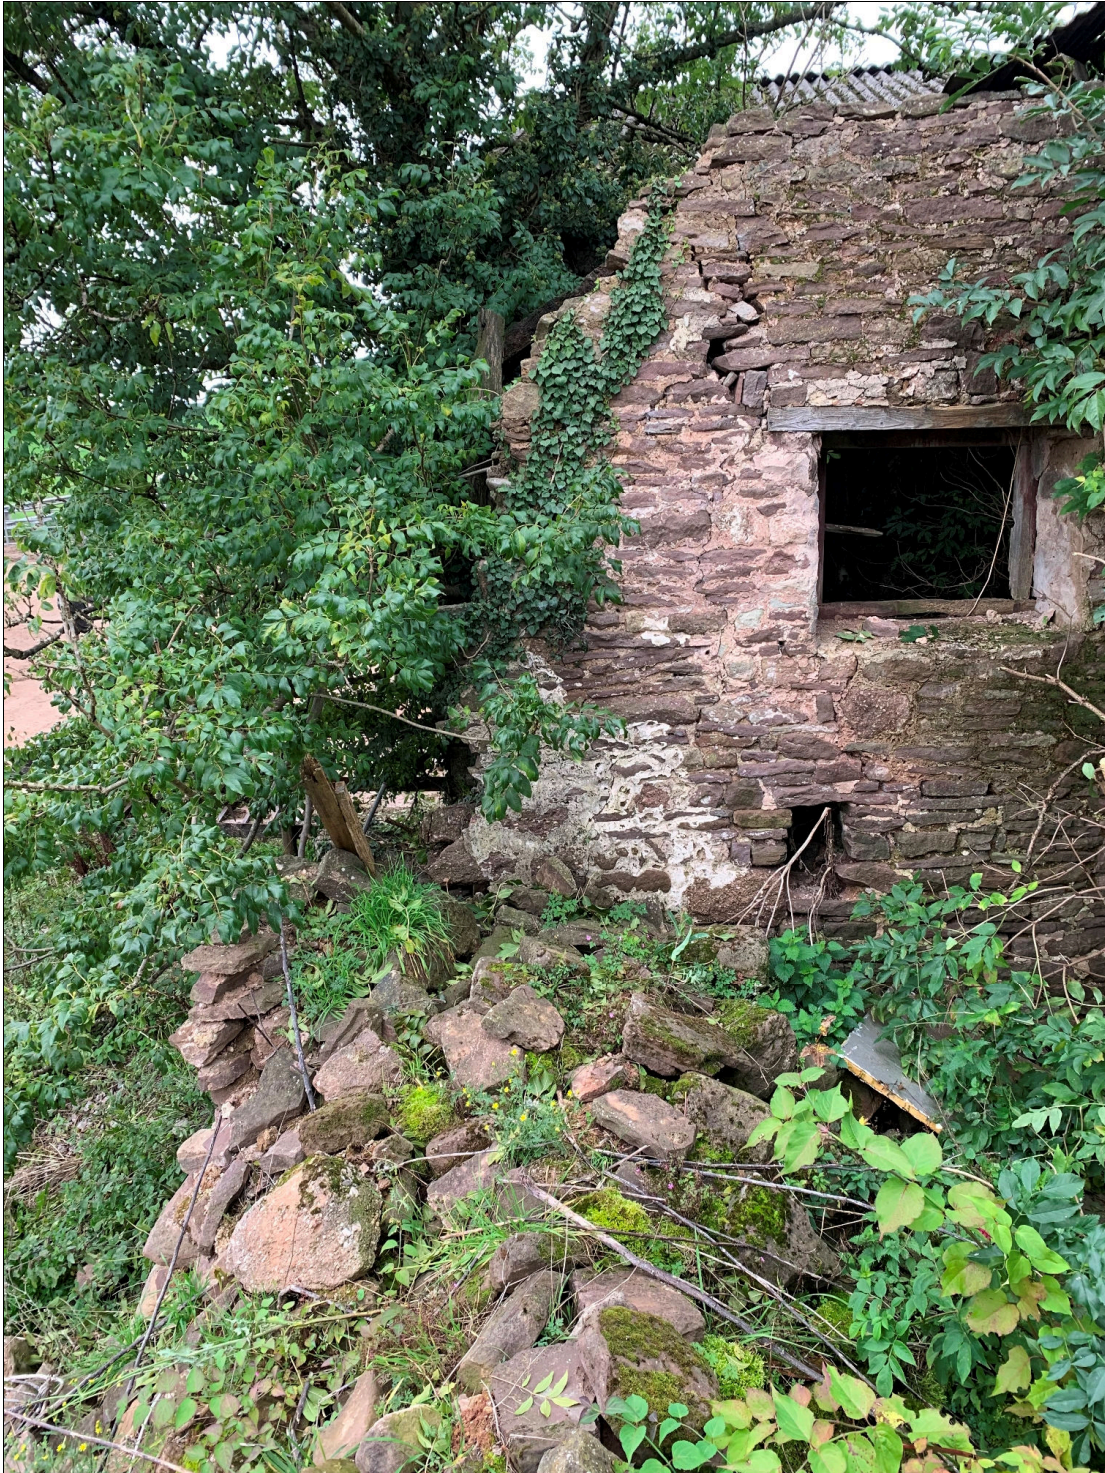
8.3.5 The southern gable wall of the barn has collapsed, and its rubble lies to the south of the building (Plates 1 & 55). No features survive, although it is thought that this wall was not the original gable wall of the barn as it appears to have been inserted between the lateral walls of the barn (Plates 4 & 5). During the 19th and 20th centuries an extension, now lost, stood attached to the outside of this wall and it is possible that the original gable wall was replaced when this extension was constructed.

Plate 55: LLN2020_0055 - A view of the rubble marking the line of the southern gable end of the barn. This view seems to suggest that the gable wall which collapsed was not the original gable wall but was a later insert which did not bond with the lateral walls. Looking west.

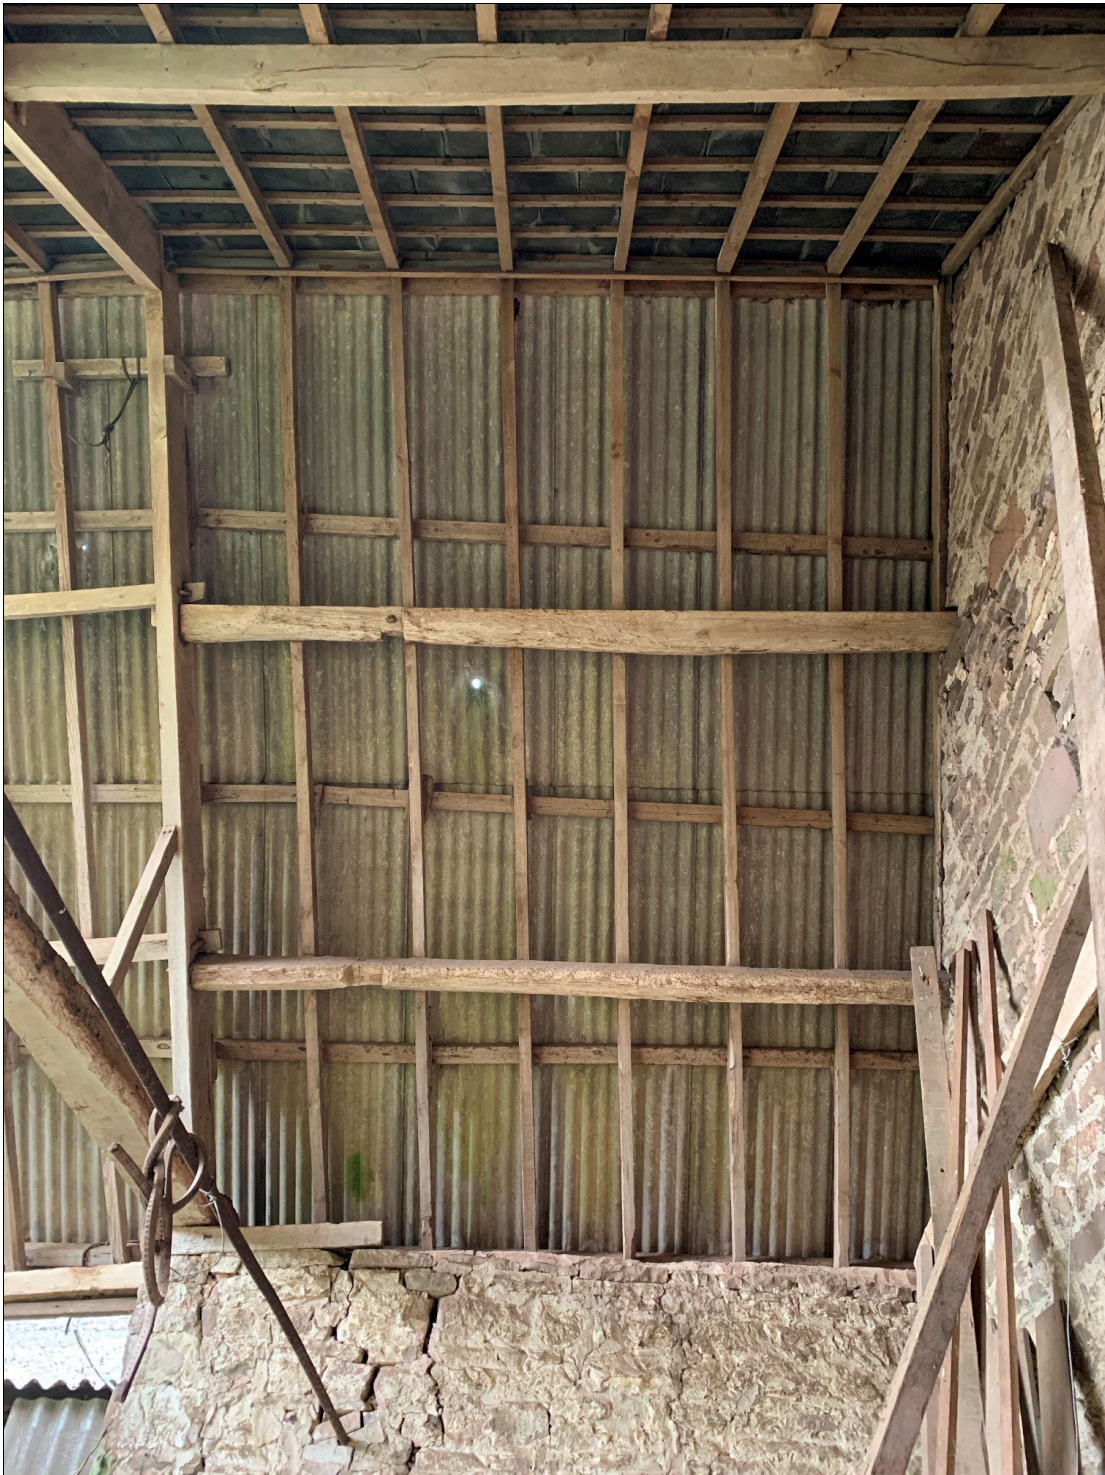
Plate 65: LLN2020_0065 - A view of the roof inside the northern end of the barn. The purlins appear machine sawn and relatively recent, but the rafters appear to be reused timbers from an earlier roof. The truss to the left appears to be machine sawn (later 19th century) whilst the beam at its base is clearly earlier. It seems likely that a new slate roof was put across the barn when the cow house was added to its northern end. It appears that timbers were reused or replaced in the barn roof at this time. Looking west.

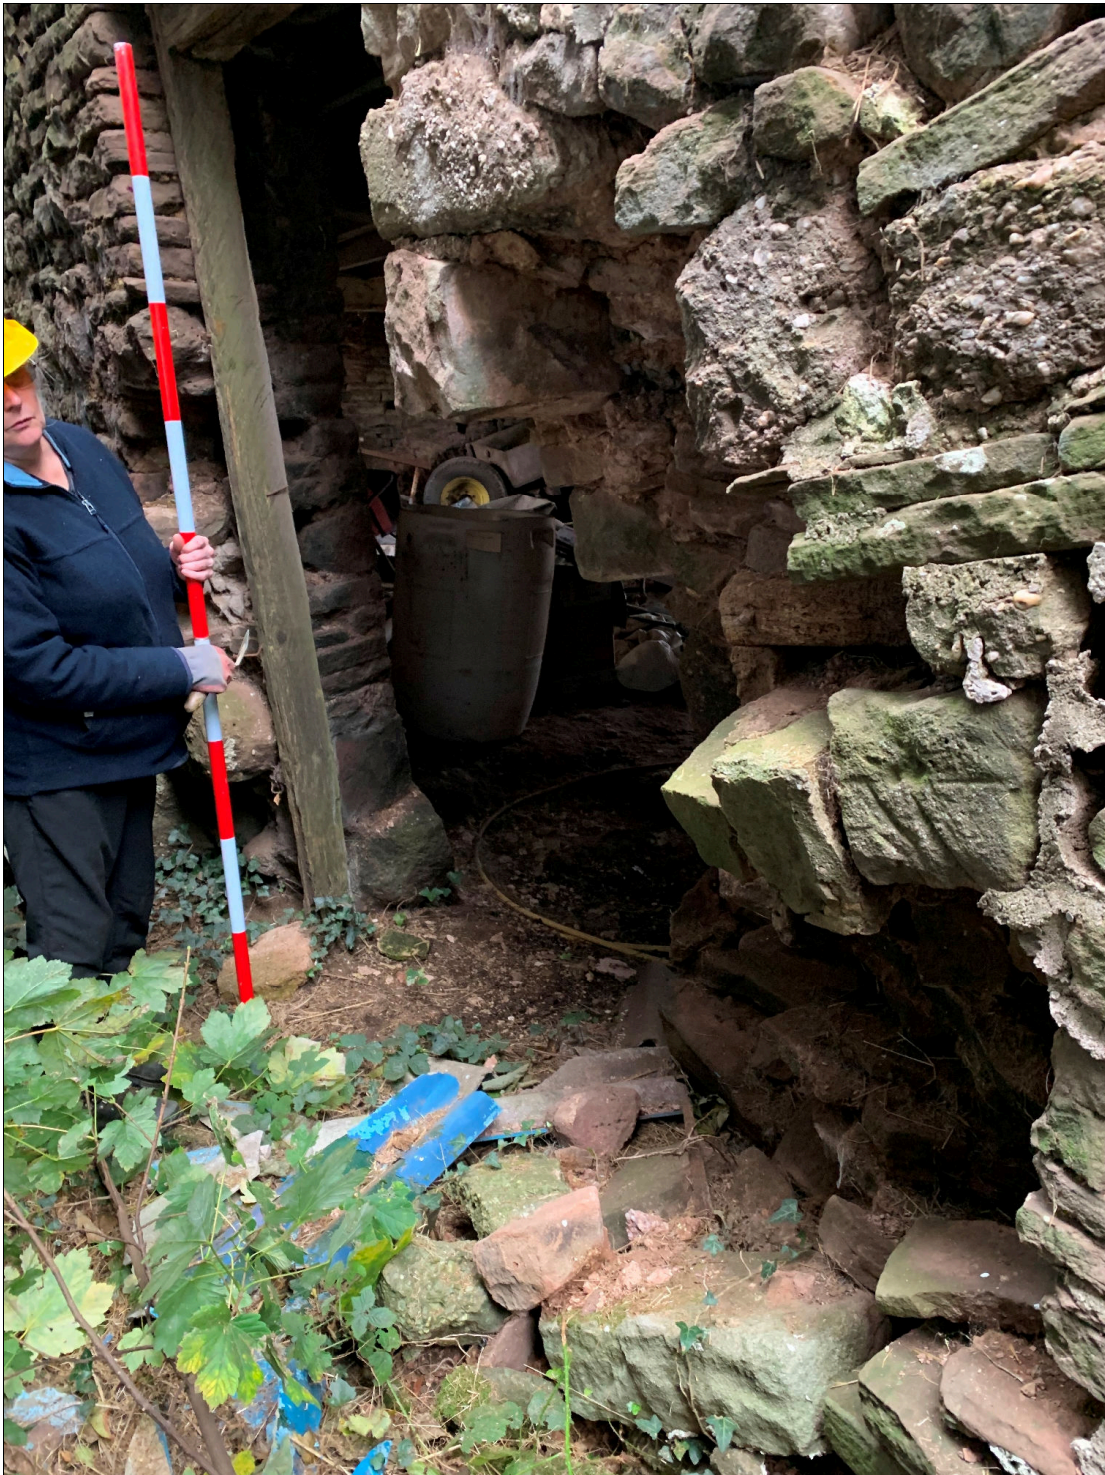
Plate 70: LLN2020_0070 - A view of the damaged wall at the northwestern corner of the barn, where it seems the lower quoin stones are missing. The cow house door is left of centre. Looking northeast.

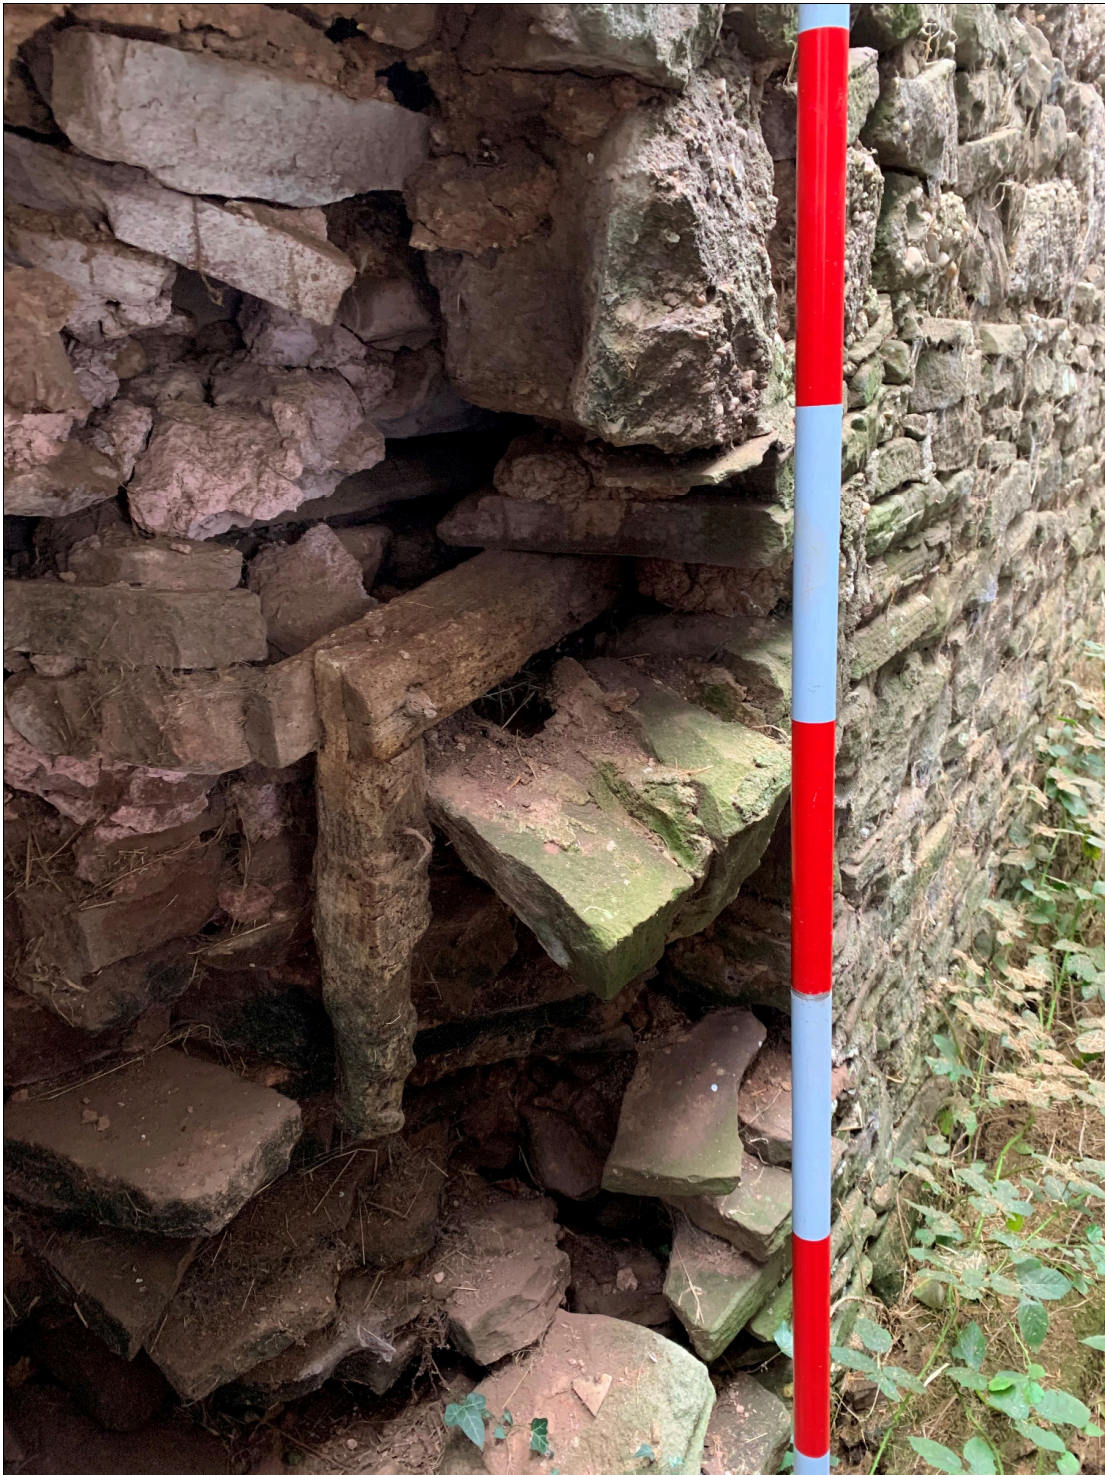
Plate 71: LLN2020_0071 - A view of the damaged wall at the northwestern corner of the barn showing a timber frame, possibly an old window frame, built into the fabric of the wall. Note that there is also lime mortar within the core of the wall. Looking southeast.

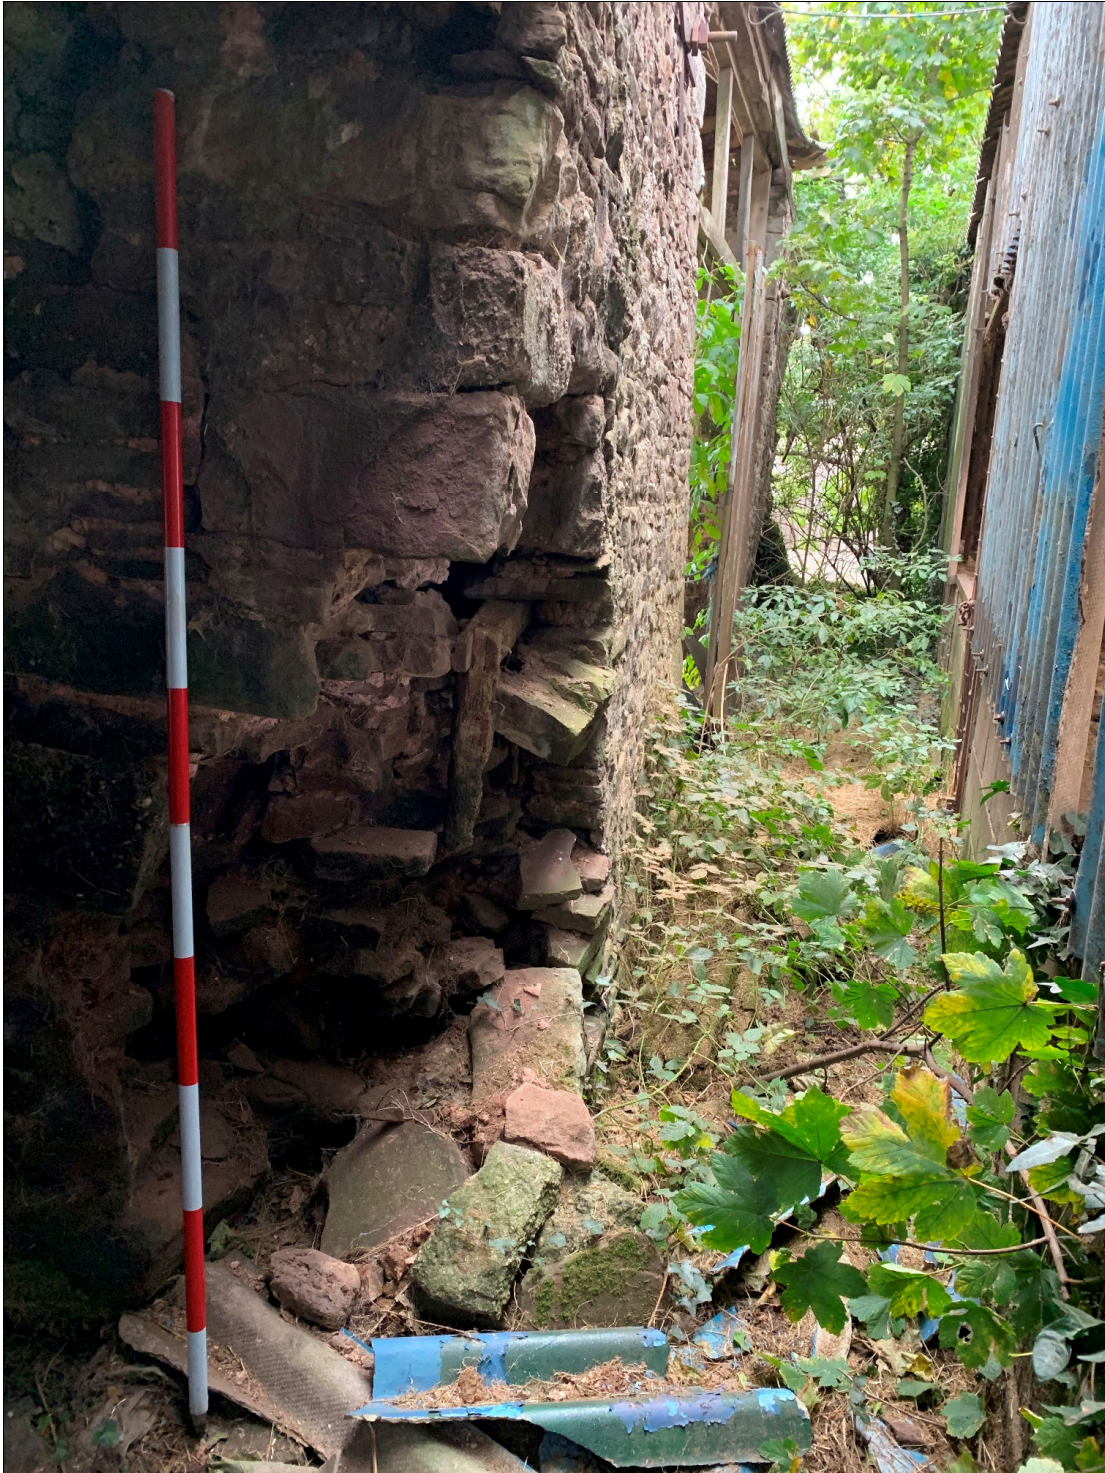
Plate 72: LLN2020_0072 - A view of the damaged wall at the northwestern corner of the barn. Looking south.
