CPAT Report No. 1905

Pentre Haughton, Llandrinio

Historic Building Survey

Client name: Sylvia Pritchard
 CPAT Project No: 2645
 Project Name: Pentre Haughton, Llandrinio
 Grid Reference: SJ3096018917
 County/LPA: Powys
 Planning Application: 21/2051/FUL
 CPAT Report No: 1905
 Event PRN: 214632
 Report status: Final

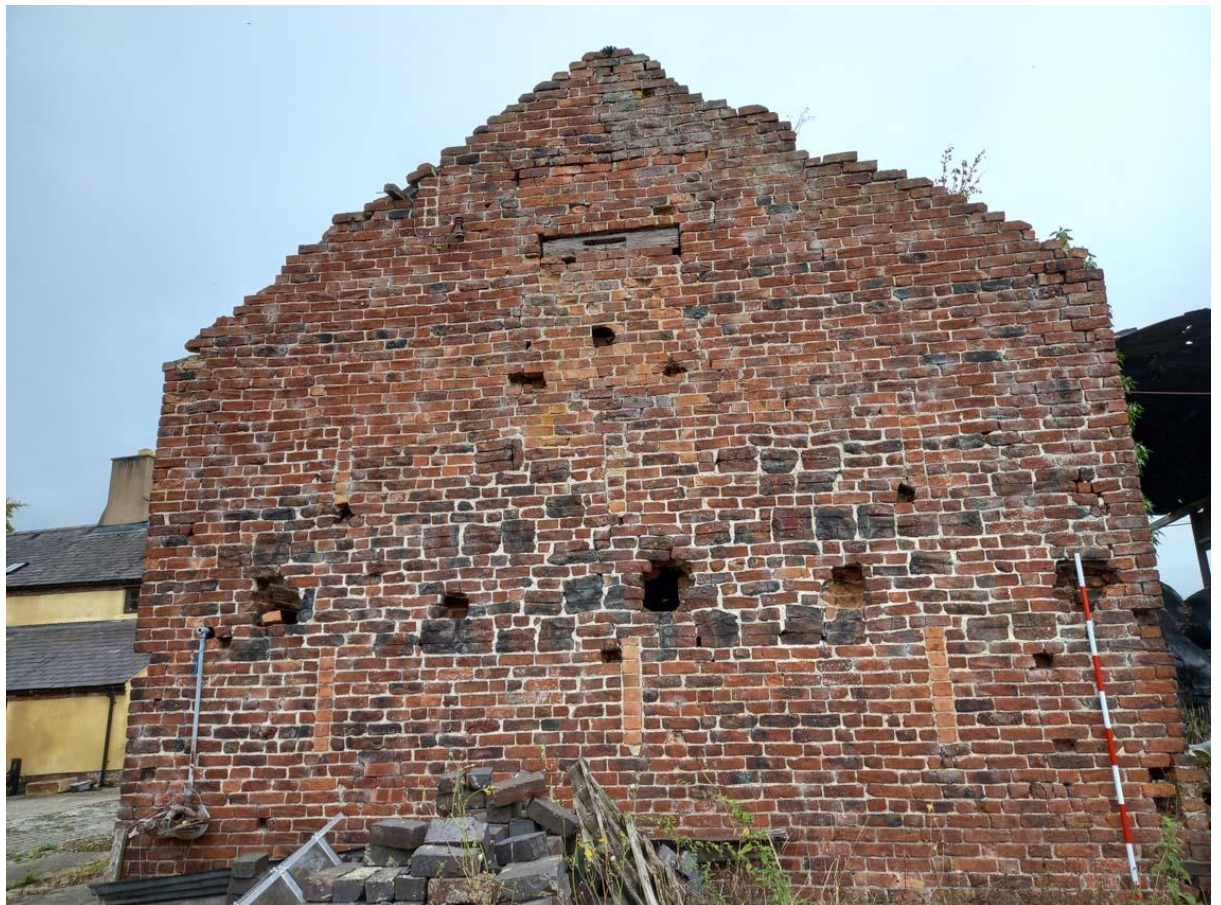
- 2.2. The cow house at the northern end of the barn complex is the earliest building other than the farmhouse (Figure 4). There is evidence that another bay was built to the north elevation of this building during the late 19th Century as shown on the 1901 OS Map and evidenced with the apertures created at half height for the first floor joists. Originally this building would have been finished with a Welsh slate roof, but the replacement corrugated tin roof has caved in leaving the historic roof timbers open to the elements.
- 2.3. This is an early example of a cow house, which is identifiable as there would appear to be no original window openings within the cow house, the single window to the rear looks to have been a later addition along with the hay loft above (Figure 4). The cow house is likely to have been solely ventilated by the ventilation slits to the rear and end gable.

Fig. 4 North-facing gable end of cow house; note joist holes, infilled ventilation slots and window (CPAT 5005-006)

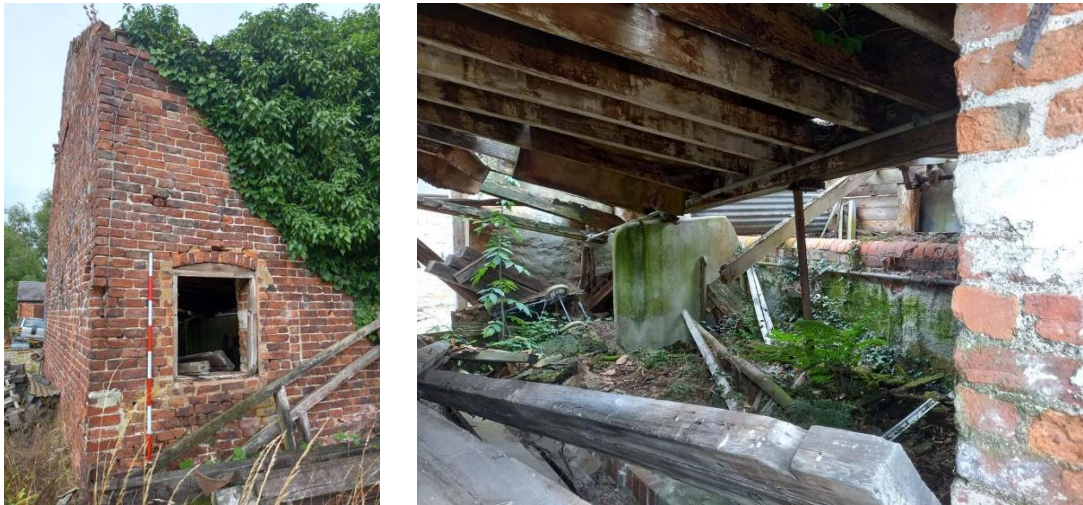
- 2.4. Internally there is a raised brick platform on which the cows would have been tethered with a drainage and manure channel behind (Figure 5). The original stalls have been replaced with precast concrete dividers.

Fig. 5 Window at north-west corner and view through it to cow stall and plinth, with collapsed hay loft (CPAT 5005-007 and 008)

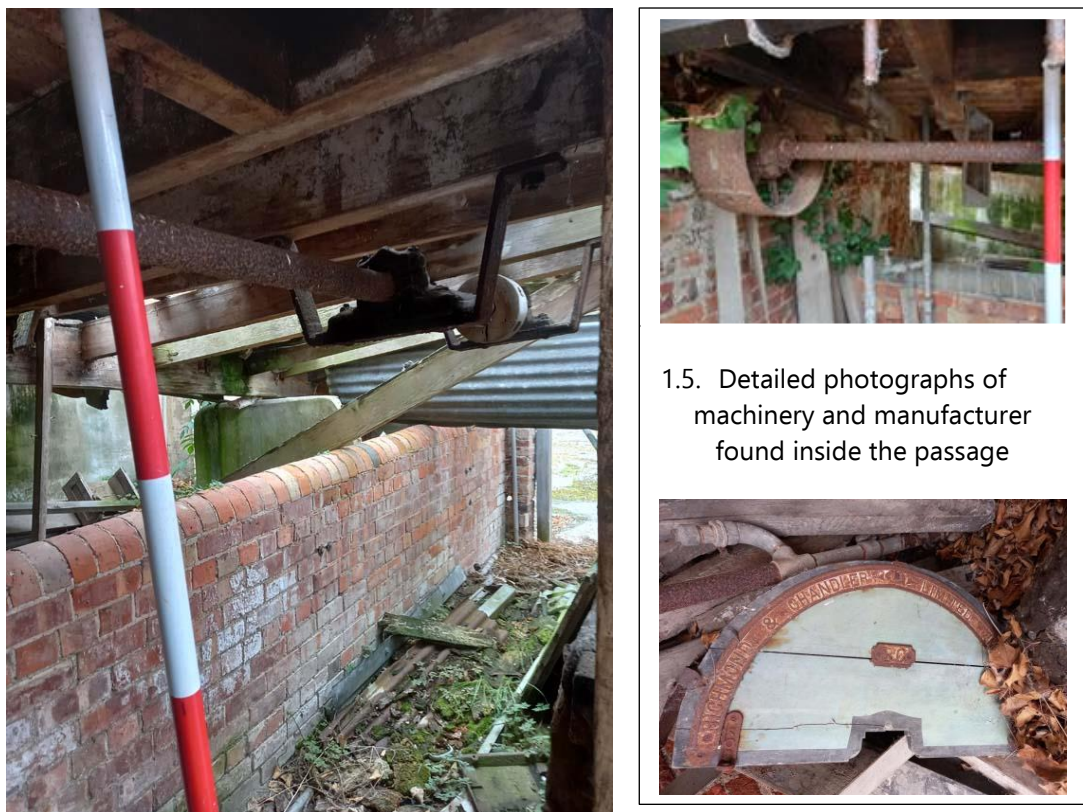
- 2.5. Two half height brick walls provide the feeding passage through the cow house and into the barn (Figure 6). A pump survives within this walkway which was used to pump water from the nearby river into the cow house.

Fig. 6 Passageway between cow house and barn, with detail of machinery preserved in situ (CPAT 5005-022, 020 and 021)

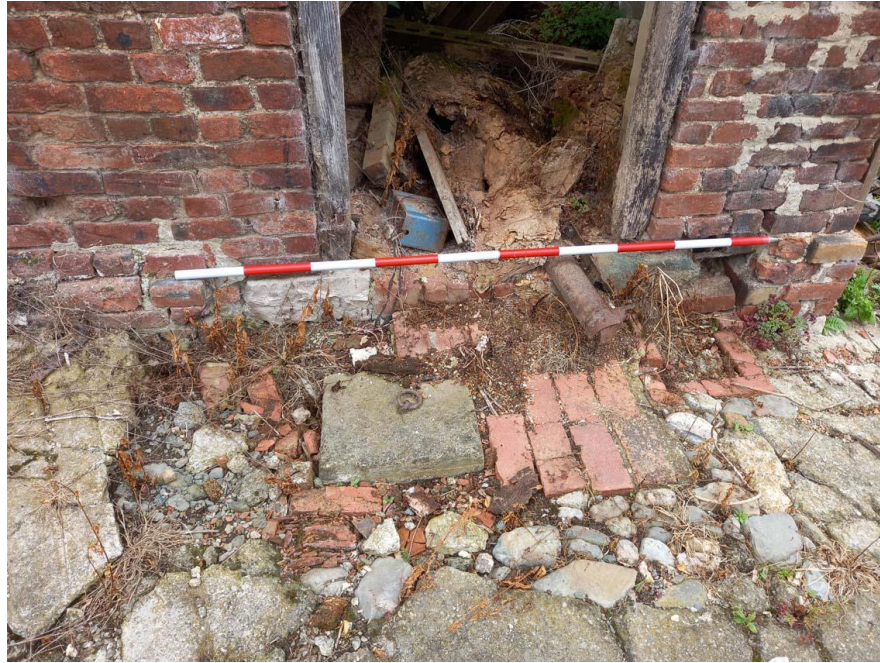
- 2.6. The western side of the cow house had a single ground-floor window at the north-western corner, and a door opposite in the eastern wall which showed drainage and other modifications to the building at the threshold (Figure 7). Further south along the eastern elevation a second doorway gave access to the passageway, and adjacent to this a third door was the northernmost of a pair of entrances to the barn (Figure 8).

Fig. 7 Detail of threshold and foundations at north-eastern corner of cow house (CPAT 5005-028)

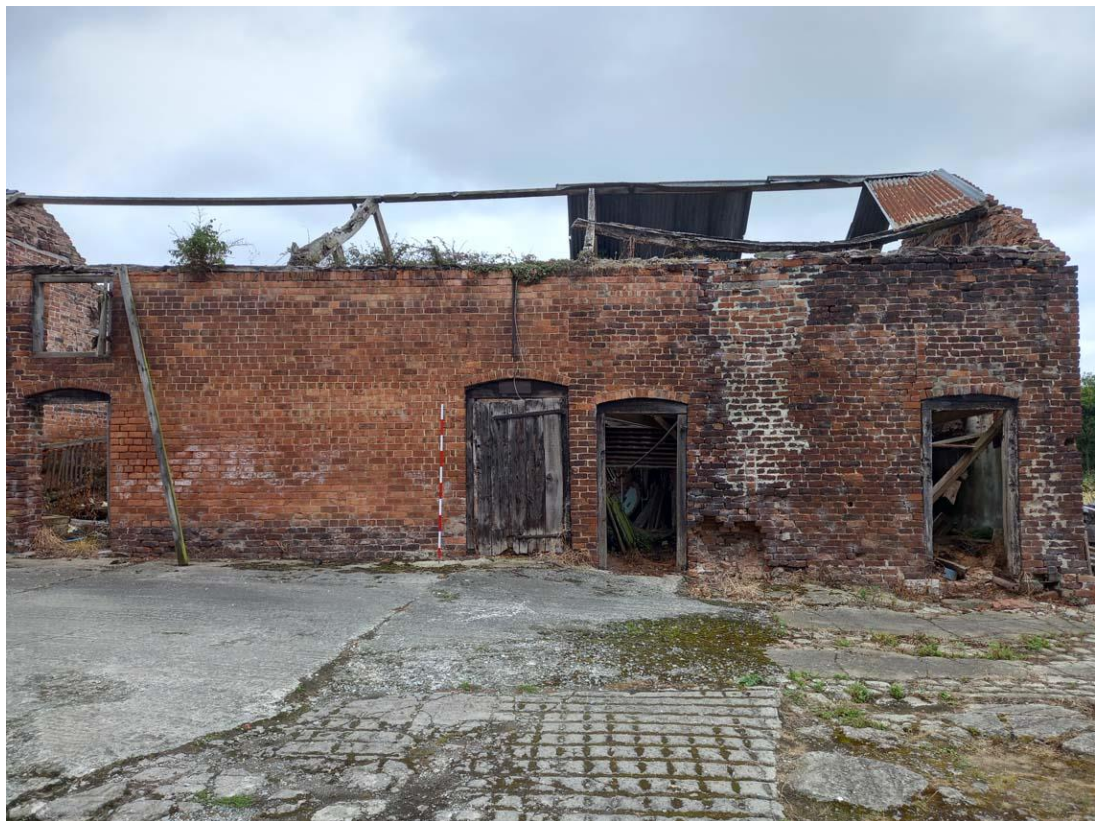
Fig. 8 Eastern elevation of northern part of barn complex (CPAT 5005-034)

- 2.7. The barn section of the range has been heavily altered/infilled/rebuilt around the middle of the 19th Century. The window and door to the south is of the same brick and construction type as the cow shed to the north, with more recent brickwork in between (Figure 8). In Berrys' opinion, however, there is no evidence that this is an infill of a threshing barn. Along the western side of the barn the old brickwork continues for much of the wall, but newer brickwork occurs around a doorway at the north-western end of the barn (Figures 9 and 10), suggesting this was an insert that involved a relatively expansive repair to the wall in this location. A slate floor is laid between the two opposing doorways in this zone.

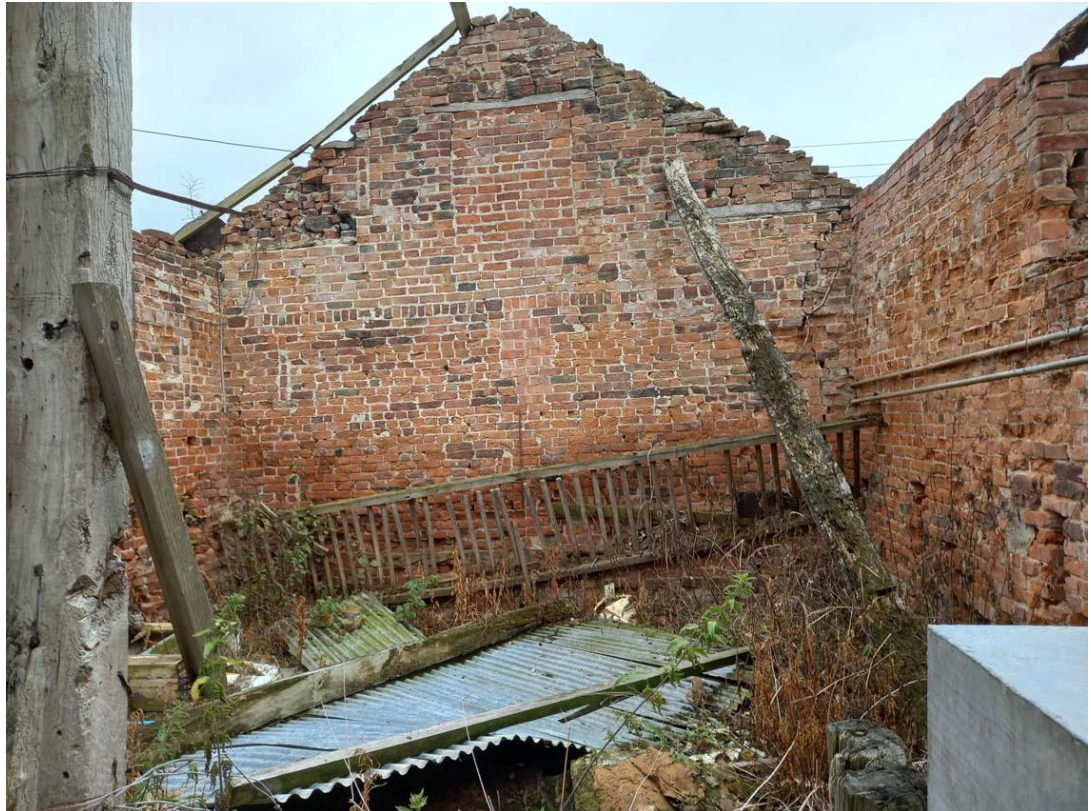
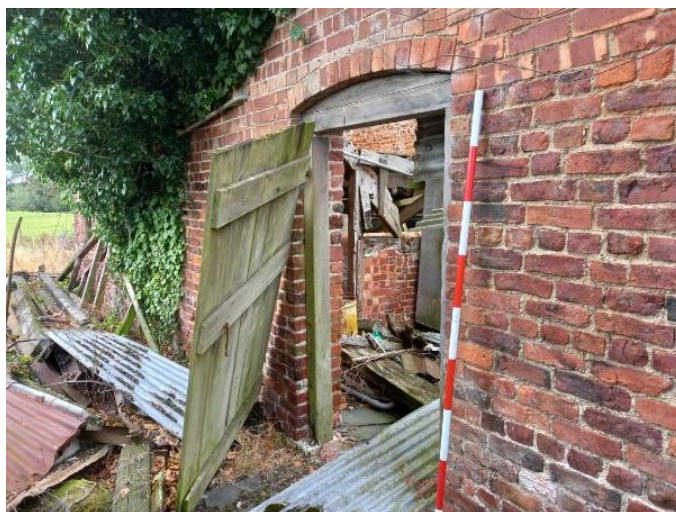
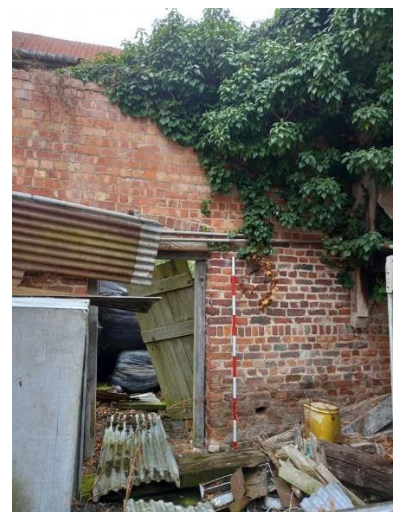
Fig. 9 Interior of southern gable to barn and old brickwork along walls (CPAT 5005-014); change in brickwork in west elevation around the inserted doorway (CPAT 5005-010 and 018)

- 2.8. Ventilation slots and a first floor window in the southern gable are infilled (Figure 9), and replicate the evidence seen in the northern gable of the cow house. In the west elevation, however, the ventilation slots remain open.
- 2.9. The roof was supported on raking Queen post trusses (Figure 10), and windows at first floor level in both west and east elevations show there must once have been a loft. Various timber fixtures and fittings survived in the barn including a boarded wall against the passageway (Figure 10) and wall-mounted hay feeder (Figure 9). A low, relatively modern brick wall with timber uprights sub-divides the barn (Figure 10 foreground).

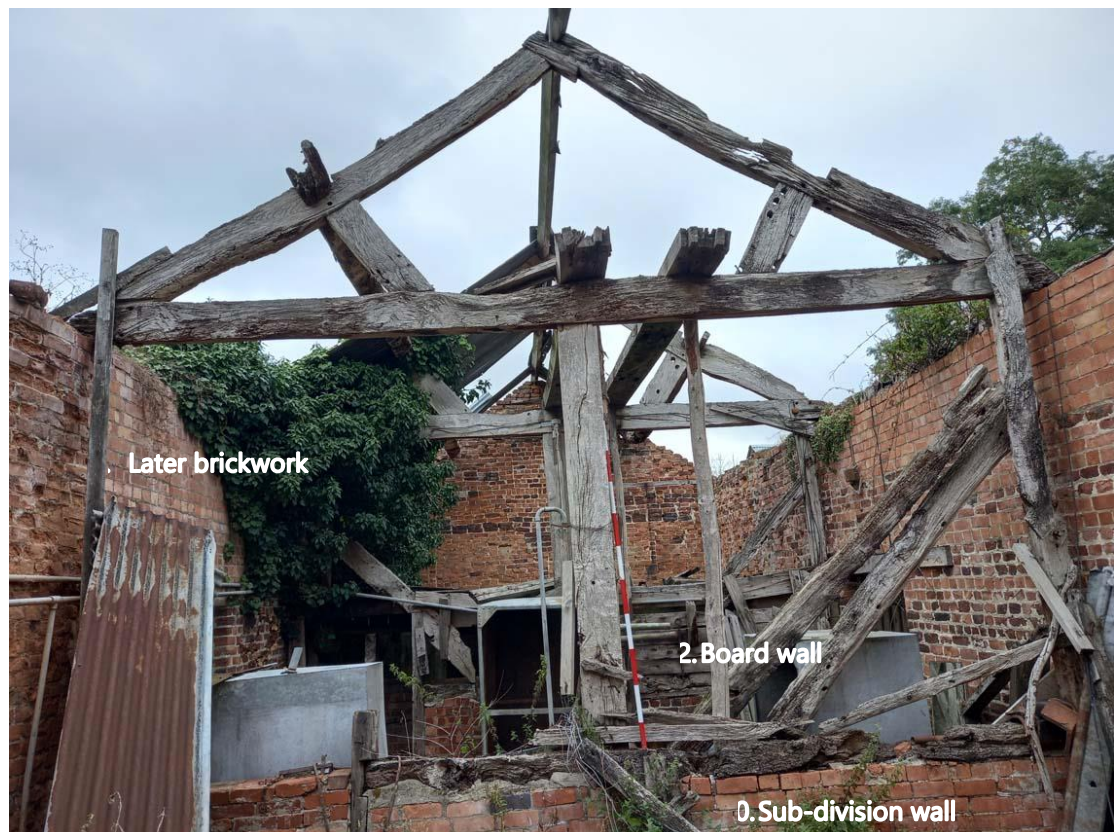
Fig. 10 Interior of barn showing raking Queen Post roof trusses (CPAT 5005-039)

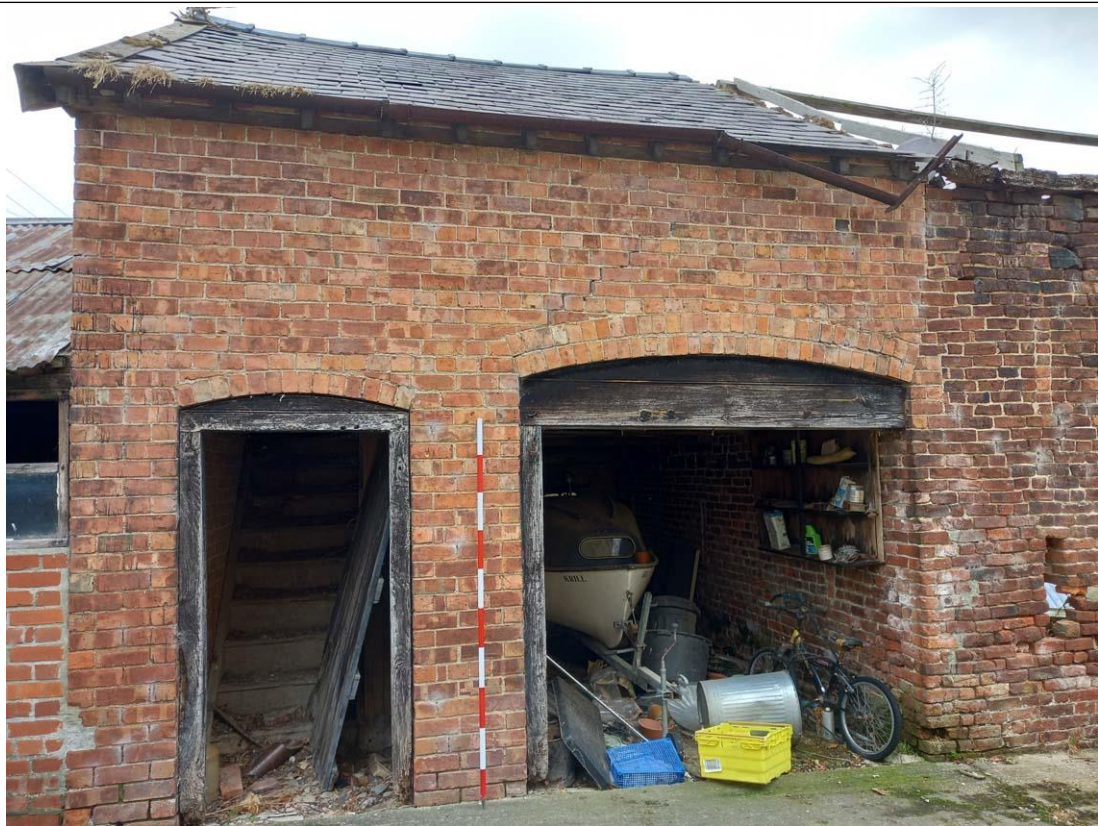
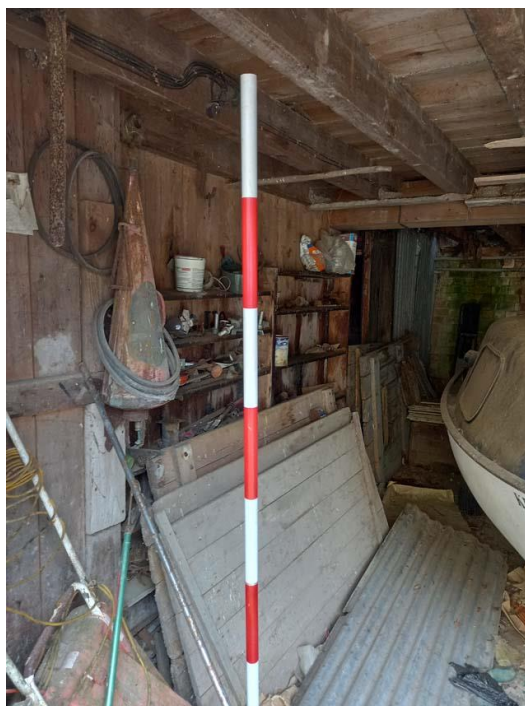
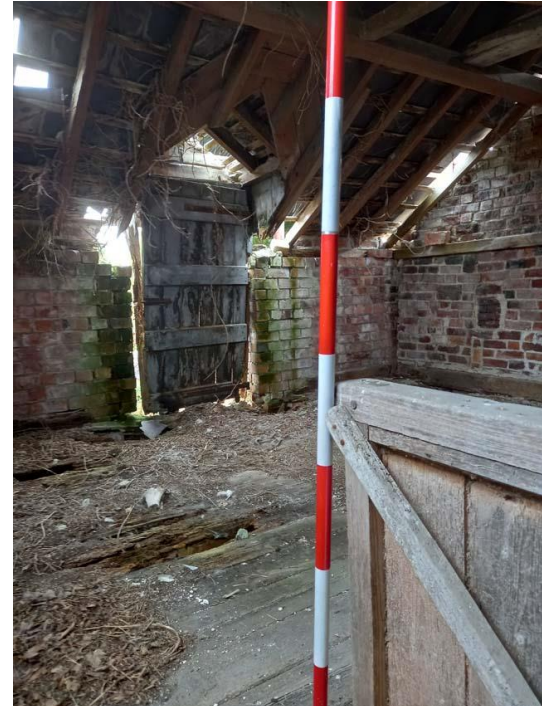
- 2.10. The Cart Shed is a later construction to the barn and cow house. It is likely to date to the mid 19th Century, possibly around the same time as the barn was rebuilt due to the appearance of the same bricks having been used.
- 2.11. The cart shed comprises a single bay structure with a separate enclosed staircase up to the granary above (Figure 11). In the west wall of the first floor is a door which would have been used to load and unload the granary. There is no evidence of a hatch or hoist for moving the grain onto the cart internally, neither is there any evidence of an external staircase providing access.

Fig. 11 Cart Shed and stairs to granary (east elevation); with details of interior ground floor and loft (CPAT 5005-041, 042 and 045)

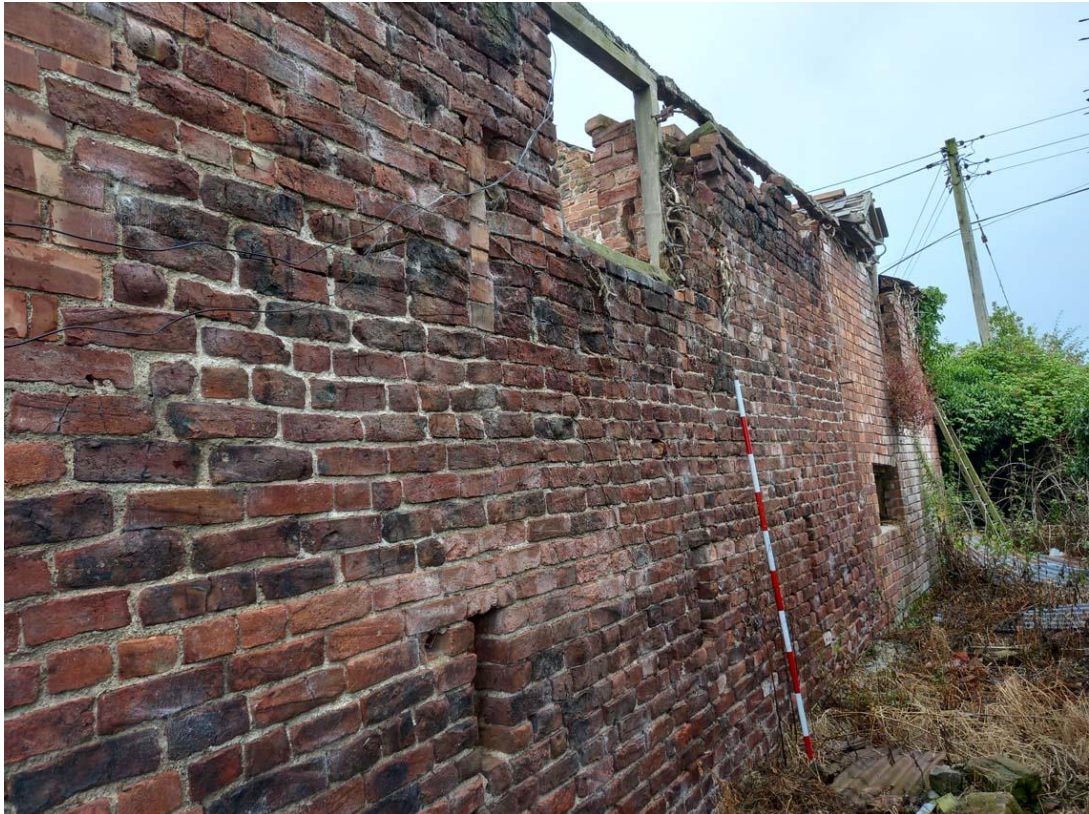
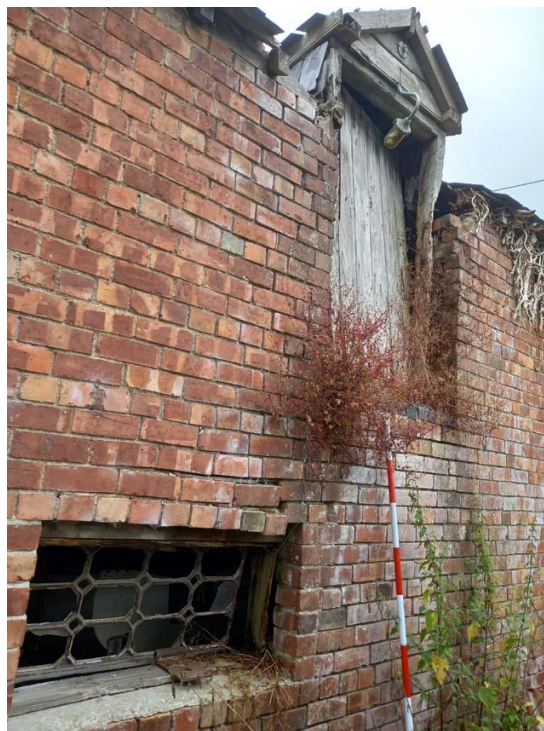
Fig. 12 West elevation of Barn and Cart Shed showing change in brickwork, open and infilled ventilation slots, windows and first floor doorway (CPAT 5005-023 and 025)

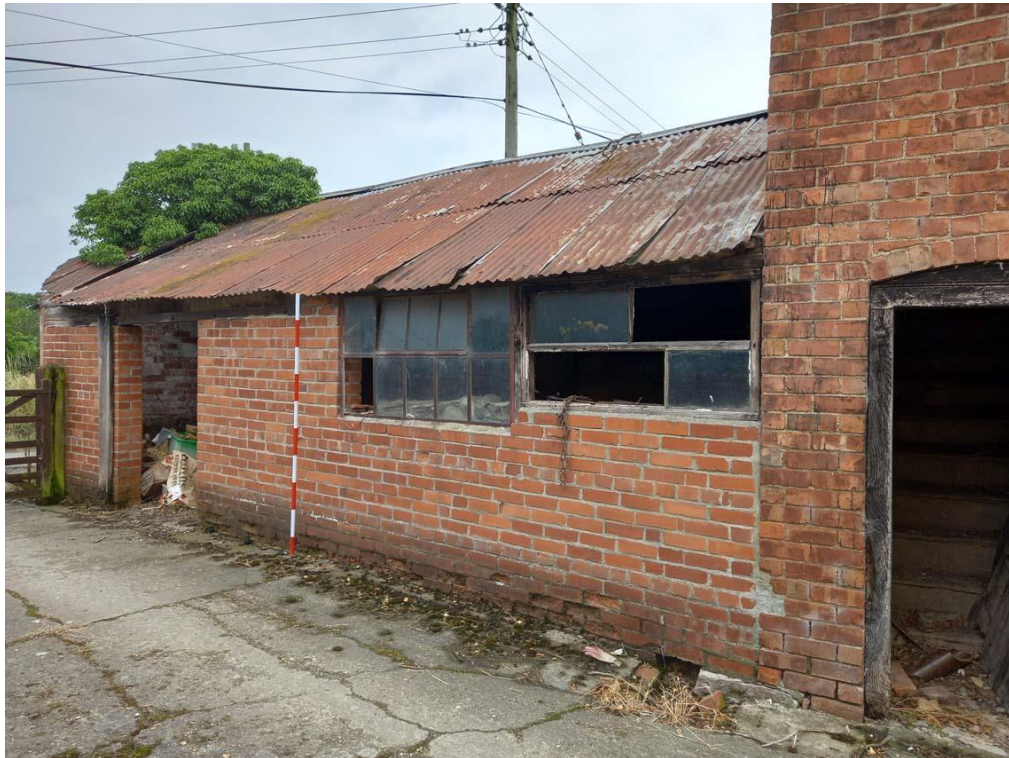
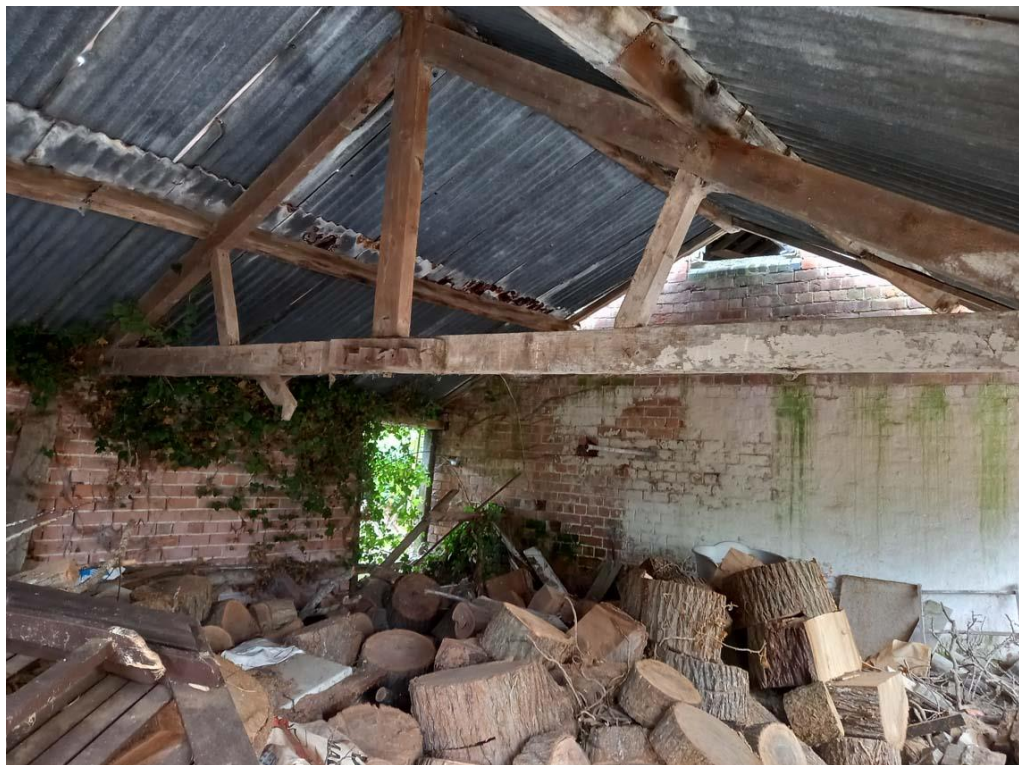
- 2.12. This was a single storey building with a corrugated iron roof, which was added to the south end of the Cart Shed between 1887 and 1901 according to Ordnance Survey historic mapping. It has doorways at its north-western and south-eastern corners, and a metal-frame window along much of the length of its eastern elevation.

Fig. 13 Store building: west elevation and interior looking north-west (CPAT 5005-048 and 053)

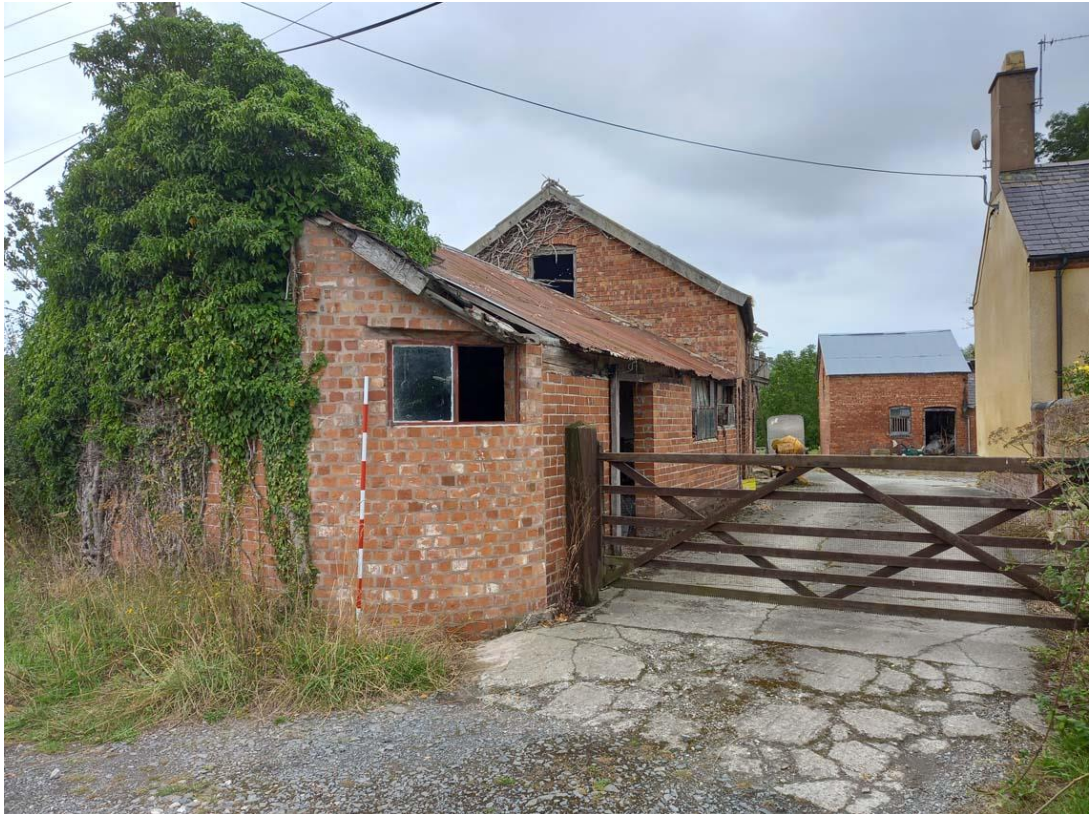
- 2.13. At the south-eastern corner of the Store, the wall is curved and incorporates a window. The brickwork can be seen to be different from the rest of the building (Figure 14), although there is consistency in the pattern of headers and stretchers of English Garden Bond design for both parts. This is an unusual feature, but may be a simple pragmatic solution to a restricted access for large carts turning from the lane into the farmyard. By constructing a curve here rather than a right-angled wall junction, a wider opening is made possible and the chance of accidental damage to the corner reduced.

Fig. 14 Store building: south-eastern corner showing curved wall (CPAT 5005-055)
