Llanishen Reservoir, Cardiff

Building Recording Level 2

Report No. 1742

April 2019

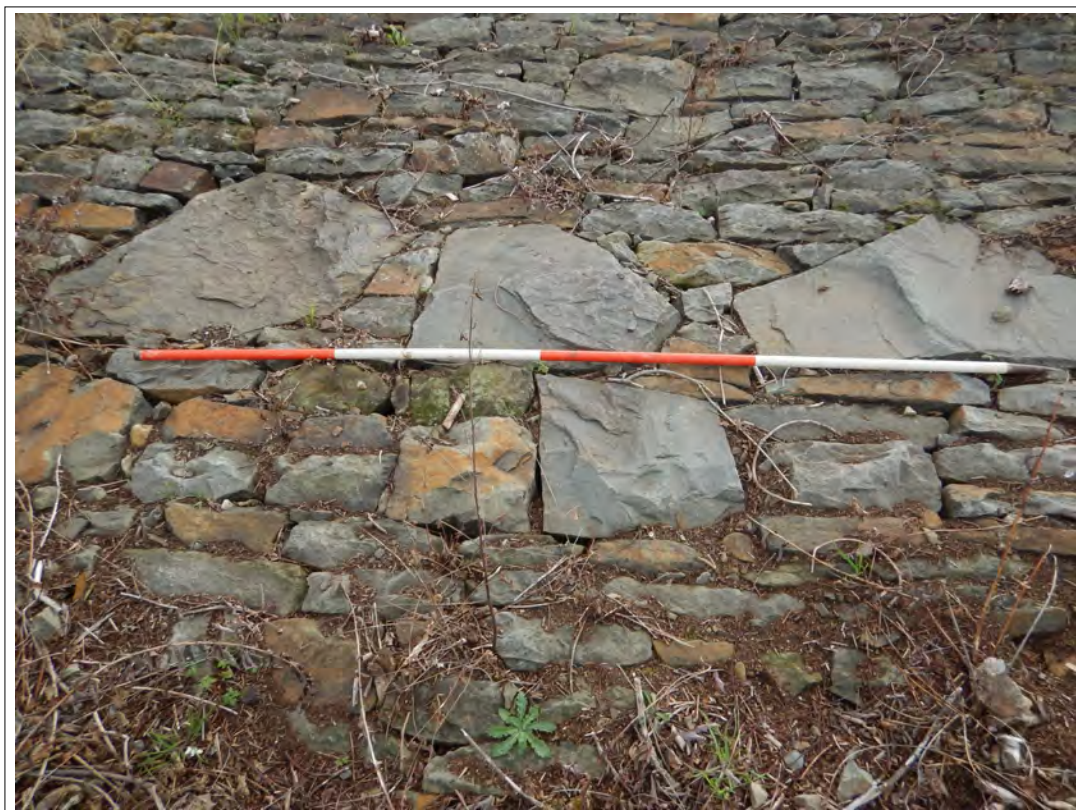
Plate 6. Detail of the interior of the pitched stone embankment, showing several unusually large stones which appear to be more recent additions. Scale 2m.

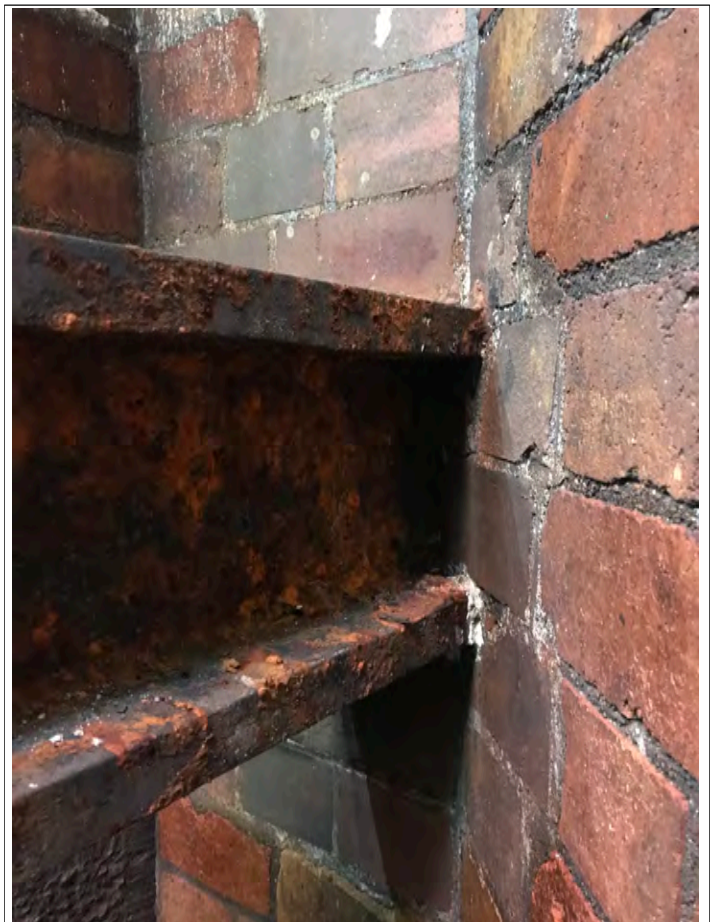
Plate 20. A later addition girder, probably part of the 1929 alterations to the valve tower, with replacement brickwork.

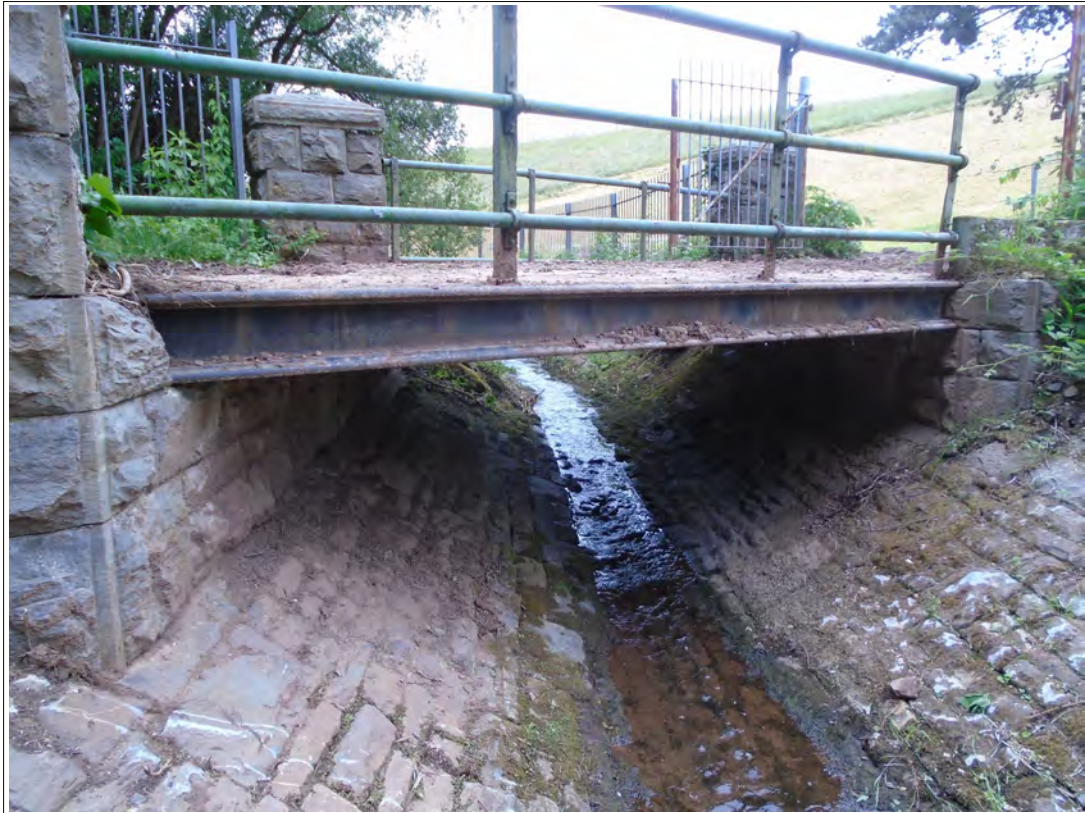
The bridge crosses the by-wash channel at an oblique angle (Plate 26). It has stone abutments to either side of the channel, constructed in rough-finish ashlar with chiselled margins. The bridge is spanned by cast iron edge beams (Plate 27) with intermediate iron rails that support three brick jack arches (Plate 28). This was all topped by a concrete slab. Three of the four corners have pillars capped with a bevelled rough-finish cap stone with chiselled margins (Plate 29). The pillar on the north-east corner is missing, but it would originally have stood the same as the others. The stone from the now collapsed pillar has been recovered during recent clearance work around the bridge. The sides of the bridge have green painted galvanized steel railings that are likely modern additions.

Plate 27. 'SEMD' bridge showing the cast iron edge beam resting on the stone abutments, looking north-west.

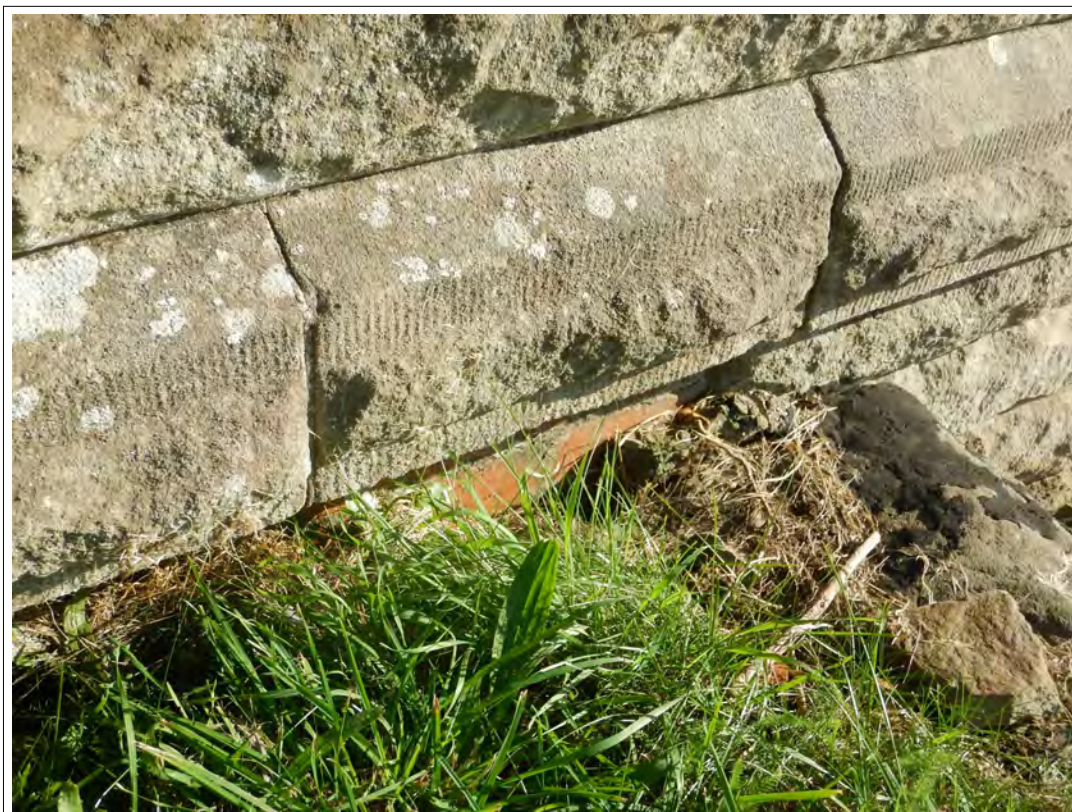
Plate 42. Detail of southern exterior wall of the Cipoletti Weir, showing exposed bricks at the base.

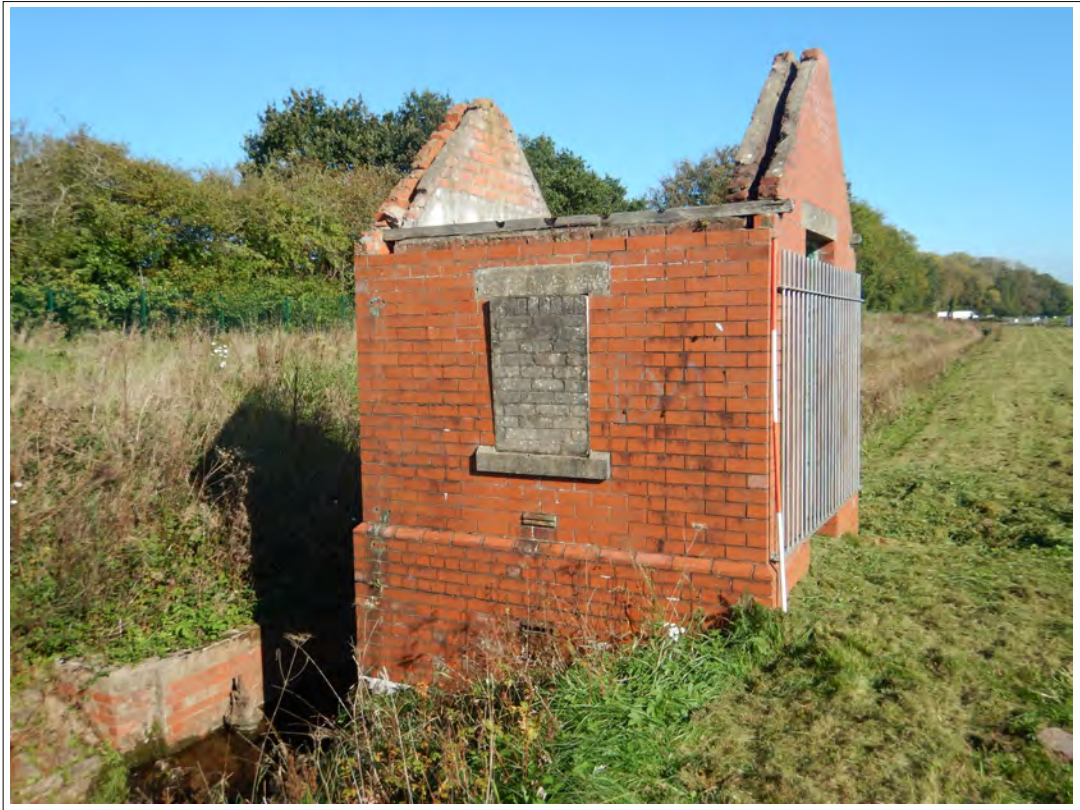
The walls of the building are still standing to full height but the roof is missing (Plate 55). The doorway has been blocked off with a metal grill. Access to the rear of the building was restricted by the by-wash channel and undergrowth on the bank behind.

Plate 55. The Gauging Station building, looking north. Scale 2m

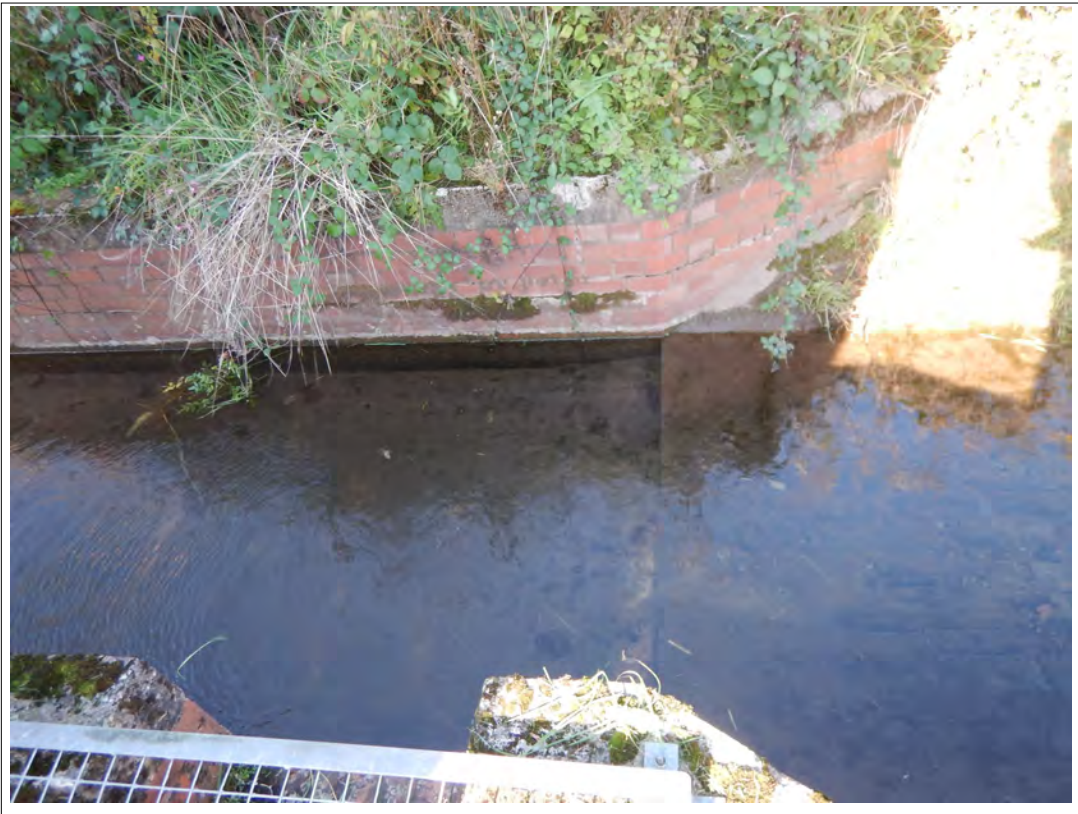
Plate 63. Modified section of the by-wash channel to the rear of the Gauging Station building, looking west.

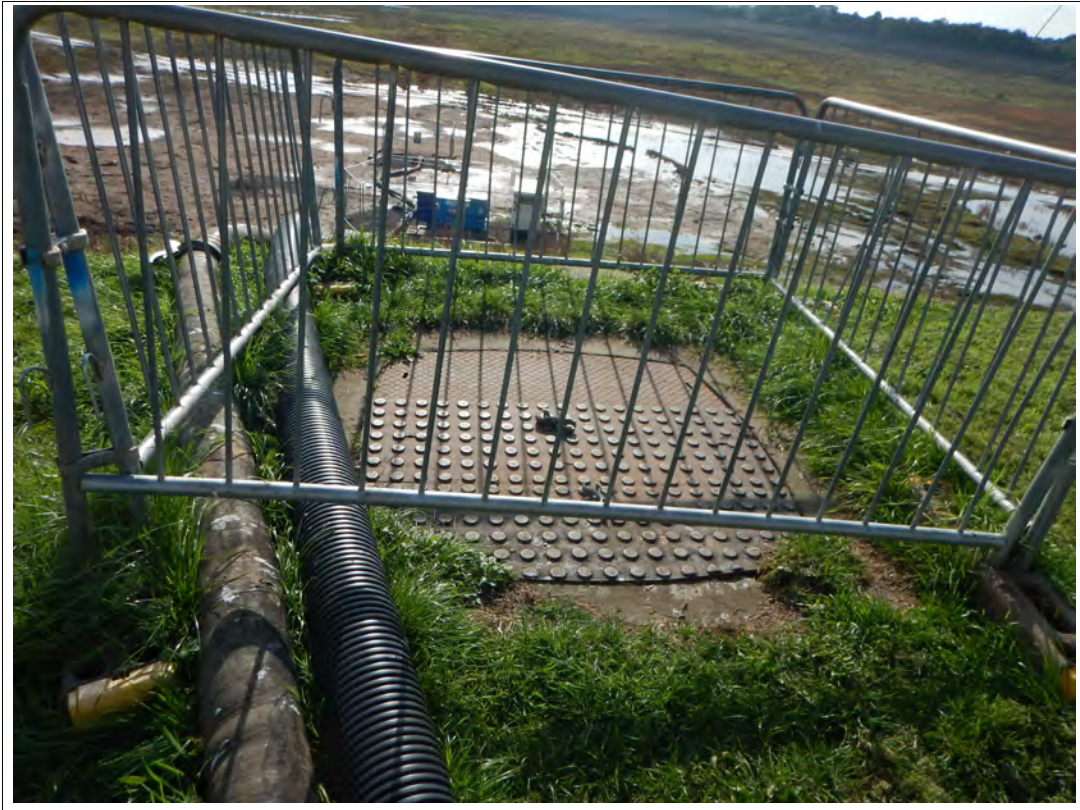
On the northern bank of the reservoir, situated where the bank follows the southernmost extent of Lisvane Reservoir, is an isolated valve chamber (Plate 75). The chamber is not specifically noted in the listing text but is considered curtilage listed due to the operational link to the reservoir. An architect's drawing dated to 1884 shows that this is an original feature of the reservoir (Figure 23). All that is visible above ground is a well-dressed stone surround flush with the ground surface, and a large cast iron cover. The architect's plans show the extent of the underground shaft.

Plate 75. Isolated Valve Chamber on the northern bank of the reservoir.

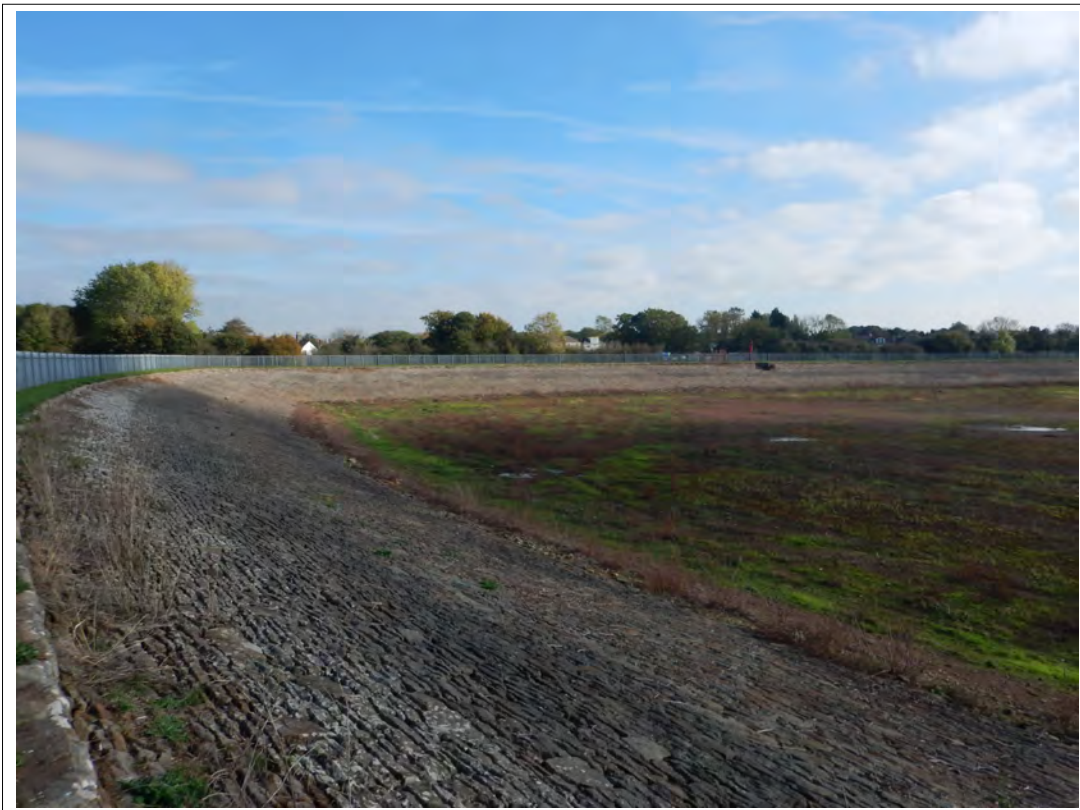
The pipe penetration is located at the north-east of the reservoir (Plate 76). It extends from the top of the interior embankment into the reservoir. It is not specifically noted in the listing and is clearly a later addition.

Plate 76. North-east bank of the reservoir, with a pipe penetration visible on the far bank, looking south-east.
