MAESTEG TOWN HALL
HISTORIC BUILDING RECORDING
ISSUE 01: OCTOBER 2019

MAESTEG TOWN HALL: HISTORIC BUILDING RECORDING

Purcell was commissioned to carry out a Level 3 historic building recording (HBR) to Maesteg Town Hall to fulfill condition 12 xiii of consented application P/18/761/LIS for the renovation and extension to the building to create a sustainable future use as a cultural arts centre.

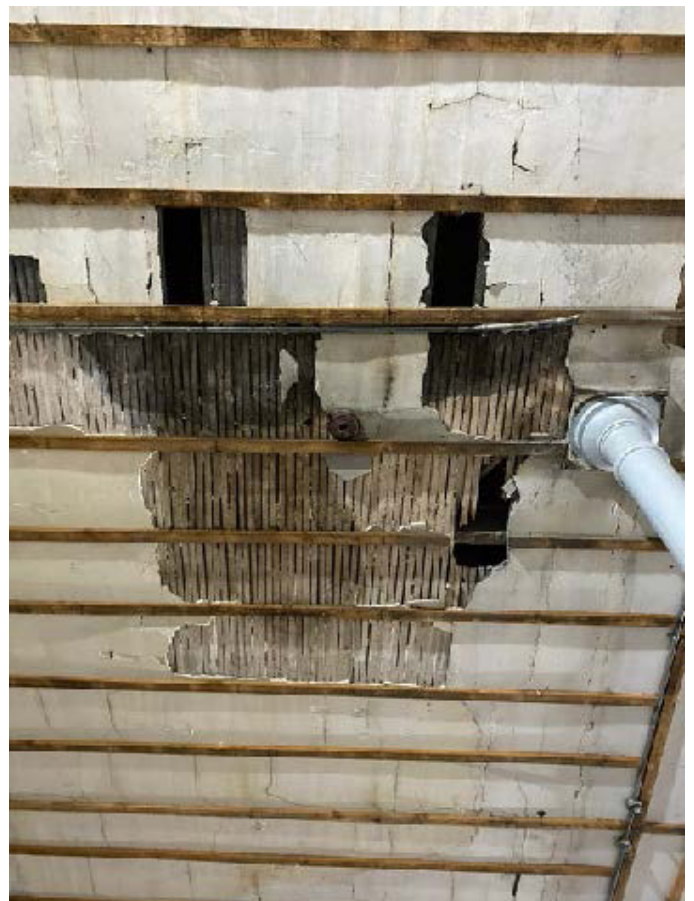
The 1980s tin tile matt black ceiling was removed from the market hall, revealing the original 19th century plain lath and plaster ceiling that was hidden above. Large areas of this plasterwork were damaged or hollow and a grid of battens that the tin ceiling was fixed to was acting as support for the plaster and securing it in place.

The historic lath and plaster supported by timber battens.

The battens and the lath and plaster were retained, with a new ceiling suspended beneath.

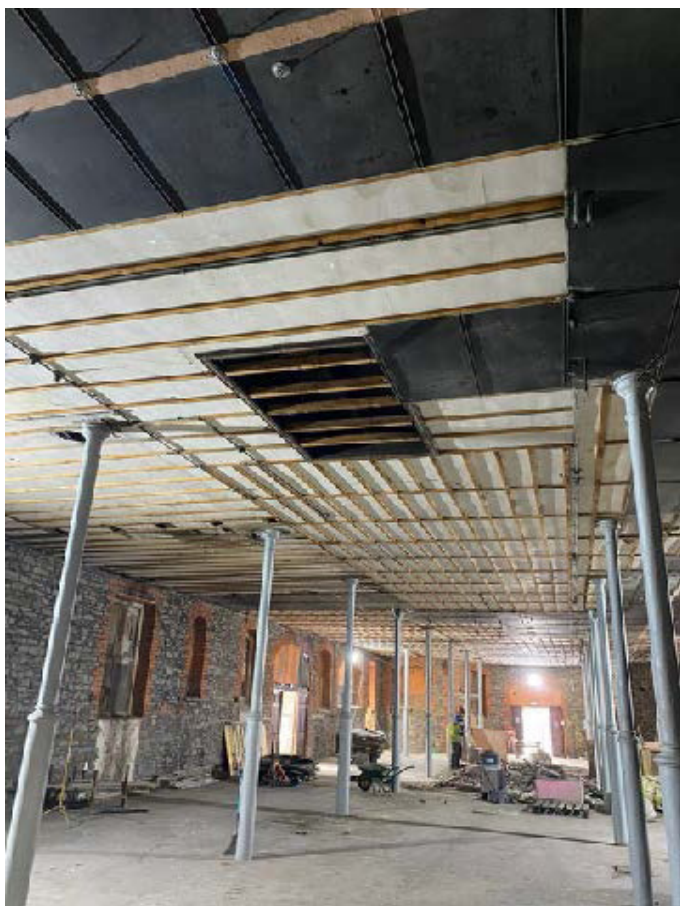
Upon revealing the original ceiling noted above, a hatch was revealed within the separating floor between the Market Hall and the Main Hall above. This is assumed to be a historical means of transferring goods from one floor to the other.

The ceiling hatch between the Market Hall and the Main Hall.

The hatch was retained along with the historic plasterwork and has been re-concealed above the new suspended ceiling.

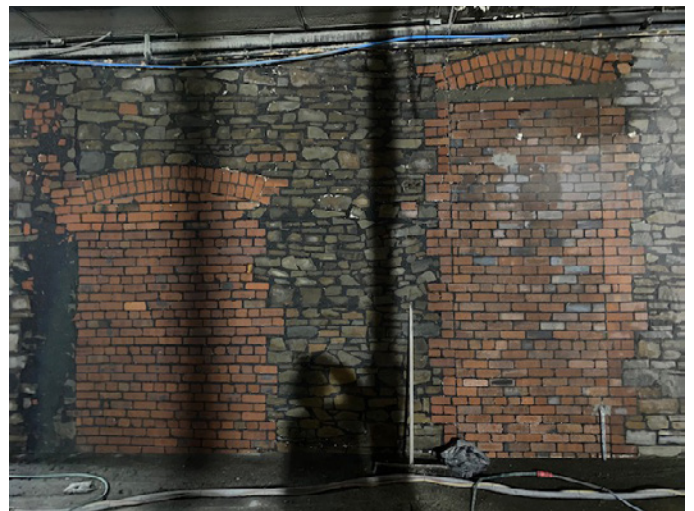
Two 19th century infilled door openings were found in the western external wall to the Market Hall which were also uncovered once multiple layers of masonry paint were removed.

The two infilled door openings to the west external wall of the Market Hall.

The infilled openings have been retained and are visible within Market Hall with the masonry walls exposed in the new scheme, revealing the legibility of the previous planform.

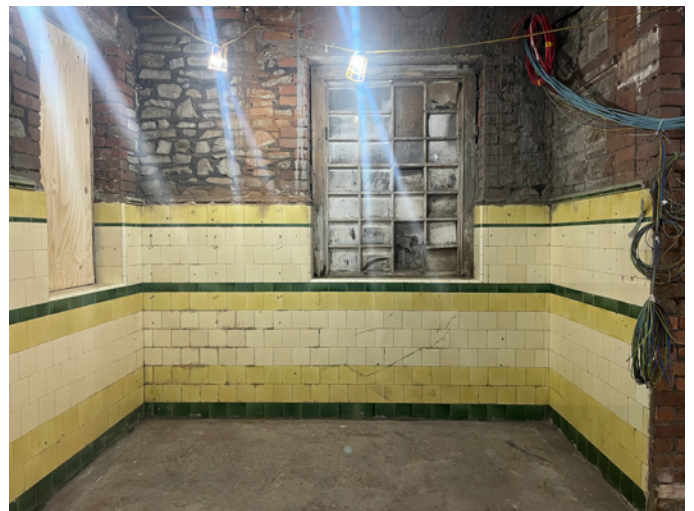
Decorative green, cream and yellow glazed tiles were revealed after wall drylinings were removed to LG03 and LG05 adjacent to the Market Hall. It is not known what the historic function of these room were to warrant the decorative tiling.

The yellow, cream and green decorative tile scheme to rooms LG03 and LG05.

The tiles were retained to LG05 and will remain visible in the completed scheme. The tiles to LG03 were removed as they had been extensively damaged.

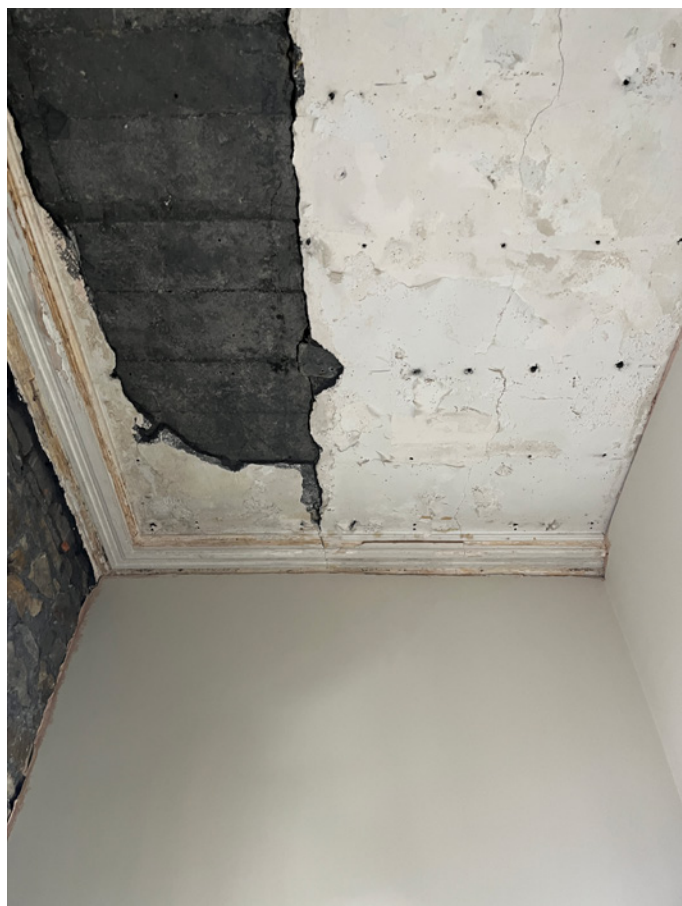
A plaster cornice and plain ceiling was revealed within staff office. Unfortunately, sections of this plasterwork had deteriorated and had been damaged, however the cornice was repaired and reinstated to a matching decorative scheme.

The damaged cornice and plaster ceiling to the staff office which was repaired to a matching decorative scheme.

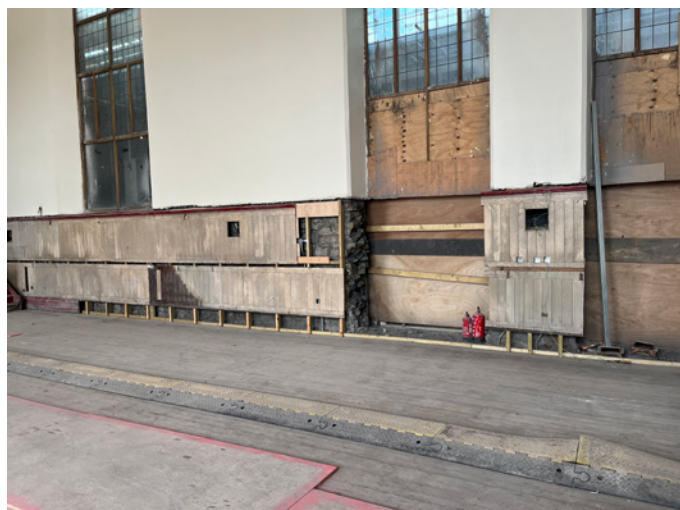
A 19th century scheme of decorative timber wainscoting was revealed in the Main Hall after the removal of 1970s panelling that had been obscuring the original feature.

The timber wainscoting within the Main Hall.

The original wainscoting was retained and extensively repaired with matching profiles and replacement sections.

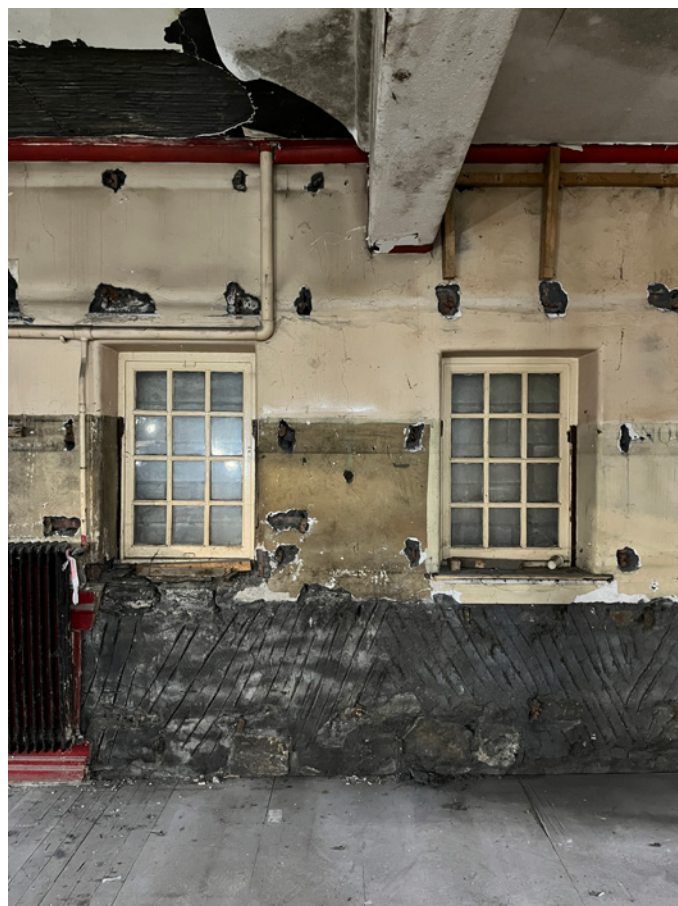
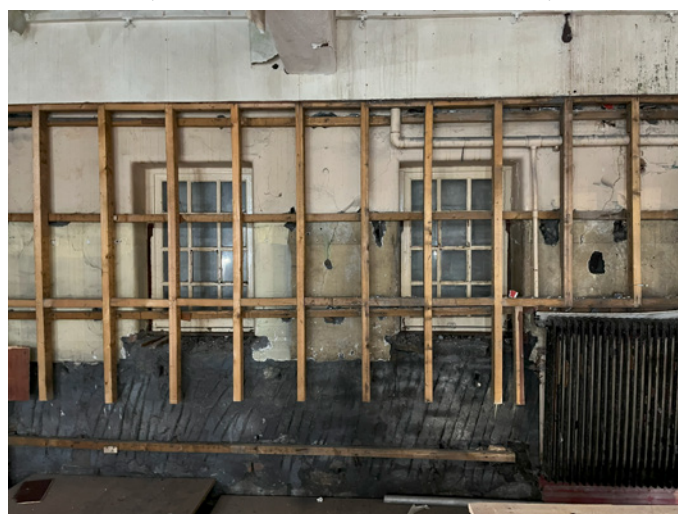
Former 19th Century Windows to East_West of Main Hall beneath Balcony 2

Four timber framed multipaned 19th-century fixed casement windows, two on the east elevation and two on the west elevation, were revealed within the Main Hall beneath the balcony canopy. These were previously obscured behind 20th century wall linings.

The four 19th-century windows uncovered behind modern wall linings in the Main Hall beneath the balcony.

The four windows were repaired and retained as features within the Main Hall.

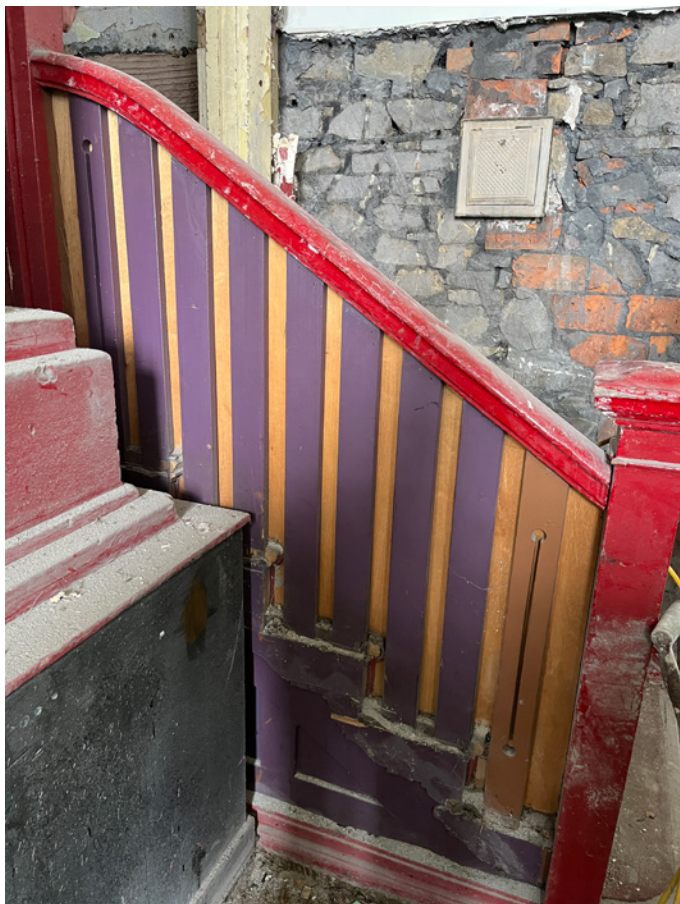
A historic balustrade to the front steps of the stage in the Main Hall was revealed upon the removal of modern plywood cladding that had been obscuring it. The uncovering of this feature has also revealed a previous decorative scheme to the Main Hall.

The historic balustrade to the front steps of the stage in the Main Hall.

The balustrade has been retained and repaired where necessary with matching profiles. The repaired balustrade has been redecorated to be incorporated within the new decorative scheme within the building.
