Hebron Chapel, Clydach Swansea

Standing Building Recording

Report No. 1008

Date: **March 2011**

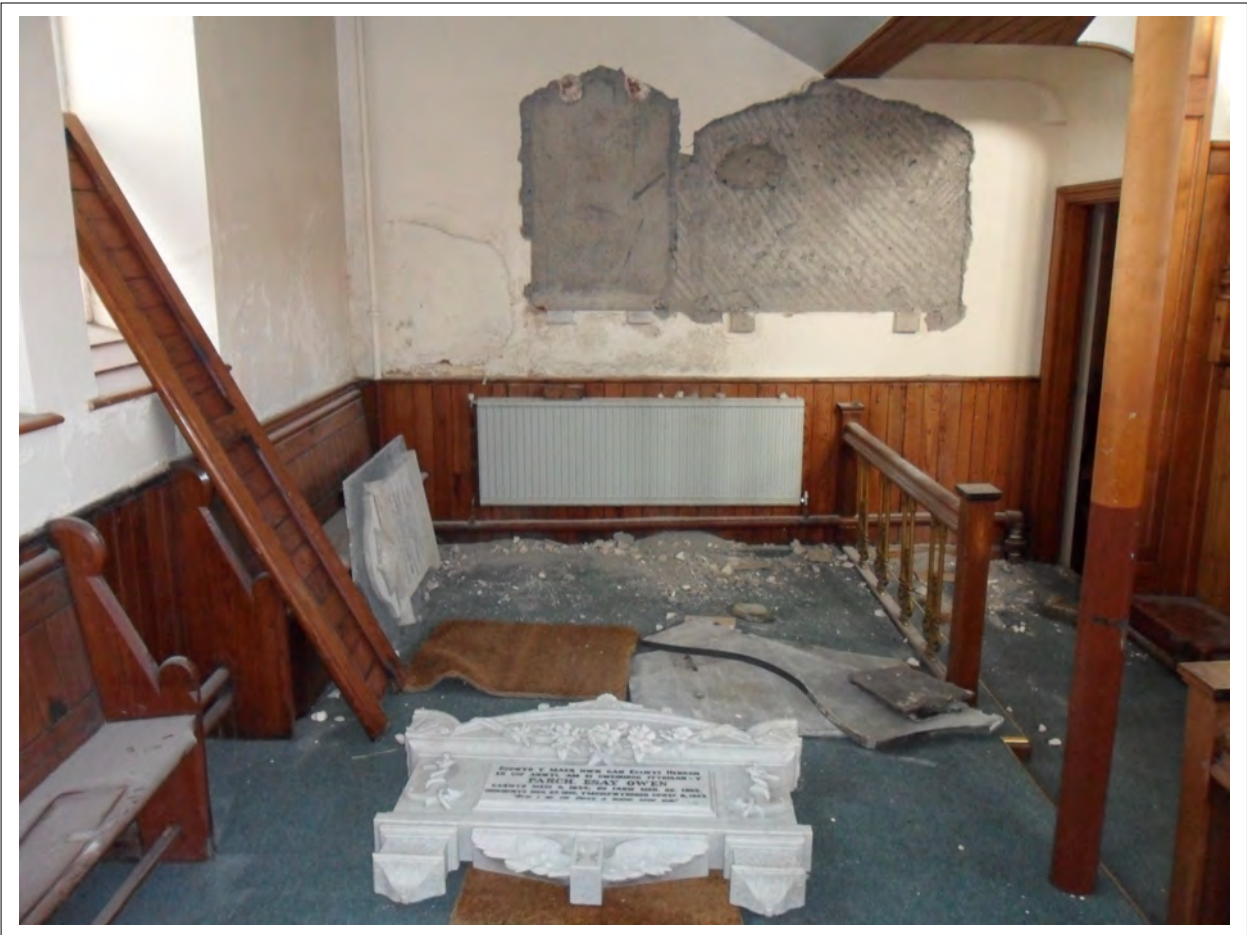
4.1.4 The removal of the War memorials from the walls afforded the opportunity for the fabric of the Chapels walls to be observed. The walls appear to be constructed of faced stones which have been rendered in mid to dark off grey lime mortar.

Plate 6:View of small enclosure within Chapel during memorial removal

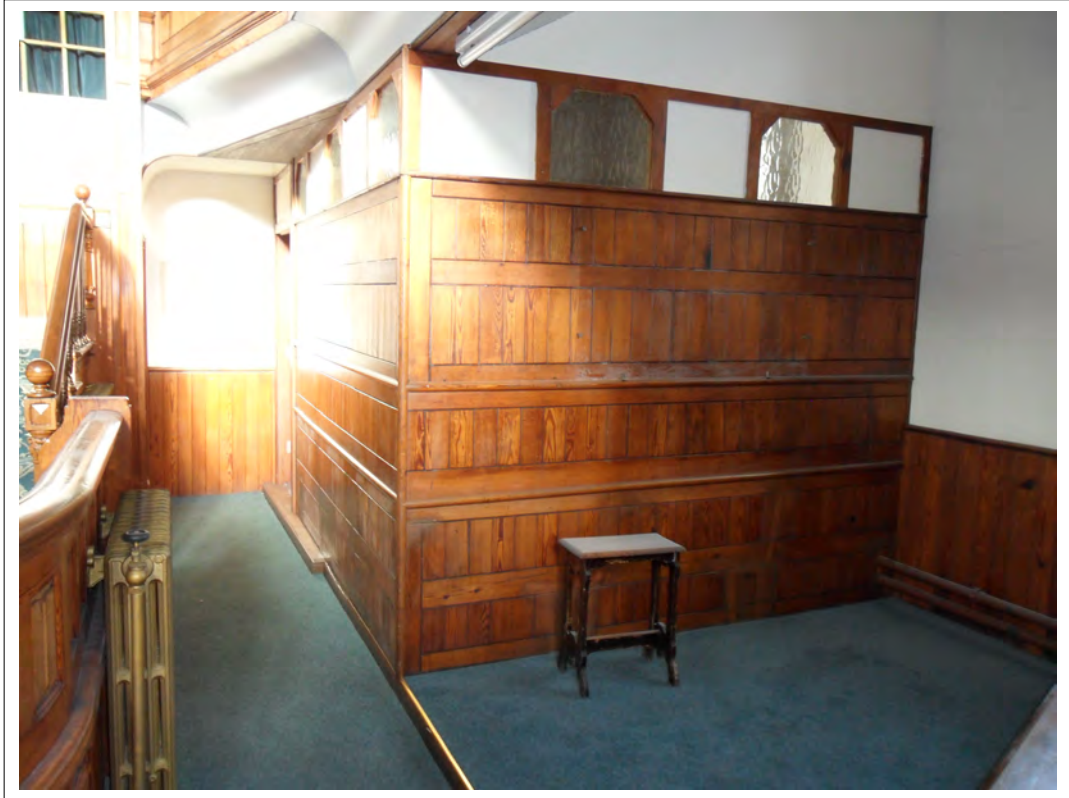
- The structural additions at the NW end, previously mentioned (para 1.3.2), Plates 41-45, 52.
- The 'Office' space within the Chapel itself (Plates 15, 17-19)
- The blocked window in the NW end of the Chapel, Plate 53.

Plate 15: View of small office enclosure in north east corner

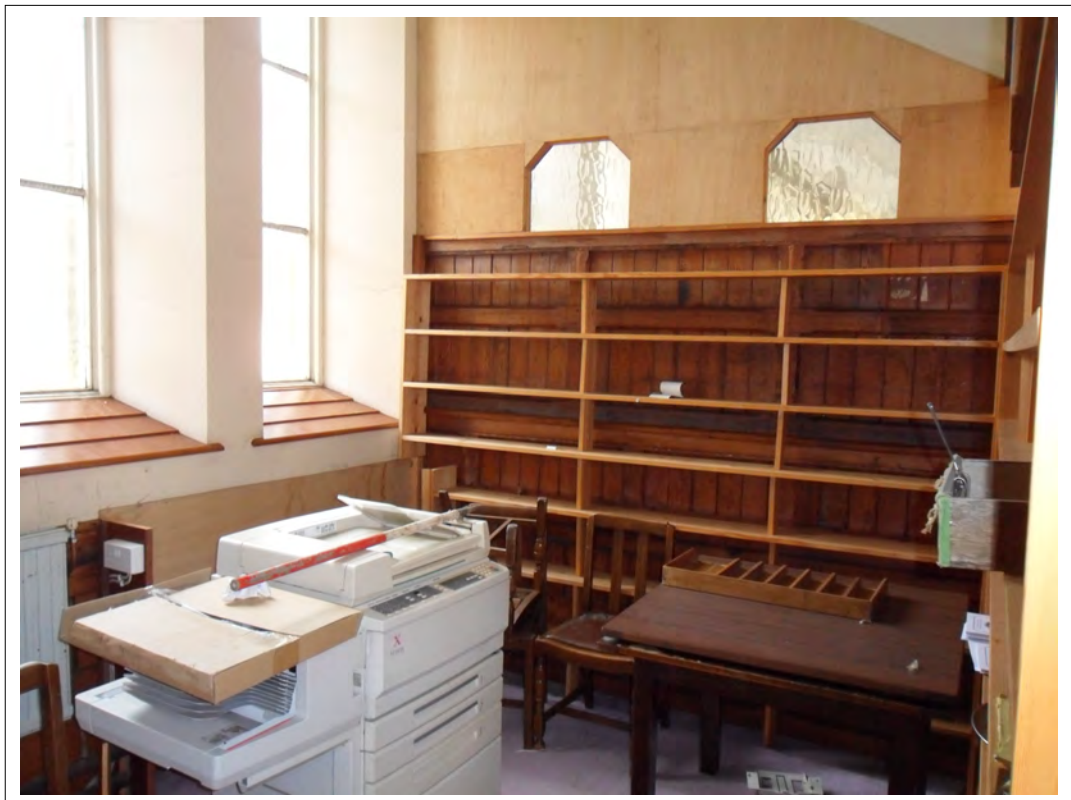
Plate 18:View within modern office enclosure

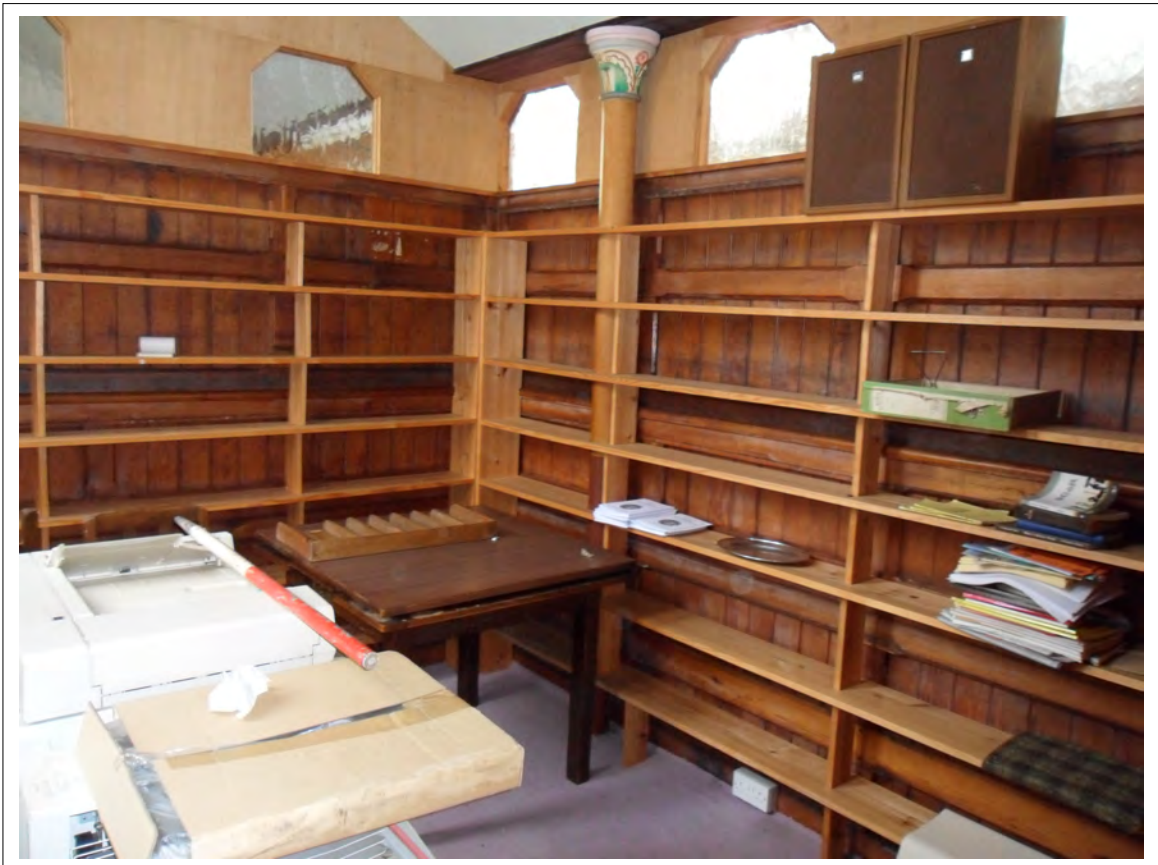
Plate 19: View within modern office enclosure

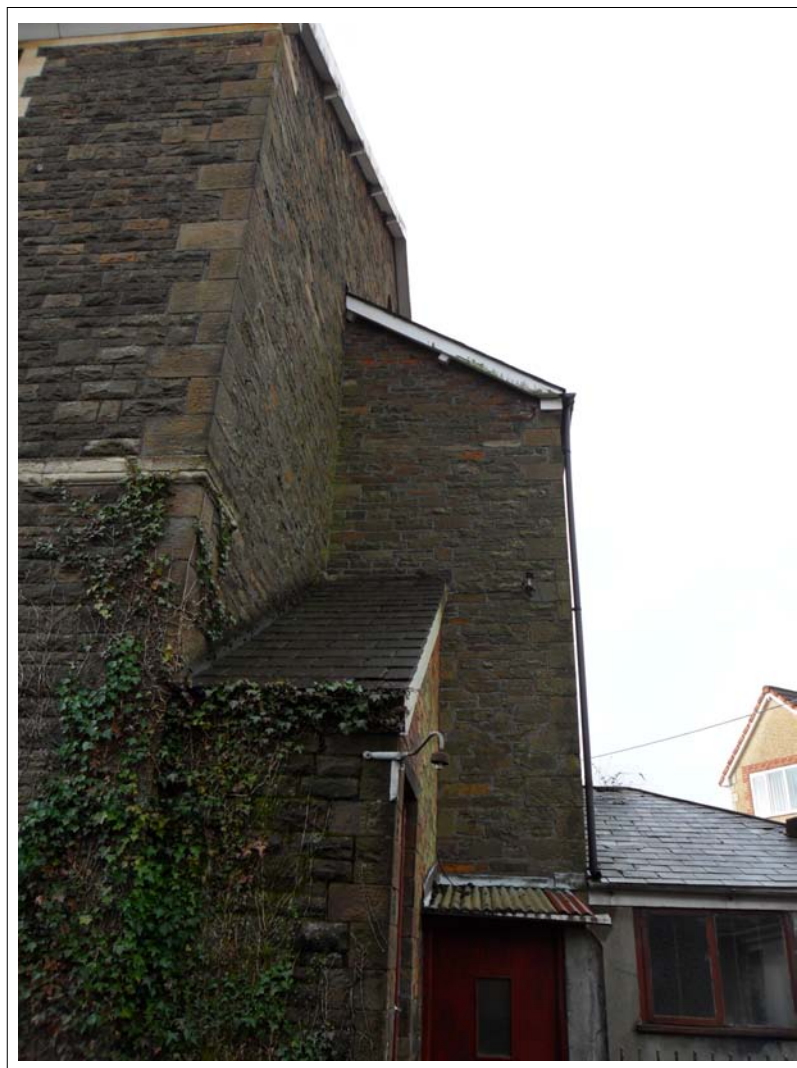
change is evident. Some evidence of recent change can be seen in the modern additions at the NW end, this appears to have occurred in two periods, the 1960s and the 1980s and is backed up by cartographic evidence.

Plate 46: View of building additions at NW end
