Forge Washery, Lower Brynamman

Archaeological Assessment & Site Visit

By
Philip Poucher

Report No. 1177

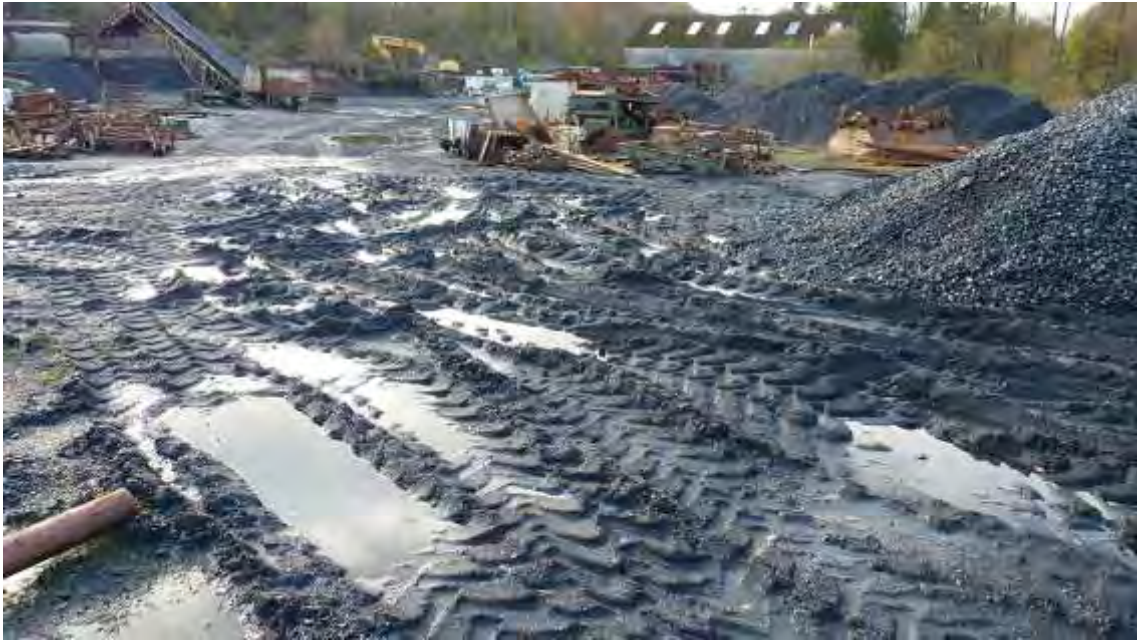
Photo 5: View showing typical ground conditions across the site, consisting of coal sand overlying hard-core rubble.

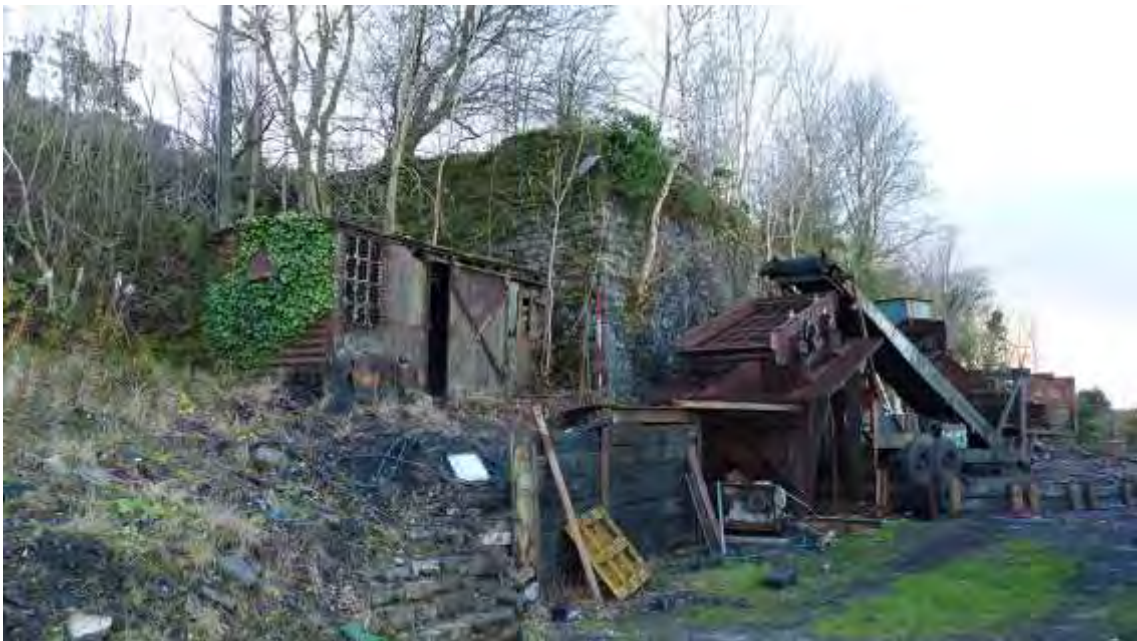
- 3.1.5 This wall is not maintained, although it appears in relatively good condition. The top of the charging bank platform is tree and scrub covered, with ivy and similar vegetation obscuring the top and corners of the wall. Small trees have established themselves in the various openings in the wall, with root activity likely to cause continued degradation of these openings. Former washery machinery has been placed up against the wall, and rubble has been piled against its base.

Photo 10: View SW showing the charging bank wall in the background. 2m scale.

- 7.2.2 The Charging Bank and possible Boiler House Wall along the southern edge of the site is a Grade II Listed structure. Any works associated with the consolidation and repair of this structure should be undertaken in consultation with Cadw and will require Listed Building Consent. The main charging bank platform wall appears in relatively good condition although the small trees growing within the structure clearly have the potential to damage the integrity of the wall; the wall would clearly benefit from their removal. The areas around them should then be repointed using mortar appropriate to the rest of the structure. The wall of the possible Boiler House may require more extensive consolidation work, but this would need to be examined in more detail following clearance works in front of this section of walling.

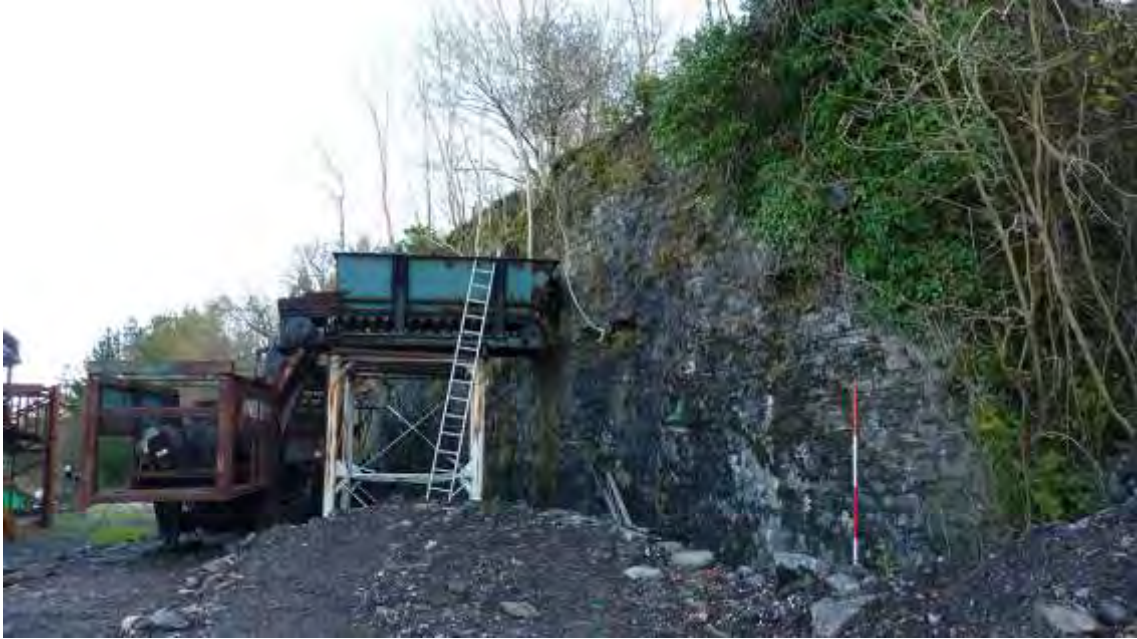
Photo 11: View E of the charging bank wall. 2m scale.

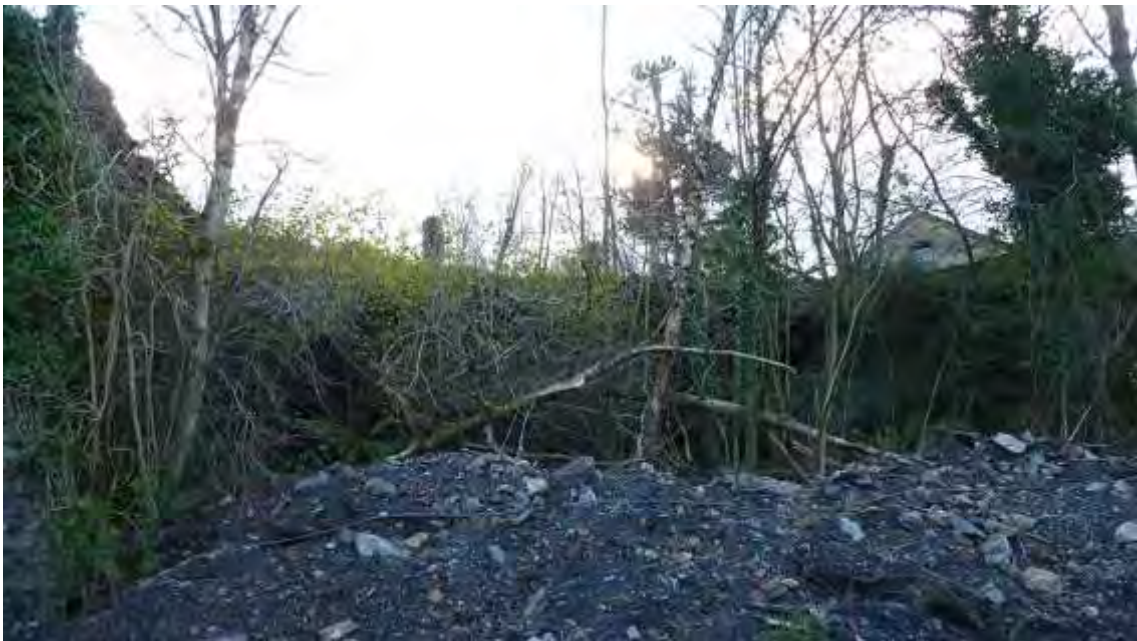
- 3.2.5 The area in front of this section of wall is covered in trees and dense undergrowth. The very uneven ground beneath this undergrowth appears to consist of dumped material. A long pile of rubble and waste material c.2m to 3m high has also been dumped in front of this area of scrub, further limiting access into this area. The walling itself in this area is in a worse state of repair to the main charging bank wall, facing stones and brickwork have clearly come away, which may threaten the integrity of the arches.

Photo 12: View SSE showing the vegetation and rubble that has built up in front of the possible Boiler House Wall.

- 7.2.1 The trees and scrub in front of the Possible Boiler House wall should be cleared to improve visibility and access. A programme of archaeological building recording should be undertaken at this point to record any upstanding remains of the Charging Bank and possible Boiler House wall and the potential ironworks or brickworks wall located a short distance to the north. This building recording work could then provide further more detailed recommendations as to their consolidation.

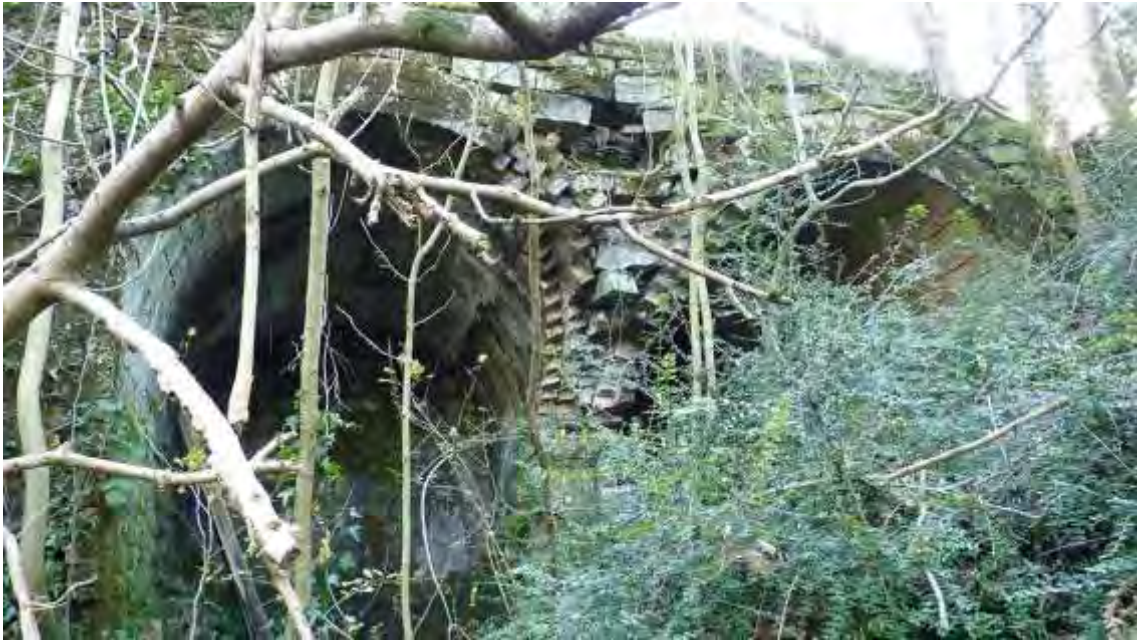
Photo 13: View SSE of the easternmost arched recesses within the wall.

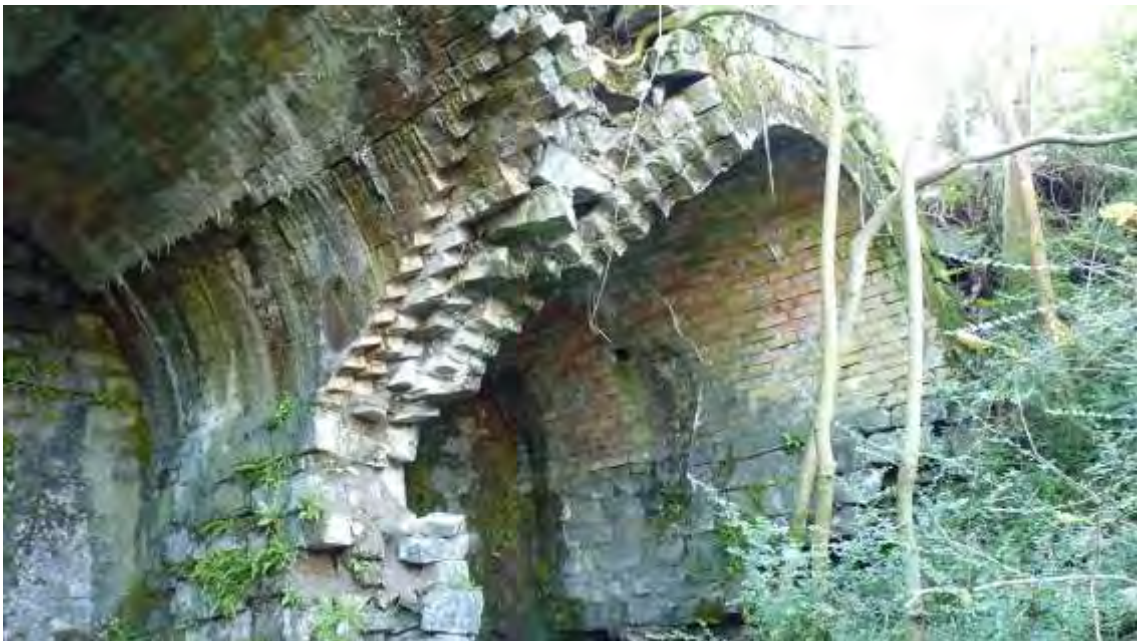
Photo 14: View SE showing more detail on the arched recesses.

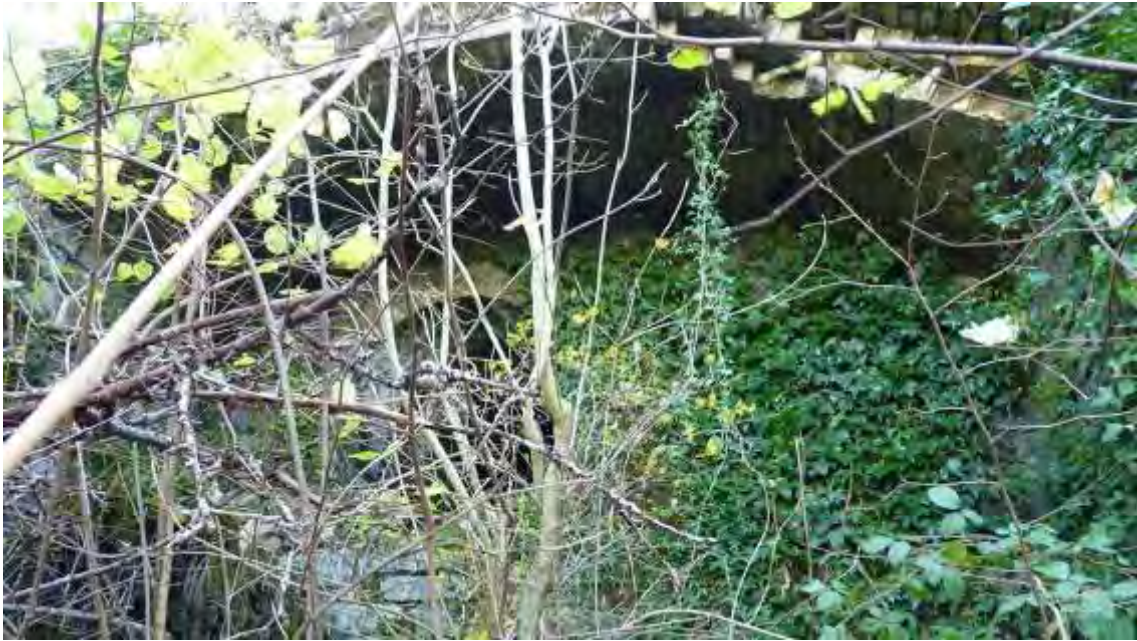
Photo 15: View S of the westernmost arched recess, shrouded in undergrowth. The smaller arched passage is just about visible in the centre.

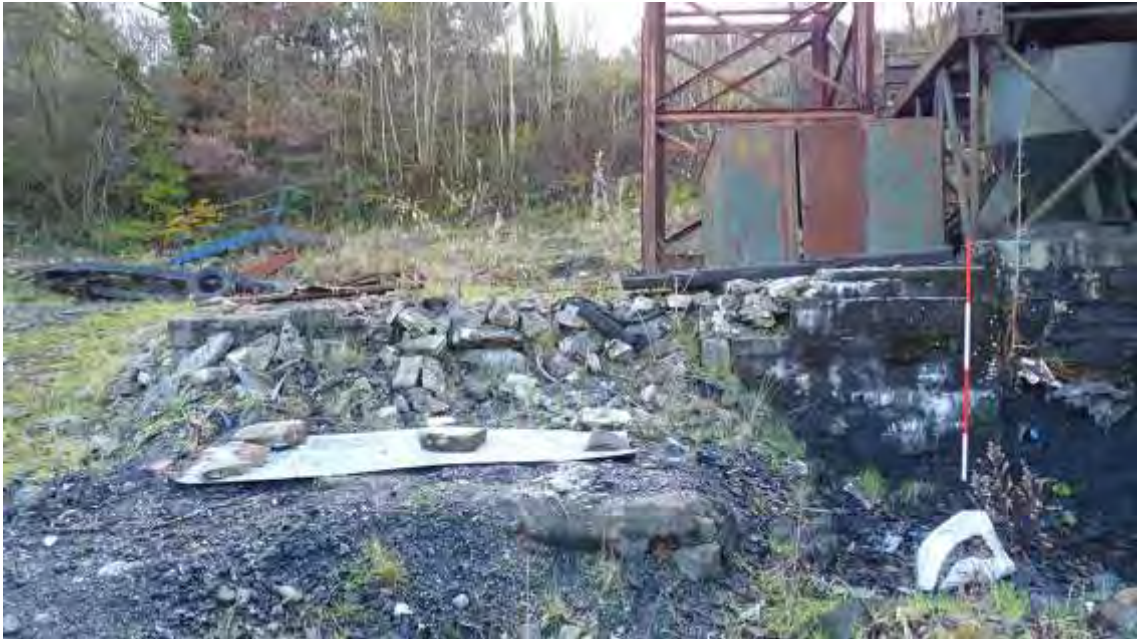
Photo 17: View SSE showing the ends of two walls thought to be remnants of the ironworks buildings (see section 3.3.2). 2m scale.

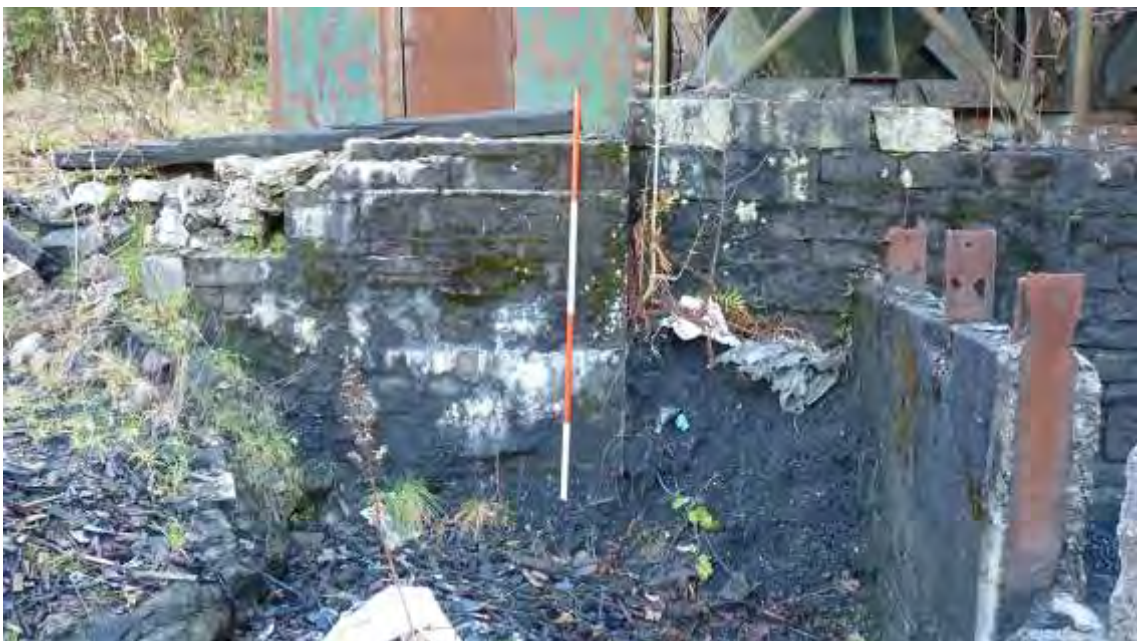
Photo 18: View SSE showing the two adjoining early walls, thought to be surviving elements of the ironworks and brickworks buildings. 2m scale.

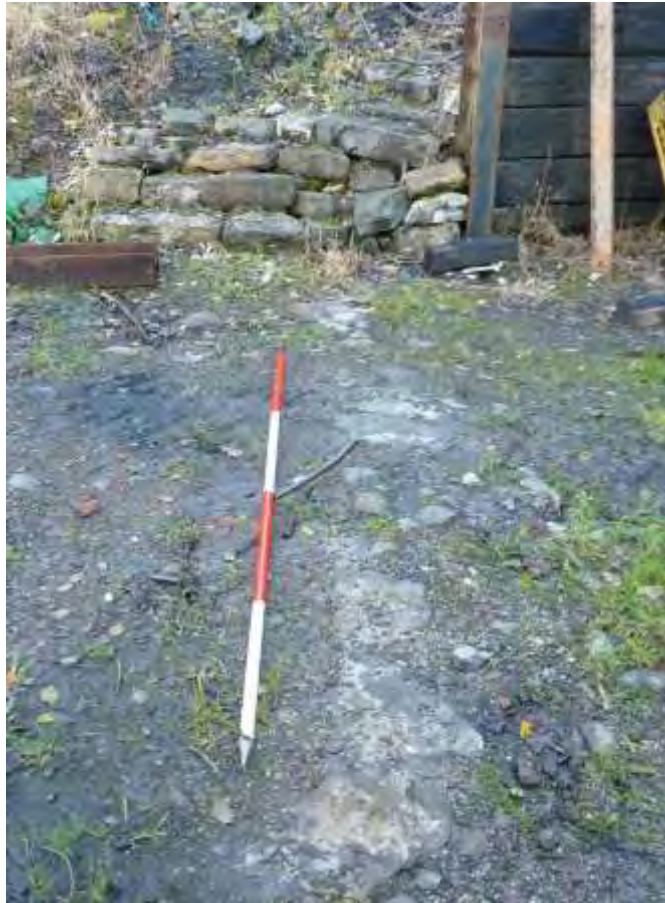
- 3.3.7 The walling at the eastern end is partly tumbled and appears to have become more obscured or degraded since it was described in the previous DBA (Page 2002). The later stretch of stone walling as it currently stands appears in relatively stable condition, even with the passage and use of machinery in the near vicinity, although its western extent has become obscured and possibly damaged by the movement of vehicles. The condition of the fragment of walling visible on the ground surface to the south is unclear, although the passage of vehicles across this area is likely to be degrading the visible surface of the wall.

Photo 21: View SSE of the remains of an earlier mortared stone wall visible in the ground surface, to the right of the 2m scale.

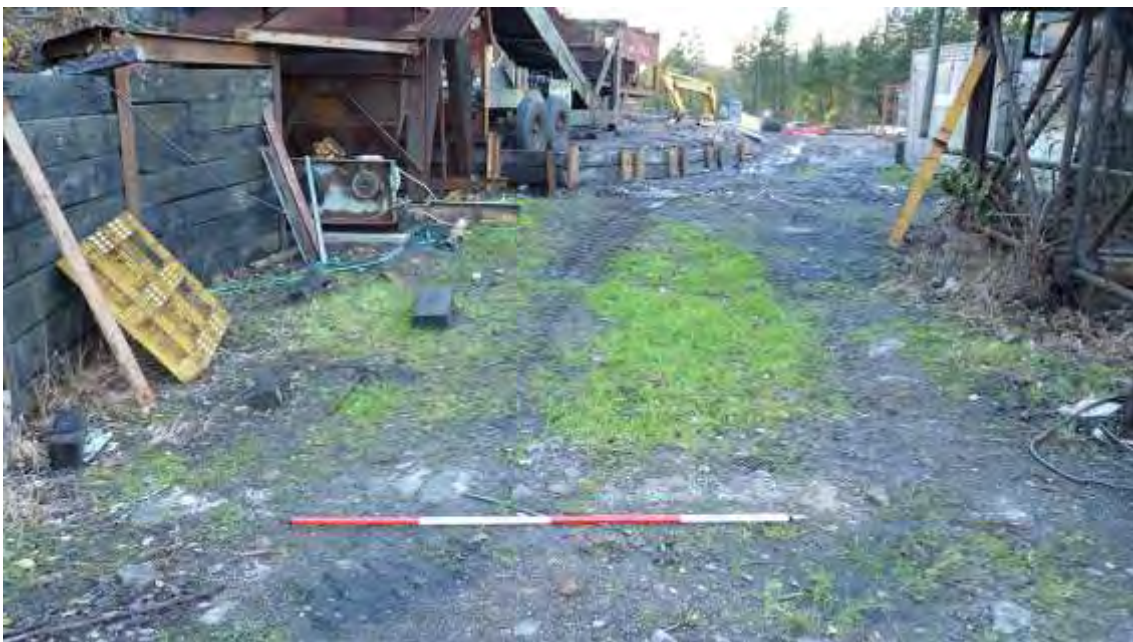
Photo 22: View WSW along the raised area that covers the site of the blast furnaces and main brickworks building. The remains of the earlier stone wall is visible just above the 2m scale.
