Barn at Rhyd Lydan Aberhafesp Powys

Level 3 Historic Building Record

Richard Hayman

September 2024

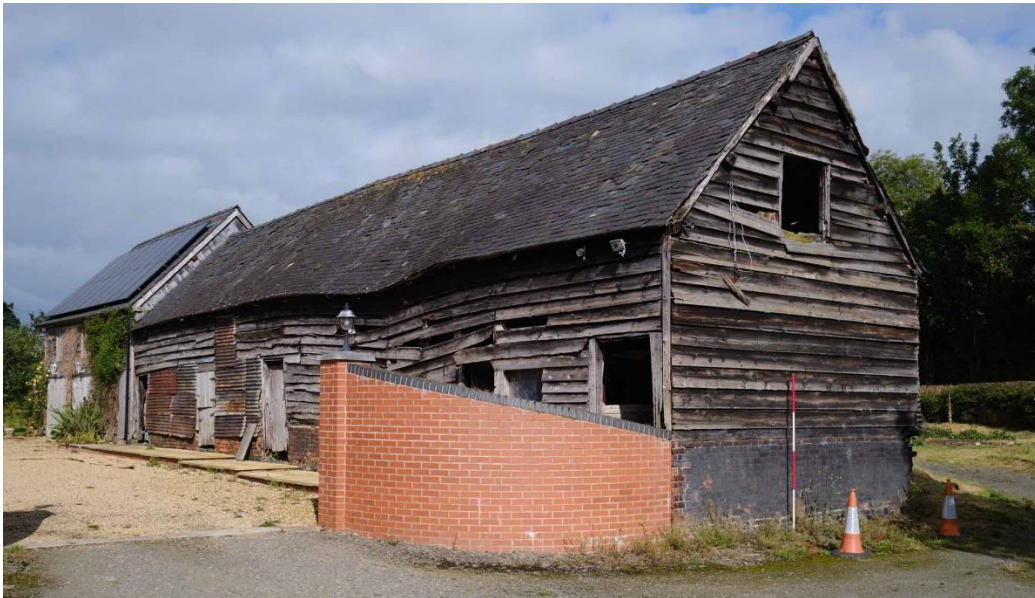
The farmstead is set back from the road and the barn is on the north side of the farmhouse. The house is two-and-a-half storeys, built of coursed rubble stone except for the brick front, and is probably the house marked on the 1845 Tithe map, albeit altered over time and extended in the early twenty-first century. The former yard between house and barn is now essentially a forecourt to the house, entered from the east side where modern curving brick boundary walls have been constructed, one of which abuts the south-east angle of the barn (fig 7).

Figure 7. The barn, viewed from the south-east, with modern boundary wall.

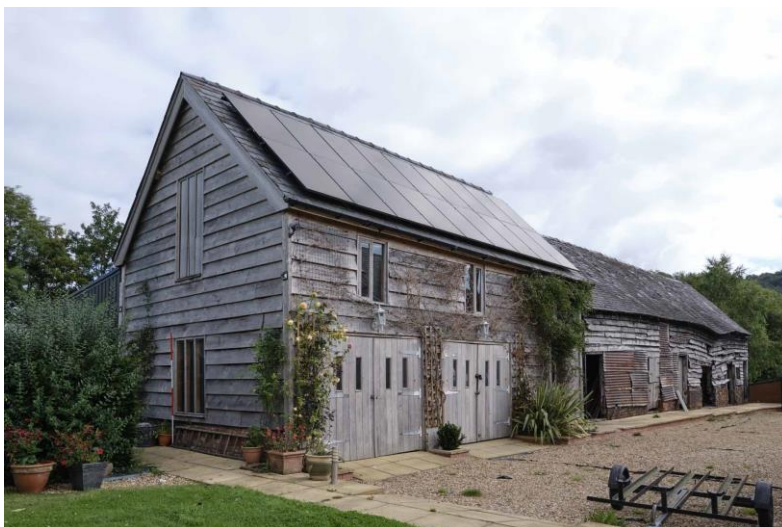
The barn consists of two ranges placed end-to-end – the former barn and a garage – of the periods described above (fig 8). Behind the garage is a modern metal-clad lean-to of no historical interest. Only the barn range on the right-hand side of the yard is to be demolished.

Figure 8. The barn viewed from the south-west..

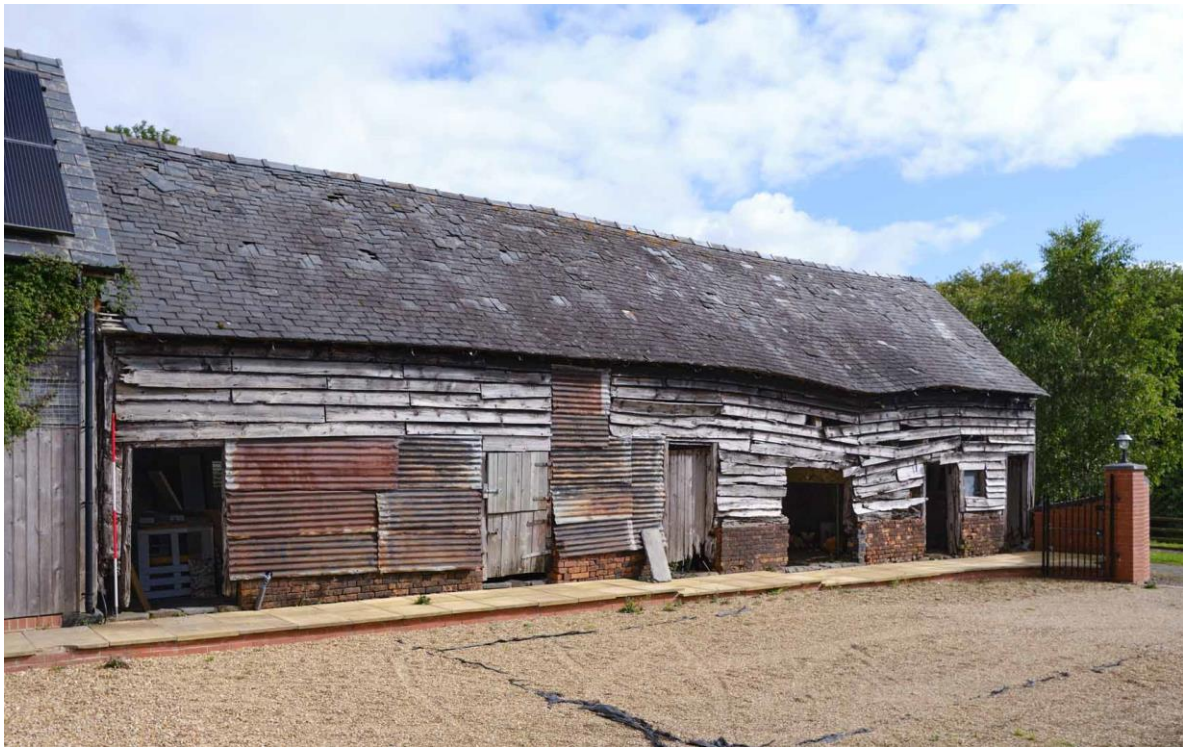
Facing the former yard to the south there are five doorways, all with replacement boarded doors (fig 9). The centre and outer doors once opened to feed passages, the other two to loose boxes. A probable sixth doorway, right of centre, has been obscured by the widening of the opening and cutting through the brick sill. It also opens to a loose box. A small window at the right end is a late insertion. In the right-hand gable end is a square loft opening. The rear of the barn has three doorways, two of which open to former loose boxes and the third, at the right-hand end, opened to a feed passage (fig 10). To the left of centre a section of the sill has been breached, but the measured survey conducted in 2022 shows another doorway here. Two windows were inserted, probably in the 1870s. Their sills are of coarse-aggregate unreinforced concrete (fig 11). This, and other similar areas of concrete, are characteristic of the Gregynog Estate from the 1870s, when Lord Sudeley pioneered its use in the rebuilding of Gregynog Hall, various houses in Tregynon, and for some complete farmsteads on the estate.

Figure 9. South front of the main barn.

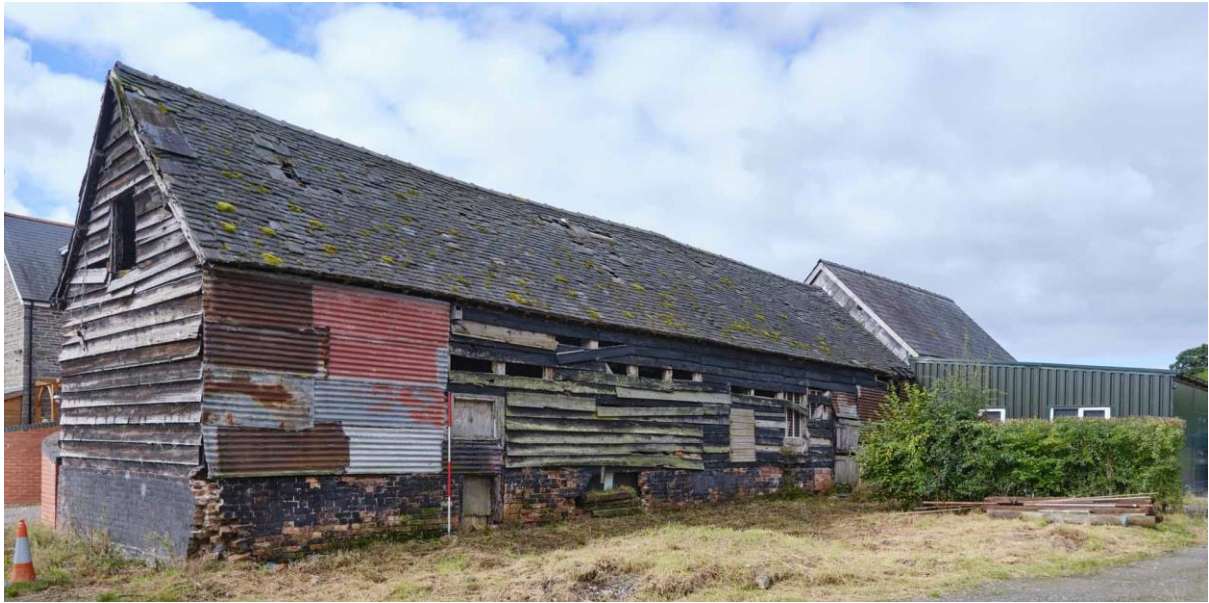
Figure 10. Rear of the main barn, looking south-west.

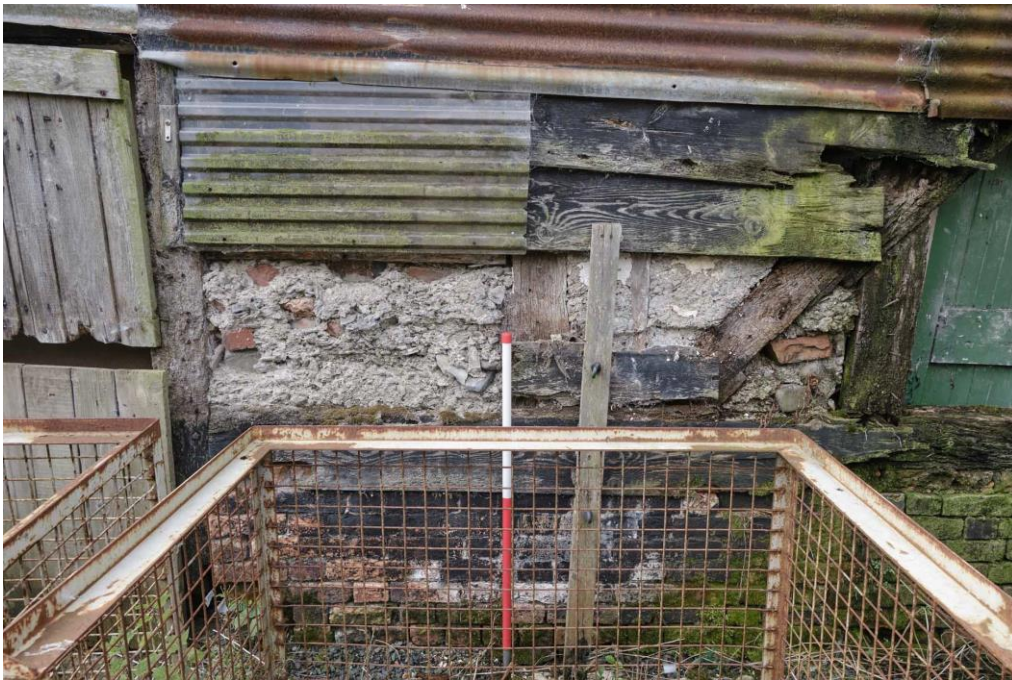
Figure 11. Unreinforced concrete in the north wall of the main barn.

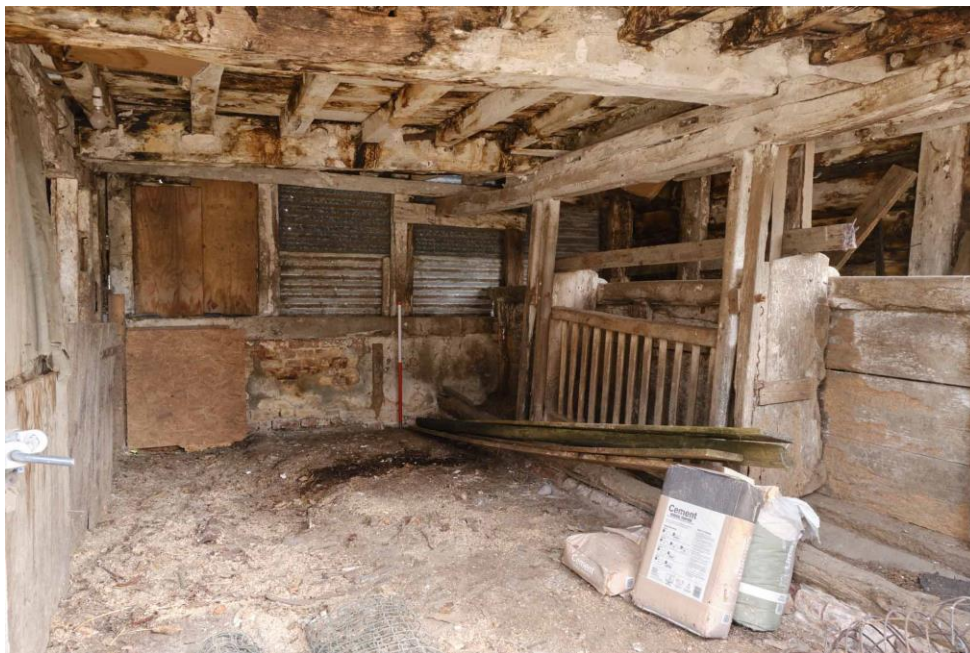
Figure 13. Unit 2, loose box, with feeding trough on the right.

timber framed. The partition between Units 3 and 4, i.e. between the lofted and non-lofted parts of the range, is set on a sill of hand-moulded bricks. In the surviving loose box (Unit 2) is a feeding trough with is single surviving panel of a wooden grille (fig 13).

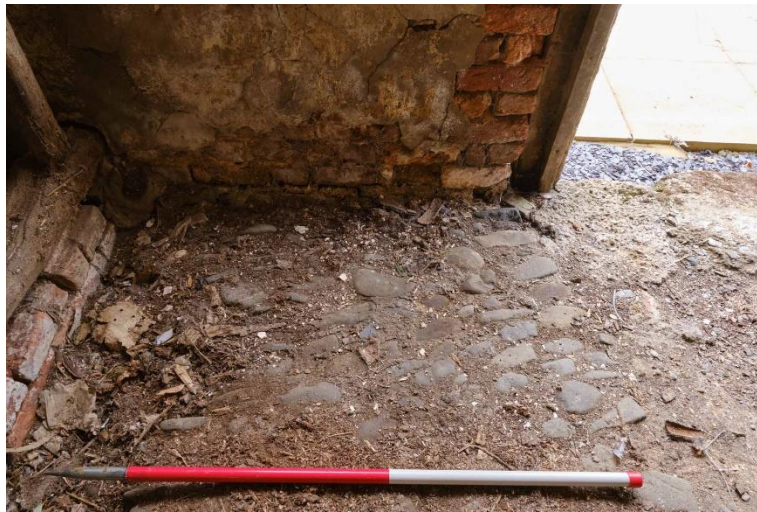
The interior is divided into four unequal bays (two of them lofted) and has partitions that now divide it into five Units at ground level, of which the feed passage (Unit 1) at the right-hand end and the former loose box (Unit 2) are the only ones in which there is specific evidence of a former use (figs 12, 13). In 2006, and as late as 2022, Unit 3 retained stalls and a feed passage on the west side, the only indication of which now is the doorway in the south wall. Likewise Unit 4 had stalls and a feed passage on the west side, of which the south and north doorways survive, as does a doorway from the passage into the adjoining Unit 5 in the later range. In places (Units 1 and 2) there are traces of a former cobbled floor, while traces of a similar cobbled surface can be seen in patches on the outside of the

building (fig 14). Inside, the cobbled floors appear to have been largely replaced by a floor of unreinforced concrete, much of which has survived within the loose box (Unit 2). Elsewhere inside the building the floor has mostly been dug out, with a consequent lower floor level.

Figure 14. Cobbled floor in Unit 2.

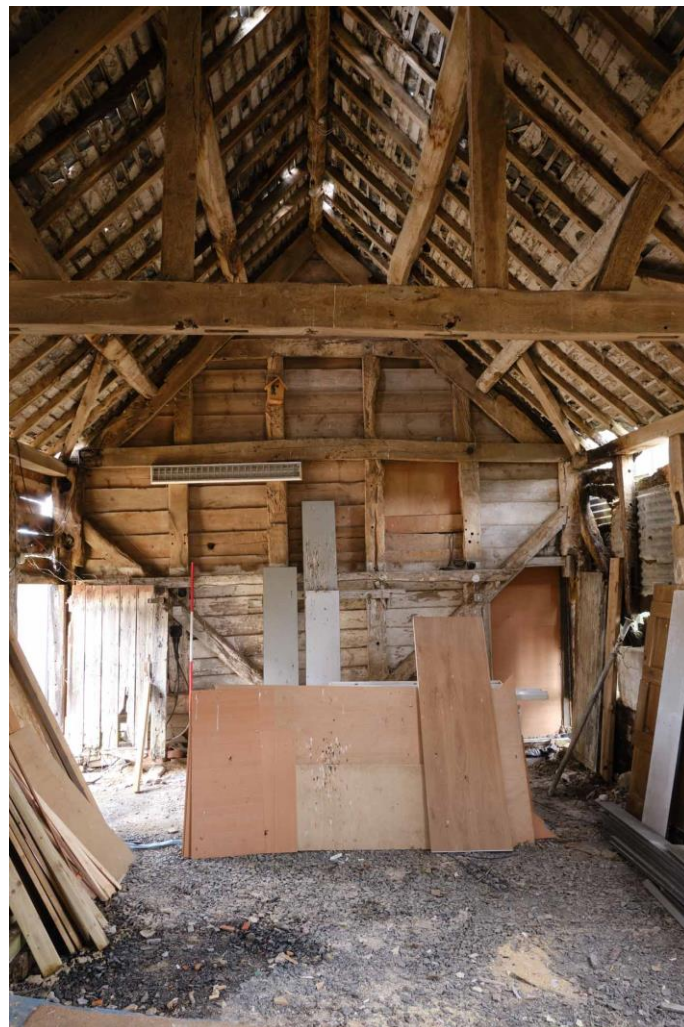
Inside the building the box-frame construction is visible, indicating that the panels would originally have been infilled with wattle and daub, while in the north wall there are passing braces. The gable ends differ. The east gable end has raking struts in the gable, while the west gable end has diagonal passing braces rising from floor level (fig 15). The partitions are

Figure 15. West gable end of the main barn, showing the passing braces.

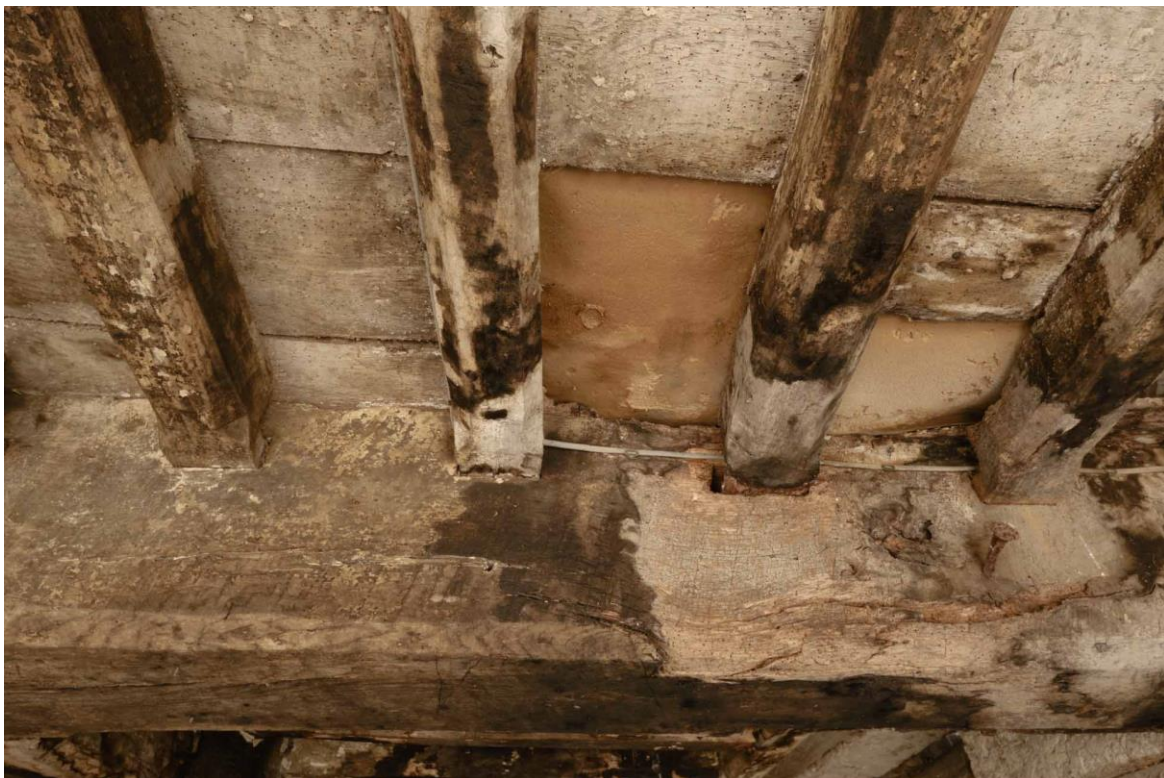
The loft (Unit 7) is carried on chamfered spine and cross beams, with joists, all of which appear to have been re-used from another building (fig 16). The spine beams do not extend the full length of the loft, but terminate above the partition between Units 1 and 2. The chamfered cross beams are composite, formed of two timbers one above the other, parts of which were in very poor condition at the time of survey. The joists are chamfered with simple stops (fig 17).

Figure 17. Chamfered joists and spine beam supporting the loft.

There are re-used timbers in the barn that could have come from an earlier house – the stop-chamfered joists and beams that support the loft are perhaps the best example. The

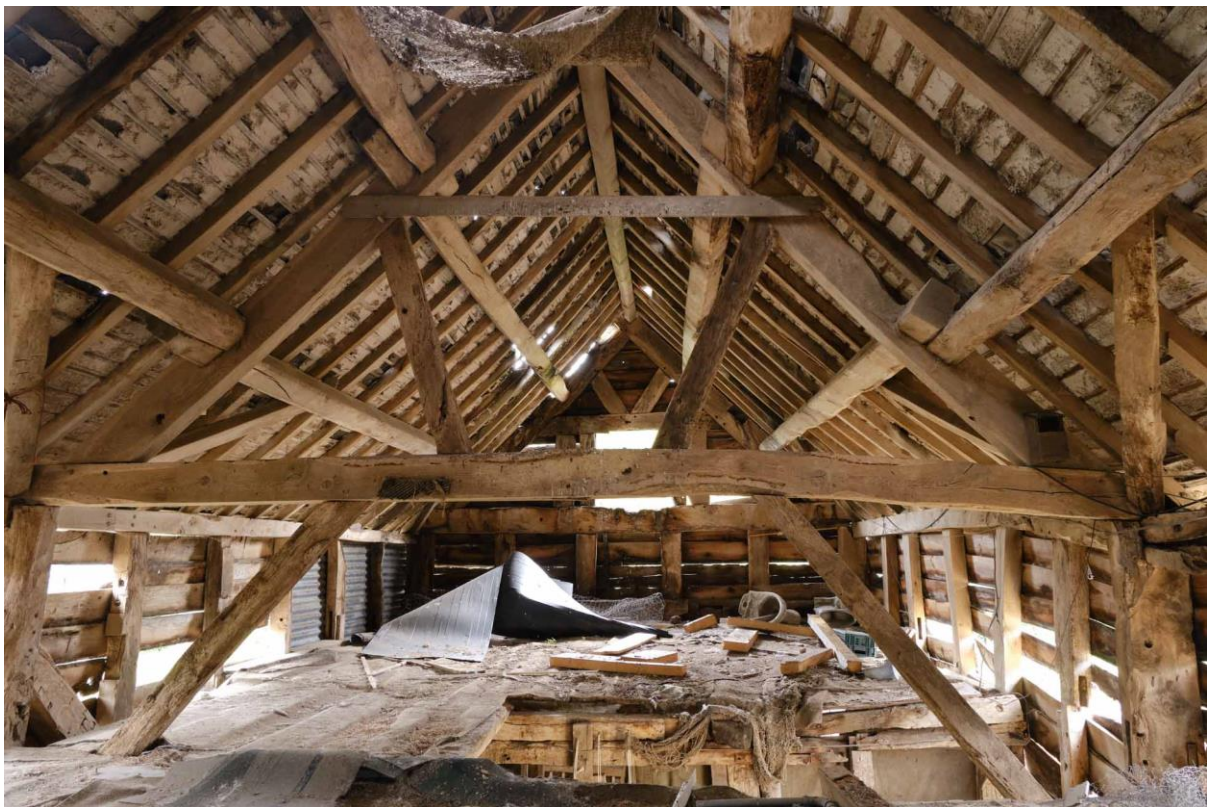
In the roof there are two trenched purlins on each side and there is a single tier of simple windbraces, mainly over the loft. The trusses vary. Truss C is above the loft (fig 18). It is

supported by diagonal braces rising from the cross beam below and consists of a tie beam with raking struts. However, the components of the truss differ in such a way as to suggest that it has been made up using a variety of timbers. The principals, for example, have a machine-sawn evenness that the cross beam lacks, and the thin collar beam may have been a later addition. Truss B, at the west end of the loft, stands above a brick sill (fig 19). It is the most weathered of all the timber-framed components that make up the barn, suggesting that it was originally an exterior gable end. It has tie and collar beams, to which queen posts have been crudely added. The principals and beam have mortices indicating former framing, or timber-framed partition, and on the underside of the principals are sockets that held the staves for wattle panels, indicating that, if it was not an external gable, it was once a closed truss. Mortices on the underside of the tie beam, as well as sockets for staves, indicate the former framing and infill panels. The extant timber-framing below the tie beam is later, probably integral with the construction of the barn and the creation of the loft. Truss A is also a queen-post truss, with outer raking struts, but of more modern sawn timber (fig 20). On the underside of the principals are mortices that suggest that originally the roof had raking struts instead of queen posts. Mortices on the underside of the tie beam indicate the former presence of timber framing here.

Figure 18. Truss C.

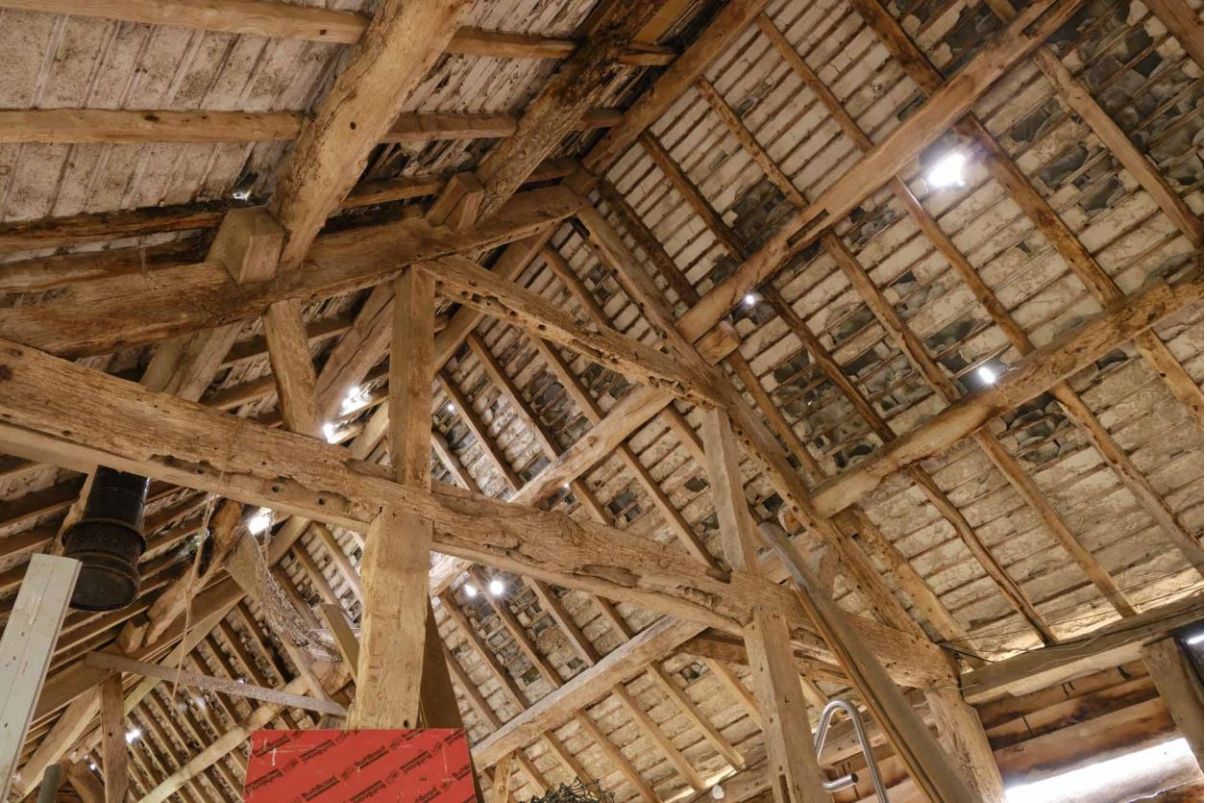
Figure 19. Truss B.

The main barn is divided into two main sections – the lofted and unlofted parts – the junction of which is Truss B and a partition set on a brick sill. This was probably once an external gable but it is unlikely that it indicates two phases in the main barn because the brick sill is continuous across the whole range.

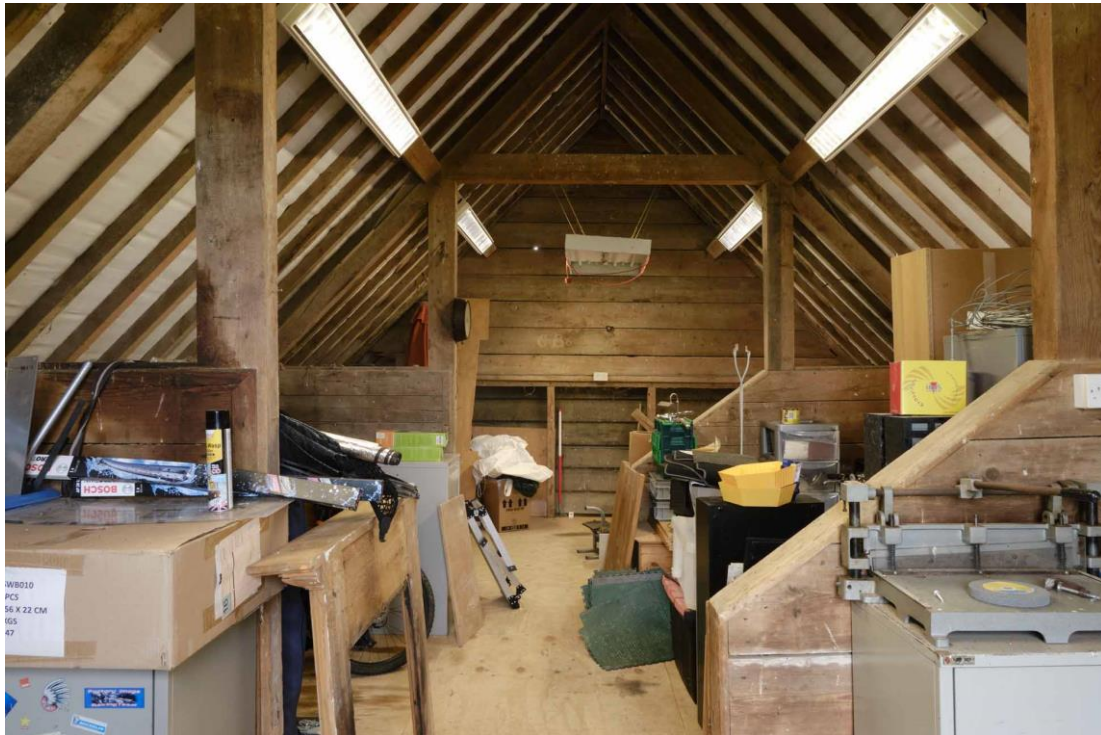
Interior fixtures have been removed from the ground floor (Unit 5 in fig 12). However, in 2006 there was a feed passage across the rear, entered by a door from the main barn, and a full-length brick feeding trough spanning the length of the room. In the loft (Unit 6) is the three-bay roof, of machine-sawn trusses, which consist of a collar beam and posts supported on the loft floor beams, which allows for a passage through the centre of the loft (fig 21).

Figure 21. Loft (Unit 6) in the garage.
