LEVEL 3 BUILDING RECORDING OF A FORMER BARN AT GETHLEY BARN, LLAN Y NANT FARM, TRELLECH GRANGE, NP16 6QN

Report by: Trysor

June 2021

Trysor Project No. 2020/770
GGAT HER EVENT PRN : E009532

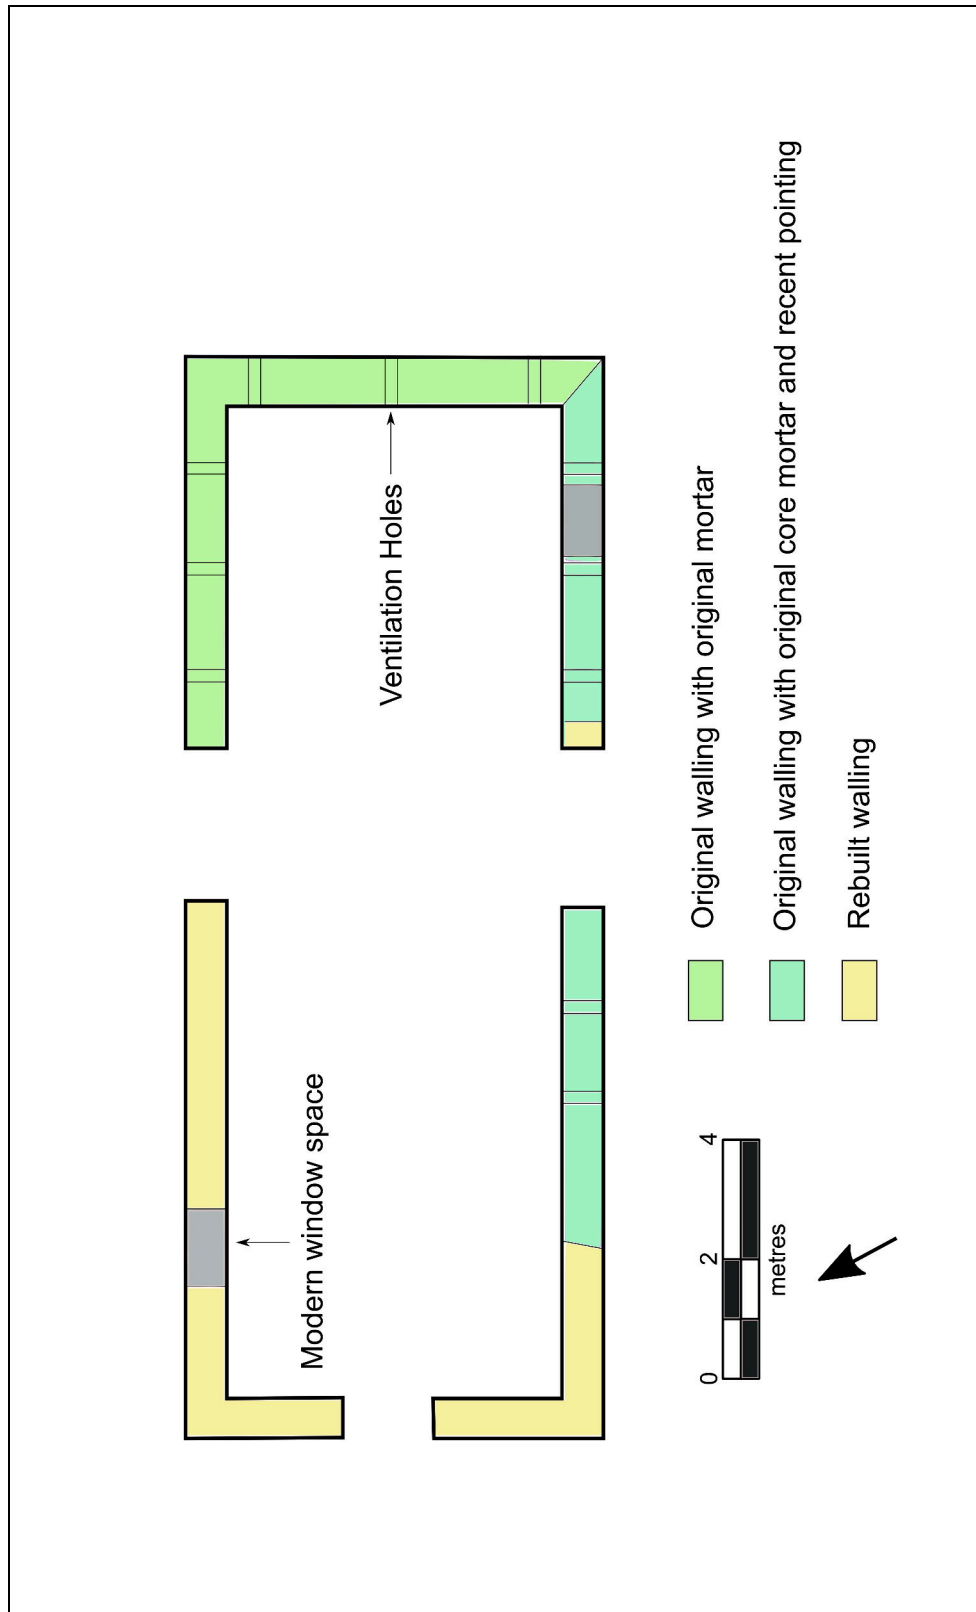
Figure 10: Plan of the Gethley Barn threshing barn, showing development phases.

9.3 The second identifiable phase of development occurred after the threshing barn was damaged during a bombing raid during the Second World War. The blast destroyed or severely damaged the western end of the building. Post-war aerial photographs show that the building was still roofed in 1946, but do not show the condition of the stone walls at the western end of the building (Welsh Aerial Photography Unit, 1946, 4650 RAFCPEUK1828 3301).

9.5 After the roof slates were stolen from the threshing barn the roof timbers and walls of the barn deteriorated. The roof timbers were removed and worst affected parts of the walls at the western end of the barn were replaced with the present walls, built with the stones from the original structure. This represents the third phase of development at the threshing barn. Some repairs and modifications were also made elsewhere, such as the reconstruction of the eastern door reveal of the doorway in the southern lateral wall and the insertion of a new window at the eastern end of the same wall.

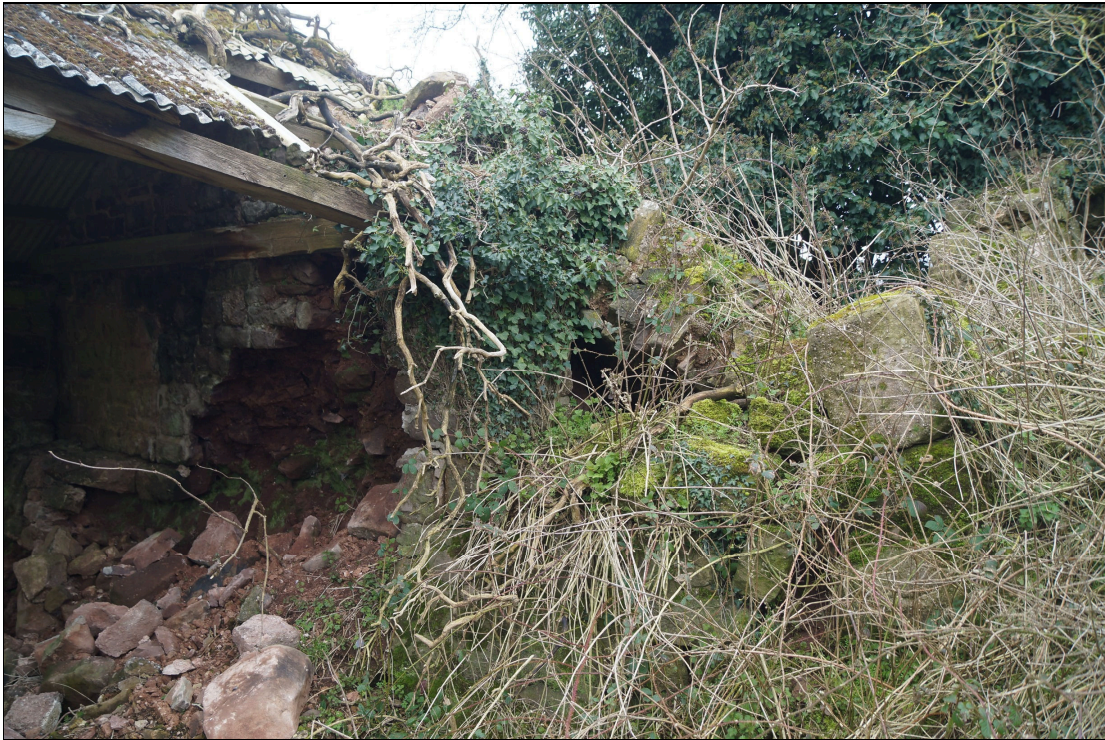
Plate 19: GTB2021_019 - A view of the eastern end of the open-sided storage shed showing the ruinous fragments of the original building and the collapsed southern end of the northern barn. Looking east.

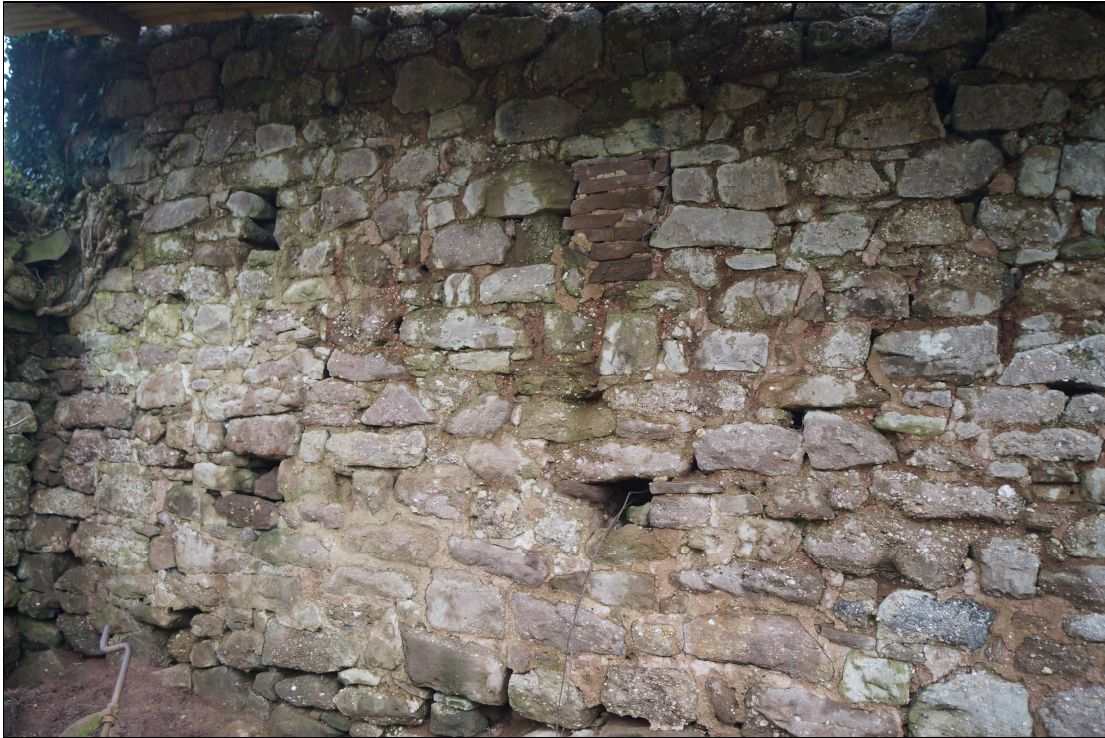
Plate 21: GTB2021_021 - A view of the eastern end of the external side of the northern lateral wall of Gethley Barn showing four ventilation holes, one of which has been blocked up. Looking south-southeast.

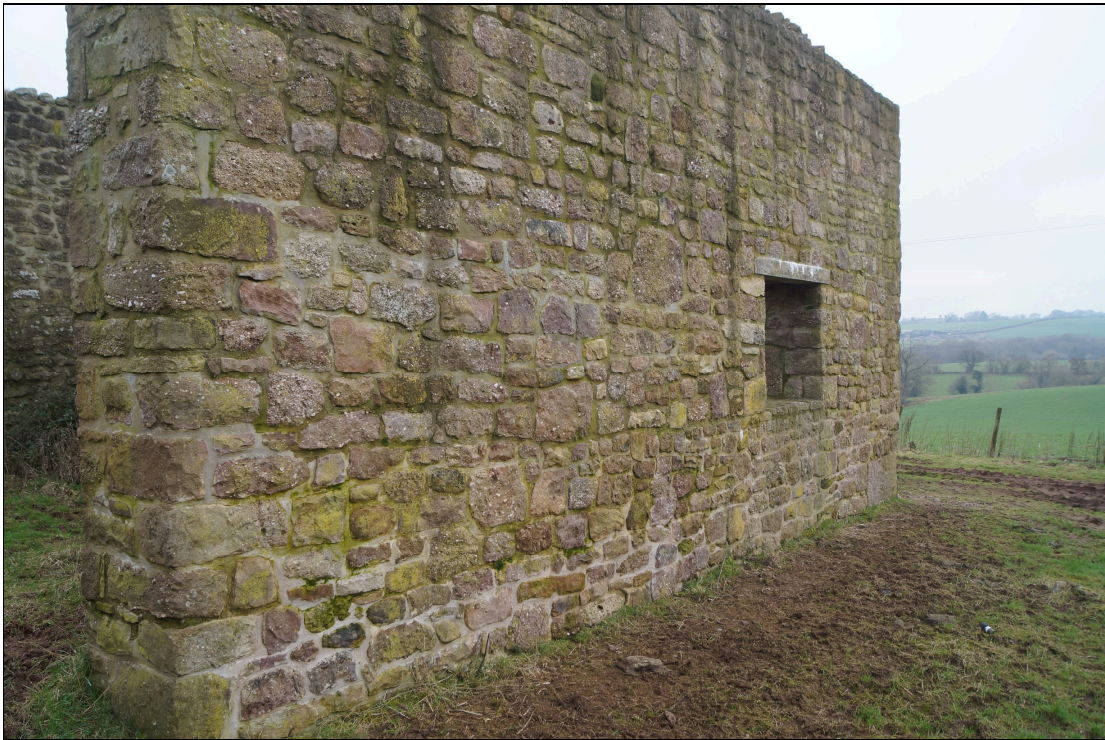
Plate 23: GTB2021_023 - A view of the western end of the external side of the northern lateral wall, which has been completely reconstructed on the original wall line. Looking west.

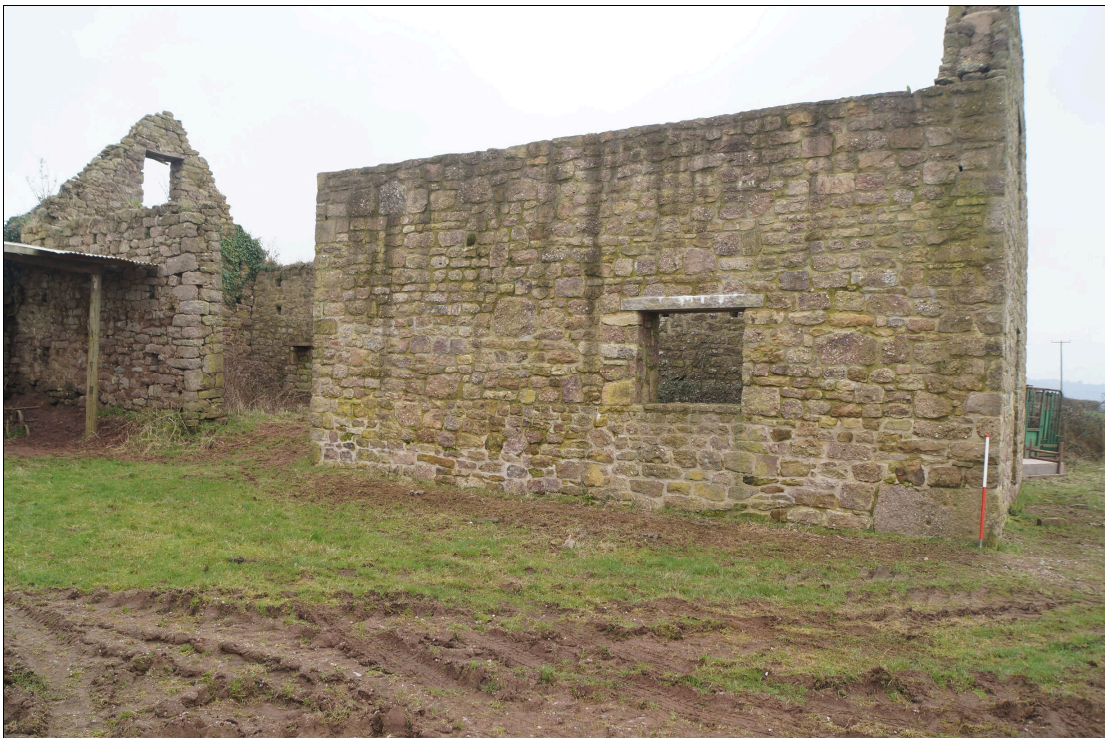
Plate 26: GTB2021_026 - A view of the western end of the threshing barn, showing the reconstructed section of the building. Looking south-southeast.

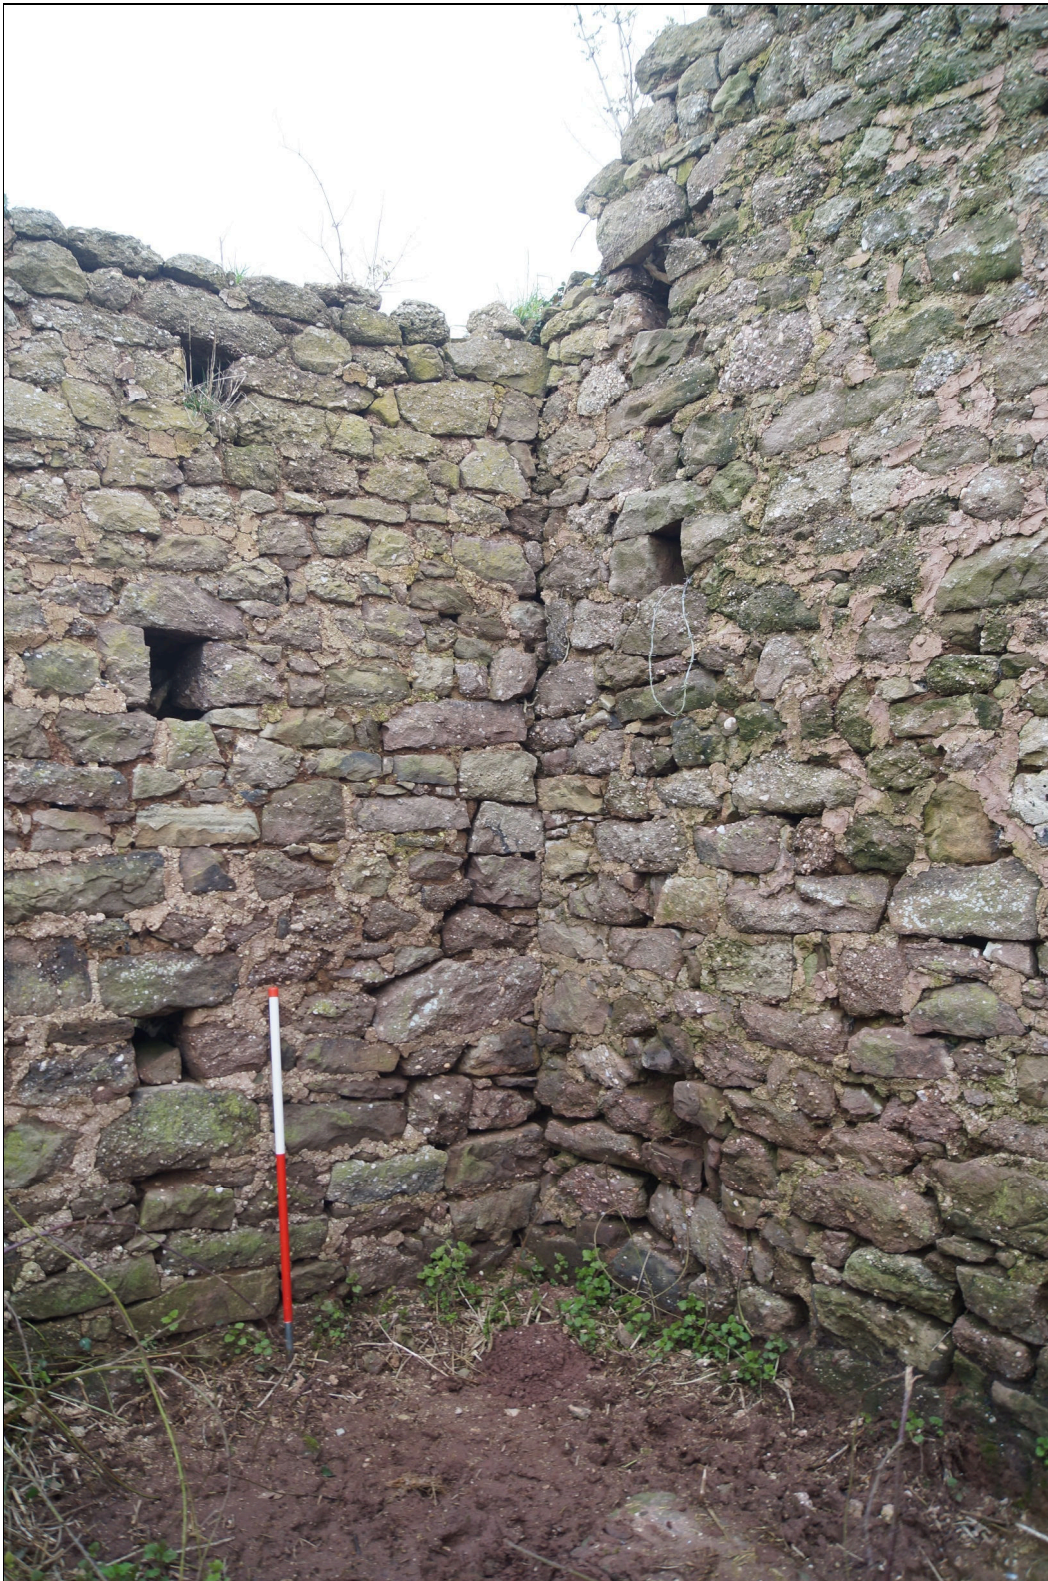
Plate 38: GTB2021_038 - A view of the inside of the northeast corner of the threshing barn showing a straight joint where the lateral wall and gable wall meet. This compares with the threshing barn at Llan y Nant Farm. Looking east-northeast.

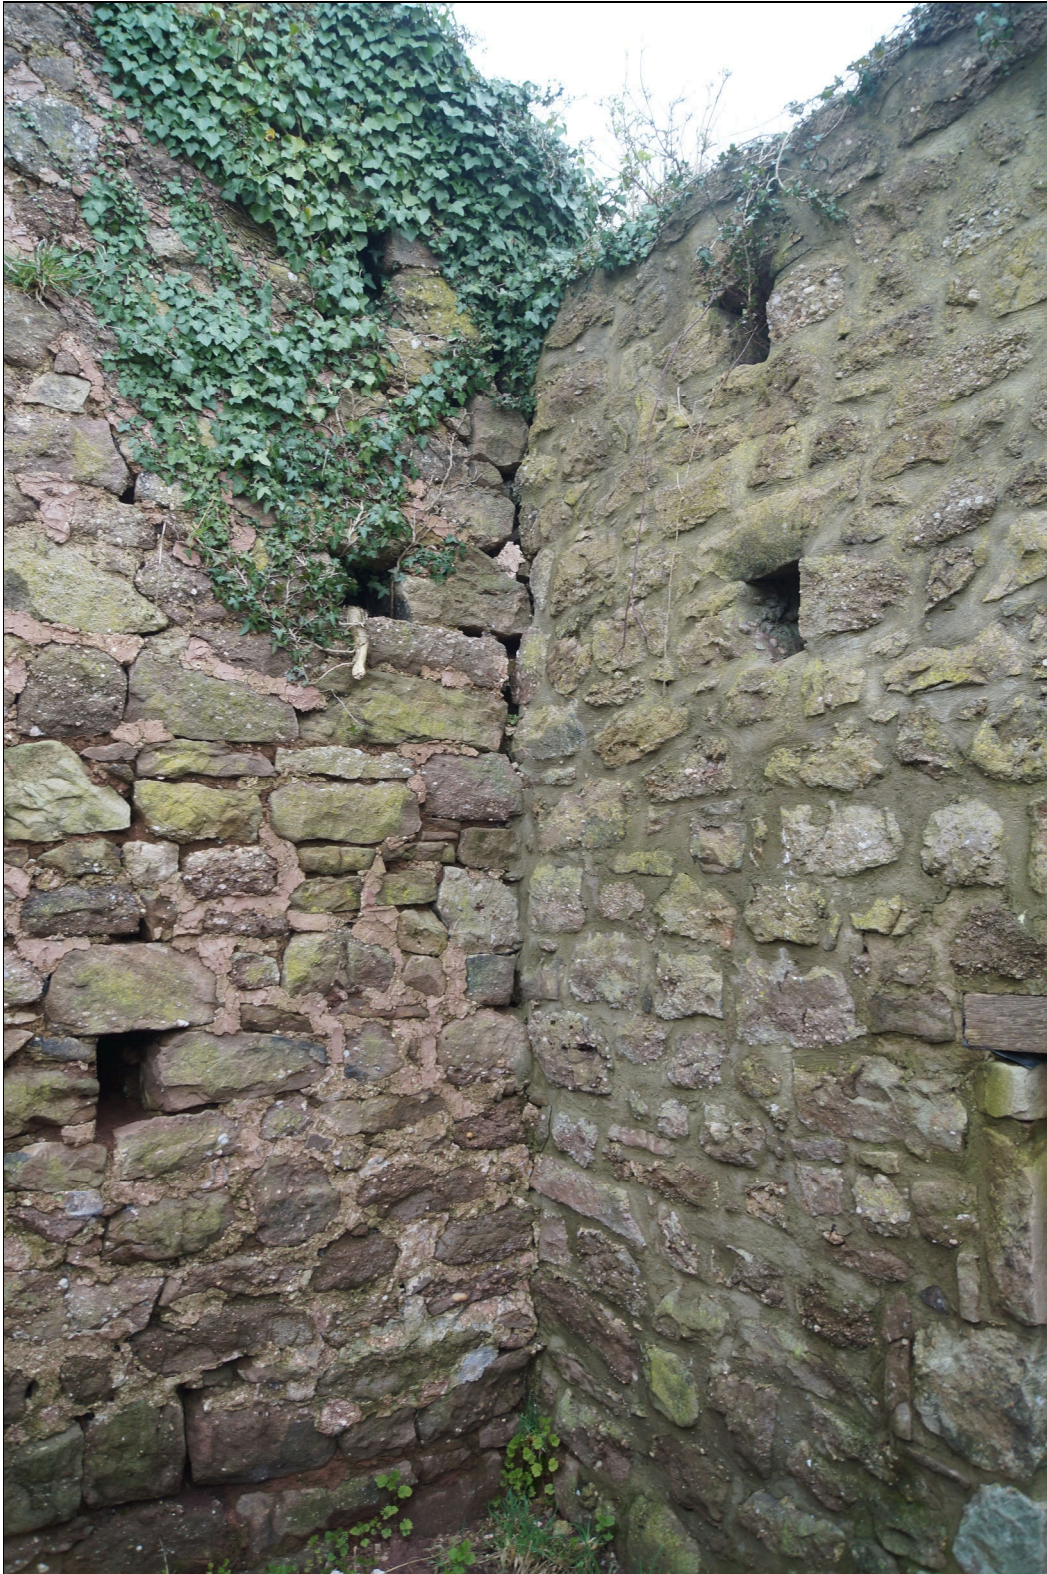
Plate 39: GTB2021_039 - A view of the inside of the southeast corner of the threshing barn showing a straight joint where the lateral wall and gable wall meet. Looking south.

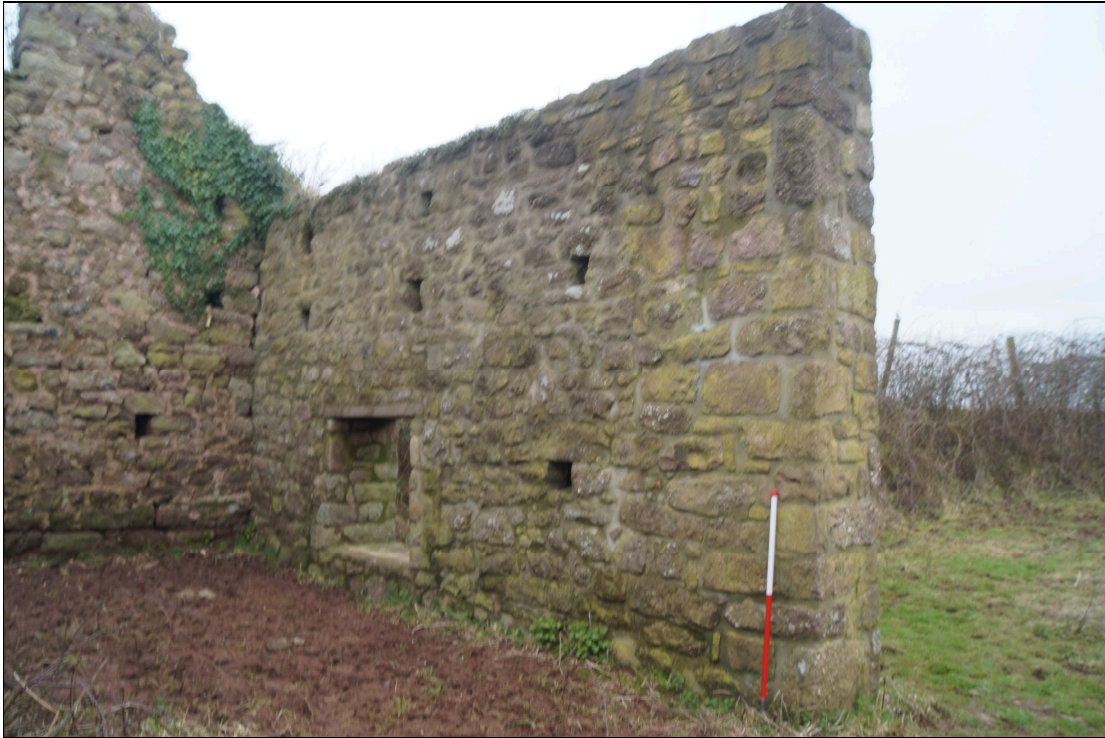
Plate 40: GTB2021_040 - A view inside the eastern end of the threshing barn, showing the original eastern end of the southern lateral wall. The door reveal to the right has been repaired in modern times. Looking south-southeast.

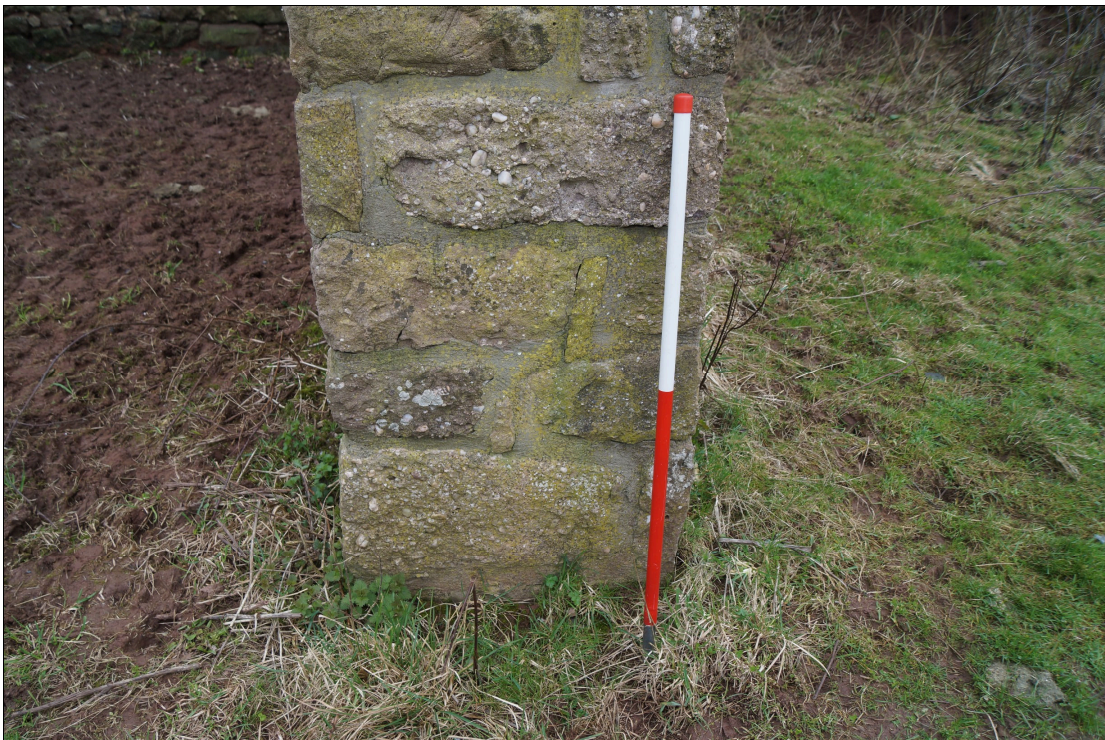
Plate 41: GTB2021_041 - A view of the door reveal at the eastern side of the southern doorway into the threshing barn. This is a modern reconstruction. Looking east-southeast.

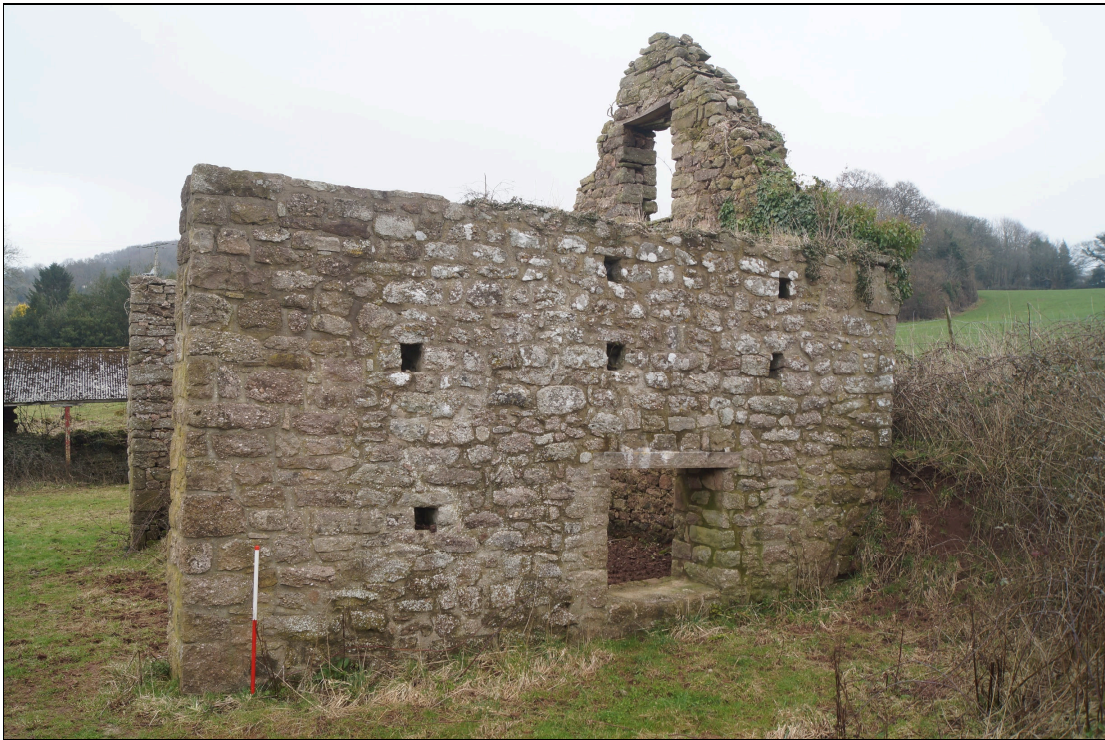
Plate 42: GTB2021_042 - A view of the eastern end of the threshing barn, showing the original eastern end of the southern lateral wall. The door reveal to the right has been repaired in modern times and the window is a modern insert. Looking east-northeast.

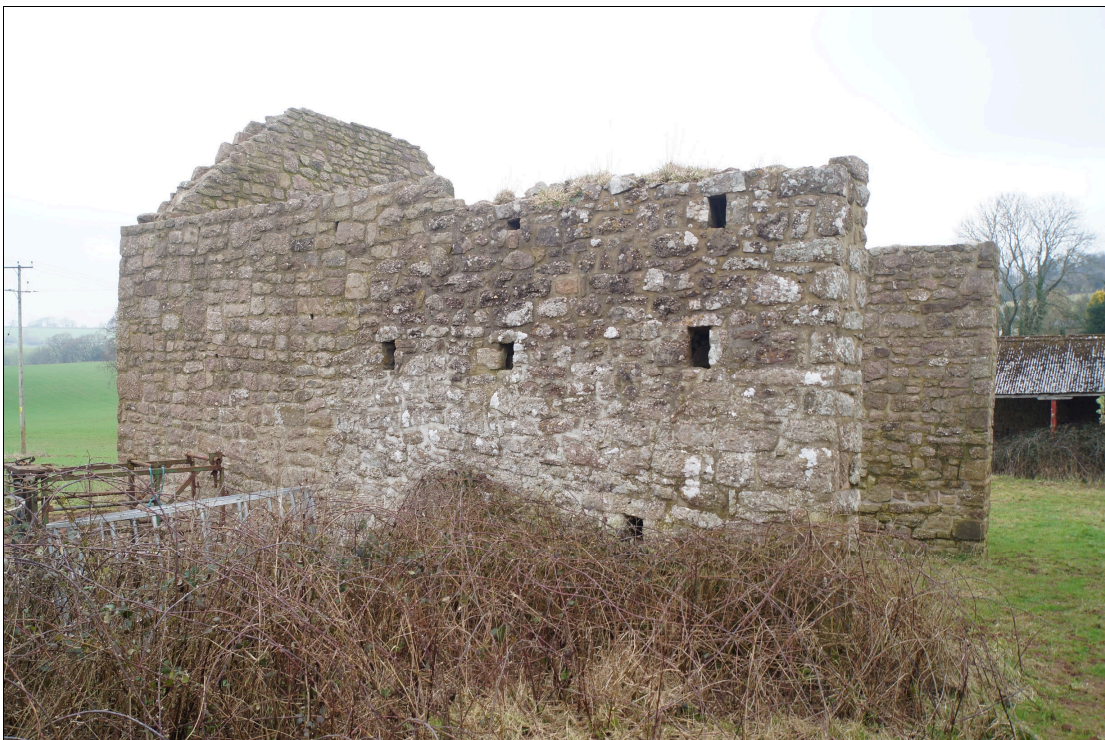
Plate 43: GTB2021_043 - A view of the western end of the threshing barn, showing the rebuilt western end of the southern lateral wall. The section of wall with ventilation holes is original. Looking north.

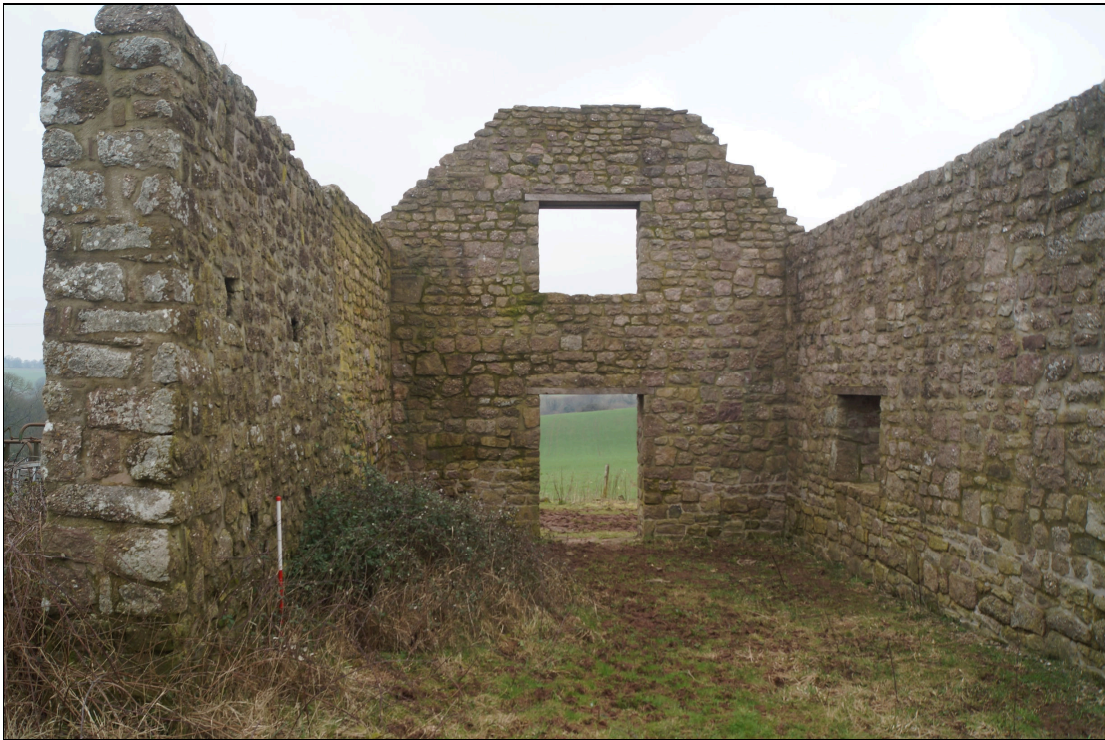
Plate 46: GTB2021_046 - A view inside the western end of the threshing barn, showing largely reconstructed walls. Only the first part of the wall to the left is original. Looking west-northwest.

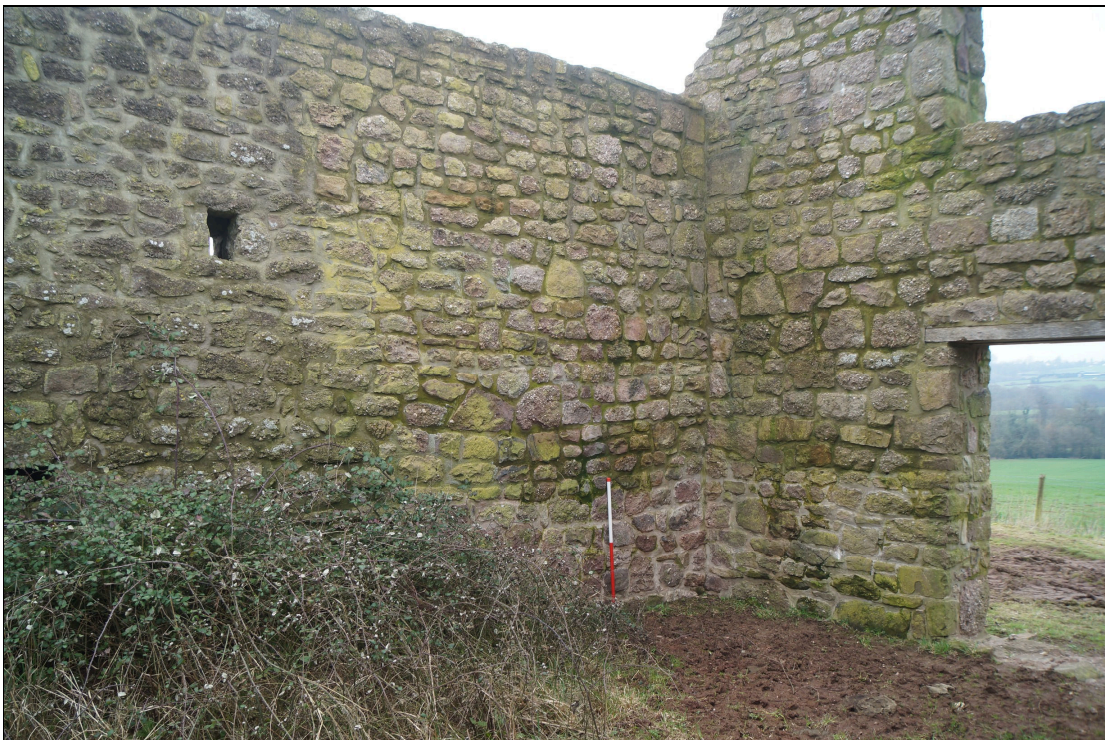
Plate 47: GTB2021_047 - A view inside the western end of the threshing barn, showing the reconstructed wall bonded with the original wall to the left. Looking west-southwest.

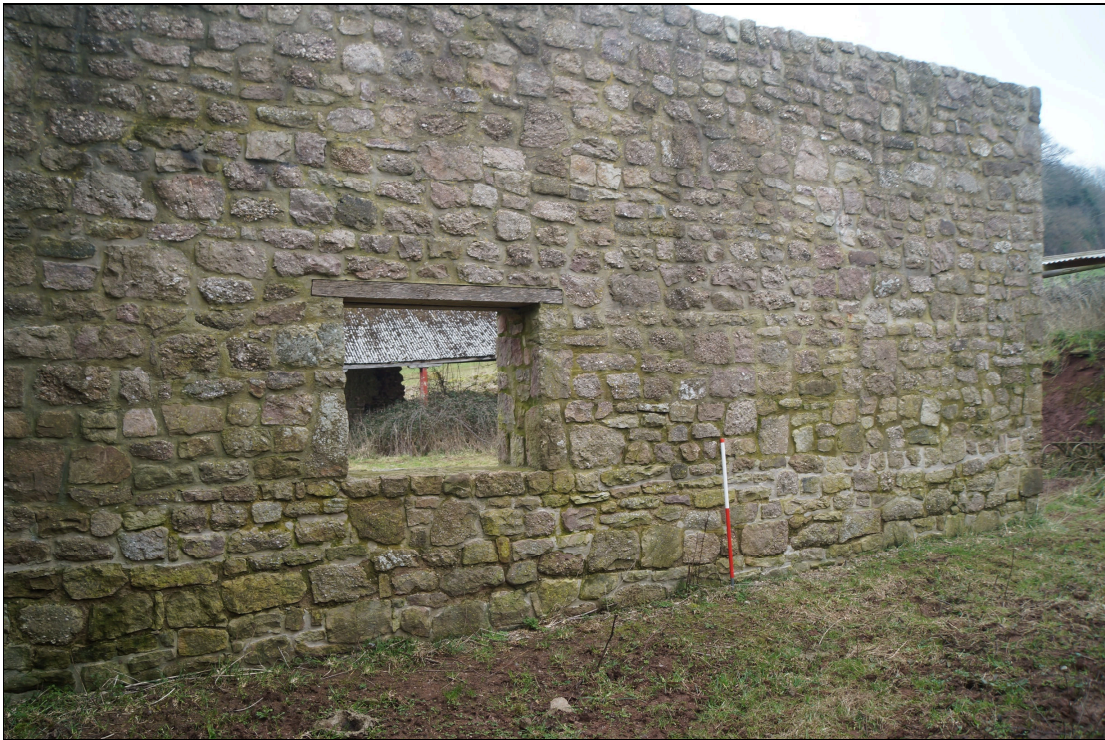
Plate 48: GTB2021_048 - A view outside the western end of the southern lateral wall, which has been reconstructed on the original foundation. Looking northeast.

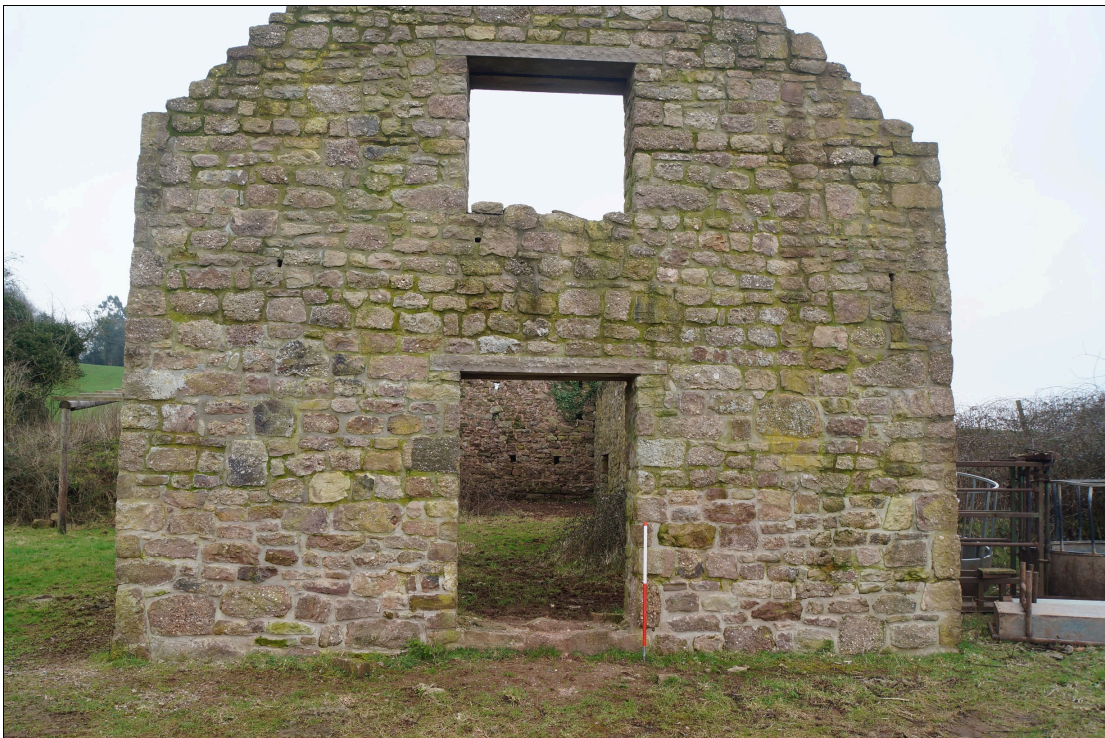
8.3.8 The western gable wall of the threshing barn has been completely rebuilt in roughly coursed stone since the 1990s. Previously, this wall was a breeze-block replacement of the gable wall damaged by bombing

Plate 49: GTB2021_049 - A view of the wholly reconstructed western gable wall. Looking east-southeast.

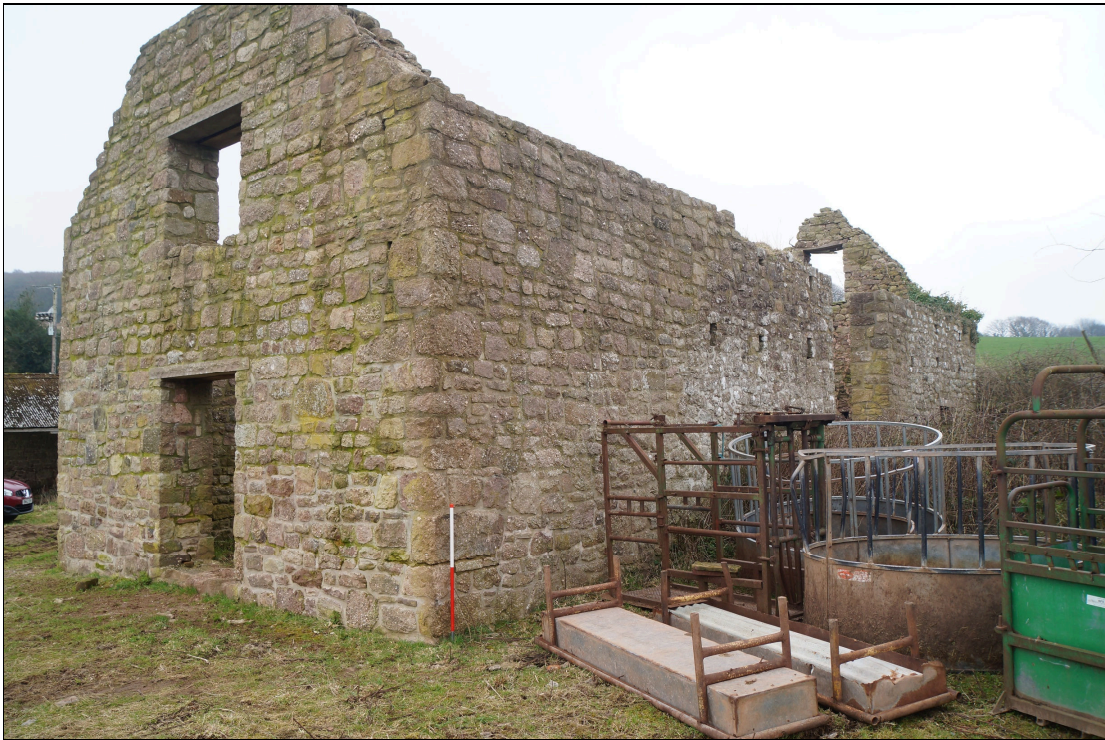
Plate 52: GTB2021_052 - A view of the threshing barn showing the largely reconstructed western end. Looking northeast.
