Historic Building Recording

Hillside, Erbistock

Report Number: 24-1087

Client: T Walker
Author(s): Blair Poole
HER Event No: PRN 220224
Planning Application: P/2023/0574
Document Ref: 24-1087-HBR-v1.1
Date: 5 December 2024
NGR: 335112,342100

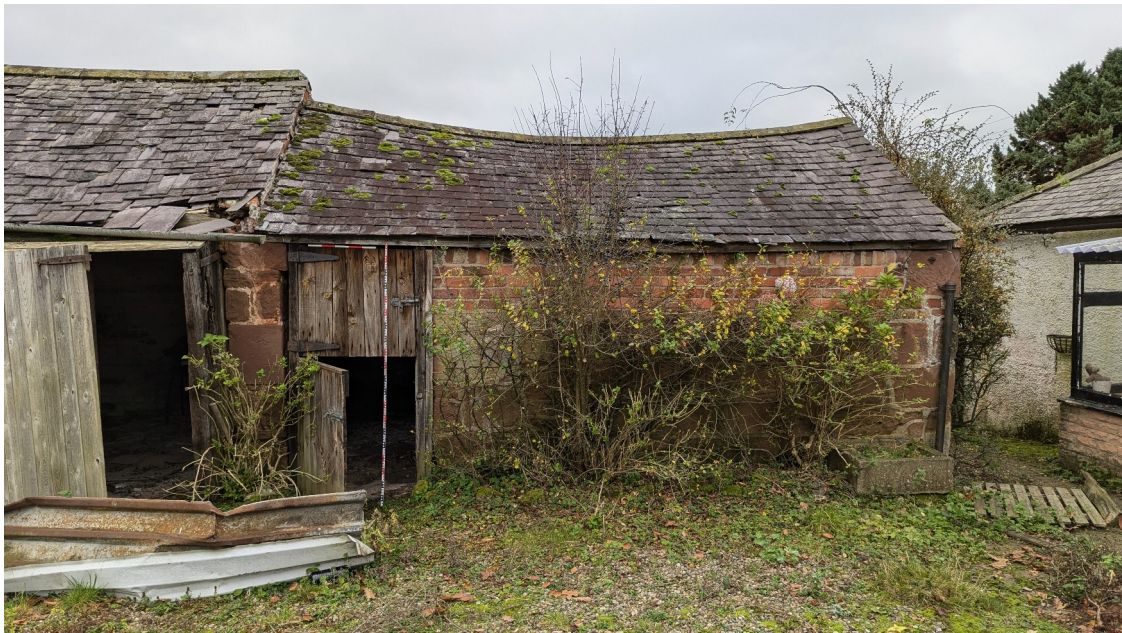
6.4.4 The western elevation of the southern bay (Plate 5) shows the multiple phases of repair work that have been carried out over the years. The body of this bay represents the earliest phase of construction, pre dating 1843 possibly late 18th century in date, and has a sandstone core of regular coursed large blocks extending up to 1.7m above ground level. Above this four stretcher coursed orange bricks, 220mm by 110mm by 70mm, can be seen. A header course of the same brick forms the wallplate course.

Plate 5: The west elevation of the southern bay

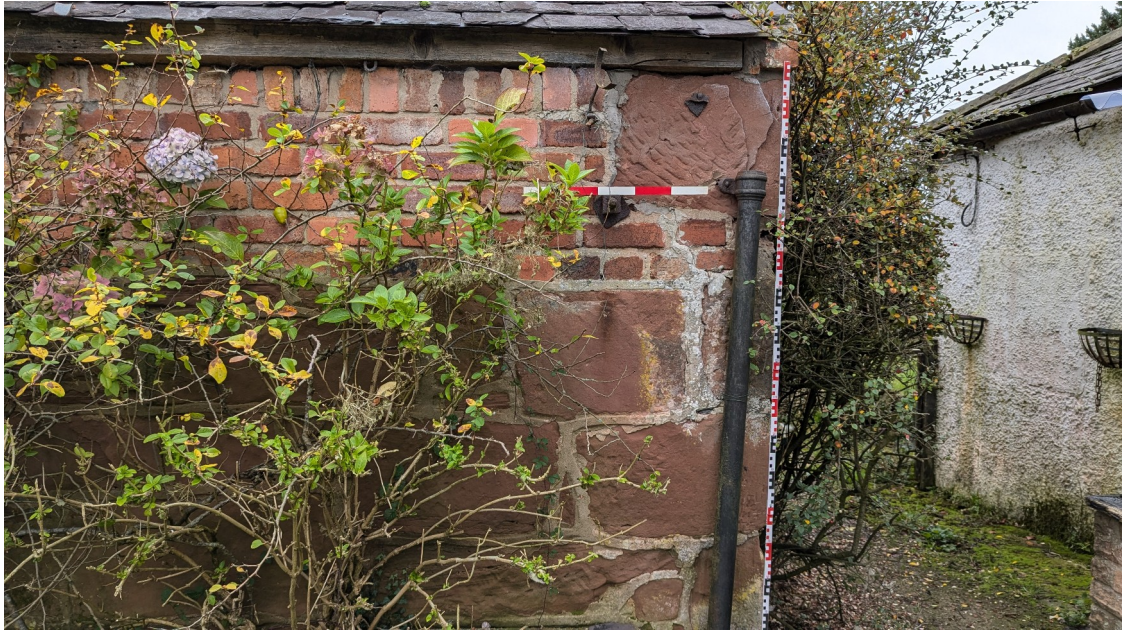
6.4.6 At the southern corner the sandstone blockwork continues to the fascia. Although the gutter is missing from the eaves a cast iron downpipe is affixed to the southwestern corner (Plate 6). At the top of the sandstone blockwork the remnants of a broken metal tie plate can be seen. Only the upper and lower bolt heads with fragments of metal survive. However, of the eastern elevation the complete S-shaped tie plate is present and discussed below (6.4.20).

Plate 6: The southwest corner of the structure

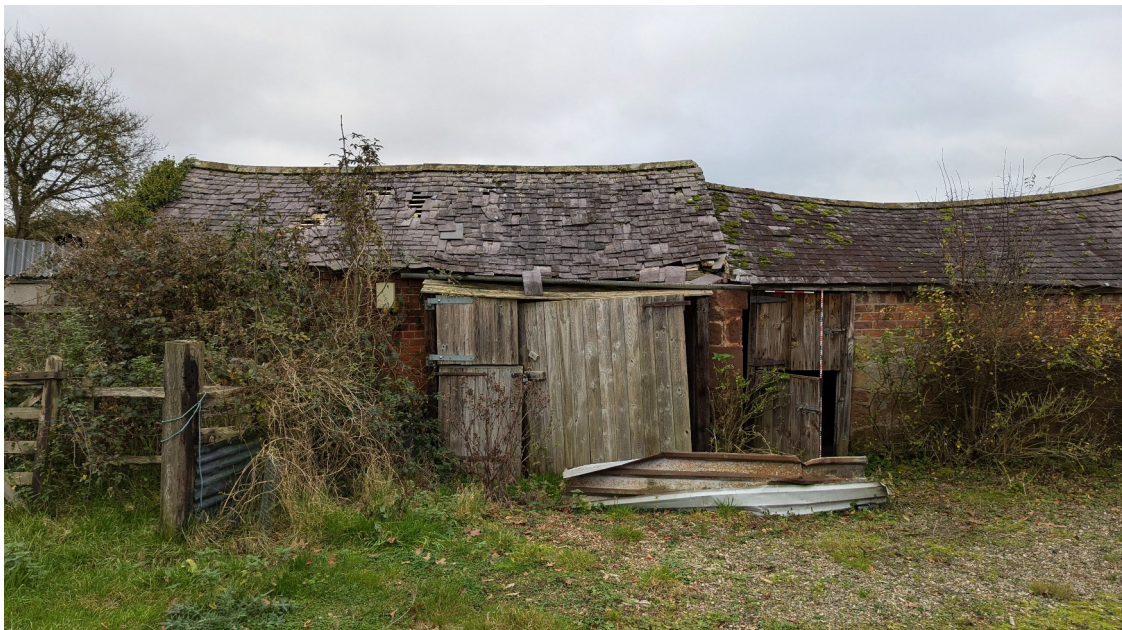
6.4.7 The central bay of the western elevation was of red brick, 220mm by 110mm by 80mm, in English Garden Wall bond with a light cream, soft, mortar (Plate 7). This brick material in the central bay differed from that seen on the repair work to the southern bay indicating distinct phases of modification or repair (Plate 6).

Plate 7: The central bay of the western elevation

6.4.8 The central bay represents the second phase of construction of the structure, also pre-dating 1843, but more likely early 19th century in date based on the material type and appearance. As with the southern bay there was evidence of repair in areas, but on the whole the form and character of the bay was intact.

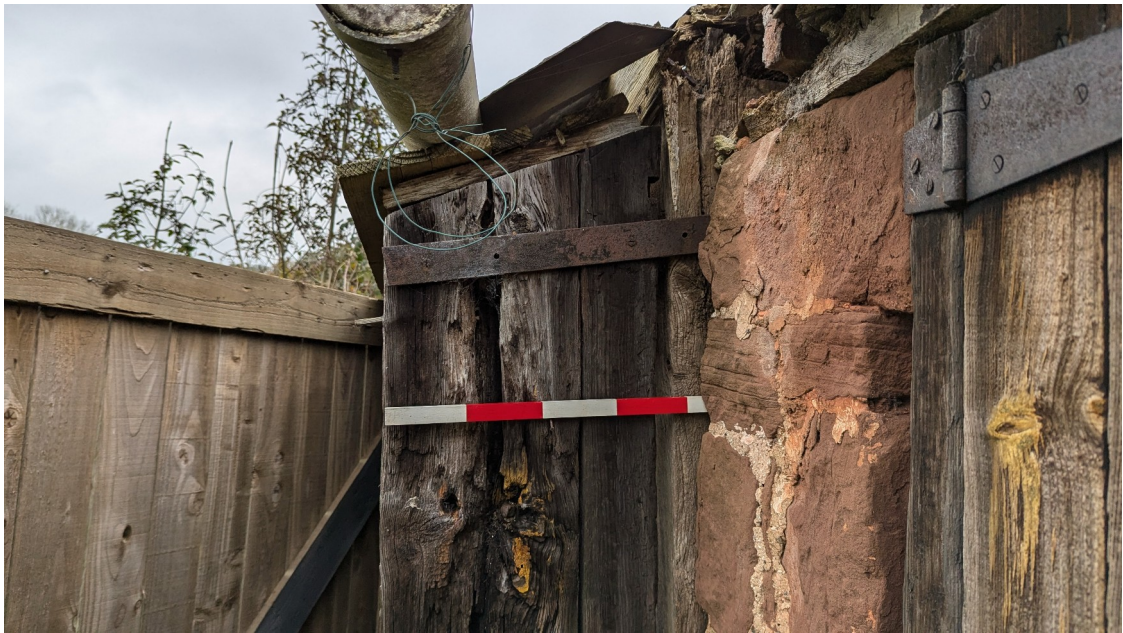
6.4.9 The southern portion of the elevation was taken up by a wooden door that appears to be a late 20th century replacement to an earlier doorway. No remains of the earlier door were present, and the new framework had been constructed of

timer protruding from the elevation by 400mm (Plate 8). An asbestos gutter was noted above the doorframe.

Plate 8: Timber framework for 20th century door to Room D

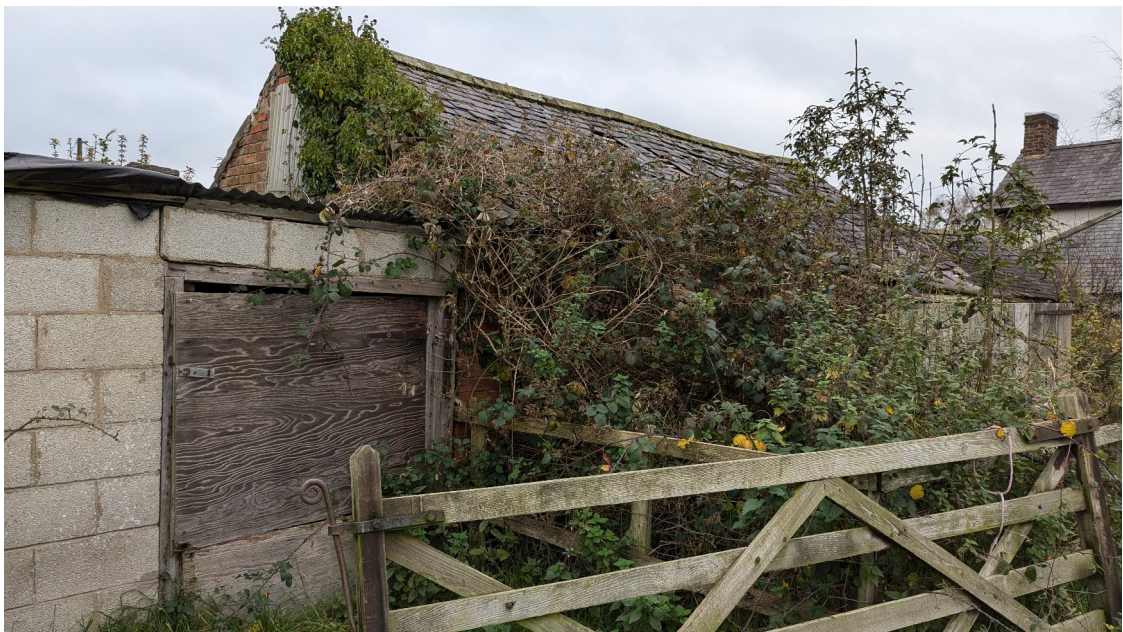
6.4.10 A window was present at the northern end of the central bay however, this was obscured by vegetation on the external elevation only visible during the internal survey (Plate 9).

Plate 9: Junction of north and central bays on western elevation. Vegetation can be seen covering the window location

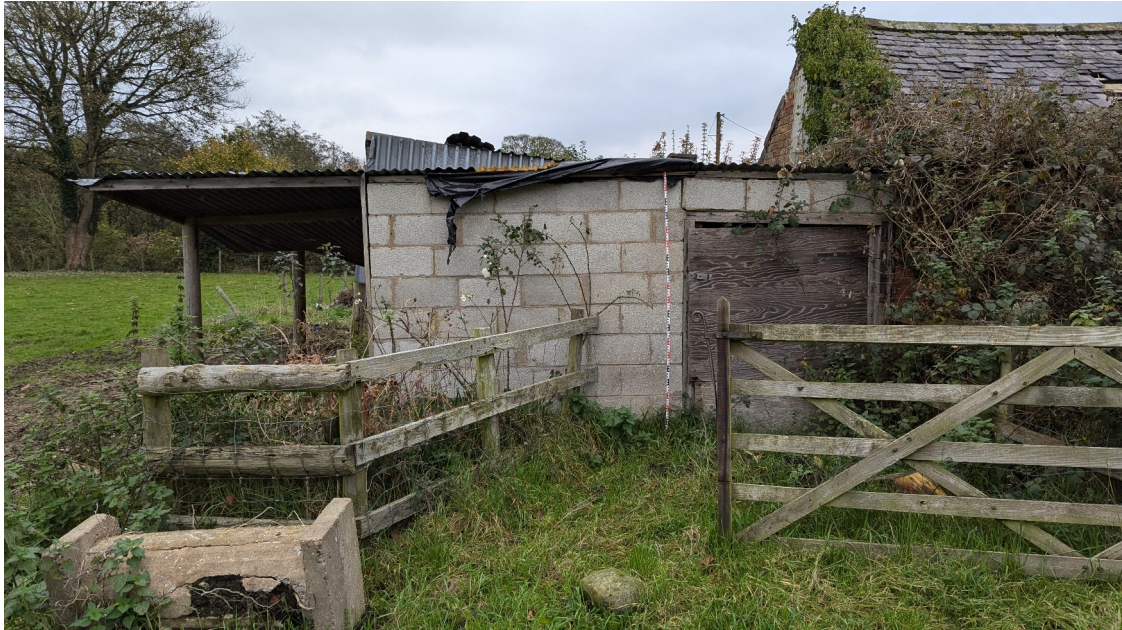
6.4.11 The northern bay of the western elevation was a 20th century concrete pig sty in regular coursed blockwork, with a flat corrugated metal roof (Plate 10). This element represents the fourth phase of construction on the outbuilding dating to between 1920 and 1962. The fabric and form suggest post 1950.

Plate 10: North bay on western elevation

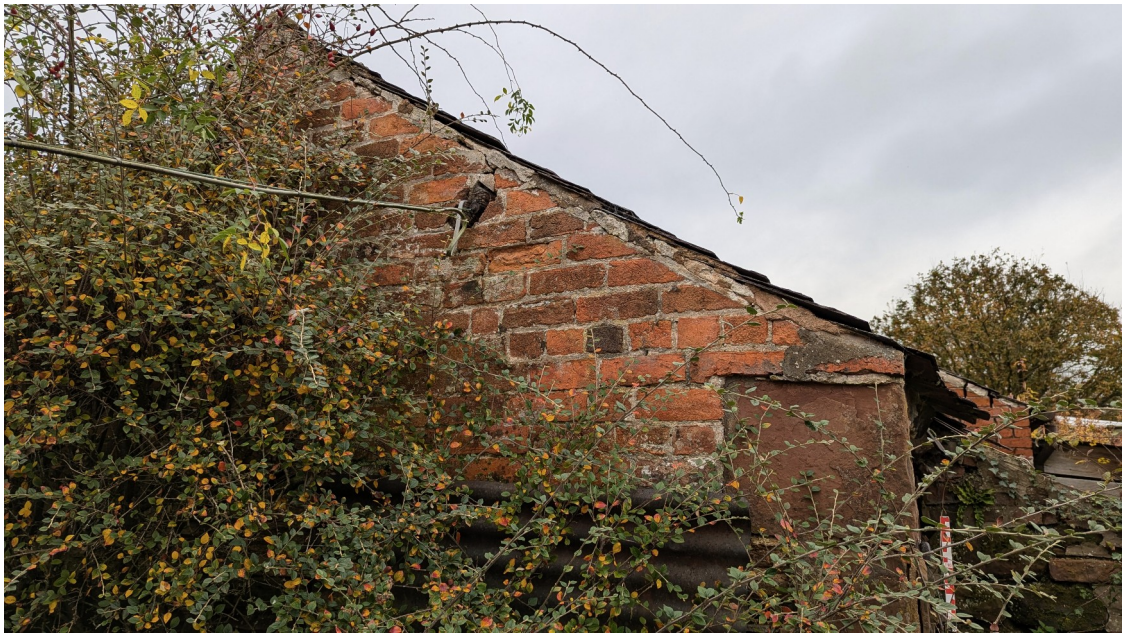
6.4.14 The elevation contained several phases of repair and modification. The eastern portion contained a wooden doorway up to 1.2m above ground level, above which a corrugated metal sheet covered the doorway, which ceased at 1.6m above

ground level, where a timber summer beam supported the brick gable (Plate 12). Although visible on the external face, this is much clearer internally.

Plate 12: Southern elevation, showing brick gable, sandstone edge and corrugated metal shuttering

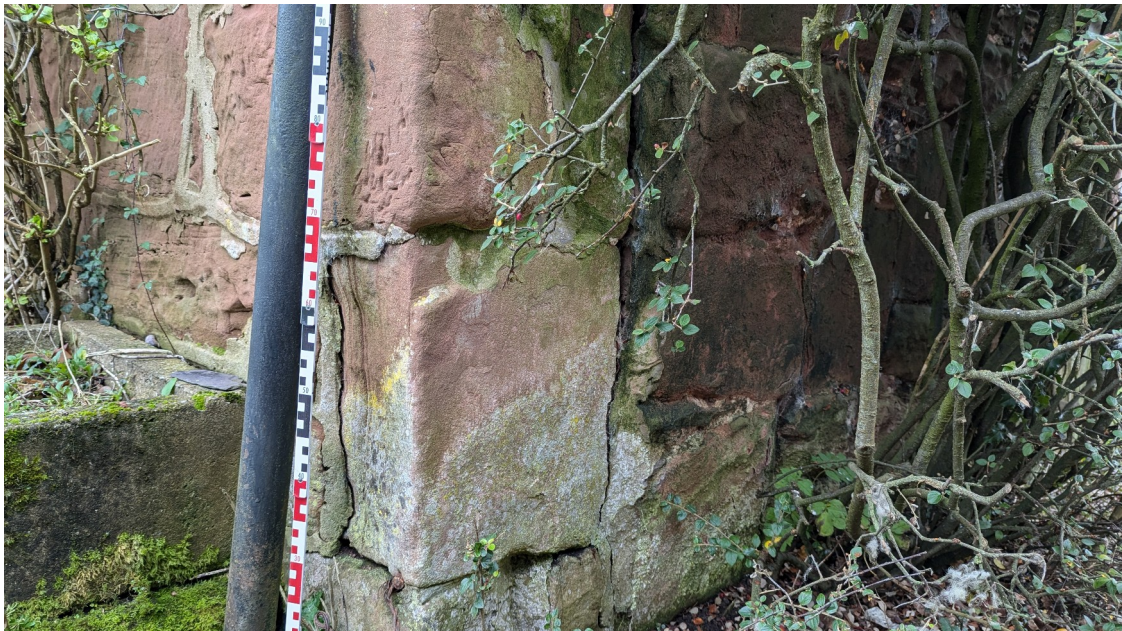
6.4.15 The western section of the wall contained sandstone blockwork that was clearly a later infill phase and butted against the original sandstone edge to the bay (Plate 13). This infill was at the location of the OS benchmark that has been lost during previous repair works.

Plate 13: Southern elevation, showing junction of sandstone blockwork

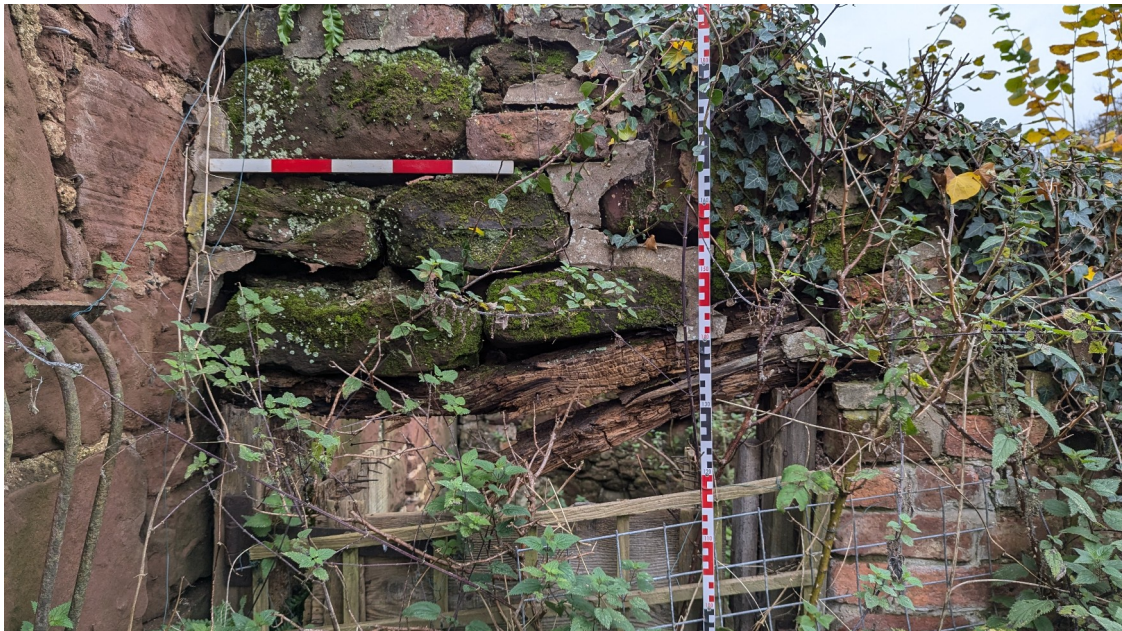
6.4.17 The lean to wall was of an extremely rough construction with a combination of brick, cobble and sandstone blocks butting against the main structure (Plate 15). A small window opening was present with rotten wooden lintel, and no discernable cill present. This was likely used as a store room.

Plate 15: Southern elevation, lean to construction

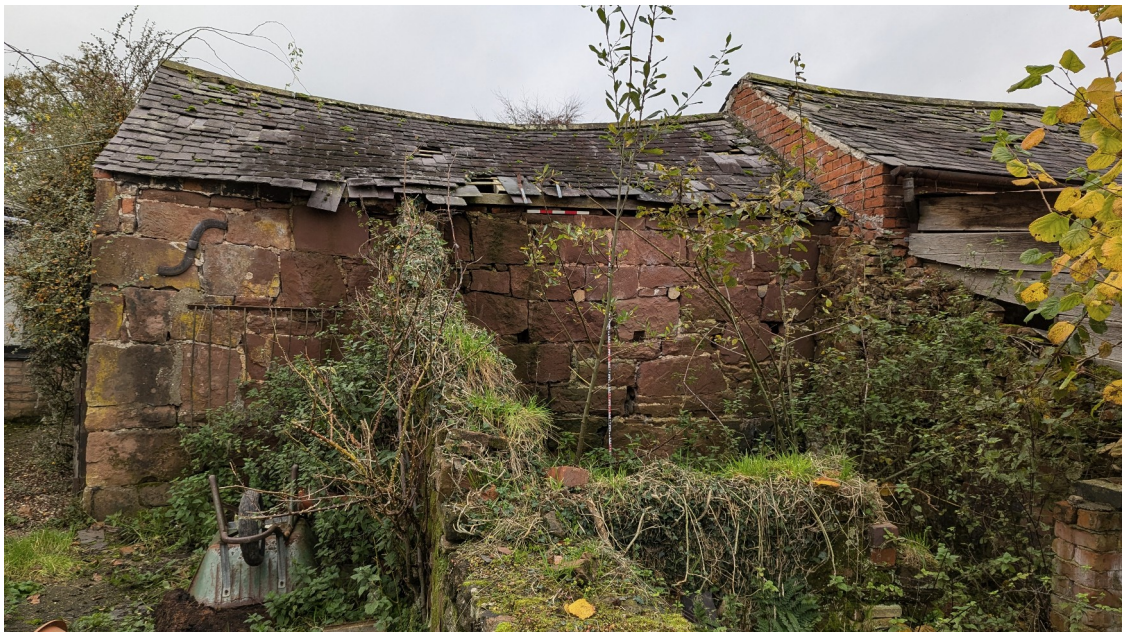
Plate 18: Eastern elevation, southern bay

6.4.20 The eastern elevation of the southern bay was of squared coursed sandstone and forms the most complete section of the original structure (Plate 18). At the upper part of the southeast corner of the elevation an S-shaped tie plate was present. This forms the counterpart to the broken tie plate seen on the western elevation. A series of six offset voids 80mm in diameter were present in two rows of three, with the upper three infilled with mortar. It is thought that these were

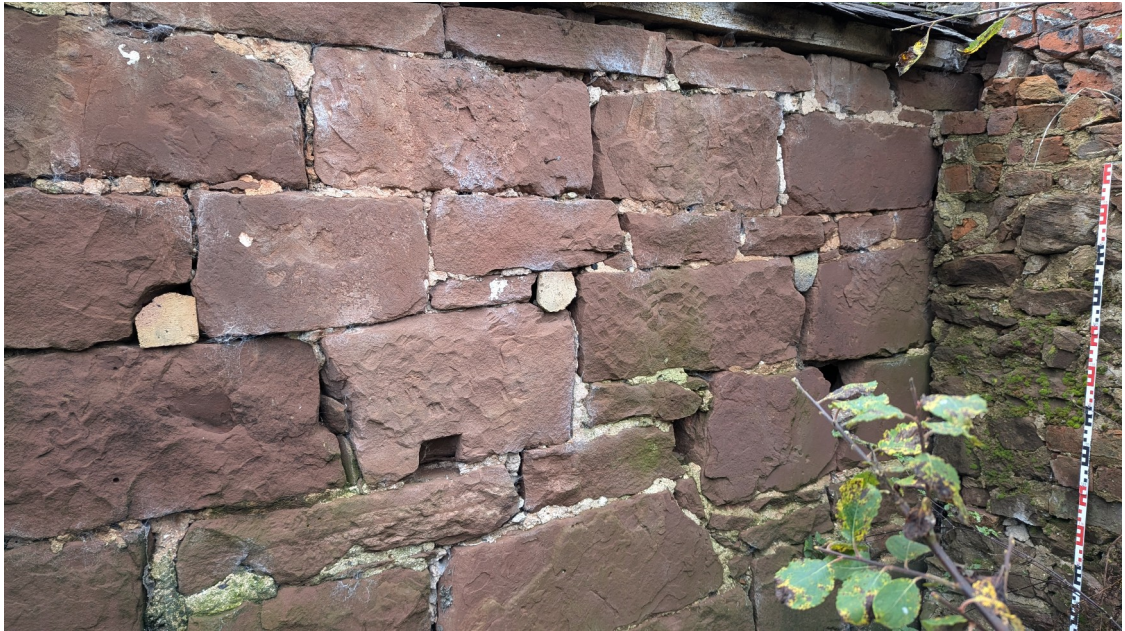
breather holes for the outbuilding to allow air flow, and are a typical element of agricultural structures.

Plate 19: Eastern elevation of Room C showing breather voids

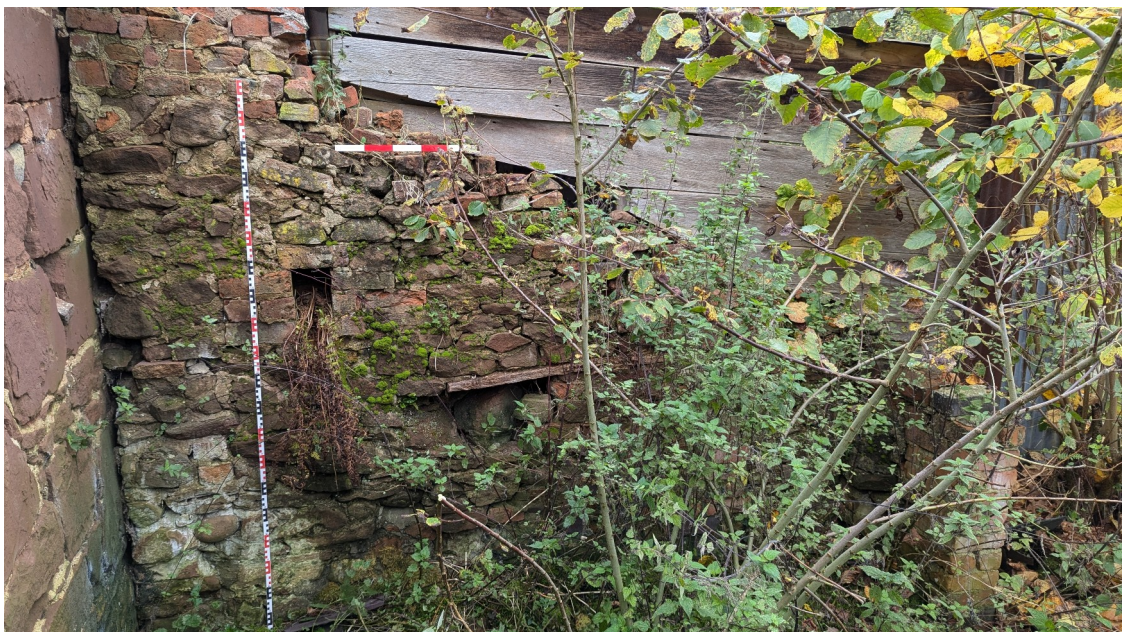
6.4.21 Butting this section of the eastern elevation is the remnant of the dividing wall between Rooms A and B, which can be seen to be a rough construction of sandstone, brick and cobbles (Plate 20). This phase dates to between 1872 and 1898 and appears to use readily available materials with limited concern for aesthetic value.

Plate 20: Wall between Rooms A and B

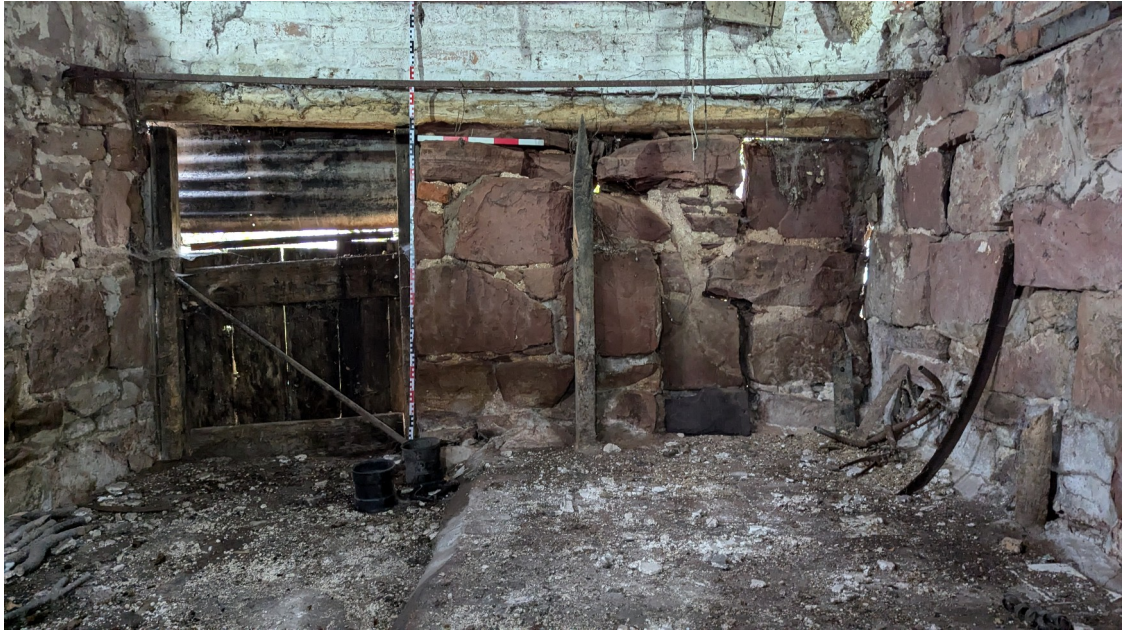
6.5.10 The southern wall of Room A (Plate 30) had a sandstone lower section, up to 1.5m above ground level. The sandstone blockwork was mainly late infill material in random courses and mortar sections. Although some of this may be re-used original material, it is clearly a later repair to the structure.

Plate 30: Room C lower section of southern wall

6.5.11 Set within the repair section was a small doorway at the eastern corner, with a 20th century softwood frame and lower section of a stable door. The upper part of the doorway was blocked with corrugated metal sheet (Plate 30). Repair work at the western corner butts the historic fabric at the southwestern corner and may relate to rebuild following a small area of collapse, as the surrounding fabric gives no indication of a proper edge as would be expected for the infill of a deliberate void for a doorway.

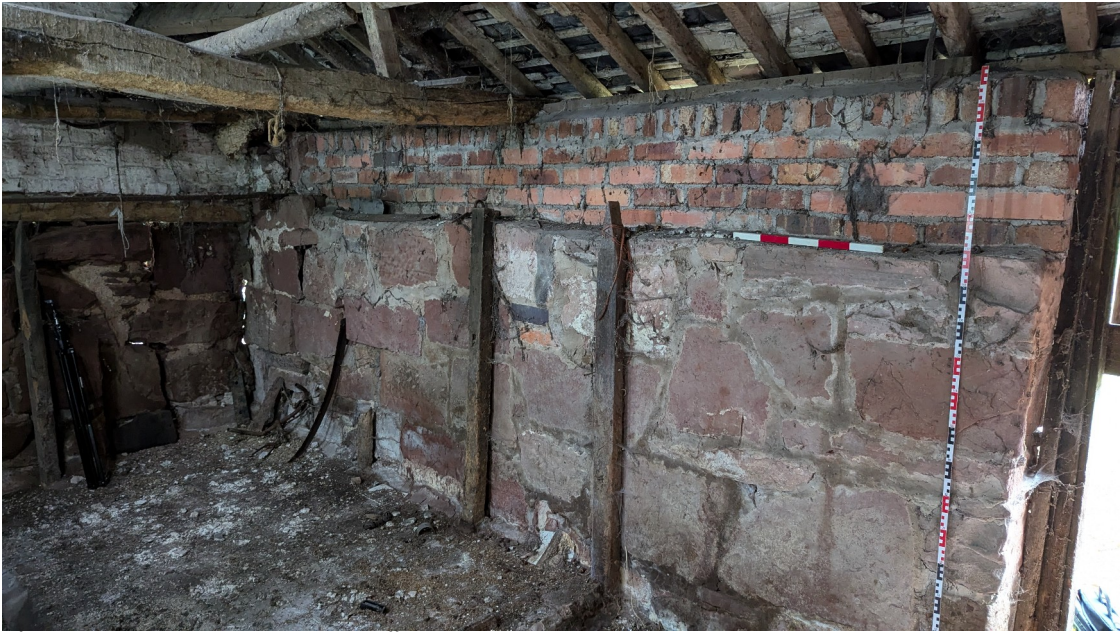
Plate 32: Room C upper western wall

6.5.14 The western wall contains original sandstone blockwork, seen in random coursed blocks up to 1.5m above ground level, matching the levels of the southern wall. Above this brickwork extends to 2m above ground level (Plate 32). As external stone work suggests the roof level was close to, or slightly higher, than the current roof line, it is likely the roof had previously collapsed and during replacement this part of the western wall was repaired with brick to raise it to an appropriate level during the 20th century.

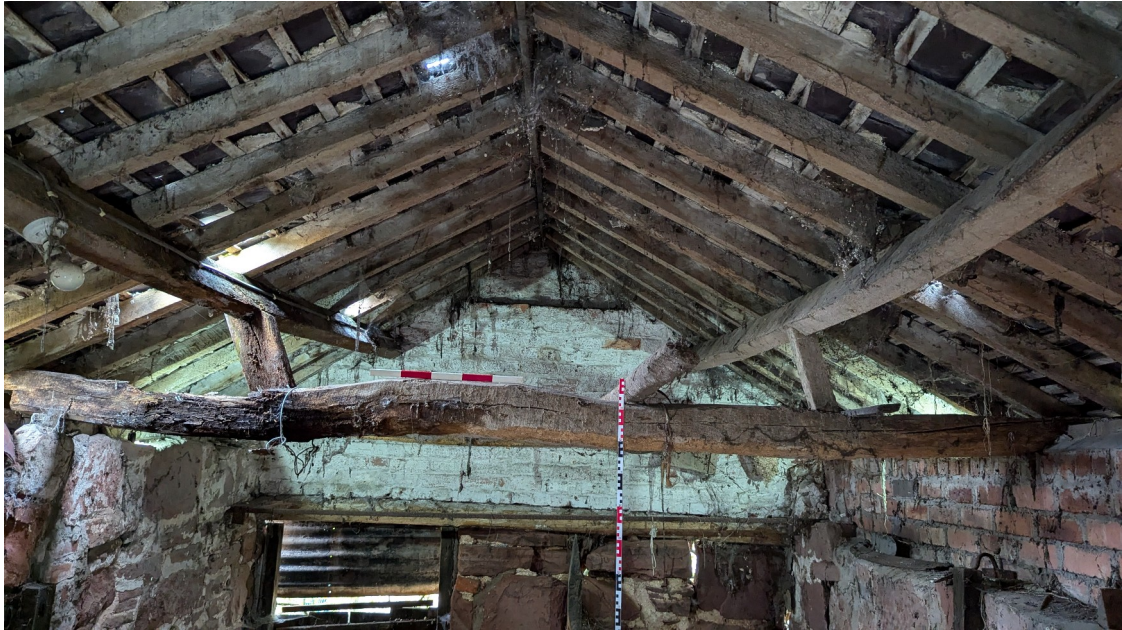
6.5.15 Some elements of the roof structure may represent re-use of earlier material, such as the tie beam, however, the purlins and rafters are all later materials (Plate 33).

Plate 33: Room C roof structure

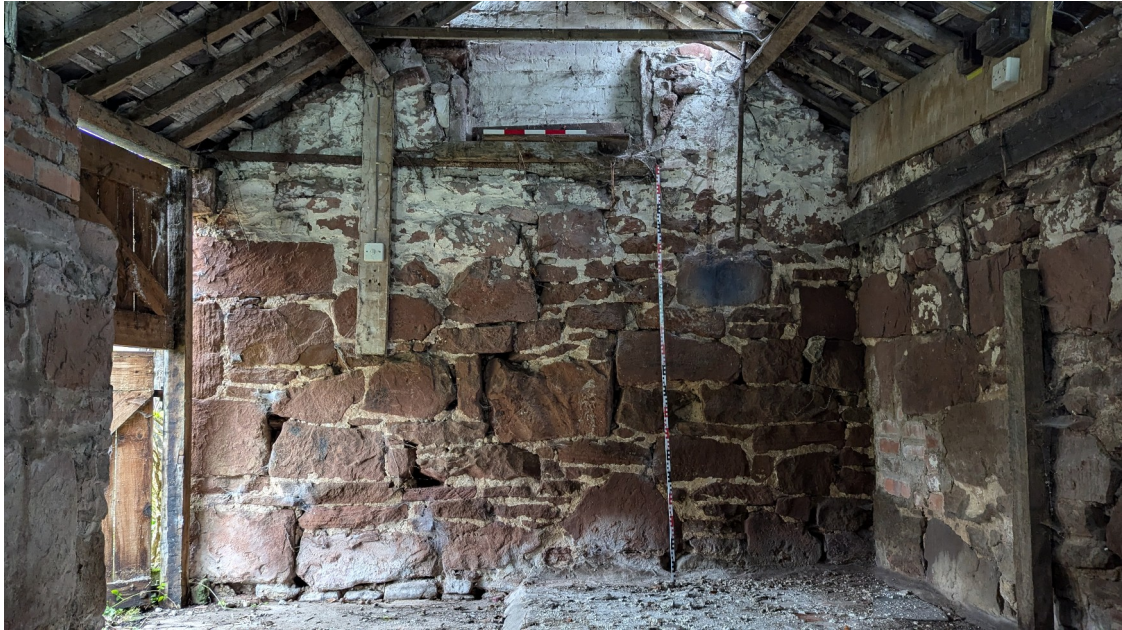
6.5.17 The north wall represents one of the most intact faces of the structure's first phase of construction with random coursed sandstone blockwork leading to the gable, with no brick repair in the upper section (Plate 35). However, the top of the gable is incomplete.

Plate 35: Room C north wall

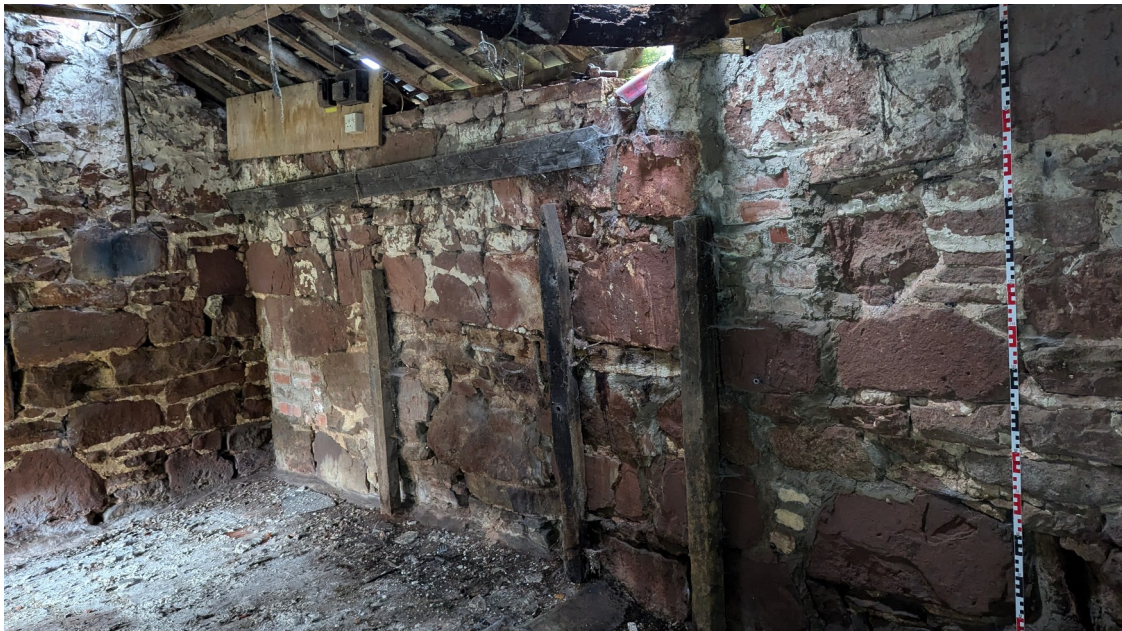
- 6.5.18 The upper part of the wall, forming the gable, contains a recess, missing its upper part, that may have formed a window or loading hatch in the past. The recess has stone cill and side frame in situ. The brick infill visible on this face is formed by the later construction of Room D.
- 6.5.19 The east wall of Room C contains multiple phases of repair, with elements of sandstone and brick repairs set within elements of early sandstone blockwork.

Plate 36: Room C east wall

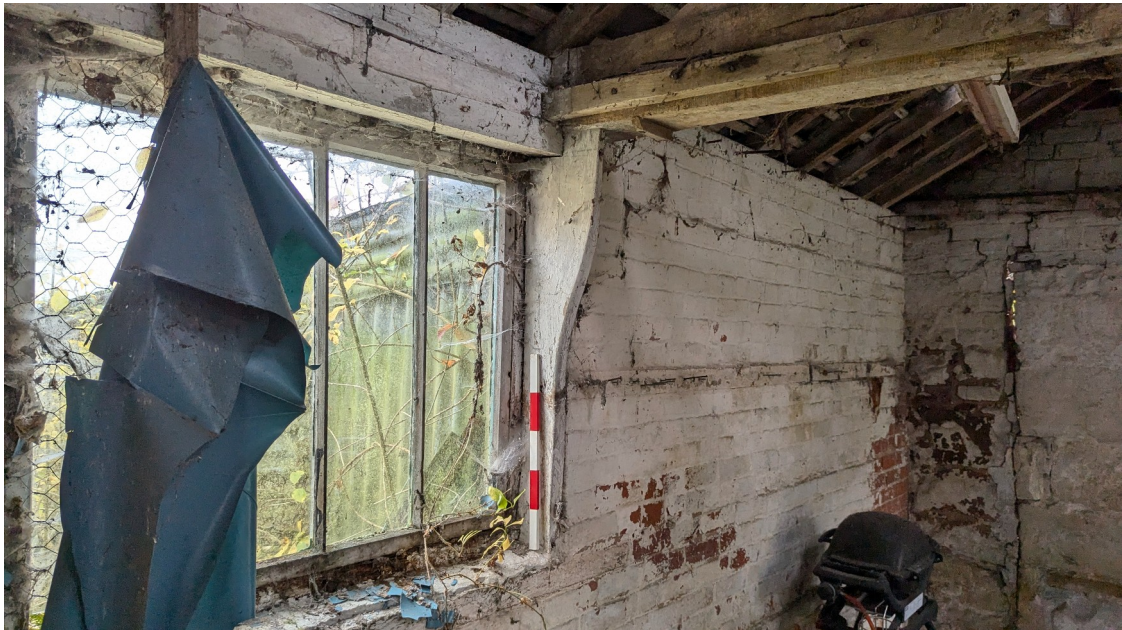
6.5.26 Of note was the re use of a wooden piece of furniture, possible part of an old Welsh Dresser, in the southern window frame. This item had been attached to the frame and extended beyond the wall to act as a form of support for the roof structure, which appears to be a later replacement (Plate 41).

Plate 41: Room D eastern window

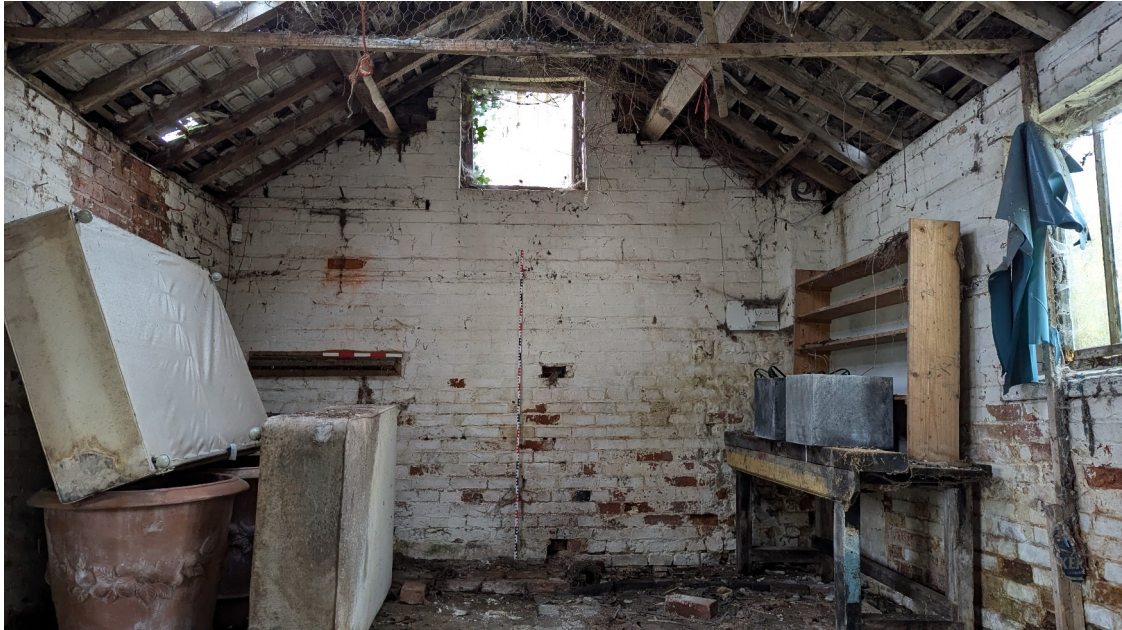
6.5.27 The northern wall of Room D was of brick n English Garden wall bond painted white (Plate 42). Within the upper section of the gable was a window aperture with no cill or lintel visible on this face, however, a wooden frame was visible at the external brick skin.

Plate 42: Room D northern wall

6.5.28 The gable walls had been modified when the roof structure was replaced and the rough modification around the location of the purlins is evidence of this (Plate 42).
