Mulberry House, Pen Y Pound, Abergavenny

Archaeological Level 3 Building
Recording

Report No. 1846

October 2019

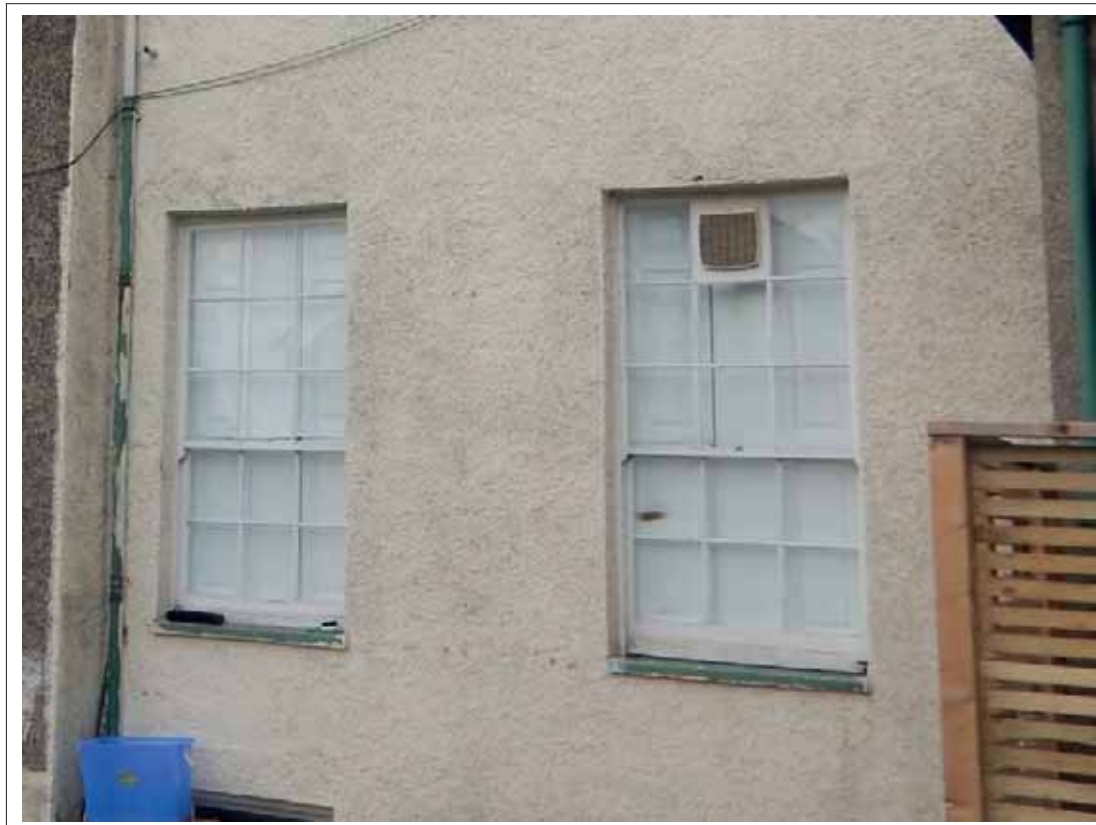
The ground floor windows, two to either side of the central bay, are six-light over nine-light sash windows (Plate 13). The windows are slightly recessed with no visible surround. They have simple concrete sills. The central upper pane of the southernmost window has been replaced by a ventilation unit.

Plate 13. Sash windows to ground floor of rear elevation of Mulberry House, looking west.

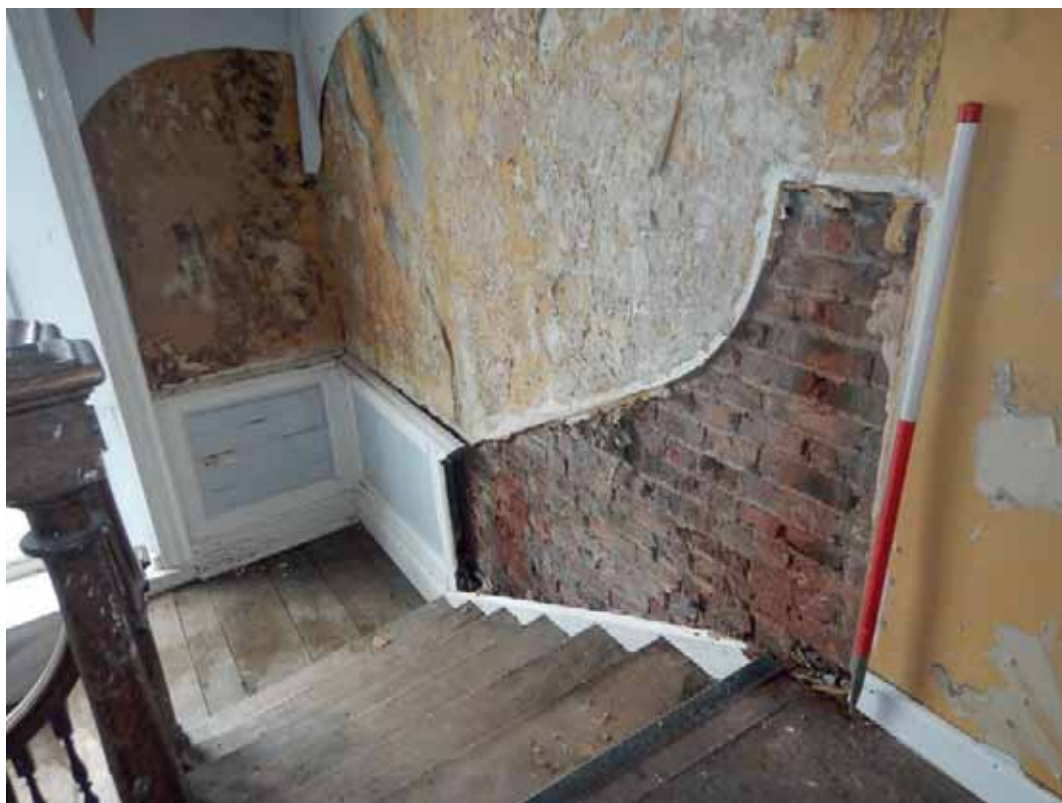
Plate 21. Exposed brick under damaged panelling to the top flight of the main staircase, looking south-east. 1m scale.

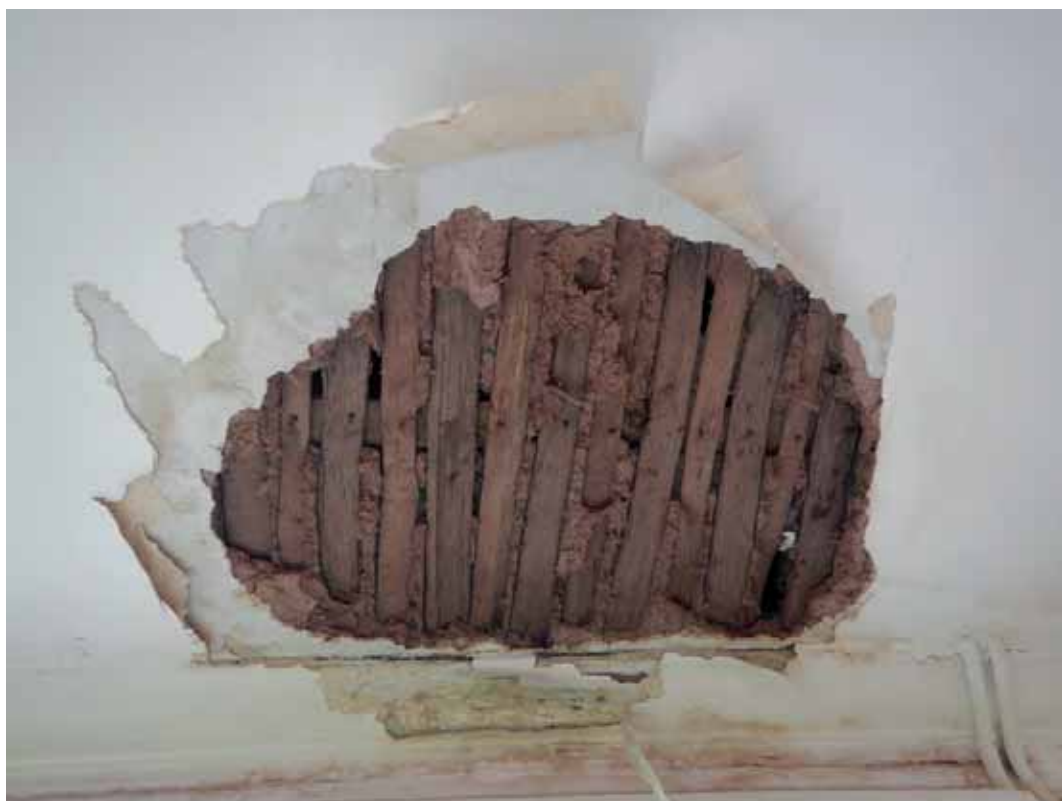
The ceiling is painted paper over plaster with a moulded cornice (Plate 49). It is in poor condition, showing water damage in places. There is a hole in the plaster near the east wall which reveals the original lathe and lime plaster construction (Plate 50).

Plate 50. Damaged ceiling in Room 1.2, showing original ceiling construction.

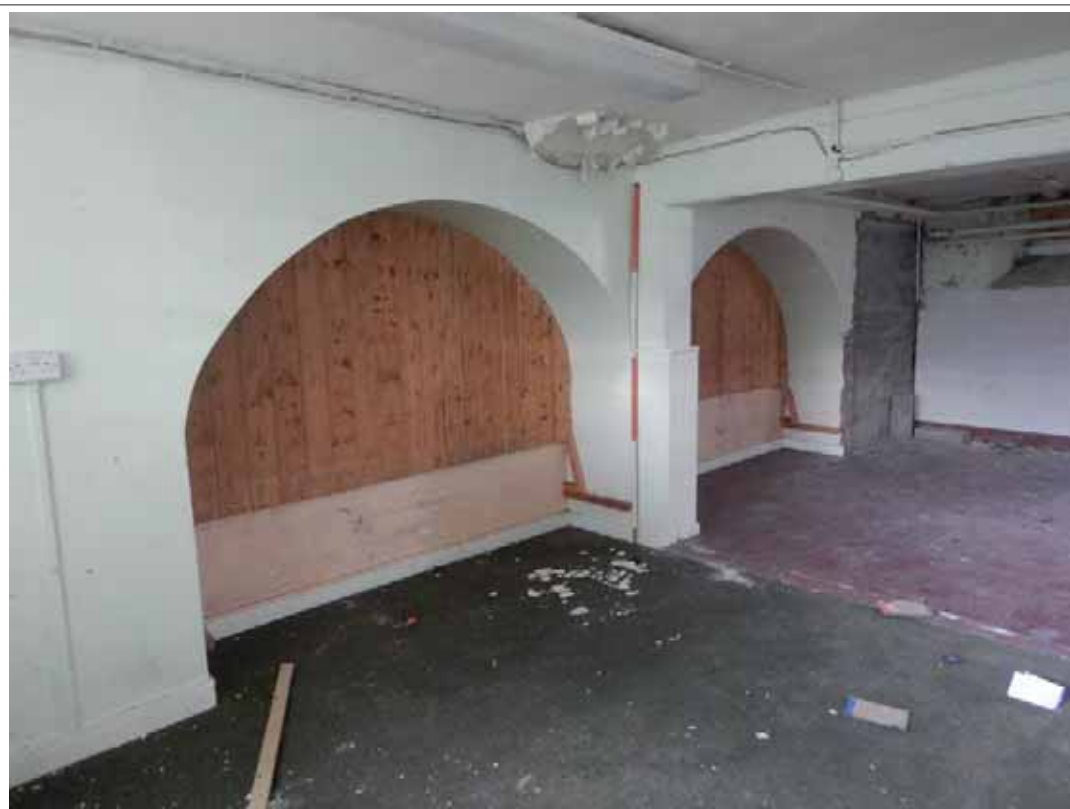
Room -1.7 is a large room that covers the entire width of the northern end of the basement (Plate 104). It was probably originally two room, with a small spur of the original dividing wall visible extended south from the north wall. This would have been replaced by the metal rebar that has been boxed in.

Plate 104. Room -1.7, looking north-east. 2m scale.

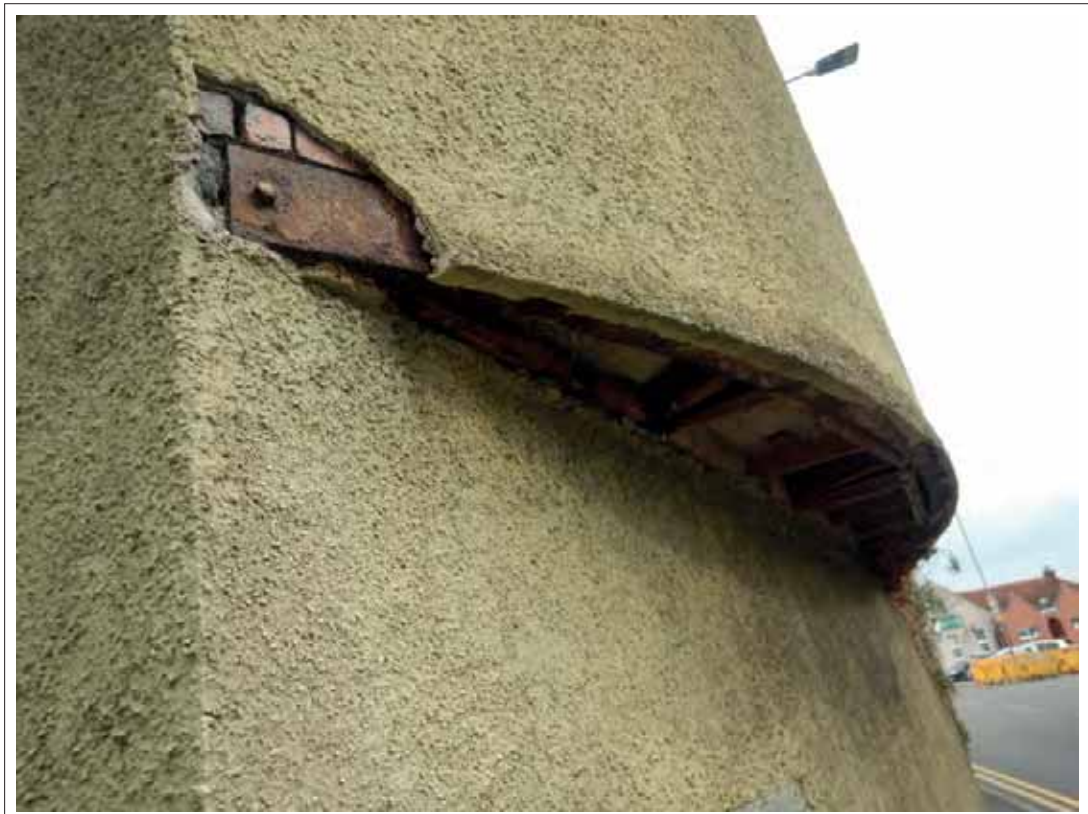
The ground floor is the exterior of the chapel (Room 0.6). This section projects out from the rest of the wall in a gentle curve or apse. A small section of render has broken off, revealing an iron frame and red brick above. The underside is also exposed, revealing timber supports (Plate 116). There is lead flashing to the top of the projection. The top of this 'apse' is above the level of the original roof line and so is likely to date from the 20th alterations.

Plate 116. Detail of apsidal alteration to the south elevation of the south annex, looking east.

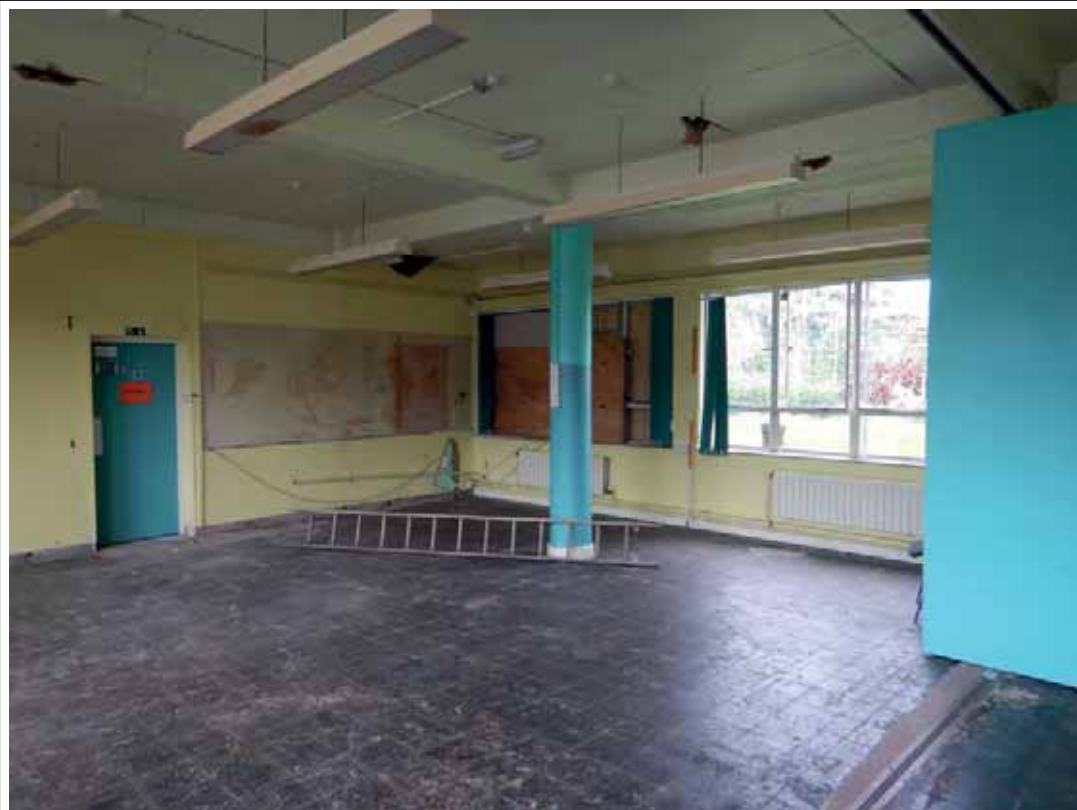
The ceiling is painted plaster in poor condition, with several areas of damage and signs of damp. The ceiling is supported by a single column to the north-east of the room (Plate 165). There are four boxed in metal rebars, three running perpendicular (east – west) to the orientation of the building one running north – south in line with the wall of the eastern hallway. There are fourteen suspended linear fluorescent light fixtures.

Plate 165. Workshop, looking north-east, showing supporting column. 2m scale.

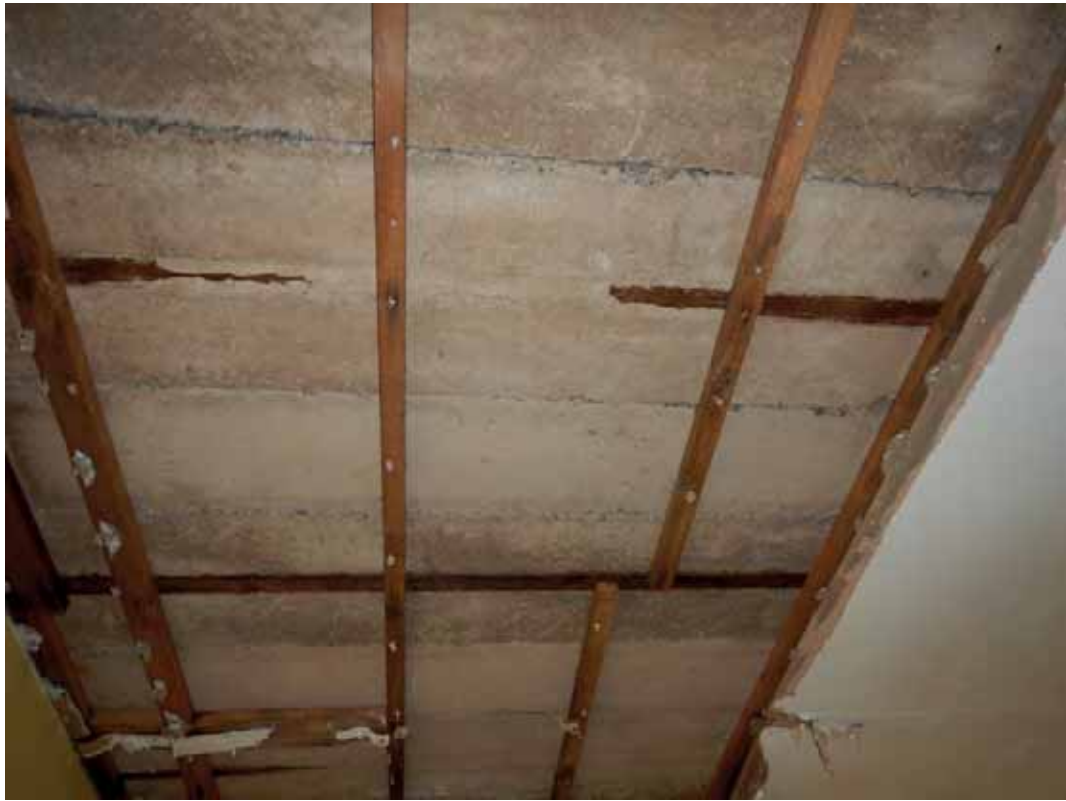
The ceiling is painted plaster with two flush modern light fixtures. It is in very poor condition with half of the width of the ceiling missing plasterboards, exposing the concrete beam floor of the room above (Plate 173).

Plate 173. Detail of damaged ceiling in ground floor washroom revealing concrete beam construction.

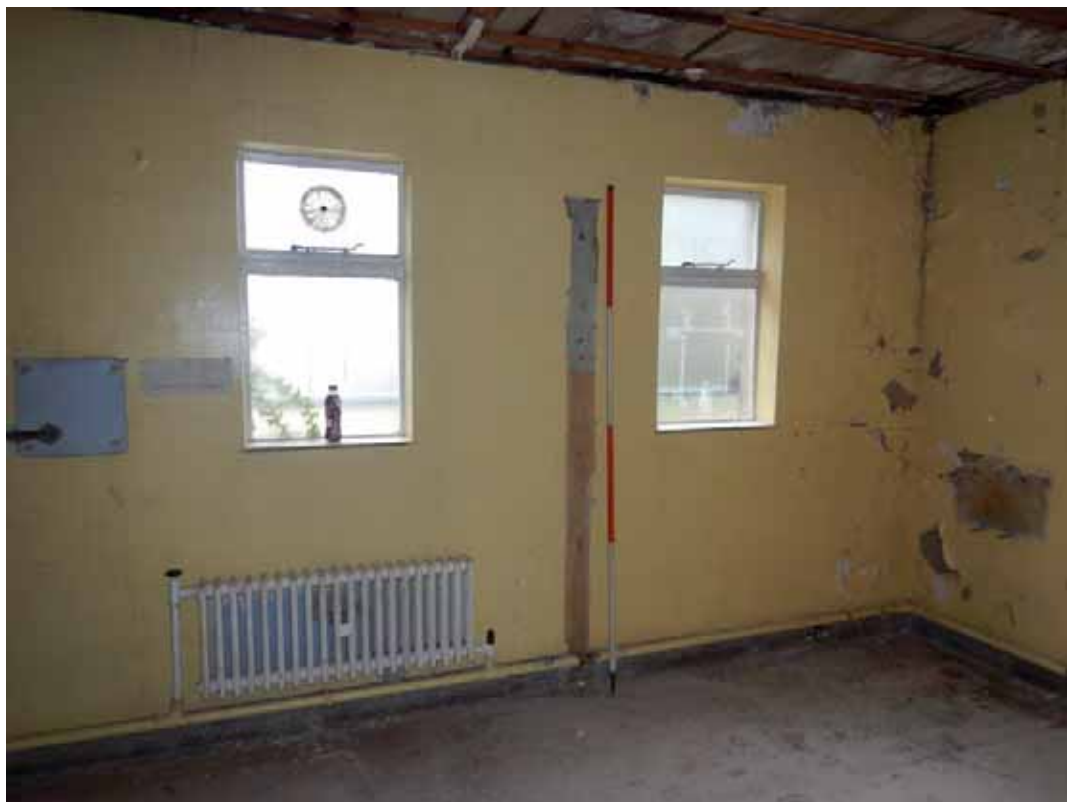
The walls are painted plaster, in very poor condition with areas of peeling paint and others showing signs of damp. There are three recessed single pane two light windows on the eastern wall with tiled sills (Plate 174). There are two doorways on the north and west walls, both the doors and frames have been removed. There is a single radiator on the eastern wall.

Plate 174. Windows to east wall of ground floor washroom, looking east. 2m scale.

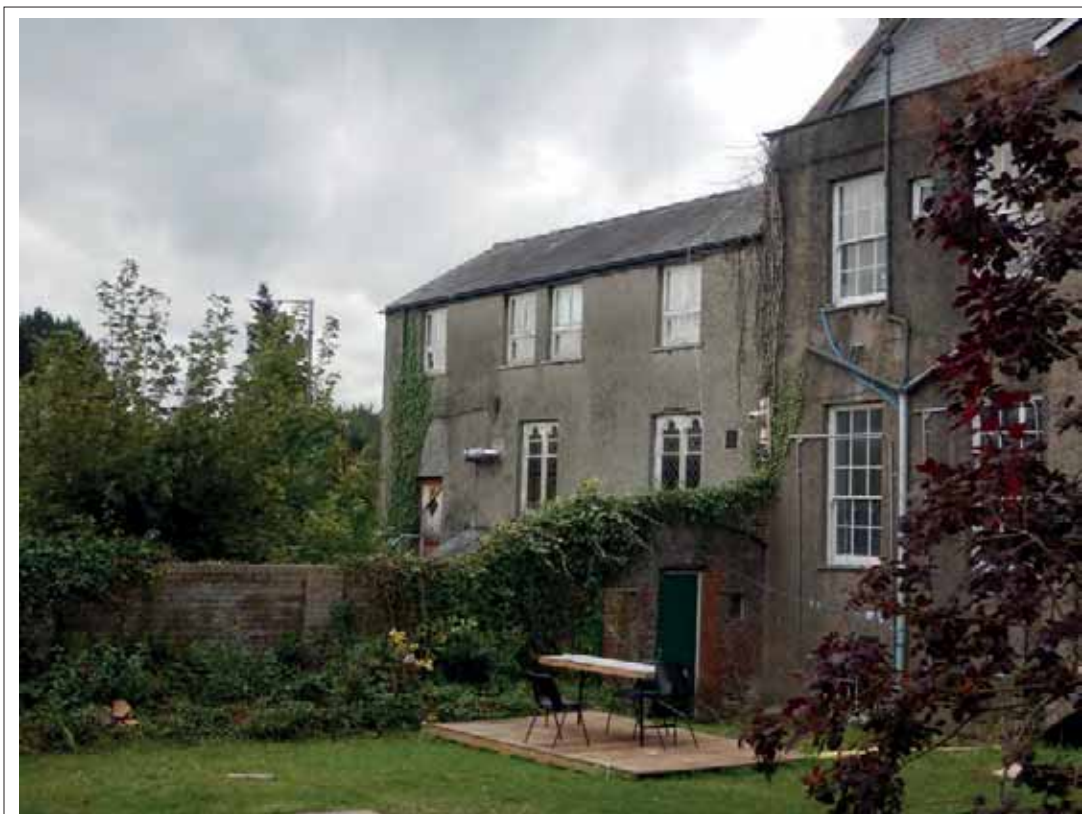
Plate 234. Extant original section of south wall with modern replacement to east, looking south-east.

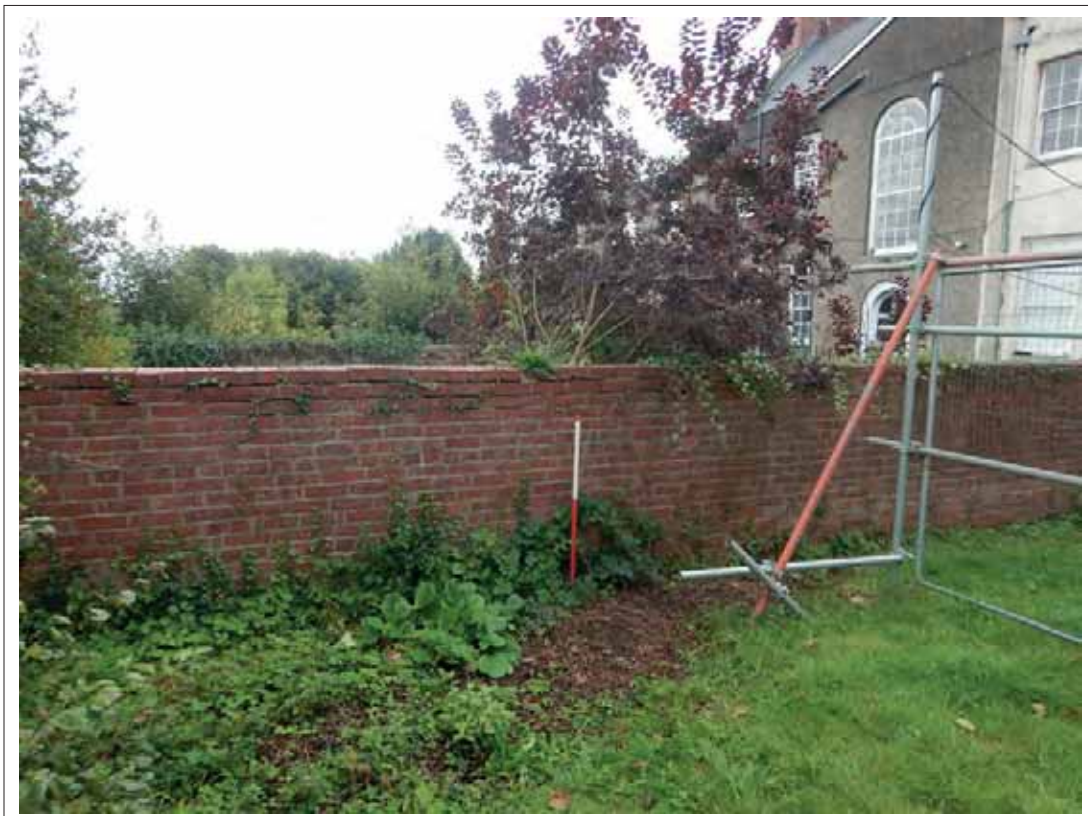
Plate 235. 20th century replacement of a central section of the walled garden. 1m scale.
