Barmouth Viaduct, Abermaw, Gwynedd

Desk Based Assessment and Site Visit

Report No. 1903

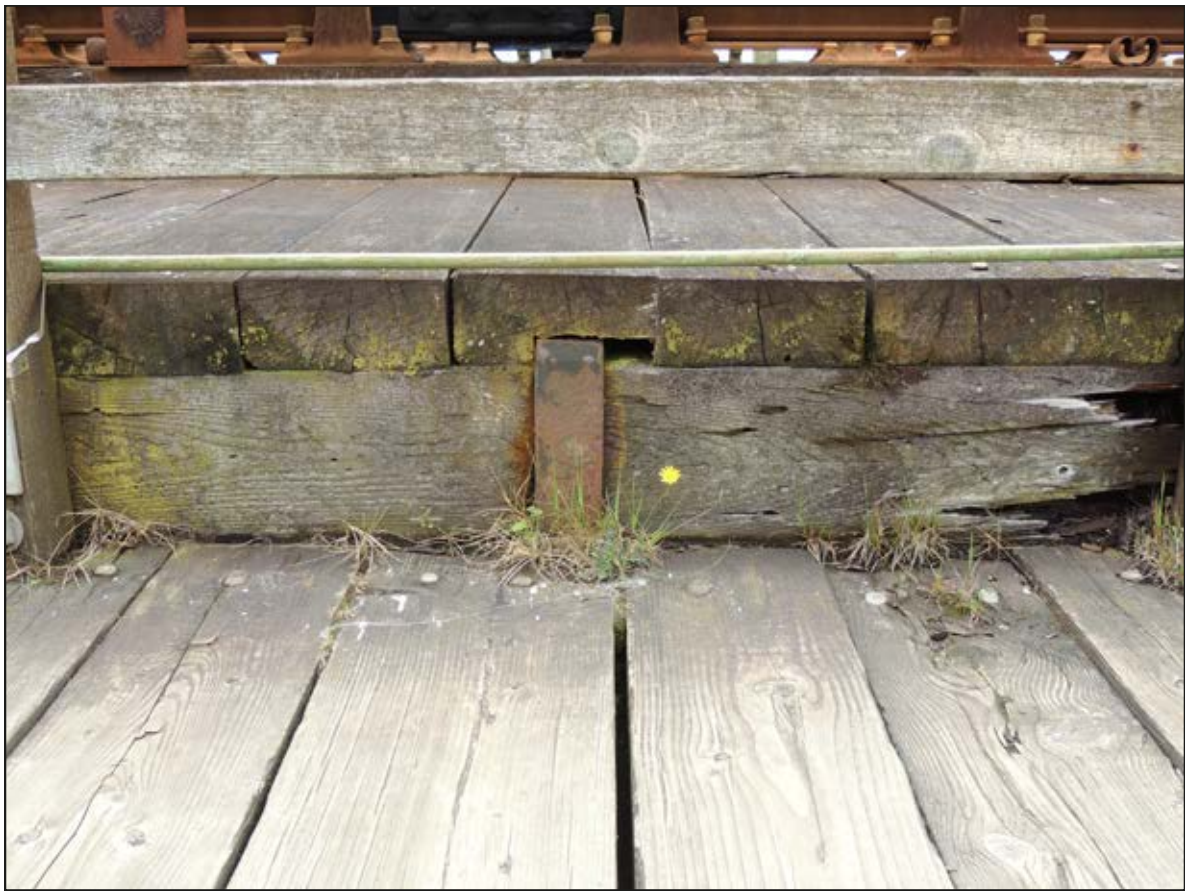
longitudinal outer beams rest on the horizontal support beams of the trestle beneath and fixed together via a metal strap fixing. Some of the longitudinal outer beams, especially those observed between trestles 5 and 6 were in a bad state of disrepair as the wood is rotting away and the metal strap was heavily corroded (See plate 12 and 26). However, refurbishments have been undertaken on other longitudinal outer beams where the wooden beam has been replaced and two metal plates have been bolted to the neighbouring beams either side to offer extra stability (See plate 14). The refurbishments detailed above were carried out within the last five years according to the engineer that was in attendance during the site visit.

Plate 12. SW facing shot of damaged longitudinal outer beam with metal strap between trestle 5 and 6.

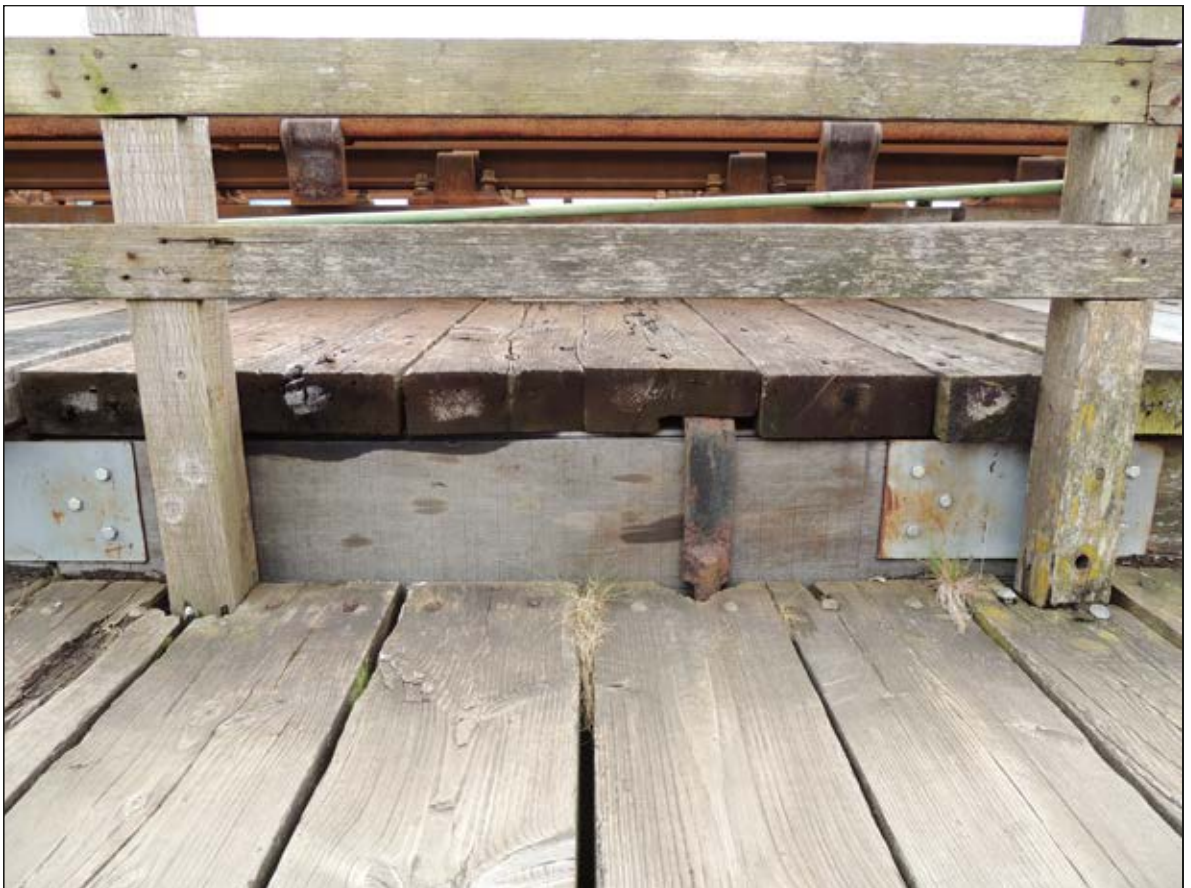
Plate 14. SW facing shot of replacement longitudinal outer beam and metal strap with metal plate reinforcements inbetween trestle 12 and 13.

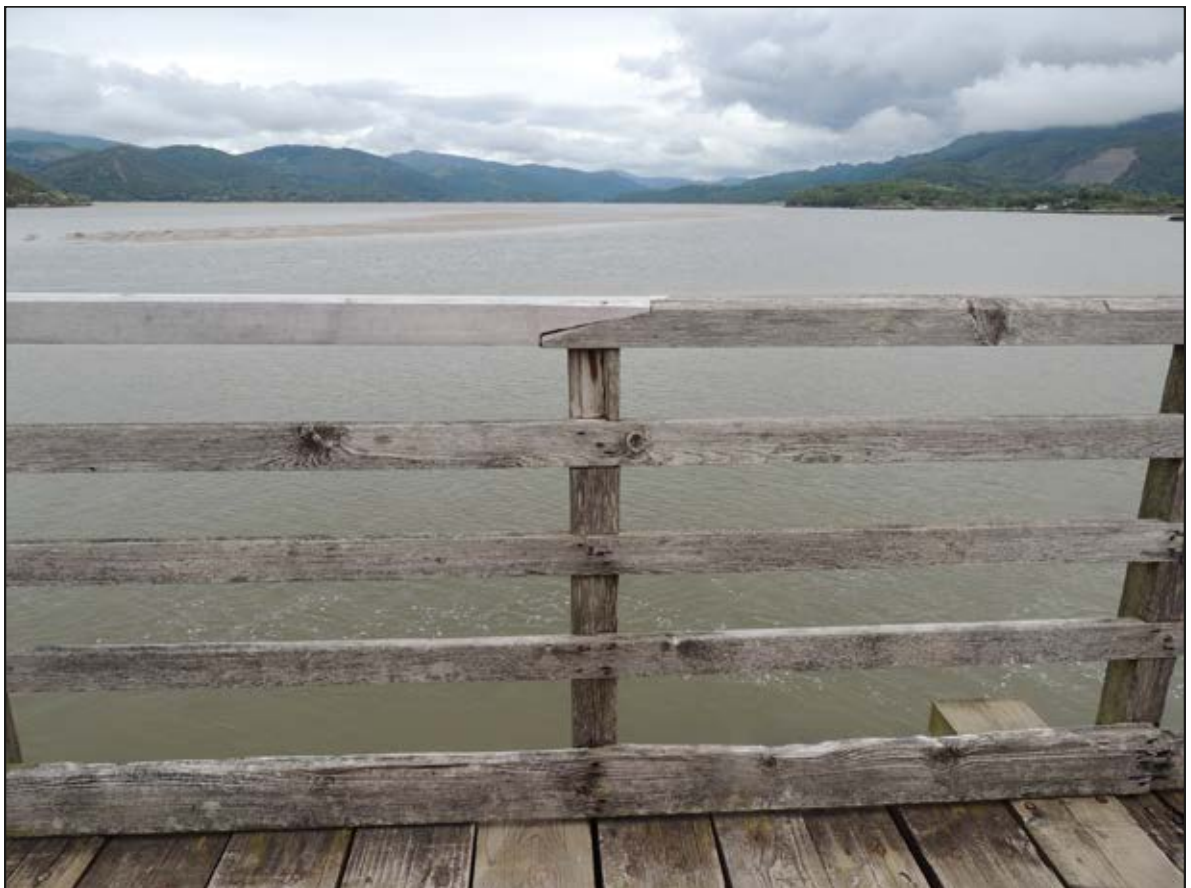
- 7.3.2. The survey commenced from the SE end of the viaduct at trestle one. The transverse deck planks that make up the pedestrian walkway of the viaduct vary in states of preservation, due to them being replaced over time. A large number of the deck planks appeared to have been replaced in recent times due to the colour of the planks being much lighter in appearance, compared to older ones with clear signs of weathering and wear, and a lot of them were clearly bowing towards the centre (See plates 17 and 18). The outer handrail of the pedestrian walkway also contained replacement components exemplified by lighter shaded timbers, again these were clear to see and were most likely replaced at the same time as the transverse deck planks of the walkway (See plates 16 and 18).

Plate 16. NE facing shot of repaired timber hand rail of walkway at trestle 14.

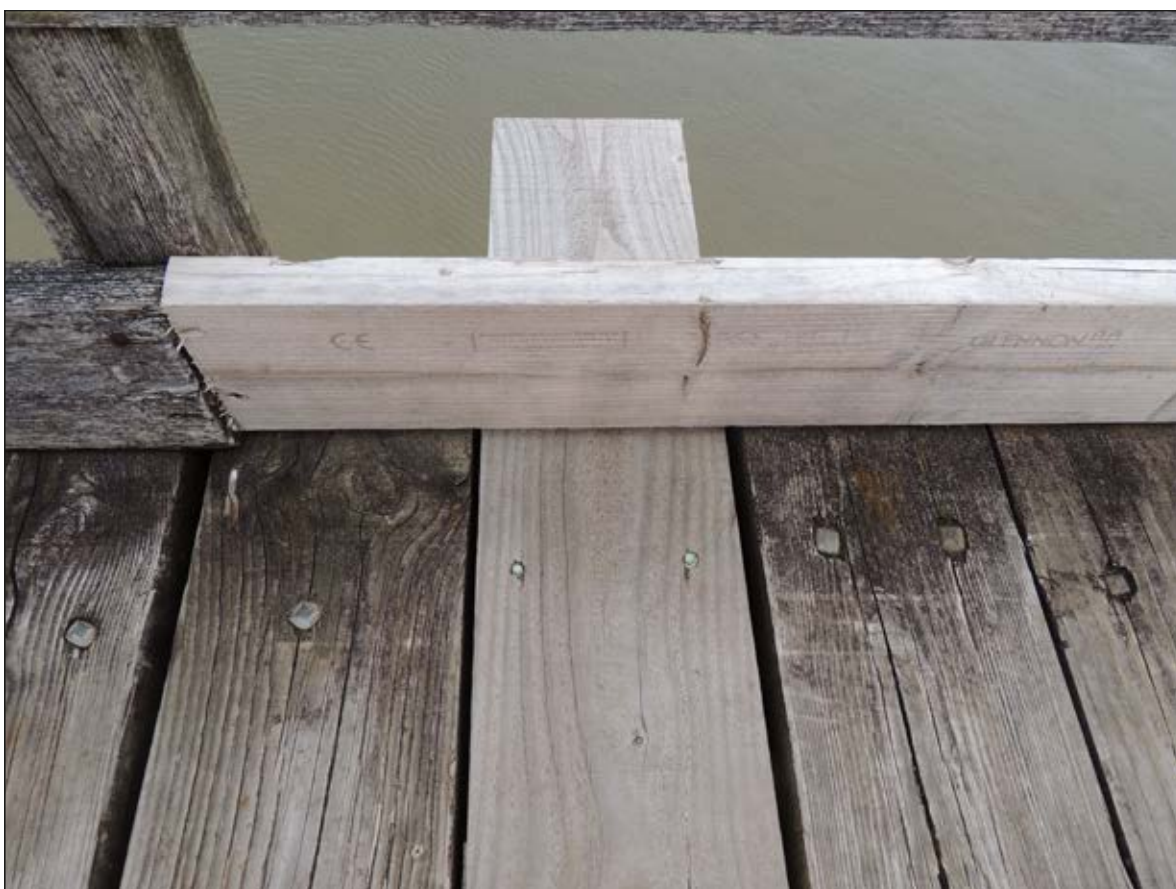
Plate 18. Plan shot of replacement transverse deck planks and kick board on handrail on walkway at trestle 20.

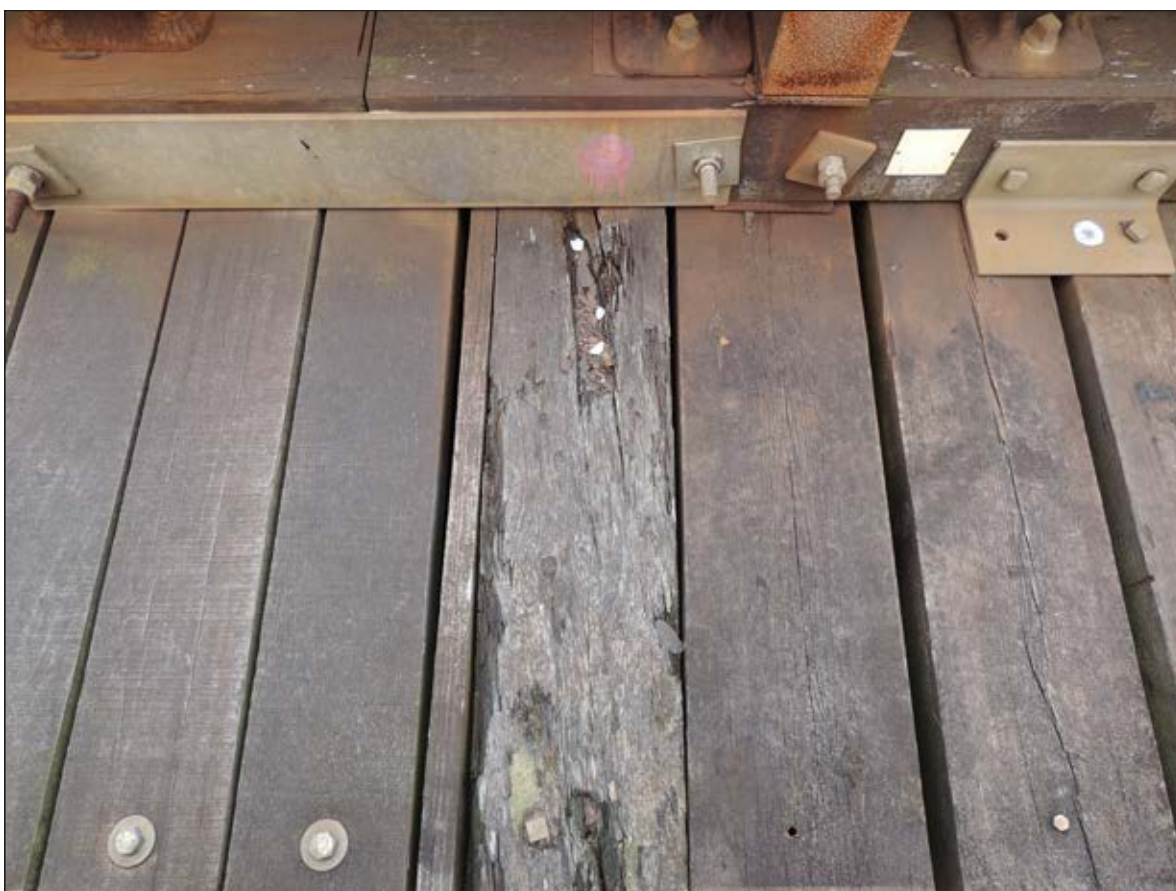
- 7.3.4. There was clear evidence of repairs undertaken on the transverse deck planks on the railway track at various points along the line. These repairs were observed on trestle 50 where there is a group of planks that differed slightly in appearance and fittings used to secure them to the trestle beneath (See plate 20). The planks are all fairly dark in appearance due to weathering and grime, from being in such close proximity to the track as the diesel trains passing over will emit dust and dirt discolouring the timber over time. There is one plank in particular that is heavily decayed and in clear need of replacement, compared to the others either side of it. The metal fittings used on this group of planks to secure them differ in appearance indicating three phases of refurbishment, with the most recent having a much larger bolt with the addition of a washer (See plate 20).

Plate 20. Plan shot of 3 phases of transverse deck plank replacement exemplified by the changing fixtures and preservation of timbers at trestle 50.

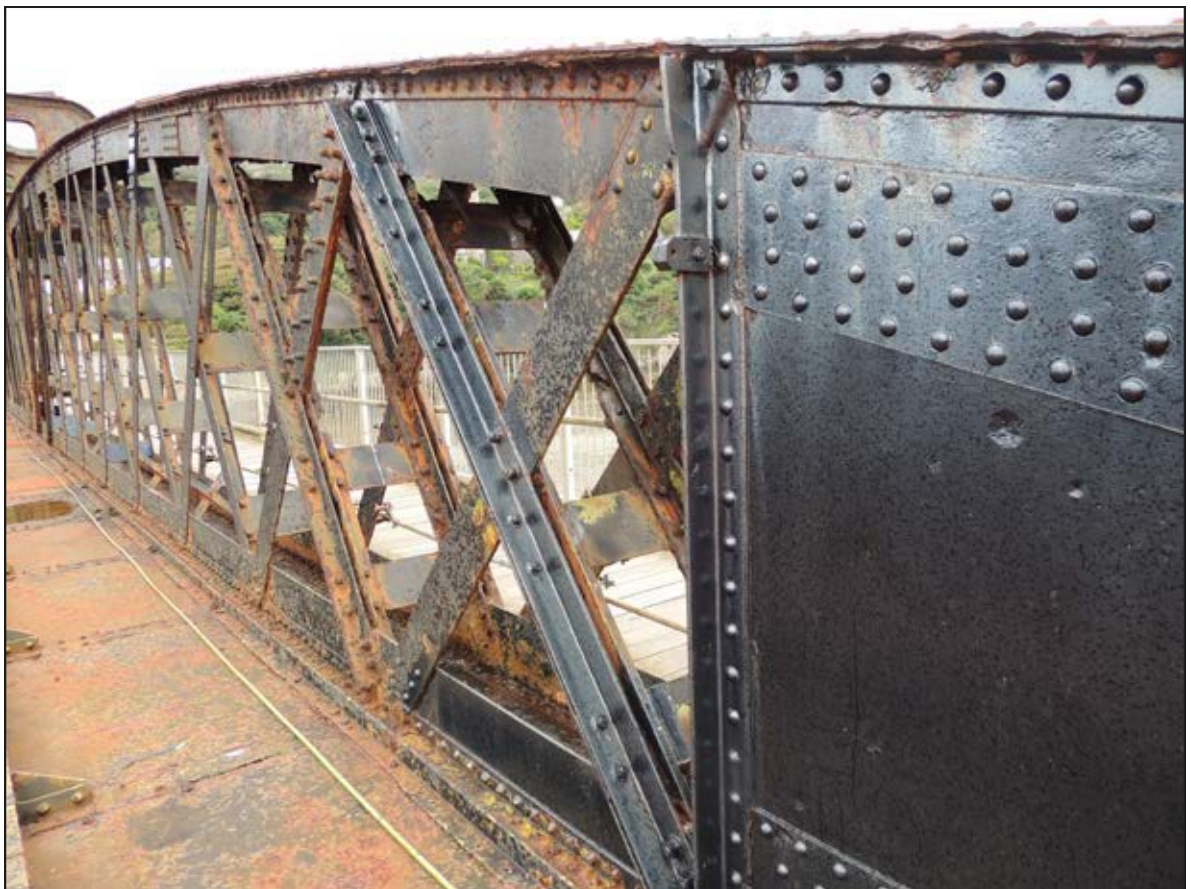
Plate 28. N facing shot of replacement metalwork on the hogback lattice trusses on the span of the viaduct.

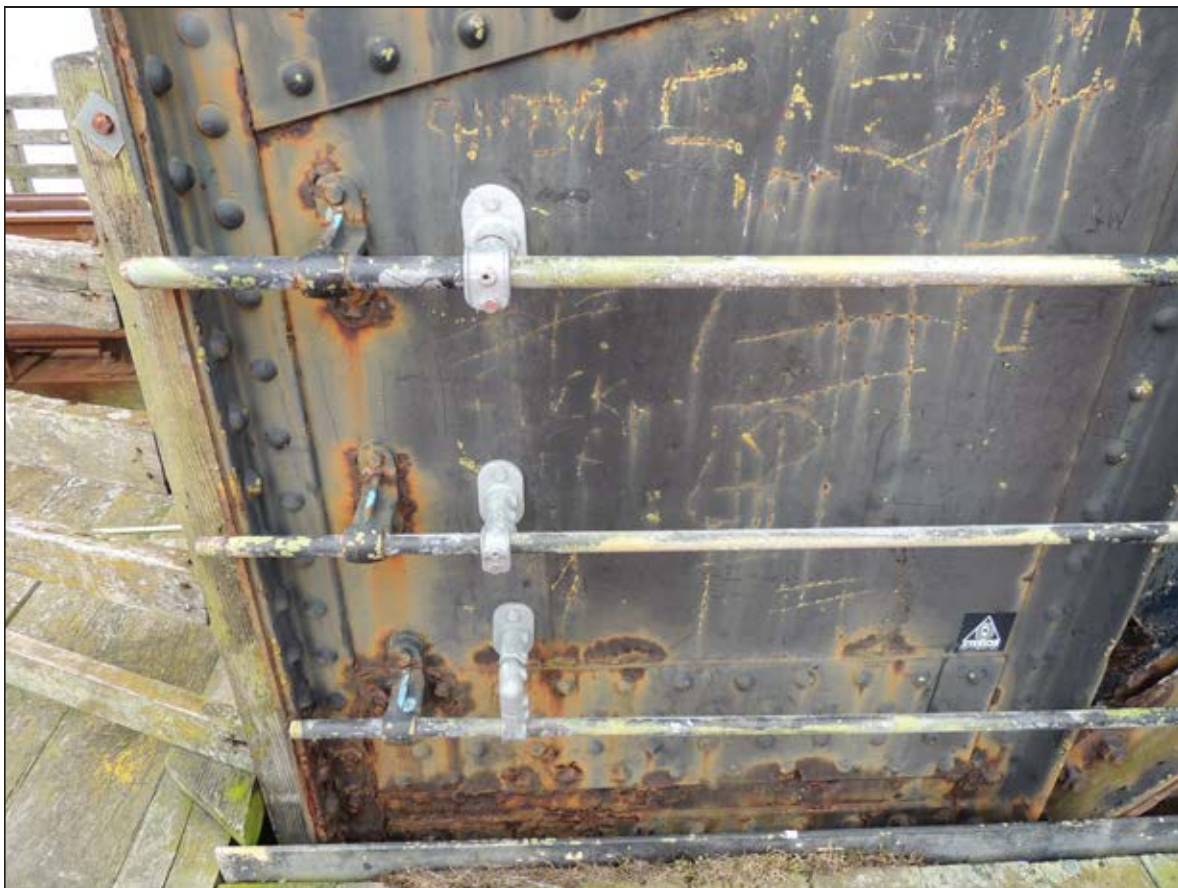
- 7.3.9. A metal handrail with modern stainless-steel clamps was observed on the NE facing elevation of the swing bridge. The handrail runs the entirety of the spans of the swing bridge and is attached to the lattice work on the trusses. Modern stainless-steel clips have been added in recent times as the original fittings have corroded. The stainless-steel clips are clamped to the metal work and do not appear to penetrate it, probably due to the frailty of the metal work they are attached to. Some older fittings were present and functioning and appeared corroded (See plates 31 - 32).

Plate 31. SW facing shot of stainless steel handrail clamps of NE elevation of hogback lattice trusses on the spans of the viaduct.

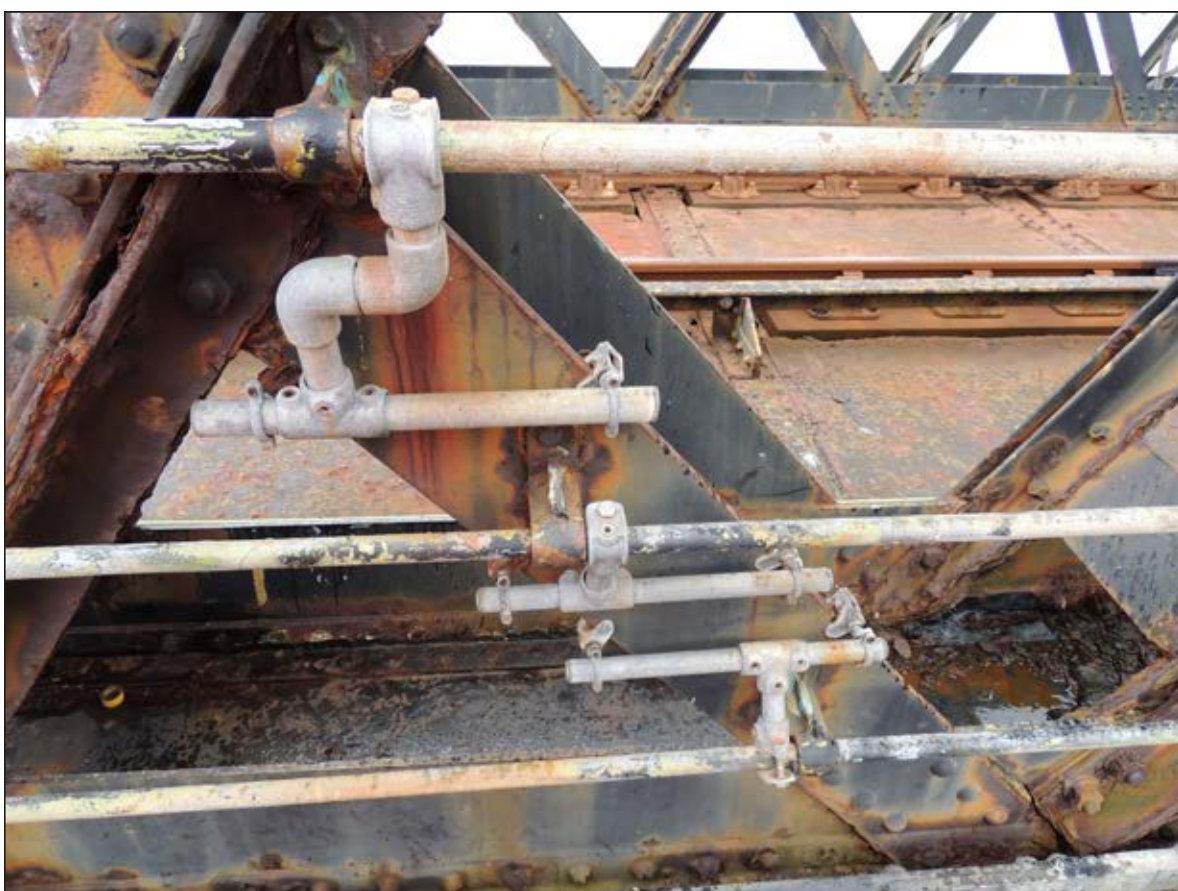
Plate 32. SW facing shot of stainless steel handrail clamps attached to corroded lattice trusses on the spans of the viaduct.

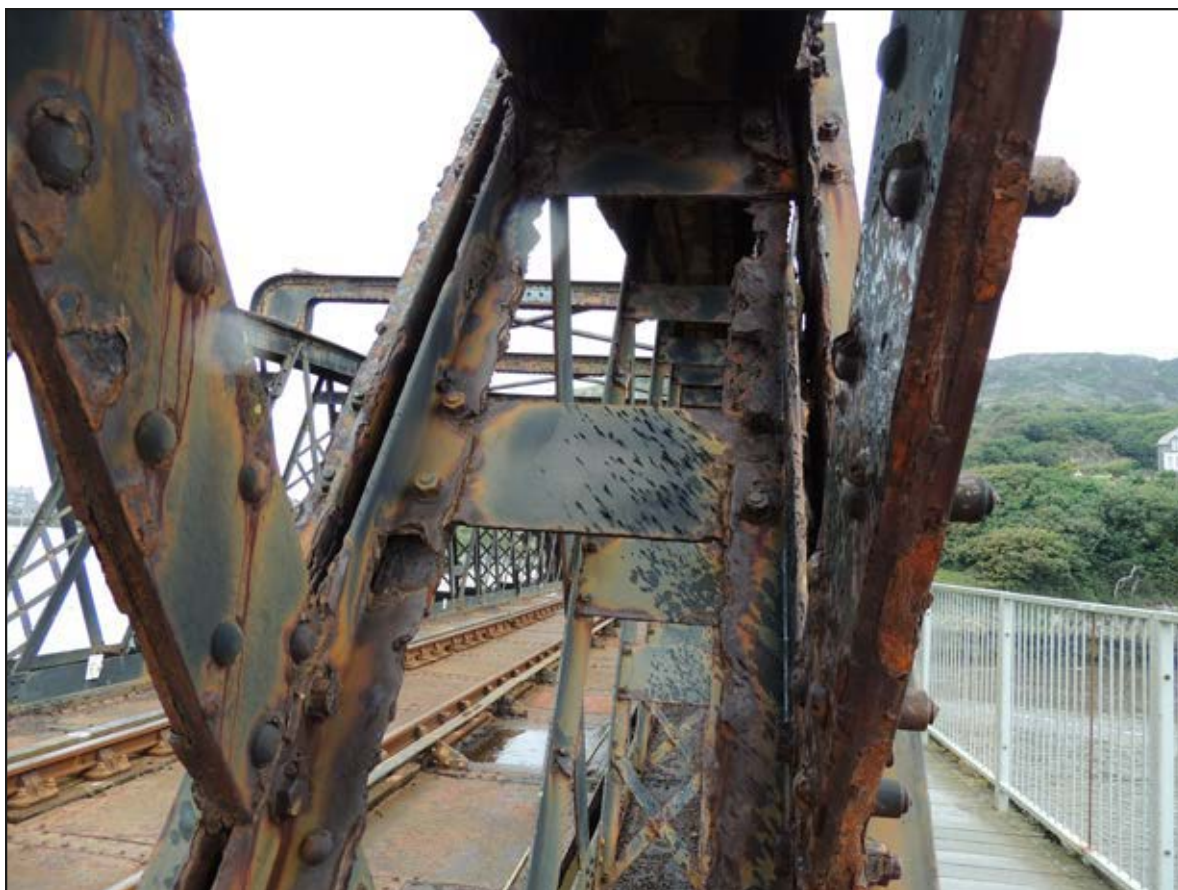
Plate 33. NW facing shot of repairs made to lattice work on the hogback trusses on the span of the viaduct.

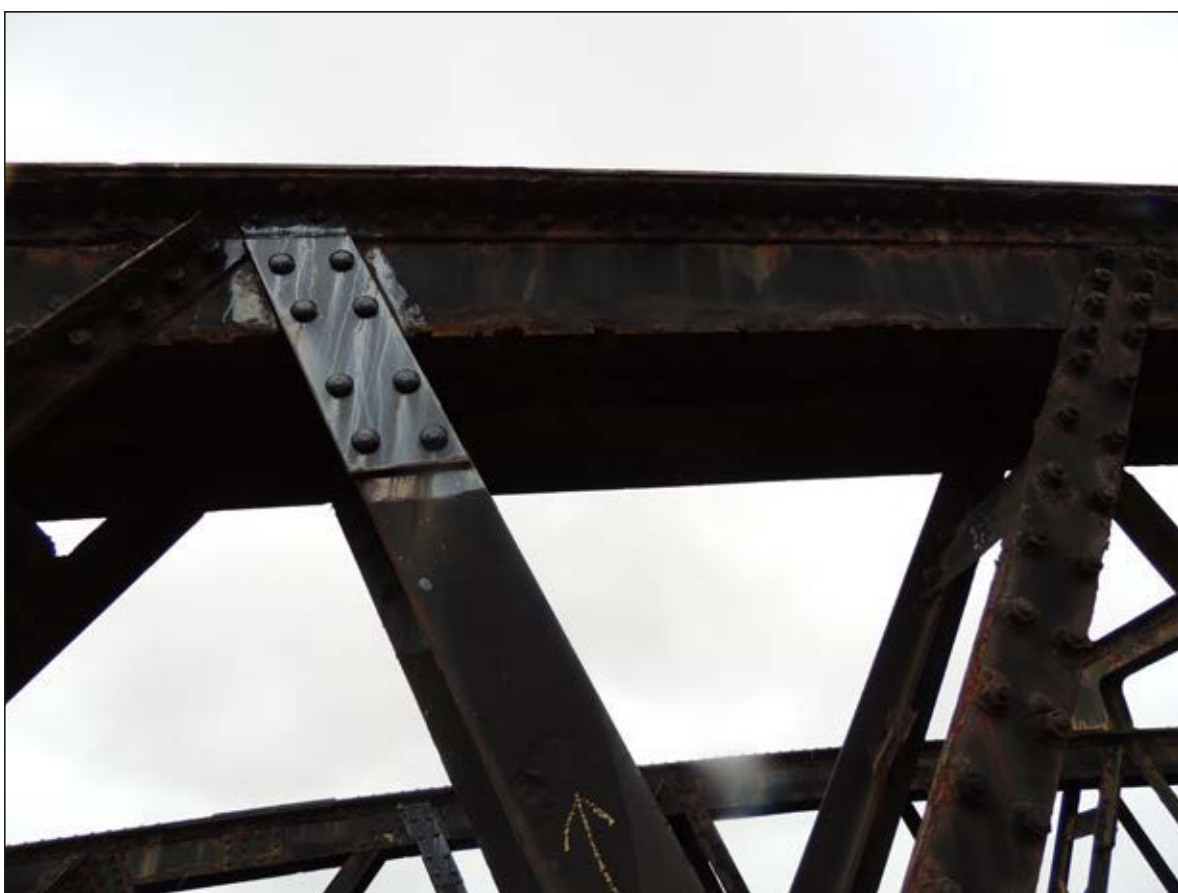
- 7.3.7. In addition to the above, the outer diagonal girders that the rectangular plates are attached have been replaced and fixed to the top of the span via a riveted rectangular plate (See plate 34). The SW facing elevation of the southernmost span retained some of the diagonal lattice work on the trusses, and where there was corroded lattice work, these too have been removed and replaced with riveted rectangular plates. However, on some of the trusses there was an absence of either lattice work or plates and appeared to have no central structure to the truss whatsoever (See plate 36).

Plate 34. SW facing shot of steel riveted plate added to strengthen the lattice trusses on the NE elevation of the span of the viaduct.

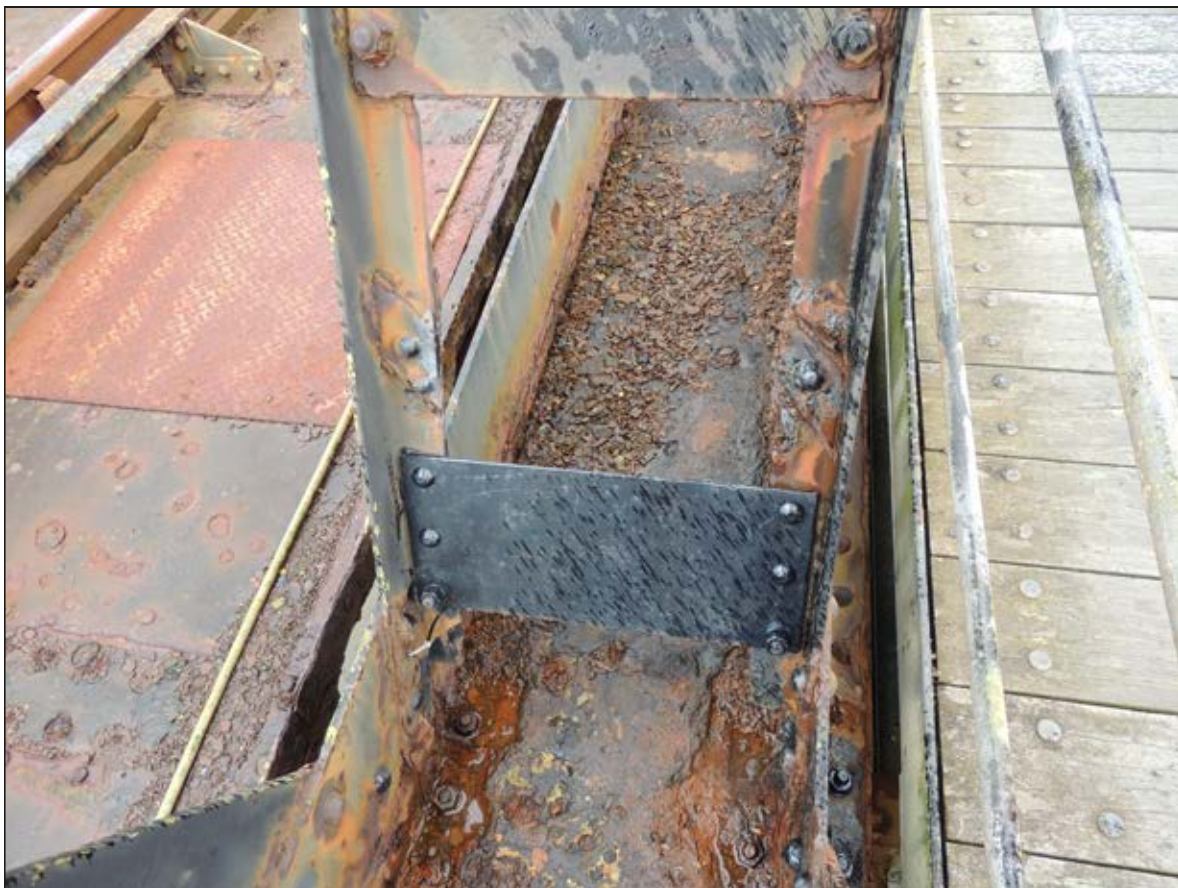
- 7.3.6. The swing bridge located at the northwesternmost end of the viaduct was observed and has had numerous repairs carried out on the structure. The spans of the viaduct are constructed using the hogback lattice truss design, fixed with rivets and bolts. It was evidently clear when surveying the swing bridge that modern repairs to the structure had taken place over time, as the majority of the structure has clear signs of corrosion. This was most evident on the hogback lattice trusses on the spans of the swing bridge, where the lattice supports have been removed due to their state of disrepair (See plates 33 - 36). The lattice work on the on the NE facing elevation of the southernmost span appeared to be the worst affected by corrosion, where the diagonal lattice work has been removed and replaced with horizontal rectangular plates, fixed with a mixture of rivets and bolts (See plate 35).

Plate 35. Plan shot of rectangular metal plate with rivets replacing corroded lattice work on hogback lattice trusses on the spans of the viaduct.

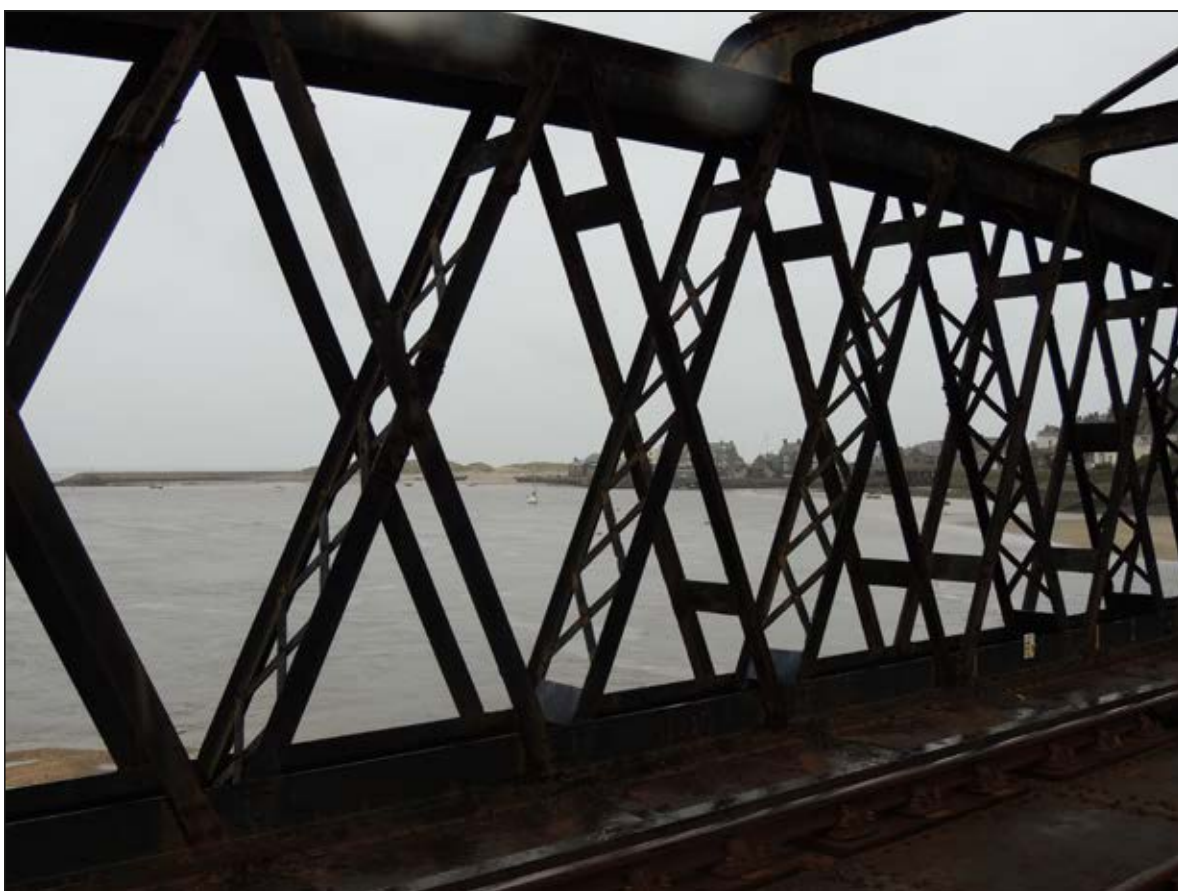
Plate 36. WNW facing shot of intact latticework on the hogback lattice trusses on the SW elevation of the spans of the viaduct.

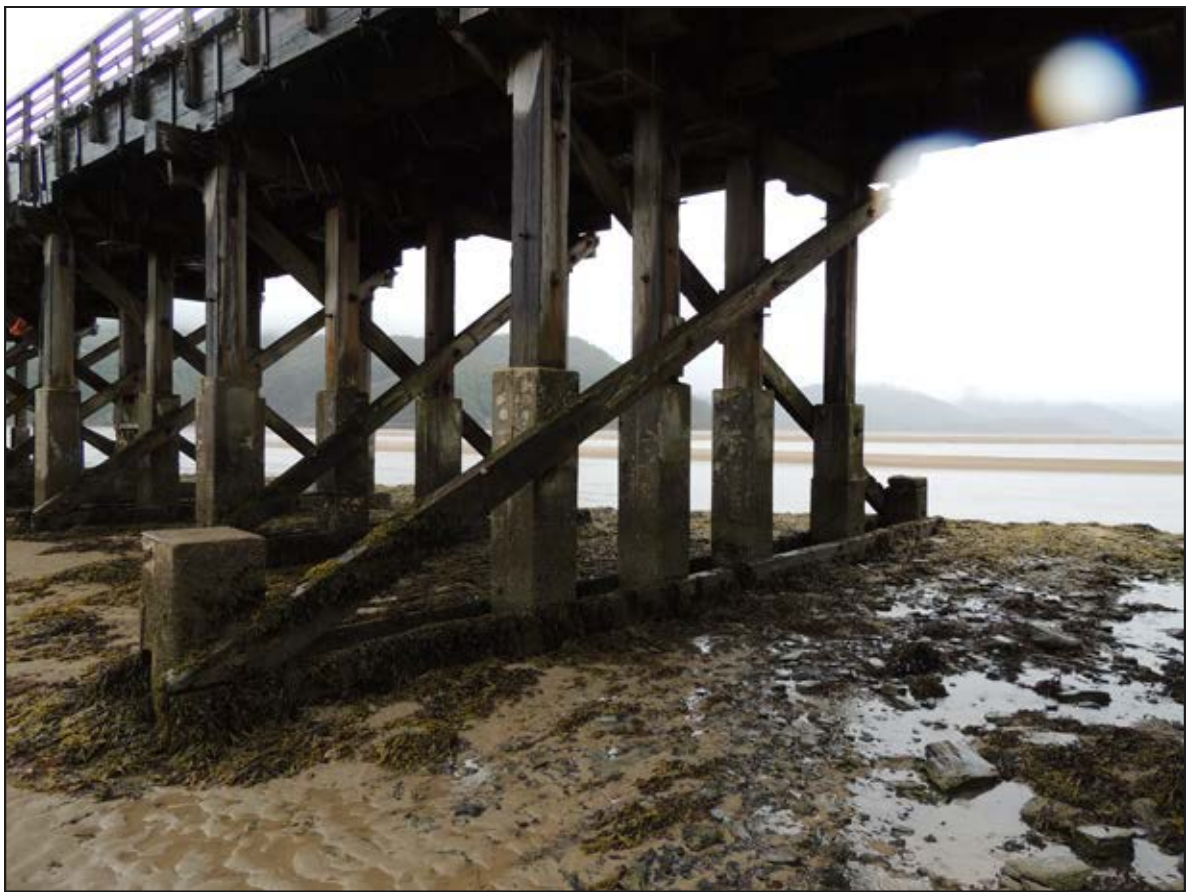
- 7.4.3. The dividing trestle of 2 and 3 has a horizontal waling at its foot, that extends out approximately 2m either side of the 4 piles that make up the trestle. The horizontal waling encloses the bottom of the 4 piles with a diagonal beam attached to the horizontal waling at the bottom, and a reinforced concrete pillar flanking either side of the trestle. The horizontal waling's are only found on every fifth trestle of the viaduct and correspond to the alterations undertaken in the 1980s (See plate 45 and figure 16.1).

Plate 45. N facing shot showing verticle piles with reinforced concrete pile casing and diagonal beam & horizontal waling of trestle 2.

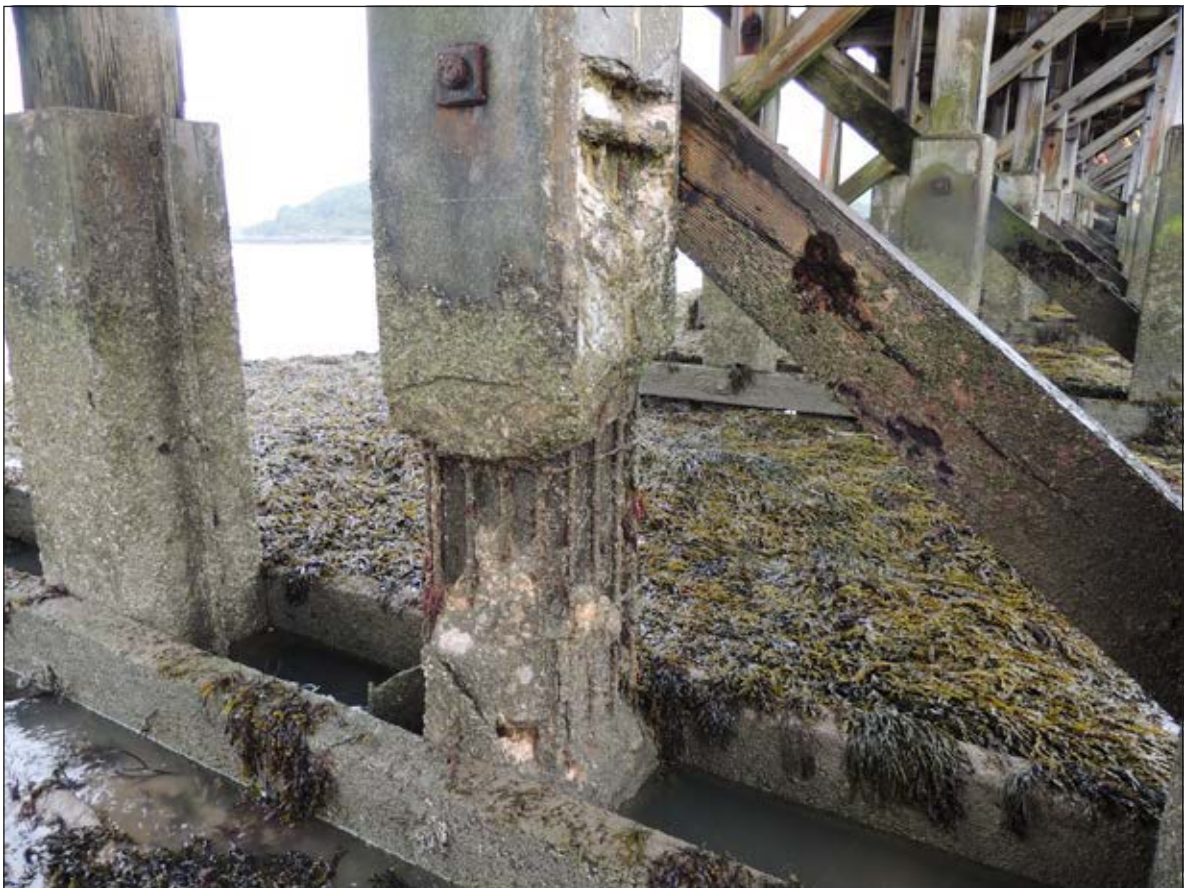
- 7.4.4. Reinforced concrete casings were observed on a majority of piles on the viaduct and were added as part of the alterations of the 1980s. The casings were added to protect the timber piles at the foot of the trestles from *Teredo Navalis*. However, water erosion has caused significant damage to the concrete casings and stripped them down to the rebar beneath (See plate 46). The worst affected by the water erosion are the piles on the seaward side of the viaduct. Observed on trestle 14 and 32 are what appears to be white plastic PVC coverings clipped together on two sides by metal fixings (See plates 47 and 50). Again, engineering plans could not be obtained to determine the date of when these were added, however the engineer who was present noted that they were probably from the 1990s.

Plate 46. ESE facing shot of damaged reinforced concrete pile casing with exposed rebar of trestle 13.

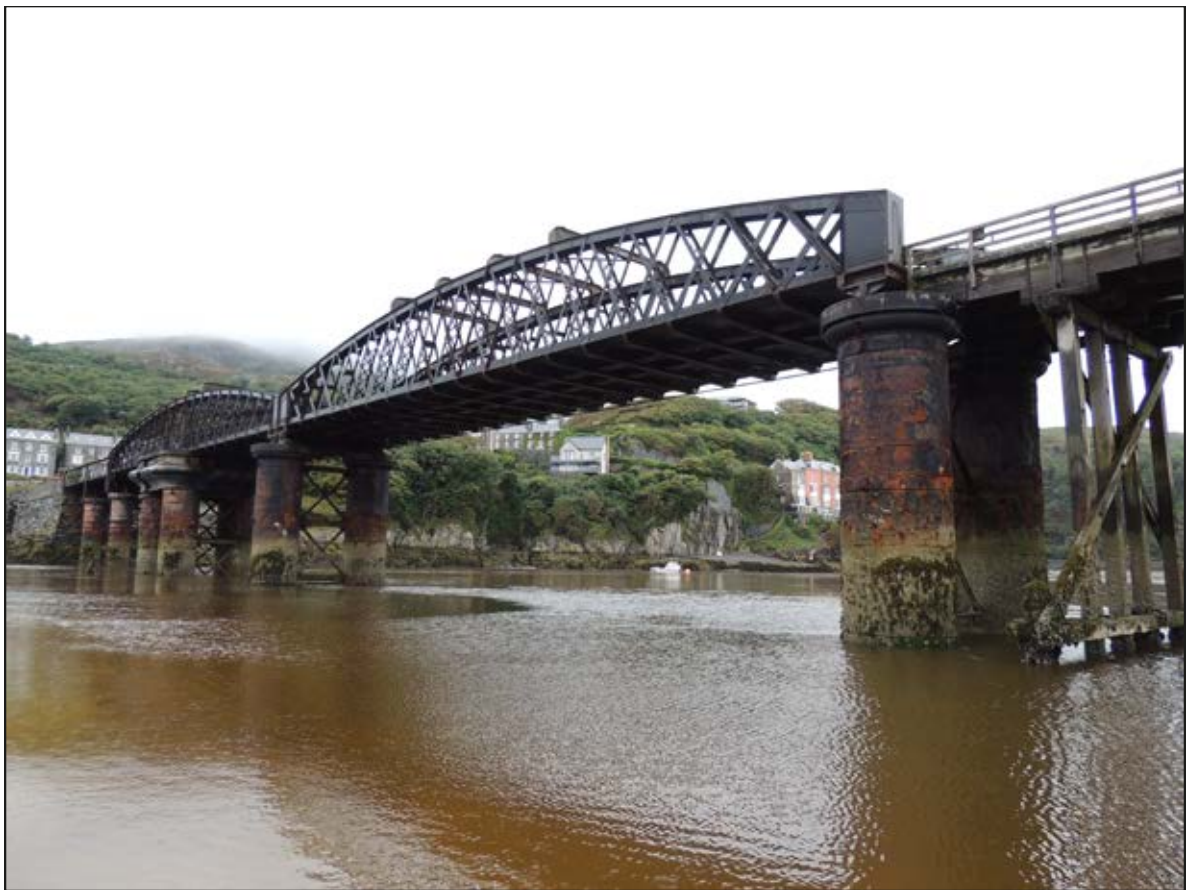
- 7.4.6. The swing bridge section of the underside of the viaduct was inaccessible due to deep waters. The cylindrical cast iron piers of the underside of the swing bridge appeared fairly corroded along with the lattice trusses connecting them. There was no evidence of alterations made to any of the cylindrical piers, however a closer inspection was needed to confirm this (See plates 61 - 64).

- 7.4.7. Atop the cluster of the four cylindrical piers at the centre of the bridge is the central pivot, to rotate the single span section when it was operational. The central pivot appeared to be in relatively good condition, compared to the lower sections of the piers (See plates 61 - 64).

Plate 61. N facing shot of swing bridge from Mawddach Estuary.

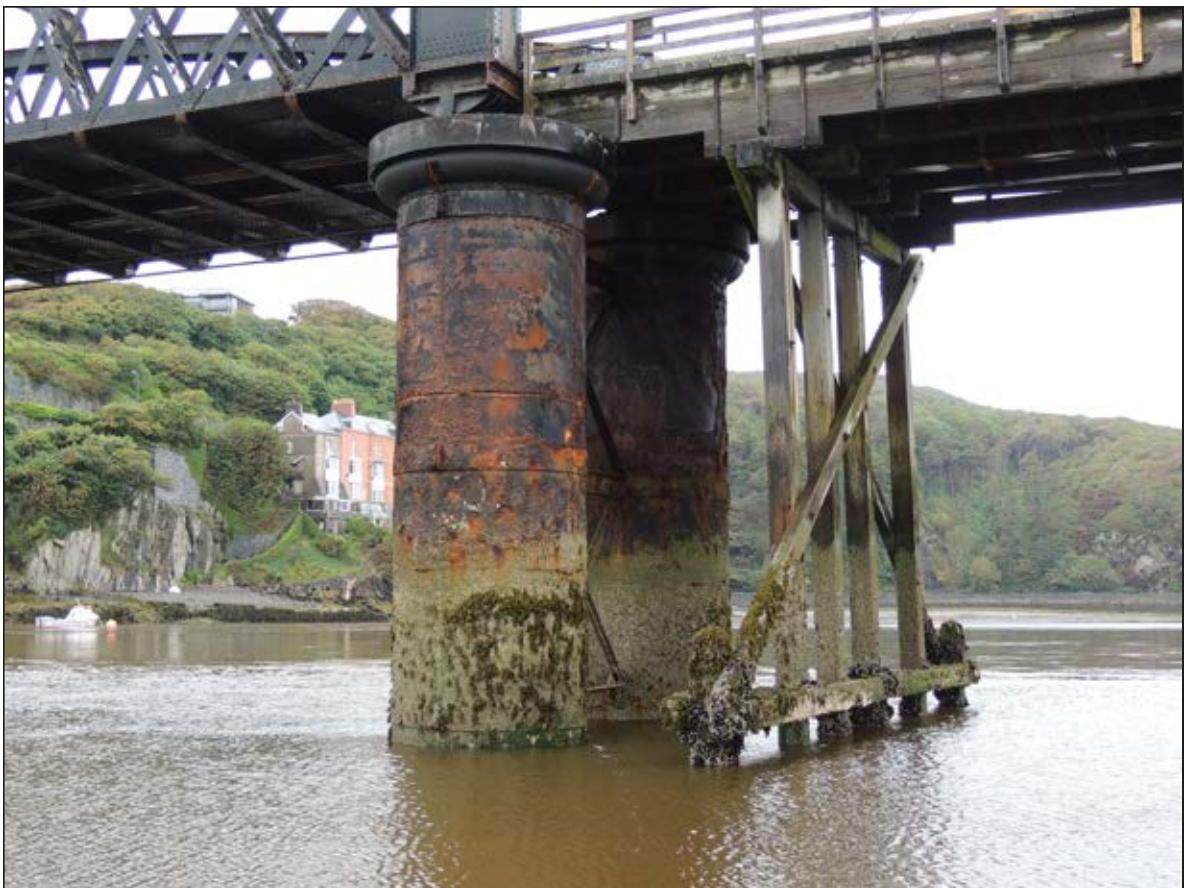
- 7.4.9. The swing bridge and its cylindrical piers beneath are the most intact portion of the structure, though corroded in parts, the alterations appear slight in comparison to the timber sections of the structure. The cylindrical piers and the central pivot have slight signs of erosion and appear relatively sound, though as mentioned previously a closer inspection was needed to clarify this.

Plate 62. N facing close up of cast iron cylindrical piers.
