Sea View Labour Club, Barry

Level 2 Building Survey

Report No . 1967

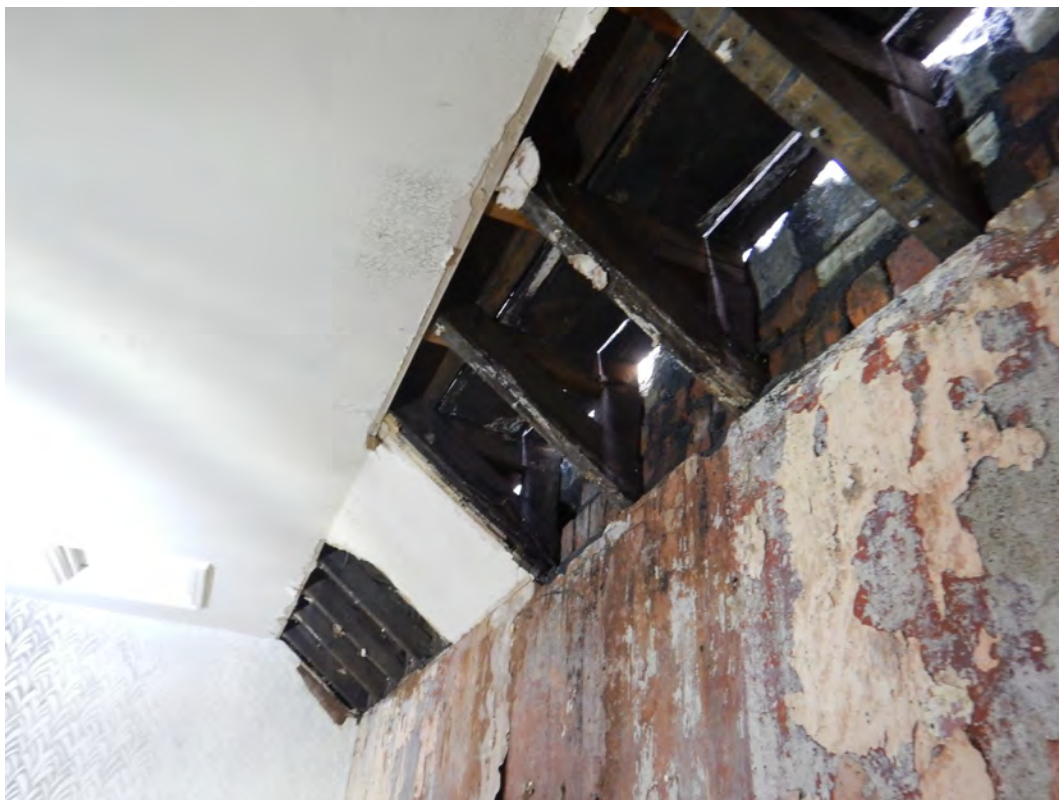
Plate 123. Damage to ceiling in Lounge, looking south

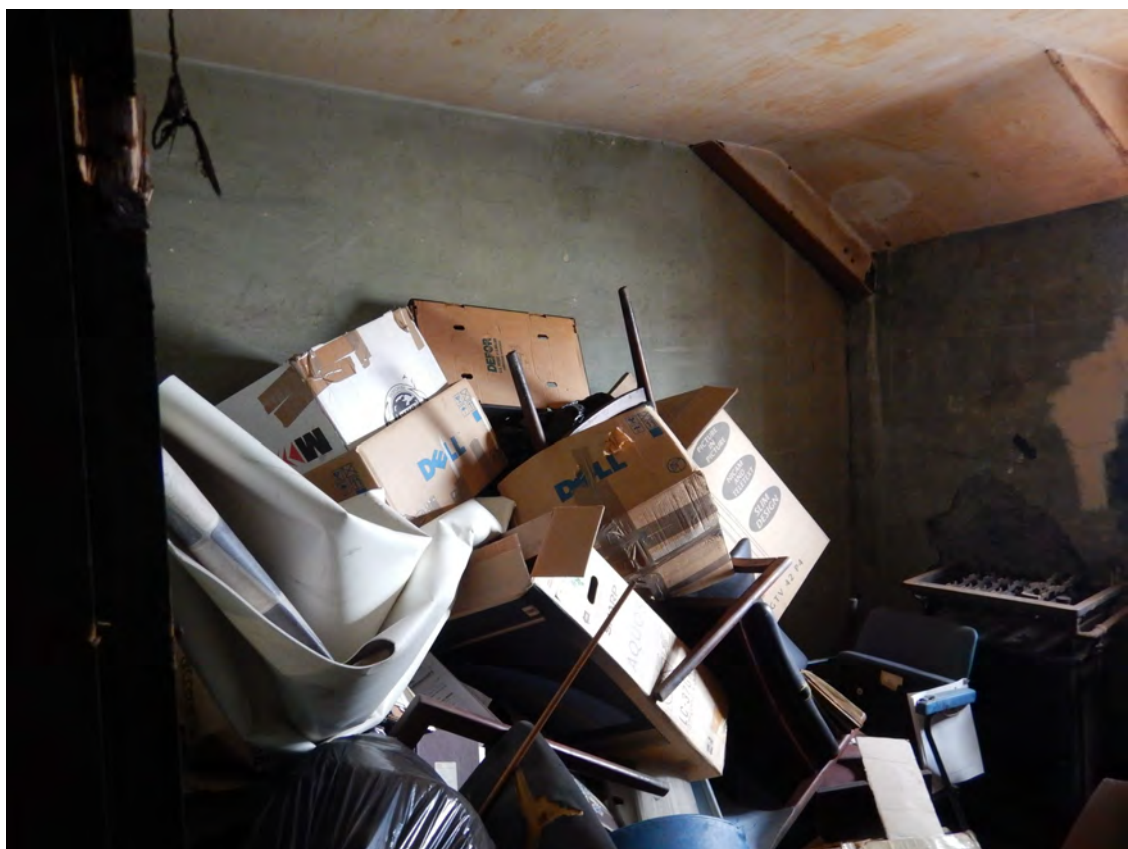
Plate 156. Second Floor Room 1, looking west

- 5.74. Room 1 is located to the south-west of the stairwell. The room was inaccessible due to being full of rubbish (Plate 156). It has exposed floorboards, moulded wood skirting boards and painted plaster walls and ceiling in poor condition (Plate 157). The ceiling slopes to the exterior (north-west) of the building, and there are two exposed rafters with plaster to the sides. There is a wooden framed window on the north-west wall.

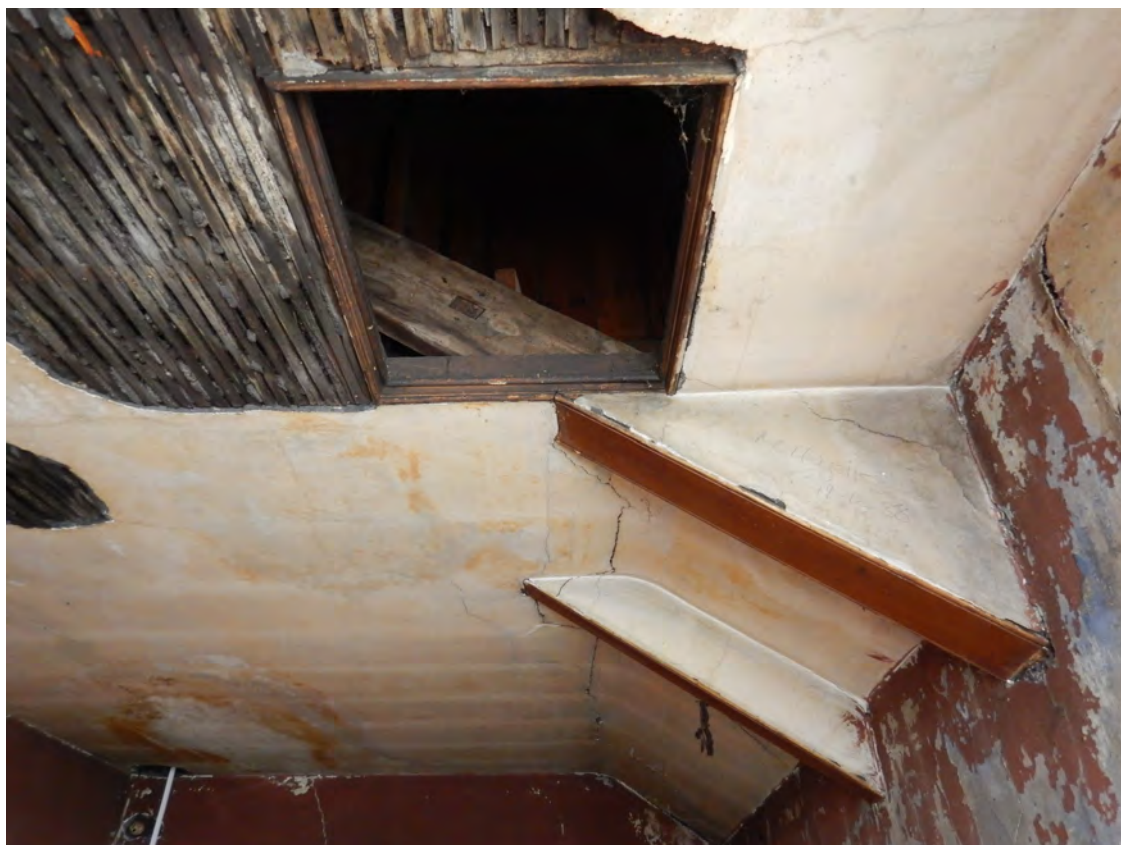
Plate 162. Room 3, looking north-east

- 5.76. Room 3 is located in the south corner of the building. It has wooden floorboards, moulded wood skirting boards, brown painted plaster walls and plaster ceiling in poor condition (Plate 162). The ceiling slopes to the south-east side, and there are two exposed beams with plastered sides (Plate 163). A large area of the ceiling plaster has

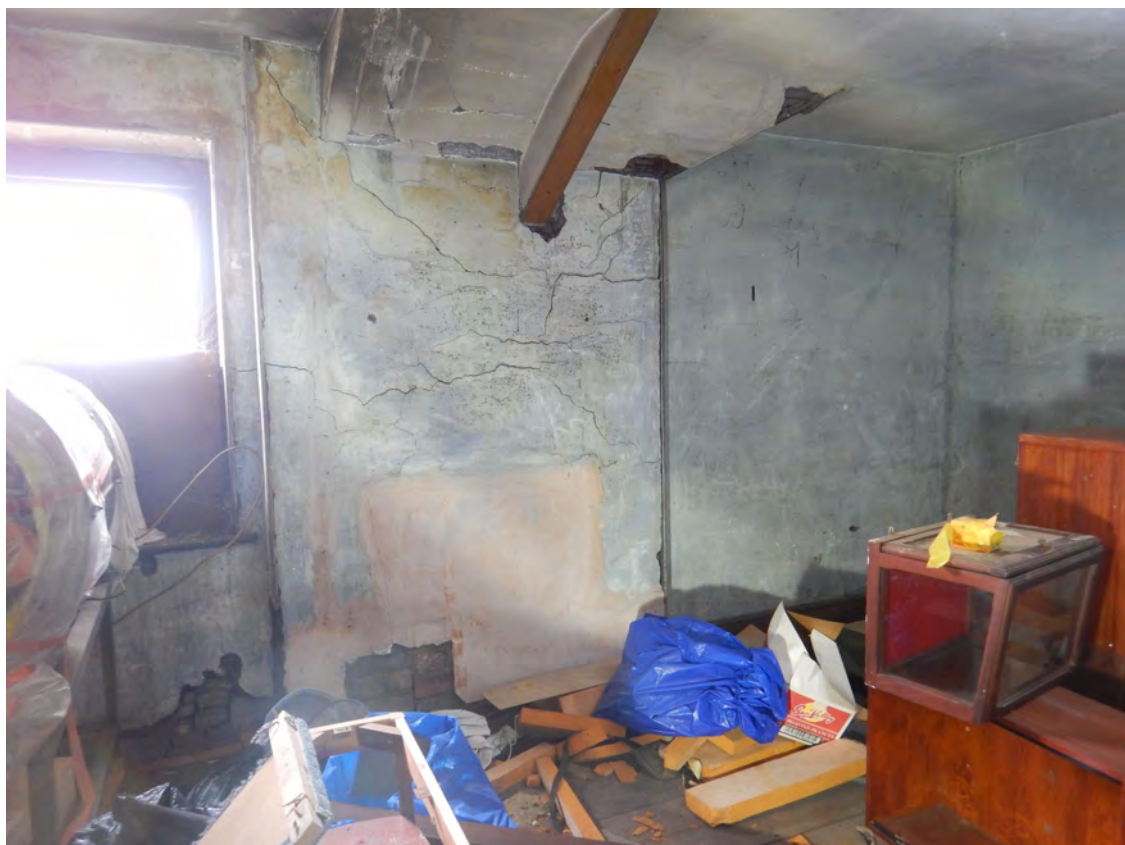
Plate 179. Room 8, looking north

exposed in some places (Plate 178). There is an exposed rafter to the centre of the exterior wall (Plate 179). A section of the wall in the southern corner has been recently replastered (Plate 180). There is a window to the north-west wall, which has been partially blocked to allow the fitting of a fan unit (Plate 181). The window is wooden framed, and two lights remain unblocked. It is recessed, with wood to the reveals. The door to the corridor on the south-east wall is missing but there is a moulded wooden frame (Plate 182).

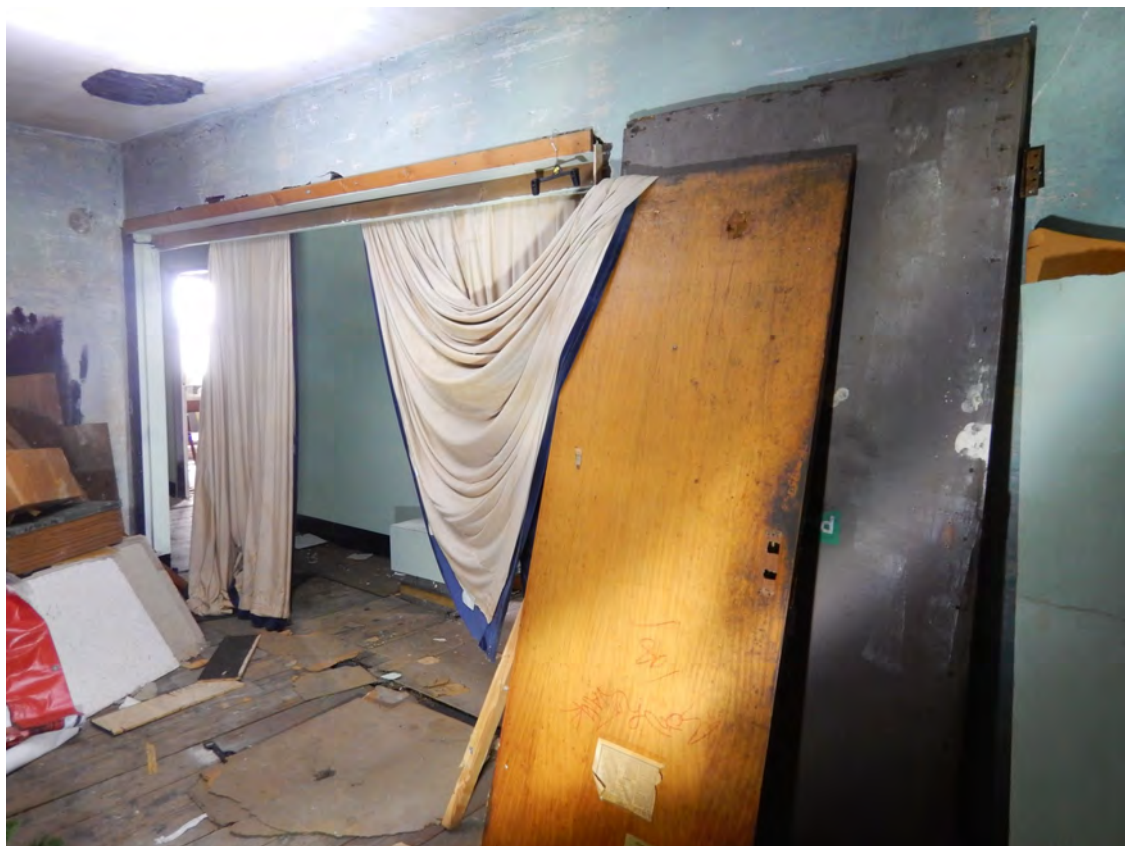
Plate 189. Room 10, looking south

- 5.84. Room 10 is at the north corner of the building. It has a large, flat arch opening from the corridor covered by a blue curtain (Plate 189). It has exposed floorboards and painted plaster walls and ceiling in very poor condition (Plate 190 and 191). The ceiling slopes down to the north east edge (Plate 192). To the left of the north-east wall is a fireplace with exposed brick chimney breast (Plate 193). To the north-west wall is a modern wooden fire door in plain wooden frame (Plate 191).

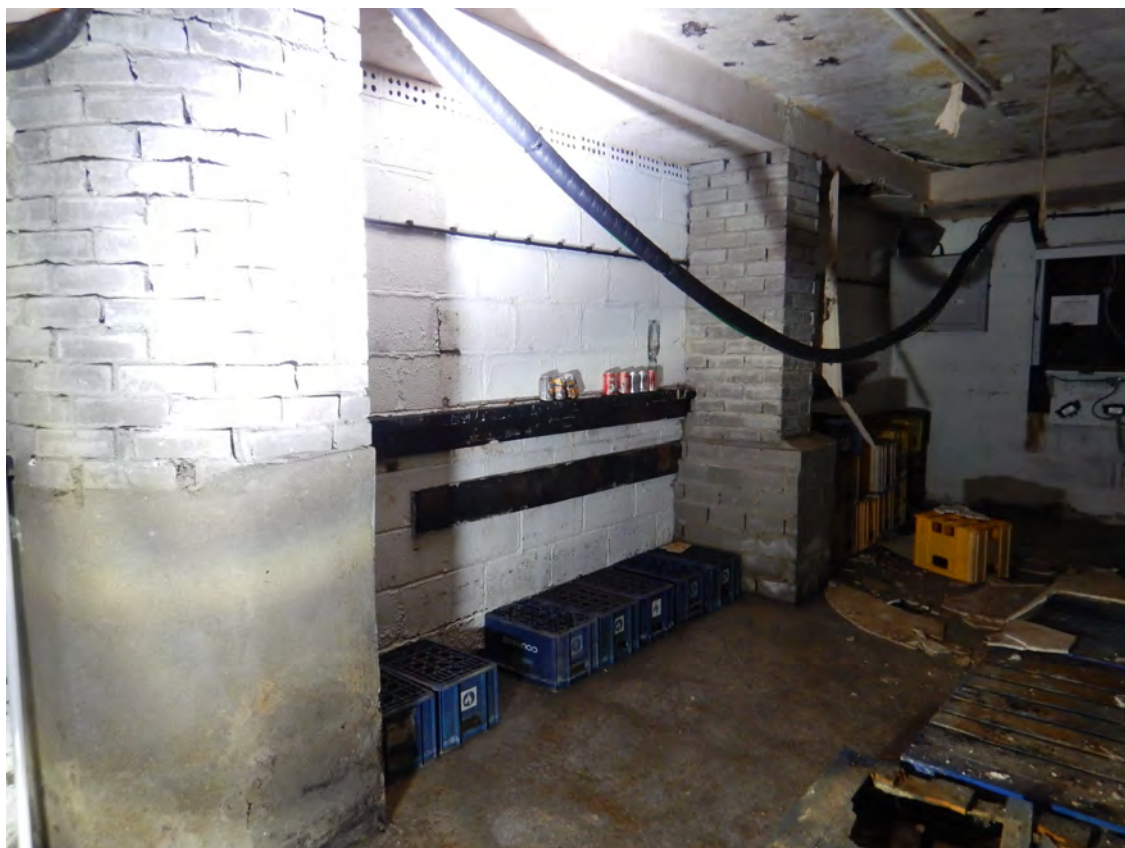
Plate 214. Room 4, looking west

- 5.91. Room 4 is largely as the other Basement rooms (Plate 213). Its north-west and south-west walls are breezeblock rather than rubble stone (Plate 214). Along the north-east wall are the fittings and pipes for beer barrels (Plate 215). As in Room 2, there are recently built or replaced brick pillars (Plate 216).
