The Hanbury Arms Caerleon, Newport

Historic Building Recording

CA Project: CR1416

November 2023

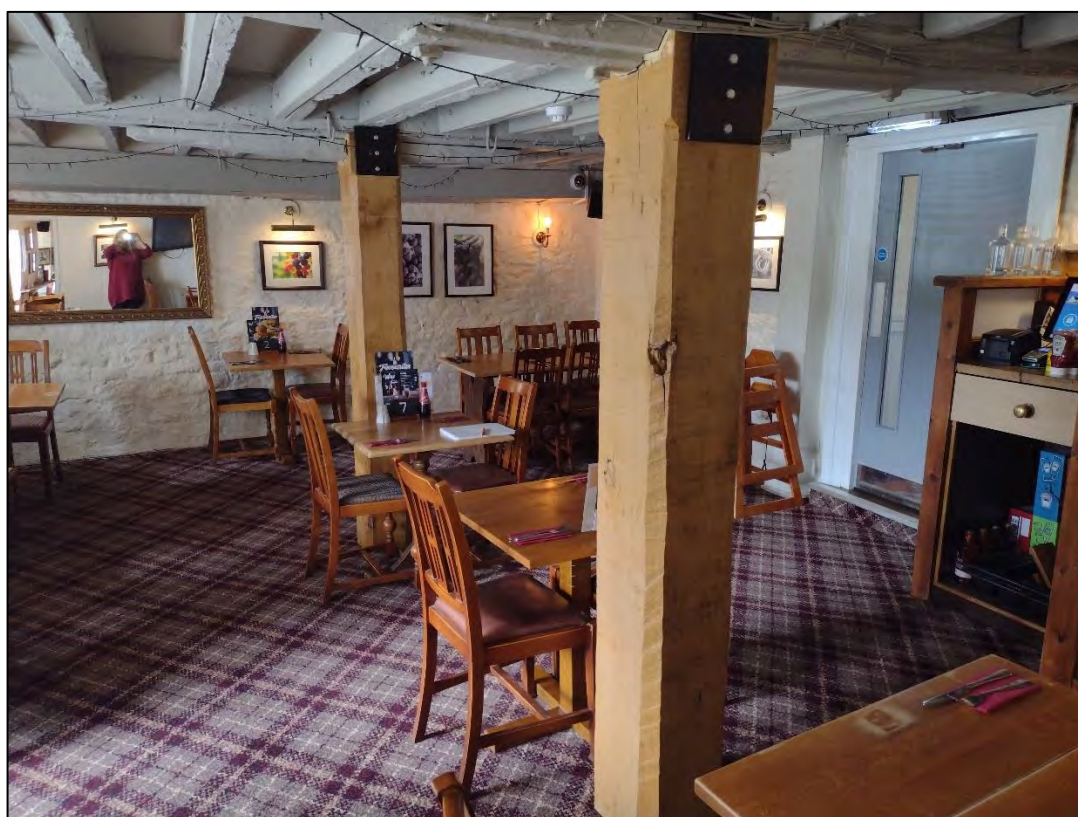
Photo 2 The ground floor restaurant with unauthorised piers

- 5.16. The oak piers and steel plates inserted in the unauthorised previous works were removed to reveal the timber beams in their entirety. There was an historic bolted iron strap to the central section of the eastern pier that have clearly been installed in the previous phases of stabilisation works, possibly 19th century in date (Photos 15 and 16). In the central section of the western beam historic support had been installed via the use of a bolted timber section spanning the central area of weakness (Photo 2).

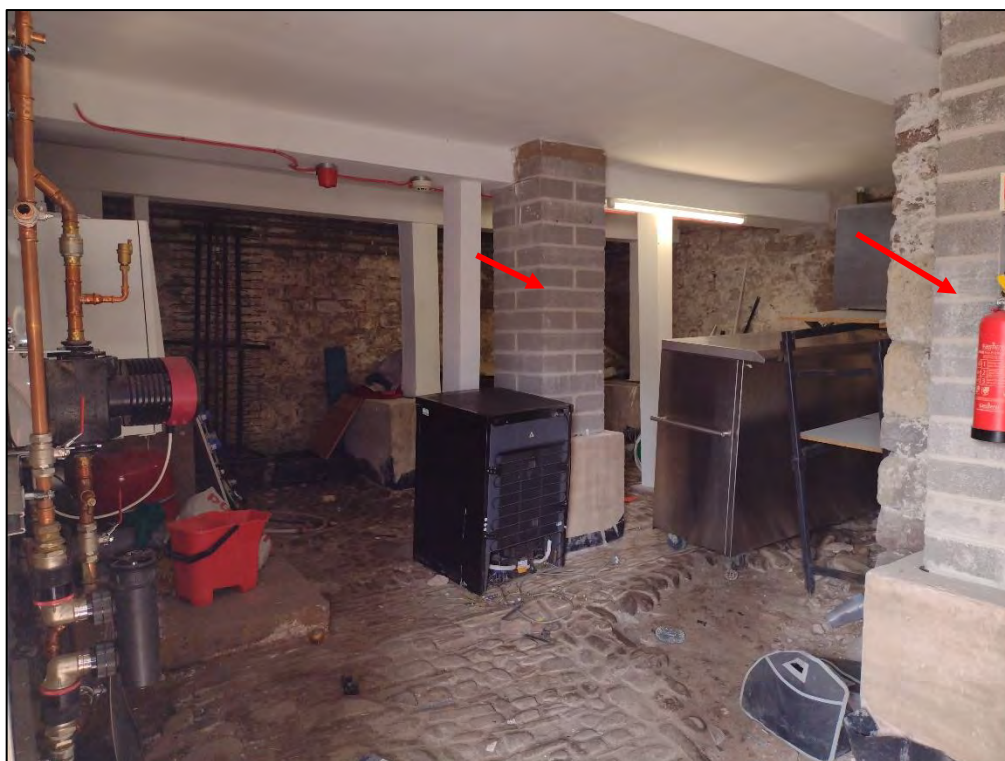
Photo 3 **The unauthorised piers in the basement (arrowed)**

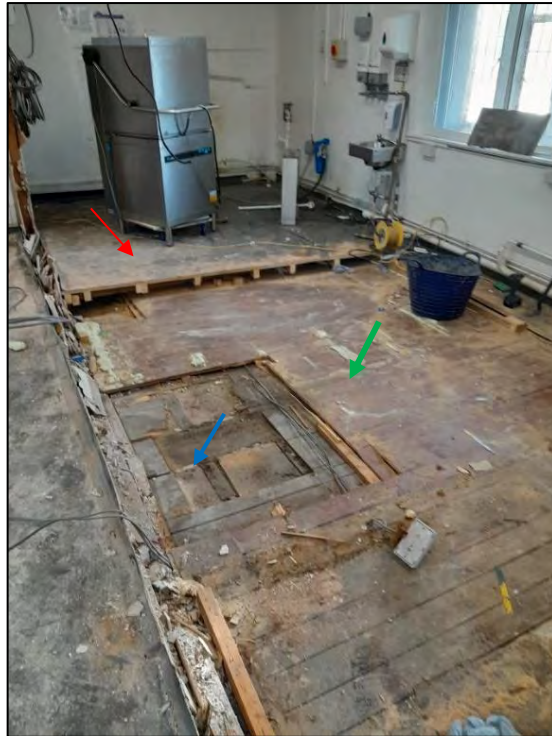
Photo 4 The floor surface during early uncovering (red arrow denotes plywood layer, green arrow the tongue and groove layer, and blue the wide oak boards)

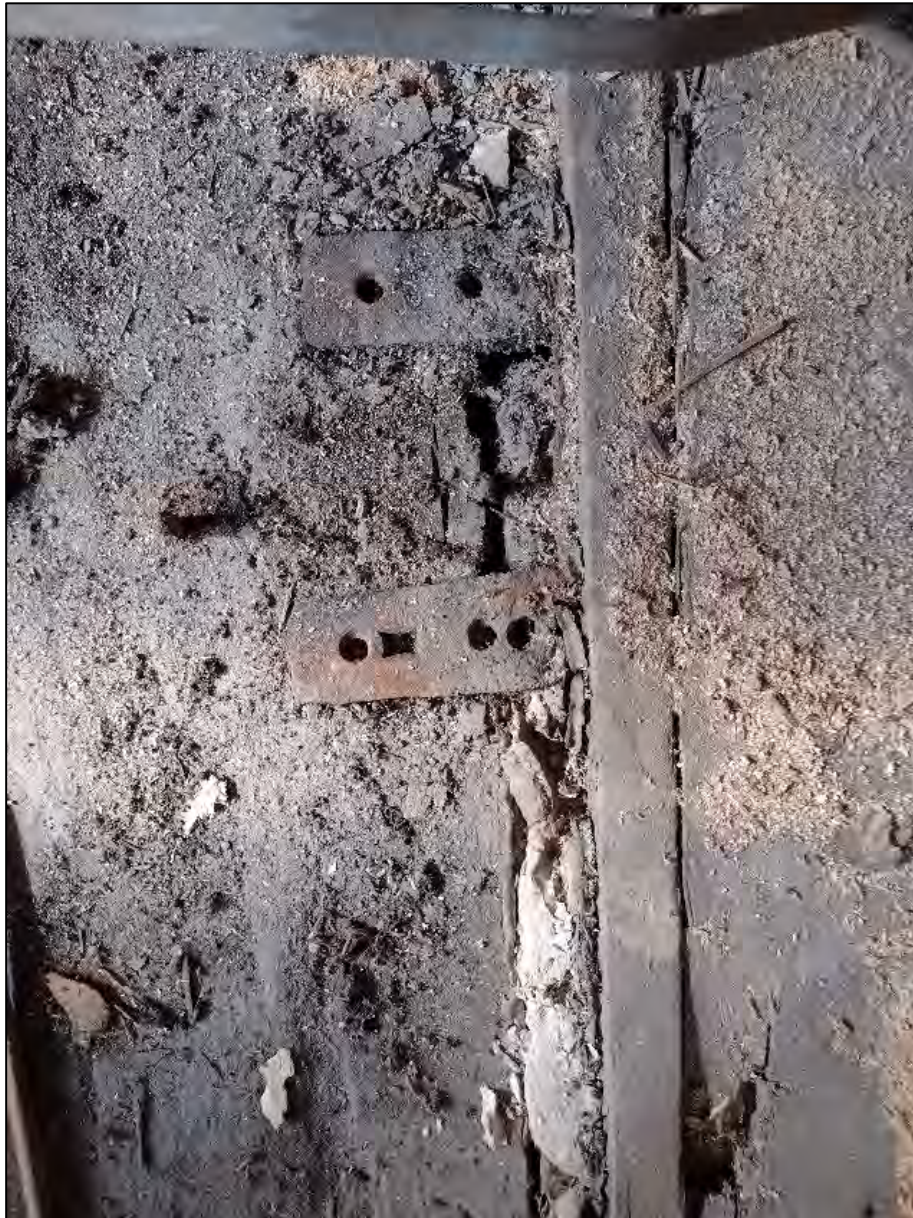
Photo 8 Evidence of previous structural additions, possibly joist brackets

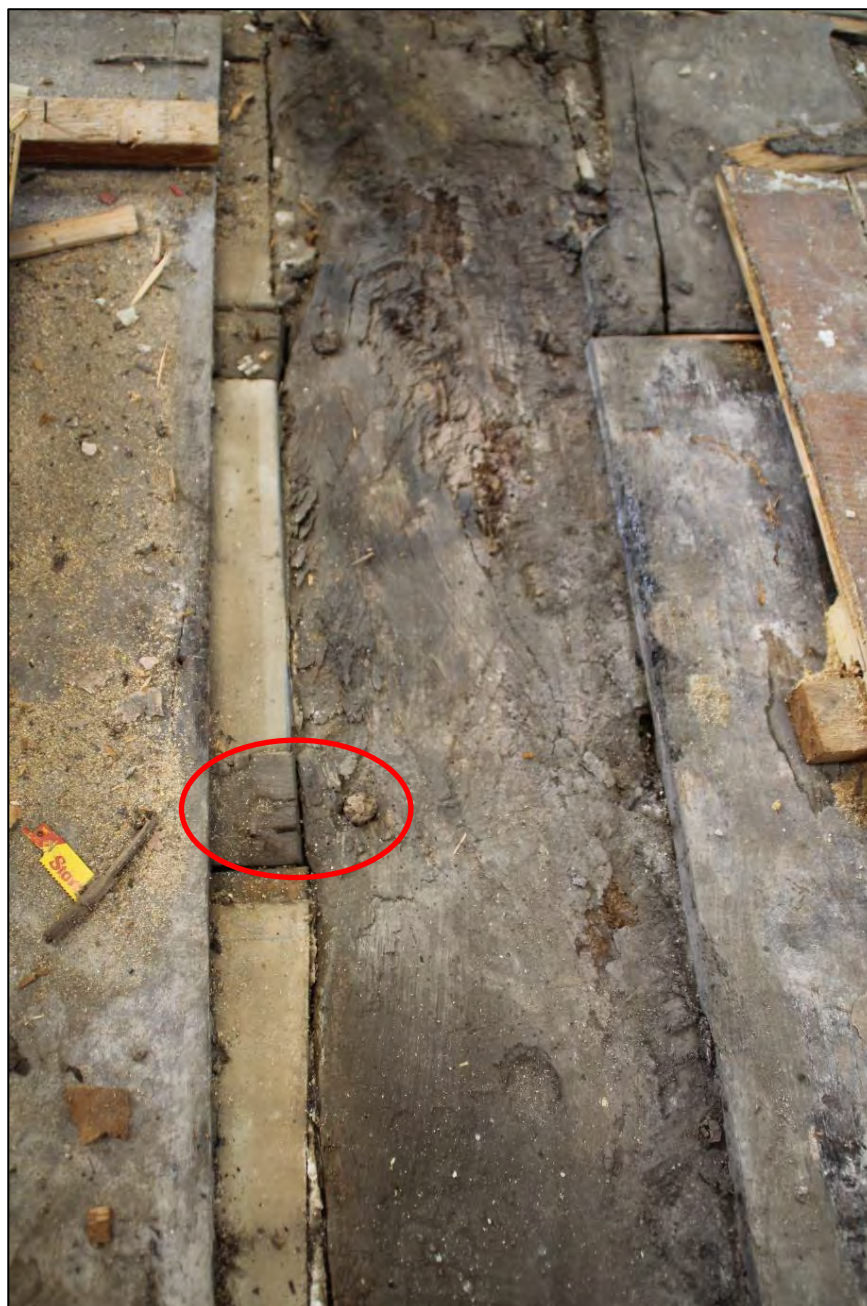
- 5.11. The ceiling joists were shown to be attached via a mortice and tenon joint evidenced by dowels at each junction of the joist (Photo 9). The historic joists are .06m x .19m deep and spaced at .40m widths. These were observed on the ground floor to be rough hand cut members and to have additional modern timbers bolted to the original joists within the central bay of the floor. The space between joists was observed to be infilled with a boarding identified by Mann Williams as hardboard, though it may be a more fibrous material, which is painted but exposed on the ground floor.

Photo 9 View of one of the beams with areas of aging, dowels to joists (circled) and boarding between joists

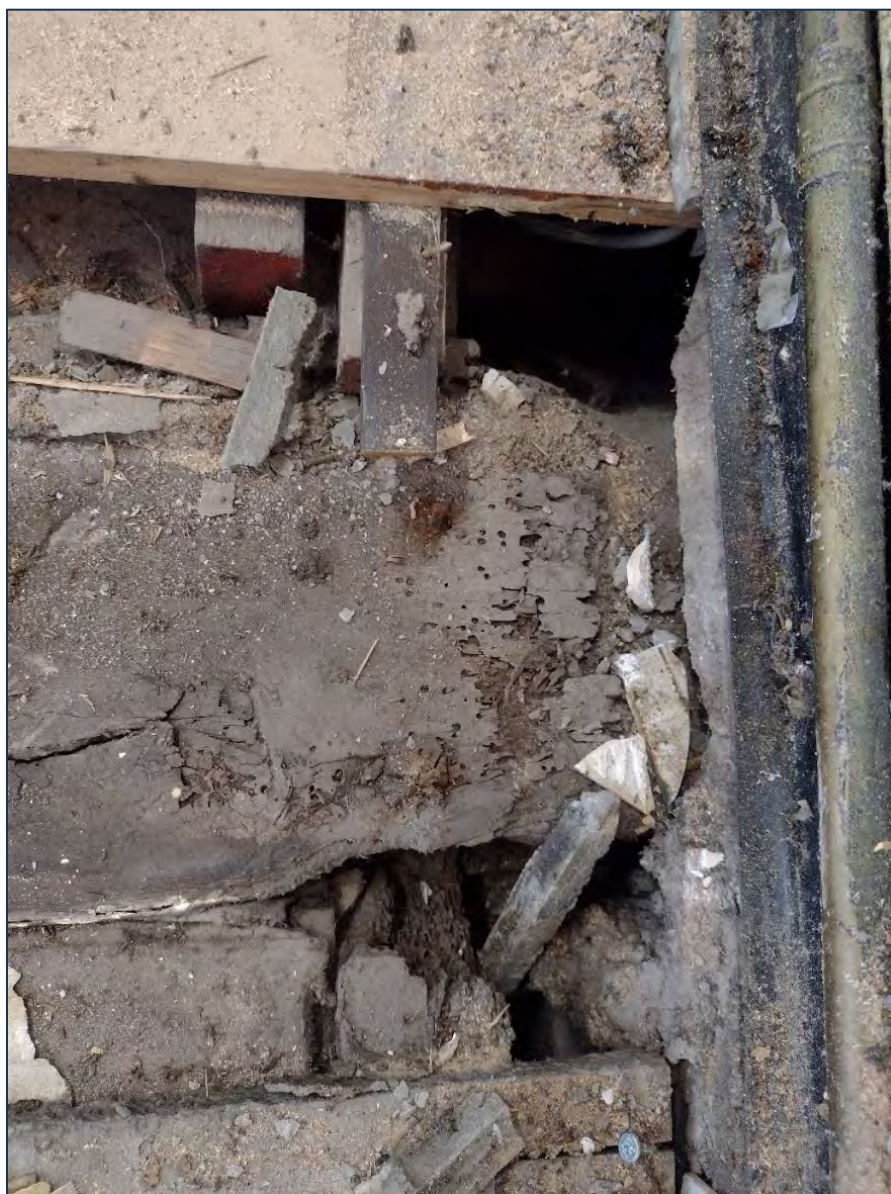
- 5.12. The south-western beam end was observed to quite substantially rotted and eroded (Photo 10) and barely resting on the wall plate if at all. The issue appears to be partially related to insect damage/rot which would indicate the presence of water ingress and damp at periods during the building's history.

Photo 10 Image of the rotted southern beam end of the western beam at the bearing of the wall plate

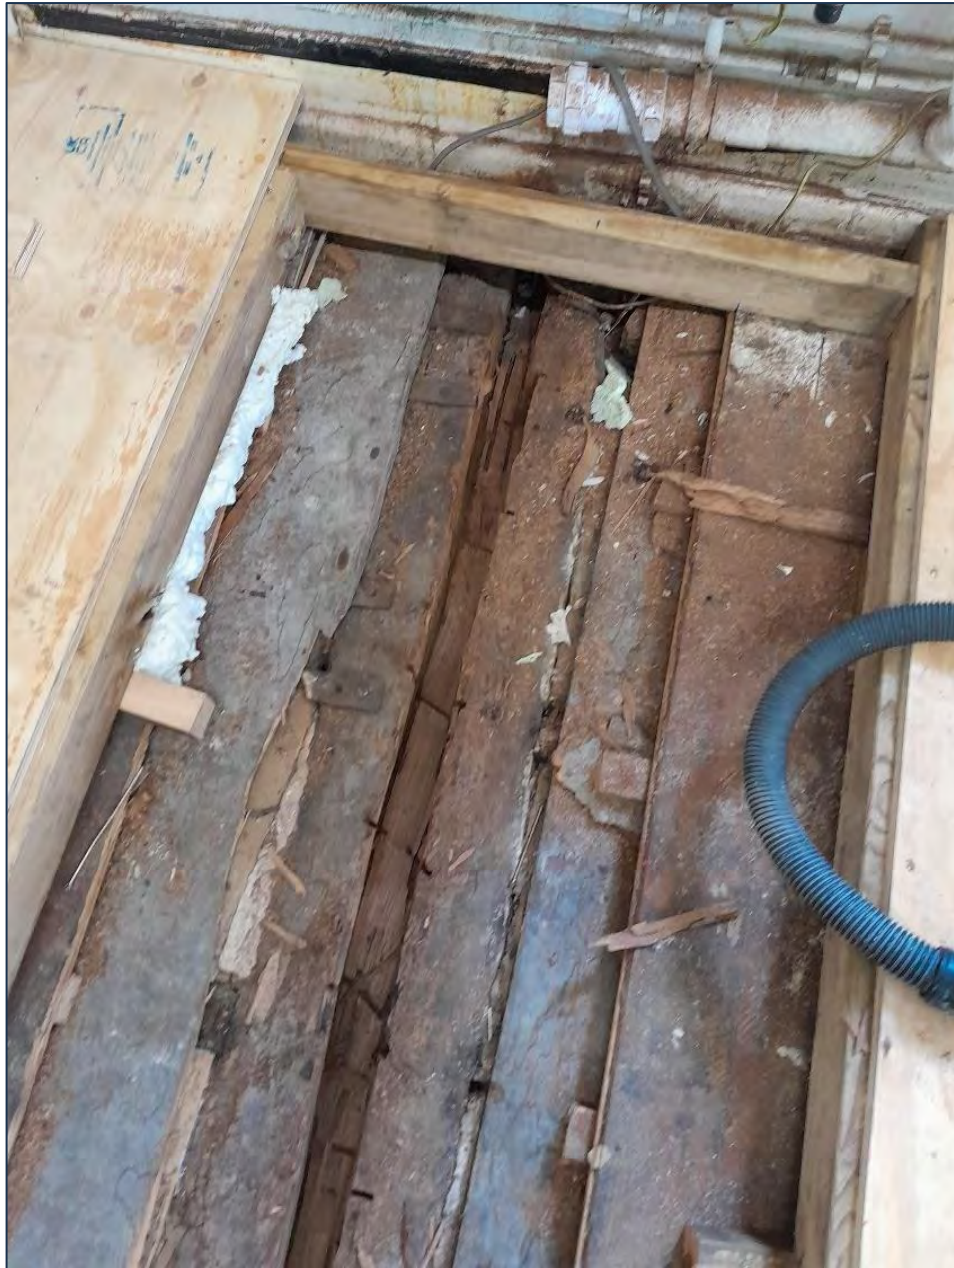
Photo 11 **View of the one of the beams with central valley ready to receive the T steel section**

- 5.13. Observations later in the remedial works illustrate the beams with a central notched valley having been cut to receive the leg of the T section of the proposed steel insertions. This confirmed the beam is of heart wood core construction which is evidenced by the lack of insect infestation or other types of deterioration associated with soft wood (Photo 11). Photo 12 illustrates both beams with the central valley have been cut out to receive the steel T section.

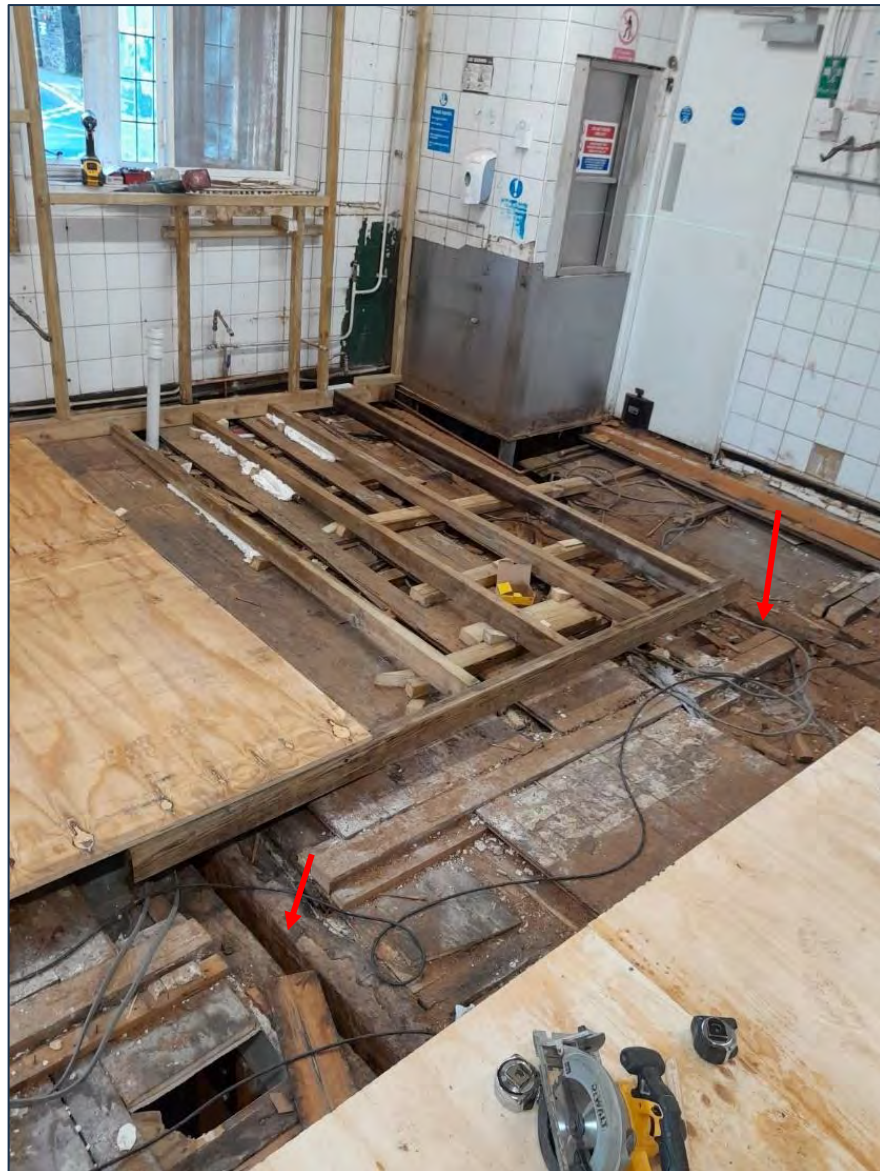
Photo 12 Both beams ready to receive the T steel section

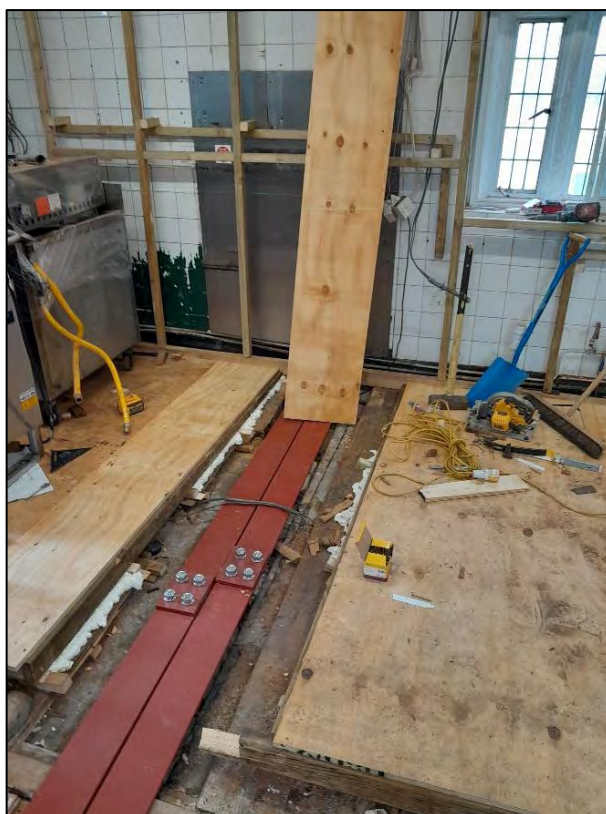
Photo 13 **The T steel installed in the western beam**

- 5.14. Photo 13 provides a view of the beam with the steel members having been installed. As detailed in the structural drawings in Appendix 1, the steel is supported on battens to the centre of the beam where the deflection is greatest. The T section is inserted a minimum of .06m into the core of the beam at the outer ends (Mann Williams structural drawings, Appendix 2), with a smaller length, c.02-3m inserted at the centre where the bowing occurs. The joists are stabilised by the insertion of steel plates at angles to the T section and secured into the joists; again where deflection is greatest the plates sit on packing pieces to maintain an even surface to the centre of the floor (Photo 14).

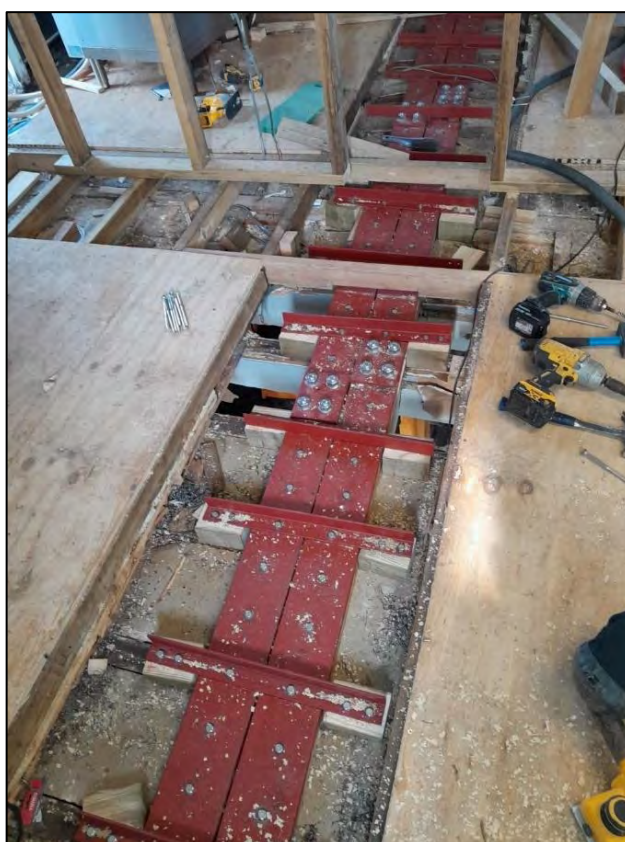
Photo 14 **The western beam with T steel and joist plates inserted**

-
- 5.15. As also seen in Photo 14, the floor surrounding the beams is being re-laid with historic fabric *in situ* and ply over as per the recent arrangement. The stud wall is being recreated centrally within the room to allow the reintroduction of the kitchen plan and equipment.

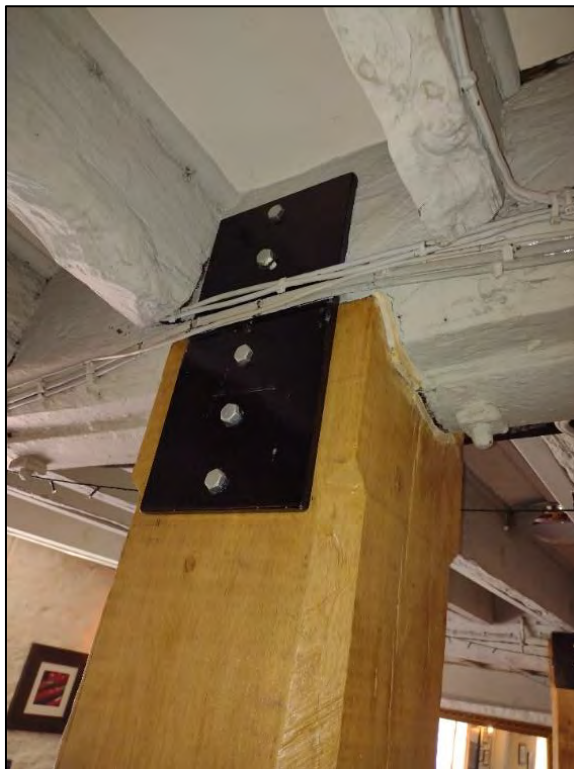
Photo 15 The interface of the to-be-removed pier and steel plate to the underside of the eastern primary beam on the ground floor

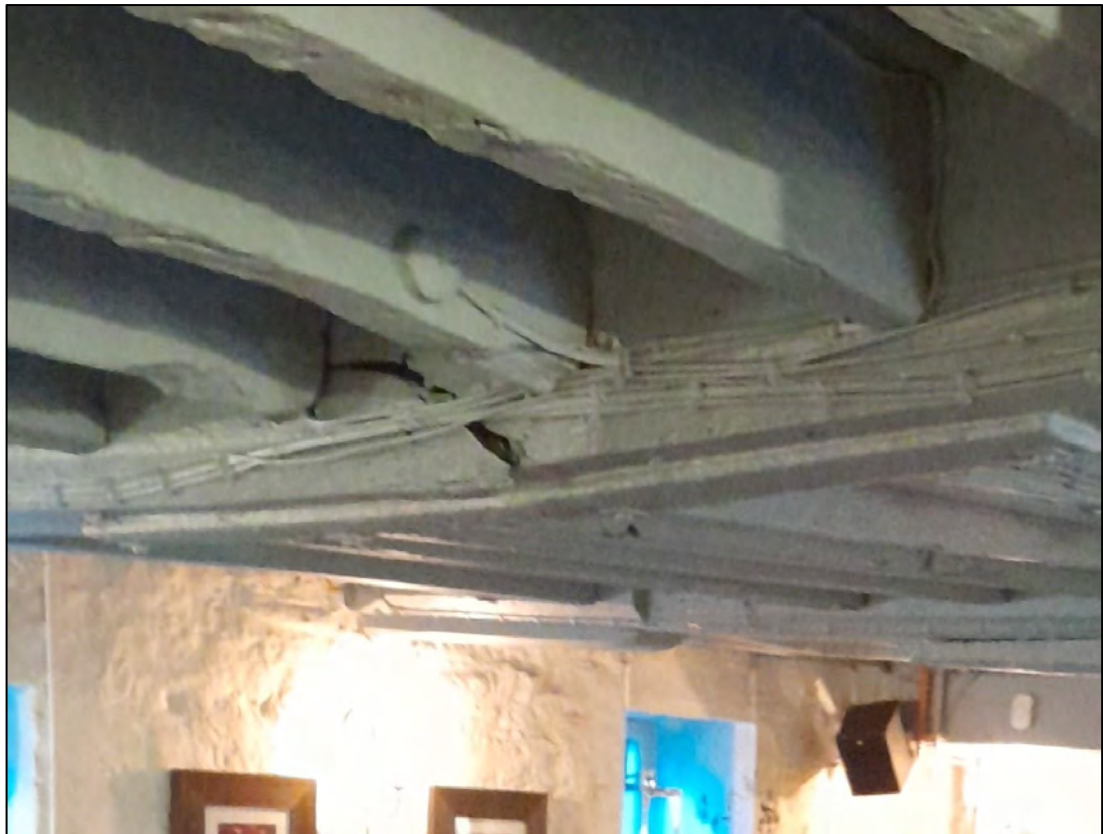
- 5.17. The eastern side of the eastern timber beam had a large crack present in the central joist bay which had been previously covered by the steel plate from the 2016 works (Photo 16). The bolted iron strap below it evidences that this is an historic crack but that it no doubt played a part in the deflection of the beam by providing an area of weakness, albeit supported, probably insufficiently by the iron strap.

Photo 16 **The eastern side of the beam with eastern pier removed**

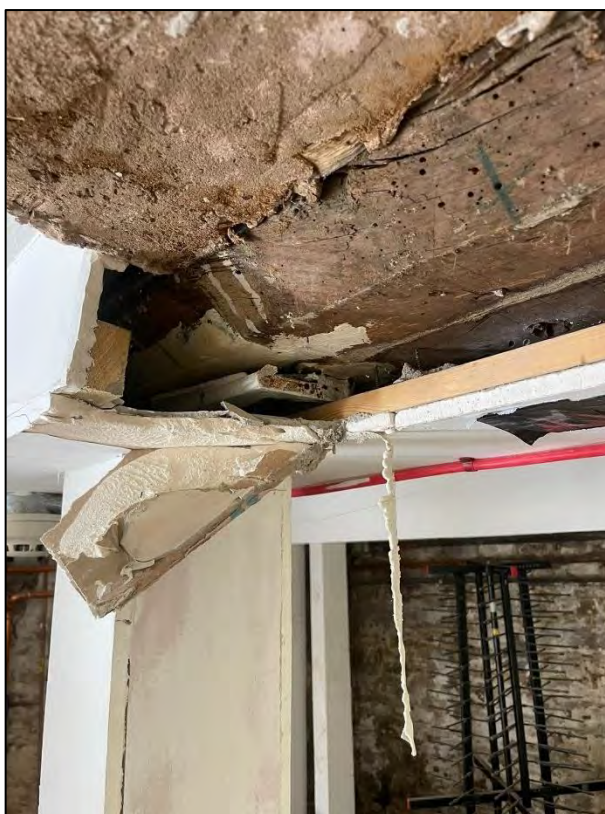
commensurate with those seen at first floor level and is therefore highly likely to be original building fabric. In the section that was exposed there was evidence of beetle infestation and nail holes from previous works.

Photo 19 **Detail of the western beam uncovered**

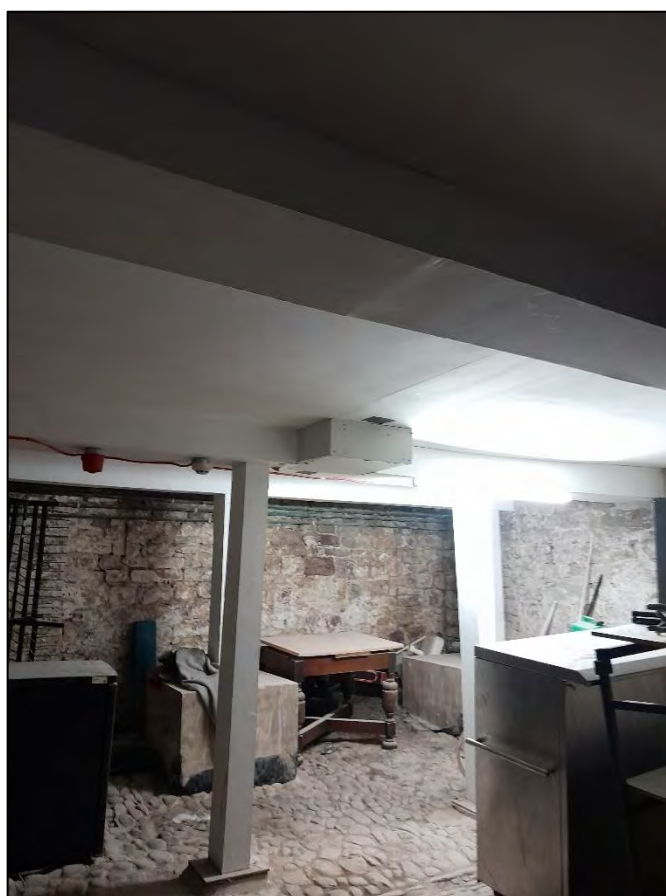
Photo 21 **The basement level with piers removed**

5.20. The areas of removal were made good as seen in Photo 21.
